Property Inspection Report

20115 Twilight Canyon Rd, Katy, TX 77449

Date of Inspection: 6/21/2018 Time: 1500

Inspector: Robert M Saji
License #10287

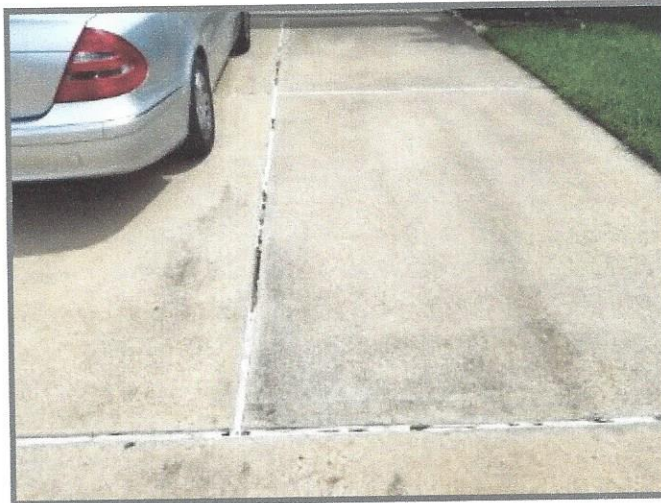
Comments: The foundation IS performing as intended in my opinion..... (At this time, the foundation appears to be supporting the structure and immediate significant repairs are not evident) , Minimal / No signs of foundation settlement were noted or found., No deficiencies were observed at the visible portions of the foundation perimeter., An average of 6 - 8 inch exposed foundation walls were noted or observed., Driveway in good shape for age and wear. No deficiencies found., Minimal damage / deterioration were noted present at the wooden expansion joints between various driveway or walkway sections. Recommend proper repairs or sealing all areas as needed to prevent issues or separation.

OK!
recaulking

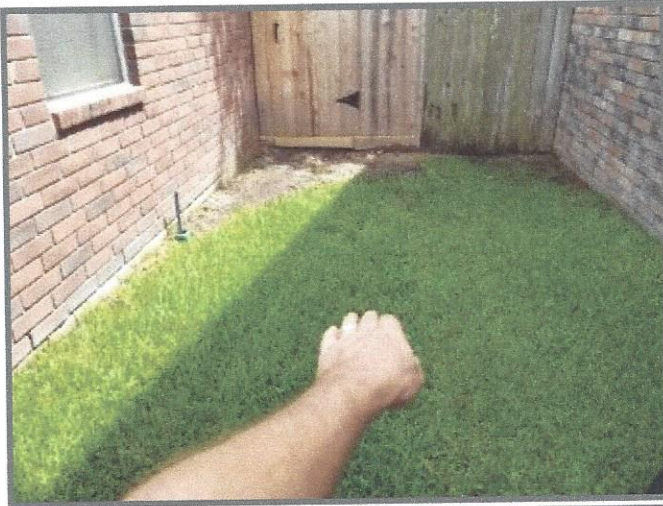
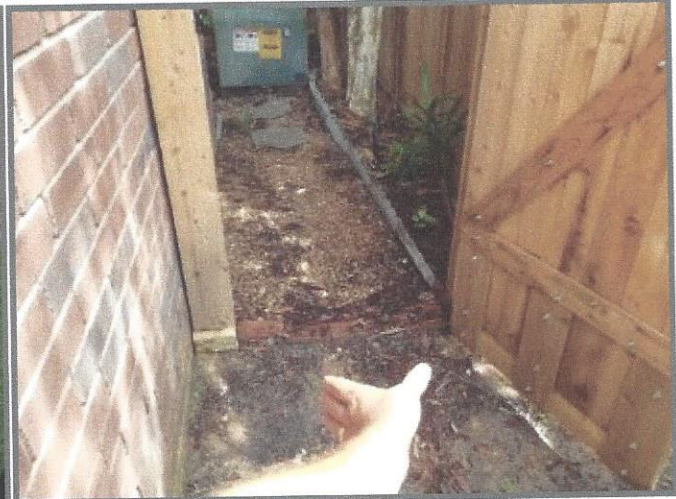
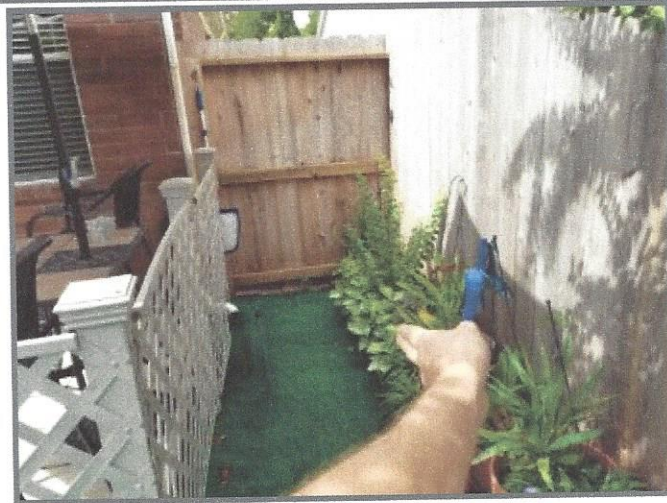
Comments: Lot grading and drainage have a significant impact on the building, simply because of the direct and indirect damage that moisture can have on the foundation. It is very important, therefore, that surface runoff water be adequately diverted away from the home. Lot grading should slope away and fall a minimum of one (6) inches within ten (10) feet of the home or building., Low and settled grading was observed along the PERIMETER of the home near the gate. This is typically the cause of no gutters at the eaves of the home resulting in soil erosion and uneven areas., Low / Uneven areas were noted present at the RIGHT of the home. Although minor recommend properly sloping all areas as needed to prevent issues of standing water. A 6 inch slope is required within 10 feet of the home., Highly recommend removing the garden / raised flowerbed at the back left of the home. Present location prevents water drainage as needed to prevent issues or standing water.

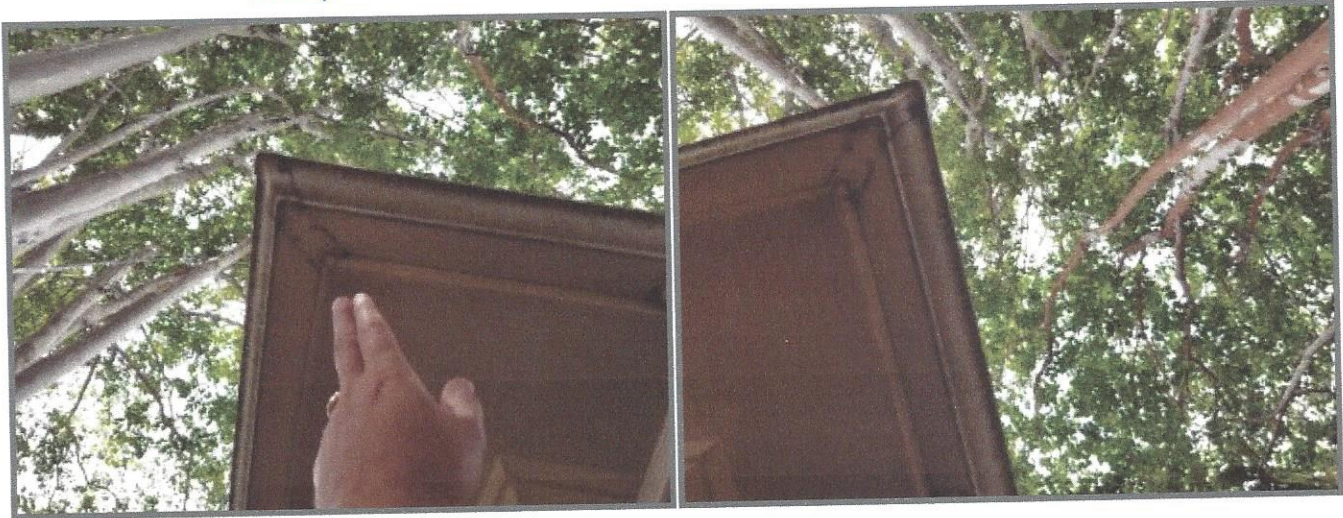
- No major system safety or function concerns noted at time of inspection.
- The roof covering for the home is functioning as intended with signs of typical wear / age.
- All flashing appeared to be in good functioning condition.
- Maintenance Tip: Keep gutters cleared of pine needles to prevent downspouts from being clogged and overflow at gutters.
- Leaking / Unsealed gutter sections were noted present at the FRONT area of the eave. Although minor some sealing will likely be needed. (mainly front of the home)

OK!
cleaned
repainted

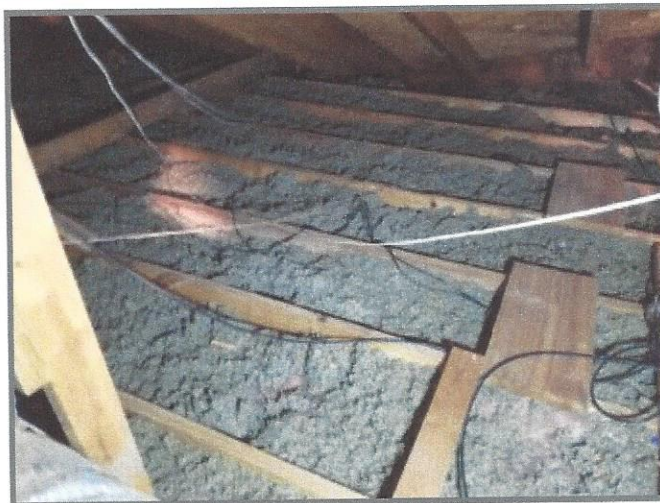
- The ventilation for the attic area appeared to be adequate. A combination of ridge vents, turbines, fans, or other approved method has been utilized.
- The attic area for the home is functioning as intended with all required structural supports present.
- A pull down ladder was noted present and in good functioning condition.
- Minimal insulation was noted present in the attic area. Recommend installing 12 + inches or as needed to prevent energy loss and achieve wanted efficiency.

Add!

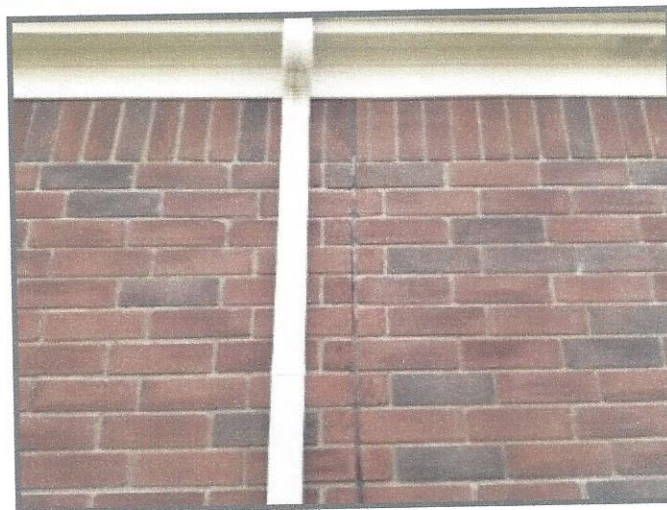
- All interior walls appear to be in satisfactory condition.
- All paint areas appeared to be in good functioning condition.
- Seal deterioration / Unsealed areas were noted present at the siding / trim intersection and expansion joints. Recommend proper updates or sealing all areas as needed to prevent issues or water intrusion and further deterioration.

OK!
recaulking

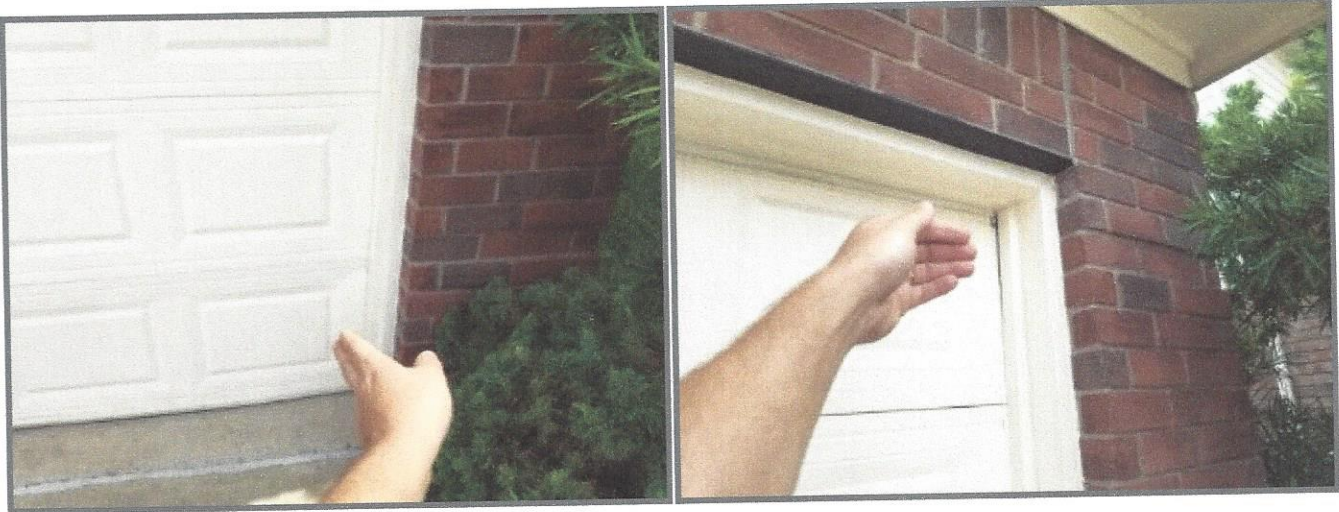
- Some of the interior / exterior doors are not functioning as intended. Some repairs / adjustment will likely be needed to prevent issues or damage to walls.
- The hardware was noted damaged / inoperable for the following doors. Some repairs / updates may be needed:

GARAGE ENTRY DOOR

- The following doors were noted sticking / rubbing or not properly functioning. Although minor some repairs or adjustment will likely be needed:

BACK DOOR ... RUBBING AT THE BOTTOM

OK!

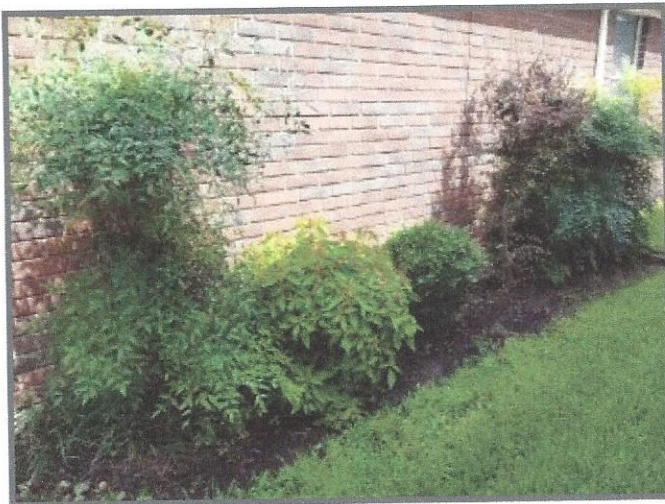
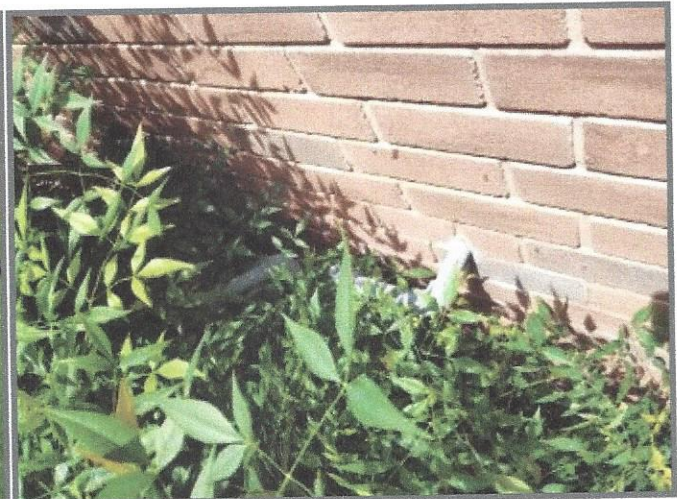
- Many large tree limbs were noted overhanging the home and its rooftop OR in close proximity. Some trees were also noted in close proximity to the home. Recommend properly cutting / removing all trees and limbs within 5 feet of the home or as needed to prevent issues or damage.

- Minimal signs of foliage was noted in close proximity to the home located on the FRONT of the home. Recommend properly removing all foliage away from the home or as needed to prevent issues or termite / vermin intrusion.

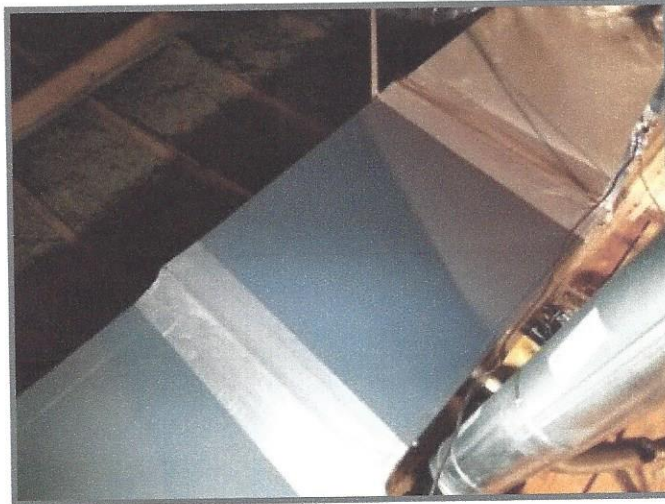
- The return and supply registers appear to be in good functioning condition.
- The air supply system for this homes appears to be functional with good workmanship found.
- Missing / No "pookie" or fiber paint were noted present at the plenum connections. Although no concerns were found recommend properly sealing all areas with this paint as needed to prevent issues or loose connections.

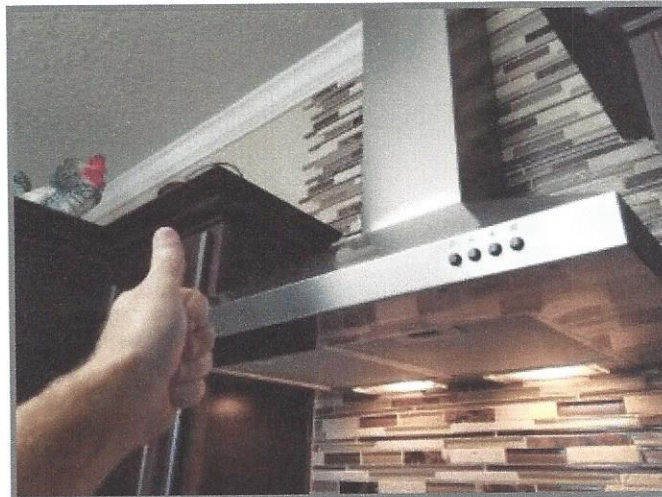
- The range / cooktop is operating as intended.
- Anti-tip bracket is missing from range installation. See label inside oven door. All free-standing, slide-in ranges include an anti-tip device and is essential in the safe operation of the range. It provides protection when excess force or weight is applied to an open oven door. Carried by home building centers.
