## PROPERTY INSPECTION REPORT

**Concerning:** 4547 Brinkley Street, Houston, TX, 77051  
(Address or Other Identification of Inspected Property)

**By:** Martin Lavergne TREC #8717 December 20, 2021  
(Name and License Number of Inspector) (Date)

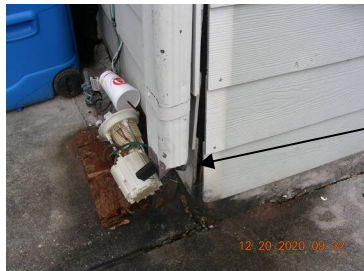
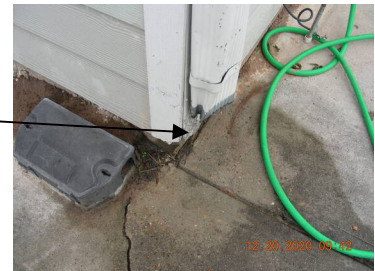
- The property shows no signs of ponding or negative slopes near the foundation in the front yard. The homeowner should continue to maintain adequate slab exposure (~3 – 6 inches) where plant bedding areas meet the house.
- The gutter downspouts terminate too close the exterior wall of the home in various locations. The end of the gutter downspouts should direct water away from the walls and terminate further from the foundation.

Examples of gutter downspouts that terminate too close to the wall and foundation

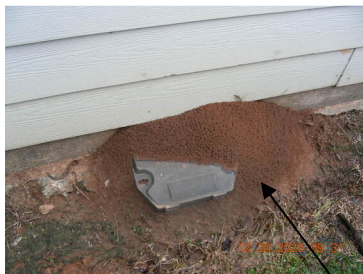
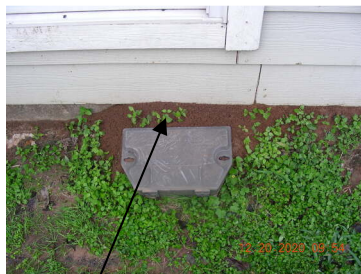
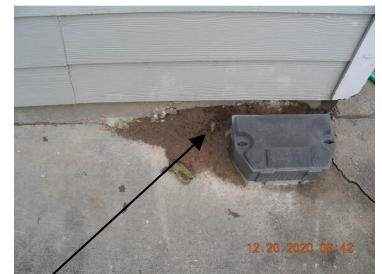
- There are active ant mounds and rodent traps at various locations around the exterior of the home. It is recommended that the ants get exterminated by a licensed pest control applicator so that they do not enter the structure of the home. Also, the rodent traps should be evaluated to ensure that they are still potent for rodent control, or be replaced if not. In addition, the homeowner should verify that the home has had the recommended wood destroying insect treatment prior to the start of the home's construction.

Examples of active ant mounds and rodent traps in various locations

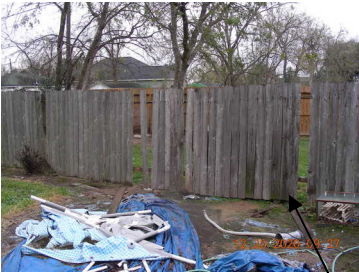
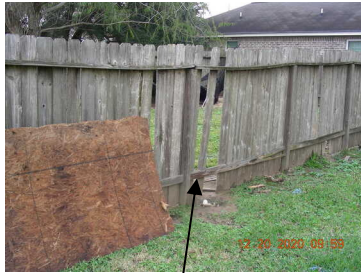
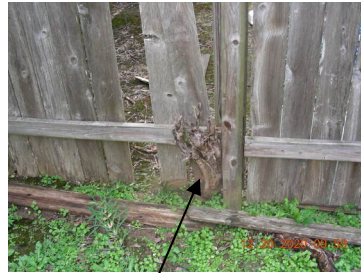
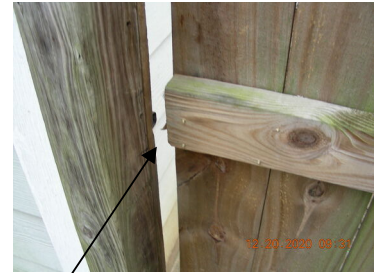
- There is some bare ground and holes in the side and back yards of the home that should be filled with soil and covered with grass sod to prevent any further erosion in the yard. In addition, there is debris in the backyards that should be removed. Also, the fence boards are damaged in various locations and are in need of repair. It should also be noted that the fence gates do not have latches allow the fence gates to be opened from inside the back yard, therefore, the fence gates should have latches installed that allow the gates to be opened from either side of the gate so that a person does not get trapped inside the back yard when the gate closes.

Examples of damaged fence boards and fence gate without latch on inside of gate

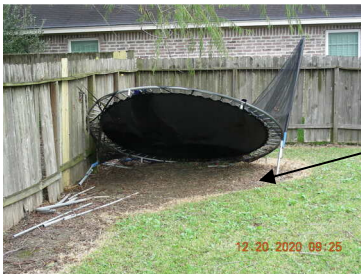
Examples of debris and bare earth in backyards

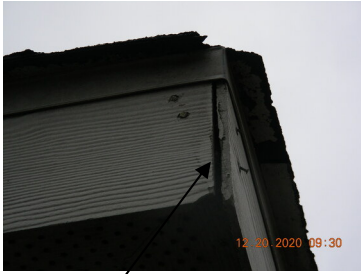
Example of damaged fascia board

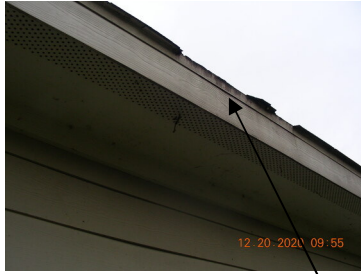
Examples of damaged shingles

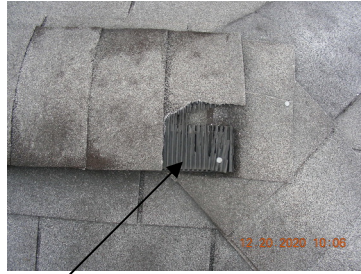
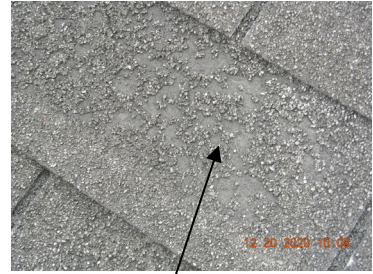
- The asphalt composition shingles appear to be performing as intended. However, the shingles appear to be reaching the end of their useful life, as the shingles are starting to delaminate (granules on shingle surface wash off) and deteriorate in various locations and there are damaged shingles that are in need of repair/replacement. In addition, there are raised roof jack flanges and exposed nail heads that should be repaired so that the roof jack flanges lie flat on the roof to prevent the flanges from being removed by wind lift and to prevent any water from penetrating beneath the shingles and nail heads. It is recommended that the roof get evaluated by a roofing specialist as it appears that the roof is in need of replacement.
- The PVC pipes extending through the roof jacks need to be painted to prevent any premature deterioration from the sun's ultraviolet rays.

Examples of delaminated shingles

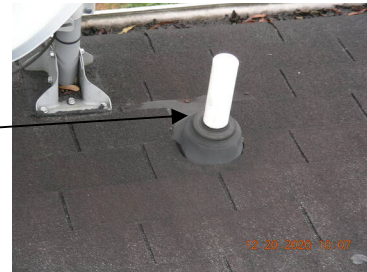
Example of PVC pipe in need of paint

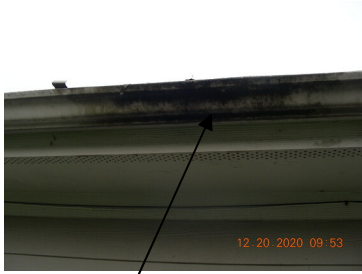
- Gutters are installed at the front and over the entryways of the home. The gutter brackets (used to fasten the gutters to the fascia boards) are starting to detach from the gutters in various locations and the gutters are filled with debris in various locations. The gutters should be repaired so that they do not fully detach from the fascia boards or leak and the gutters should be cleaned so that the gutters can handle the full capacity of water and not obstruct the flow of water through the gutters and gutter downspouts. In addition, the homeowner may want to install gutters along the sides and rear of the home. Gutters would help prevent splashing (which promotes algae growth and premature deterioration of the siding and trim around the windows and doors) and excess water buildup, erosion, and trenching near the foundation.

Example of sagging and leaking gutter and gutter holding water

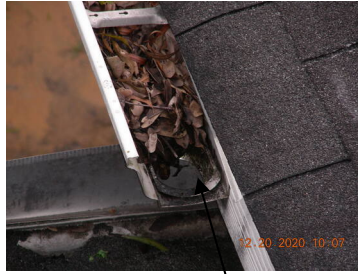
Example of damaged gutters and gutters filled with debris

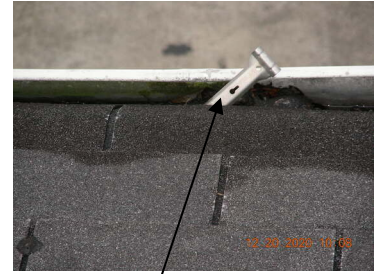
Example of detached gutter bracket

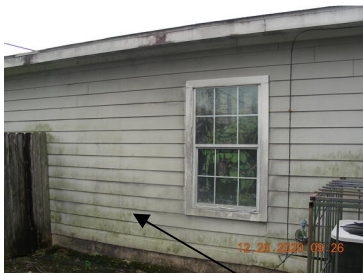
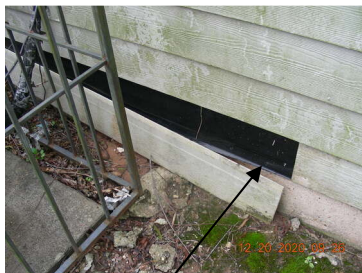
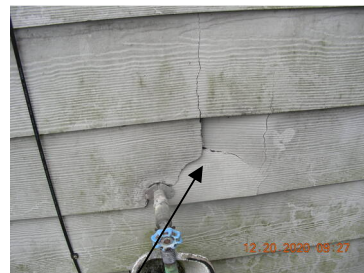
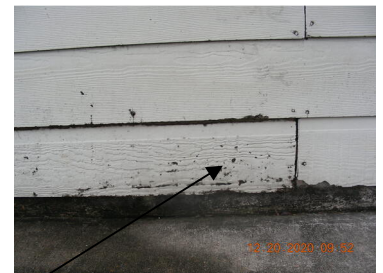
- The interior sheetrock walls are performing as intended. However, the interior walls have some blemishes/scuffs/minor damage in various locations that need repair and paint.
- The exterior cement fiber board siding walls are performing as intended; however, there is some damaged siding and trim in various locations that is in need of repair/replacement and paint. In addition, there are some areas that need sealant where pipes protrude through the walls to prevent any moisture or pest intrusions into the home. Also, there is some algae growth in various locations that should be cleaned off.

Examples of exterior wall areas that need repair, sealant, cleaning, and paint

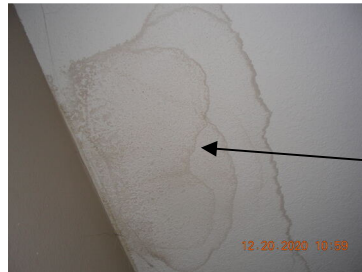
- The interior sheetrock ceilings are performing as intended throughout the house. However, there is a water stain in the utility room's ceiling in Unit B that appears to be related to a previous water leak from a busted pipe during the previous freeze in 2021, according to the tenant. The stained ceiling sheetrock is in need of repair.

Water stained ceiling in Unit B

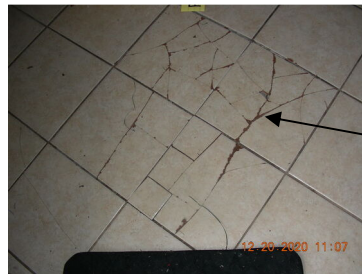
- The concrete subfloor is performing as intended throughout both units. The floors are covered with tile throughout both units, but there are some cracked and damaged tiles in both units that are in need of repair.

Example of cracked floor tiles in Unit B at front entryway

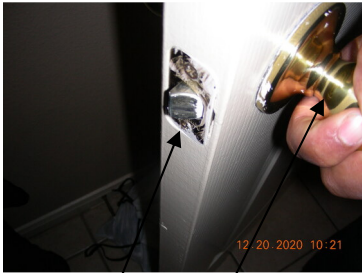
Laundry room door knob does not fully turn in unit B

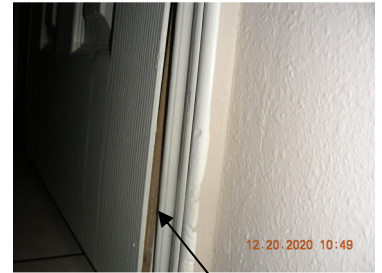
Damaged door skin on hallway door in unit B

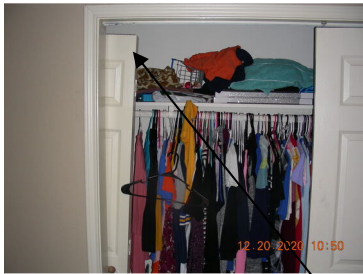
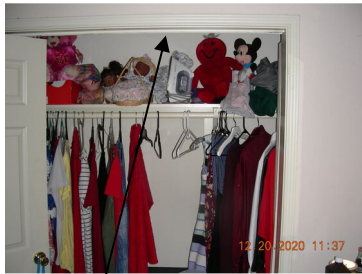
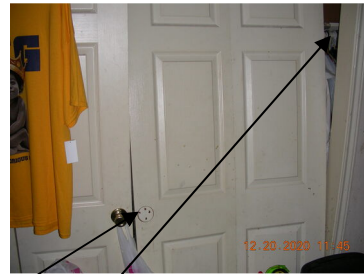
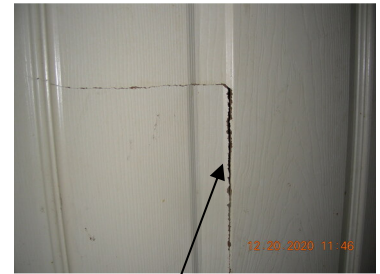
Examples of damaged closet doors in both units

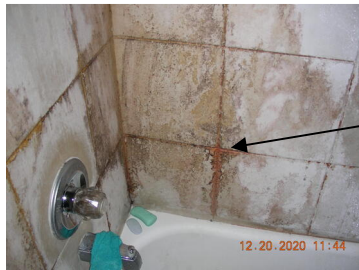
- The doors on the bathroom vanity in Unit A do not latch closed. The vanity doors are in need of repair so that they do not stay open. In addition, there is no laminate on the front or side edge of the vanity countertop in the Unit A guest bath. The laminate should be replaced to prevent the countertop wood from getting wet.
- The tile on the shower walls in the primary bath in Unit A is damaged on the surface and has some accumulated mildew growth. It is recommended that the mildew growth get cleaned off of the tile and grout and that the tile and grout get sealed to reduce the opportunity for further mildew growth. The homeowner may want to consider having the tile replaced to ensure that that there is no moisture accumulation and/or deterioration to the wall behind the tile.

Damaged tile and mildew growth on shower wall in unit A's primary bath

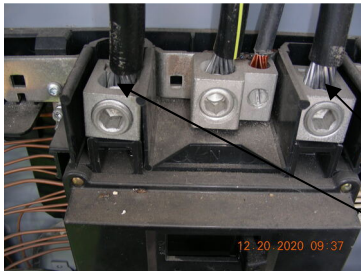
- The main aluminum power lines coming into the main panels need to have an anti oxidant coating to prevent the wires from corroding. Also, sealant is needed along the tops and sides of the exterior electric service panels.

Main aluminum power lines need antioxidant coating

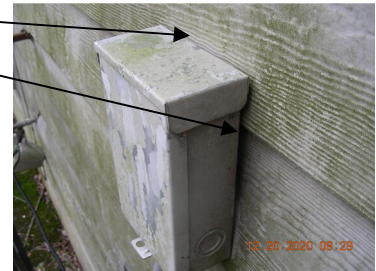
Sealant needed on top and sides of electric panels

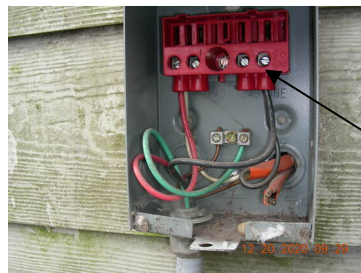
- The air conditioner power disconnect circuit at the rear of Unit A is directly wired to its panel. A service disconnect "pullout" should installed at this location so that the power to the air conditioner can be shutoff without disconnecting the wires so that the air conditioner can be safely serviced.

Unit A air conditioner circuit does not have a disconnect pullout

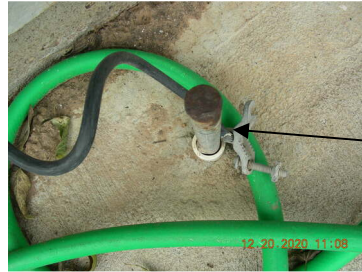
- The ground wire clamp for Unit A is not attached to its ground rod. The ground wire clamp should be securely attached to its ground rod so that the home's electrical system is safely grounded.

Ground wire clamp not attached to ground rod

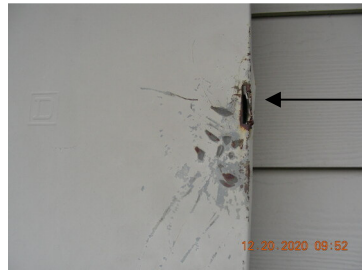
- The latch on the cover on the main panel for Unit B is damaged and in need of repair.

Damaged latch on unit B main electric panel

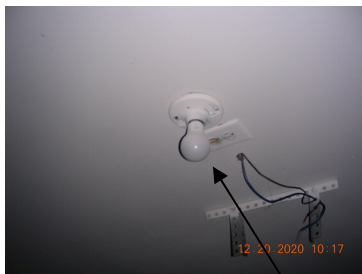
- The kitchen, bathrooms, garage, and exterior outlets at the front entryways are GFCI protected, but not all are labeled as such, as they should. The rear outlets near the air conditioner units are not GFCI protected, as they should be. These unprotected outlets should be repaired by a licensed electrician to ensure that they offer the proper GFCI protection. Ground Fault Circuit Interrupter outlets are needed to prevent electrical shocks and shorts where outlets are located in wet locations.
- The exposed light bulbs in both garages and in Unit A need protection around the light bulbs due to the increased risk that they can be broken in these locations.

Exposed light bulbs in garages need protection

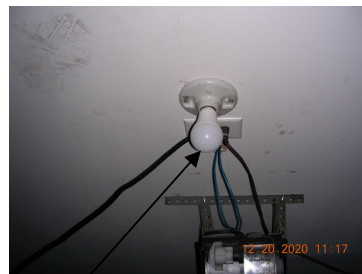
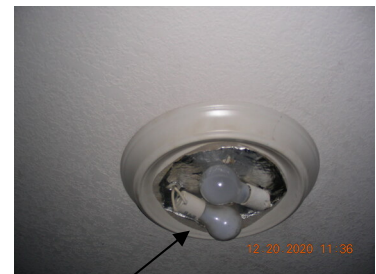
Missing globe on light fixture in unit A

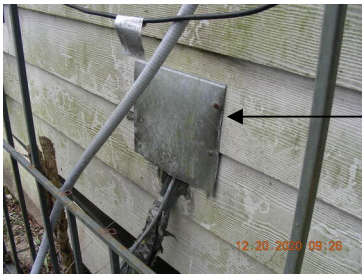
- Due to the outside temperature being below 60°F, neither of the air conditioner units could be run to verify their functionality and cooling efficiency. Running an air conditioner when the temperature is near or below 60 degrees can cause damage to the coils and/or condenser. It is recommended that the systems get serviced/repared now, and annually thereafter, as part of routine maintenance.
- For both units, hooded shields should be installed over the exterior wall locations where the air conditioner lines enter the home to further prevent any moisture penetration into the home. In addition, more insulation is needed on the exterior refrigerant lines for both A/C units. Also, there is some algae growth on each of the air conditioners' condenser pads that should removed.

Hooded shields needed over A/C lines

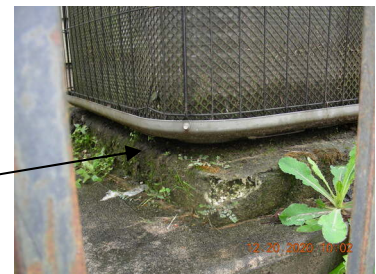
Algae growth on A/C condenser pads

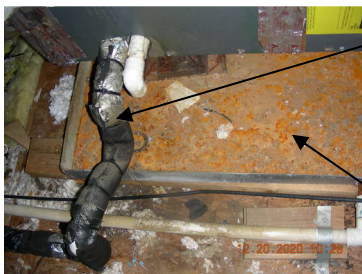
- It was noticed that the A/C refrigerant line at the condenser unit for Unit B was frosting up when the buyer, Aaron Lavergne, viewed the property on Tuesday, December 14, 2021. At this time, it was also noticed that there was no warm air being expelled from the fan of the condenser unit while the air conditioner was running. This is further evidence that the A/C unit for Unit B is in need of repair.
- There is some rust accumulation in both of the air conditioners' overflow drain pans (in the attic). The rust in the overflow drain pans appear to have been caused from condensation leaks through the evaporator boxes. It is recommended that both A/C units, particularly the evaporators, get evaluated and/or serviced and repaired by a qualified A/C technician. Also, the rusted drain pans should be treated with a rust inhibitor or get replaced.

No maintenance stem on unit B's primary condensate drain line

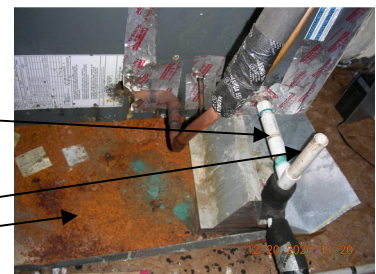
Rust accumulation in A/C drain pans

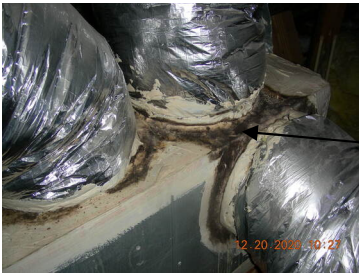
- There is some mildew staining on both of the air conditioners' air boxes in the attic. It appears that there may be some condensation forming on the outside of the supply air boxes. It is recommended that the A/C systems get serviced now to ensure that the units are optimally performing, and annually thereafter, as part of routine maintenance.

Mildew staining on A/C air boxes in attic on both units

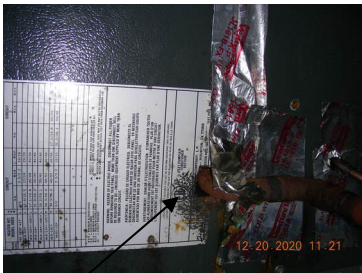
- The refrigerant line to the evaporator (in the attic) in Unit A is not sealed to its evaporator box. The evaporator line should be sealed to its evaporator box to prevent air from leaking out of the A/C system and into the attic. In addition, the low voltage wires (in the attic) on both of the A/C units are exposed and should be protected.

Refrigerant line is not sealed against evaporator box in unit A

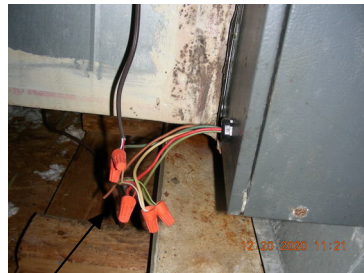
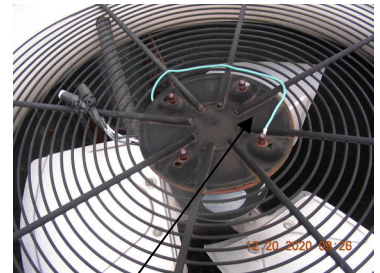
Exposed wire on Unit A condenser unit

- The serial number tag on Unit A's condenser unit has faded off so the manufacturer, age, and specifications for the unit could not be determined. However, it appears that the condenser unit for Unit A has had a previous repair, as evidenced by the exposed wires attached to the fan grill on this unit.

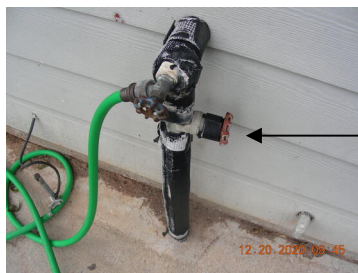
- The main water shutoff valve for Unit B is located on the front exterior garage wall. The homeowner should exercise the valve through the on/off position every so often so that the valve does not become stuck open. The water meter and main water shutoff valve for Unit A was not located. The seller should advise the buyer, Aaron Lavergne, to the location of the water meter and main water shutoff valve for Unit A.

Main water shutoff valve for Unit B

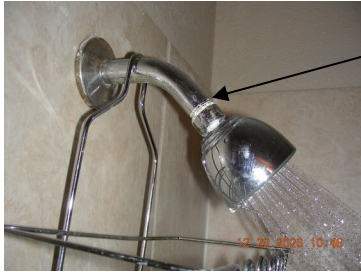
- The water pressure on the guest lavatory in Unit B is lower than expected. It appears that the lavatory is in need of repair/replacement.
- The showerhead in Unit B's guest bath leaks where the showerhead is attached to its water supply pipe. The leak is in need of repair. In addition,

Water leak on Unit B guest bath showerhead

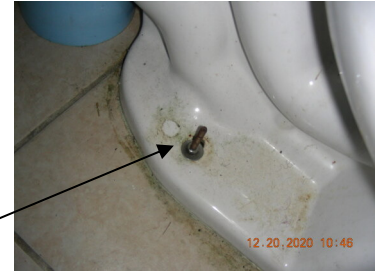
the toilet bolt caps are missing on the toilet in Unit B's guest bath. The toilet bolt caps should be replaced.

Missing toilet bolt caps on Unit B guest bath toilet

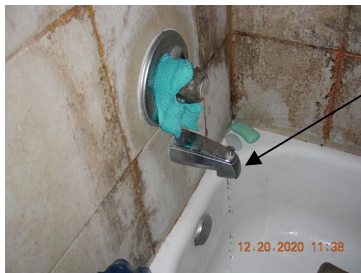
- The bathtub faucet handle in Unit A's primary bathroom leaks when the faucet is turned to the off position. In addition, this bathtub valve is installed in reverse and does not fully turn through its expected range; that is, the bathtub faucet has hot water output when it is first opened and cold water is selected and cold water output when turned as far left as it can go and hot water is selected. This bathtub faucet valve is in need of repair so that hot and cold water flow when the faucet handle/valve is turned to the respective positions.

Unit B primary bathtub faucet leaks when the handle is turned to the off position

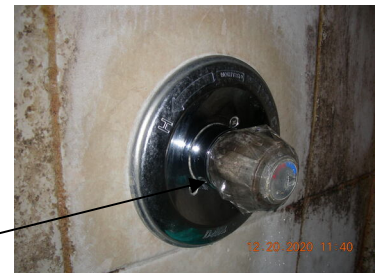
Unit B primary bathtub faucet handle has reversed water output when the respective temperatures are selected

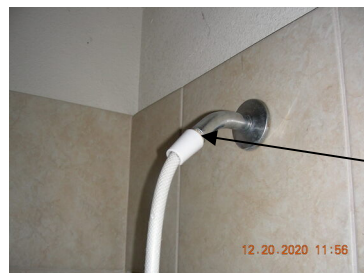
- The showerhead in Unit A's guest bath leaks where the showerhead is attached to its water supply pipe. The leak is in need of repair. In addition, the showerhead is damaged and in need of replacement.

Water leak on Unit A guest bath showerhead

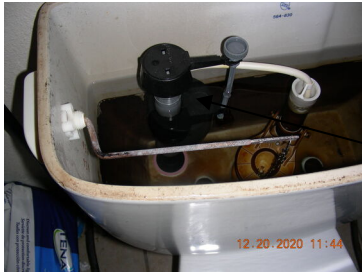
- Both of the toilets in Unit A continue to have water running after the toilet tanks fill with water after a flush. In addition, the toilets intermittently do not begin to fill after a flush. The fill valves on the toilets in Unit A's bathrooms are in need of repair/replacement.

Unit A toilet fill valves are in need of replacement

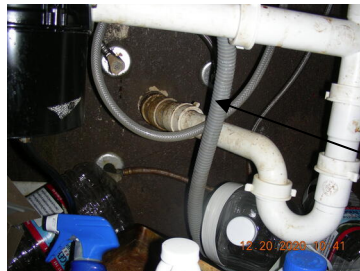
- The plumbing drain lines in both units function as intended. However, testing the clothes washer drain lines is beyond the scope of this inspection.
- The dishwasher drain line in Unit B should have an anti – siphon loop to prevent any backflow from the sink into the dishwasher.

Dishwasher drain line in Unit B should loop and enter the cabinet higher to prevent backflow from the sink drain line into the dishwasher

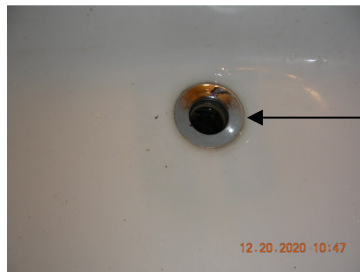
- The drain stops are missing in the bathroom lavatories in both units. The drain stops and the drain stop levers are in need of replacement in the bathrooms.

Example of missing drain stop on bathroom lavatory

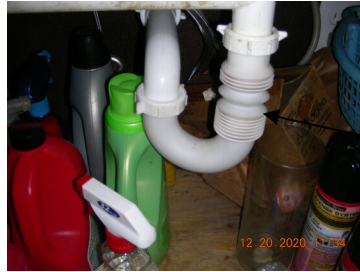
- The kitchen sink drain line in Unit A has corrugated pipe installed within the drain line. The corrugated pipe should be replaced with rigid, smooth wall drain pipe since the corrugated pipe tends to trap debris in the drain line a susceptible to create clogs in the drain line. It should be noted that the cabinet base under the kitchen sink in Unit A has been replaced previously after some water damage to the original cabinet base.

Corrugated pipe should not be permanently installed in the kitchen sink drain line in Unit A

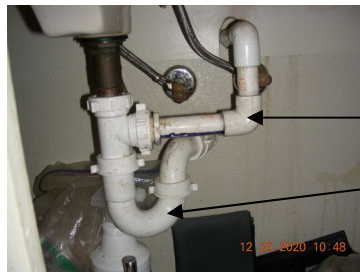
- The guest bathroom lavatory drain pipes in both units may have condensation forming where the air conditioner's primary condensate drain line is attached to the drain pipe. These drain pipes should be insulated to prevent condensation from forming around the pipes and dripping onto the cabinet base.

Example of drain pipes that may need to be insulated to prevent condensation from forming around drain pipes and dripping onto cabinet base

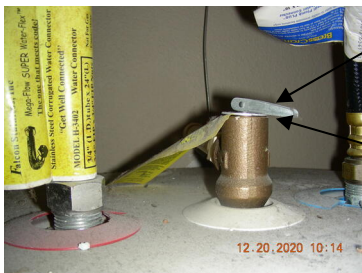
- Each unit has a 40 gallon electric water heater installed in the utility room of each unit. The water heaters function as intended.
- The temperature and pressure relief valves (TPRV) on both of the water heaters were found to be stuck closed. The TPRV's are in need of replacement/repair so that the valves can open and relieve pressure in the water heater's tank if the valve senses that the water heater's water temperature has gotten too hot or built up too much pressure in the tank. The water heater drain lines are located on the exterior front side garage walls. The homeowner should verify that the TPRV valves are not leaking by monitoring leaks at the temperature and pressure relief valve and drain pan drain lines.

Example of TPRV that is stuck closed

TPRV should be opened once a year, or so

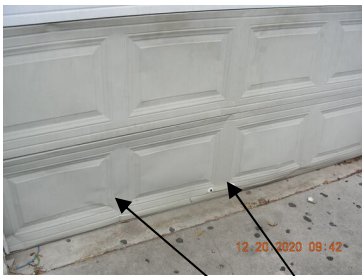
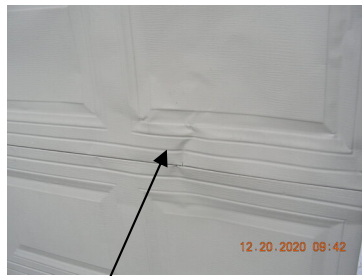
- The garage door operator in Unit A does not function. This garage door operator is in need of repair/replacement. The garage door operator in Unit B has been removed and is in need of replacement.
- Both garage doors are damaged and both garage doors guide wires have pulled off of the pulleys they should be on, so neither of the garage doors can be opened manually. Both of the garage doors' manual opening hardware is in need of repair so that the garage doors can be opened.

Damaged garage doors

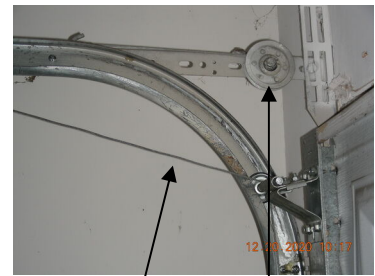
Example of garage door guide wire off of pulley prevents the garage door from opening
