## PROPERTY INSPECTION REPORT

Concerning: 2207 Bernardo De Galvez Avenue, Galveston, TX 77550  
(Address or Other Identification of Inspected Property)

By: Danny Marlow Lic.#: 23187 03/25/2021  
(Name and License Number of Inspector) (Date)

**Inspection No. 521350-643**

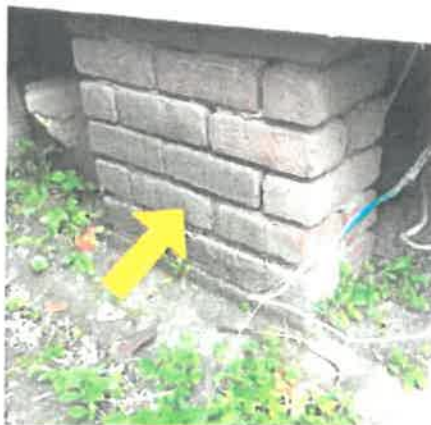
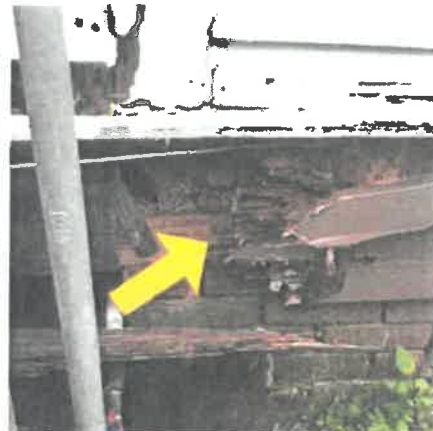
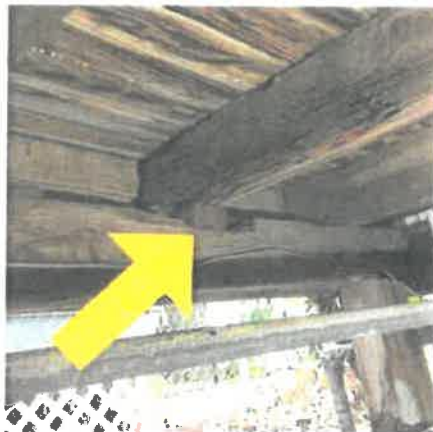
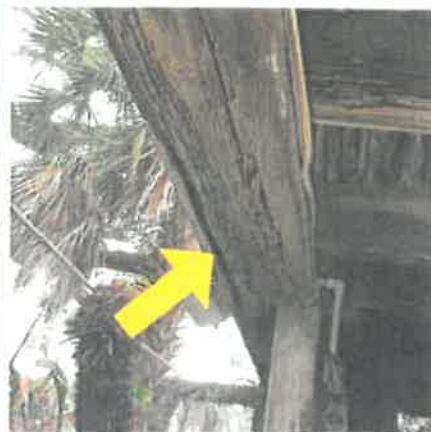
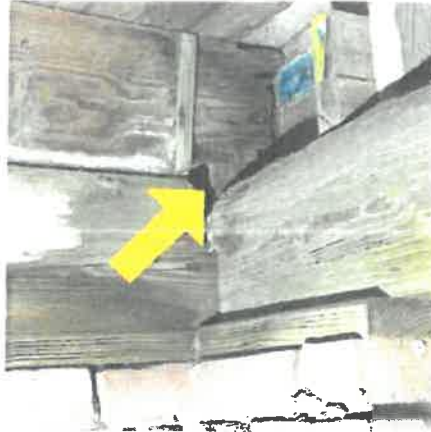
- Foundation is pier & beam and was performing as designed at time of inspection.
- There were various pilings where mortar was noted as being deteriorated/missing. Recommend having qualified contractor evaluate and repair as needed to prevent further deterioration and damages.
- There was wood rot/deterioration noted at various support beams under home. Recommend having qualified contractor evaluate the extent of damage and repair as needed to prevent further deterioration and damages.

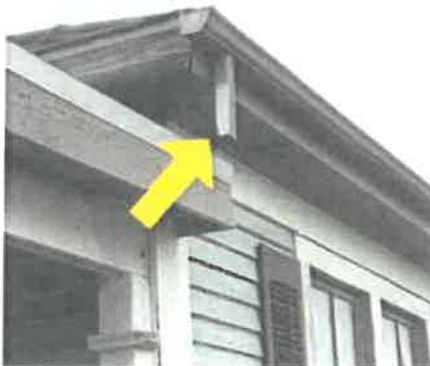
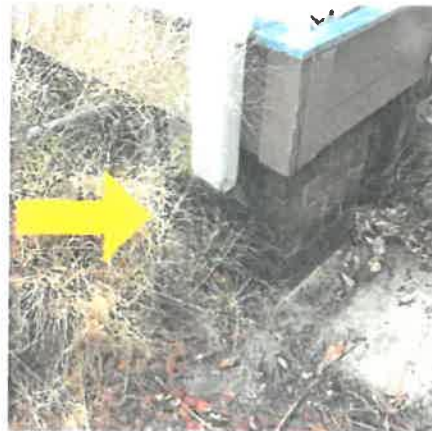
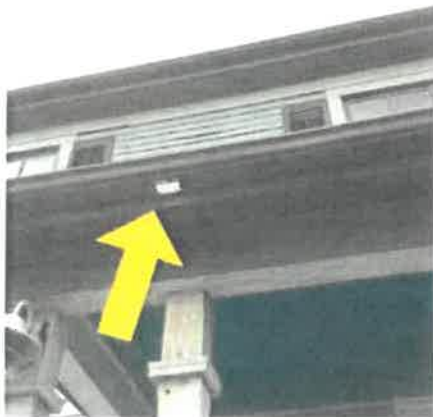
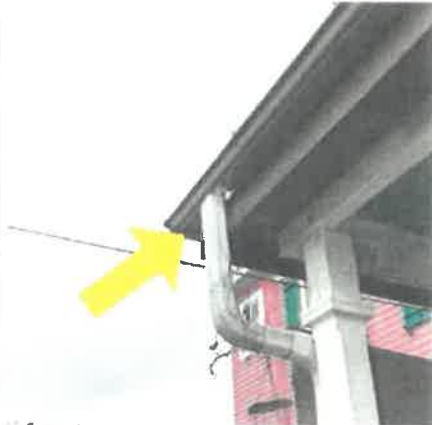
- There were miscellaneous areas where downspouts were noted as being damaged or missing. Recommend repairs for proper drainage.
- Downspouts improperly discharging water against foundation. Redirect and extend all downspouts away from foundation.

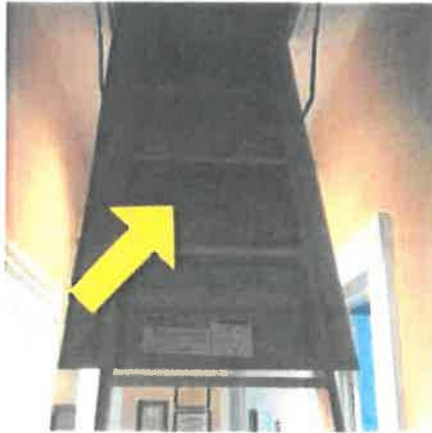
- Attic spaces were observed from the attic access/work platform. Some areas are not visible from this vantage point and were not inspected.
- Insulation was approximately 8" inches thick at time of inspection (vermiculite & radiant barrier).
- Insulate pull down stairway door to promote insulation barrier to reduce moisture/condensation related damages and promote energy efficiency.

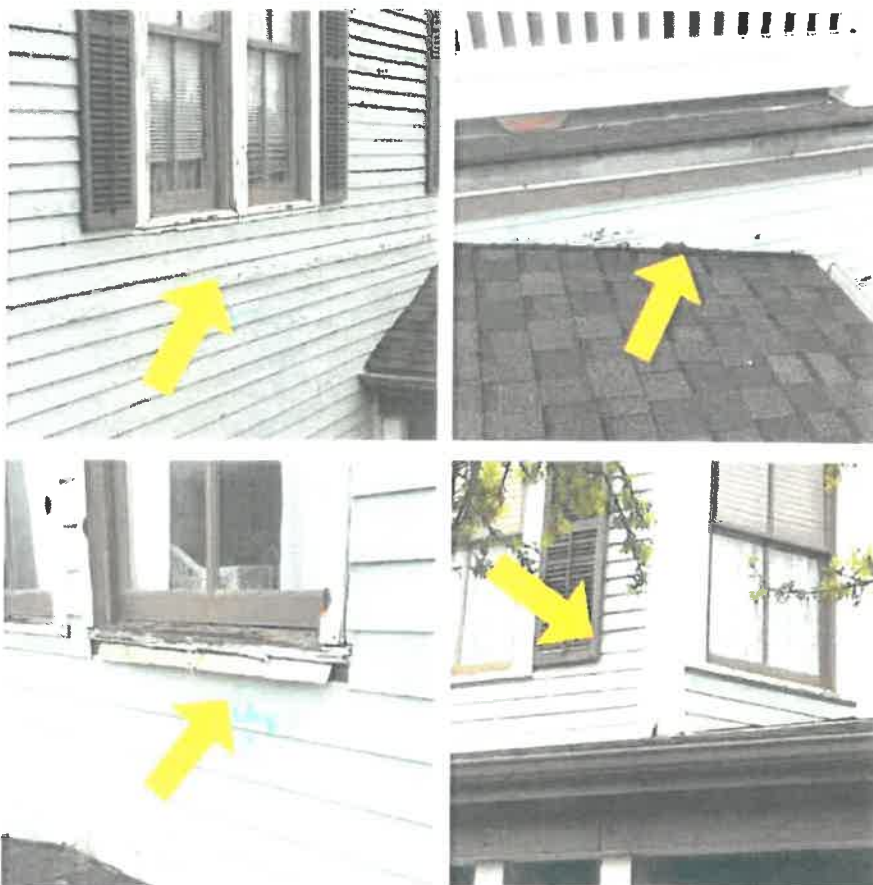
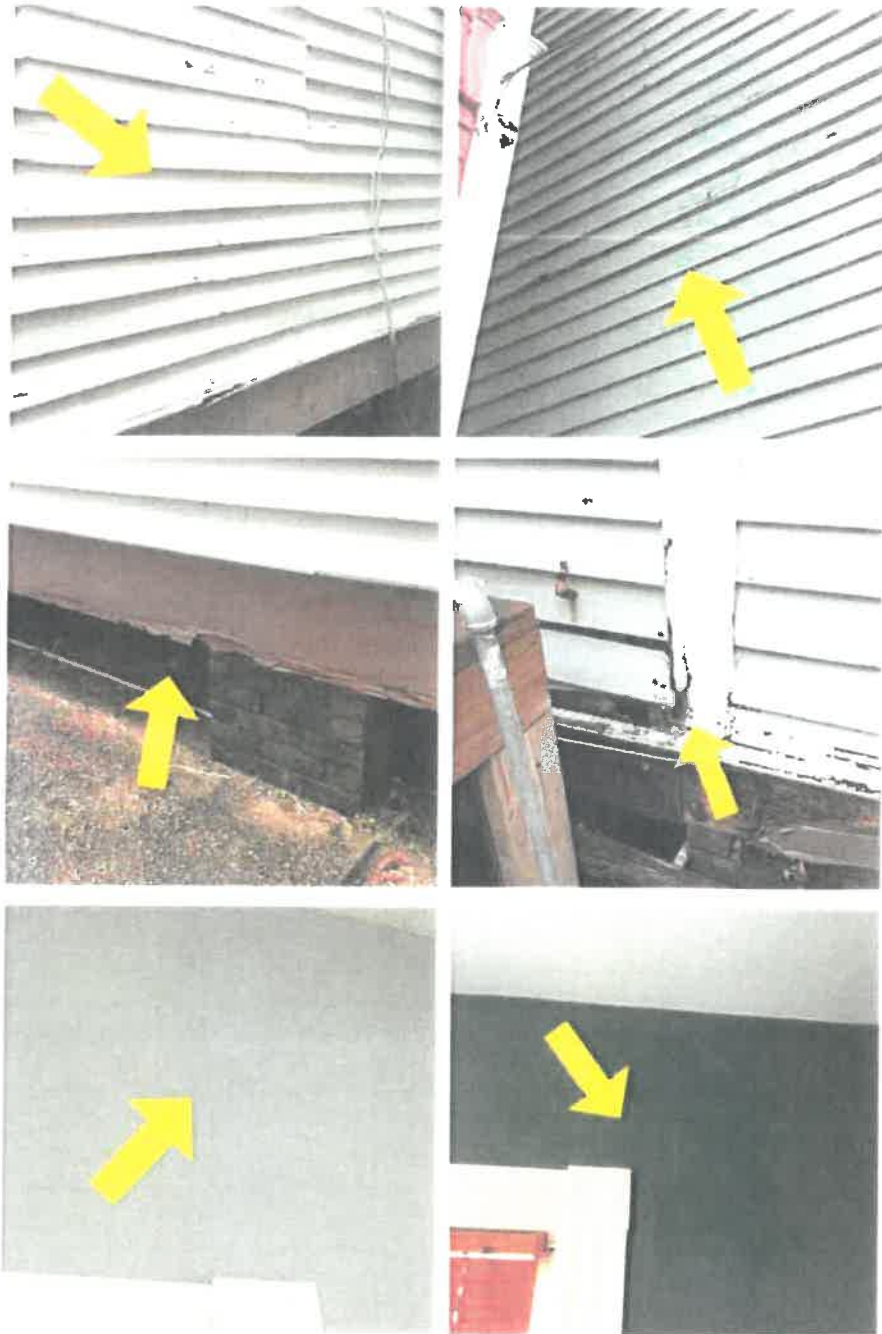
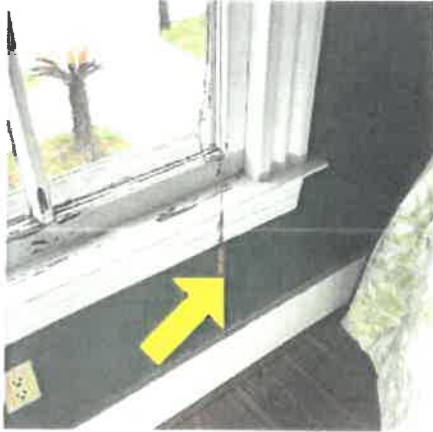
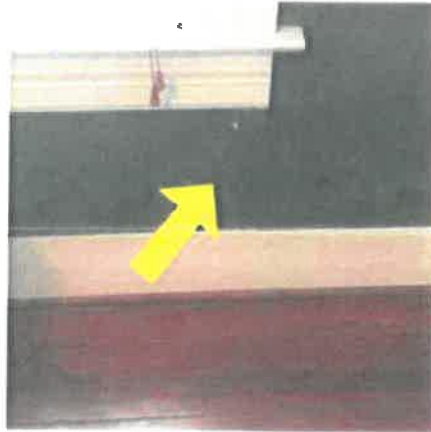
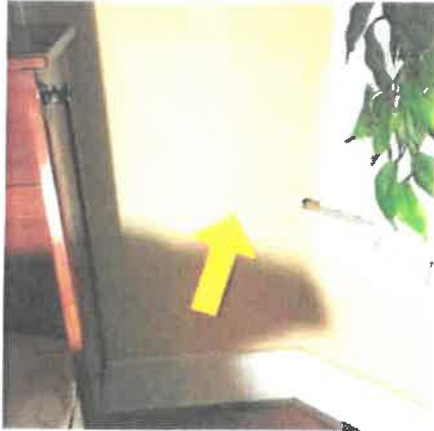
- Wood siding with wood trim (exterior). Drywall with wood trim (Interior).
- There was moderate to heavy wood rot/deterioration noted at multiple areas of siding. Recommend having qualified contractor evaluate the extent of damage and repair as needed to prevent further deterioration and damages.
- There were miscellaneous stress cracks noted at walls (typically associated with settlement).
- There were possible moisture related damages noted at wall under window in front bedroom (possible previous window leak).

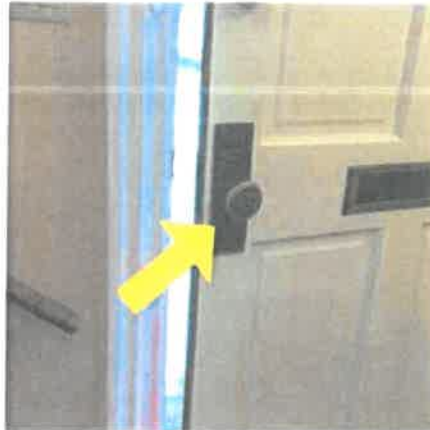
- Door knob on interior of front door was noted as being damaged. Recommend repairs for proper operation.

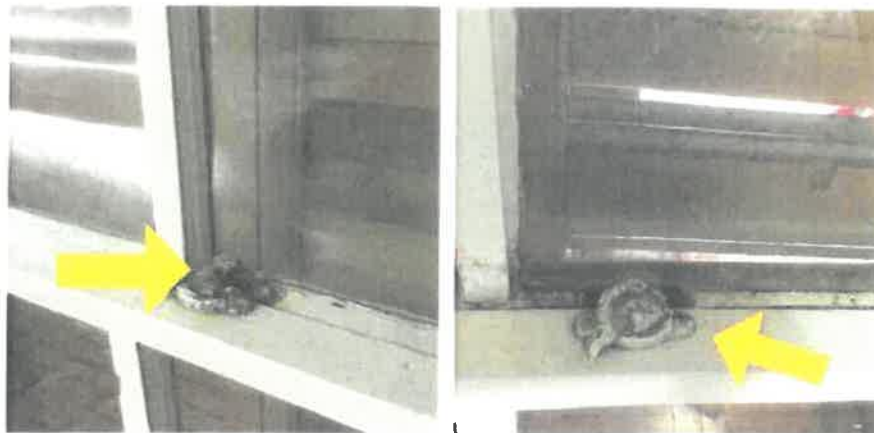
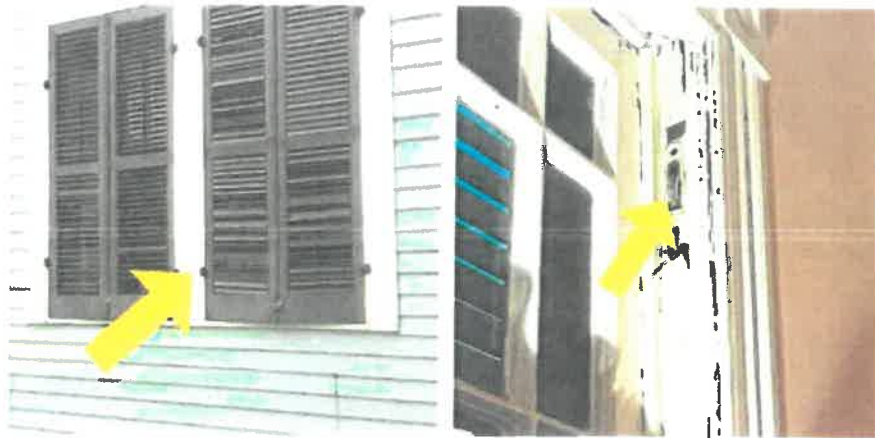
- Windows are old and in various states of repair.
- Some windows were not opening (possible painted shut).
- There was missing or damaged hardware noted at multiple windows. Recommend repairs for security.
- Multiple exterior window shutters were noted as being damaged. Recommend repairs as needed for proper operation.

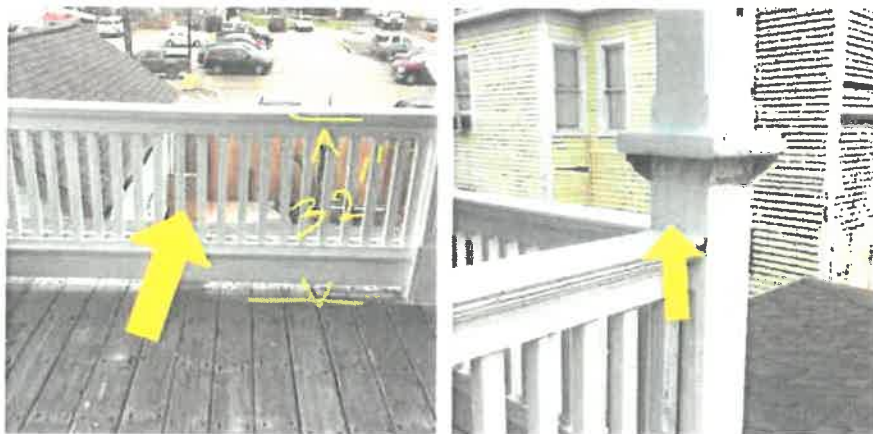
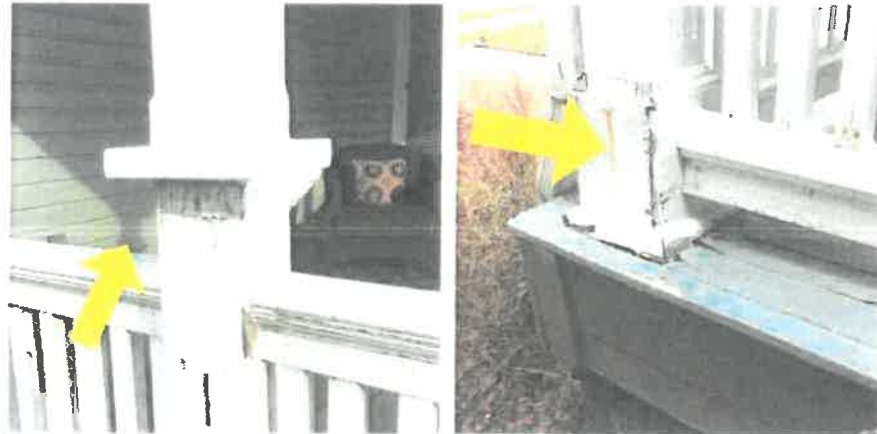
- Guardrail height on decks were measured at 32". Guardrail height should be 36" - 42", this is a safety hazard and should be corrected for safety.
- There were miscellaneous damages noted at deck boards and trim. Recommend repairs as needed.

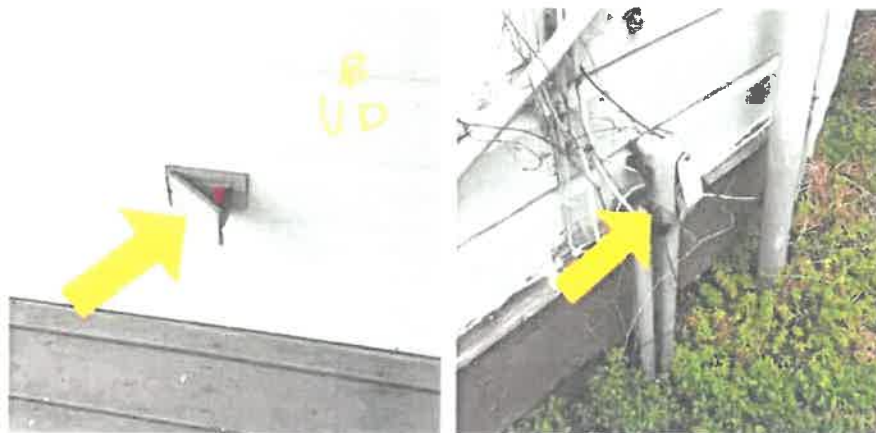
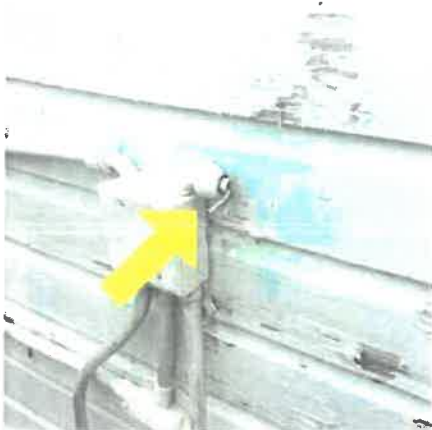
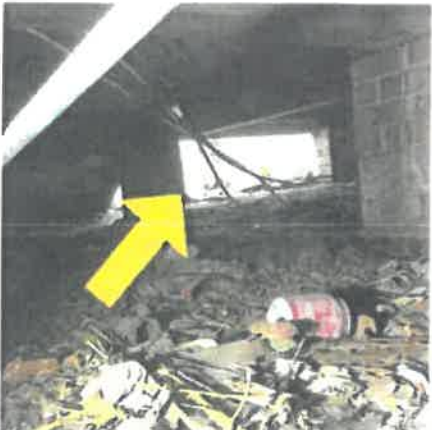
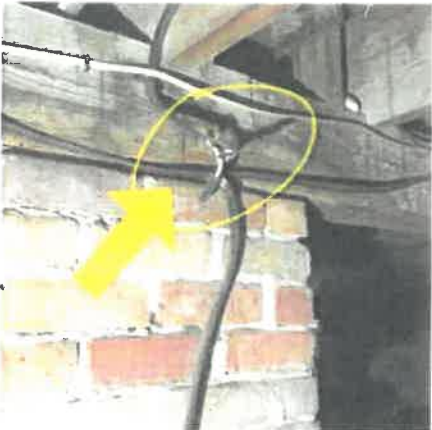
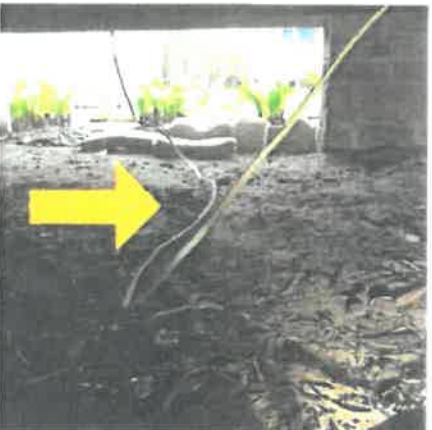
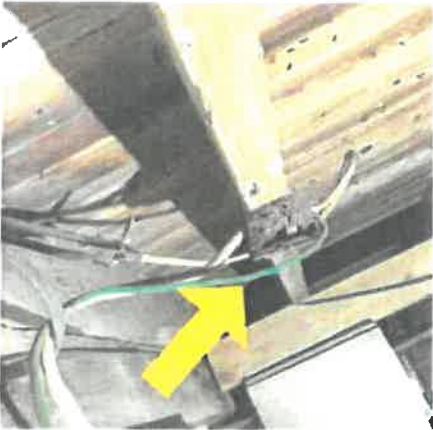
- Multiple receptacles are not GFCI protected in required areas. Receptacles in wet areas, outside and in garage are required to be GFCI protected to reduce the risk of electrical shock(kitchen & exterior).

- Receptacle on upper back deck was showing to have hot and neutral wires reversed when tested. Recommend repairs needed for proper operation and safety.

- There was a damaged junction box cover noted at back of garage. Recommend repairs for intended protection and safety.
- There were exposed wires noted at back exterior of garage. Recommend having licensed electrician evaluate and terminate properly for safety.

- There were open wire splices noted on underside of home. Wire splices should be made in a closed junction box. Recommend having licensed electrician evaluate and repair as needed for intended protection and safety.

- There were miscellaneous wires noted as not being properly supported under home. Recommend having licensed electrician evaluate and repair as needed.

- There was damaged/deteriorated junction boxes noted under home. Recommend having licensed electrician evaluate and repair as needed for intended protection and safety.

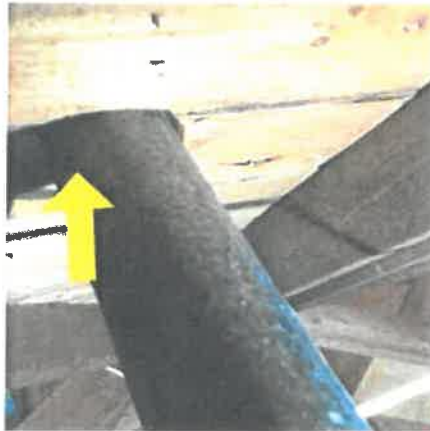
- (1) Package unit(manufactured in 2017).
- System was heating as designed at at time of inspection.
- (1) Forced air furnace.
- Natural gas energy source.
- System could not be tested due to no internet connection at thermostat. Recommend having tested when internet connection is restored.
- Furnace vent clearance to combustible material is insufficient and is a fire hazard. The vent is required to maintain a 1" gap to all combustible materials.

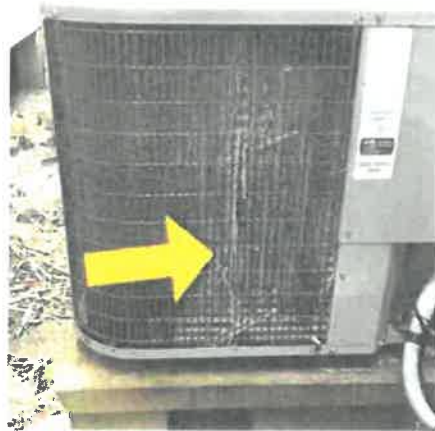
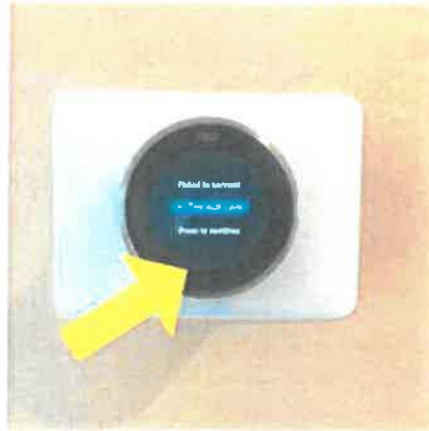
- (1) Package unit downstairs (manufactured in 2017).
  - System was cooling as designed at time of inspection.
  - (1) Split system (manufactured in 2015).
  - System could not be tested due to no internet connection at thermostat.
- Recommend testing when internet connection is present.
- There damaged/deteriorated coils noted at condenser. Recommend having HVAC technician evaluate and repair as needed.

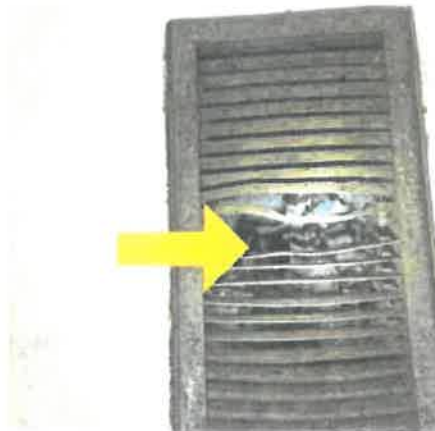
- There was damaged duct work noted at floor register in kitchen.
- Recommend having HVAC technician evaluate and repair as needed for proper air flow.

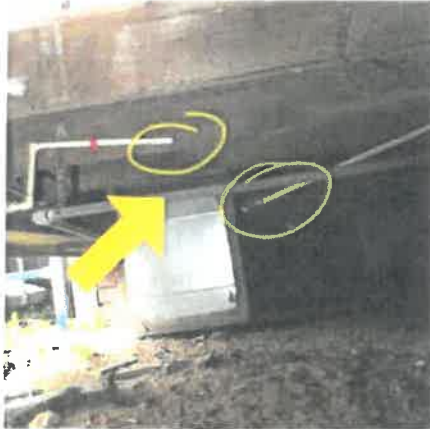
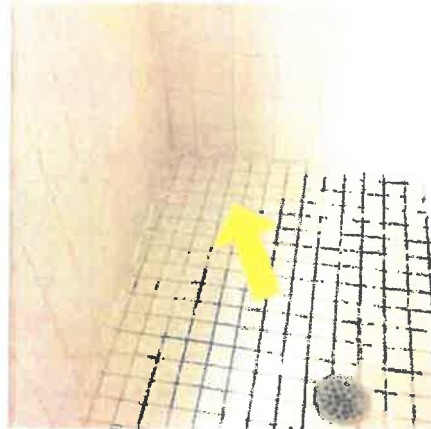
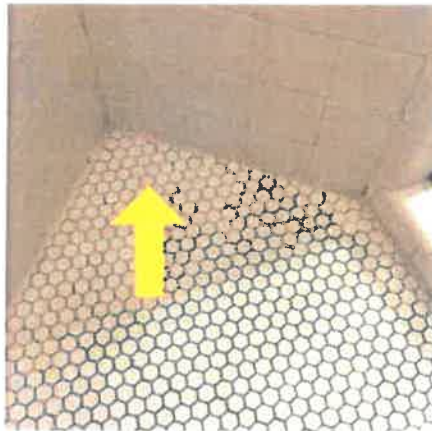
- Water meter is located in front yard at street.
- Static water pressure was 64 psi. at time of inspection. Normal water pressures should be between 40 and 80 psi.
- Water line to hose bib on left side of home was noted as being broken/disconnected under home. Recommend repairs for proper operation.
- Tile grout/caulk repairs required at both shower enclosures.

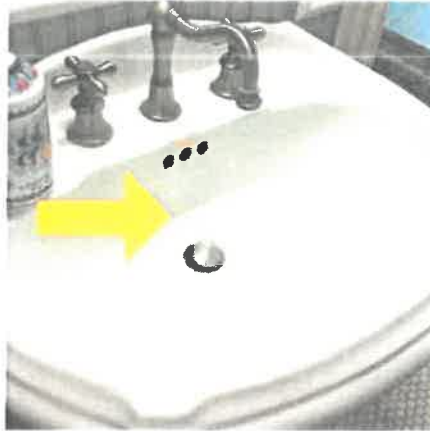
- Sink in hallway bathroom was noted to be draining slowly (possible blockage). Recommend having licensed plumber evaluate and repair as needed for proper drainage.

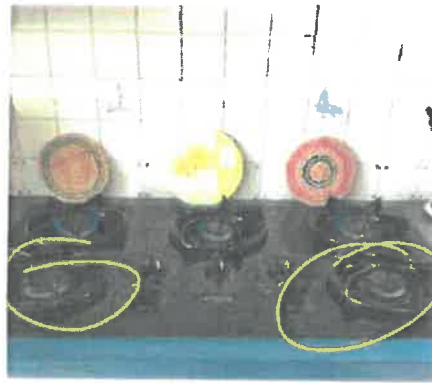
- Front cook tops were not lighting at time of inspection. Recommend repairs as needed for proper operation.

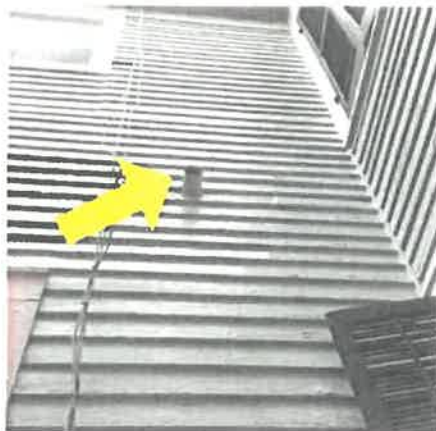
- Exterior vent cover was missing. Recommend replacement.

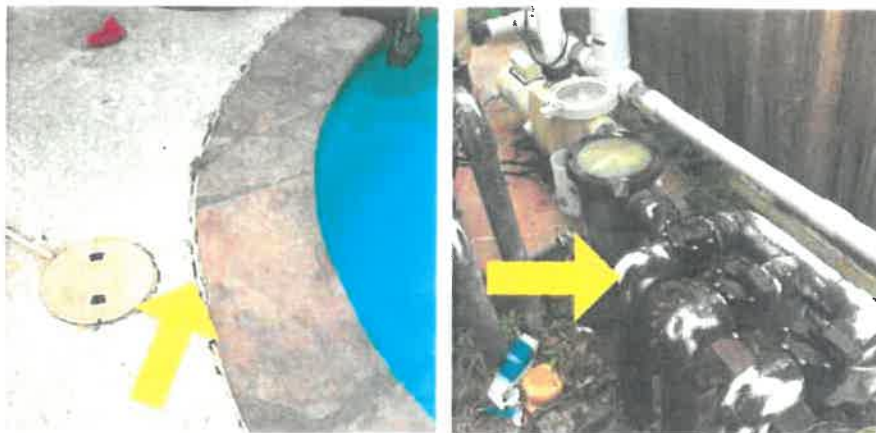
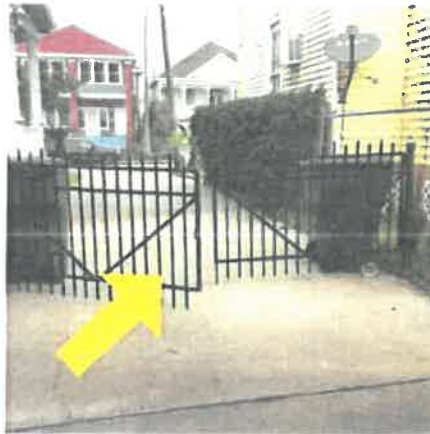
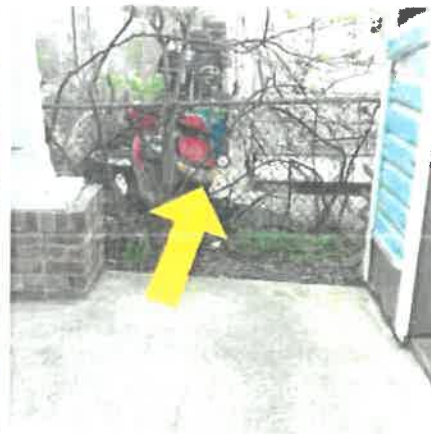
- Gunitite with plaster construction.
  - Pool equipment and was operated on the day of inspection and appeared to function as intended.
  - Re-caulk/re-seal the gap between the coping and the deck.
  - Fence is not proper height. May not meet local requirements.
  - Pump/filter pipe components are not labeled to indicate function. Recommend having equipment labeled for proper operation.
- "The following Pool Safety Barrier improvements should be considered to provide additional barriers to accidental entry into the pool by unsupervised children.

- Installation of a self-closing/self latching mechanisms serving the pool barrier fence gates that provides enough force for positive gate latching.

- The latches should be relocated to the inside of the gates

- Lower the bottom of the fences and gates to within 2" of the grass/soil surfaces when closed

- Install latch barriers so that there are no openings greater than 1/2" within 18" of the latch release mechanism to prevent a young child from reaching through the gate and releasing the latch.

Install door alarms on all home doors providing access to the pool area. These doors should be self-closing and self-latching or locks beyond the reach of children."

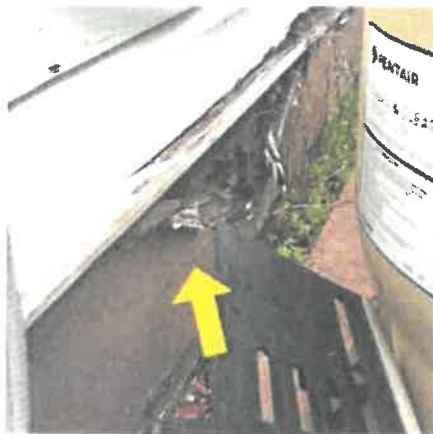
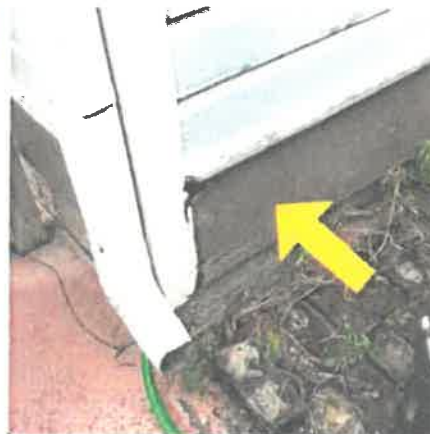
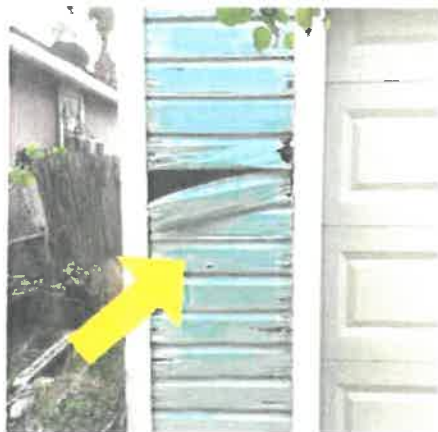
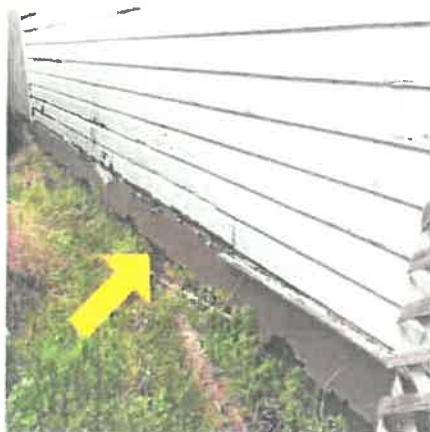
- Exterior was noted as showing heavy wood rot/deterioration. Recommend having qualified contractor evaluate the extent of damage and repair as needed to prevent further deterioration and damages
