PROPERTY INSPECTION REPORT

Concerning: 2207 Bernardo De Galvez Avenue, Galveston, TX 77550
(Address or Other Identification of Inspected Property)

By: Danny Marlow Lic.#: 23187 03/25/2021
(Name and License Number of Inspector) (Date)

Inspection No. 521350-643

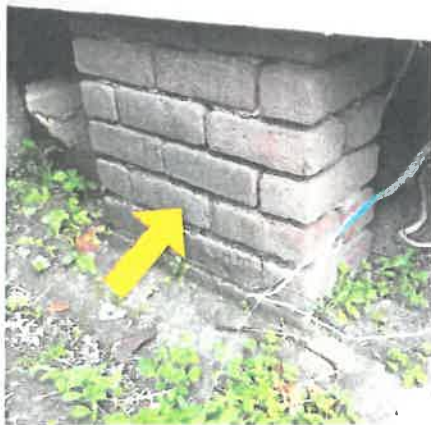
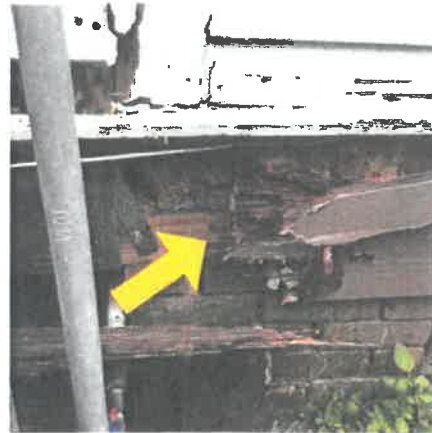
- Foundation is pier & beam and was performing as designed at time of inspection.
- There were various pilings where mortar was noted as being deteriorated/missing. Recommend having qualified contractor evaluate and repair as needed to prevent further deterioration and damages.
- There was wood rot/deterioration noted at various support beams under home. Recommend having qualified contractor evaluate the extent of damage and repair as needed to prevent further deterioration and damages.

REPLACED
6/21

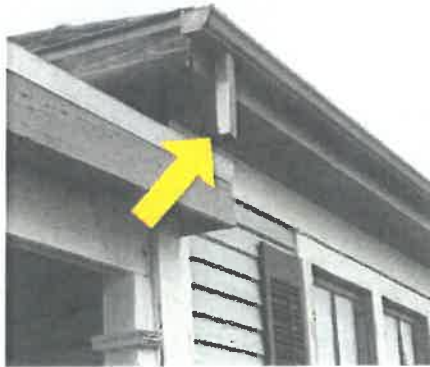
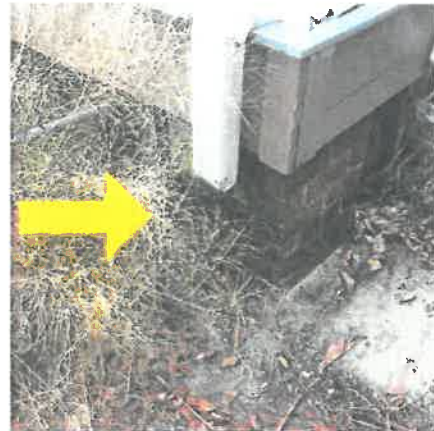
- There were miscellaneous areas where downspouts were noted as being damaged or missing. Recommend repairs for proper drainage.
- Downspouts improperly discharging water against foundation. Redirect and extend all downspouts away from foundation.

DOWN SPOUTS
REPAIRED
6/21

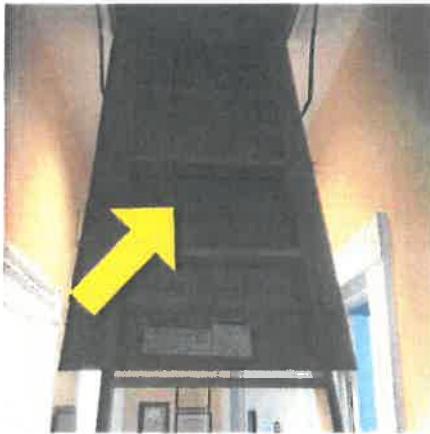
- Attic spaces were observed from the attic access/work platform. Some areas are not visible from this vantage point and were not inspected.
- Insulation was approximately 8" inches thick at time of inspection (vermiculite & radiant barrier).
- Insulate pull down stairway door to promote insulation barrier to reduce moisture/condensation related damages and promote energy efficiency.

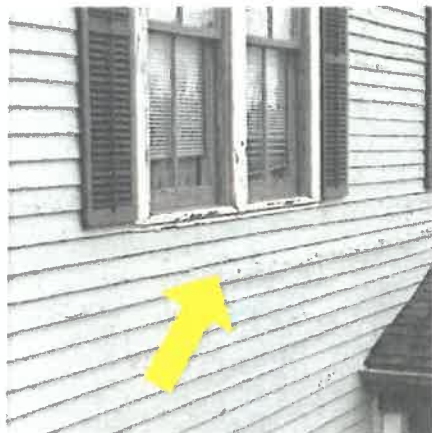
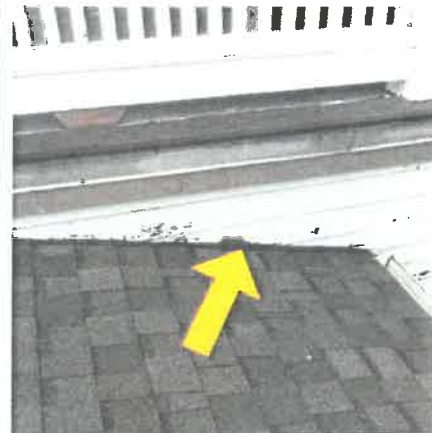
- Wood siding with wood trim (exterior). Drywall with wood trim (interior).
- There was moderate to heavy wood rot/deterioration noted at multiple areas of siding. Recommend having qualified contractor evaluate the extent of damage and repair as needed to prevent further deterioration and damages.
- There were miscellaneous stress cracks noted at walls (typically associated with settlement).
- There were possible moisture related damages noted at wall under window in front bedroom (possible previous window leak).

REPAIRED
5/21

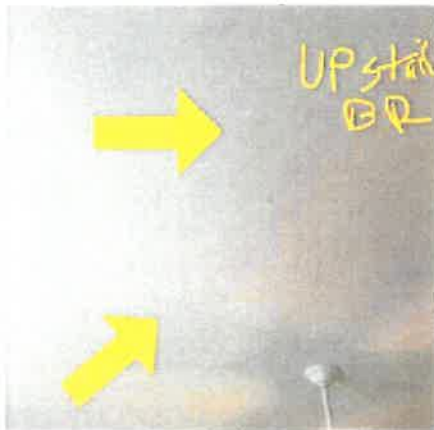
- There were stress cracks noted at ceilings in upstairs bedroom and in kitchen (typically associated with settlement).

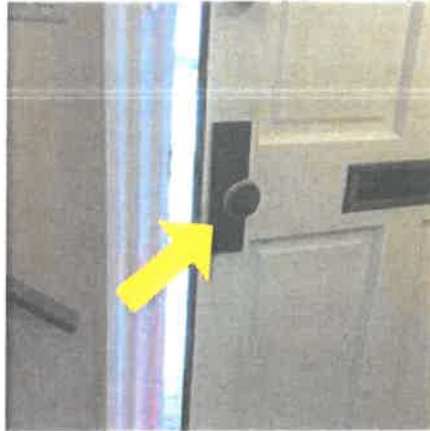
- Door knob on interior of front door was noted as being damaged. Recommend repairs for proper operation.

REPAIRED
5/21

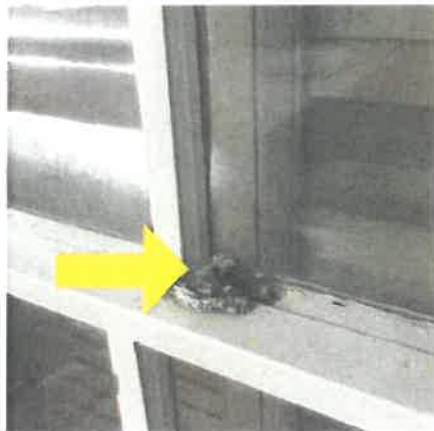
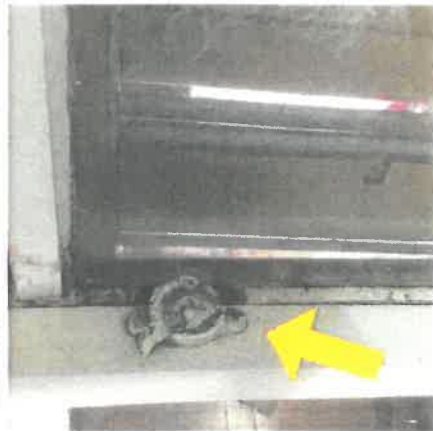
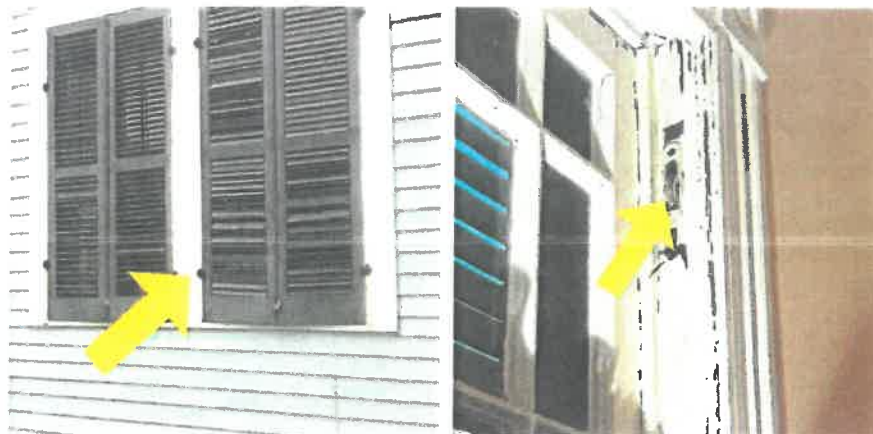
- **Windows are old and in various states of repair.**
- **Some windows were not opening (possible painted shut).**
- **There was missing or damaged hardware noted at multiple windows. Recommend repairs for security.**
- **Multiple exterior window shutters were noted as being damaged. Recommend repairs as needed for proper operation.**

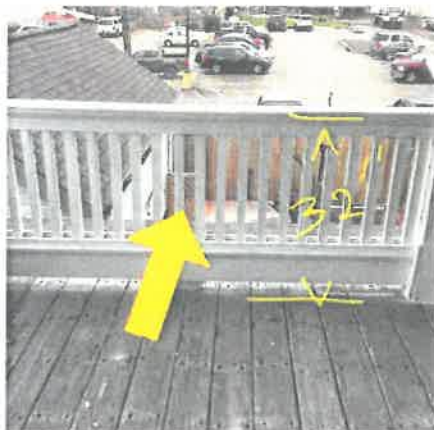
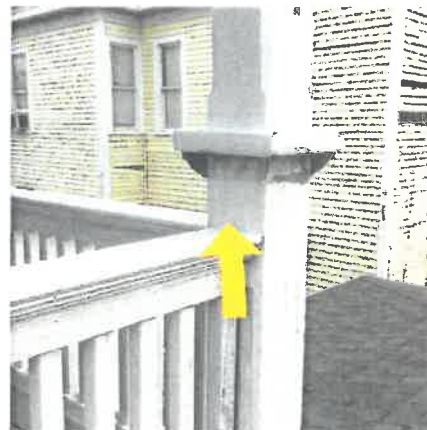
- **Guardrail height on decks were measured at 32". Guardrail height should be 36" - 42", this is a safety hazard and should be corrected for safety.**
- **There were miscellaneous damages noted at deck boards and trim. Recommend repairs as needed.**

REPAIRED
3/21

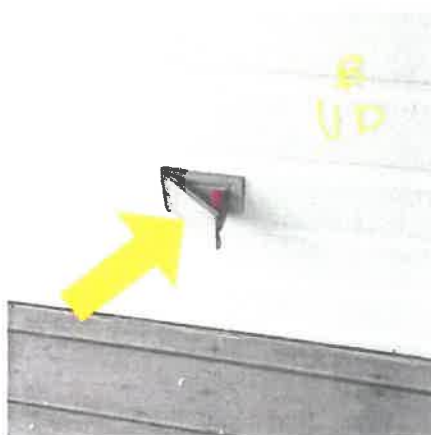
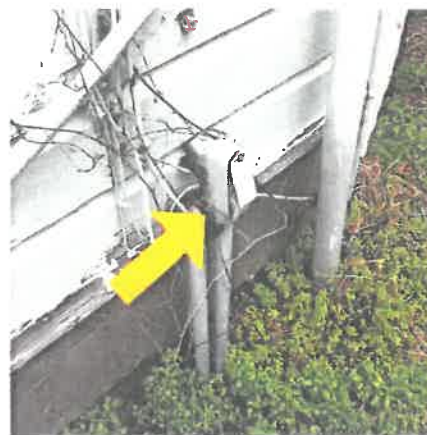
- Receptacle on upper back deck was showing to have hot and neutral wires reversed when tested. Recommend repairs needed for proper operation and safety.

- There was a damaged junction box cover noted at back of garage. Recommend repairs for intended protection and safety.
- There were exposed wires noted at back exterior of garage. Recommend having licensed electrician evaluate and terminate properly for safety.

REPAIRED
5/21

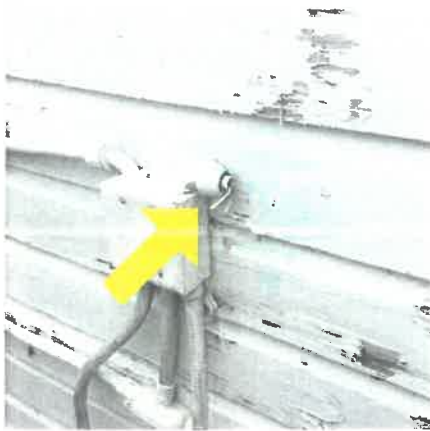
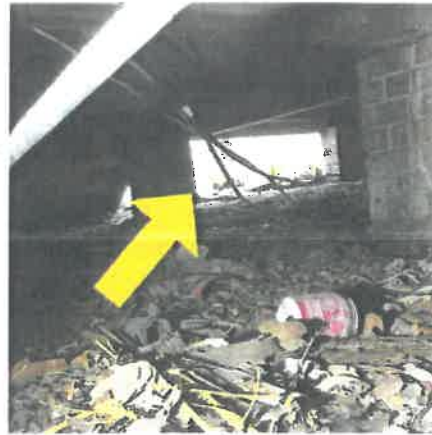
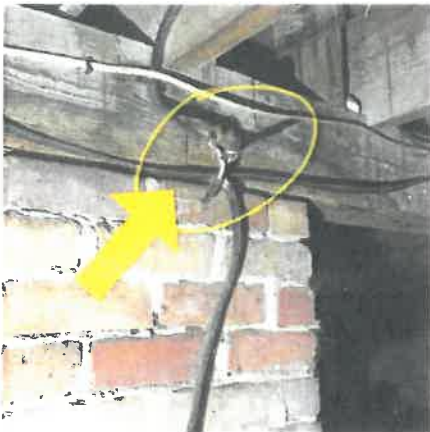
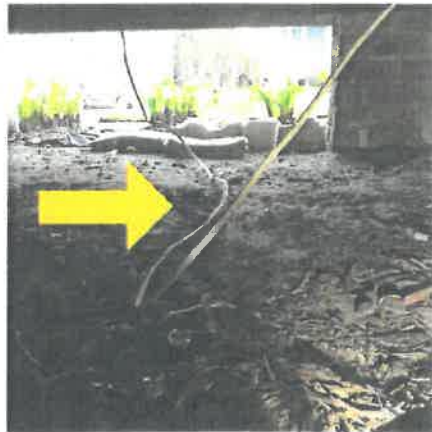
- There were open wire splices noted on underside of home. Wire splices should be made in a closed junction box. Recommend having licensed electrician evaluate and repair as needed for intended protection and safety.

- There were miscellaneous wires noted as not being properly supported under home. Recommend having licensed electrician evaluate and repair as needed.

- There was damaged/deteriorated junction boxes noted under home. Recommend having licensed electrician evaluate and repair as needed for intended protection and safety.

REPAIRED
5/21

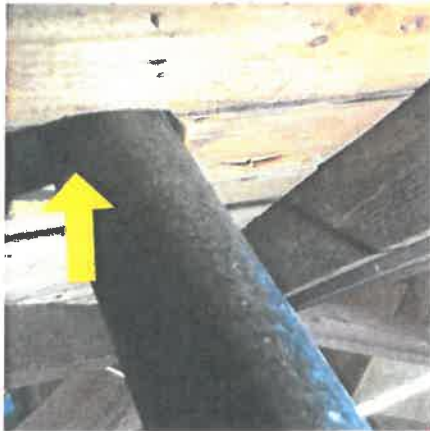
- (1) Package unit(manufactured in 2017).
- System was heating as designed at at time of inspection.
- (1) Forced air furnace.
- Natural gas energy source.
- System could not be tested due to no internet connection at thermostat. Recommend having tested when internet connection is restored.
- Furnace vent clearance to combustible material is insufficient and is a fire hazard. The vent is required to maintain a 1" gap to all combustibile materials.

REPAIRED
5/21

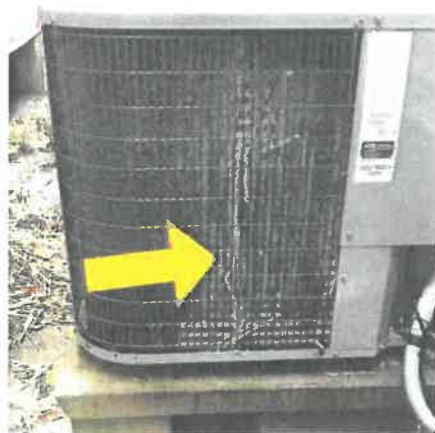
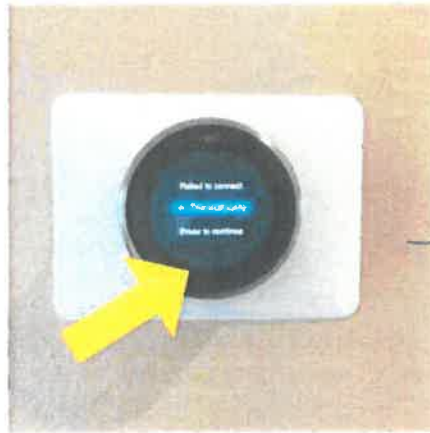
- (1) Package unit downstairs (manufactured in 2017).
 - System was cooling as designed at time of inspection.
 - (1) Split system (manufactured in 2015).
 - System could not be tested due to no internet connection at thermostat.
- Recommend testing when internet connection is present.
- There damaged/deteriorated coils noted at condenser. Recommend having HVAC technician evaluate and repair as needed.

INTERNET
CONNECTED

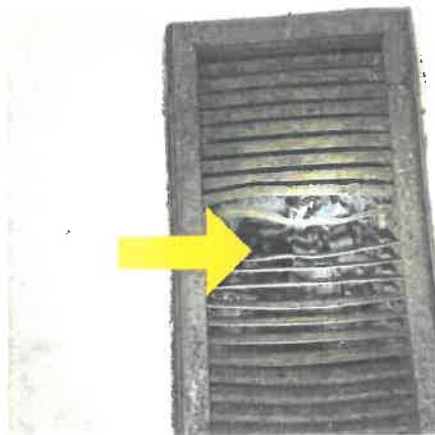
- There was damaged duct work noted at floor register in kitchen.
- Recommend having HVAC technician evaluate and repair as needed for proper air flow.

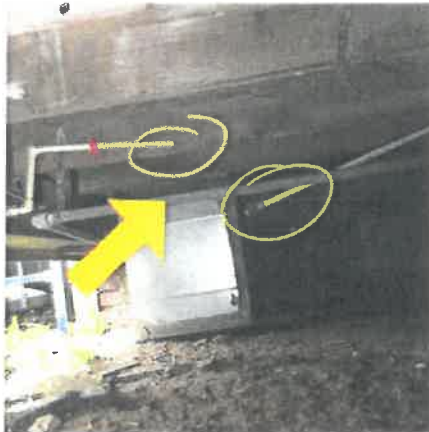
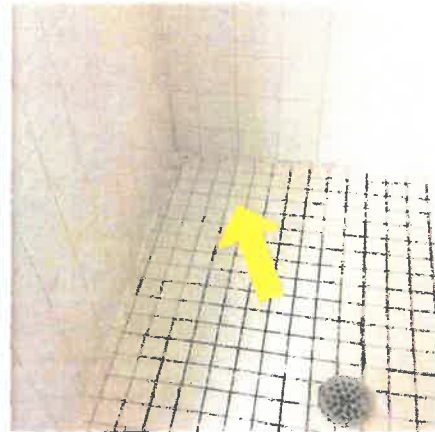
- Water meter is located in front yard at street.
- Static water pressure was 64 psi. at time of inspection. Normal water pressures should be between 40 and 80 psi.
- Water line to hose bib on left side of home was noted as being broken/disconnected under home. Recommend repairs for proper operation.
- Tile grout/caulk repairs required at both shower enclosures.

REPAIRED
5/24

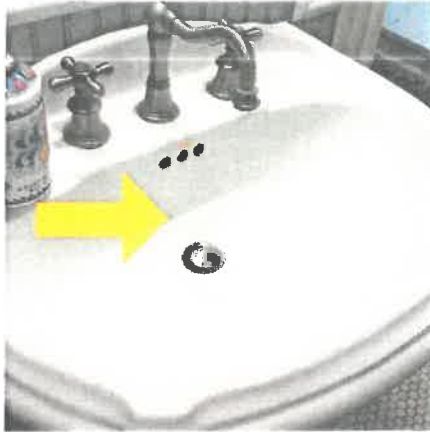
- Sink in hallway bathroom was noted to be draining slowly (possible blockage). Recommend having licensed plumber evaluate and repair as needed for proper drainage.

Draining properly 5/21

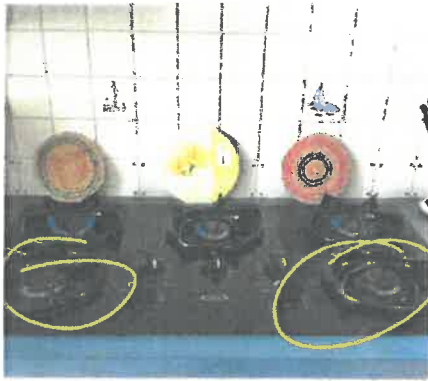
- Front cook tops were not lighting at time of inspection. Recommend repairs as needed for proper operation.

→ COOKTOP REPLACED
5/21

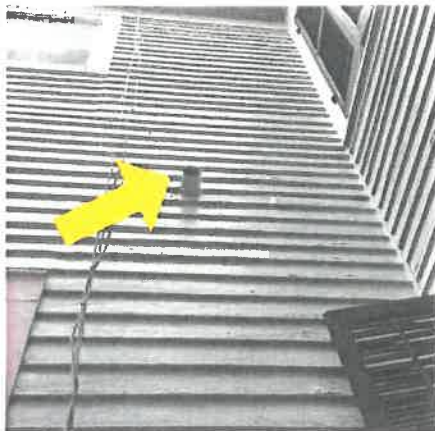
- Exterior vent cover was missing. Recommend replacement.

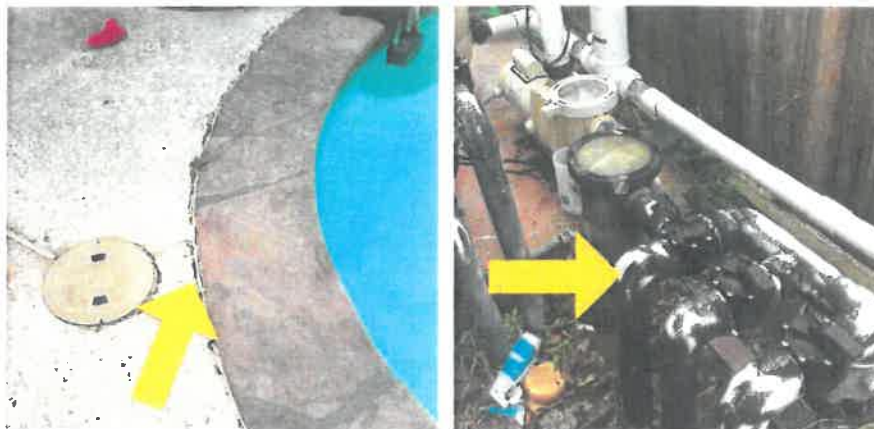
- Gunite with plaster construction.
 - Pool equipment and was operated on the day of inspection and appeared to function as intended.
 - Re-caulk/re-seal the gap between the coping and the deck.
 - Fence is not proper height. May not meet local requirements.
 - Pump/filter pipe components are not labeled to indicate function. Recommend having equipment labeled for proper operation.
- "The following Pool Safety Barrier improvements should be considered to provide additional barriers to accidental entry into the pool by unsupervised children.

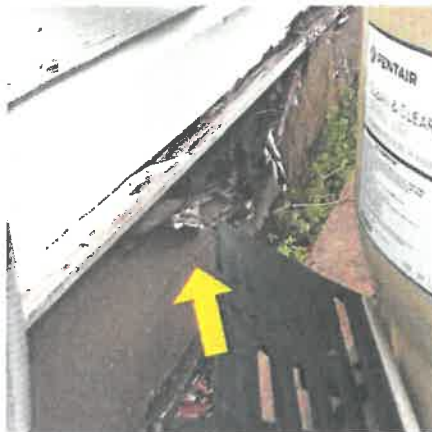
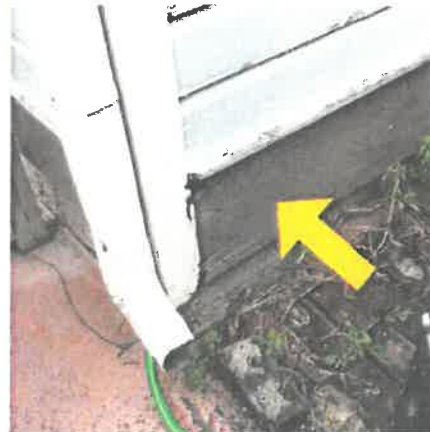
- Exterior was noted as showing heavy wood rot/deterioration. Recommend having qualified contractor evaluate the extent of damage and repair as needed to prevent further deterioration and damages

REPAIRED 5/21
