PROPERTY INSPECTION REPORT

Prepared For: BRITTNIE ADAMS
(Name of Client)

Concerning: 12803 FAIRLANE DRIVE, BROOKSIDE, TX 77581
(Address or Other Identification of Inspected Property)

By: Stephen Perry, Lic #7854 04/06/2021
(Name and License Number of Inspector) (Date)

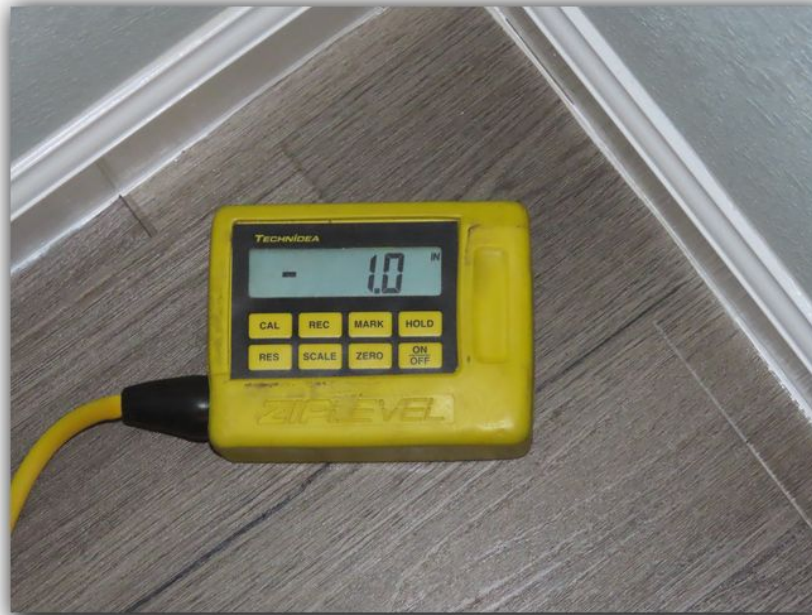
AS PART OF THE FOUNDATION INSPECTION THE ELEVATION OF THE FLOOR WAS CHECKED FOR EXCESSIVE SLOPE WITH A "ZIP LEVEL/ PRO-2000"- ("HIGH PRECISION ALTIMETER"). A REFERENCE POINT WAS SELECTED IN THE MIDDLE OF HOUSE AND ELEVATION MEASUREMENTS WERE TAKEN IN EACH ROOM. **IT WAS DETERMINED AFTER CAREFUL EVALUATION OF THE DATA OBTAINED THAT THE FOUNDATION ELEVATION/SLOPE IS WITHIN ACCEPTABLE TOLERANCES. THERE WAS SHOWING -1" INCH LOW ON THE FRONT RIGHT CORNER OF THE HOME IN THE FRONT SECONDARY BEDROOM, AND -.7" TENTHS OF AN INCH LOW IN THE KITCHEN AREA ON THE BACK LEFT CORNER OF THE HOME, OTHER LOCATIONS WERE SHOWING LEVEL TO - 1/2 INCHES LOW. THESE TOLERANCES ARE NOT**

CONSIDERED EXCESSIVE, BUT TO INDICATE SOME SETTLEMENT. RECOMMEND MONITORING FOR ANY FURTHER SIGNS OF SETTLEMENT. IN ADDITION, THERE IS WATER DRAINING NEAR THE HOMES PERIMETER FOR THE KITCHEN AND LAUNDRY DRAIN PIPES AND CAN AFFECT FOUNDATION PERFORMANCE IF NOT CORRECTED, IMPROVEMENTS TO THE DRAINAGE AROUND THE HOME AND ROOT BARRIER SYSTEMS FOR THE LARGE TREES NEAR THE HOME AS WELL IS RECOMMENDED FOR FOUNDATION PERFORMANCE.

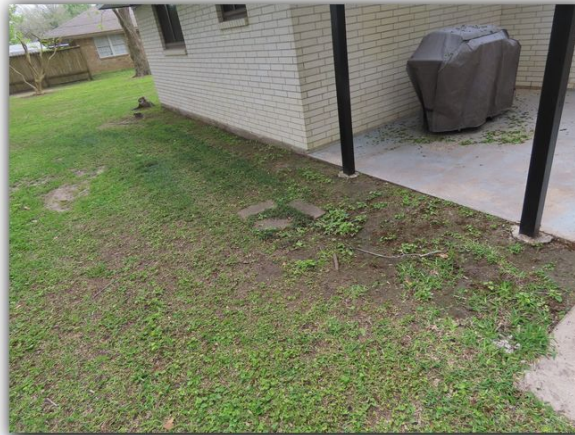
- Improper drainage from foundation, PLUMBING ACTIVELY DRAINING NEAR THE HOME ON THE BACK LEFT CORNER FROM THE KITCHEN SINK AND LAUNDRY. IN NEED OF REPAIRS BY A PLUMBER/SEPTIC EXPERT.**

- I DO RECOMMEND FRENCH DRAINS ON THE LEFT, BACK, AND RIGHT SIDES OF THE HOME FOR IMPROVED DRAINAGE, IMPROVEMENTS TO THE LOW UNEVEN AREAS OF THE GRADING NEAR THE HOMES SLAB, AND IN THESE LOCATIONS THAT APPEAR TO HAVE WATER PONDING, ROCKS/GRAVEL INSTALLED ALONG THE HOMES PERIMETER, GUTTER DOWN SPOUTS TERMINATING TO THE FRENCH DRAINS AS WELL; IN NEED OF FURTHER EVALUATION BY A LANDSCAPE AND IRRIGATION EXPERT**

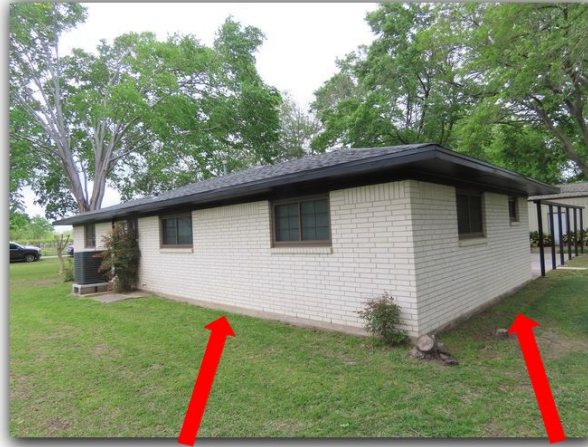
Inadequate grading clearance to exterior wall surface

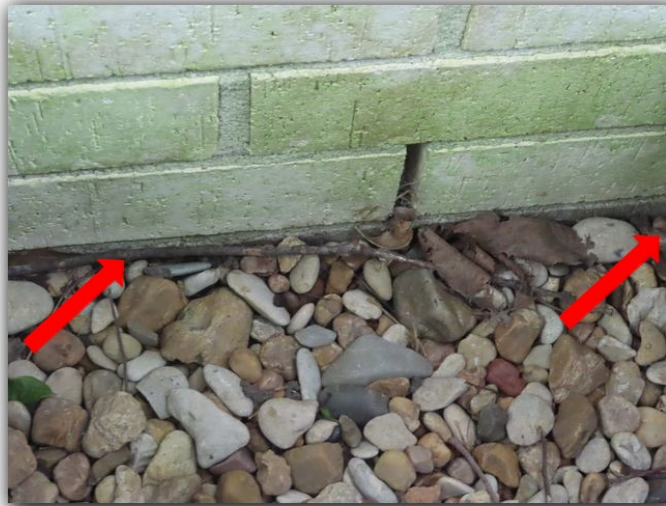
Trees/heavy foliage close to structure; recommend that the trees and shrubs close to the home have a root barrier system installed or roots pruned back between the home and tree. trees close to the home and large roots from trees and shrubs growing underneath the home can affect foundation performance. **(DEFICIENCY)**

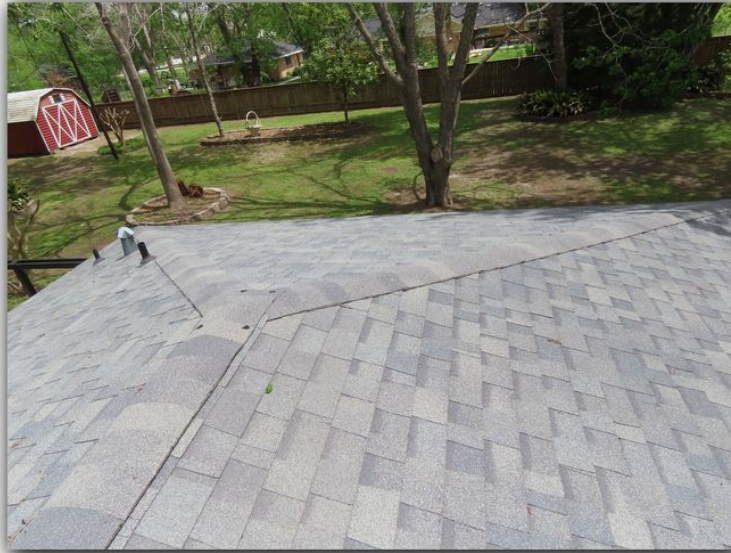
Roof decking deflection and / or sagging ; recommend evaluation and repairs by a roofing expert.(DEFICIENCY)

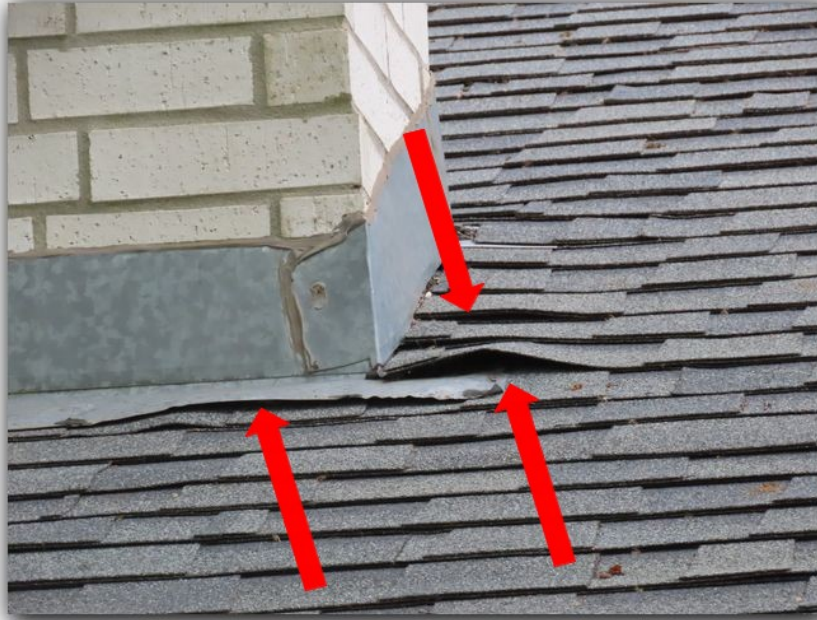
- **THERE IS SOME RAISED SHINGLES DUE TO PROTRUDING NAILS THAT NEEDS TO BE REPAIRED BY A ROOFING EXPERT. (DEFICIENCY)**

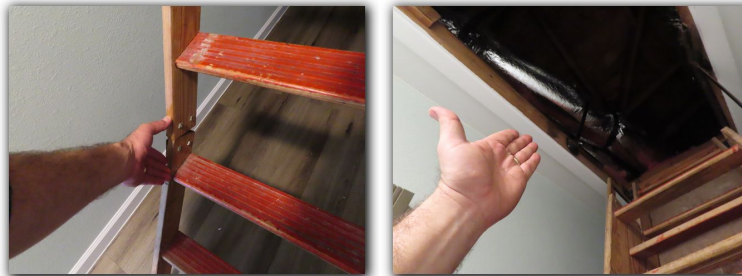
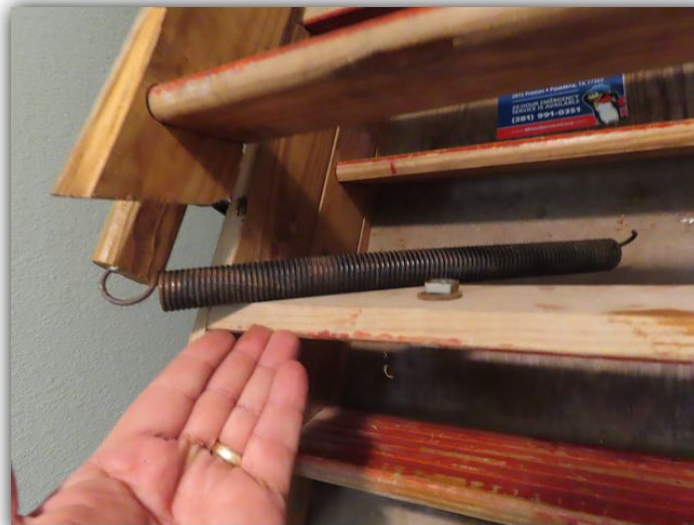
Damaged access ladder; SPRING CAME OFF DURING INSPECTION WHEN JUST OPENING THE LADDER AND WAS REINSTALLED. THE HARDWARE IS LOOSE AND DAMAGED. SAFETY HAZARD AND IN NEED OF REPLACEMENT. (DEFICIENCY)

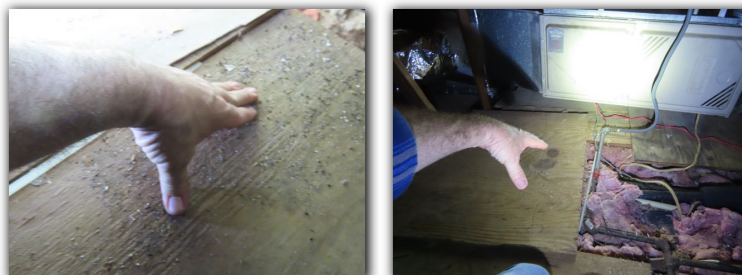
SOME OF THE FLOOR BOARDS IN THE ATTIC FOR THE PATHWAY TO THE HVAC EQUIPMENT IS NOT PROPERLY SUPPORTED/UNSTABLE AND NOT SAFE; IN NEED OF REPAIR.

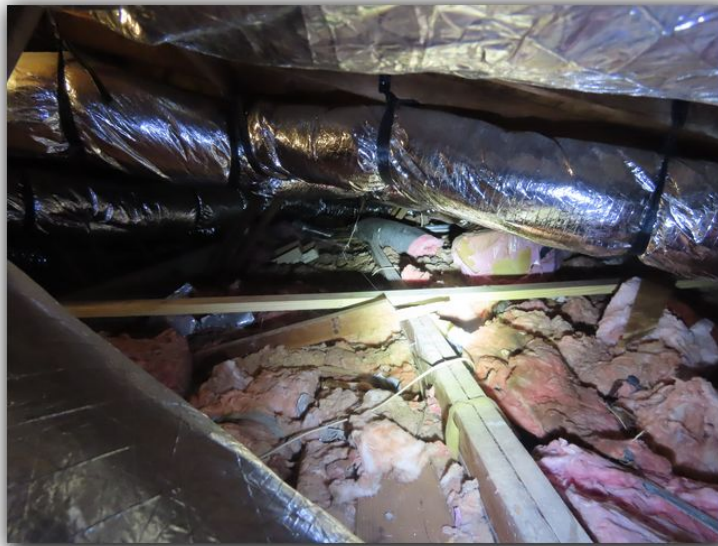
THERE IS SOME LOW SPOTS AND SOME LOW AREAS OF MISSING INSULATION ON THE ATTIC FLOOR THAT NEEDS ADDITIONAL

INSULATION ADDED. (FOR INCREASED ENERGY EFFICIENCY IT WOULD BE RECOMMENDED TO HAVE 14-16 INCHES OF BLOWN-INSULATION, TOTAL DEPTH)(DEFICIENCY)

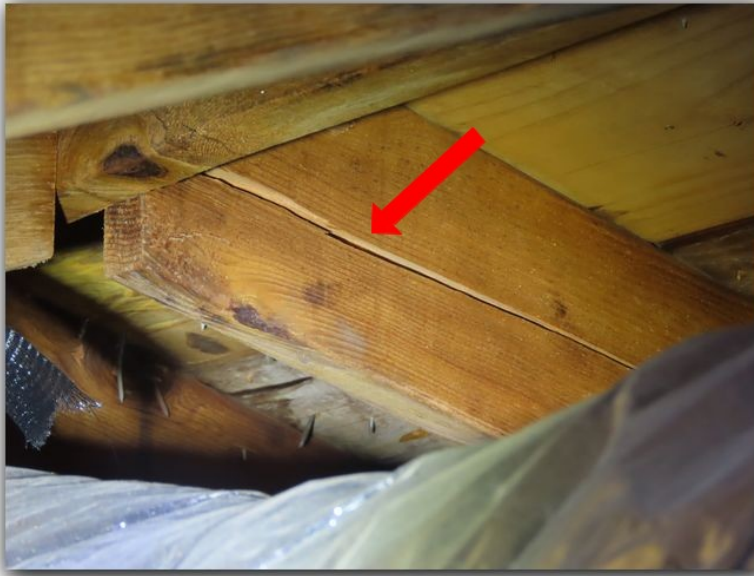
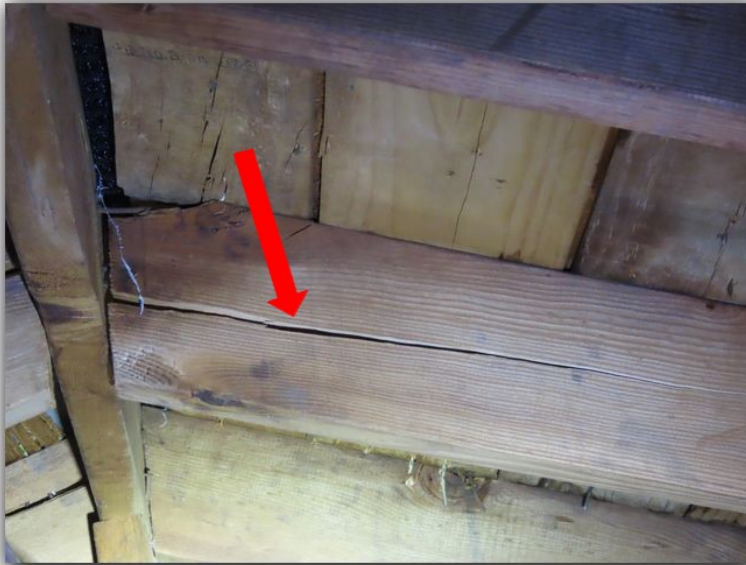
- **THERE IS SOME RAFTERS WITH SEPARATION FROM THE RIDGE BEAM THAT IS ALSO COMMON WITH STRUCTURAL SETTLEMENT AND IN NEED OF EVALUATION AND REPAIRS BY A FRAMING EXPERT.(DEFICIENCY)**

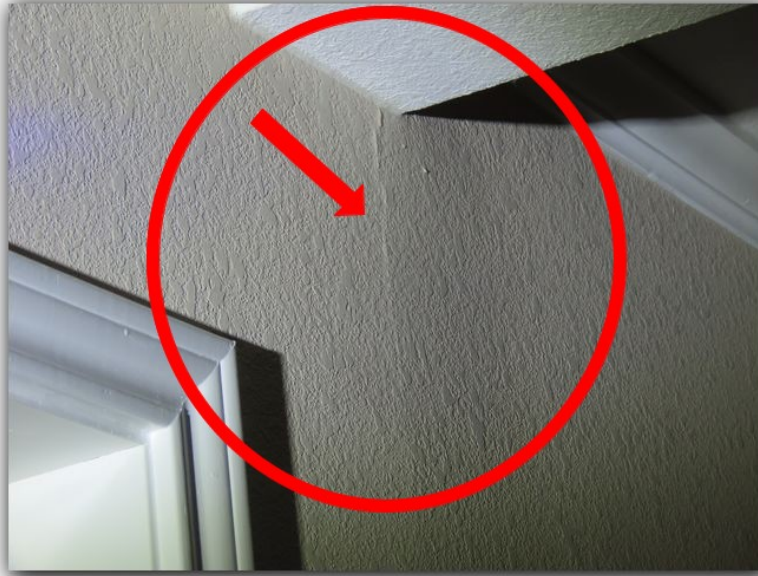
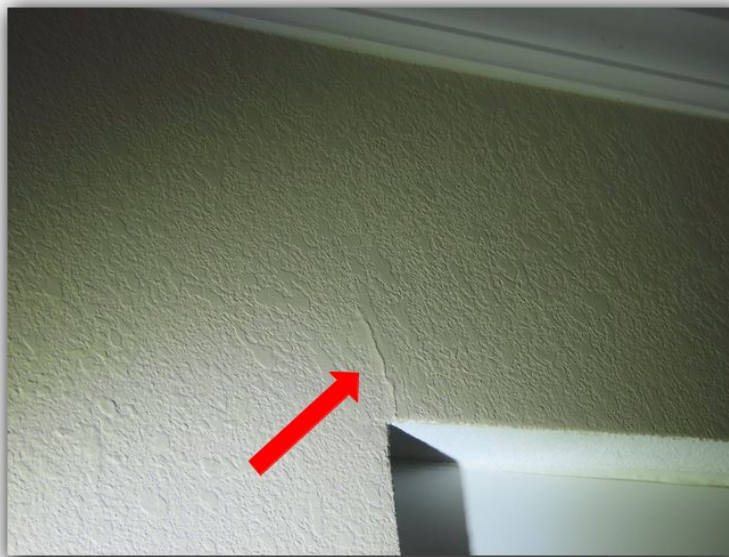
There are some settlement cracks in drywall previously patched and painted over (DEFICIENCY)

- **INDICATING STRUCTURAL SETTLEMENT THAT NEEDS TO BE PATCHED/FINISHED/TEXTURED AND MONITORED FOR ANY FURTHER CRACKING**

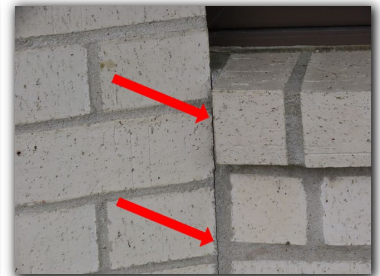
☑ Some cracks at the brick, hairline cracks in the brick on the front left corner of the home below the garage conversion window location indicating some settlement that needs to be pointed by a masonry repair expert and monitored for any further cracking or signs of structural settlement.(DEFICIENCY)

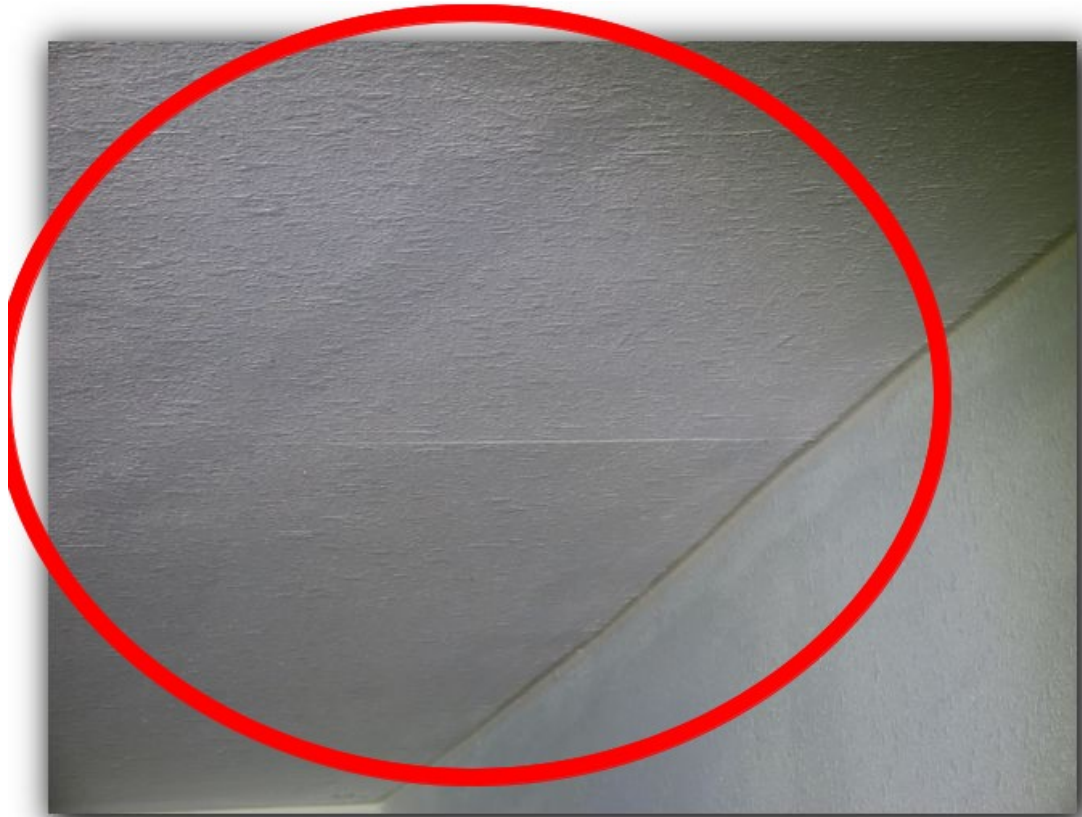
SOME PATCHWORK ON THE GARAGE CONVERSION WORK SHOP CEILING INDICATING POTENTIAL PREVIOUS LEAKS; RECOMMEND EVALUATION BY A DRYWALL REPAIR EXPERT AND ALSO A ROOFING EXPERT TO ENSURE THERE NO REMAINING LEAKS STILL PRESENT.(DEFICIENCY)

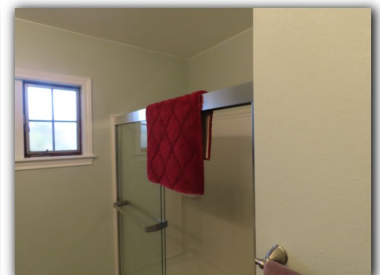
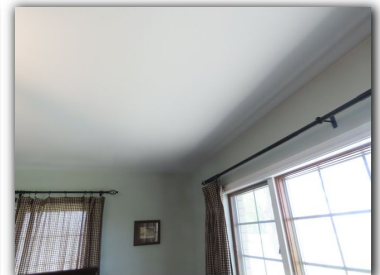
INFRARED CAMERA DID SHOW SEVERAL LOCATION OF MISSING/LOW INSULATION OR INSULATION VOIDS IN THE ATTIC ON THE CEILING IN MANY LOCATIONS THAT NEEDS TO BE PROPERLY INSULATED.(DEFICIENCY)

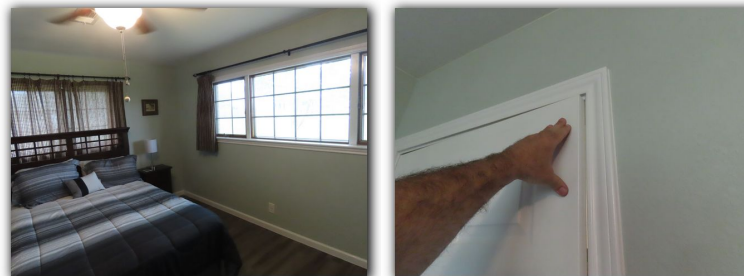
- Doors rub, stick or hit frames: _____
- SOME BEDROOM DOORS ARE RUBBING ON THE FRAME AND ALSO NOT LATCHING PROPERLY. THIS IS A SIGN OF STRUCTURAL SETTLEMENT AND IN NEED OF REPAIR BY A DOOR INSTALLATION EXPERT. (DEFICIENCY)**

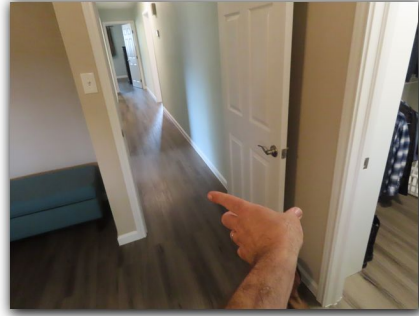
THE MASTER BEDROOM DOOR IS "GHOSTING" (CLOSING ON IT'S OWN) AND HAS A BOOT PRESENT TO KEEP OPEN. THIS IS COMMON WITH EITHER IMPROPER INSTALLATION OR STRUCTURAL SETTLEMENT AS WELL.IN NEED OF REPAIR BY A DOOR INSTALLATION EXPERT.(DEFICIENCY)

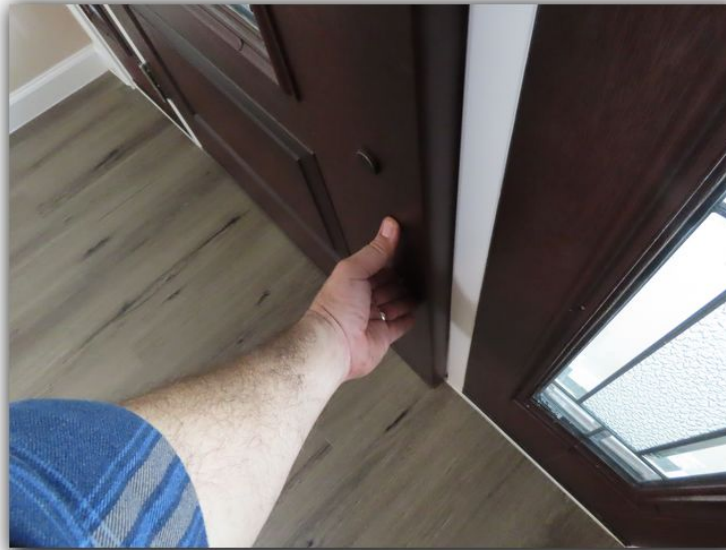
THE FRONT DOOR IS RUBBING ON THE FRAME AT THE BOTTOM; A SIGN OF STRUCTURAL SETTLEMENT AND IN NEED OF REPAIR BY A DOOR INSTALLATION EXPERT.(DEFICIENCY)

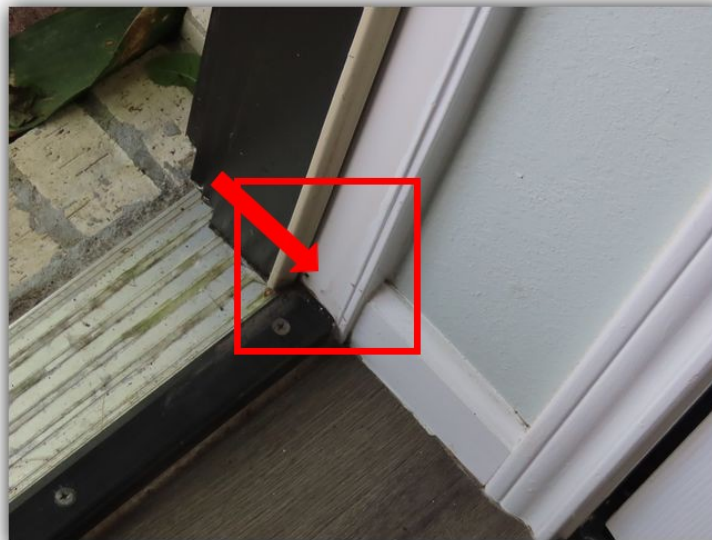
THE BACK SLIDING GLASS DOOR IS HARD TO OPEN

AND CLOSE; IN NEED OF REPAIR.(DEFICIENCY)

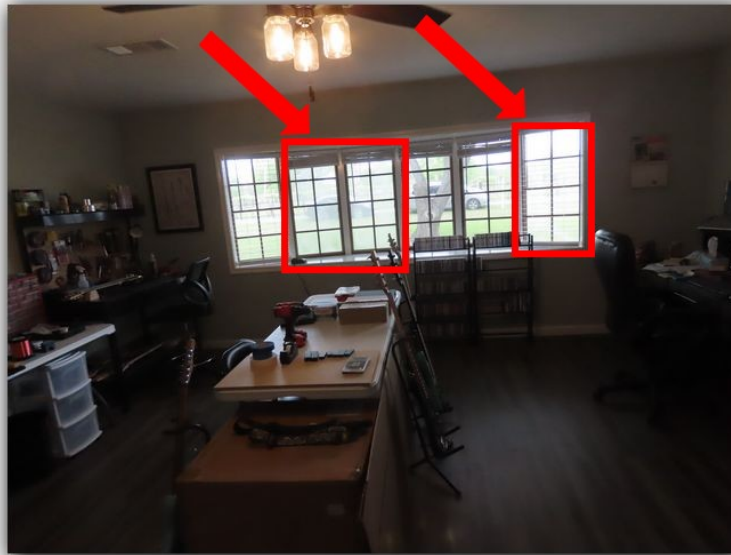
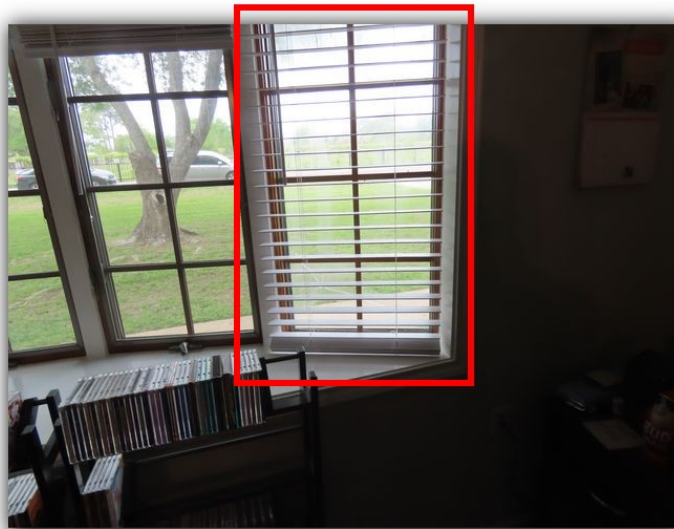
Some glass panes are damaged (DEFICIENCY)

Thermal pane window seals have failed, moisture is

present; Several windows in the front left corner workshop (garage conversion) and one window has cracked glazing as well. These windows will need replacement.(SEVERAL CASEMENT INSULATED GLASS WINDOWS WILL NEED TO BE REPLACED)(**DEFICIENCY**) **NEEDS FURTHER EVALUATION OF THE WINDOWS AND REPLACEMENT BY A WINDOW REPAIR EXPERT.(*THESE TYPE WINDOWS ARE VERY COSTLY)**

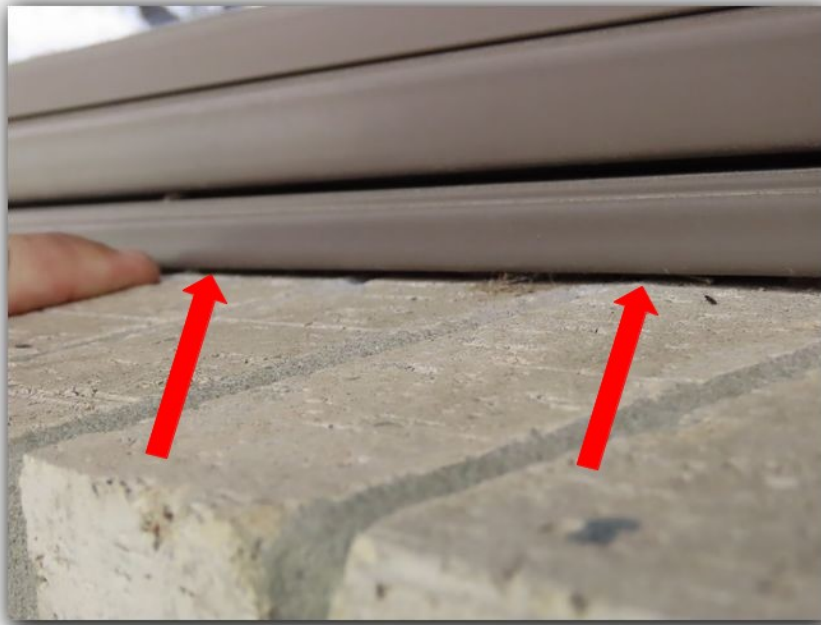
Caulking / plastic , etc. damaged and / or missing (DEFICIENCY)

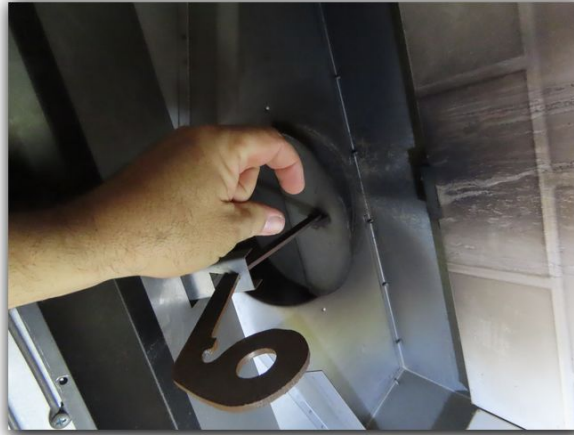
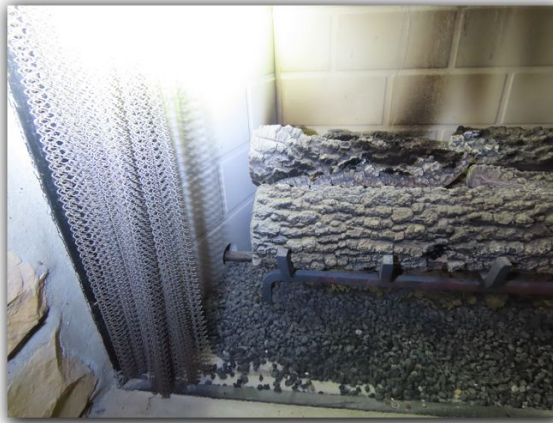
Damper does not operate properly and improperly installed. In need of repairs. (DEFICIENCY)

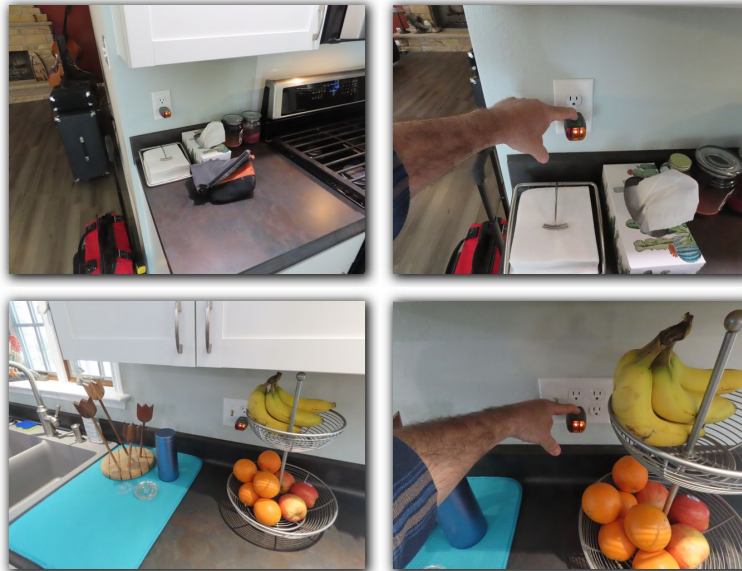
No GFCI/ARC Fault protection at one or more location. This is considered a recognized safety hazard. NOT ALL OUTLETS IN THE KITCHEN ARE GFCI, AS NOW REQUIRED, ONLY ONE LEFT OF THE SINK IS PROTECTED.(DEFICIENCY)

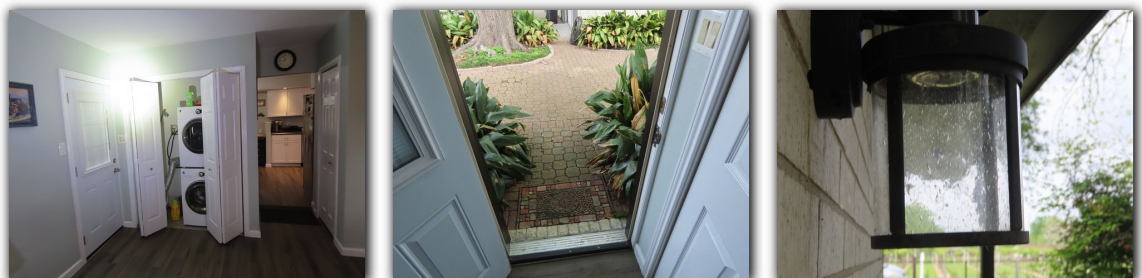
Light fixtures inoperable or in need of repair/Side porch exterior lite was not functioning or needs a bulb replacement. **(DEFICIENCY)**

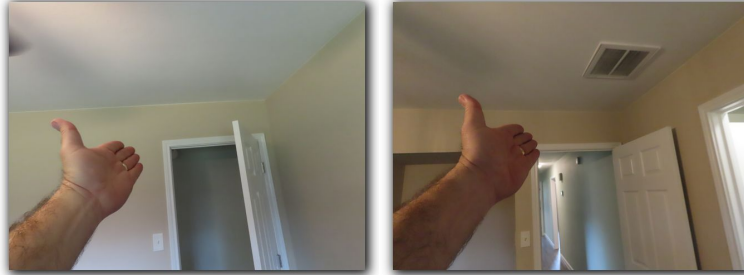
- Smoke alarms are not present in each sleeping area(DEFICIENCY)**

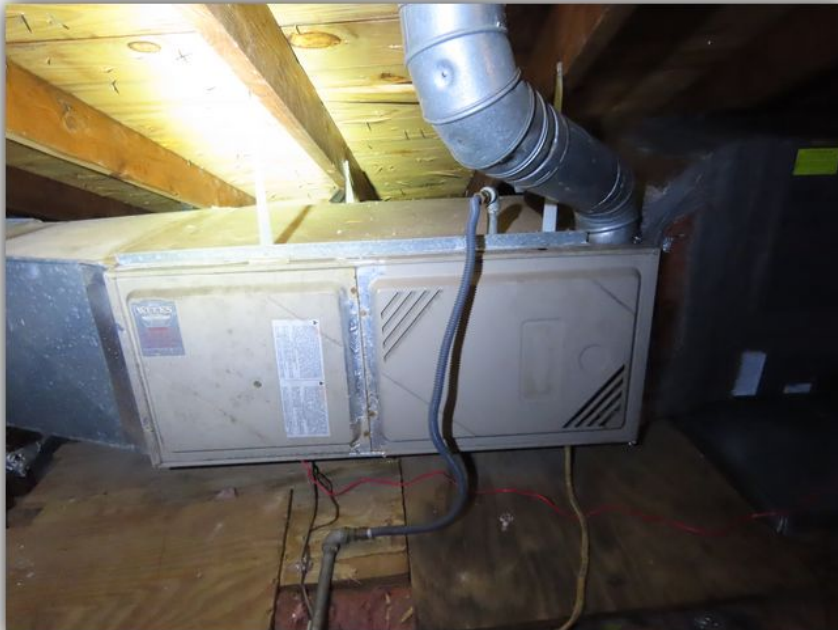
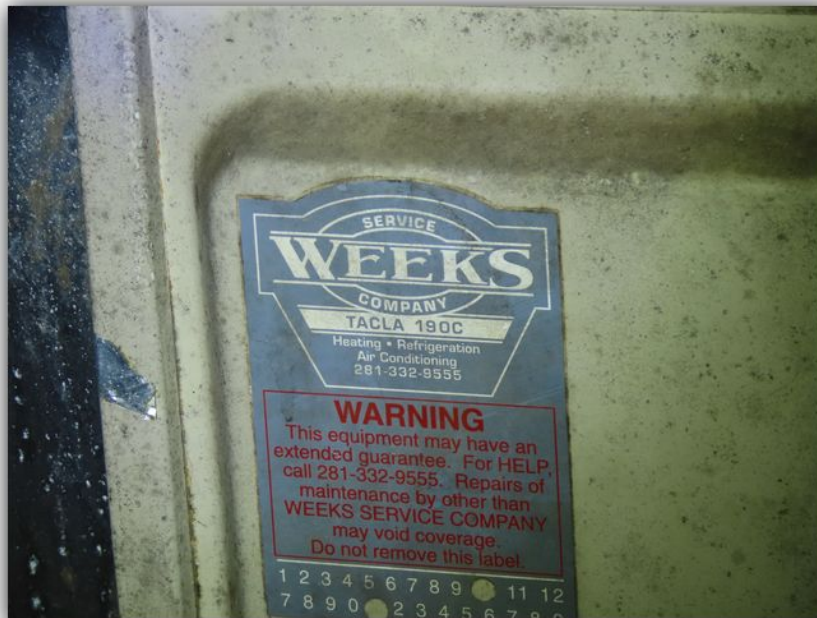
THE FURNACE IS AN OLDER UNIT AND DOES HAVE SIGNS OF A DIRTY SYSTEM; RECOMMEND FURTHER EVALUATION AND SERVICE BY A LICENSED HVAC PROFESSIONAL. **(DEFICIENCY)**

GAS FURNACES ARE RECOMMENDED TO HAVE THE HEAT EXCHANGER EVALUATED FOR CRACKS THAT CAN BE A SAFETY HAZARD BY A LICENSED HVAC PROFESSIONAL HEAT EXCHANGERS ARE OUTSIDE THE SCOPE OF INSPECTION DUE TO DISMANTLING THAT IS REQUIRED.

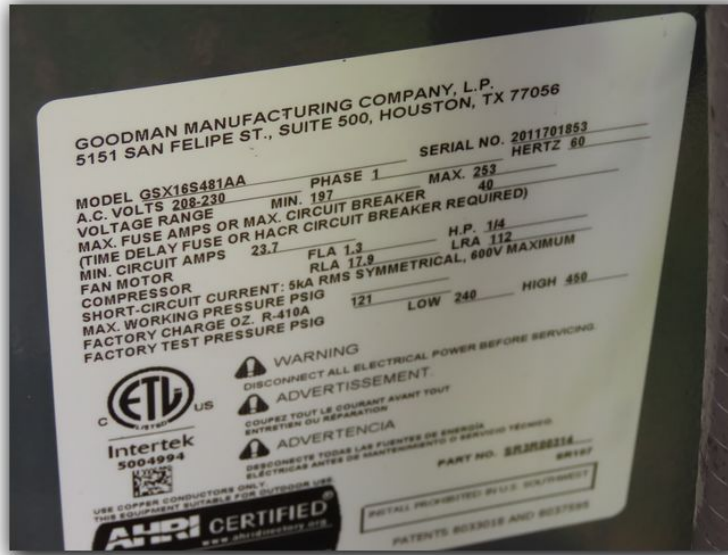
(DEFICIENCY) Temperature differential is NOT within range of 15-20 degrees Fahrenheit)

- **IN NEED OF EVALUATION AND REPAIR BY A LICENSED HVAC PROFESSIONAL(DEFICIENCY)**

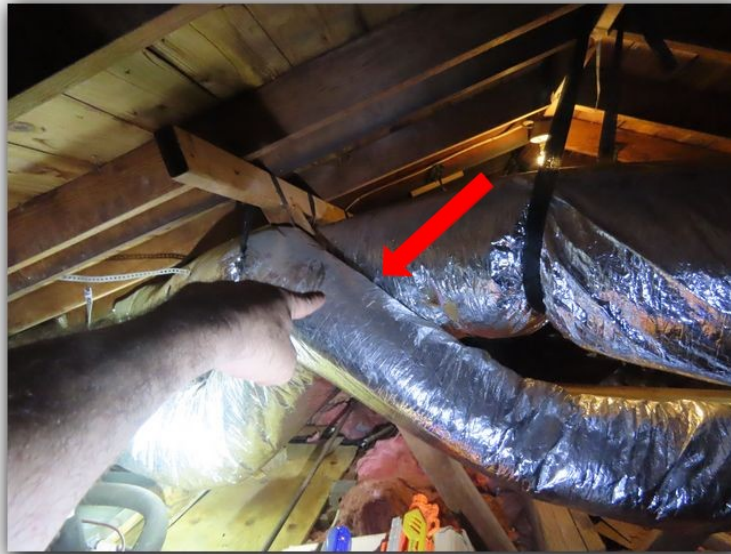
- **(DEFICIENCY) THE DUCTWORK THAT IS MAKING DIRECT CONTACT WITH EACH OTHER NEEDS TO HAVE BATT INSULATION PLACED BETWEEN THEM TO PREVENT CONDENSATION FROM FORMING.**

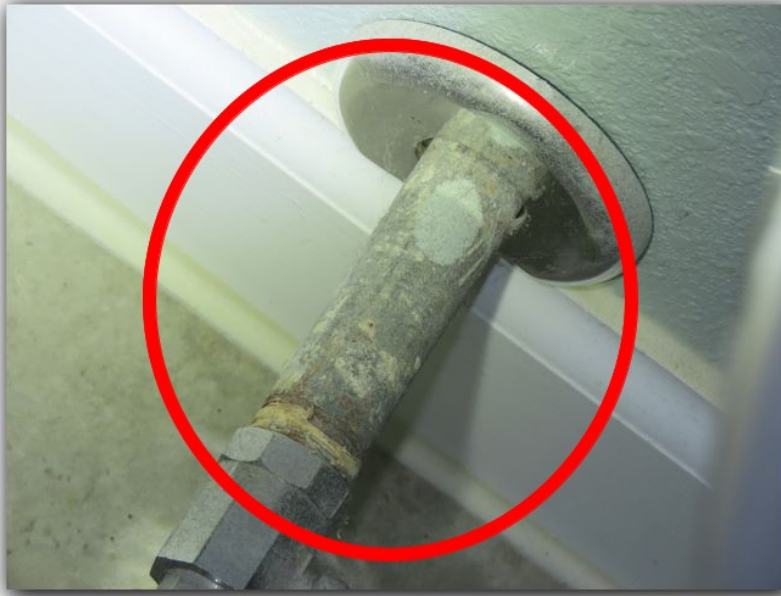
AND SHOWING IN THE ATTIC TO BE DOWN THE WALLS AS WELL. IN THE MASTER BATHROOM THERE IS GALVANIZED STEEL FOR THE COLD WATER AND APPEARS TO BE BLACK STEEL USED FOR GAS PIPING FOR THE HOT WATER NIPPLE UNDER THE SINK. RECOMMEND FURTHER EVALUATION OF THE PIPES IN THE MASTER BATH BY A PLUMBER. (DEFICIENCY)

☑ THE HOME DOES HAVE SOME GALVANIZED STEEL PLUMBING SUPPLY PIPES STILL VISIBLE AND PRESENT. GALVANIZED STEEL PLUMBING IS KNOWN FOR CORRODING ON THE INSIDE, REDUCED WATER FLOW, CLOGGED FIXTURES, AND PIN-HOLE LEAKS. THERE WAS EVIDENCE OF CORROSION, OR REDUCED WATER FLOW THAT WAS VISIBLE AT THE TIME OF INSPECTION. SOME PIPES IN THE ATTIC WERE COVERED WITH INSULATION AND NOT VISIBLE AND NOT ABLE TO GAIN ACCESS IN THE ATTIC TO THE MASTER BATHROOM OR KITCHEN LOCATIONS ONLY THE HALL BATH LOCATION. RECOMMEND OVERALL EVALUATION OF THE HOMES PLUMBING BY A LICENSED PLUMBER.

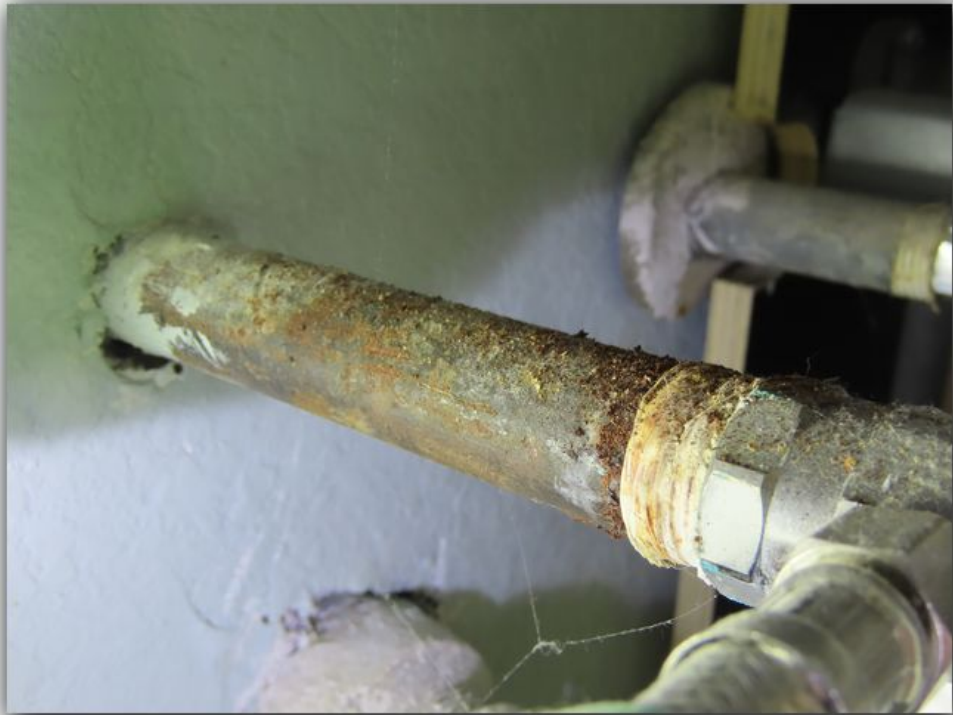
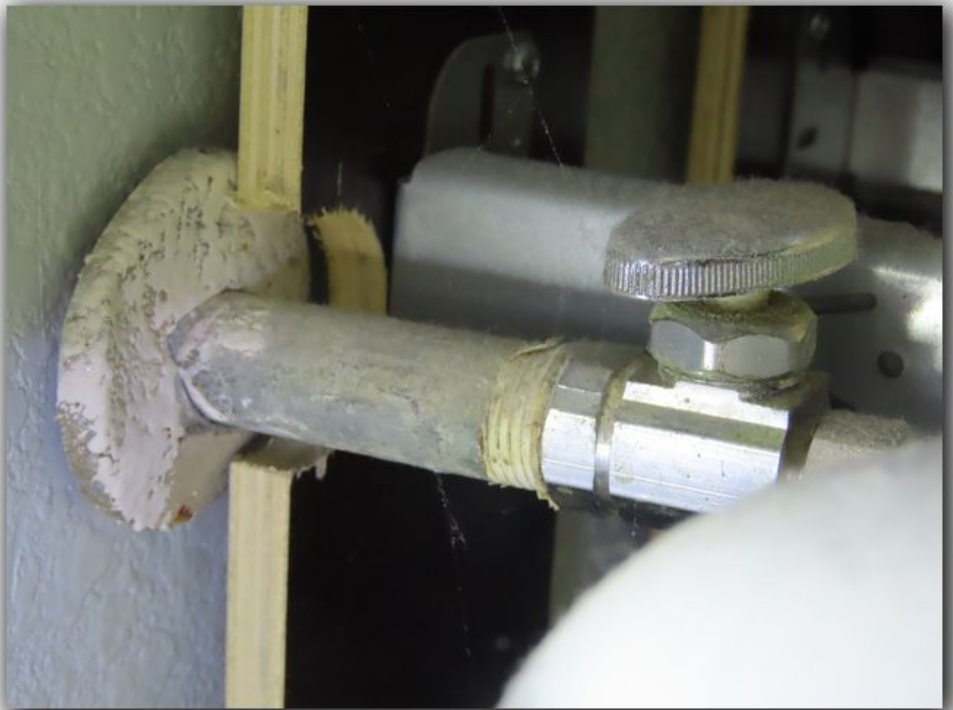
GALVANIZED STEEL PIPES UNDER THE MASTER BATH SINK THAT HAVE SOME CORROSION AND IN NEED OF REPAIRS OR REPLACEMENT BY A PLUMBER. (The hot water pipe appears to be possibly black steel used for gas piping, recommend evaluation by a plumber)

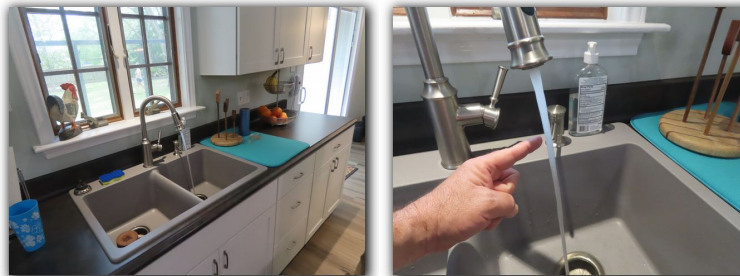
☑ THE KITCHEN SINK FIXTURE HAD WATER PRESSURE THAT WAS INCREASING AND DECREASING. RECOMMEND EVALUATION BY A PLUMBER AND ALSO A WELL INSPECTION AS WELL. (DEFICIENCY)

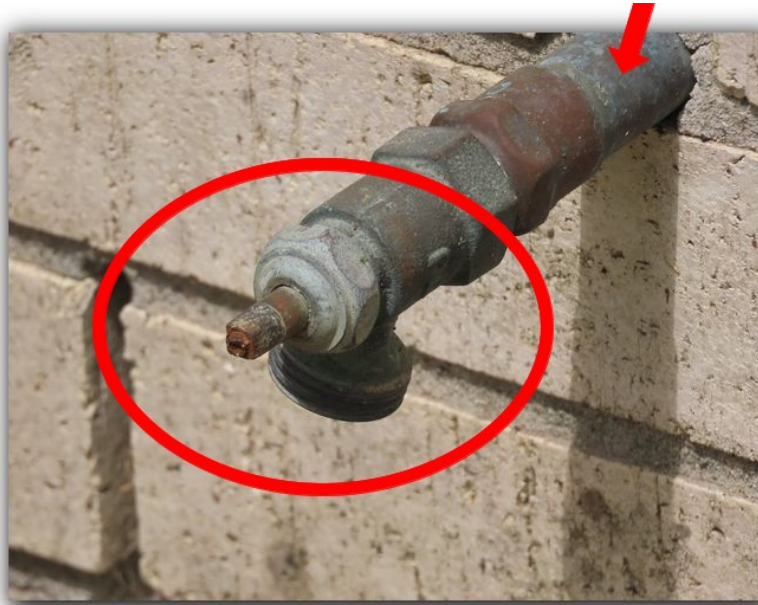
Faucet handles are loose, damaged or missing; NEEDS REPLACEMENT (COPPER SUPPLY PIPES AT THE HOSE BIB LOCATIONS) (DEFICIENCY)

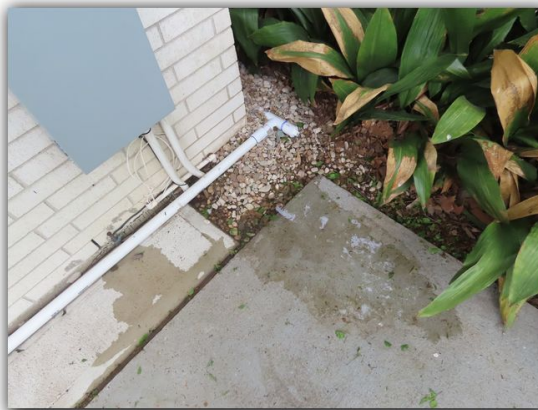
THE KITCHEN SINK AND LAUNDRY ARE DRAINING DIRECTLY OUT TO THE EXTERIOR GRADE AND PATIO, NOT TO THE SEPTIC SYSTEM. THIS IS NOT ALLOWED AND IN NEED OF EVALUATION BY A SEPTIC INSPECTOR AND MOST LIKELY WILL NEED A NEW SEPTIC SYSTEM INSTALLED. (DEFICIENCY)

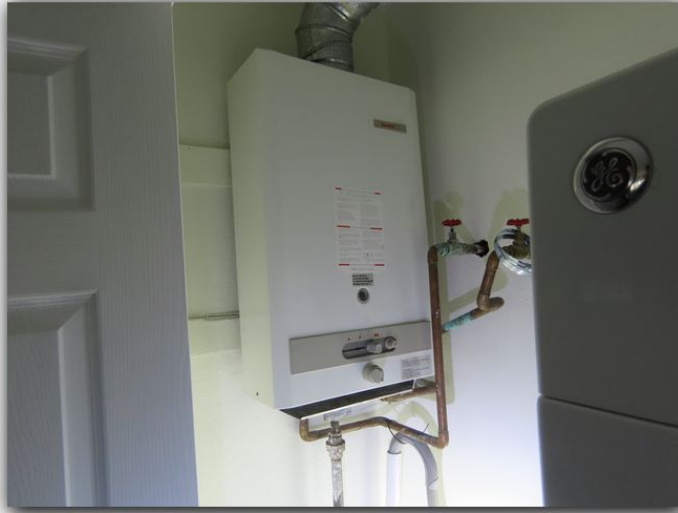
Comments: **REFER TO MANUFACTURER SPECIFICATIONS REGARDING CLEARANCES AND INSTALLATION. HOWEVER, THERE IS NOT ENOUGH CLEARANCE ON THE RIGHT SIDE WHERE THE INFORMATION STICKER IS LOCATED TO VIEW THE DETAILS OF THE AGE, SERIAL, MODEL INFORMATION. RECOMMEND EVALUATION OF THE UNIT REGARDING CLEARANCE AND PROPER INSTALLATION BY A PLUMBER.(DEFICIENCY)**

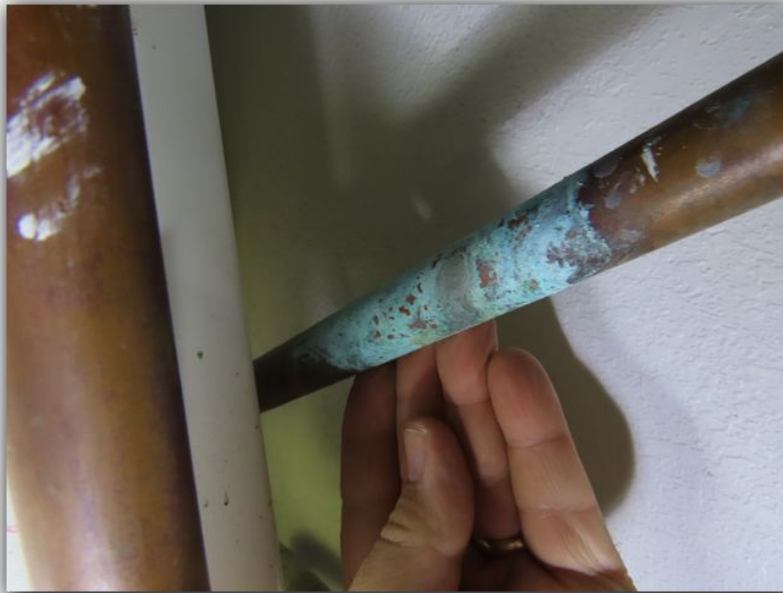
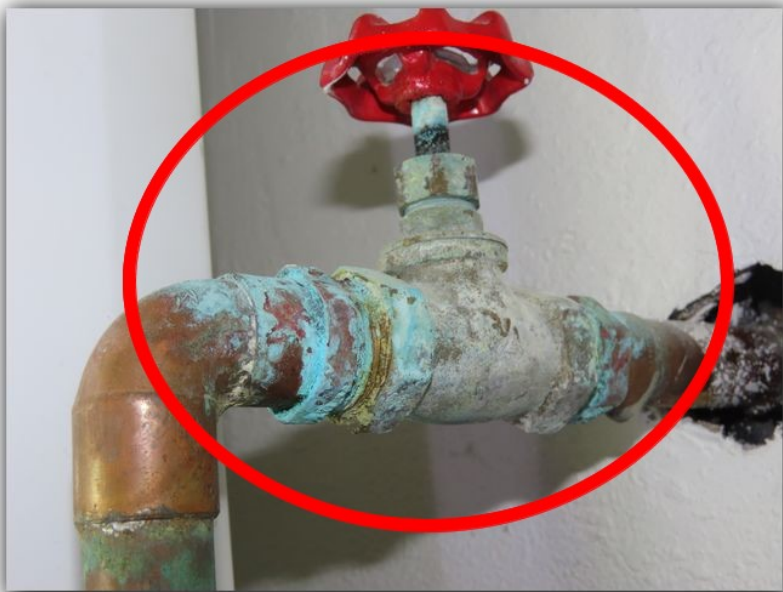
- **DEFICIENCY- Corrosion and/or signs of an intermittent leak at isolation valve and/or plumbing connections; IN NEED OF REPAIRS BY A LICENSED PLUMBER.(DEFICIENCY)**

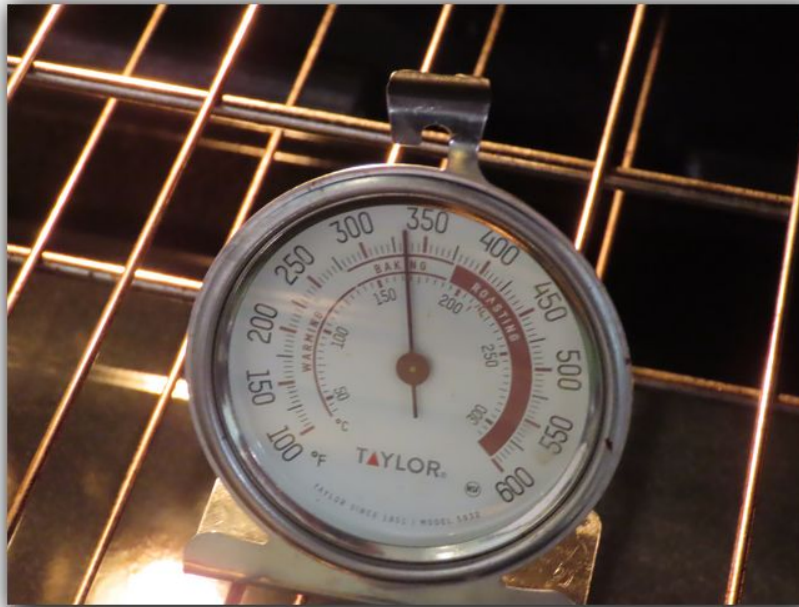
(BOTTOM OVEN) Tested at 350°F, Variance noted: **20 COLD** °F (max 25°F)

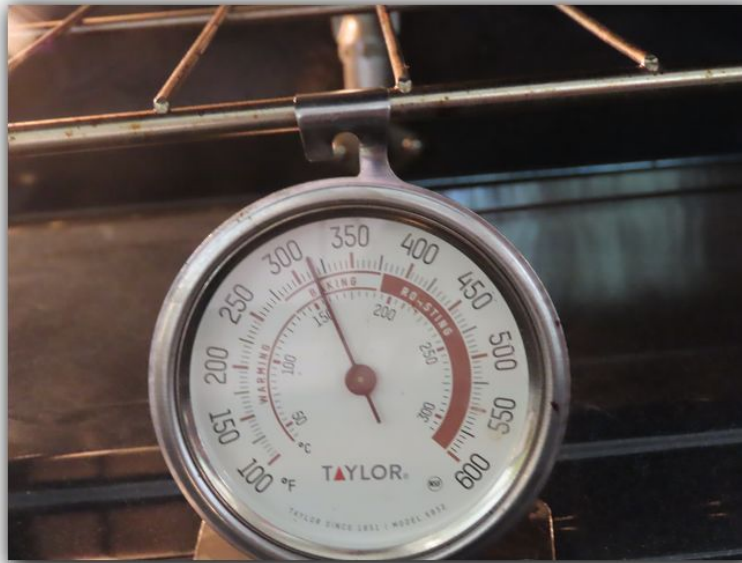
TOP OVEN WAS SHOWING 27 COLD; RECOMMEND REPAIRS BY AN APPLIANCE REPAIR PERSON. **(DEFICIENCY)**
