## **Inspection Report**

225 Narcissus

Lake Jackson, TX 77566

**By:** Jeff M Spencer, Lic #6365 11/28/2018  
(Name and License Number of Inspector) (Date)

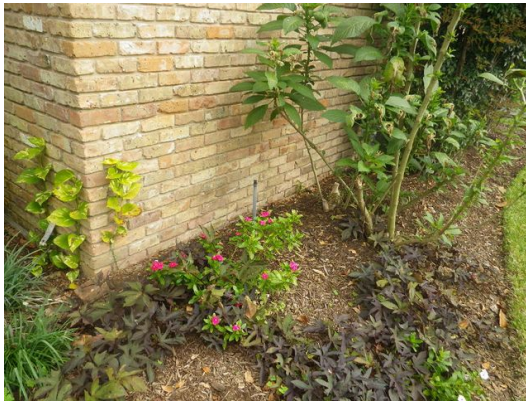
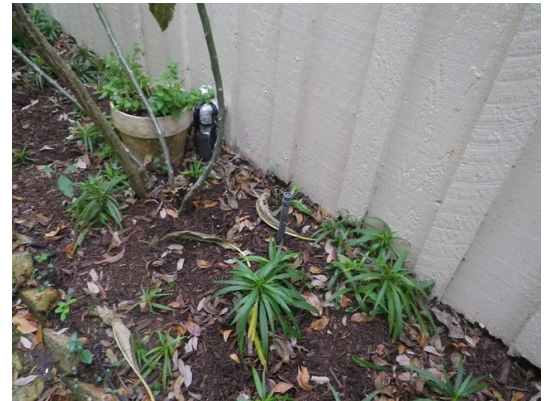
Insufficient clearance is present between finished grade and south and east walls of the house. Ideally, a minimum of 4 inches of clearance should be maintained between brick masonry and finished grade to minimize potential of damage from moisture and wood-destroying insects.

Insufficient clearance is present between finished grade and the south exterior wall of the detached garage, creating elevated risk of damage from moisture and wood-destroying insects. Ideally, a minimum of 6 inches of clearance should be maintained between finished grade and non-masonry exterior wall coverings.

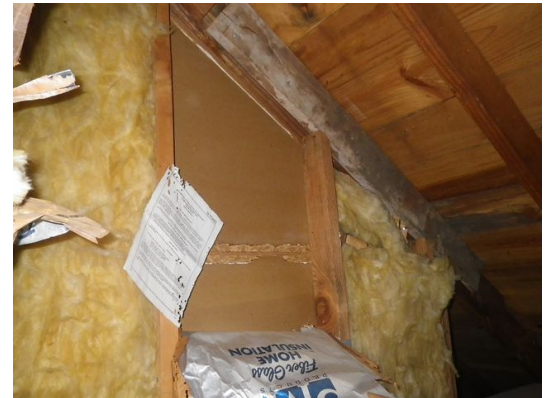
Obstruction prevented inspection of upper roof structure and insulation. All attic areas should be readily accessible. Improvement is recommended.

Insulation has partially detached from one stud bay on the north wall of the attic accessible in the second floor south bedroom closet, allowing increased thermal transfer between the attic and living area. Improvement is recommended.

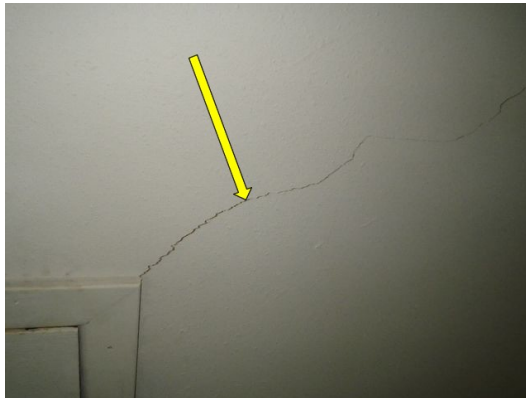
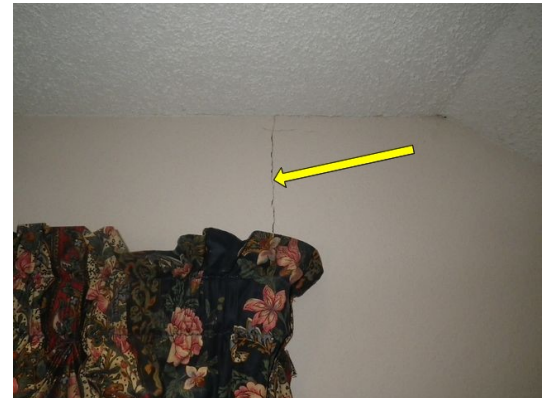
A sheetrock crack is present in the south wall of the second floor south bedroom at the upper right corner of the window opening. The crack is a type normally associated with superstructure settling. Further evaluation by a structural engineer is recommended.

A sheetrock crack is present in the rear wall of the second floor south bedroom's closet. The crack is a type normally associated with superstructure settling. Further evaluation by a structural engineer is recommended.

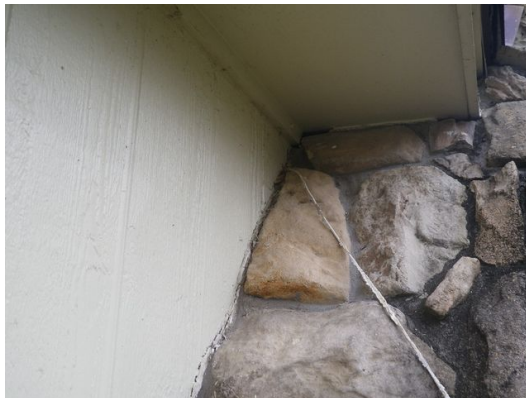
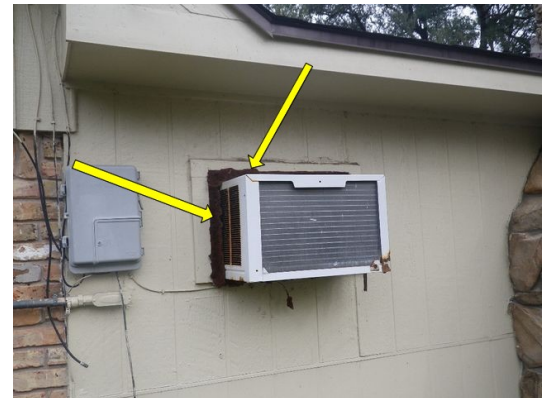
Flashing is not visible at the marriage line between the chimney and the south exterior wall. Mortar used to seal the chimney chase to the wall is porous and does not provide an effective long-term weather barrier.

Open-cell spray foam used to seal the window unit to the south wall of the rear addition can retain rainwater, causing hidden damage to wall structure and finish. Use of a manufacturer-rated seal kit is recommended.

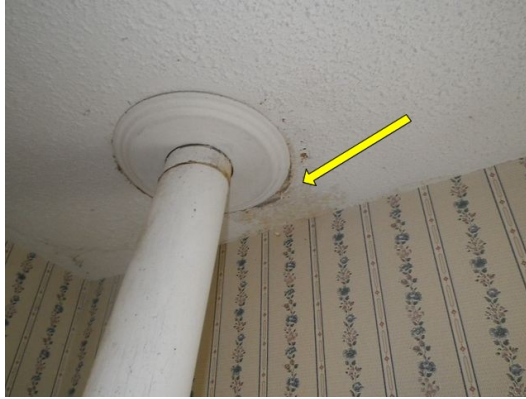
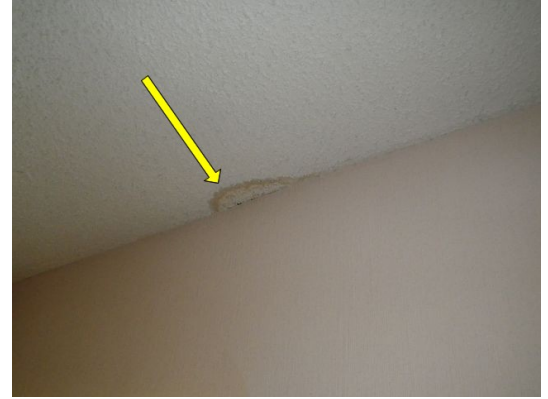
Water stains are present on the laundry room ceiling adjacent to the water heater flue secondary to previous leakage through the water heater's flue flashing. The drip cap appeared to be properly sealed the water heater flue at the time of inspection.

A water stain is present on the second floor center bedroom's ceiling near the center of the

front wall. The stain was dry at the time of inspection. Further evaluation by a roofing contractor is recommended if record of repair cannot be verified.

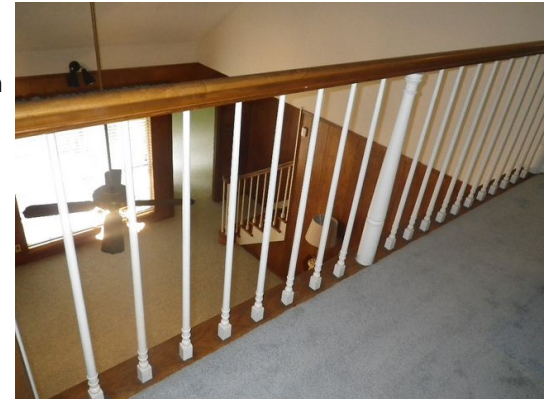
Second floor guard rails do not contain intermediate rails or ornamental closures which prevent passage of a sphere 4 inches or more in diameter as required.

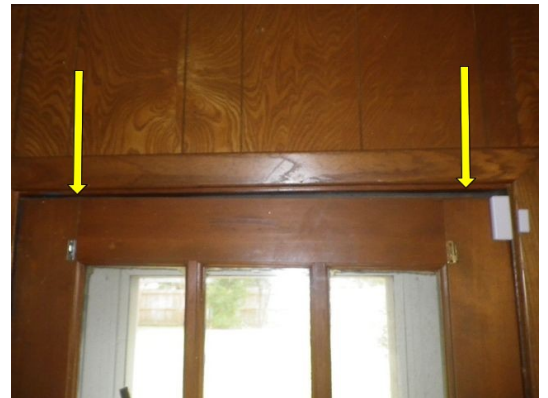
The den's exterior door jamb is racked, making the door extremely difficult to open. Adjustment is recommended.

Handles/knobs are not installed on the den's storm door.

The active panel of the sliding glass door is installed on the exterior side of the door's frame. The panel can be lifted out of the frame to gain access to living area. Re-installation in proper orientation or installation of a cam lock is recommended.

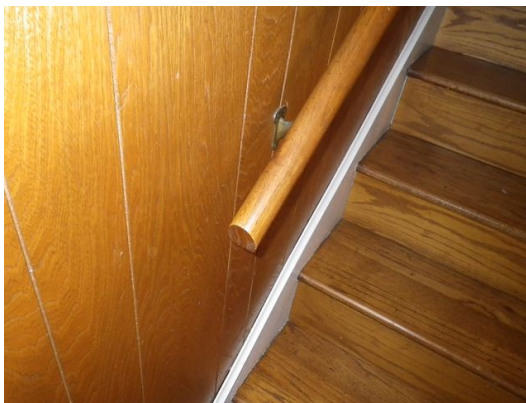
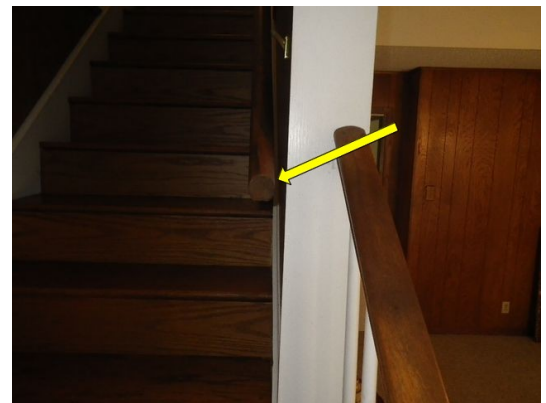
Stairway handrails are improperly terminated. The handrail should return to the wall or terminate at a newel post or safety terminal. Handrails should be continuous for the run of each flight.

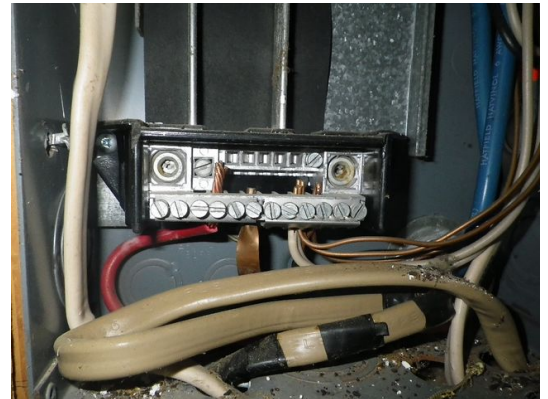
Electrical service is undersized. A 90-ampere main disconnect is installed; current codes require a service rating of a minimum of 100 amperes. Further evaluation by a licensed electrician familiar with residential load calculations is recommended.

Uses of circuit breakers are not completely marked on the panel directory as required. Improvement is recommended.

The panel and breakers are Zinsco brand products that are no longer in production. Replacement components are becoming expensive and are difficult to locate. Industry professionals consider these panels to be problematic due to their use of aluminum bus bars. Over time, oxidation of the aluminum causes increased resistance at breaker connections that can cause overheating and accelerated wear of components. Expert testing on this equipment has shown that circuit breakers do not trip about 25% of the time when exposed to overcurrent - risking overheating, fire and other hazards. The failure rate of competitive-brand circuit breakers is much less than 1%. Further evaluation of this panel by a qualified electrician is recommended.

Branch circuits in the switch panel are improperly grounded ahead of the electrical system's main disconnect; ground and neutral wires are co-mingled on panel bus bars.

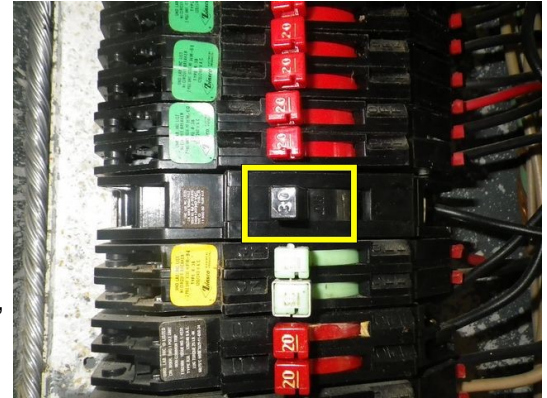
The switch panel does not contain sufficient means of full electrical disconnect. A total of 14 circuits are installed in the panel without a main disconnect breaker. Full electrical disconnect should be achieved by 6 or fewer hand movements. Repair or replacement of the panel by a licensed electrician is recommended.

A single-pole 30-ampere breaker switch is installed in the switch panel. There are no devices installed in the house requiring 120-volt, 30-ampere service. Replacement with a properly sized/rated breaker switch compatible with ampacity of connected devices is recommended.

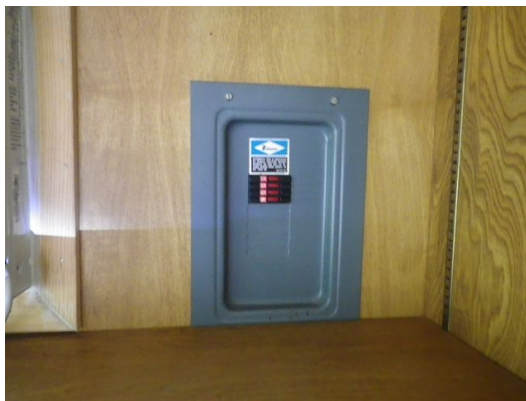
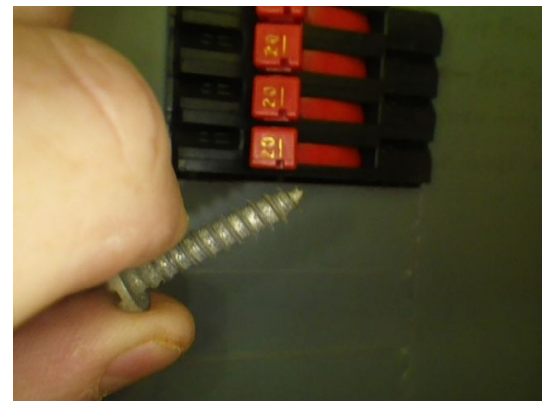
The double-pole 40-ampere breaker at the bottom of the panel has a poor connection with the bus bar, creating risk of resistance heating.

The panel and breakers are Zinsco brand products that are no longer in production. Replacement components are becoming expensive and are difficult to locate. Industry professionals consider these panels to be problematic due to their use of aluminum bus bars. Over time, oxidation of the aluminum causes increased resistance at breaker connections that can cause overheating and accelerated wear of components. Expert testing on this equipment has shown that circuit breakers do not trip about 25% of the time when exposed to overcurrent - risking overheating, fire and other hazards. The failure rate of competitive-brand circuit breakers is much less than 1%. Further evaluation of this panel by a qualified electrician is recommended.

Uses of circuit breakers are not completely marked on the panel directory as required. Improvement is recommended.

Pointed screws used to secure the dead front to the panel enclosure are not rated for use on service equipment; they are subject to penetrate wire insulation, creating risk of dead short. Replacement with blunt-tipped screws rated for use on service equipment is recommended.

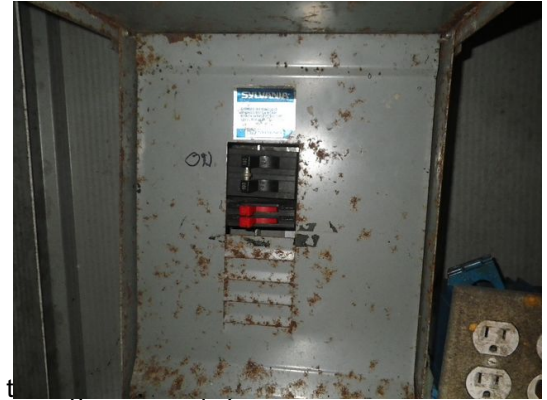
Access to the panel is obstructed by shelving and has potential to be hidden by stored items. A clear area with a minimum of 6 feet, six inches height, 36 inches depth and 30 inches width should be maintained around service panels to facilitate maintenance and repairs.

The panel and breakers are Zinsco brand products that are no longer in production. Replacement components are becoming expensive and are difficult to locate. Industry professionals consider these panels to be problematic due to their use of aluminum bus bars. Over time, oxidation of the aluminum causes increased resistance at breaker connections that can cause overheating and accelerated wear of components. Expert testing on this equipment has shown that circuit breakers do not trip about 25% of the time when exposed to overcurrent - risking overheating, fire and other hazards. The failure rate of competitive-brand circuit breakers is much less than 1%. Further evaluation of this panel by a qualified electrician is recommended.

Uses of circuit breakers are not completely marked on the panel directory as required. Improvement is recommended.

The panel and breakers are Zinsco brand products that are no longer in production. Replacement components are becoming expensive and are difficult to locate. Industry professionals consider these panels to be problematic due to their use of aluminum bus bars. Over time, oxidation of the aluminum causes increased resistance at breaker connections that can cause overheating and accelerated wear of components. Expert circuit breakers do not trip about 25% of the time when exposed to overcurrent - risking overheating, fire and other hazards. The failure rate of competitive-brand circuit breakers is much less than 1%. Further evaluation of this panel by a qualified electrician is recommended.

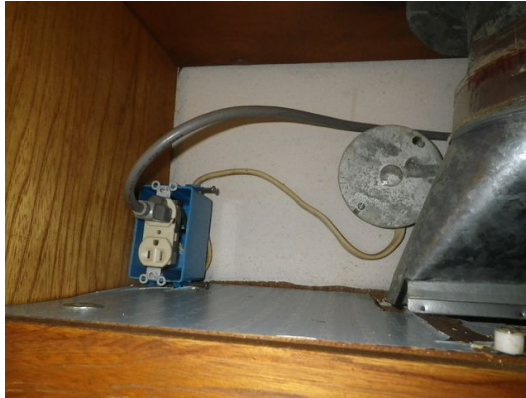
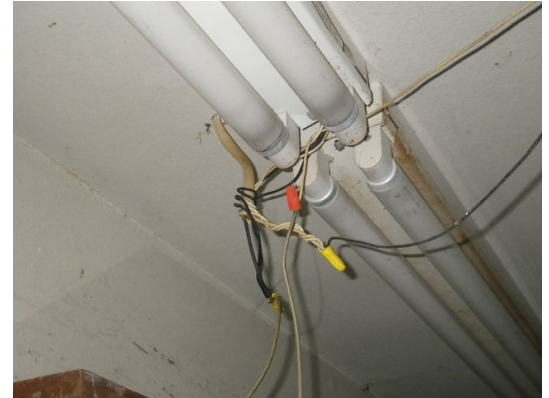
Non-metallic sheathed wire exposed in the cabinet above the microwave oven is not rated for unprotected installation and is subject to damage from stored items. The wire should be contained in flexible metal conduit or equivalent.

Unprotected connections are present on wire serving the garage ceiling fan. All wire connections should be contained in covered junction boxes that are secured to structure. All instances should be identified and repaired by an electrician.

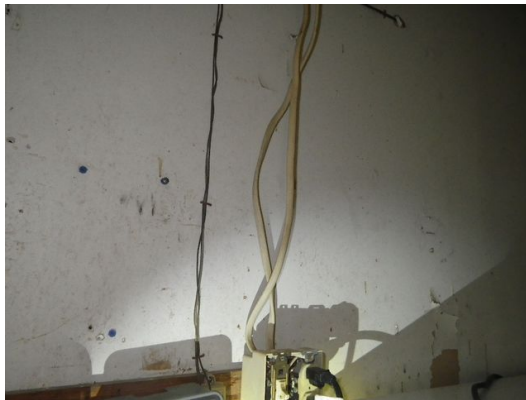
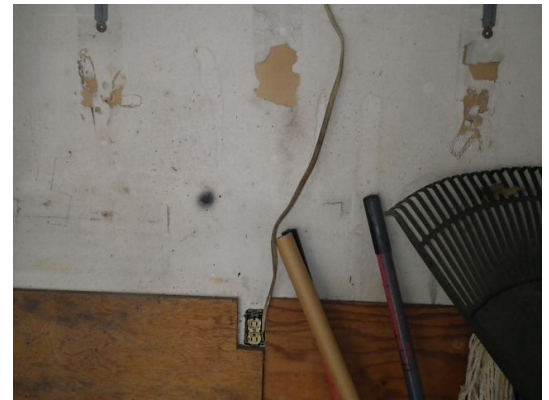
Non-metallic sheathed wires surface-mounted on the south and east interior wall of the garage are not rated for unprotected installation and are subject to damage from stored items. The wires should be contained in conduit or routed within the wall cavity.

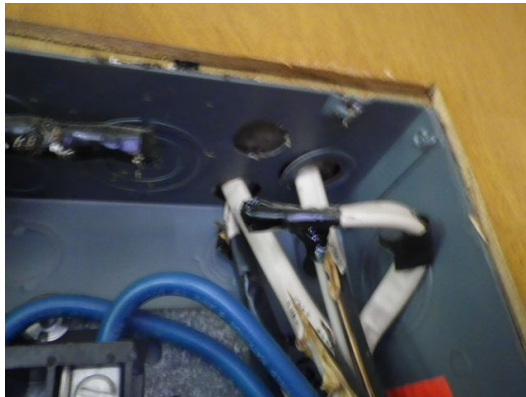
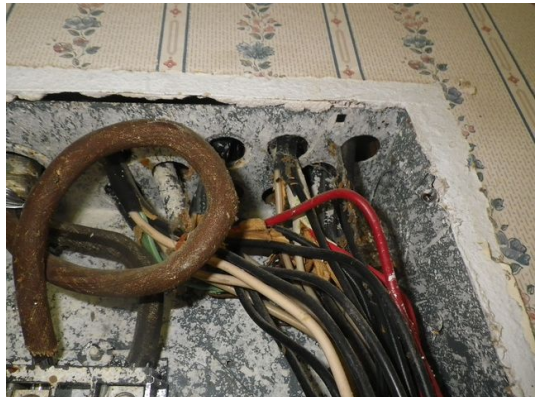
Wires entering switch panels are not protected by bushings or wire clamps as required, making them subject to abrasion damage on knockout edges.

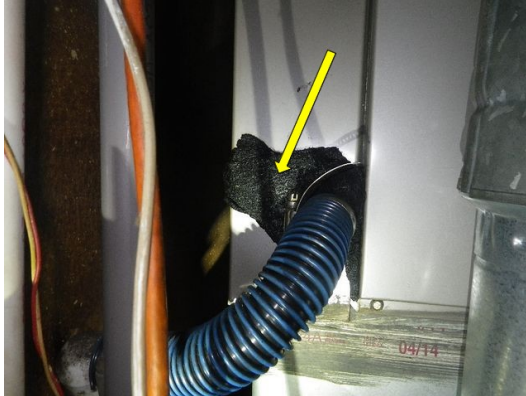
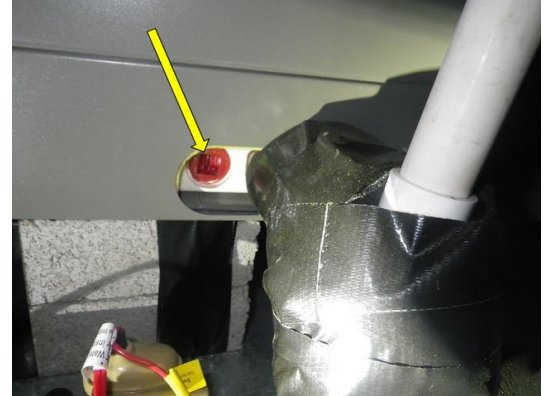
Secondary drains in evaporator coil housings of both HVAC systems are not tapped and plumbed to discharge into auxiliary drain pans as required. This condition could allow excess condensate retention in the event of primary drain obstruction that could result in accelerated corrosion of evaporator coil enclosures. Installation of drains terminating in both auxiliary drain pans is recommended.

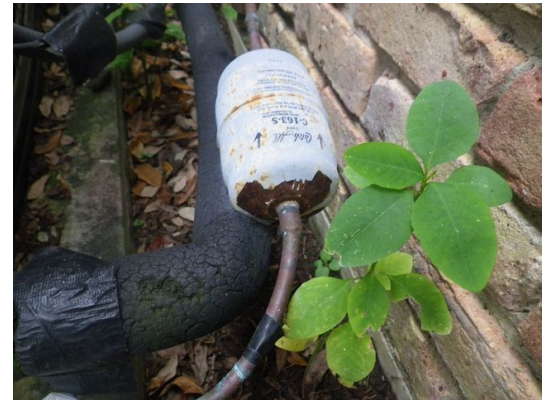
The dryer filter on refrigerant tubing of the south HVAC system is heavily rusted. Repair is recommended prior to rust-through that can cause loss of refrigerant.

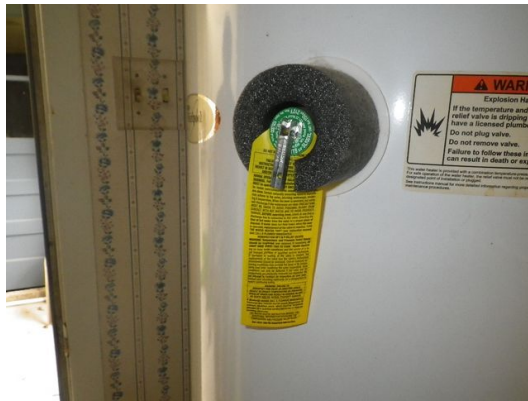
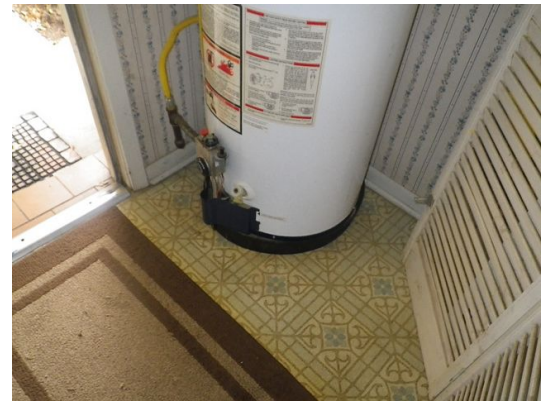
Installation of a drained safety pan is recommended. A safety pan should be present when a water heater is installed in a location where leakage could cause damage to structure or finish.

The water heater rumbles during operation secondary to mineral build-up within the tank.

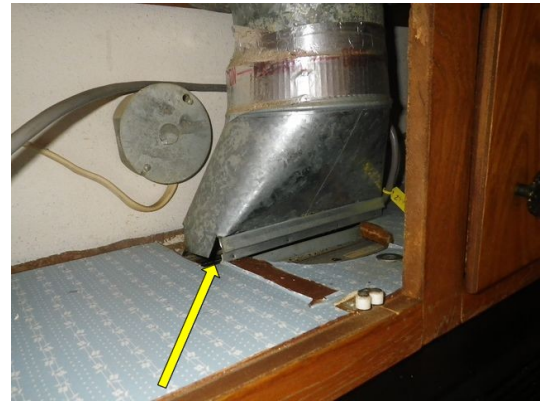
**C. Range Hood and Exhaust Systems**  
Air leaks into the cabinet above the microwave oven during fan operation, indicating improper fit and sealing of the transition on the exhaust duct. Repair is recommended.

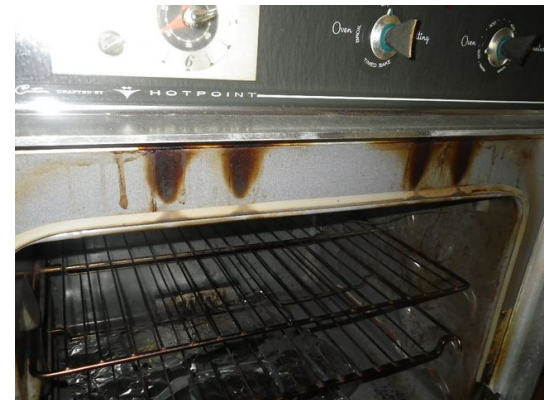
**D. Ranges, Cooktops, and Ovens**  
The cooktop's right front rheostat switch is inoperative.  
The oven door seal leaks and is in need of replacement.

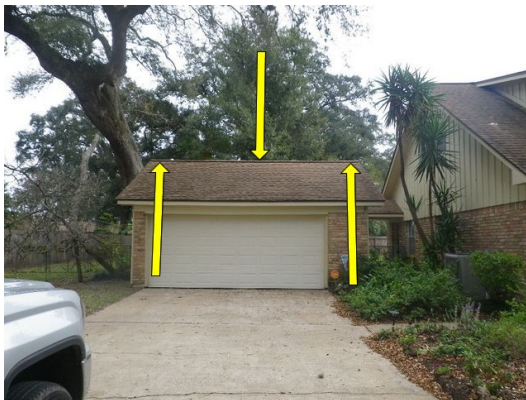
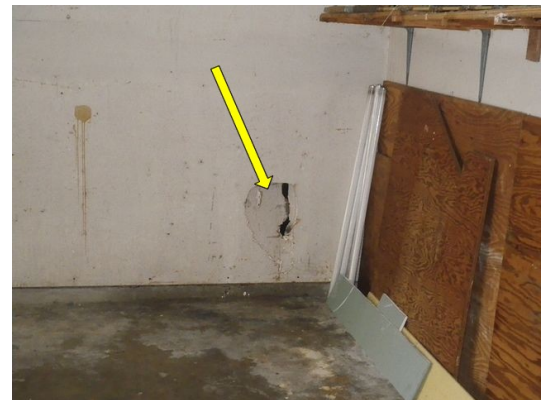
Deflection is visible in roof structure of the detached garage. Further evaluation by a structural engineer is recommended.

Sheetrock has been damaged by impact on the garage's north interior wall. Repair is recommended.

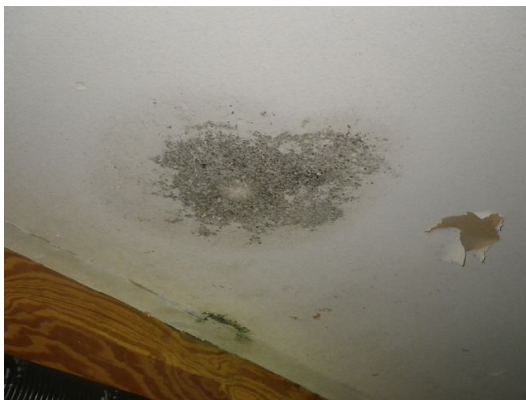
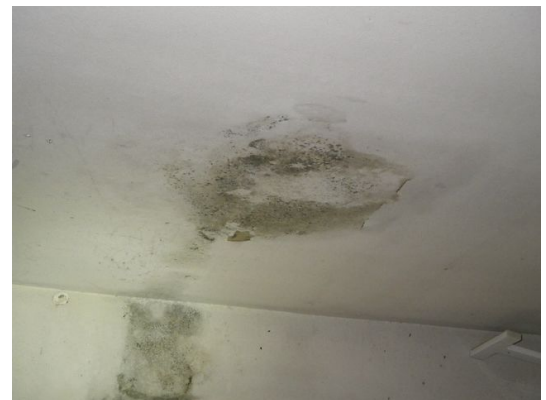
Mold growth is present on the garage ceiling, located near the ceiling center near the garage door opening and near the rear wall. The areas were dry at the time of inspection. No visible damage was present on corresponding roof surfaces and it appears that the condition pre-dates the most recent installation of roof coverings. Further evaluation is recommended if record of previous repair cannot be conclusively validated.

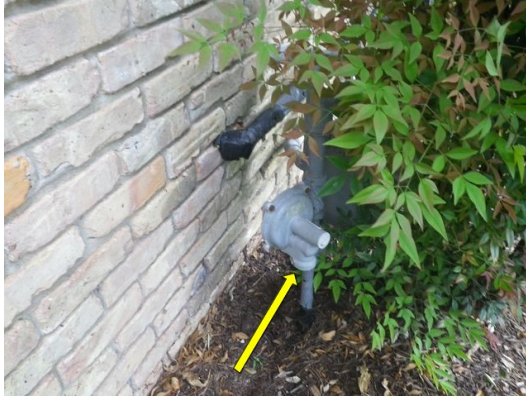
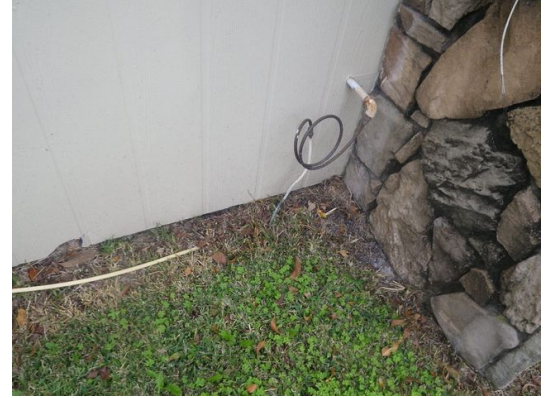
Gas is leaking from the regulator on the gas meter. Gas odors are detectable throughout the south yard area. The gas utility should be contacted for repair/meter replacement.

Gas tubing is installed on-grade adjacent to the south exterior wall, making it subject to damage from lawn maintenance equipment. The tubing should be buried at a minimum of 18 inches depth.
