PROPERTY INSPECTION REPORT

Concerning: 207 E Texas, Calvert, TX
(Address or Other Identification of Inspected Property)

By: Don Murphy, Lic ##2674 03/22/2021
(Name and License Number of Inspector) (Date)

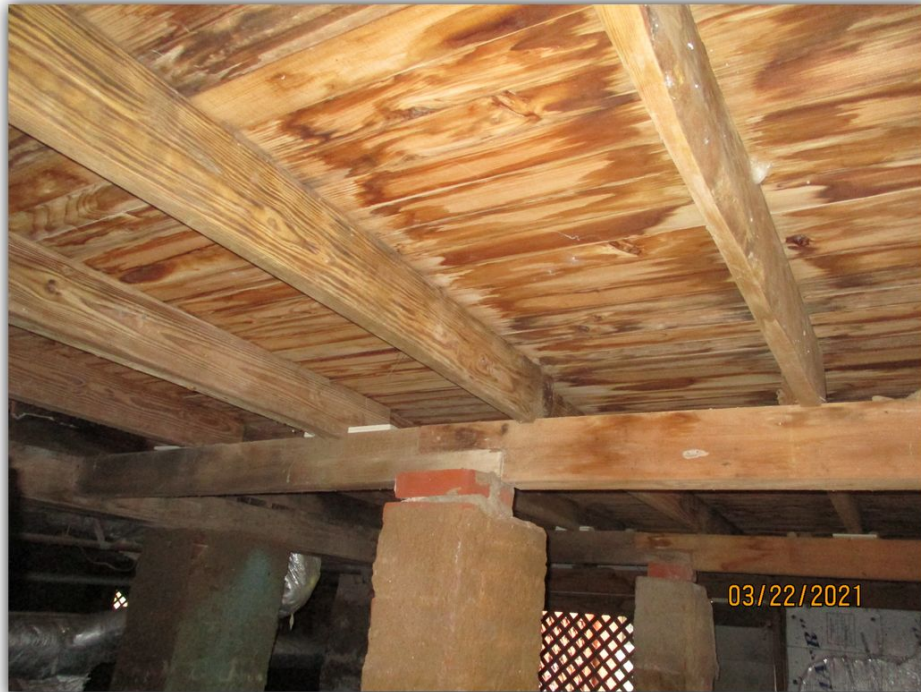
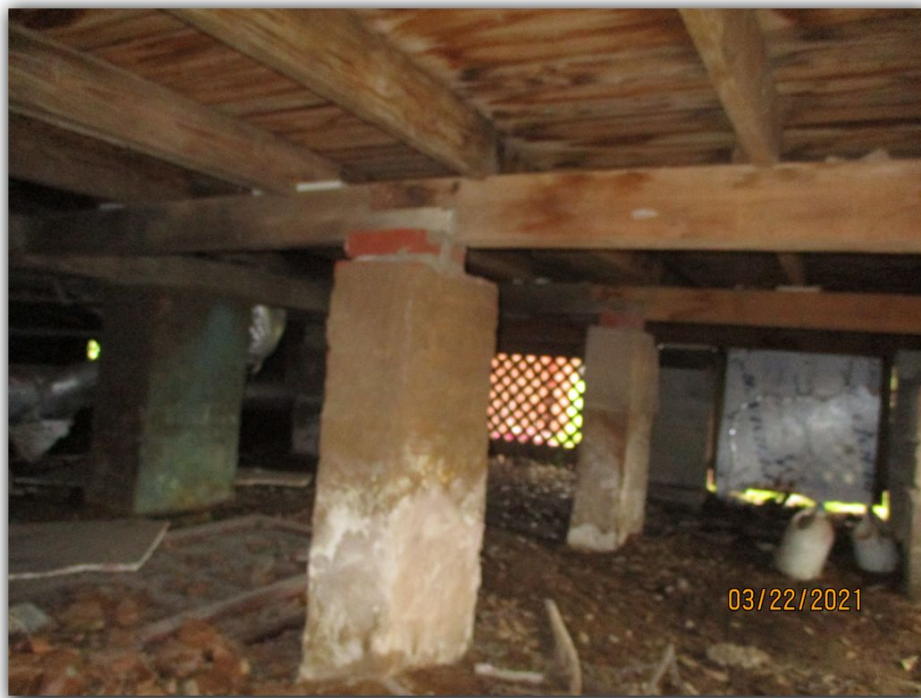
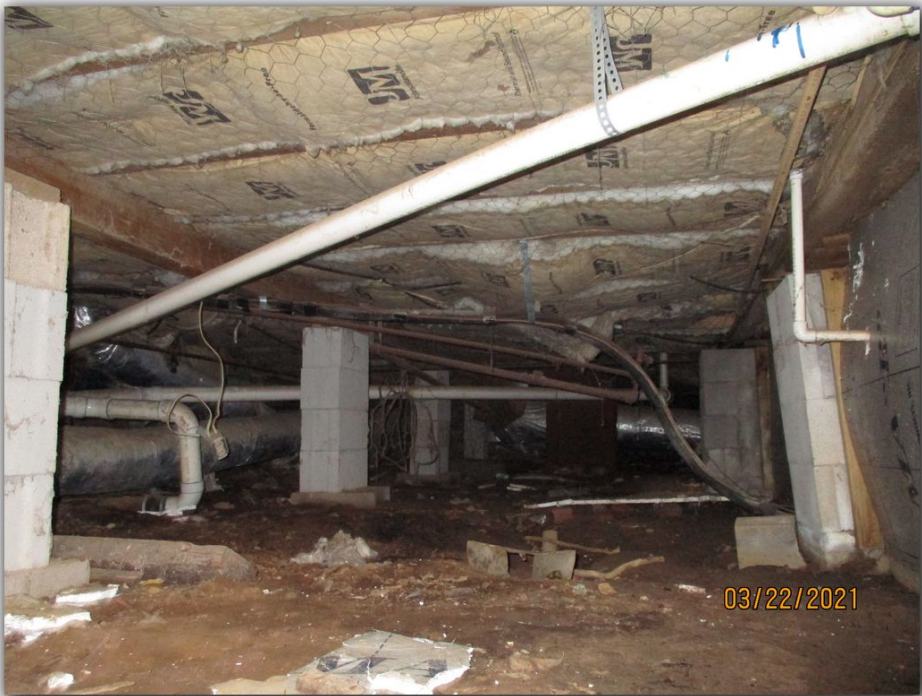
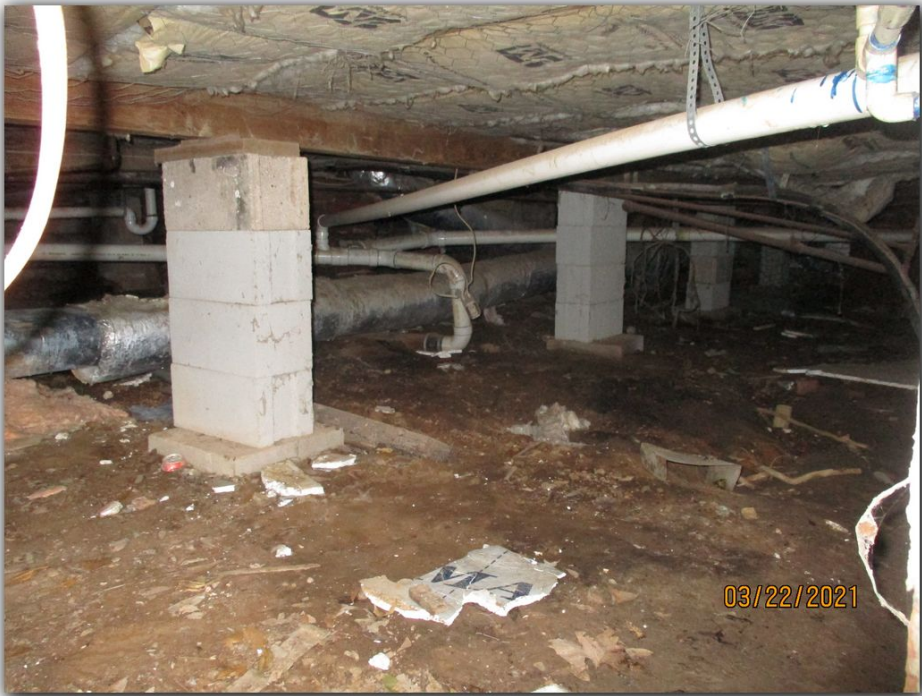
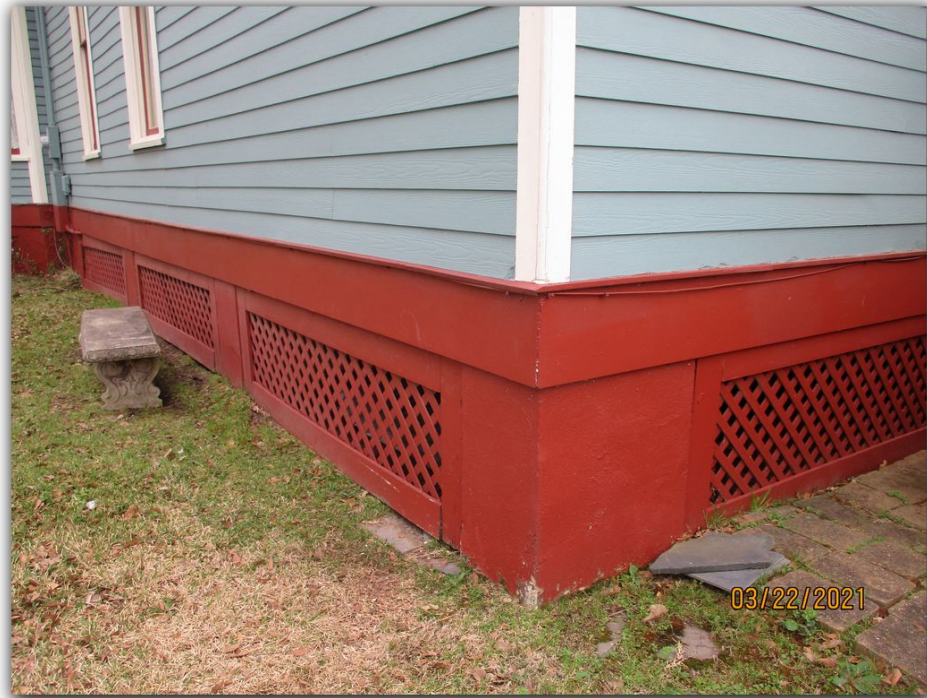
- ☒ Strike plate/alignment (on several of the interior doors).
- ☒ Twisted float joints
- ☒ The kitchen floors and consequently the upper level floors were not level
- ☒ Deteriorated brick pier/beam condition
- ☒ Some of the brick piers may need additional supports or piers installed near the brick piers.
- ☒ Door / window frames out of square

- ☒ Signs of structural movement or settling noted primarily in the kitchen area where the old brick piers are in use for foundation support. We suggest that an expert in this field be consulted for further evaluation of the structure and to provide suggestions as to what, if any, corrective actions should be taken.

In the event that structural movement is noted, client is advised to consult with a Structural Engineer who can isolate and identify causes, and determine what corrective steps, if any, should be considered to either correct and/or stop structural movement.

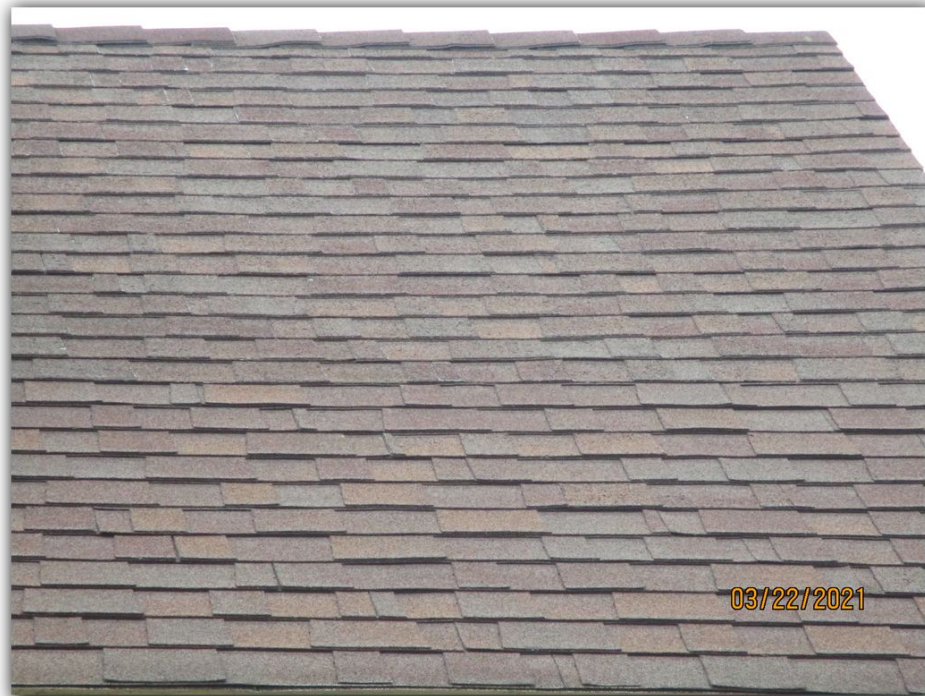
☒ Torn, damaged and perforated shingles. Some signs of hail damage and excessive wear. The roof exhibited excessive granule loss typical of long-term weathering. This is a natural part of the aging process and can be expected to continue. The roof covering is in need of replacement or extensive repairs, a Professional Roofing Company should be consulted.

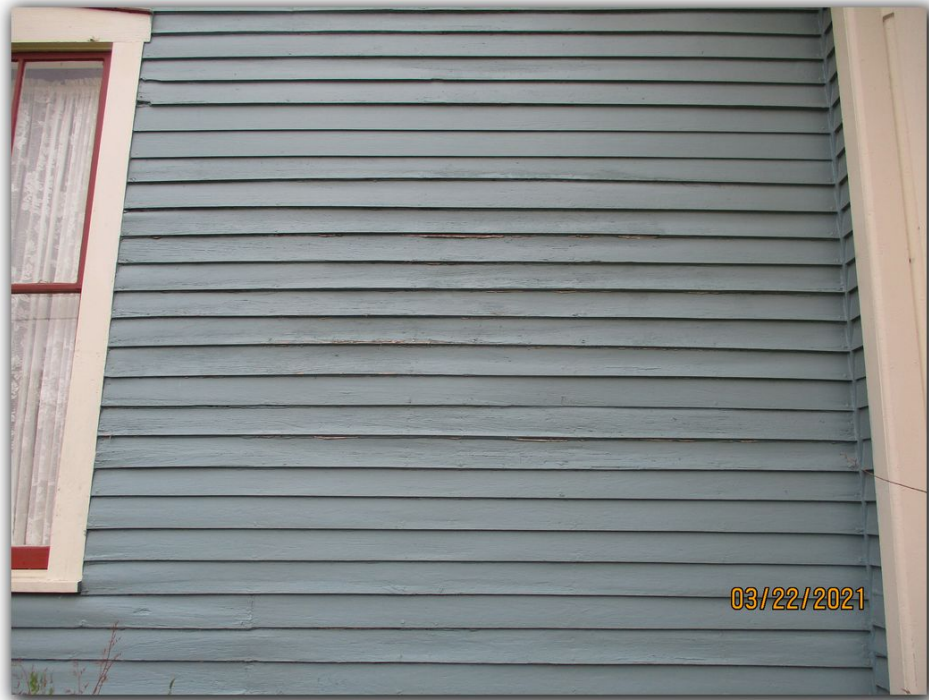
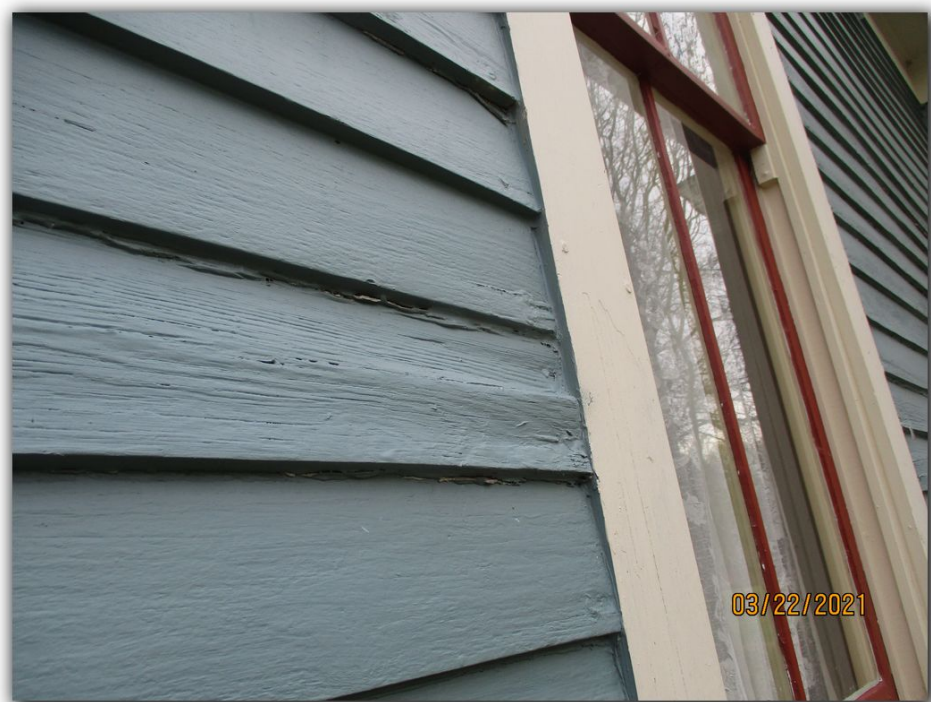
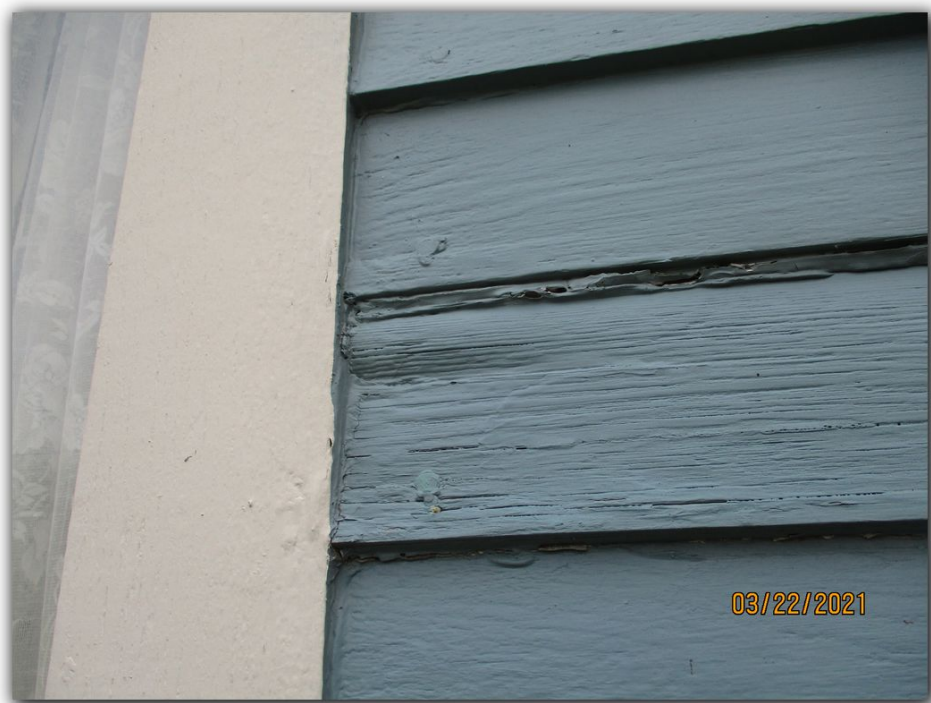
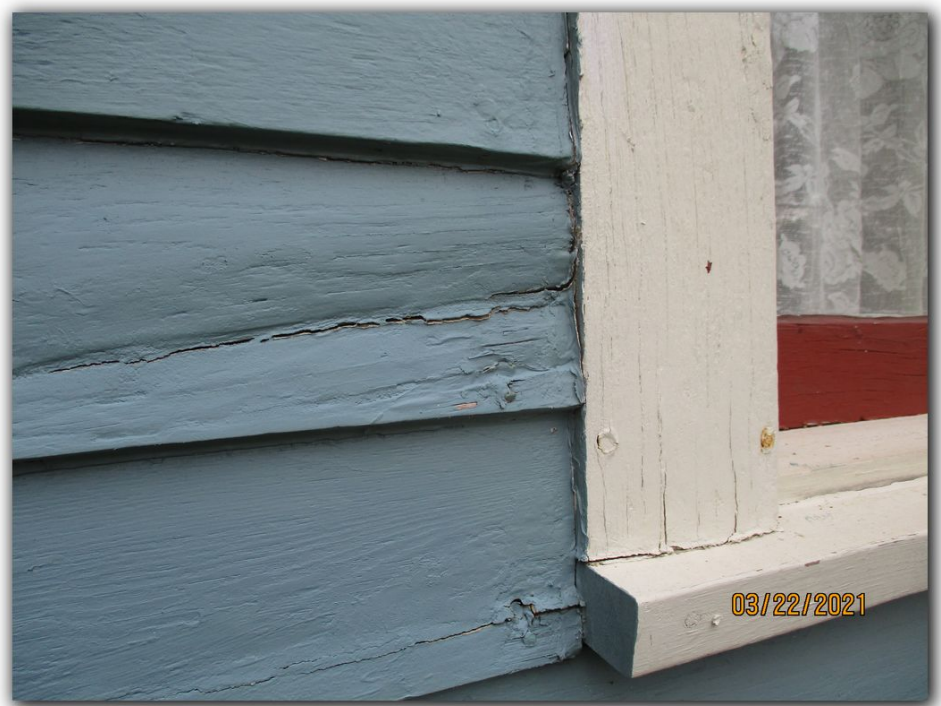
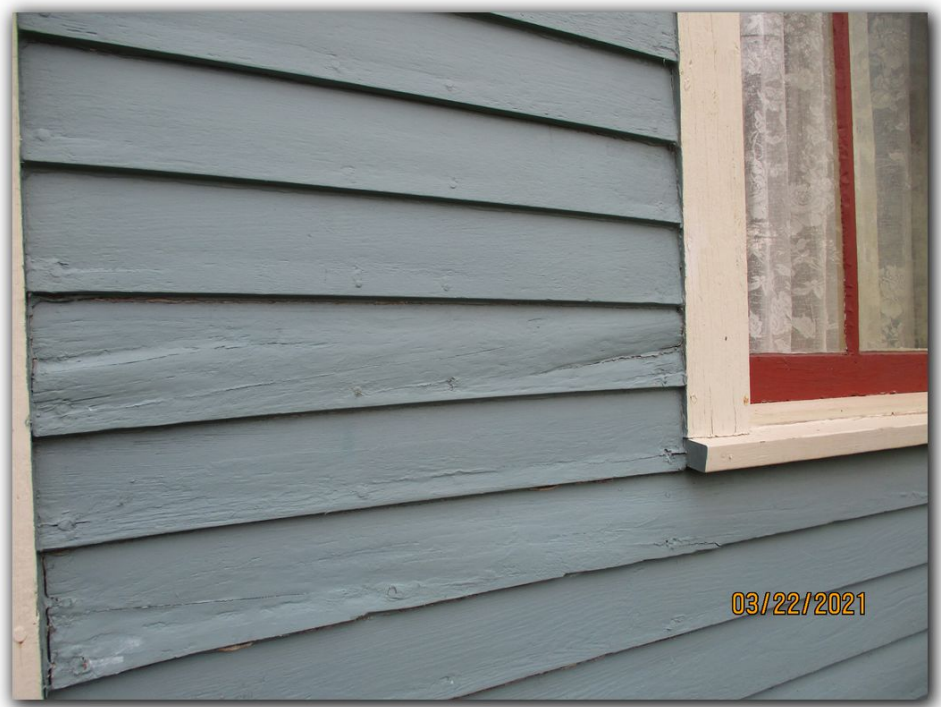
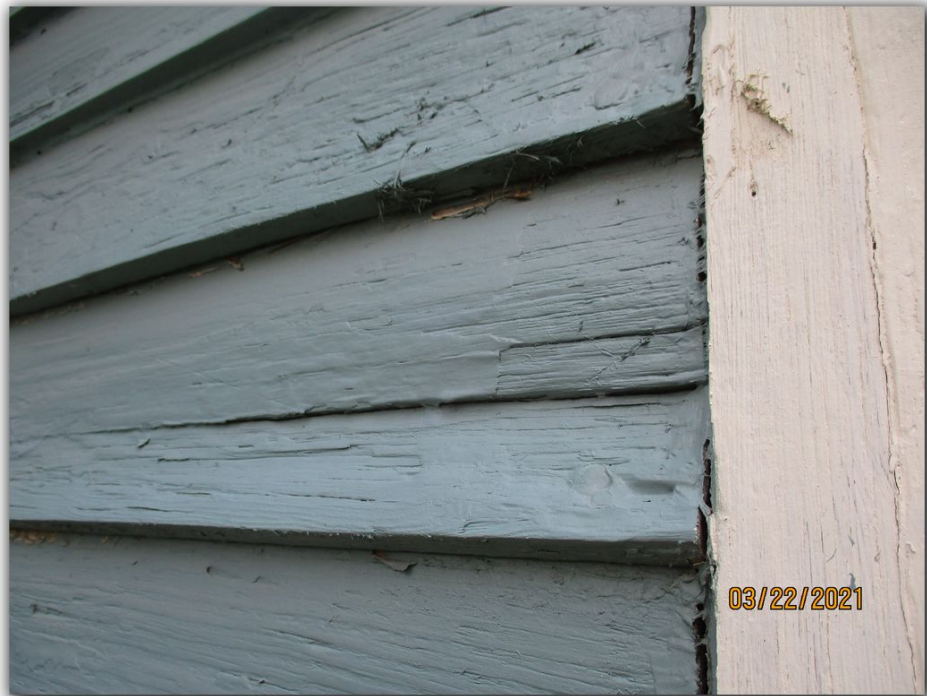
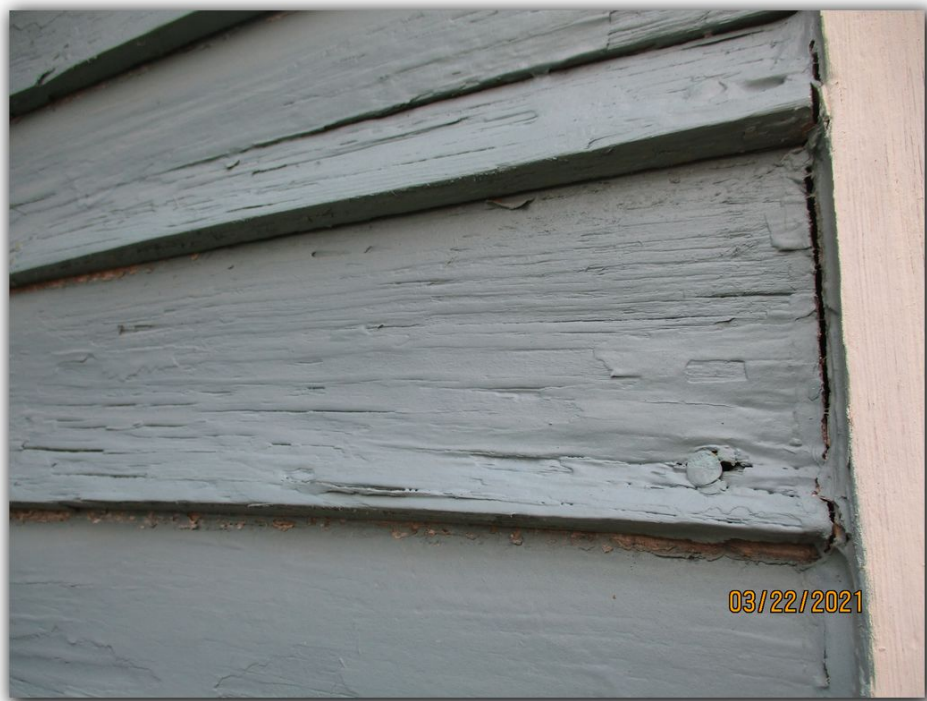
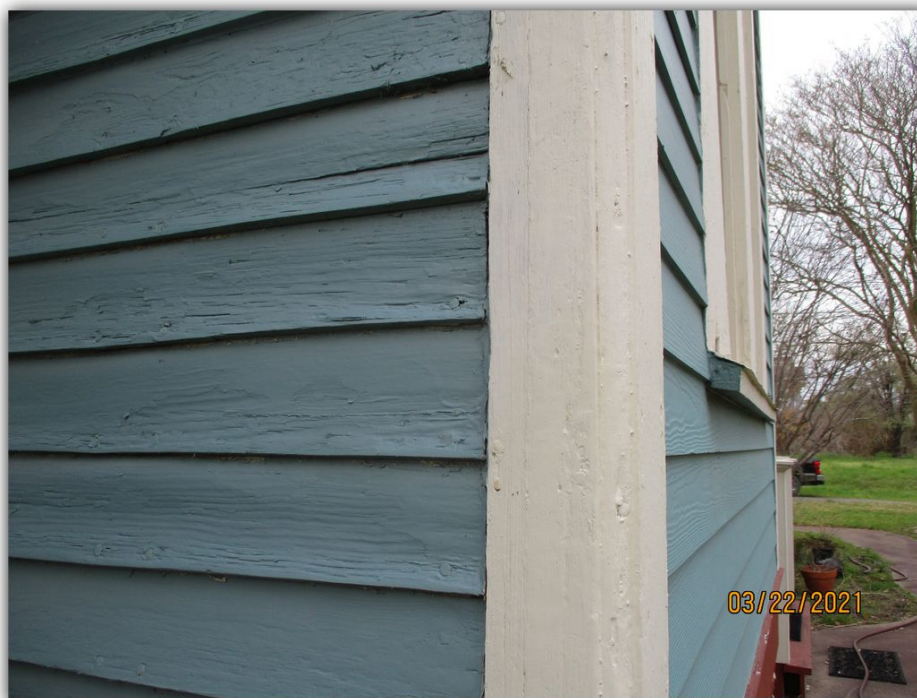
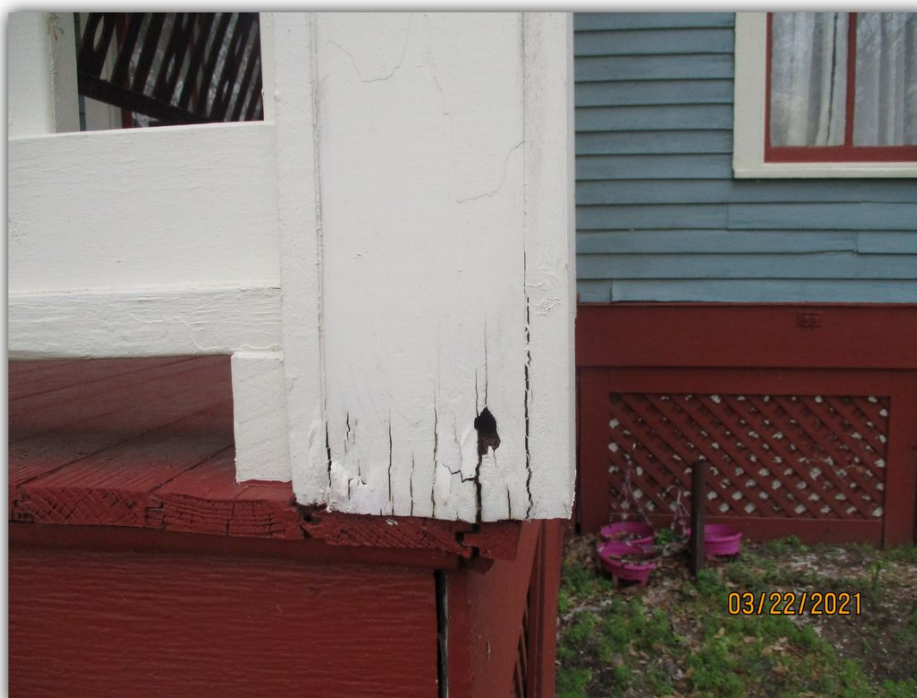
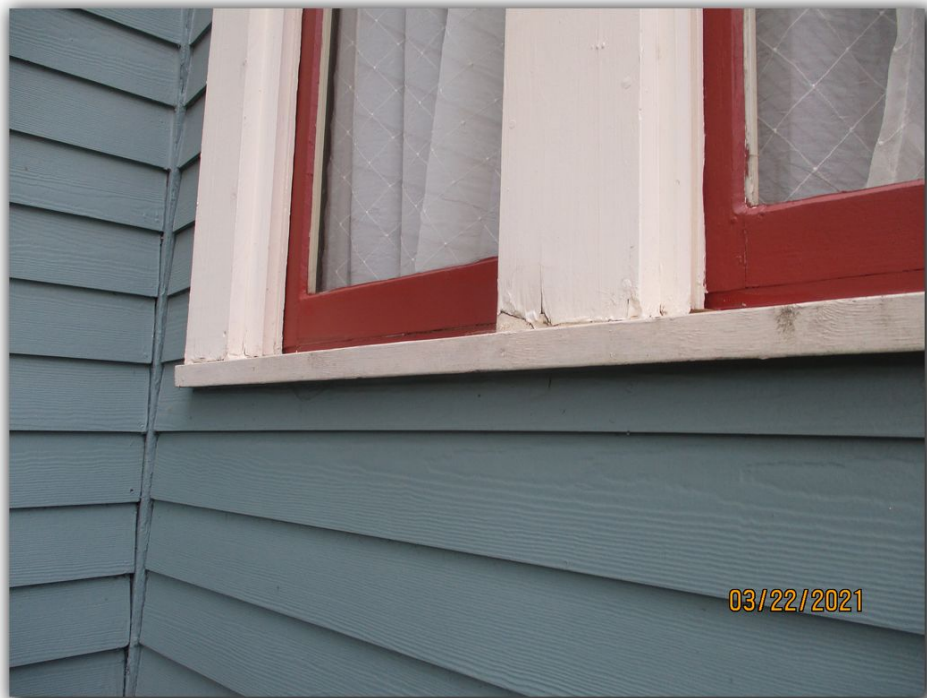
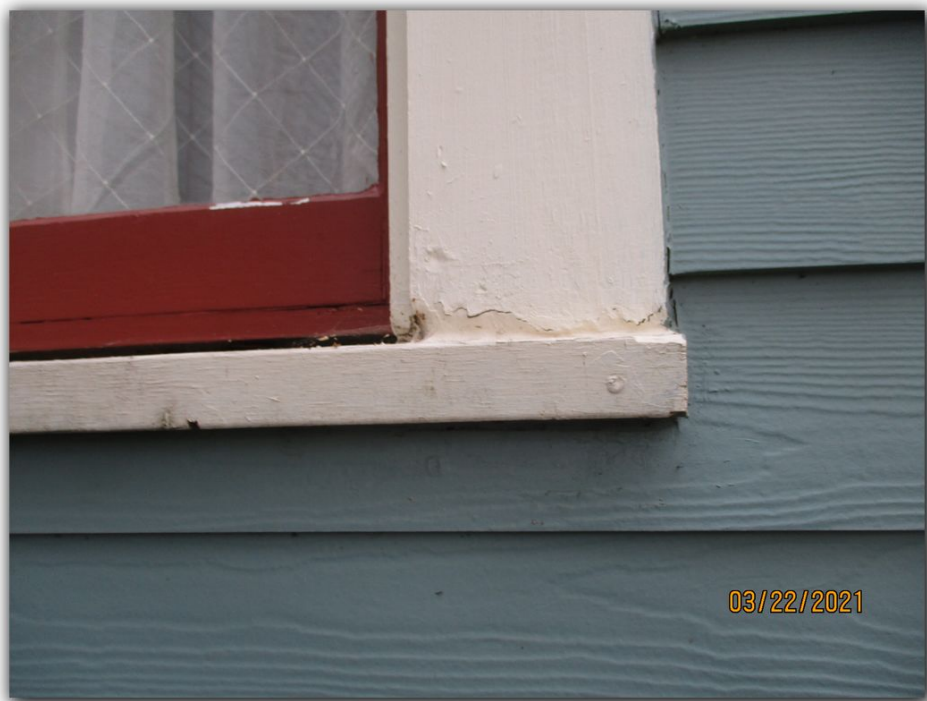
- ☒ Wood siding in the areas where the older (original) siding was located had areas with some visible decay or damage to the old siding.

- ☒ There were areas around several of the windows with the bottom areas of the window trim having some visible decay.

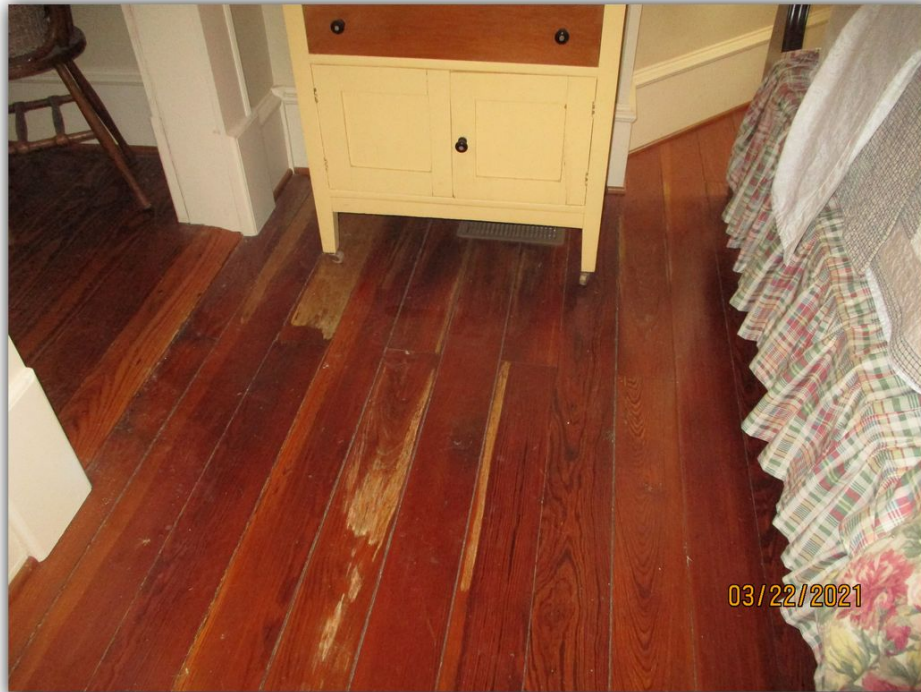
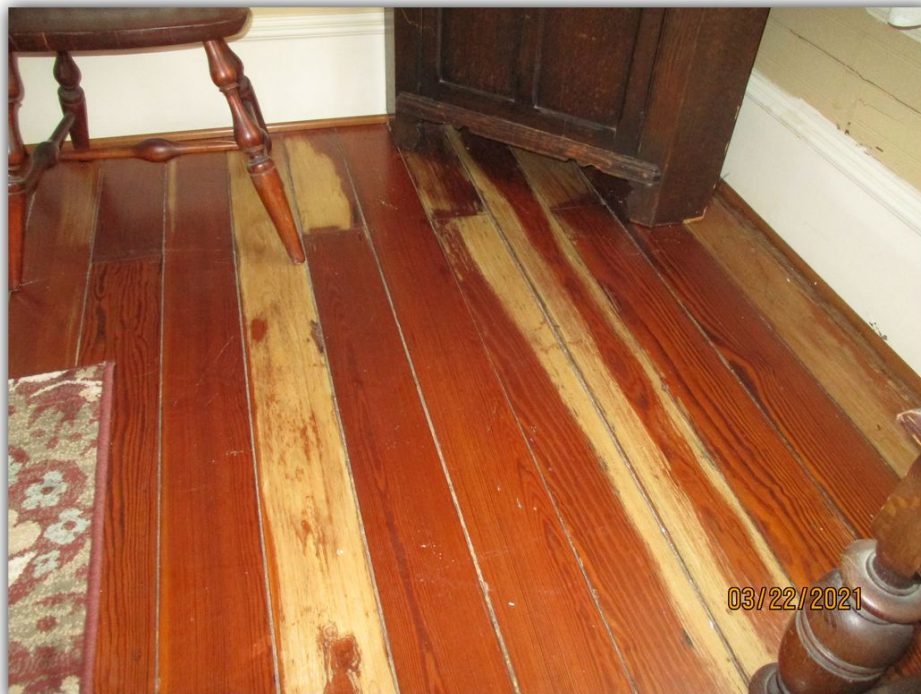
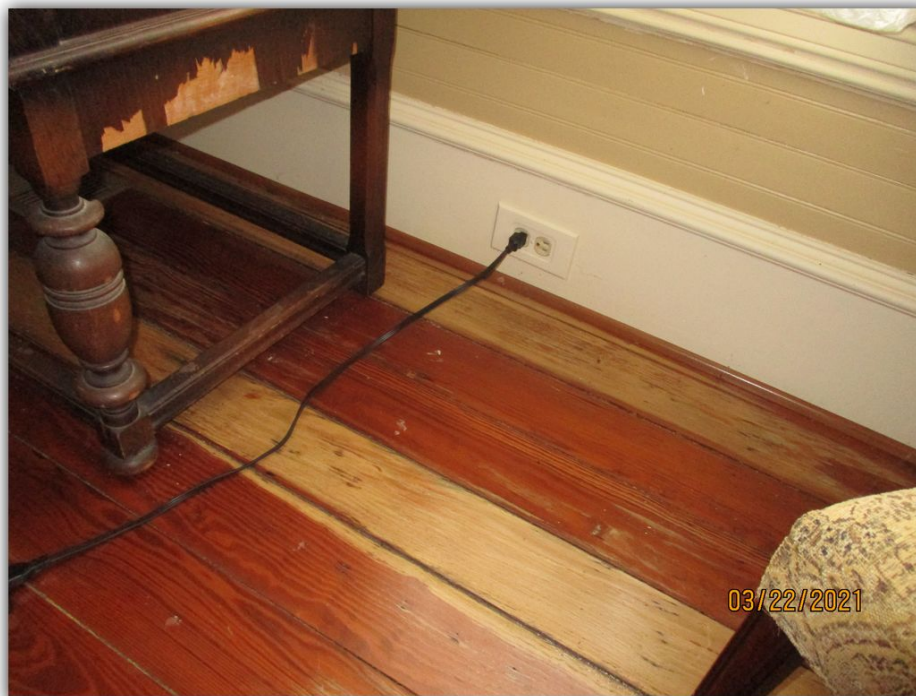
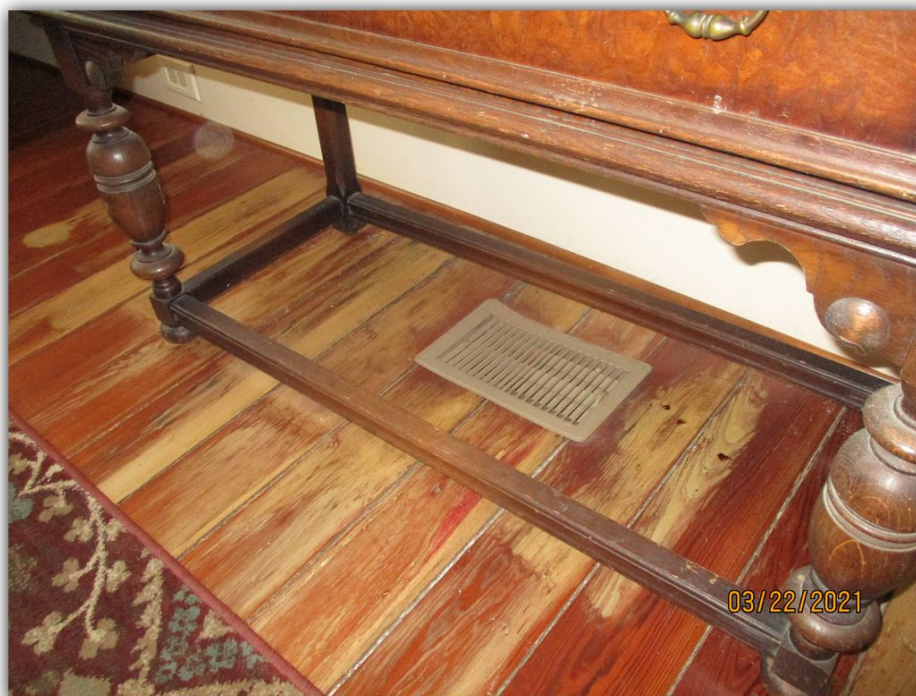
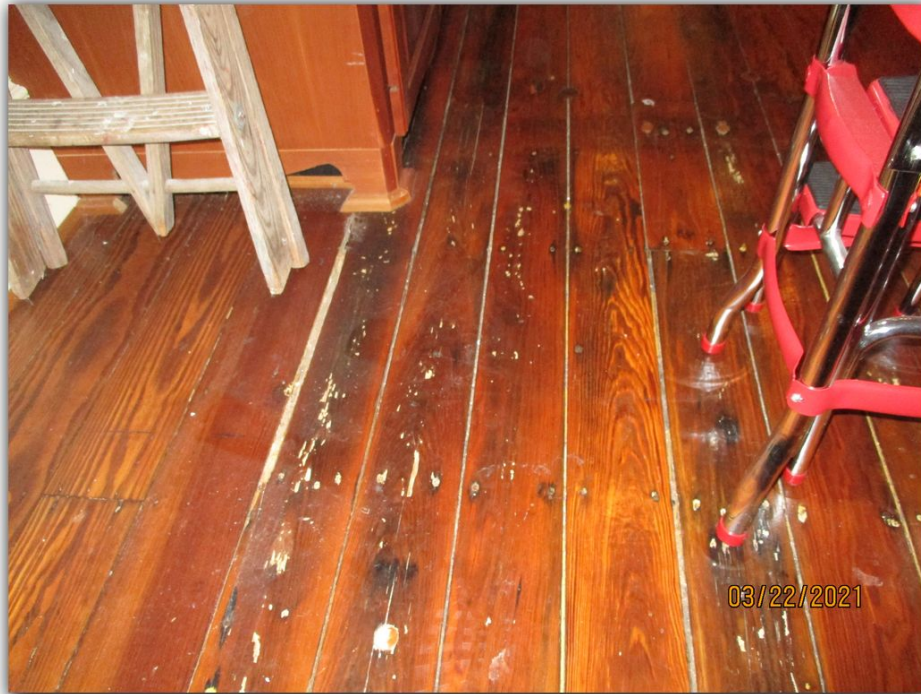
☒ In several areas of the house the interior floors appeared to be the old original pine floors. Some areas of the floor appeared to have the finish worn. The kitchen floor had some signs of old damage to the surface.

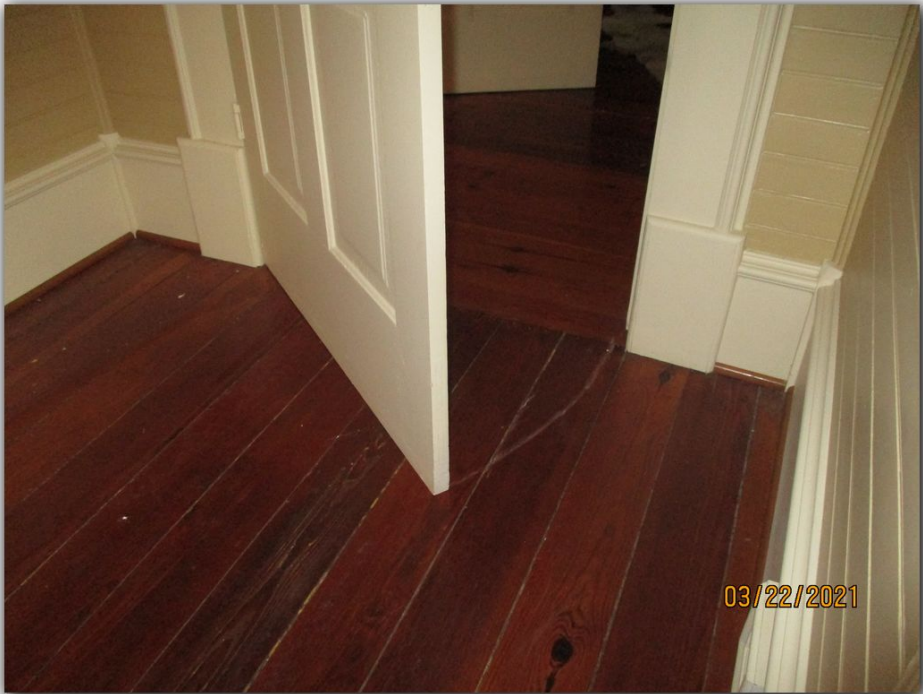
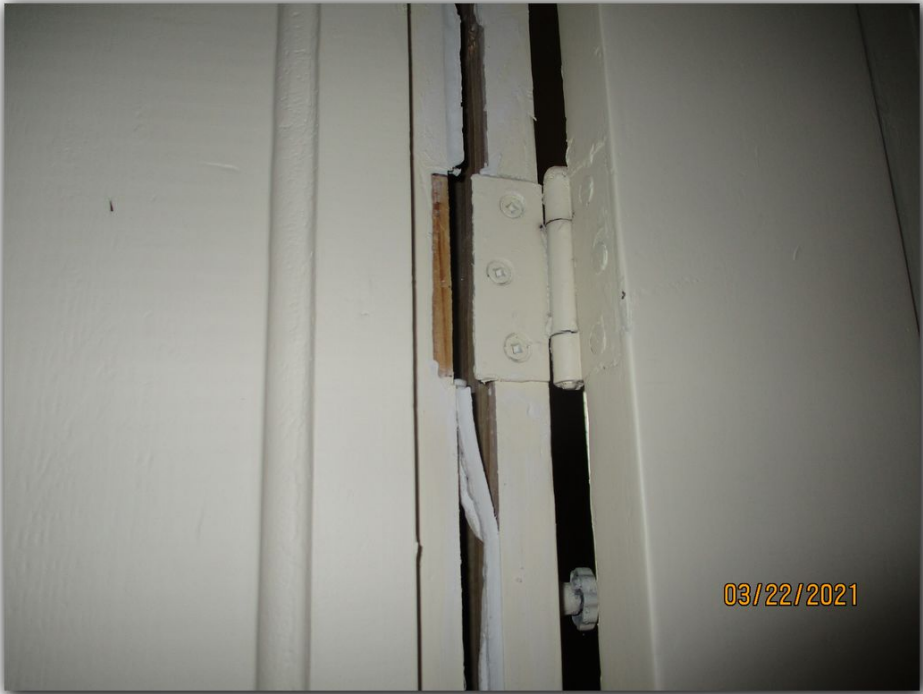
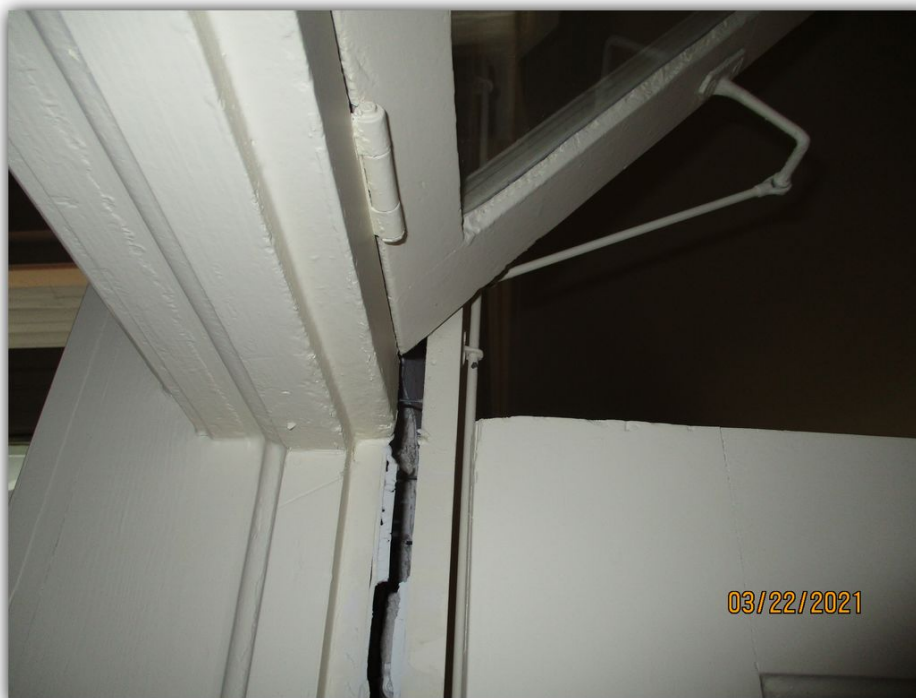
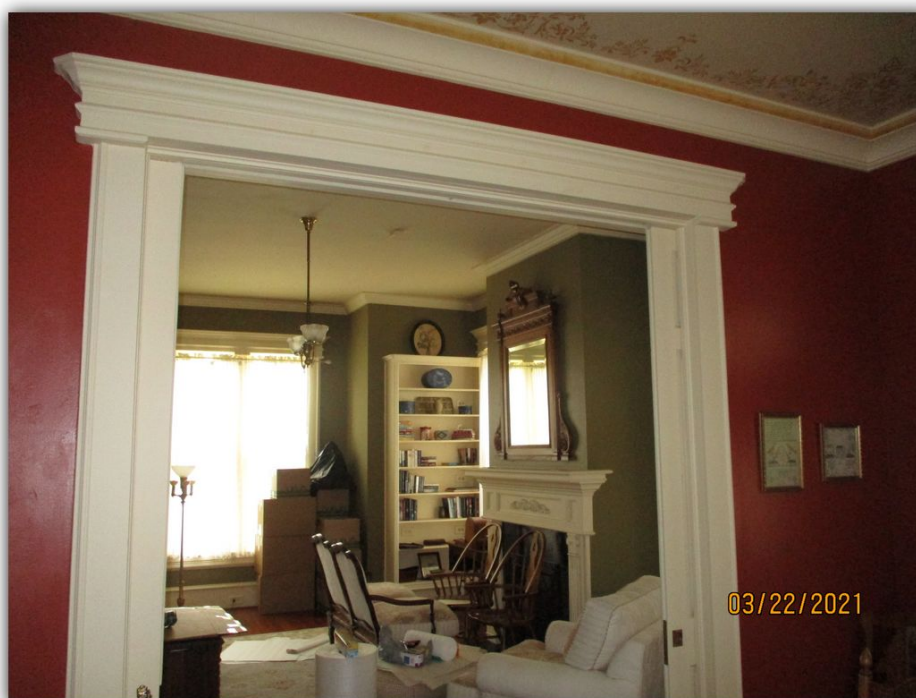
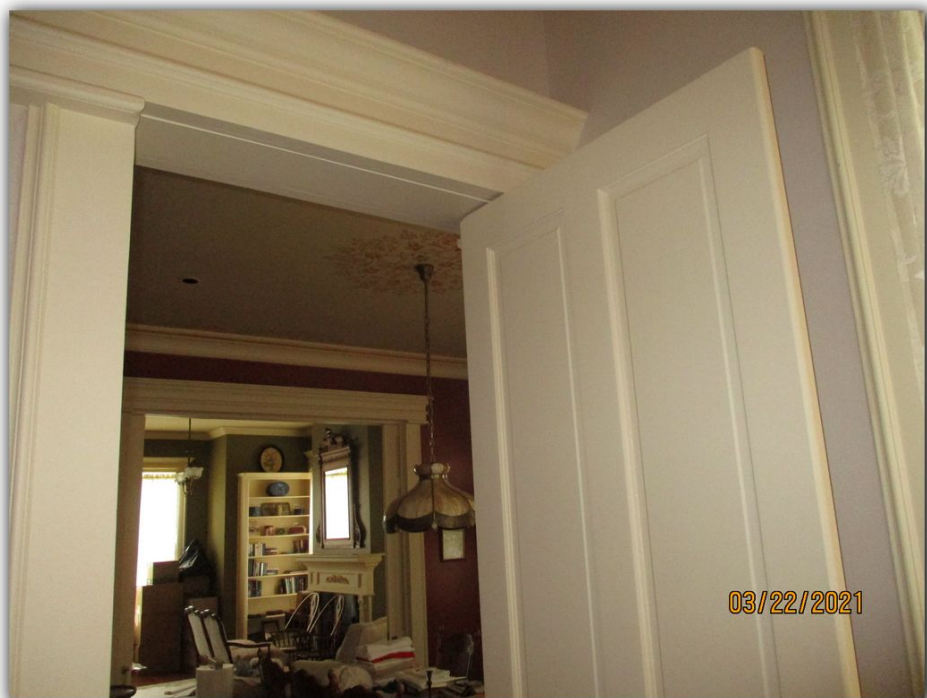
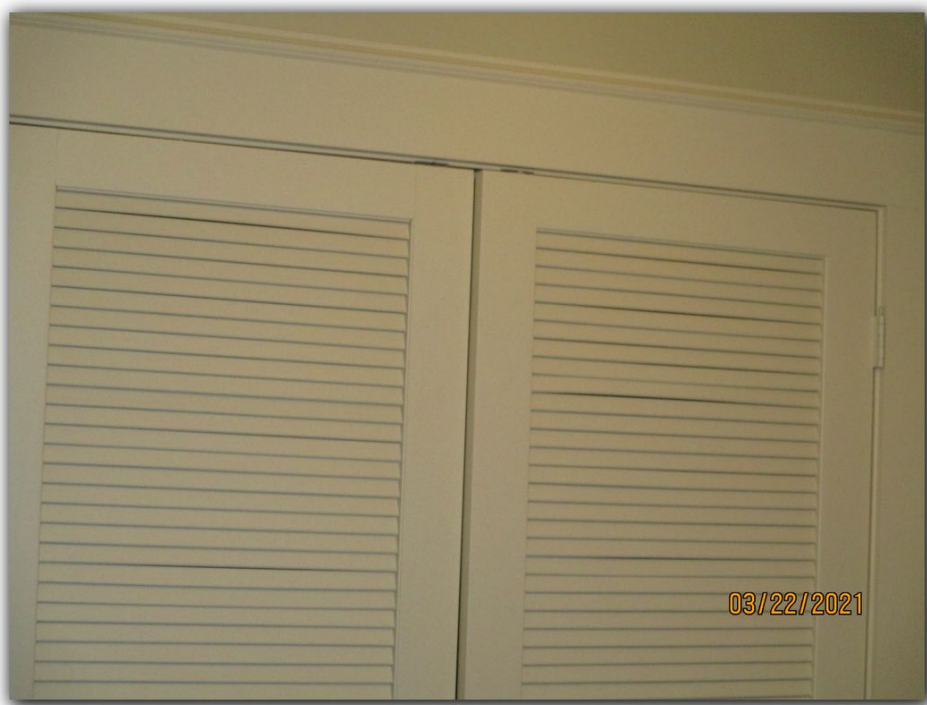
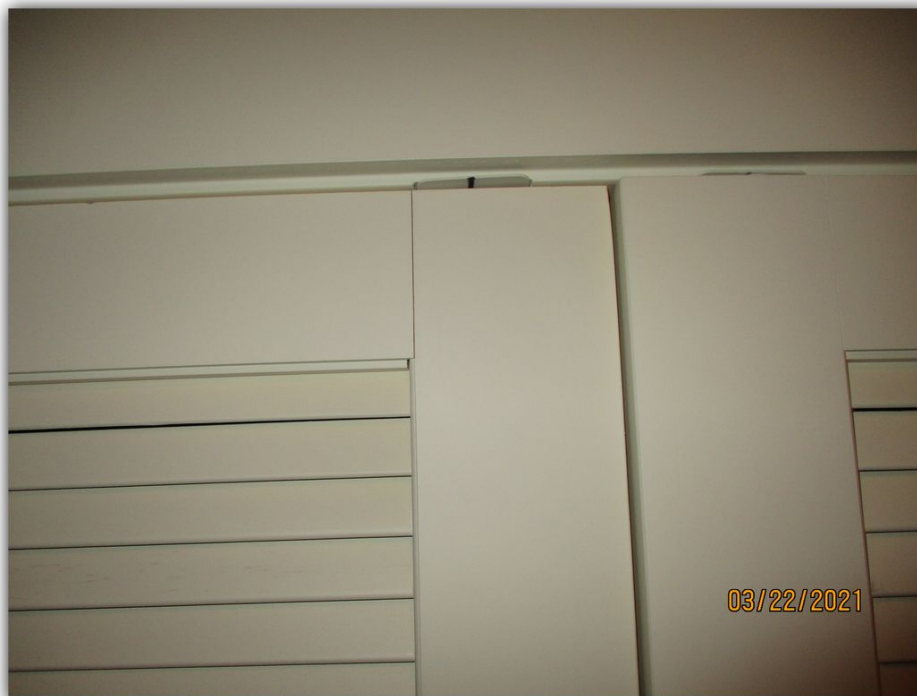
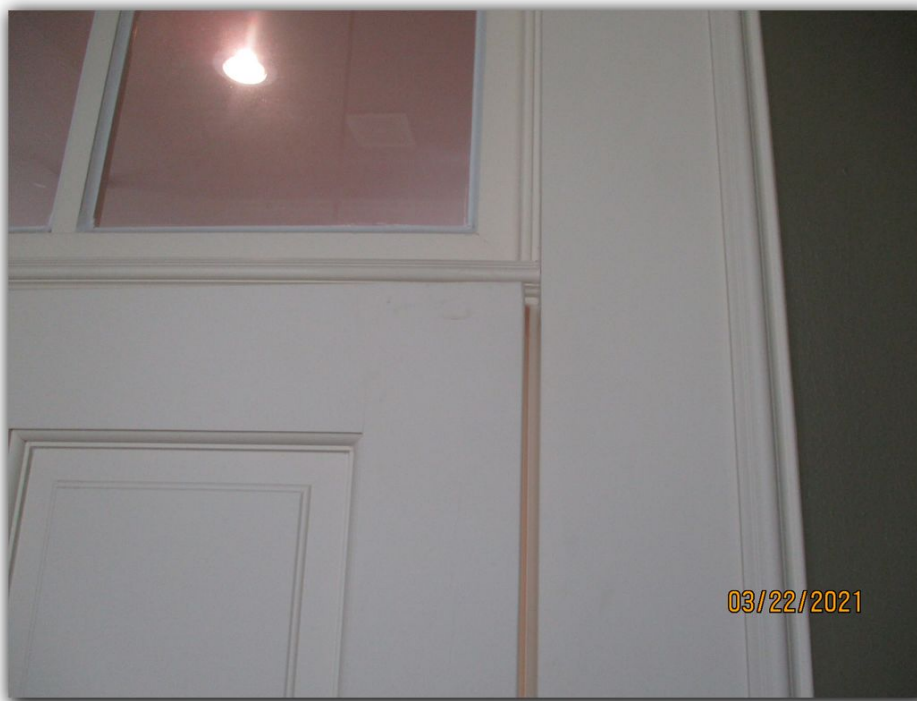
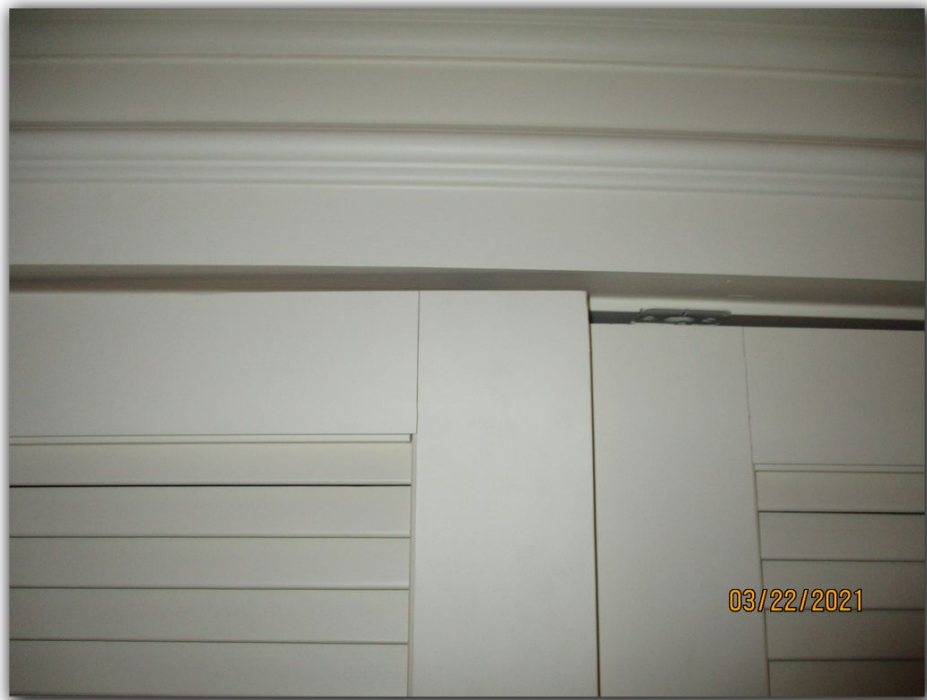
☒ There were numerous doors needing some minor adjustment or repairs. With a pier and beam structure and the typical ongoing settling of the structure, door will need to be adjusted form time to time. Currently the following doors were noted as needing some adjustment. The double action door out of the kitchen, The front parlor door (door frame separating), Master bedroom closet door (drags on the floor and the door knob did not function), The double pocket door to the front parlor (rub or hit inside the pocket frame and one section was difficult to roll),The upstairs utility closet and left rear bedroom closet double doors (needed some adjustment), the rear upstairs bathroom entry door (rubs in the frame).

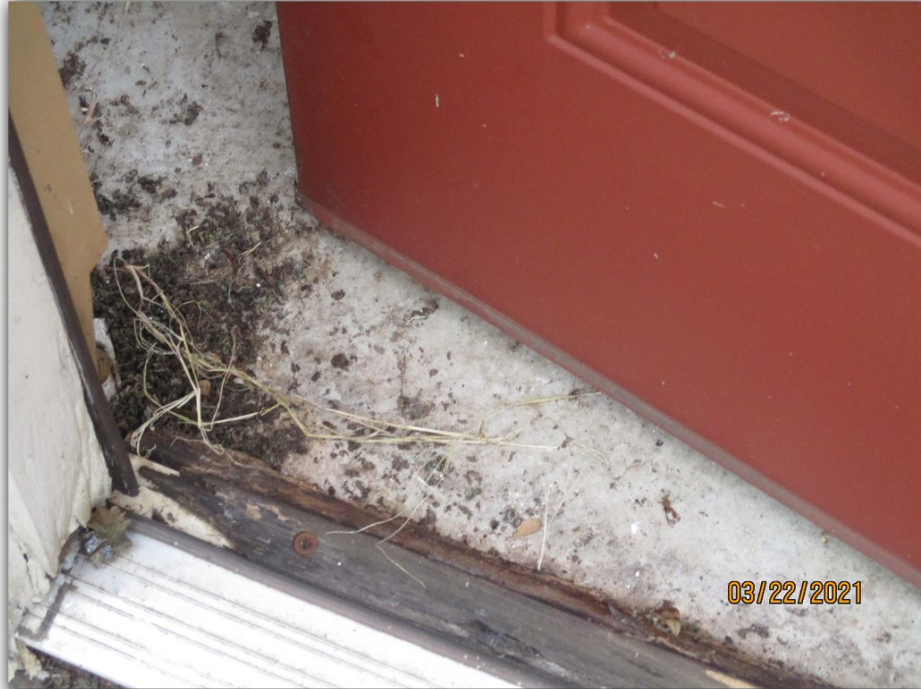
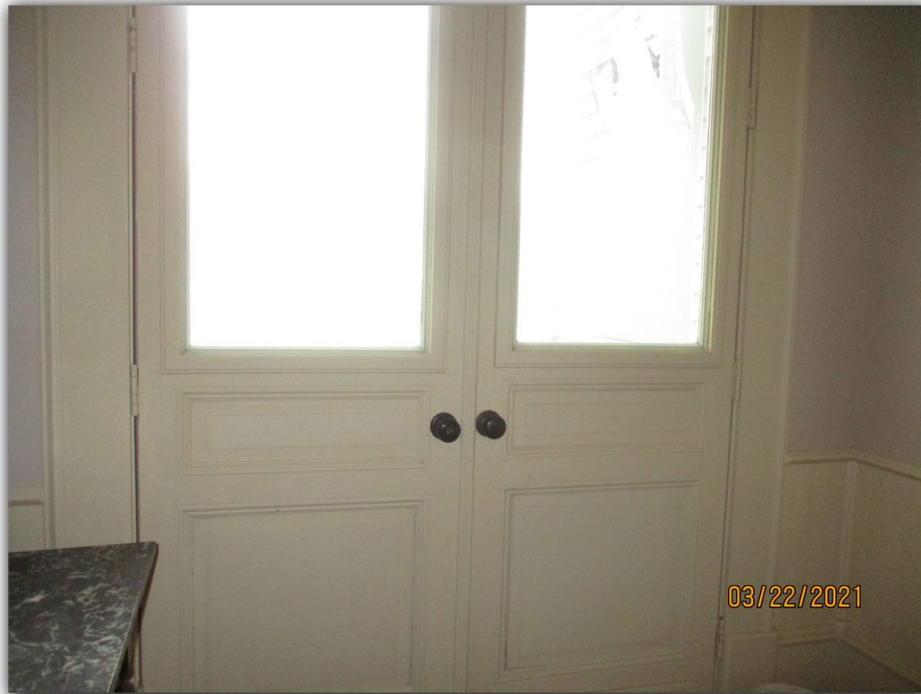
- ☑ The front exterior door could not be opened and may not be functional.
- ☑ The side exterior door to the porch and the front entry doors did not have a dead bolt locks installed.
- ☑ The rear exterior door had some visible light seen between the door and frame and may not be sealing well.
- ☑ The door to the garage had damage to the door sill.
