PROPERTY INSPECTION REPORT

Concerning: 207 E Texas, Calvert, TX
(Address or Other Identification of Inspected Property)

By: Don Murphy, Lic ##2674 03/22/2021
(Name and License Number of Inspector) (Date)

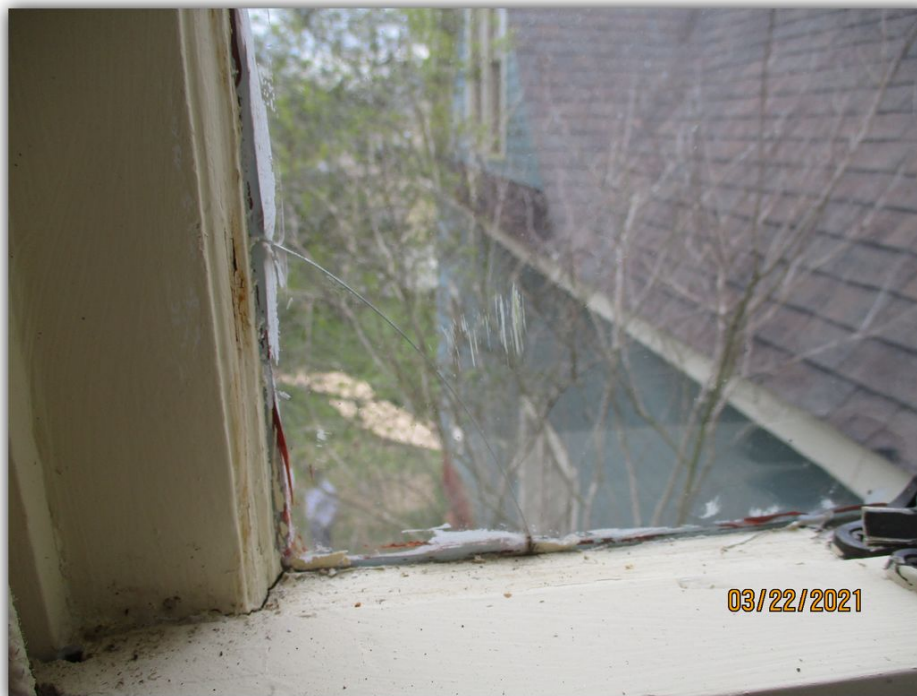
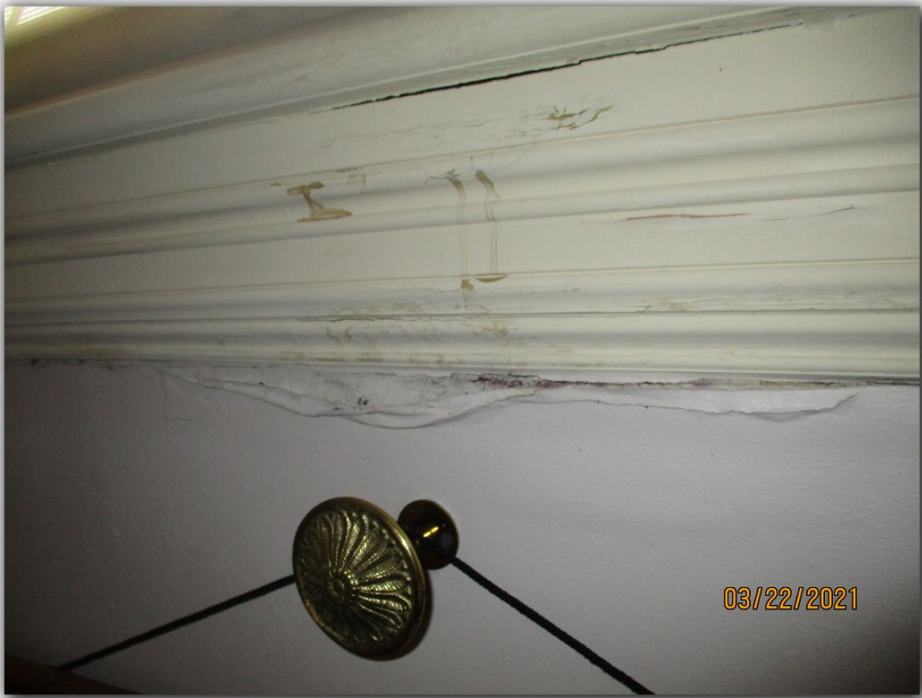
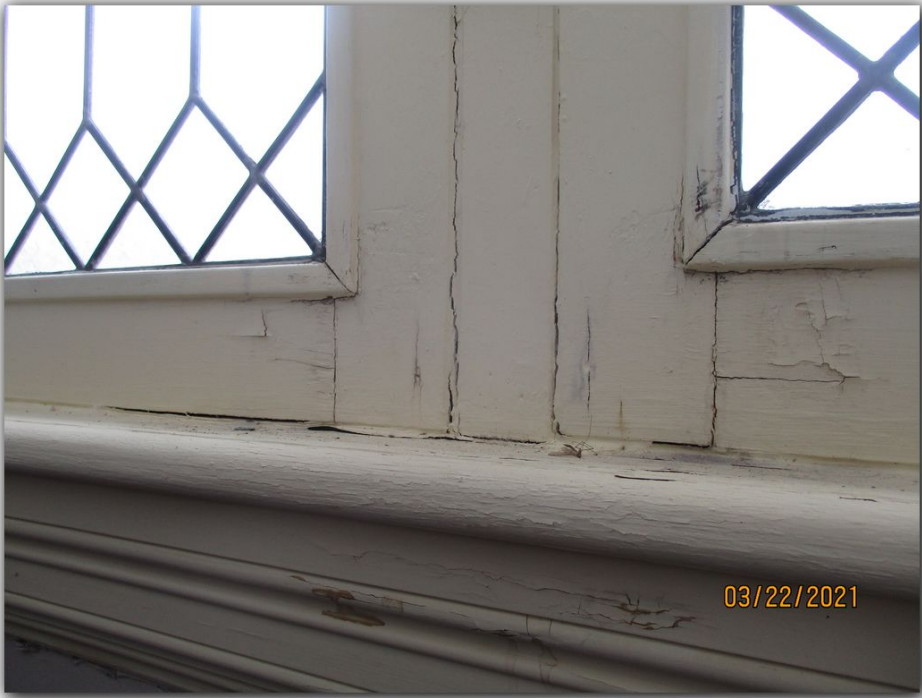
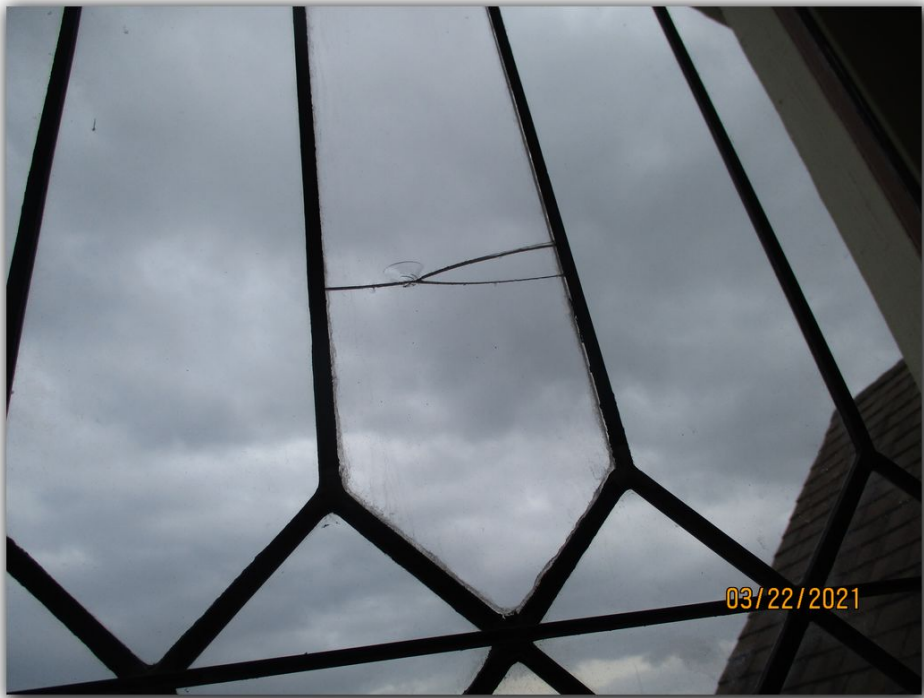
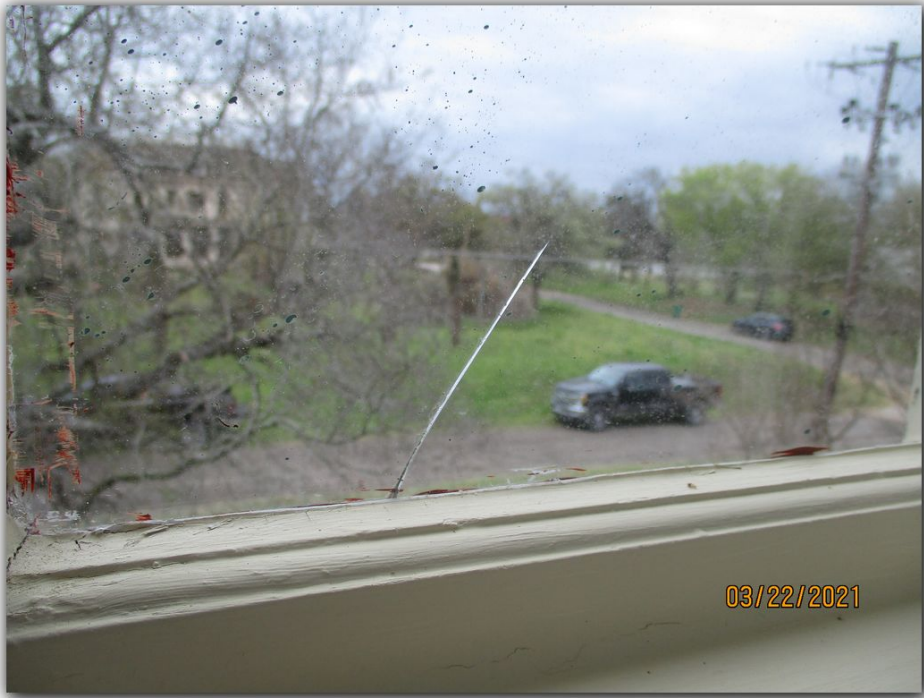
- ☑ There were at least 5 windows with cracks in the glass panes. This included the leaded glass window at the front of the upper floor.
- ☑ The windows were in generally good to fair condition. Most of the windows were not able to be open and had been caulked and painted closed. There should be at least one operable window in the bedrooms to allow for fire egress
- ☑ The window at the front of the house on the second floor level had some wood decay and water damage around the window frame and to the interior wall below the window.
- ☑ Most of the window screens were removed or missing

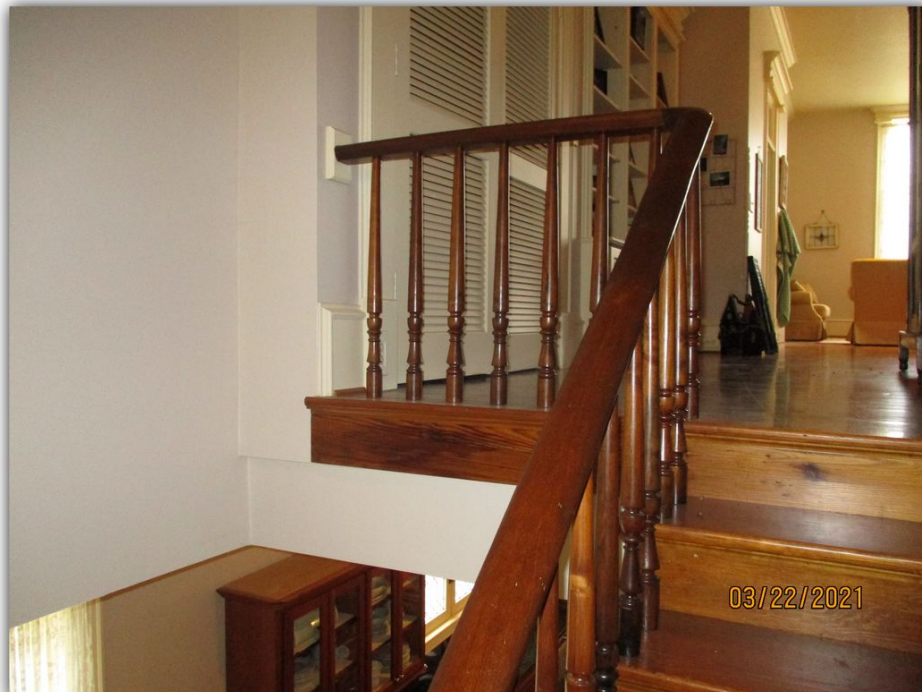
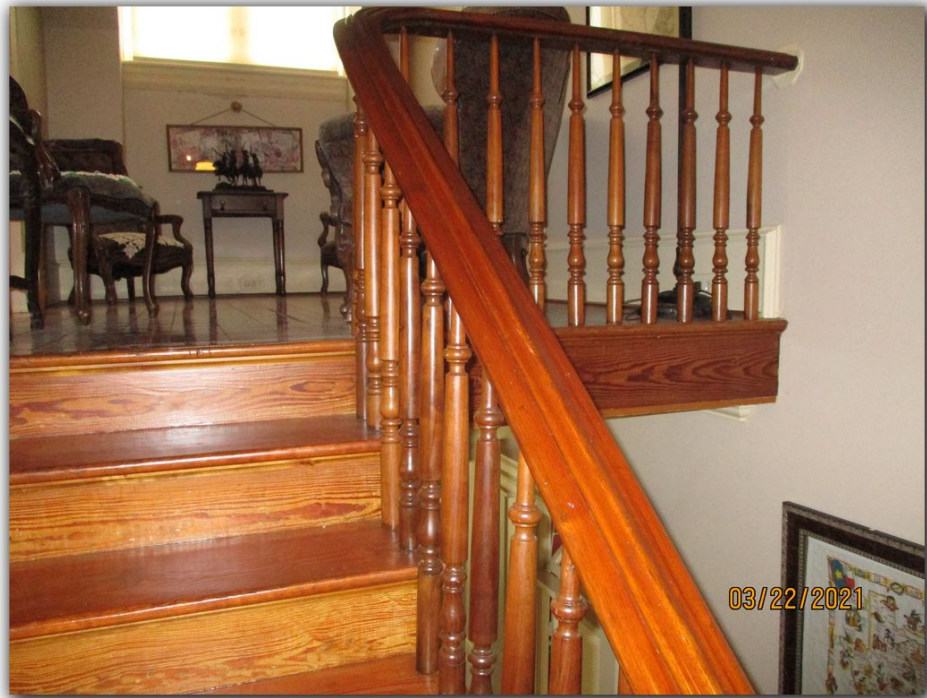
☒ There were some codes changes that had been made to interior stairs and stairwells since the construction of the structure. There are items seen that will not meet the new or current codes. This included but may not be limited to the vertical railing spacing, is grater than 4" on center, and the depth of the step treads, less than 11 inches) The structure does fall under the grandfather codes and does not have to be brought up to the current code requirements but we would like to point out the deficiency and not it as a safety concern. Hand railing not at proper height. The hand rail height was low and appeared to be lower than the current requirement of 36 inches above floor level or step level. *The stairs and stairwells were built to the codes and specifications from the time of the structures original construction. The stairwells were functional and in generally good condition at the time of the inspection. The stairs and stairwells may not meet all new code requirements but are grandfathered and not required to be brought up to meet all new codes.*

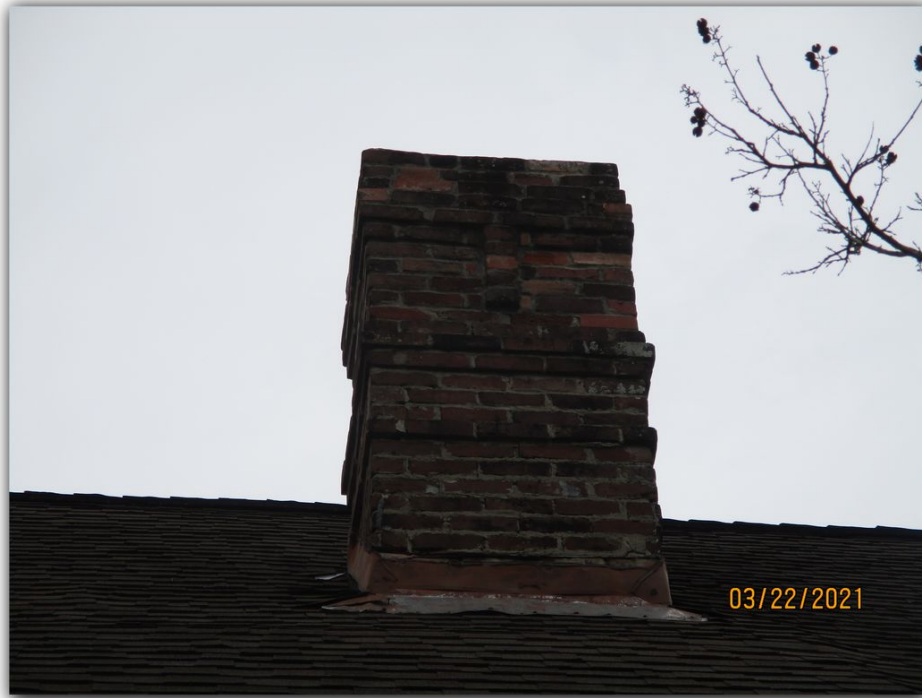
- ☒ The interior parts of the fireplaces were not accessible. We would recommend that the buyer have a professional chimney sweep or other chimney and fireplace professional to investigate the interior condition of the chimneys prior to use.
- ☒ Both of the chimney need the brick masonry tuck-pointed to repair the mortar. (The roof was not walked and the chimneys were viewed from a distance)
- ☒ The chimneys did not appear to have proper rain caps or spark screens.

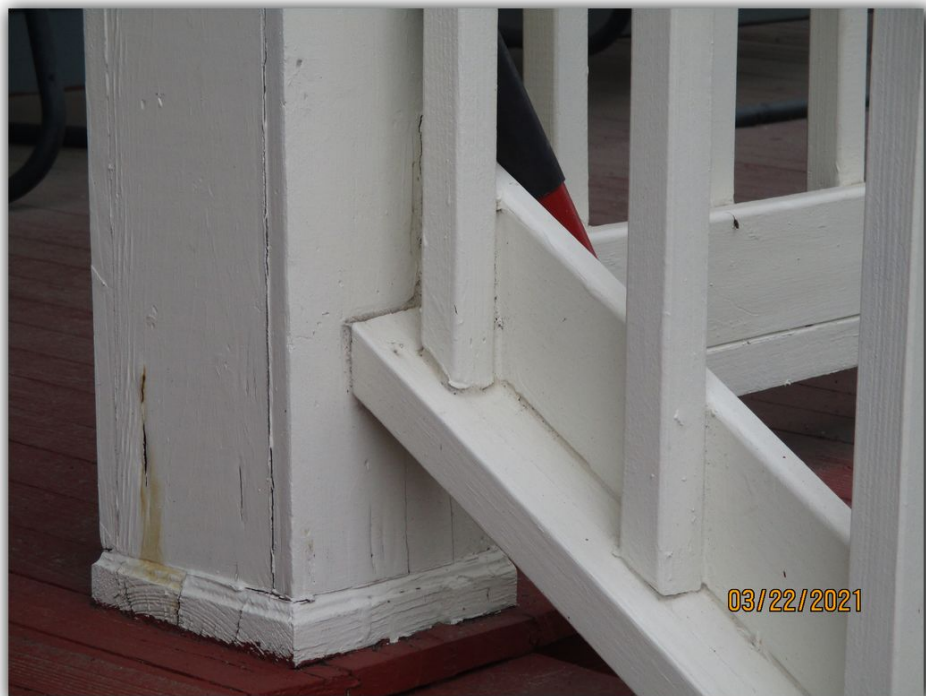
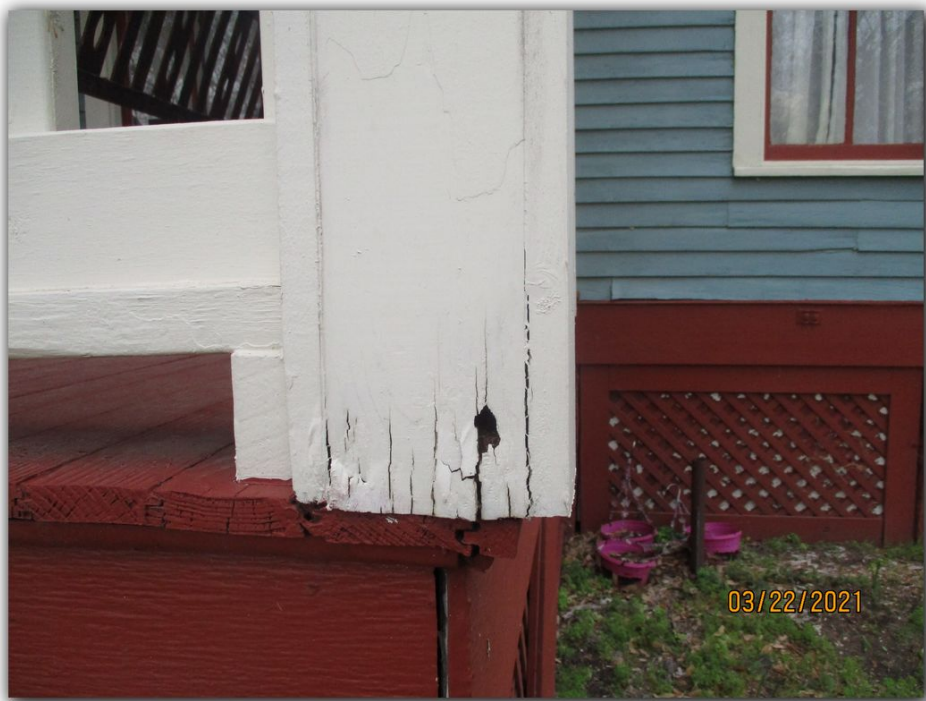
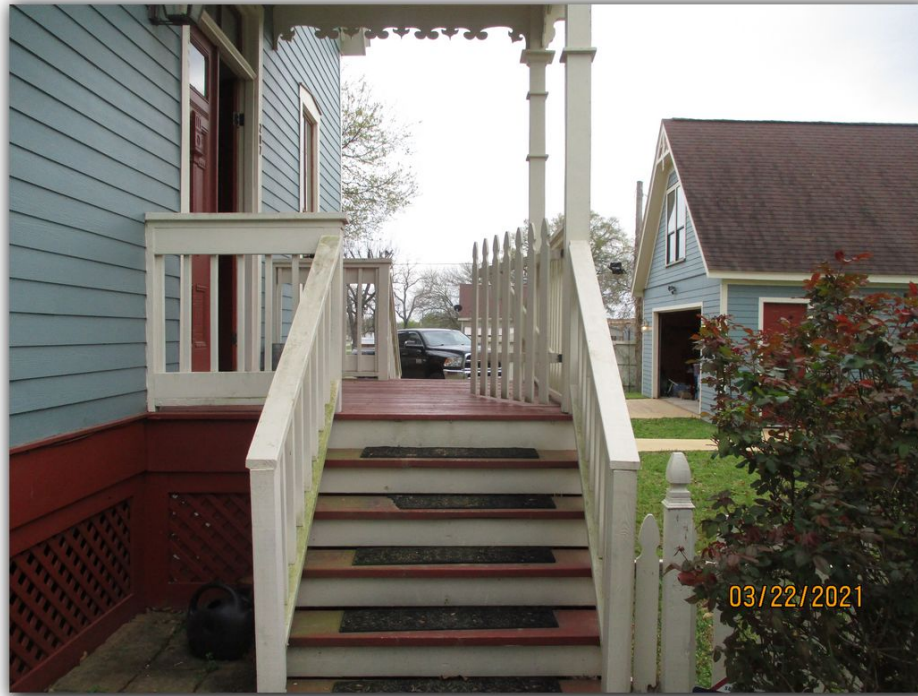
☒ There were numerous of the porch post with visible wood decay to the base of the post. (The bottom few inches of several of the post) This could affect the structural integrity of the post and the ability for the porch post to support the roof.

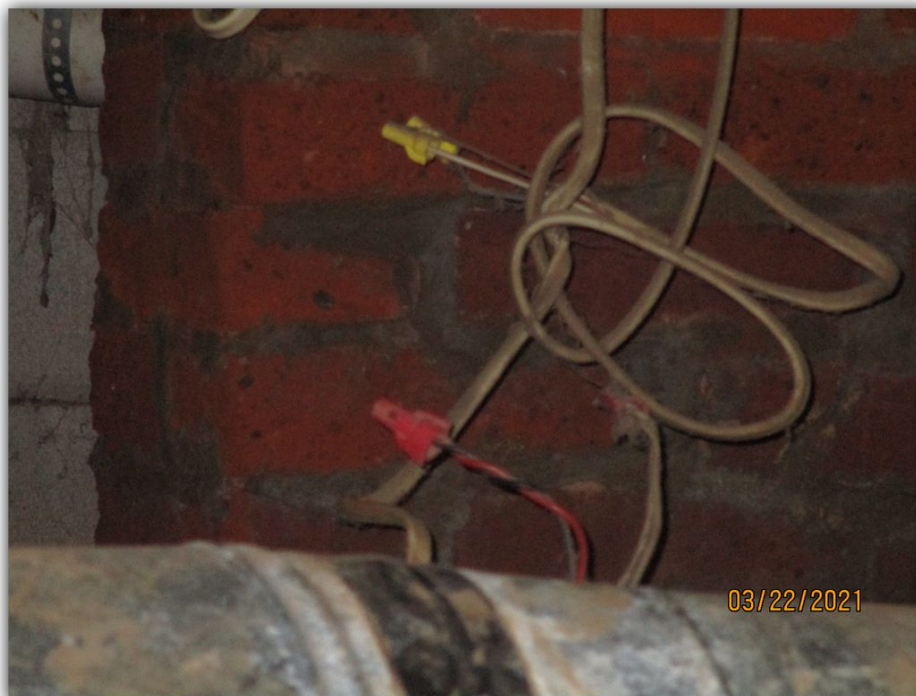
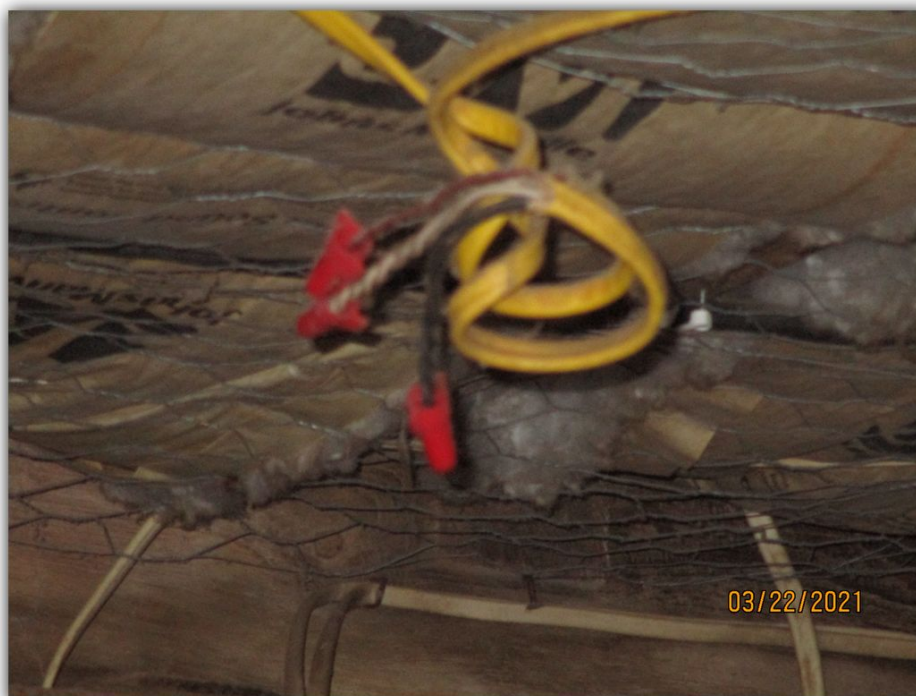
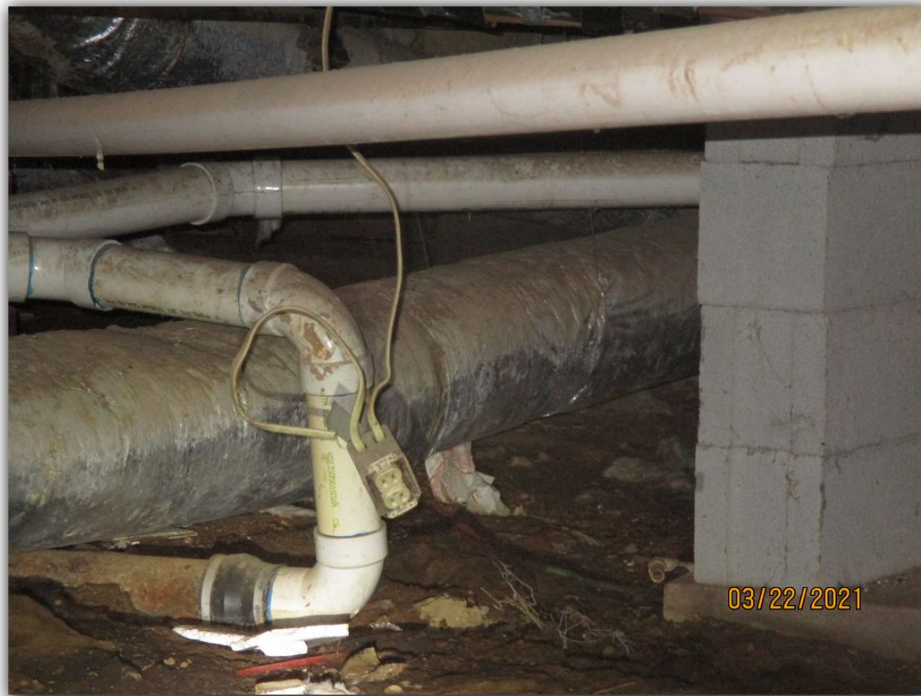
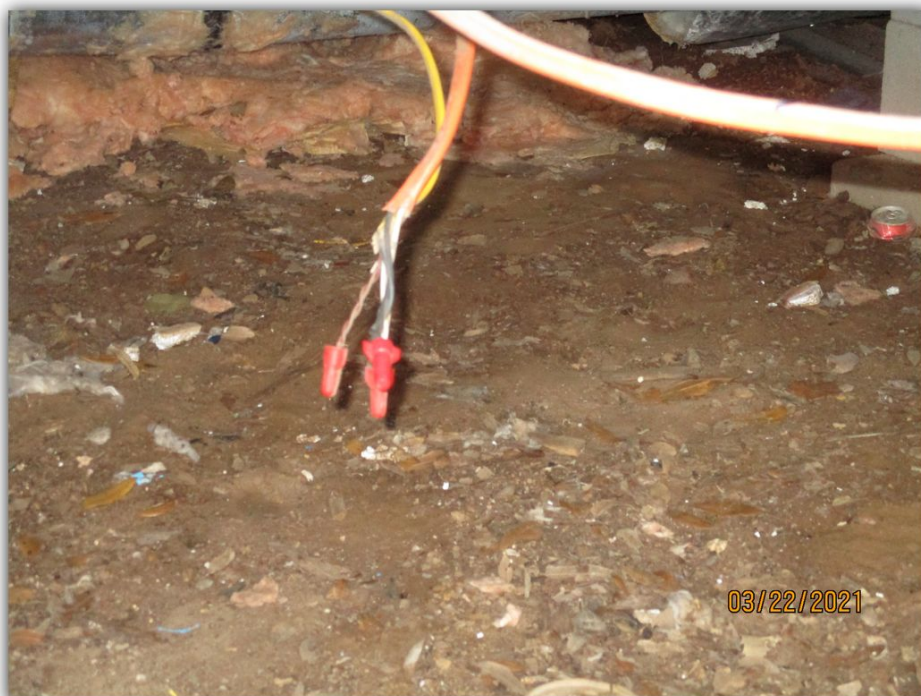
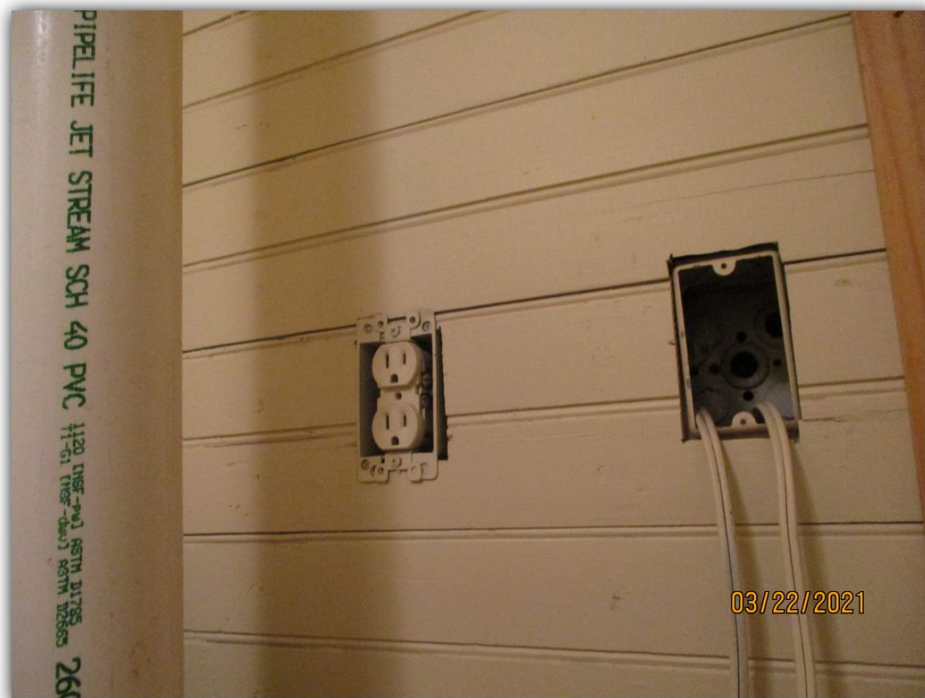
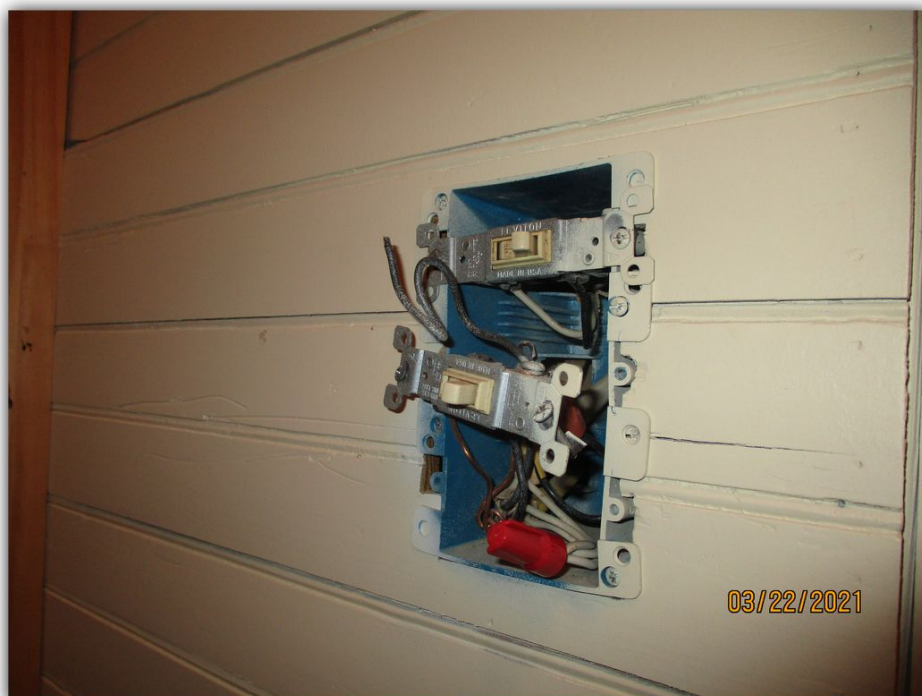
- ☒ As noted in the foundation section of the report there were loose or improperly secured wire under the house foundation. Many of these had been improperly joined without the use of junction boxes and proper wire connections. Some electrical boxes and wires were lying on ground under house. This is a potential hazardous condition for wiring and the wiring should be reviewed evaluated and repaired by a licensed electrician to meet the current code requirements.
- ☒ One or more wall outlet or wall switch did not have cover-plates installed. In the master closet there was an improperly secured wall switch and switch that did not have cover-plate.

- ☒ No GFCI/ARC Fault protection at one or more location. This is considered a recognized safety hazard. GFCI are not properly installed or operate properly installed or in place at the required locations including the kitchen and exterior outlets.

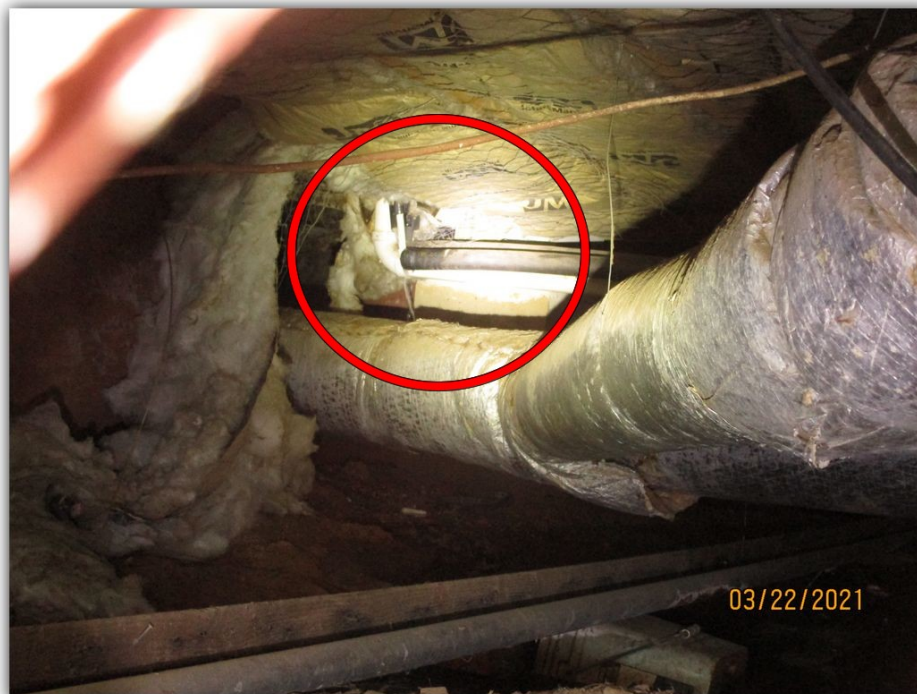
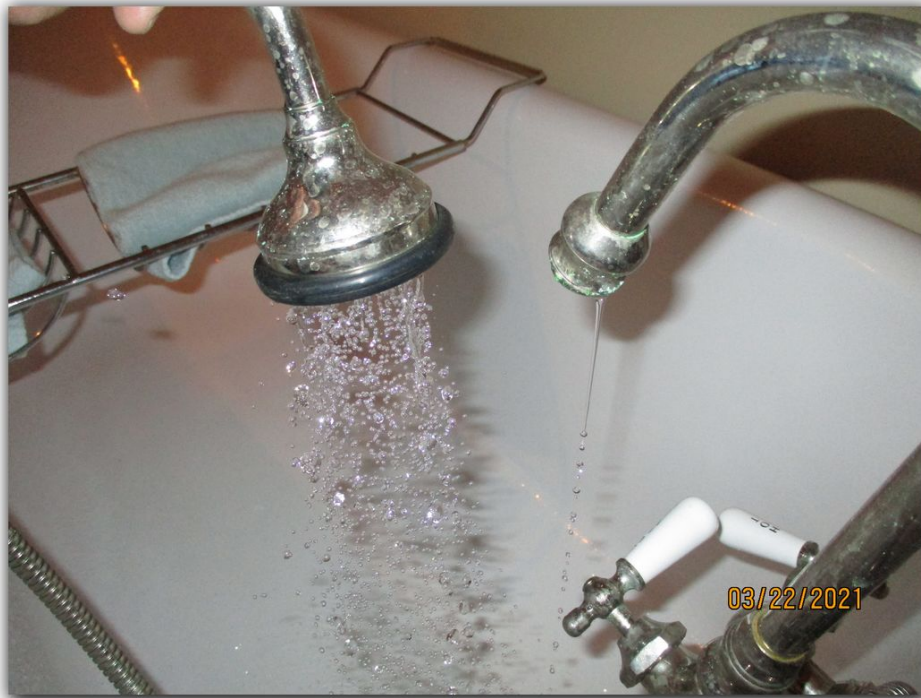
- ☑ The hand held shower in the upstairs right side bathroom had low water flow.
- ☑ In the upstairs rear bathroom the tub valve was missing the riser for the shower head. The connection was left open and if the shower diverter was turned it would leak water from this opening.
- ☑ There was a leak at one of the hot water supply lines under the master bathroom section of the foundation. The line may have burst during the last freeze and on the day of the inspection hot water was gushing out of the broken line.

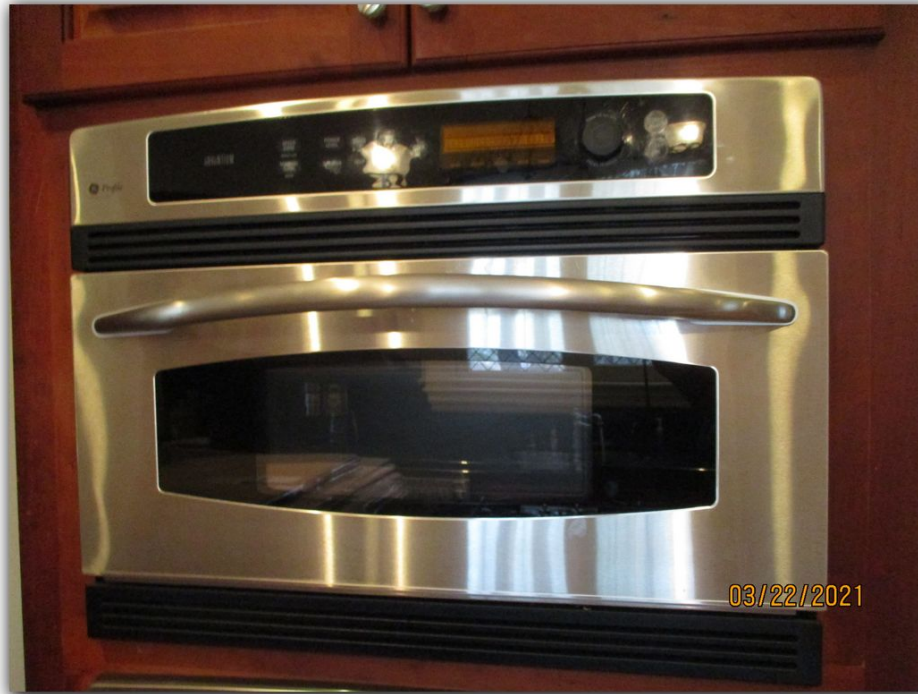
☒ The unit does not operate from the control panel and we are not able to test the unit. It may not be functional.
