**Specialty Home Inspections
Presents**

**A Home Inspection Report On
14234 Reissen Ln., Houston, TX
Sold by Rosalba Cabrera, Listed By**

Tuesday, July 13, 2021

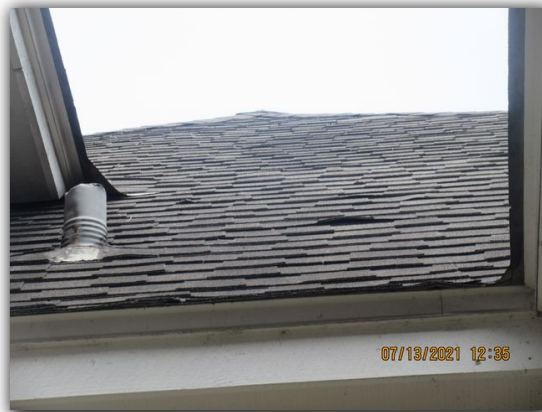
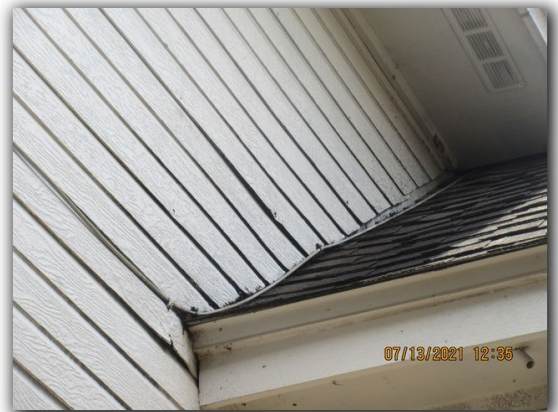
17. At least one shingle is raised on the front elevation as seen on the photo below.

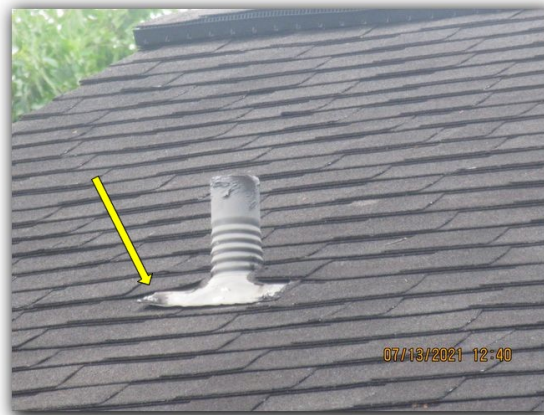
19. The plumbing roof jacks are lead and are in good condition but the base needs to be sealed and secured.

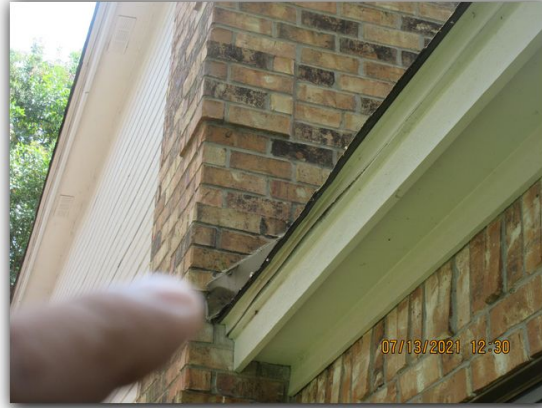
21. Missing a kick out on the flashing by the roof on the front elevation.

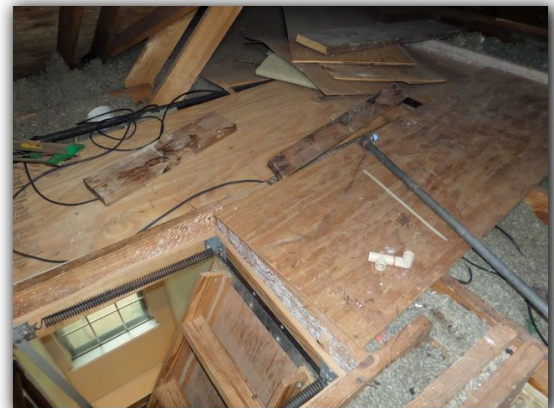
- 28. Missing foam insulation at the perimeter of the attic ladder frame as per code.
- 29. N1102.1.10 Air leakage. All joints, seams, penetrations, window and door assemblies and their respective jambs and framing; and other sources of air leakage (infiltration and exfiltration) through the building thermal envelope shall be caulked, gasketed, weather stripped, wrapped, or otherwise sealed to limit uncontrolled air movement (see photo below)

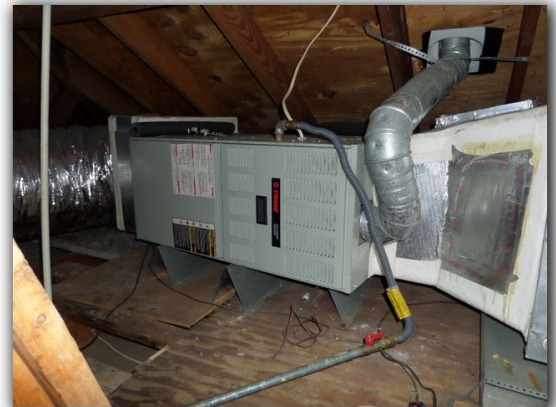
32. Improper decking methods, attic decking must be solid plywood with no obstructions in front of the furnace as per code and as seen on the left lower photo below.

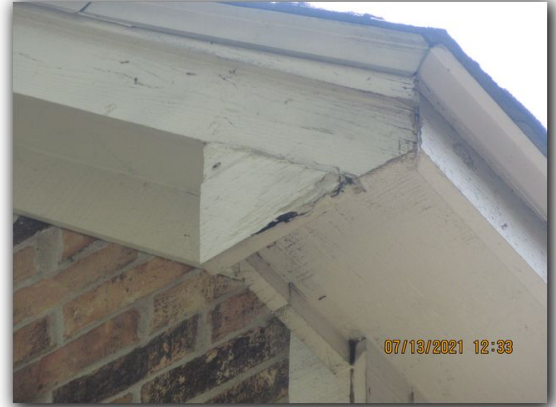
36. Minor wood rot at the over hang as seen below.

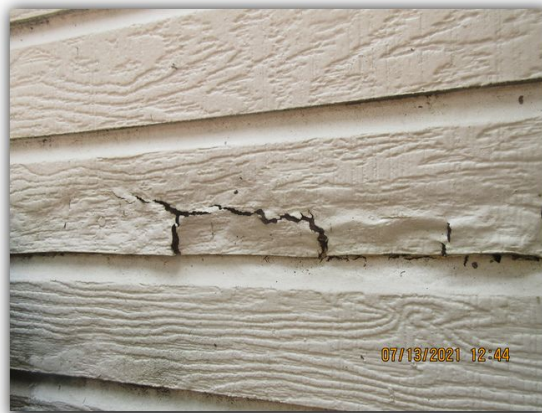
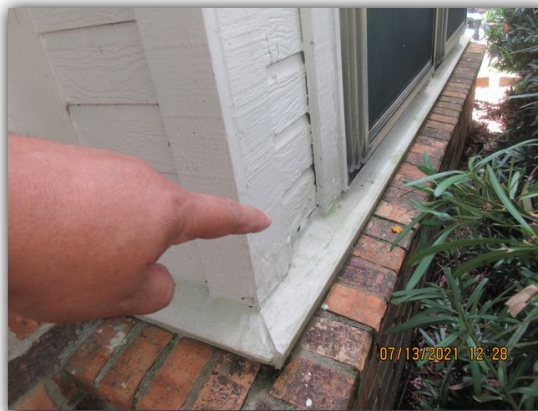
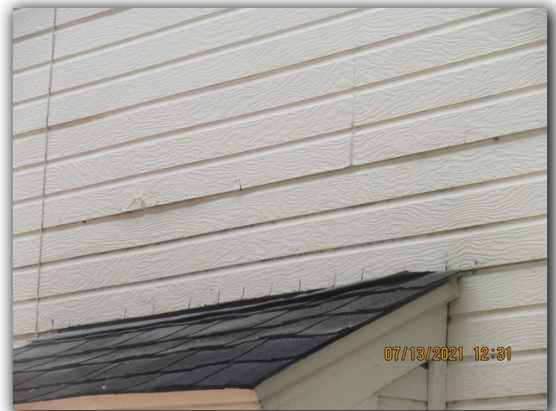
37. There is some minor wood rot at the front elevation at the base of the window on the window sill.

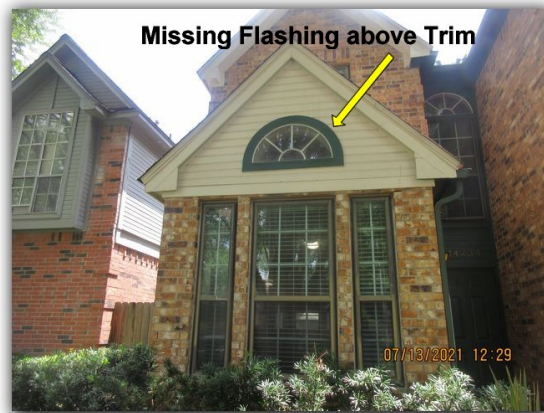
39. Missing metal flashing above arched window trim as per IRC code R-703.8.1.4 & R-703.1

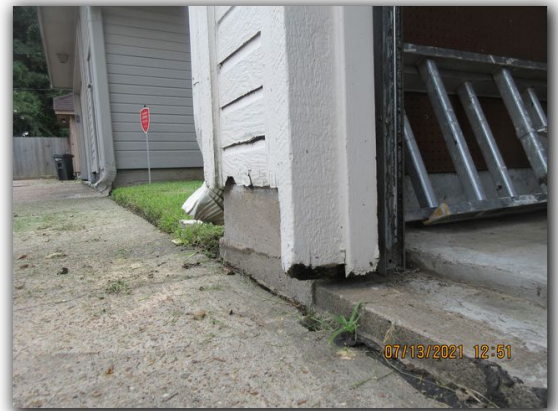
49. Garage door frame wood trim is too close to the ground, must be cut 45 degrees, painted at the base (sealed) and be two inches above the concrete floor to avoid water rot;

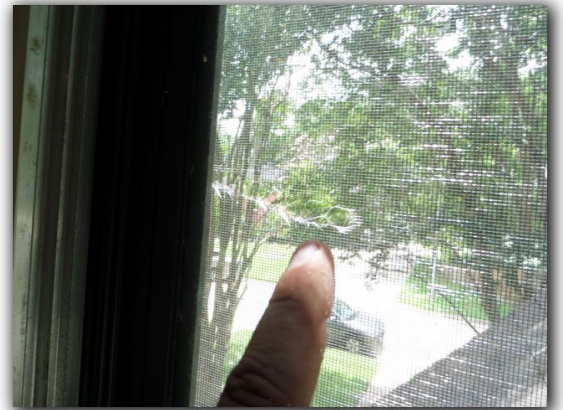
53. The screen as seen below is damaged on the exterior.

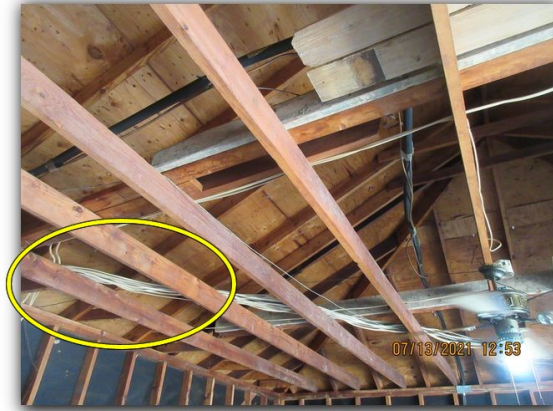
72. Improperly installed wiring method, the romex wires must be separated, not bunched at the breezeway entry point. Bunching wires can cause an increase in heat and cause a fire, a code violation at the draftstop.

73. E3302.3 Penetrations of firestops and draftstops. Penetrations through fire blocking and draftstopping shall be protected in an approved manner to maintain the integrity of the element penetrated.

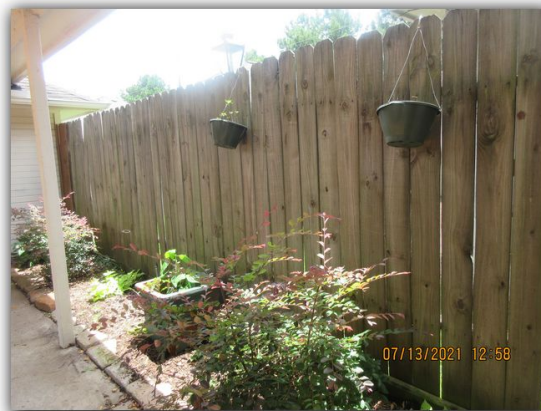
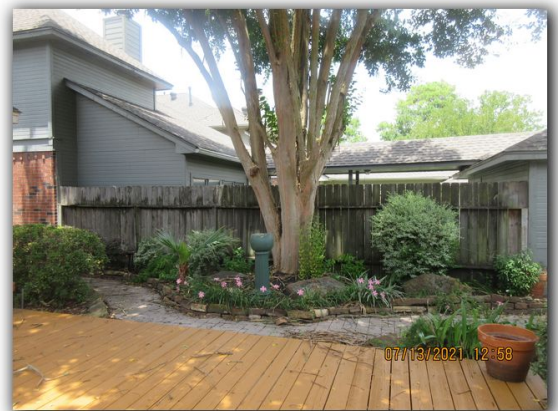
75. Some of the fence has minor wind damage.

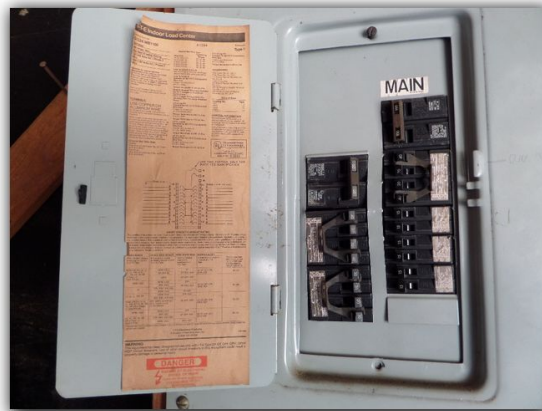
- 84. Missing arc fault interrupters as required by current code of 2008 and newer homes.
- 85. Code IRC 3802.11 requires arc fault interrupters in all circuits going into the living area.
- 86. Home is missing arc fault protection on the GFI's as required by current code.

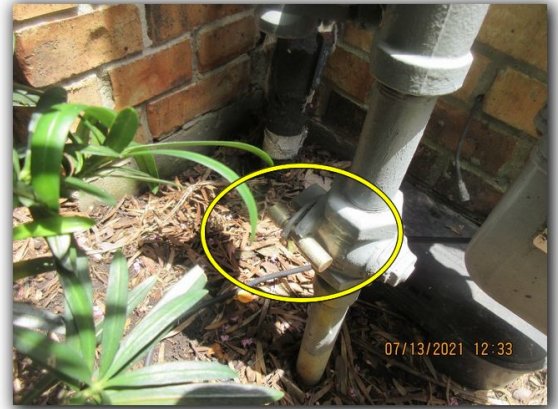
140 Gas meter was not bonded as required by code

141E3509.7 Metal gas piping bonding. Each aboveground portion of a gas piping system upstream from the equipment shutoff valve shall be electrically continuous and bonded to the grounding electrode system.

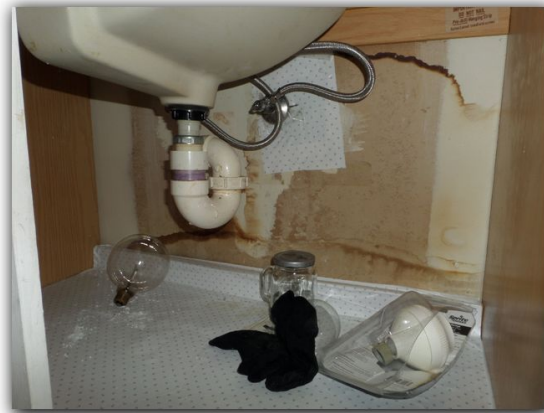
162Evidence of moisture behind one wall under a lav.

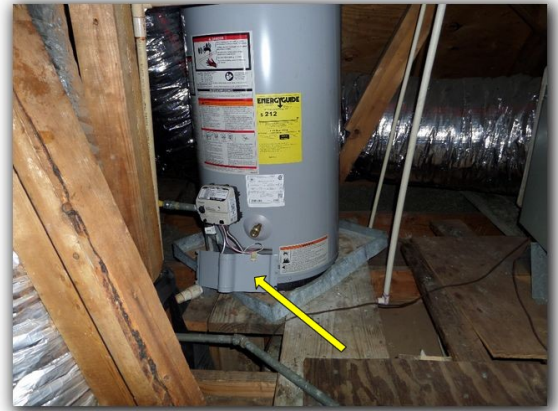
167The burner cover at the base needs to be properly secured.

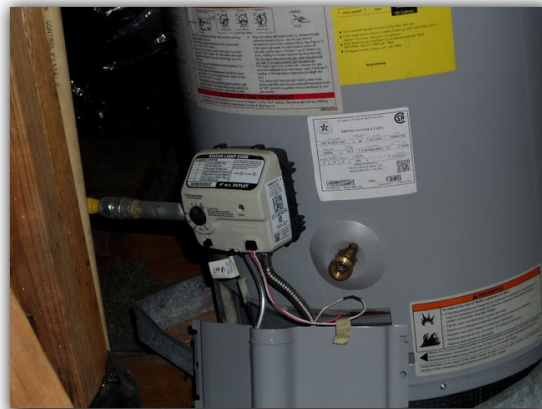
176The gas line is missing a bonding wire as required by code.

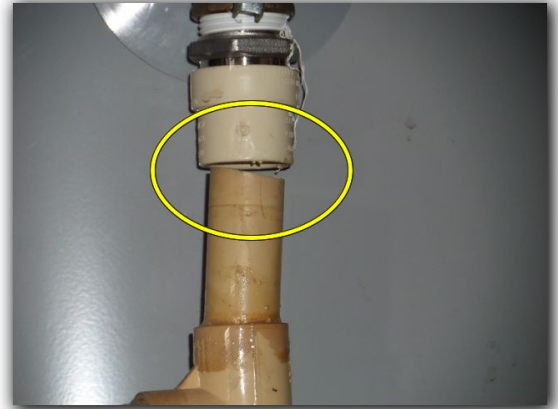
182 The PVC drain line at the T&P valve needs to be properly inserted into the joint and cemented.

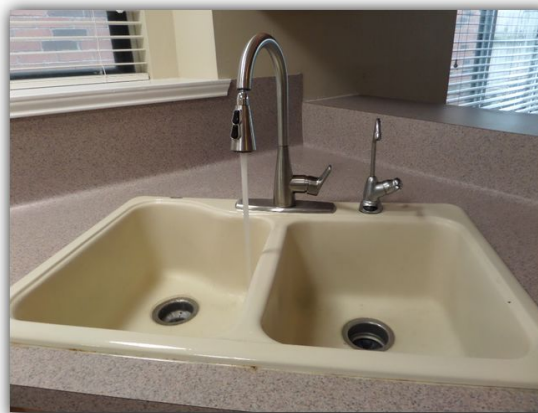
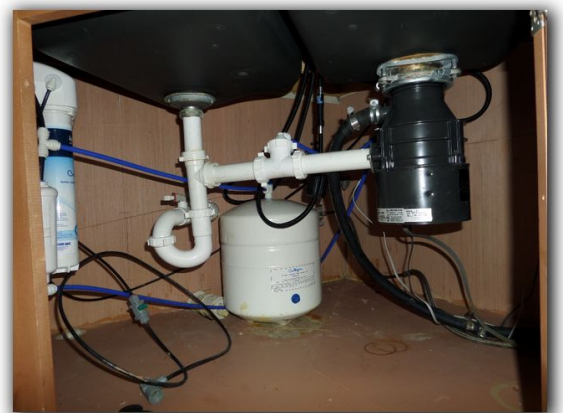
193The disposer was inoperative at the time of the inspection.

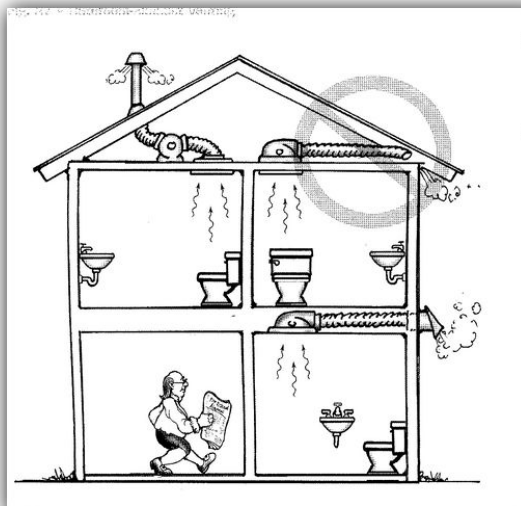
218Improperly terminating flex vents into the attic, they must terminate to the exterior as per code.

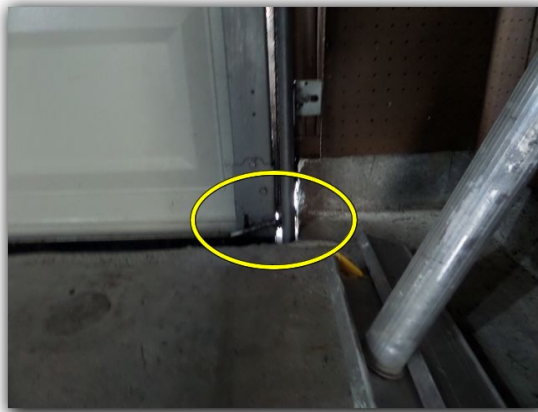
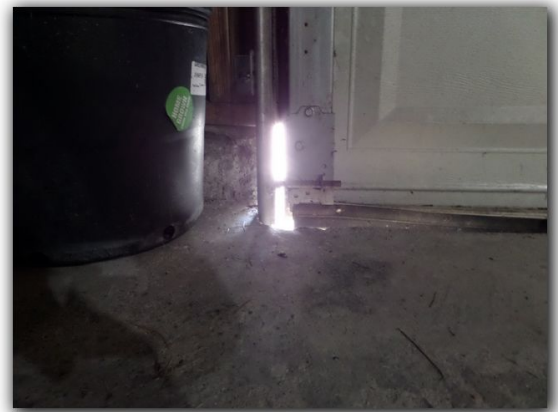
225.The lower roller as seen below is in need of repair.

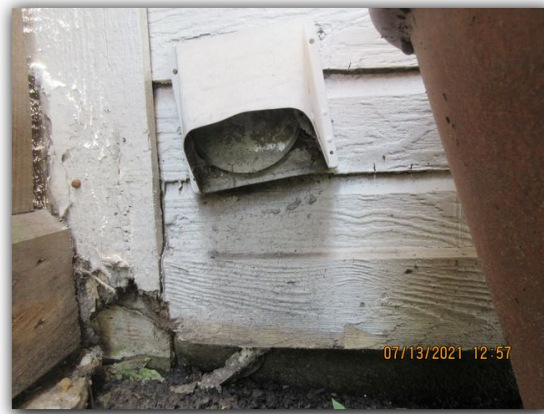
230 Dryer Vent - **G2437.3 (613.4) Exhaust material.** Dryer exhaust ducts for clothes dryers shall terminate on the outside of the building and **shall be equipped with a back draft damper.**

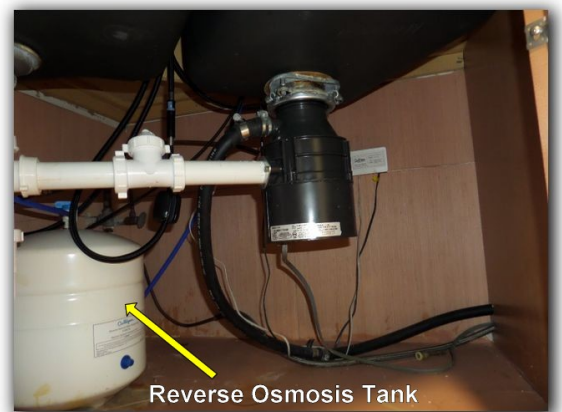
238 The kitchen counter top has a water fixture that was not working at the time of the inspection.
