North Star Inspections, Inc.

**72 Palos Verde
Panorama Village , TX 77304**

PROPERTY INSPECTION REPORT

Concerning: 72 Palos Verde, Panorama Village , TX, 77304
(Address or Other Identification of Inspected Property)

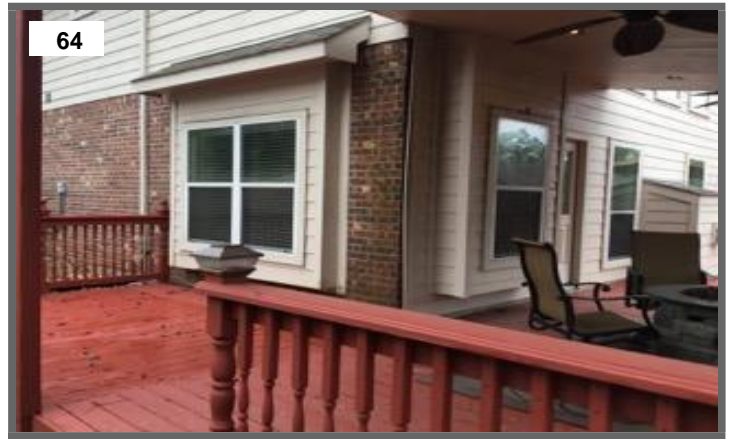
C - Signs of failed seals in the thermal pane windows may appear and disappear and temperature and humidity change. Some windows with failed seals may not be evident at the time of the inspection, windows are only checked for obvious fogging.

Lost seal
Top Middle

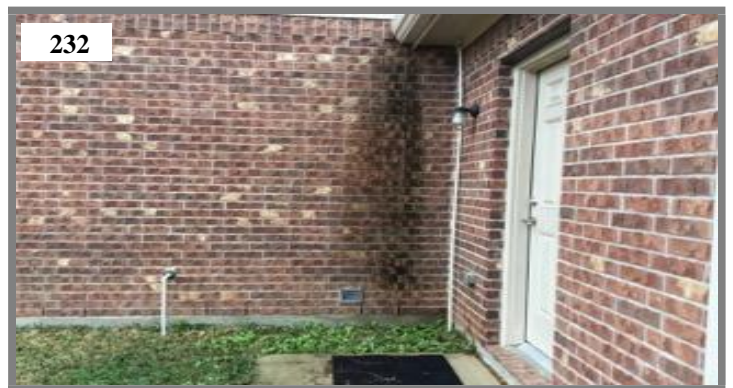
D - There is mildew on the exterior walls.
A new product, Wet & Forget can help in most of these areas, (Always follow the instructions on the container) (left rear)
There are cracks over the small garage doors .
On the interior walls when the pictures and artwork are removed there could be nails and hangers that may need to be repaired.
Minor bumps and bruises on the interior walls were noted. Nail holes should be filled and touch up paint may be needed .

Mildew

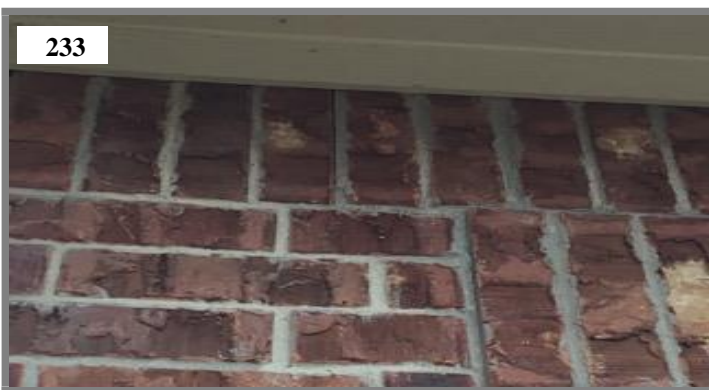
mortar crack over garage

There are cracks over the small garage doors .

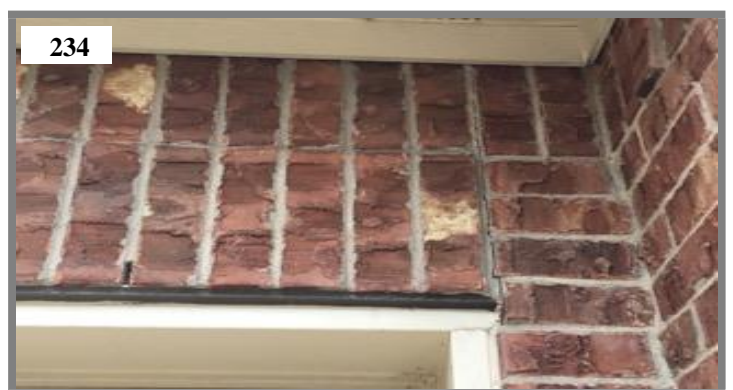
mortar crack over garage
