# PROPERTY INSPECTION REPORT

**Prepared For:** Cassy Mayes  
(Name of Client)

**Concerning:** 9230 FM 1371, Chappell Hill, TX 77426  
(Address or Other Identification of Inspected Property)

**By:** Roy Brashier, Lic #22407 02/10/2021  
(Name and License Number of Inspector) (Date)

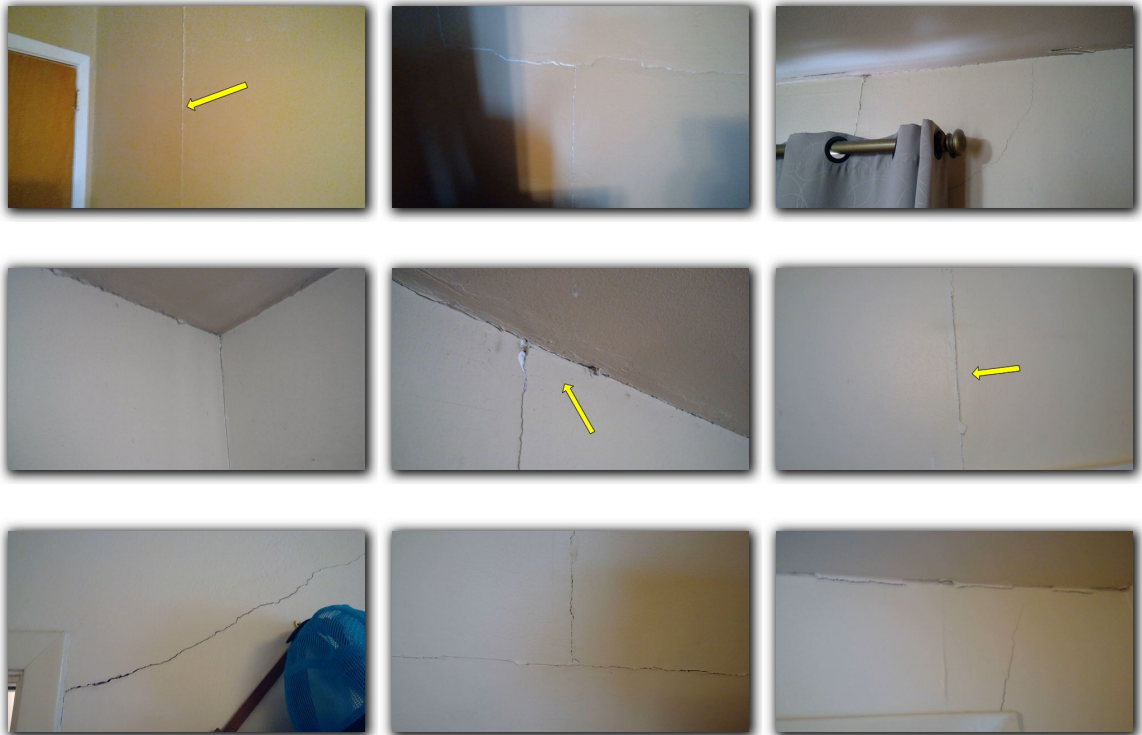
**Cracks were noted throughout the interior of the home on the wallboard.** Cracks are usually indications that some degree of movement has occurred in the structure. (in any structure some degree of movement is normal and should not be of concern ) the severity of the cracks can be an indication of the amount of movement in a structure. Recommend having a foundation specialist inspect the foundation for proper repairs.

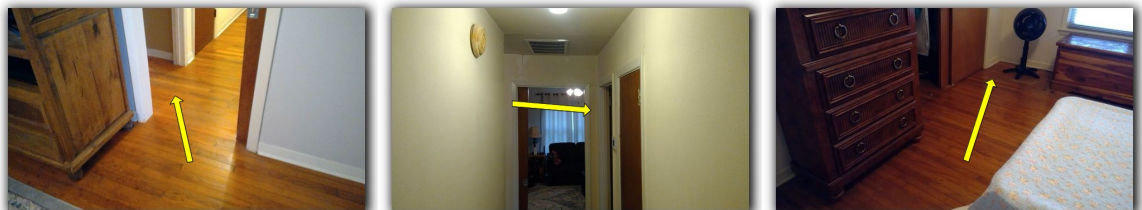
**Floor slopes are apparent.** This condition indicates that movement in the structure has occurred. Further investigation may be necessary. The need for foundation repair in some cases can be an aesthetic judgment that must be made by the homeowner or buyer.

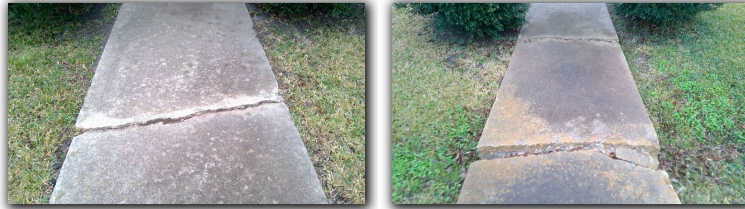
**The sidewalk has settled causing uneven joints.** This is a tripping hazard. Recommend repairs to the sidewalk for safety purposes.

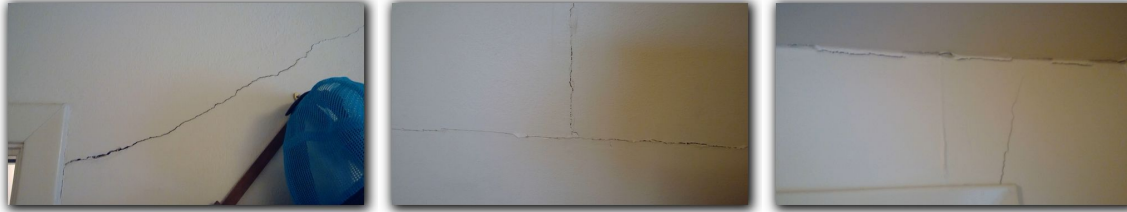
**Cracks were noted throughout the interior of the home on the wallboard.** Cracks are usually indications that some degree of movement has occurred in the structure. (in any structure some degree of movement is normal and should not be of concern ) the severity of the cracks can be an indication of the amount of movement in a structure. Recommend having a foundation specialist inspect the foundation for proper repairs.

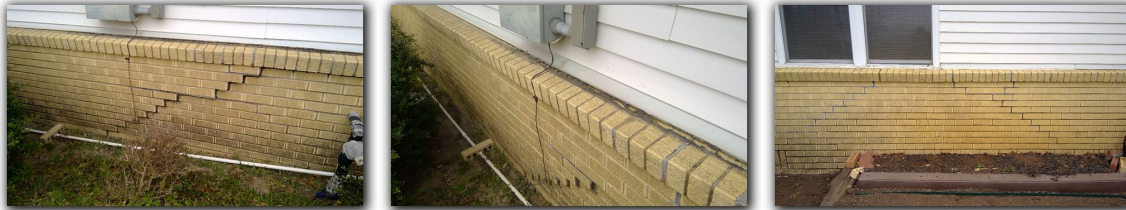
**The brick siding / skirting wall shows cracking and pulling away from the structure in multiple locations.** This is an indication that some degree of movement has occurred in the brick siding.

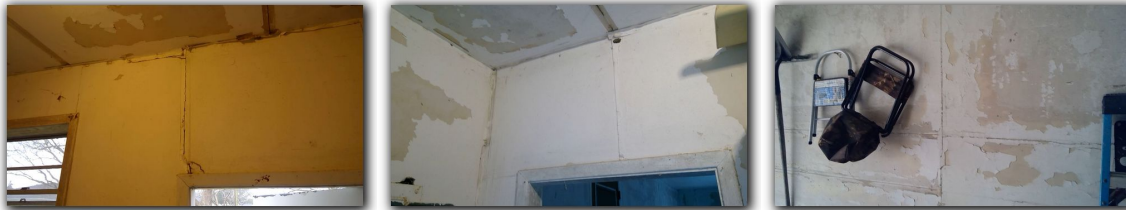
**Loose and/or weakened finishes were detected in the garage area.** This should be repaired to prevent further damage.

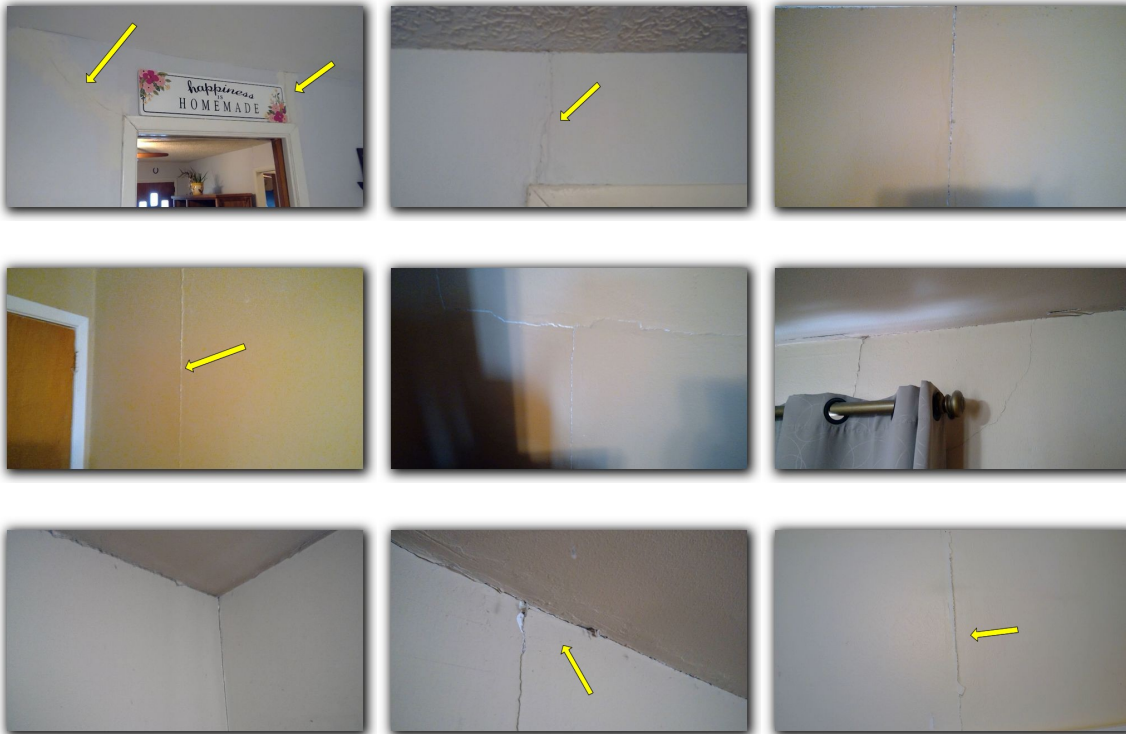
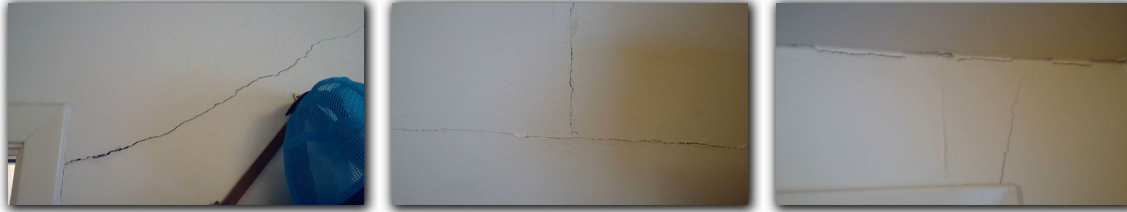
**Cracks were noted throughout the interior of the home on the wallboard.** Cracks are usually indications that some degree of movement has occurred in the structure. (in any structure some degree of movement is normal and should not be of concern ) the severity of the cracks can be an indication of the amount of movement in a structure. Recommend having a foundation specialist inspect the foundation for proper repairs.

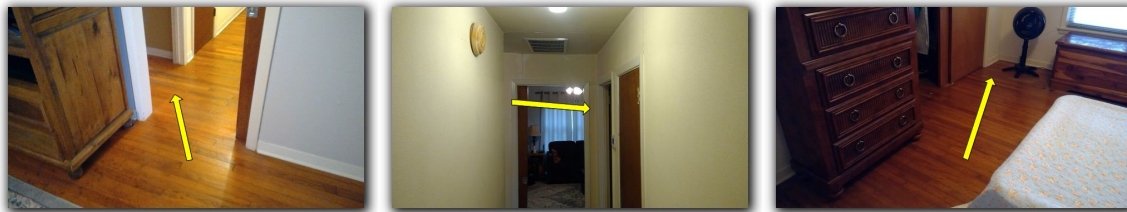
**Floor slopes are apparent.** This condition indicates that movement in the structure has occurred. Further investigation may be necessary. The need for foundation repair in some cases can be an aesthetic judgment that must be made by the homeowner or buyer.

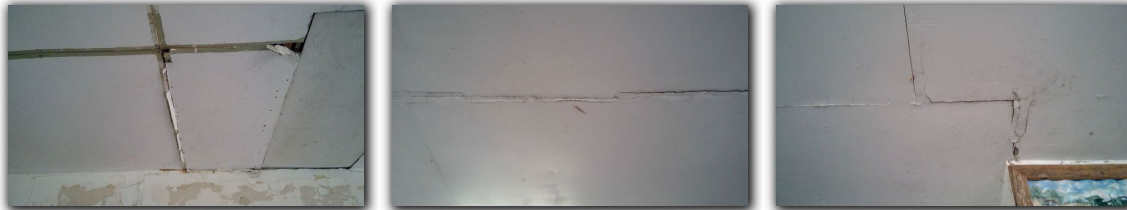
**Damage to the interior finish was observed on ceiling in the garage.** Repairs are needed.

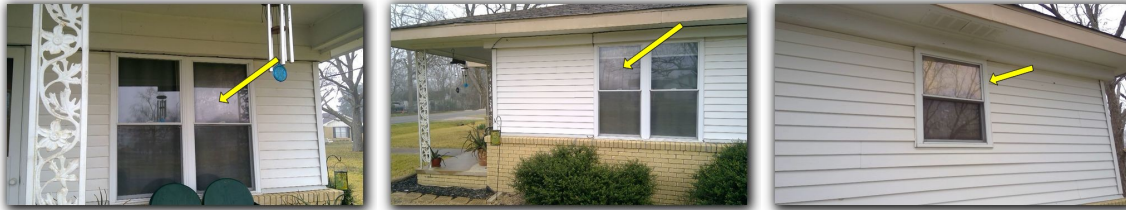
**Windows with broken seals were noted in one or more windows.** A window seal could be broken and not noticed for some time. This allows moisture inside between the panes of glass causing fogging to take place. This will eventually cause staining to the point of zero visibility.

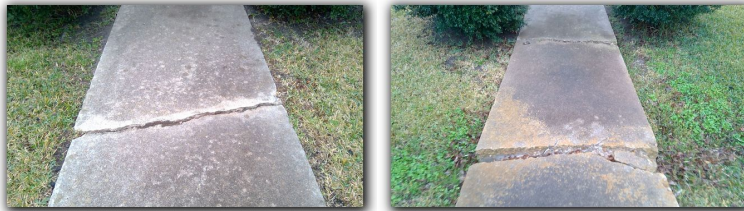
**The sidewalk has settled causing uneven joints.** This is a tripping hazard. Recommend repairs to the sidewalk for safety purposes.

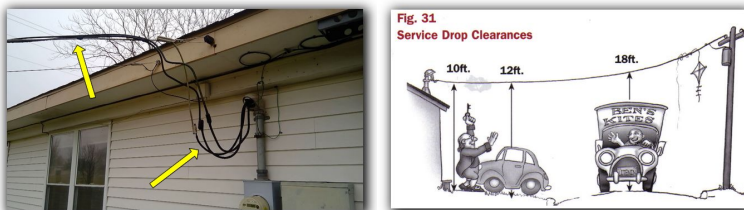
**The service wires appear to not have adequate clearance from the ground and should be repaired.** Recommend contacting the local service company for inspection and needed repairs.

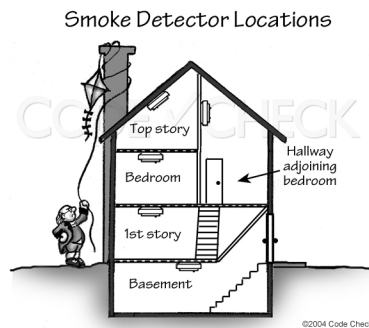
**There are not enough smoke alarms located in the home.** Under current building standards, there should be a smoke alarm located in each sleeping room, outside each separate sleeping area in the immediate vicinity of the sleeping rooms, and on each additional story of the dwelling.
