PROPERTY INSPECTION REPORT

Concerning: 17119 Horseshoe Bend, Waller, TX 77484

By: S. Brad Williams TREC# 23549 / Sunbelt Inspections 5/25/2021

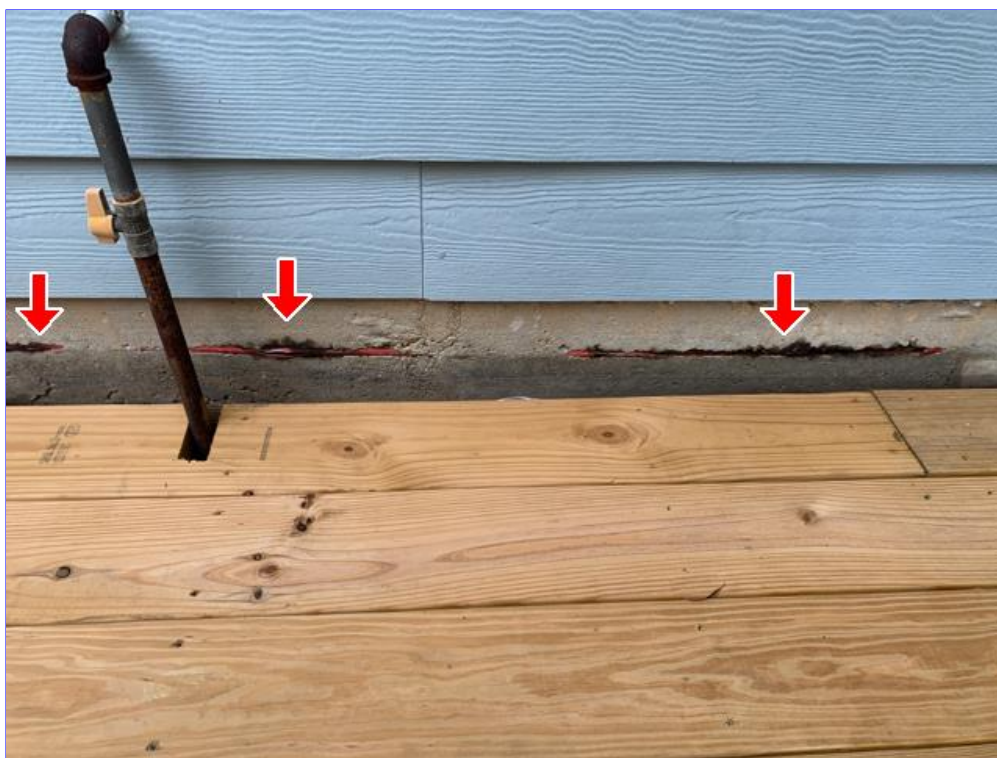
(2) At the back of the home, on the left side of the deck, an exposed post tension cable at the slab edge was observed. I recommend all exposed reinforcing be sprayed with a rust inhibitor and sealed with an appropriate cementitious epoxy.

A. Photo 1(Picture) At the back of the home, on the left side of the deck, an exposed post tension cable at the slab edge was observed. I recommend all exposed reinforcing be sprayed with a rust inhibitor and sealed with an appropriate cementitious epoxy.

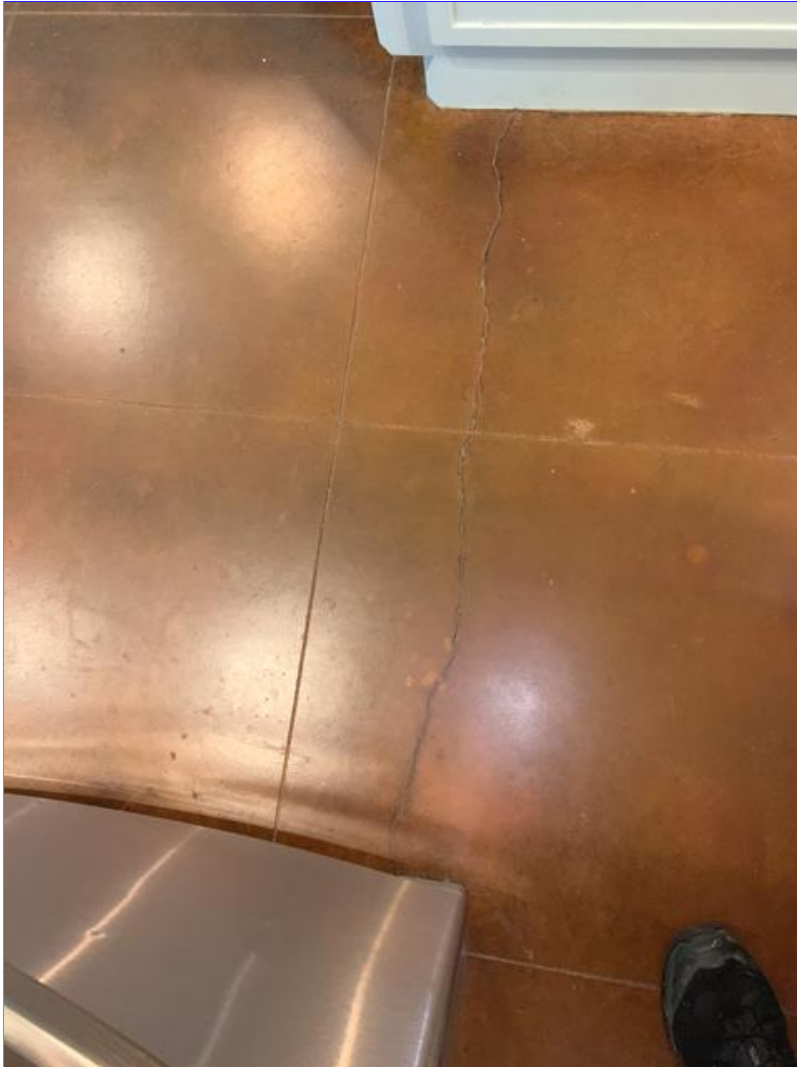
A. Photo 2(Picture) Some concrete surface cracks were observed in the interior stained concrete floors. There is little to no deflection across the cracks. This type of flexural crack is generally the result of seasonal variations in soil moisture causing the soils to shrink and/or swell exerting pressure on the foundation. This type of crack is not structurally significant.

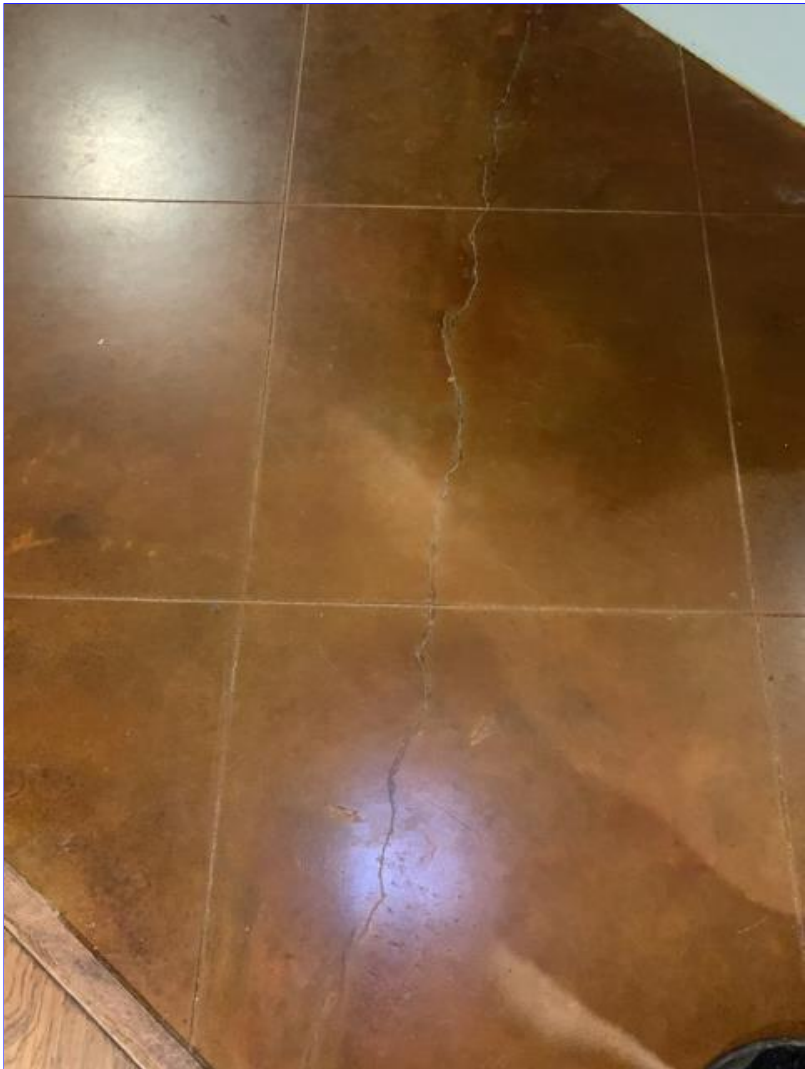
A. Photo 3(Picture) Some concrete surface cracks were observed in the interior stained concrete floors. There is little to no deflection across the cracks. This type of flexural crack is generally the result of seasonal variations in soil moisture causing the soils to shrink and/or swell exerting pressure on the foundation. This type of crack is not structurally significant.

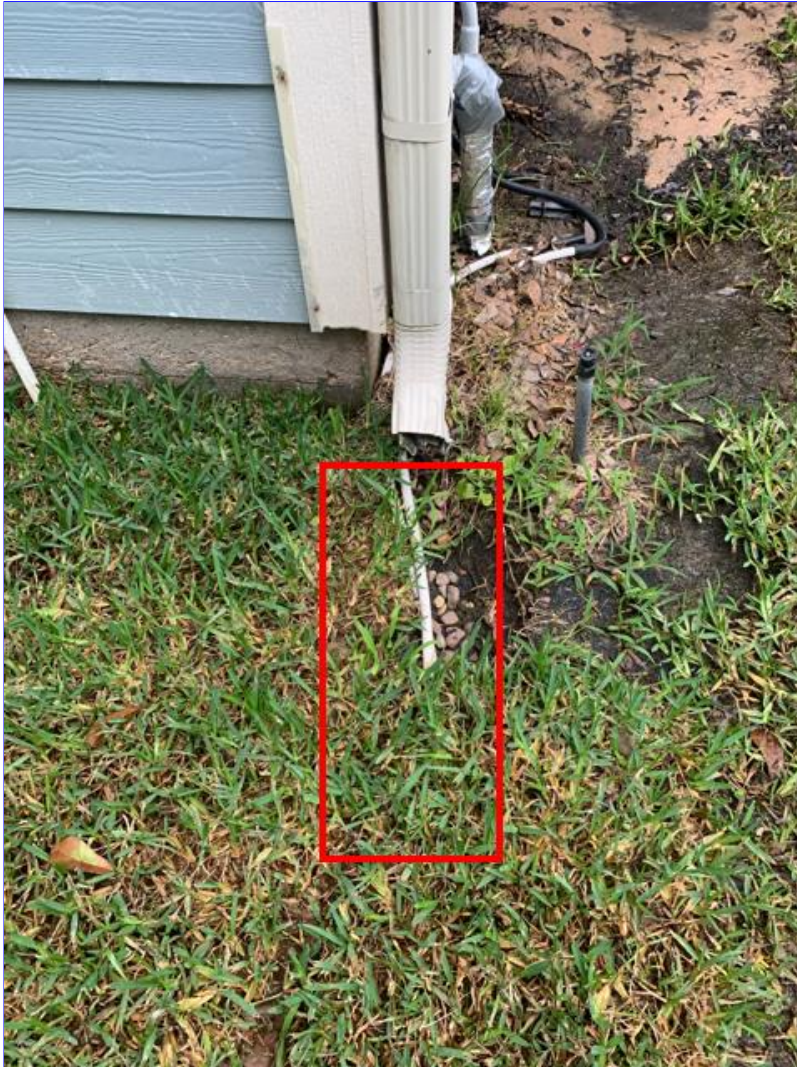
B. Photo 1(Picture) Concrete splash blocks or downspout extensions, are absent at some gutter downspouts. Gutter downspouts should discharge a minimum of 18" away from the foundation.

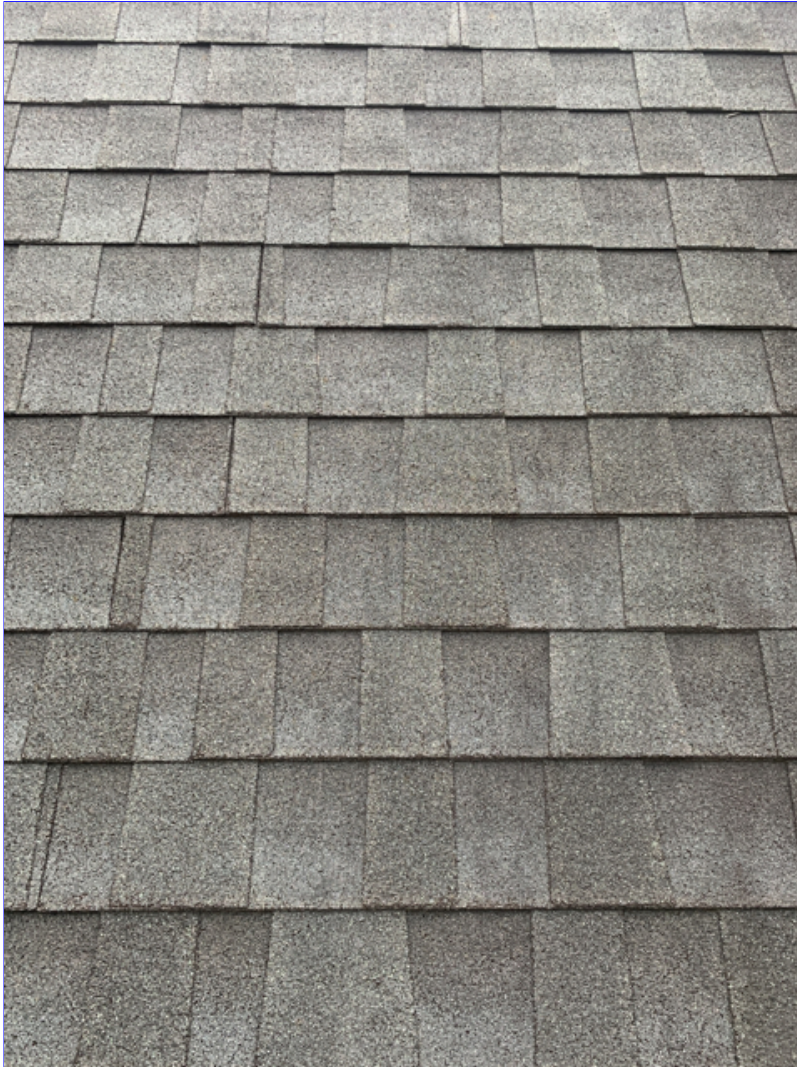
C. Photo 1(Picture) This roof covering is probably around 14 years old. This type of architectural style composition shingles typically lasts about 20 years in this climate.

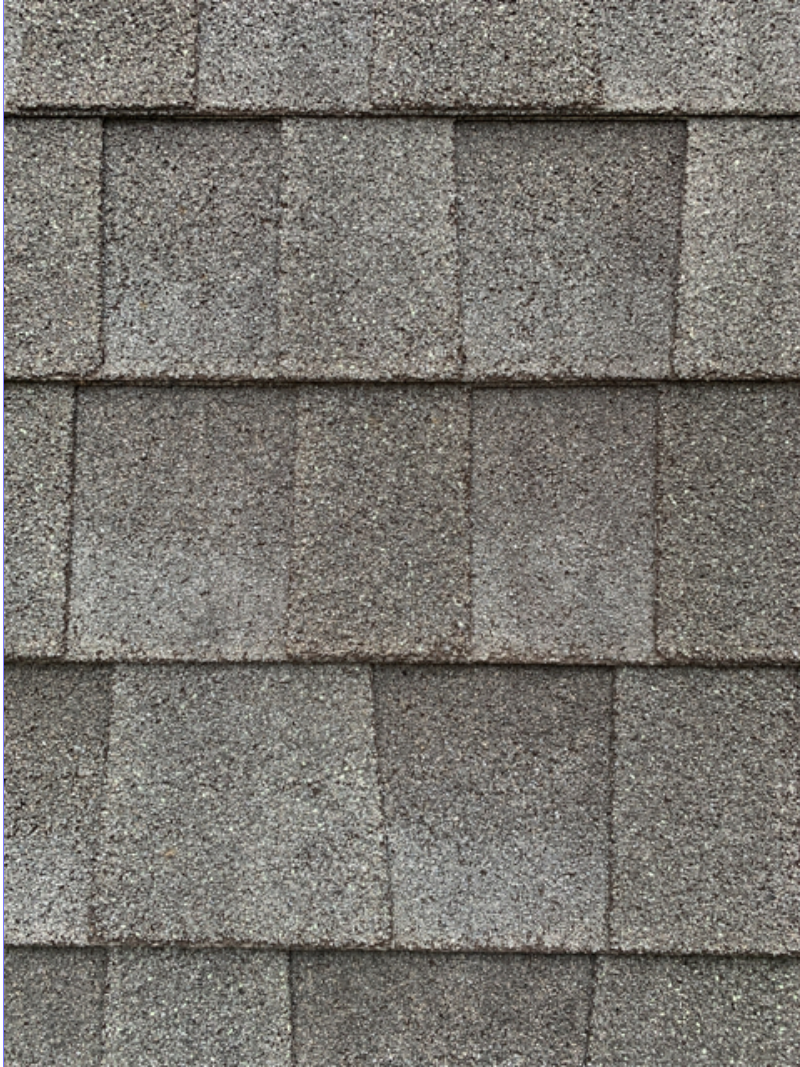
C. Photo 2(Picture) This roof covering is probably around 14 years old. This type of architectural style composition shingles typically lasts about 20 years in this climate.

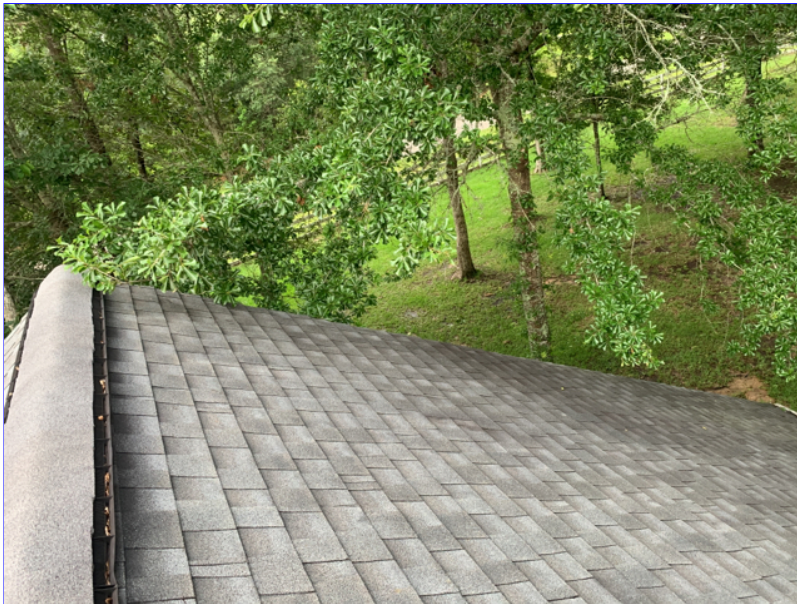
C. Photo 3(Picture) Tree limbs that are in contact with roof or hanging near roof should be trimmed. Tree limbs in contact with the shingles can cause damage. Recommend Correction

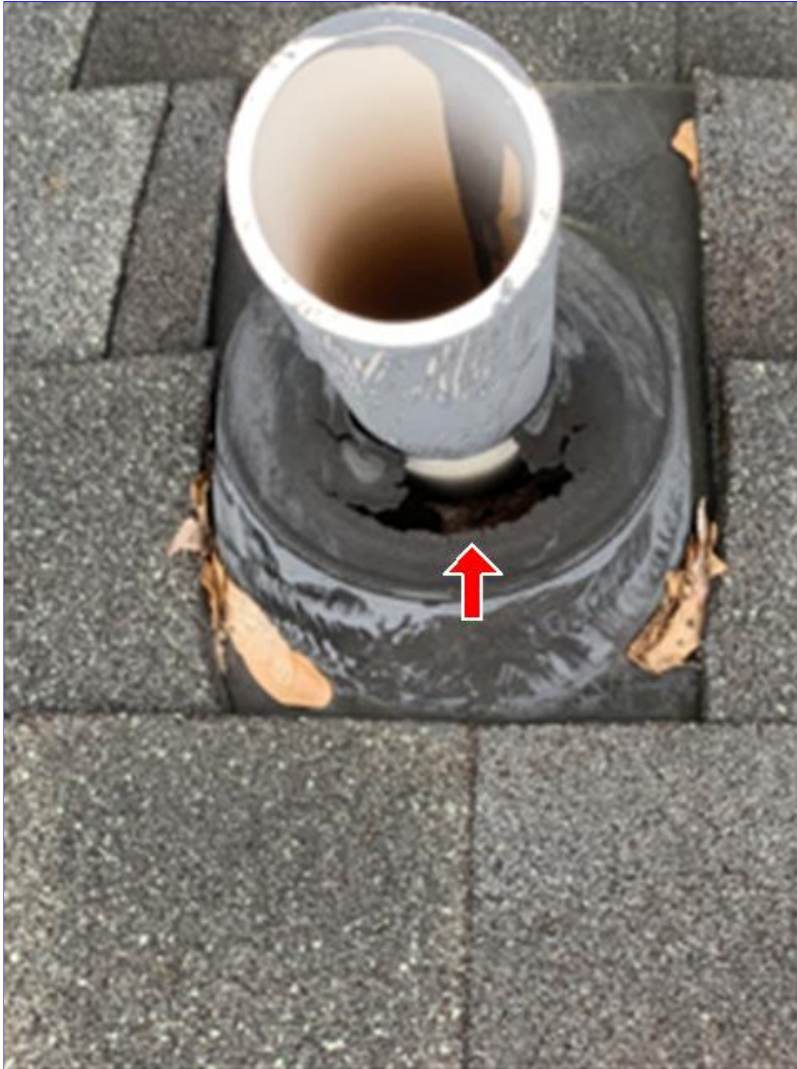
C. Photo 4(Picture) Damage was observed on one of the plumbing vent pipe boots. Recommend all vent pipe boots be resealed and/or replaced to prevent water intrusion and damage.

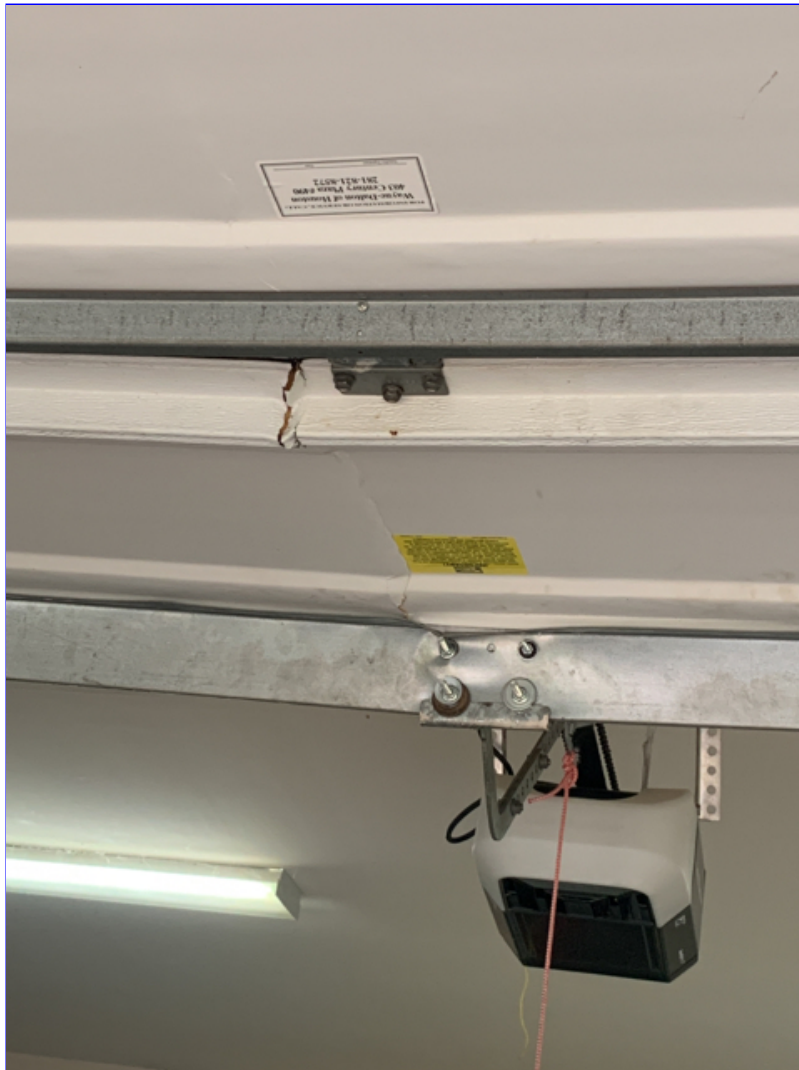
G. Photo 1(Picture) Damage was observed on the upper garage door panel.

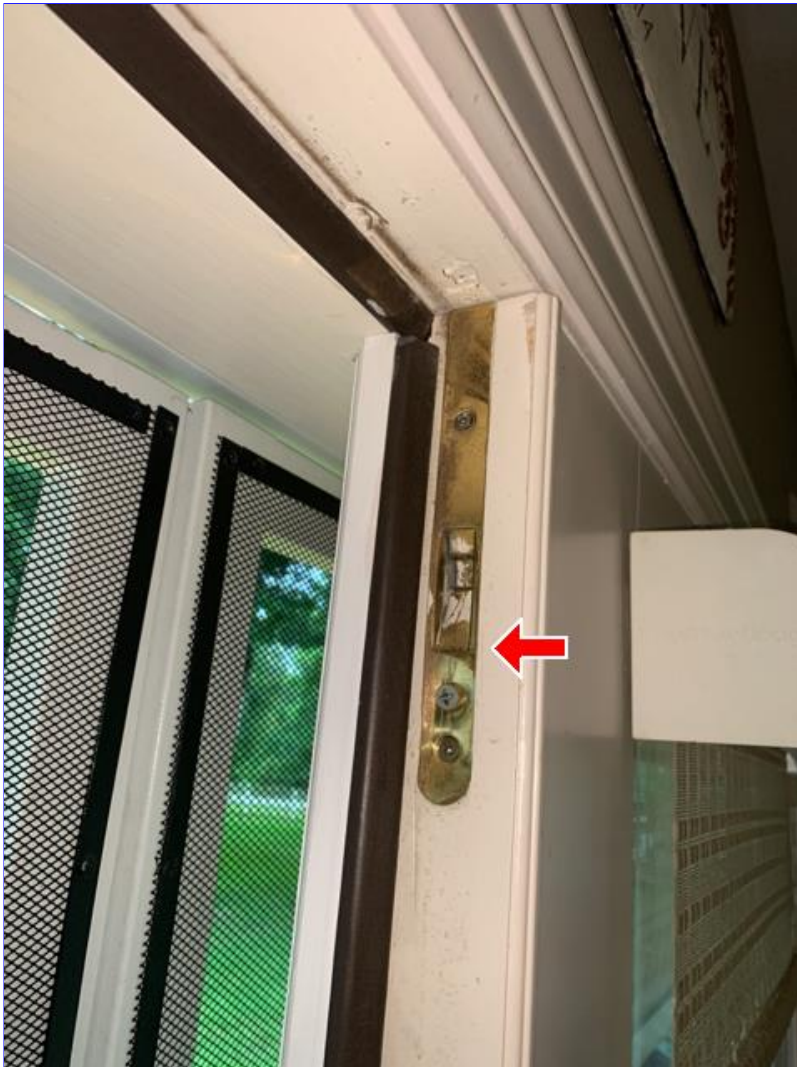
G. Photo 2(Picture) The back exterior double door slide latches are damaged and inoperable.

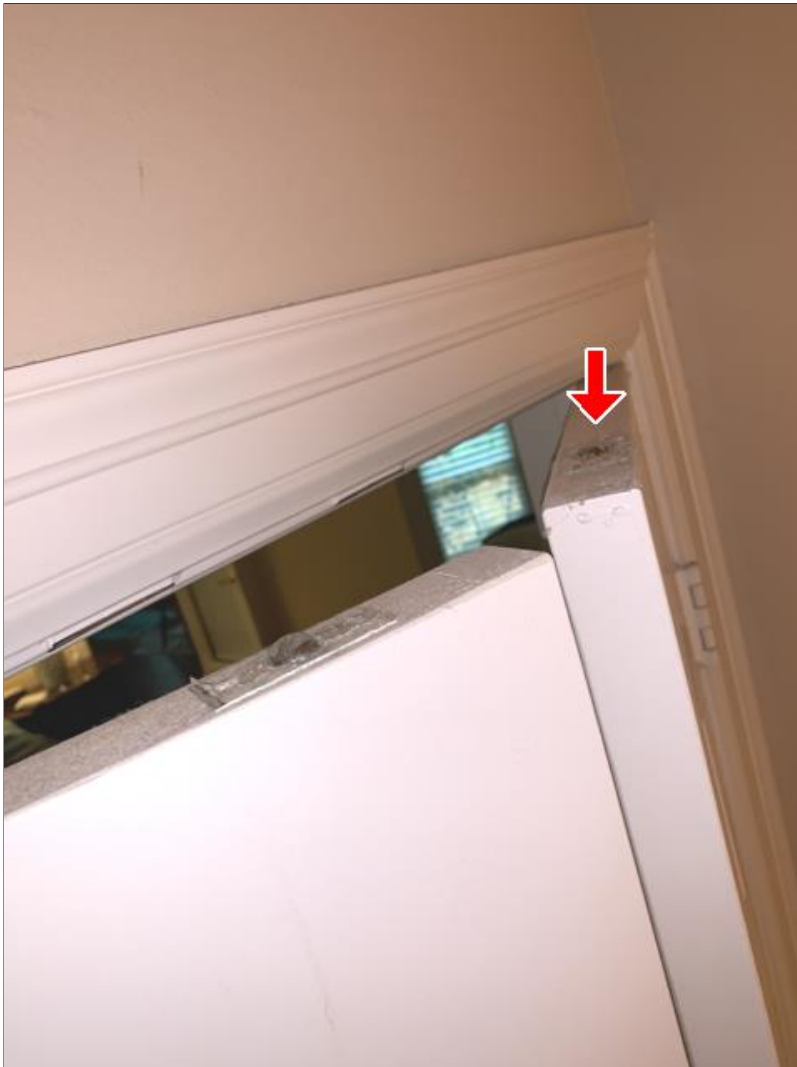
G. Photo 3(Picture) The ball catch hardware at the top of interior double doors are damaged, missing, or out of adjustment. Recommend correction.

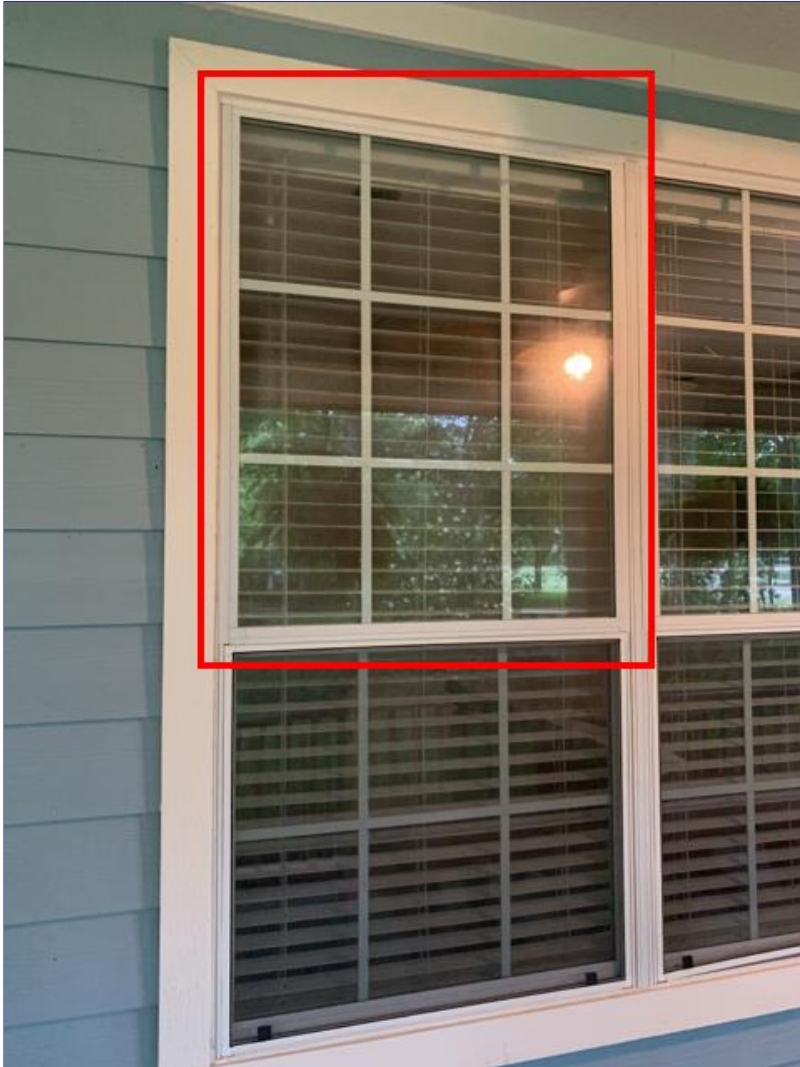
H. Photo 1(Picture) One of the front porch area window seals appears to be compromised, as suggested by condensate and mineral deposits built up between the double panes of glass.

(3) I recommend that you consult with a competent and qualified window installation/repair company to evaluate further, determine the best repair methods, estimate costs, and to perform the repairs.

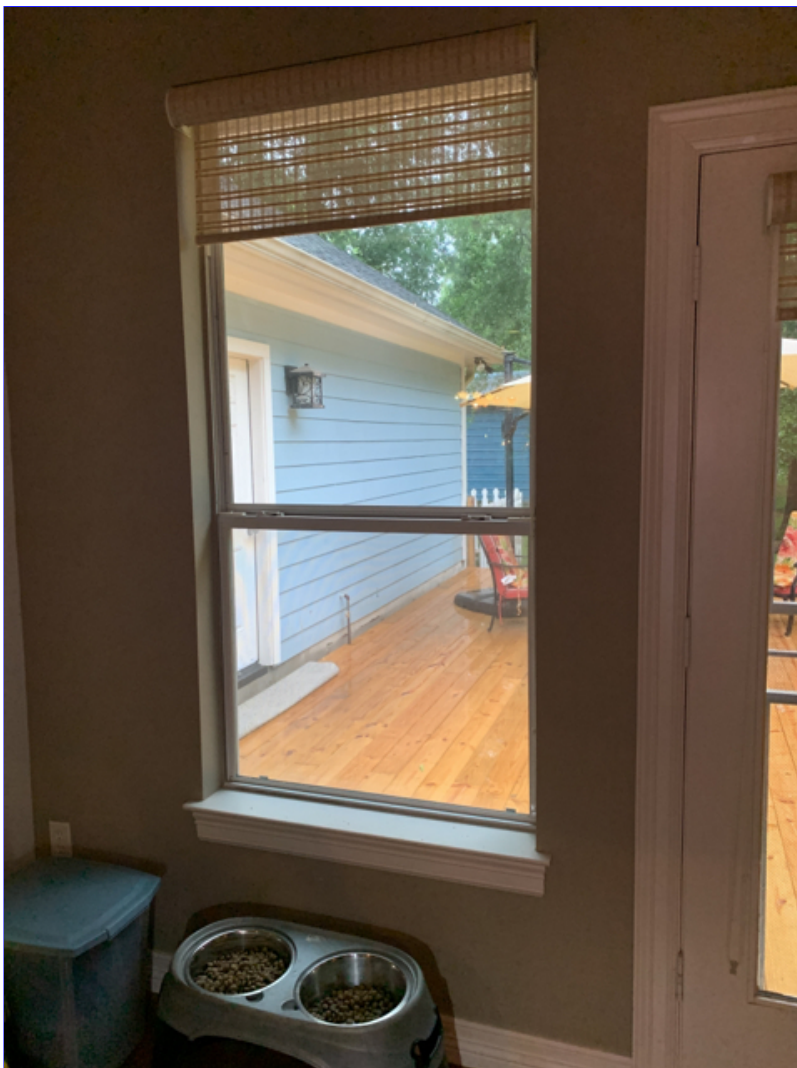
H. Photo 2(Picture) In the back enclosed sitting room/ office, the window springs on the left window have failed.

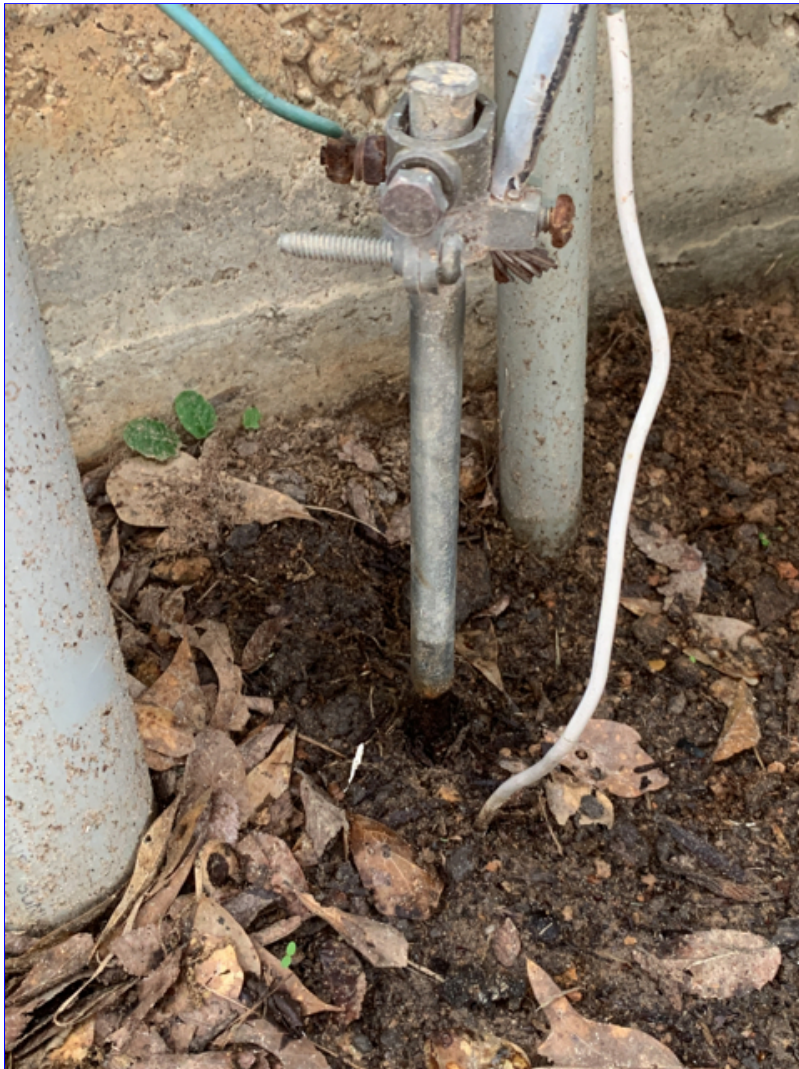
A. Photo 1(Picture) The system ground rod (electrode), is corroded. Recommend replacement.

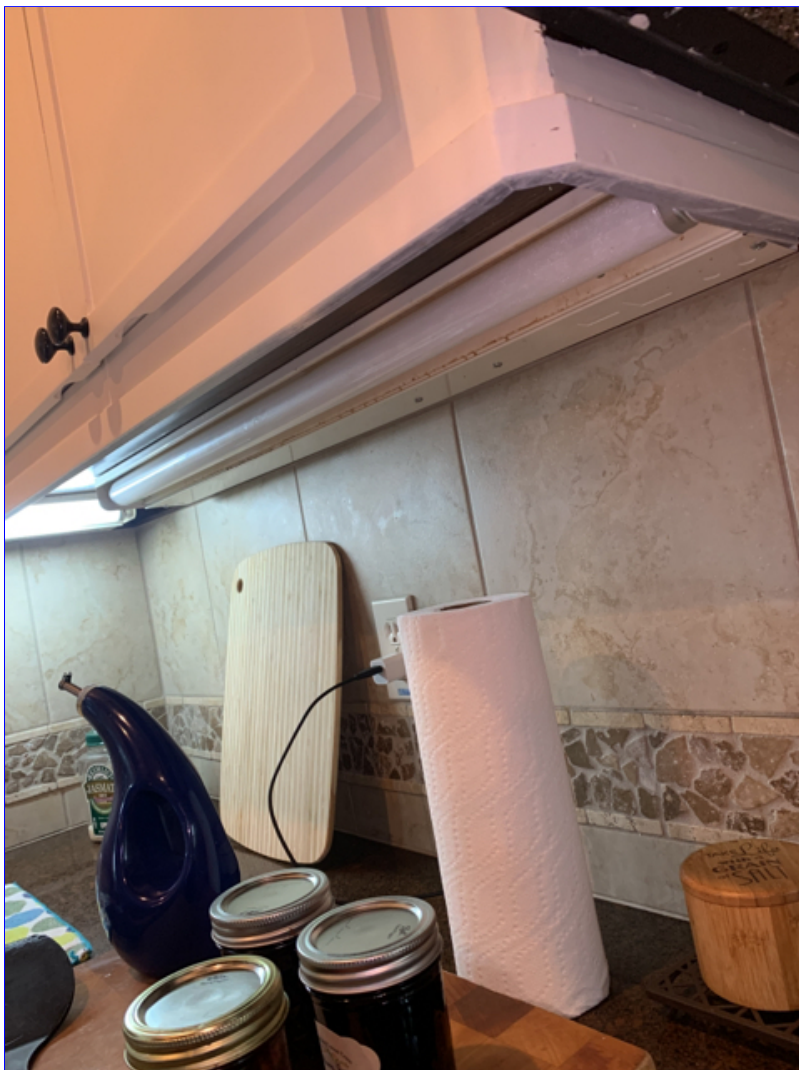
B. Photo 1(Picture) One of the kitchen under-cabinet lights did not turn on with the switch.

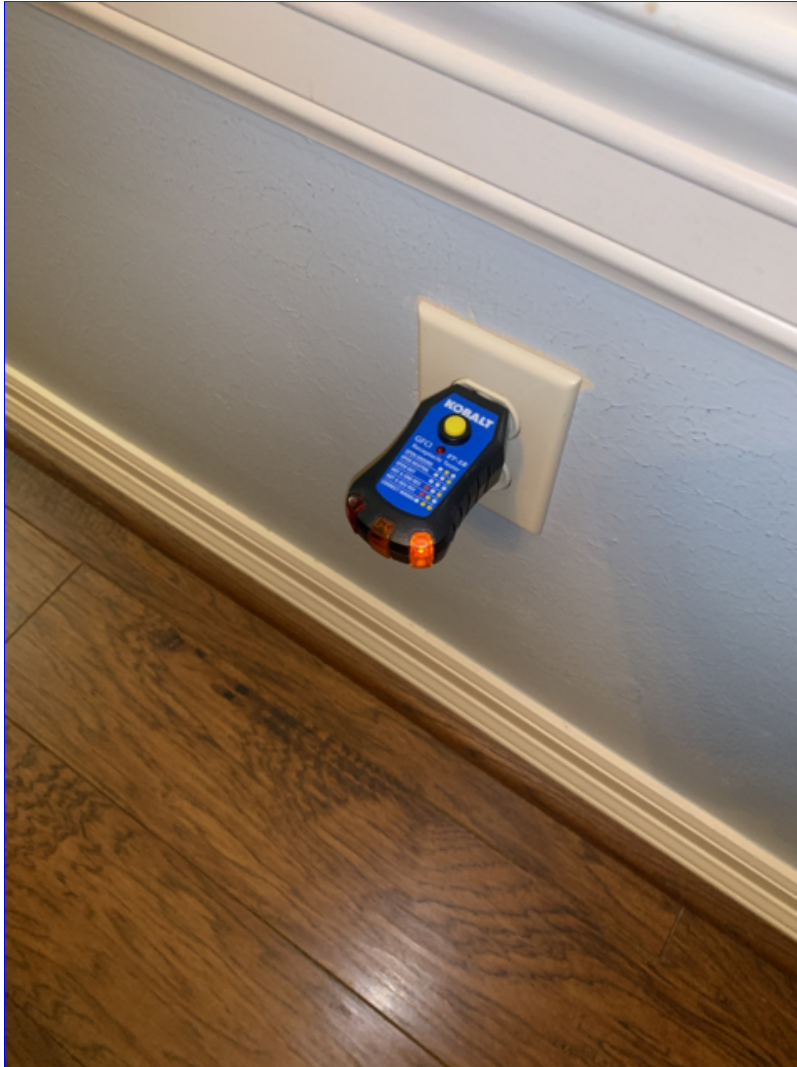
B. Photo 2(Picture) In the front bedroom, on the exterior wall, the outlet has a bad top receptacle. Recommend replacement.

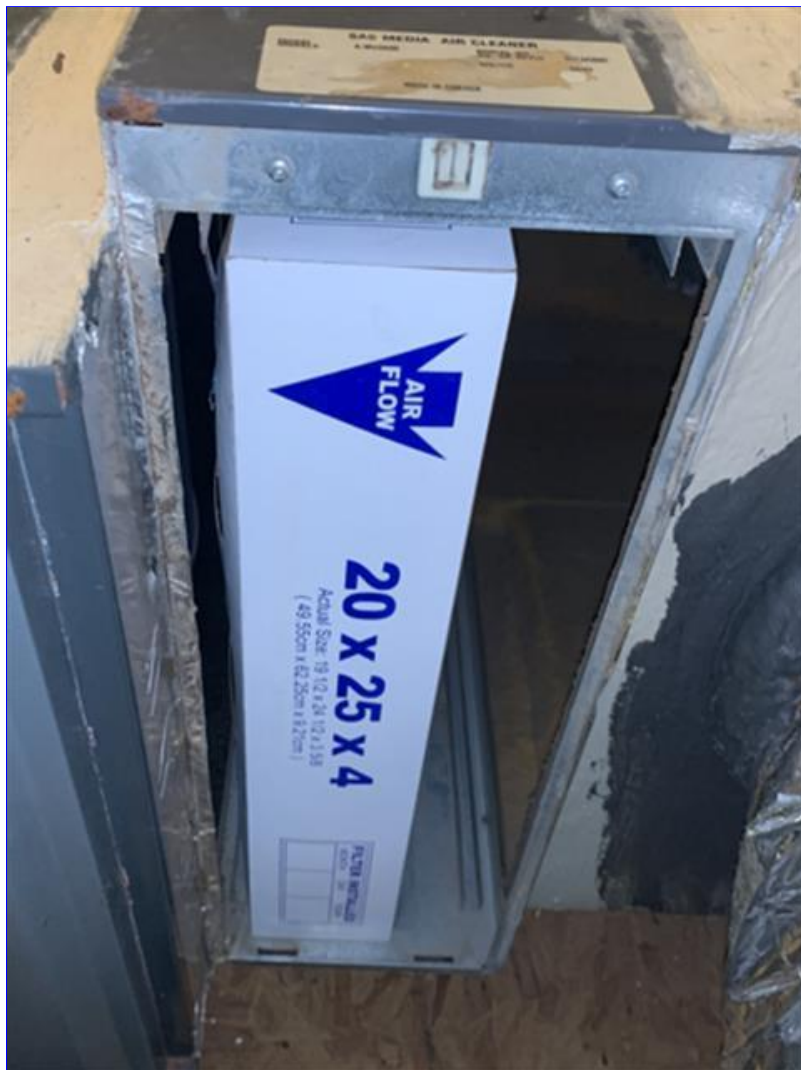
C. Photo 4(Picture) The currently installed filter is under-sized.
Recommend correction.

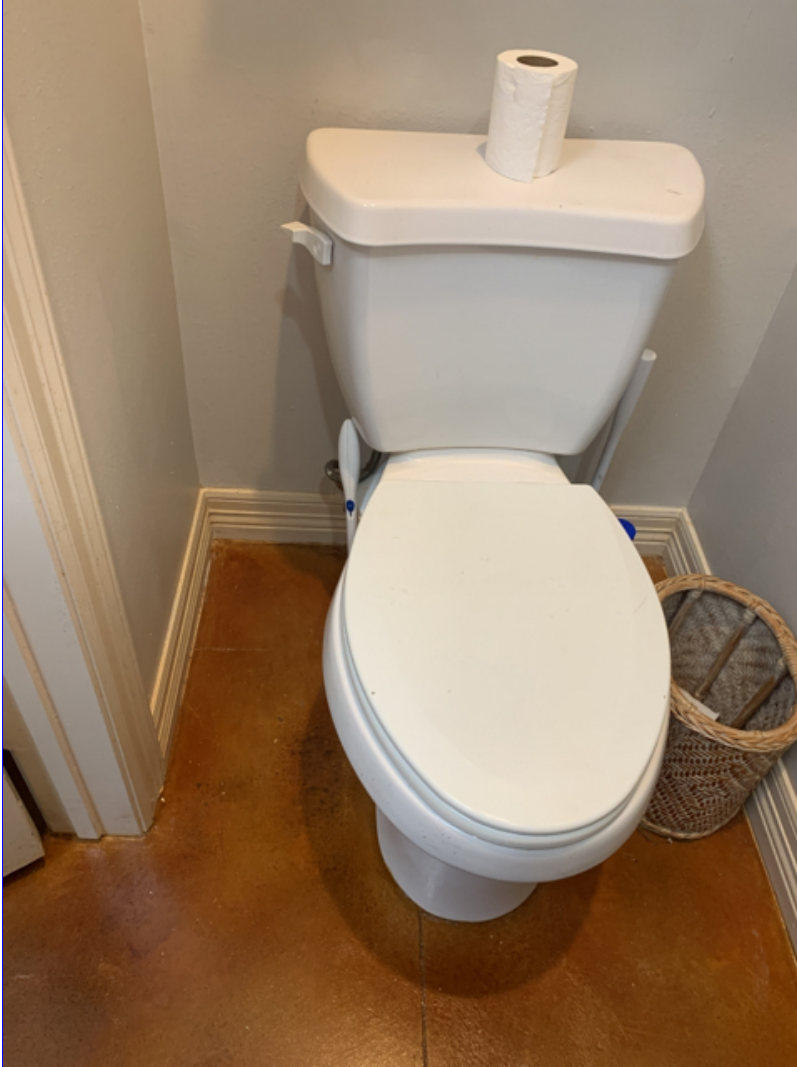
A. Photo 1(Picture) Two toilets are loose at floor. Repairs may involve re-setting the toilet on a new wax seal. I recommend a qualified licensed plumber repair or correct as needed.

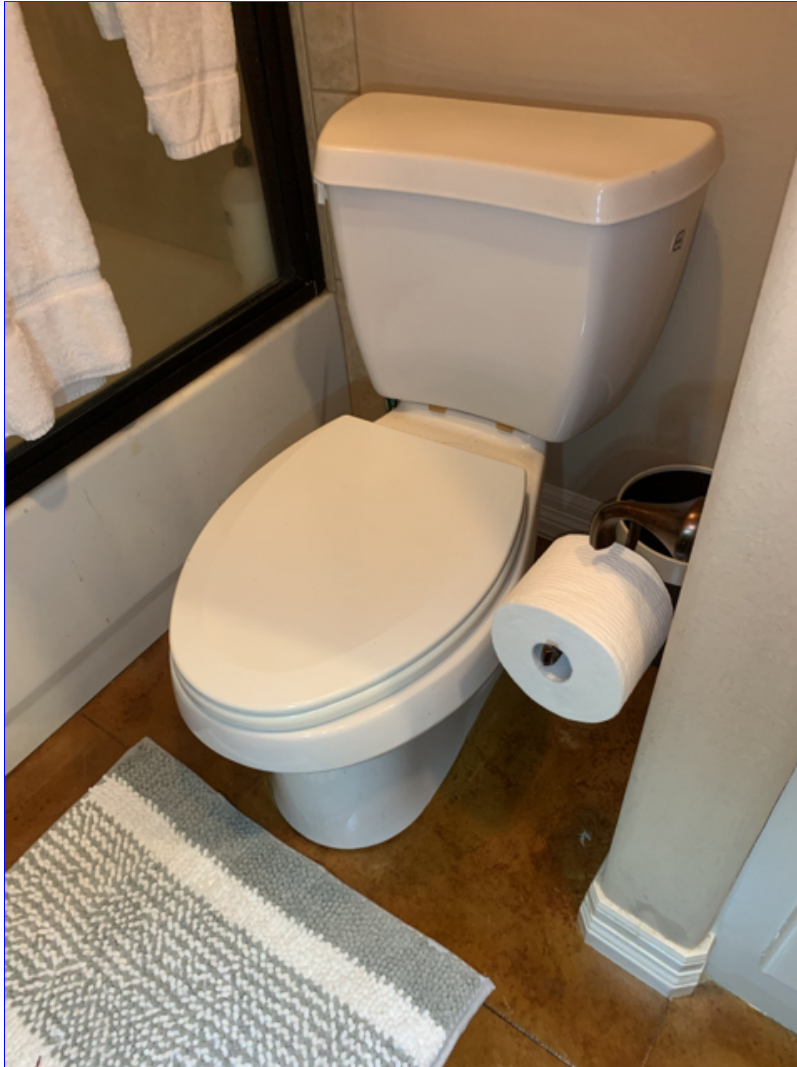
A. Photo 2(Picture) Two toilets are loose at floor. Repairs may involve re-setting the toilet on a new wax seal. I recommend a qualified licensed plumber repair or correct as needed.

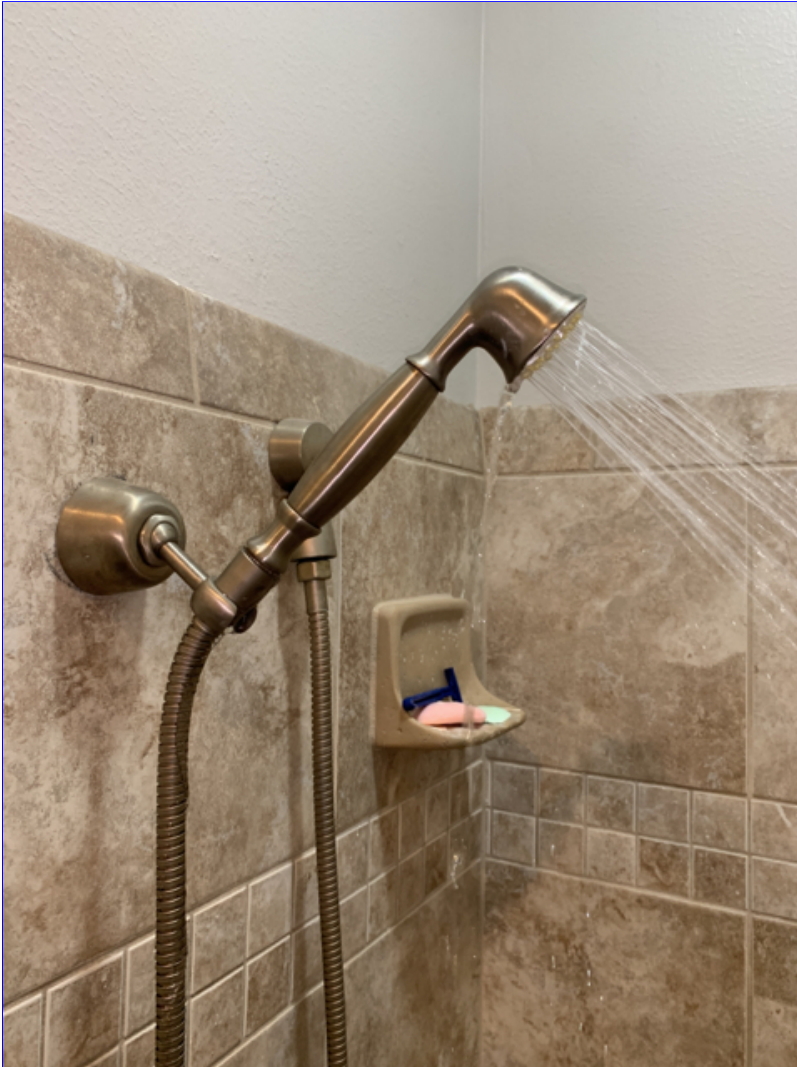
A. Photo 3(Picture) Shower head leaks were observed in some bathrooms.

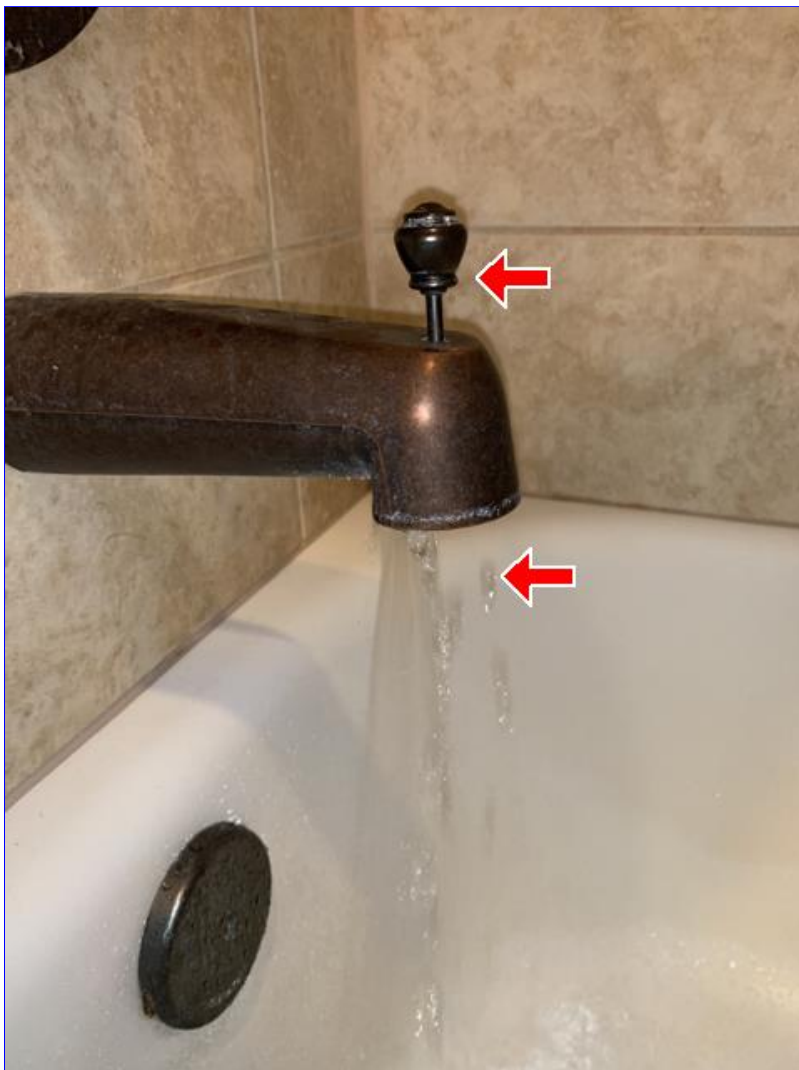
A. Photo 4(Picture) Water does not fully divert from tub spigot to shower head in some bathrooms. Recommend correction.

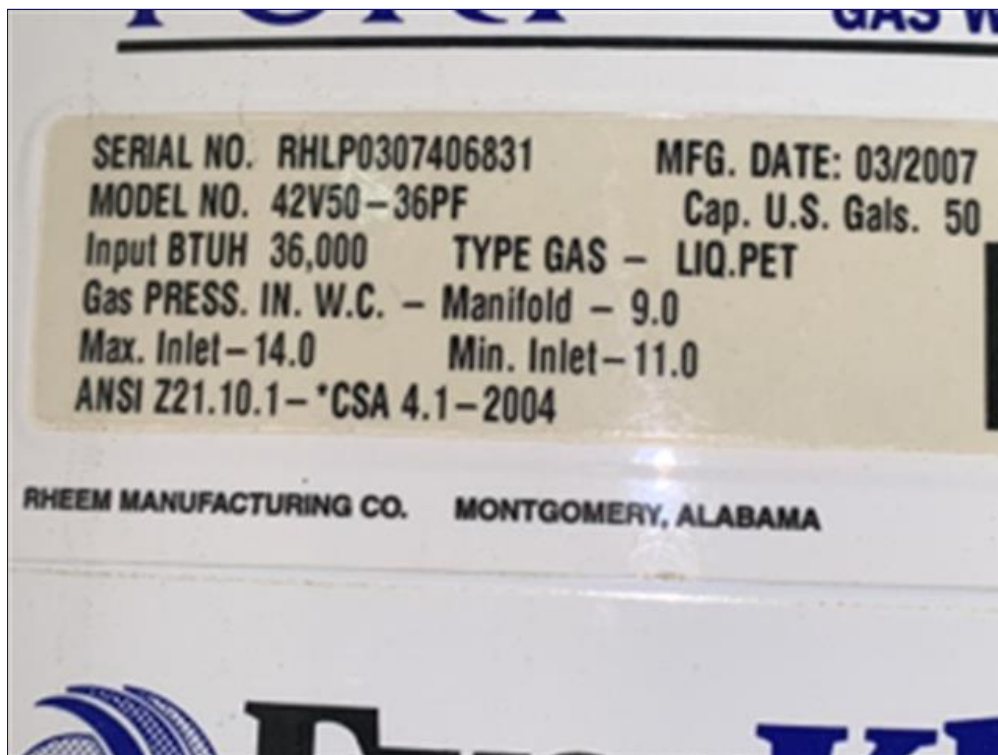
C. Photo 1(Picture) Water heater service tag.

NOTE: The water heater is old. Although the heater appears to be currently operating, it is nearing, or has exceeded, the end of the average useful service life of typical gas fired water heater (about 15 years). The heater may last a few years longer or may not. I cannot determine how long the unit will continue to operate. I recommend that you budget for replacement.

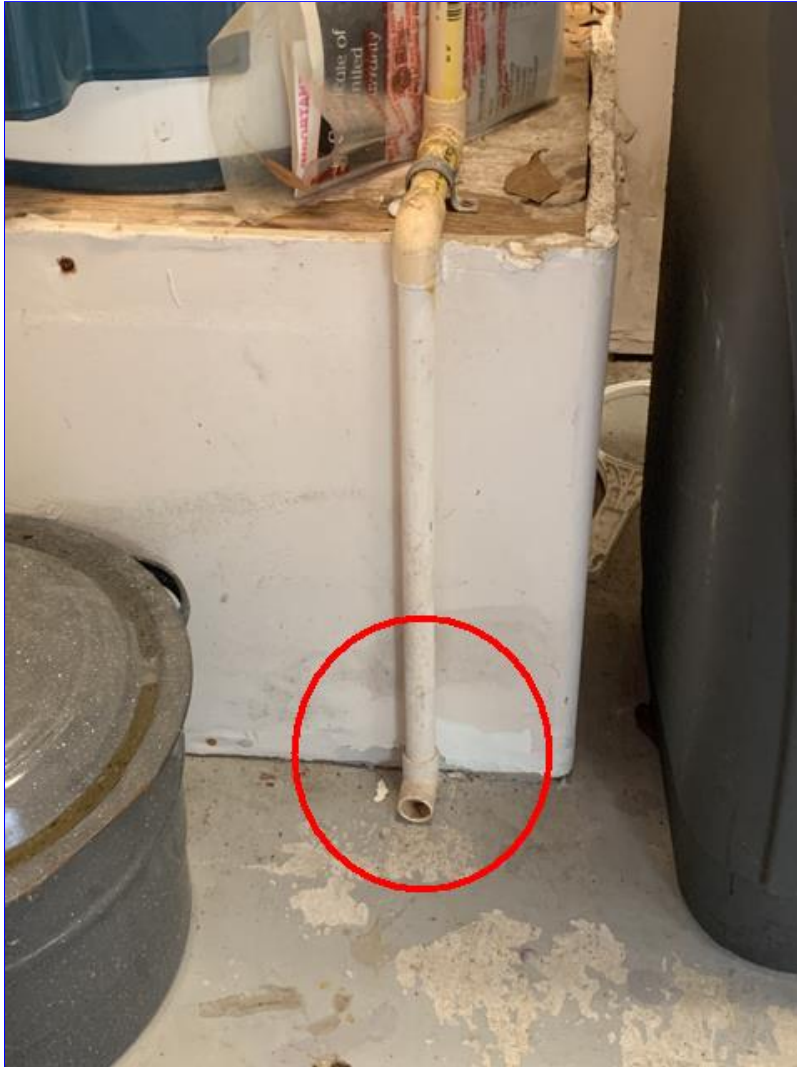
C. Photo 2(Picture) The T&P (Temperature and Pressure) relief valve piping on water heater, should extend to within 6 inches of the floor and should be pointed downward for safety.

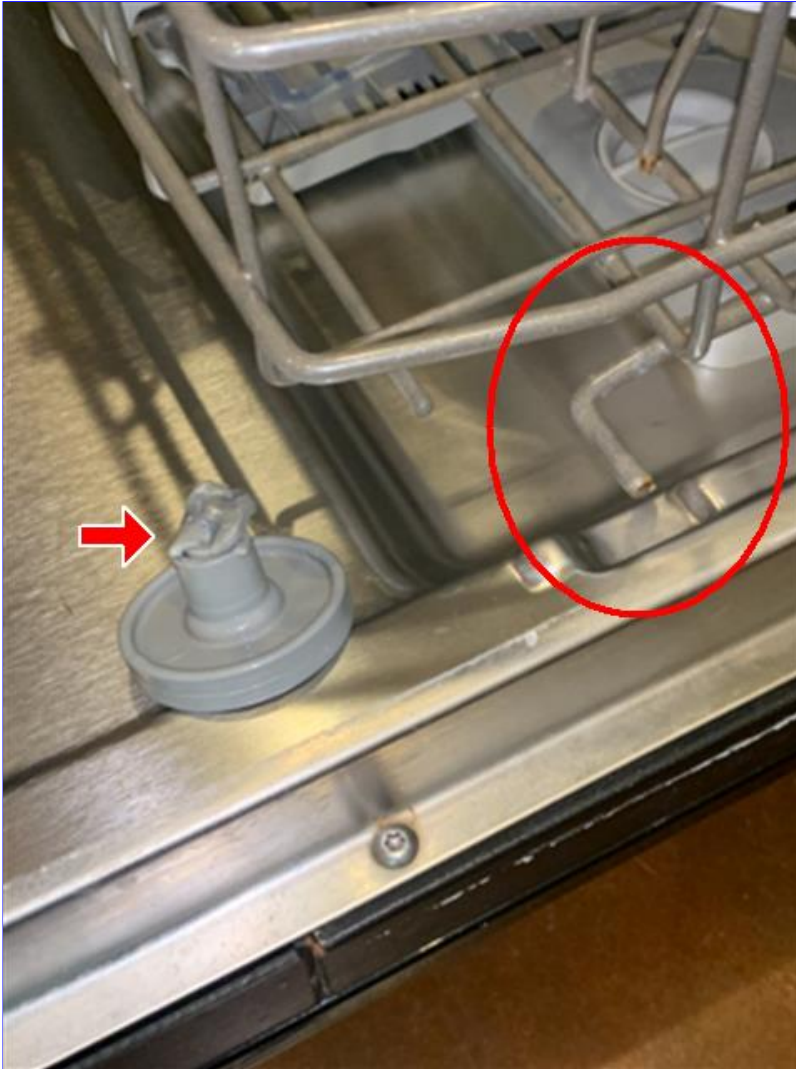
A. Photo 1(Picture) The bottom rack front right wheel is damaged. Recommend replacement as needed.

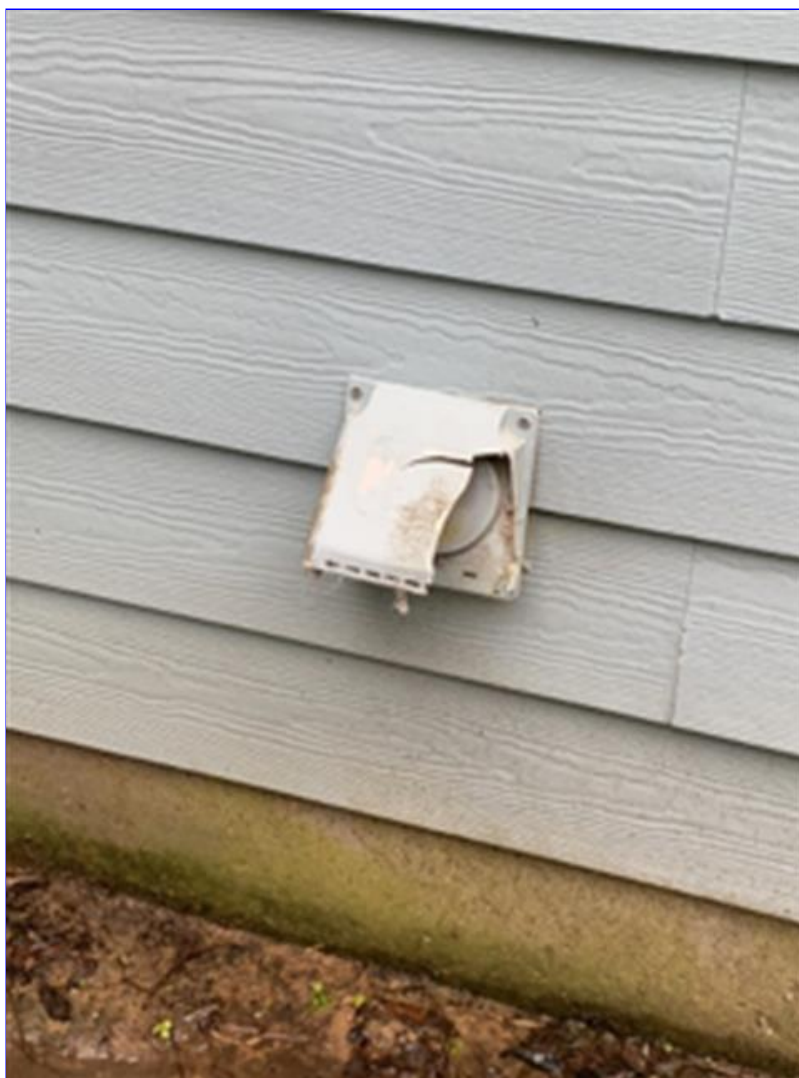
H. Photo 1(Picture) The dryer exhaust exterior cover is damaged. Recommend correction as needed.

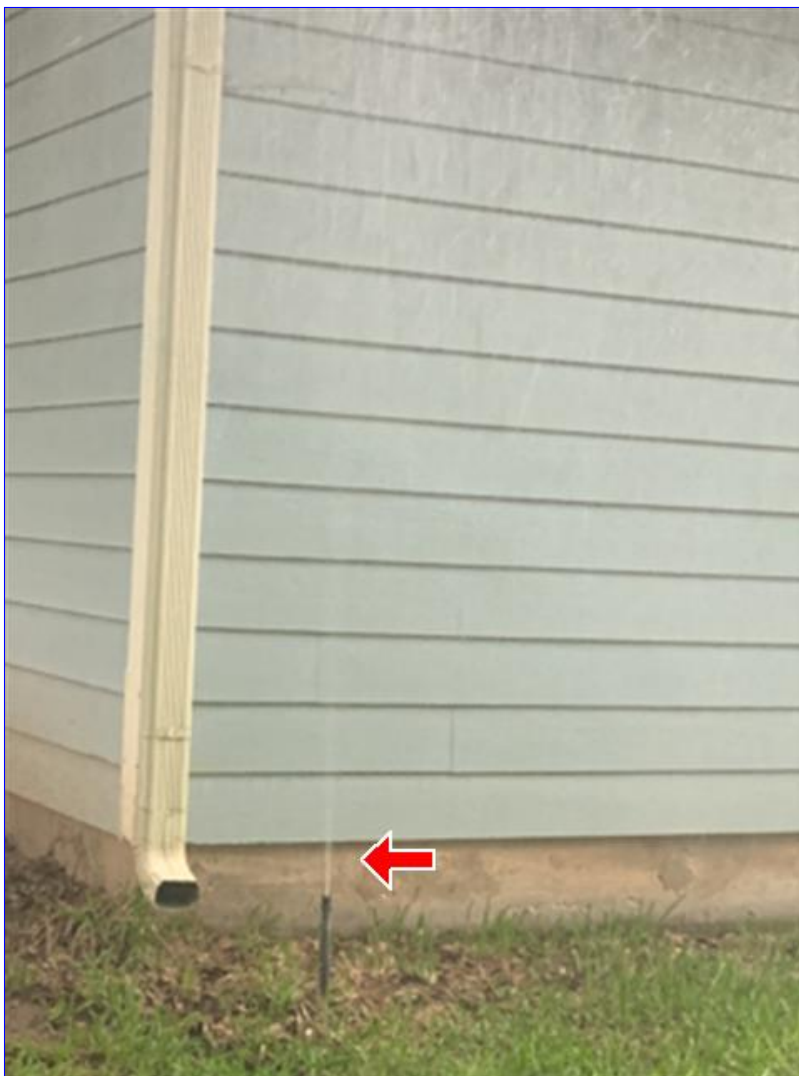
E. Photo 1(Picture) A damaged sprinkler head nozzle was observed in Zone 3.
