PROPERTY INSPECTION REPORT

Concerning: 17119 Horseshoe Bend, Waller, TX 77484

By: S. Brad Williams TREC# 23549 / Sunbelt Inspections 5/25/2021

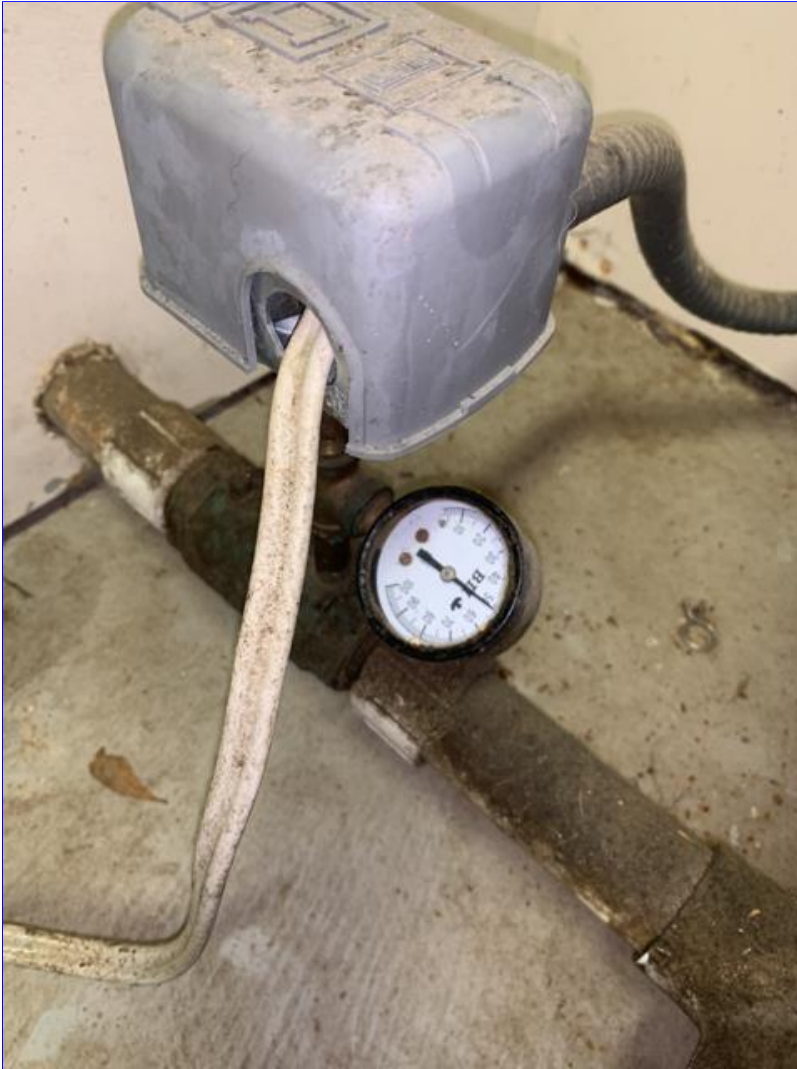
(3) The pressure gauge near the pressure switch is not registering properly. The gauge does not appear to react to pressure changes. Recommend replacement.

B. Photo 2(Picture) The pressure gauge near the pressure switch is not registering properly. Recommend replacement.
