HOME INSPECTION REPORT

PROPERTY INSPECTION REPORT

Prepared For:	Joshua Post	
	(Name of Client)	
Concerning:	5004 Hardy St, Houston, TX, 77009	
	(Address or Other Identification of Inspected Property)	
By:	Bob Wiesner (# 22223) Steven Walters (# 22910)	1-23-2018
	(Name and License Number of Inspector)	(Date)
	(Name, License Number of Sponsoring Inspector)

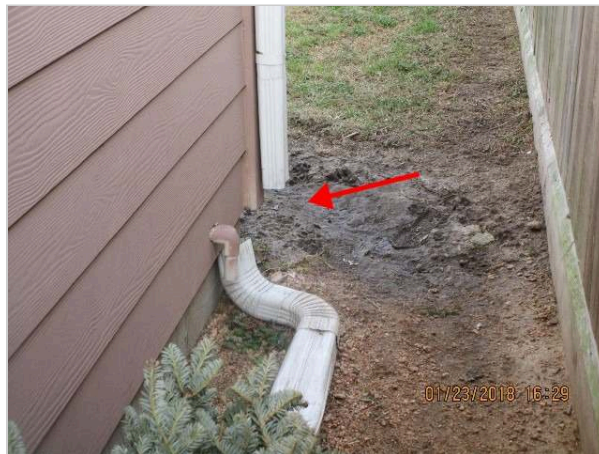
Some of the gutter downspouts were missing the bottom piece.

Gutter downspout missing bottom piece on right exterior wall

- GRADING AND DRAINAGE: Some of the gutter downspouts were missing the bottom piece.
- ROOF COVERING MATERIALS: There was a lack of adhesion in some of the shingles at the valley.

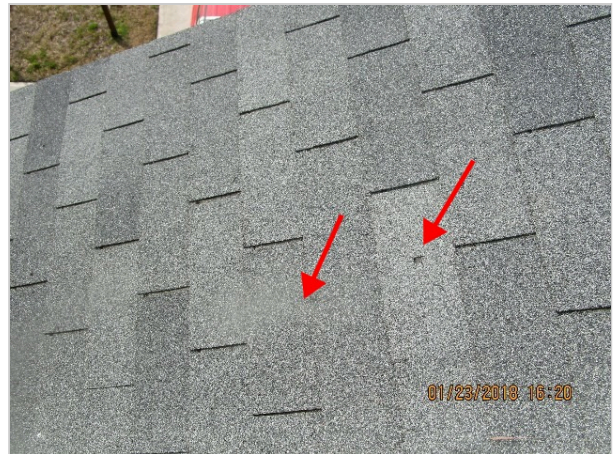
There were some damaged / bruised shingles on the front roof above the garage area.

Damage / Bruised shingles

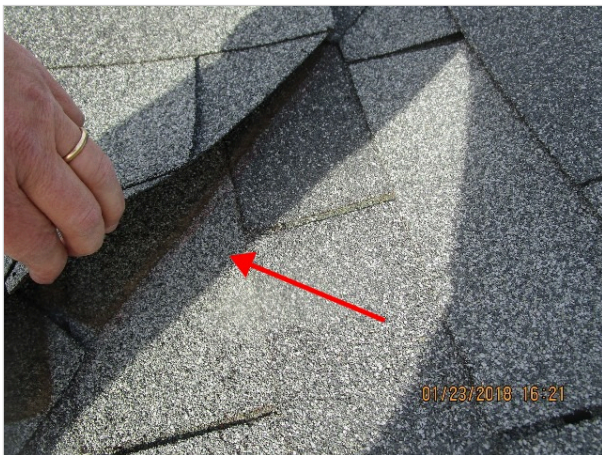
There was a lack of adhesion in some of the shingles at the valley.

Lack of adhesion at the front valley

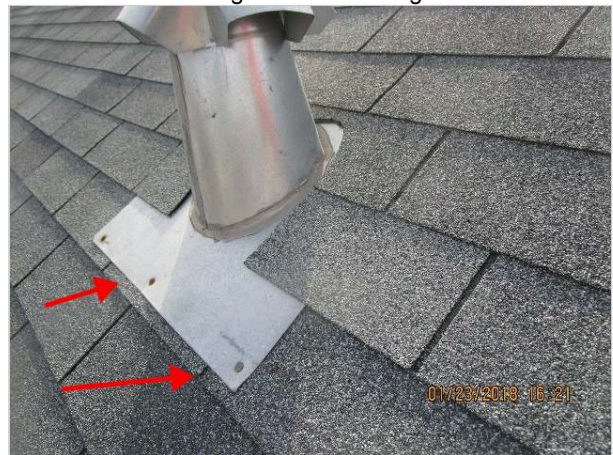
There were exposed nails in several areas. We recommend that exposed nails be sealed.

As the nails rusts, its diameter shrinks and the original hole stays the same size leaving a direct path for water to enter the attic.

Exposed nails

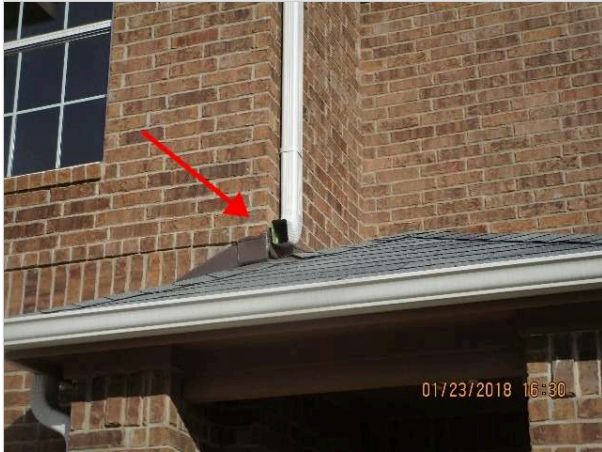
A downspout terminated on the roof above the front porch. Common industry practice recommends to avoid allowing a downspout to drain water directly onto a lower level roof. This may cause water damage and premature wear to the shingles.

This may cause water damage and premature wear to the shingles.

Downspout terminating onto a lower roof

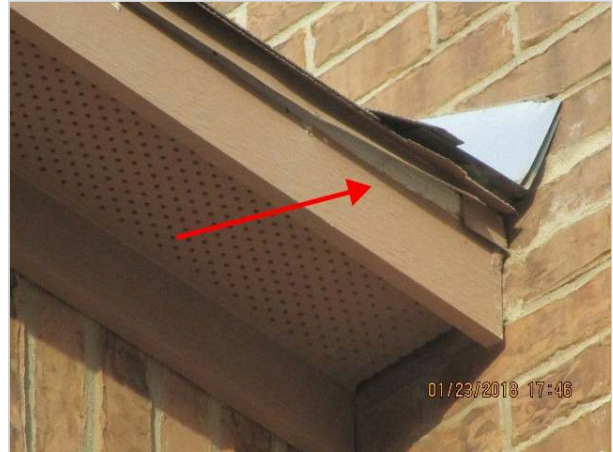
There was some drip-edge flashing that was damaged on the front portion of the roof.

Damaged drip edge flashing

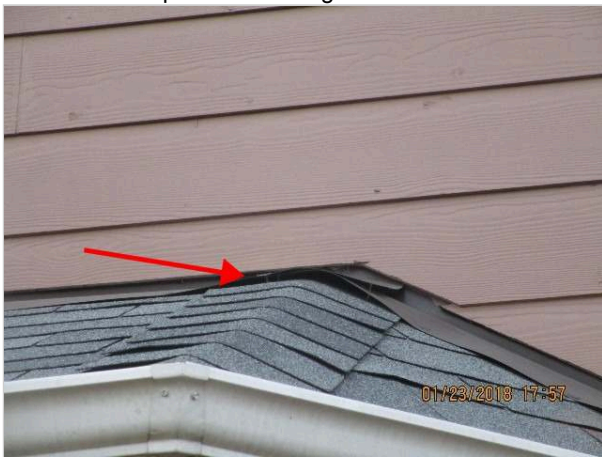
The flashing was raised at the wall / roof boundary over the bay window on the rear wall.

Raised flashing

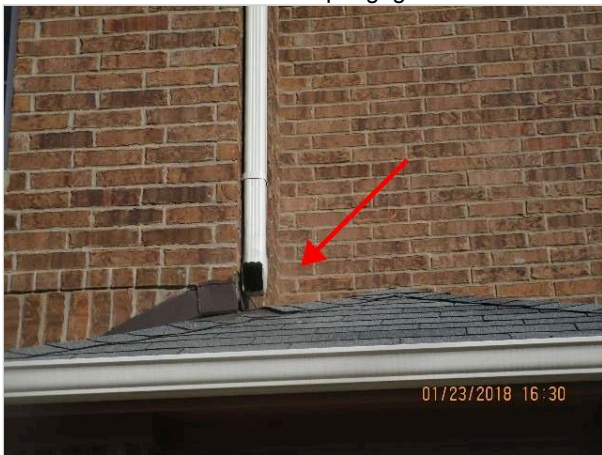
As a note, there was a small "dead-valley" above the front porch (no visible signs of leaks at the time of the inspection). A dead valley is an area on the roof that may hold water against the exterior wall.

"Dead valley"

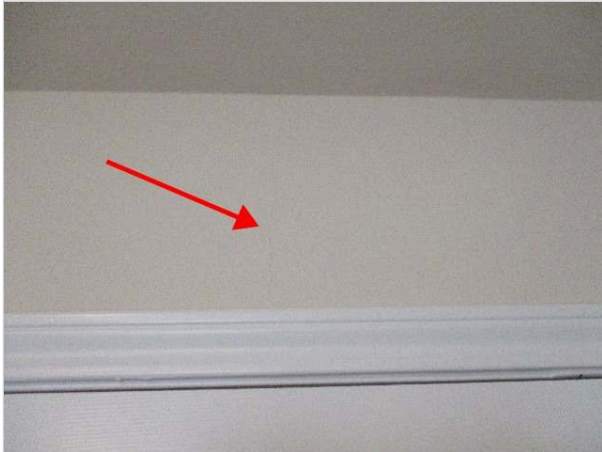
Sheetrock crack in left rear bedroom

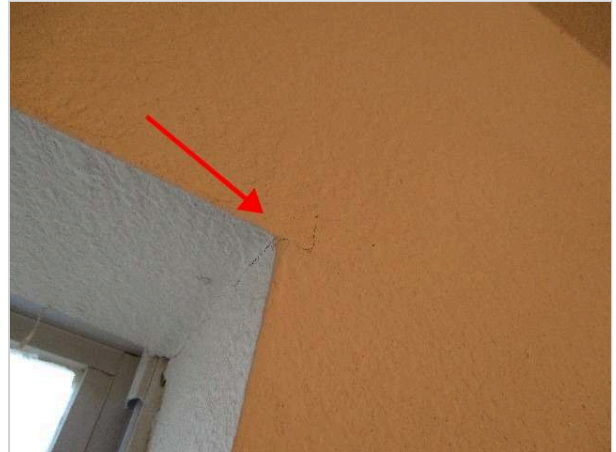
Sheetrock crack in master bathroom window

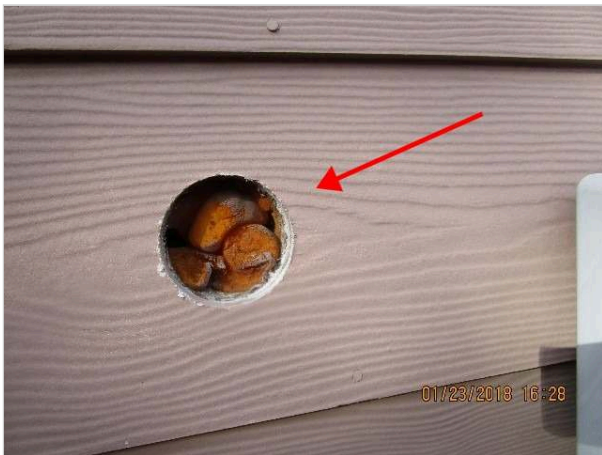
Hole in right exterior wall

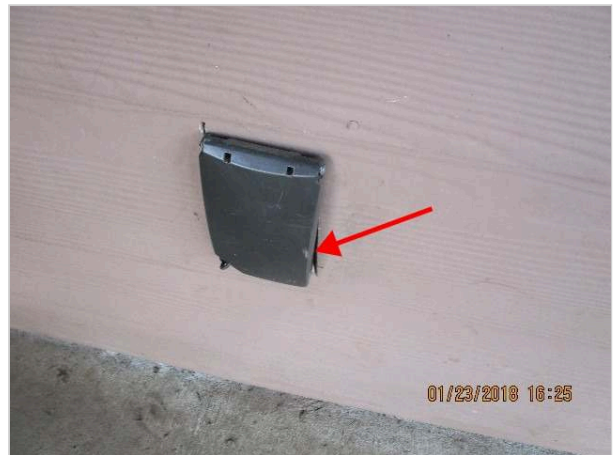
Gap in wall / Needed sealed

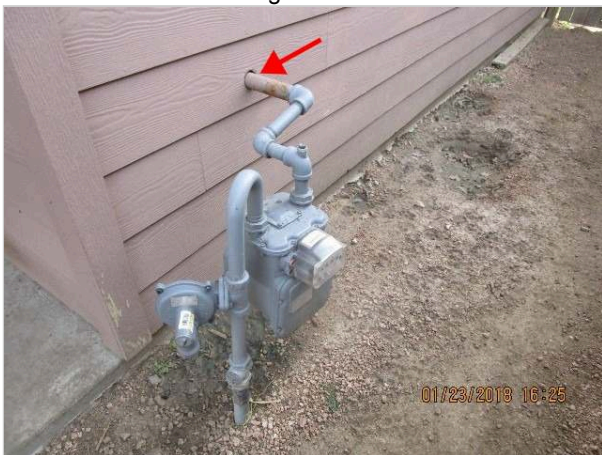
Needed sealed

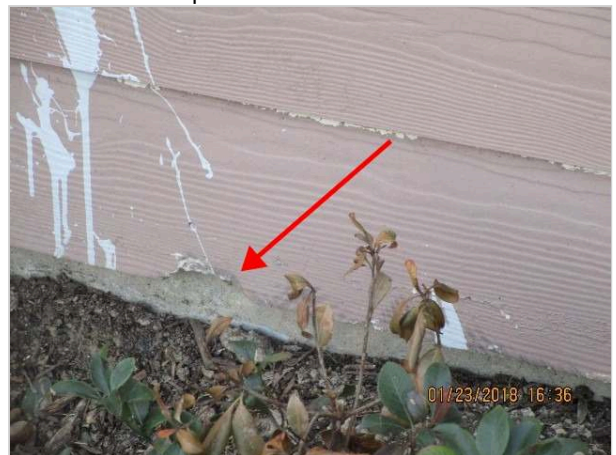
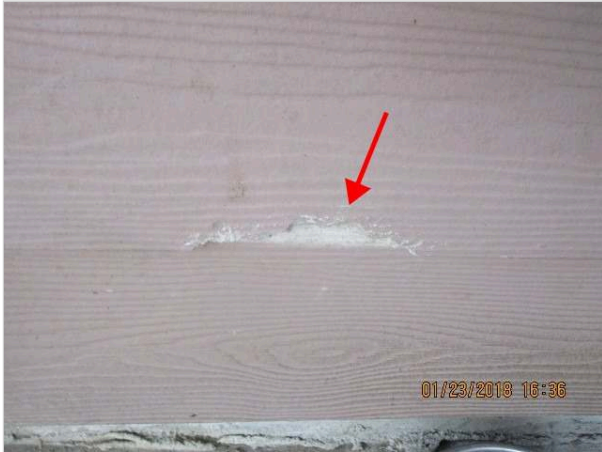
Damage

- There were several damaged areas on the exterior wood siding around the house.
- Corner areas where brick walls came together needed sealing in several areas.

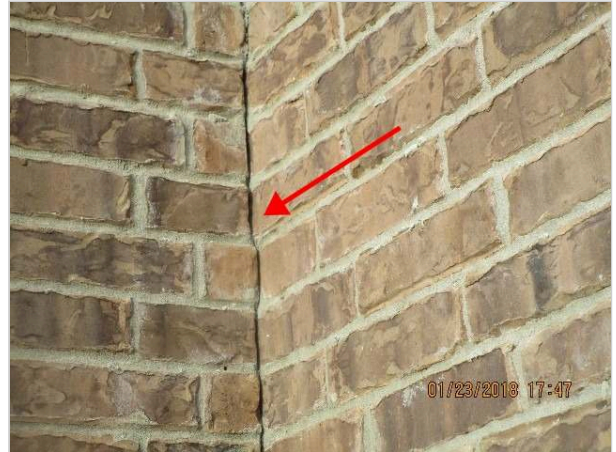
Corner area along front wall not sealed

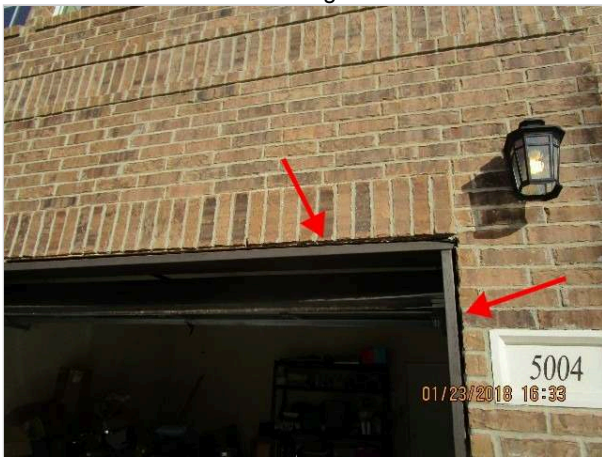
Area between the garage trim board and brick wall not sealed

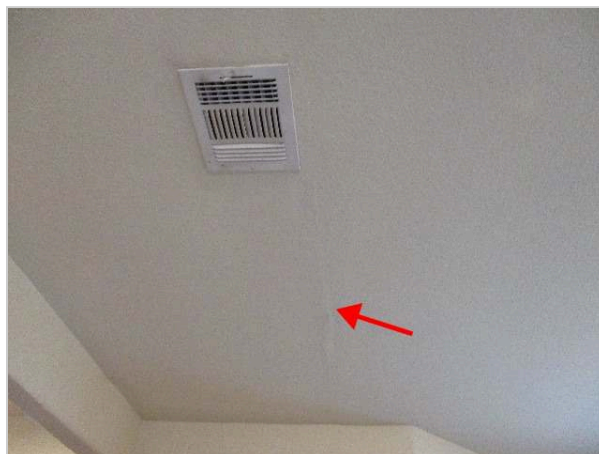
There was a stain and tape seam crack on the ceiling in the dining area adjacent to the a/c register.

Stain / crack in dining area
Page 9 of 17

- CEILINGS: There was a stain and tape seam crack on the ceiling in the dining area adjacent to the a/c register.
- There were cracks in multiple locations at the support beam between the kitchen and living room.

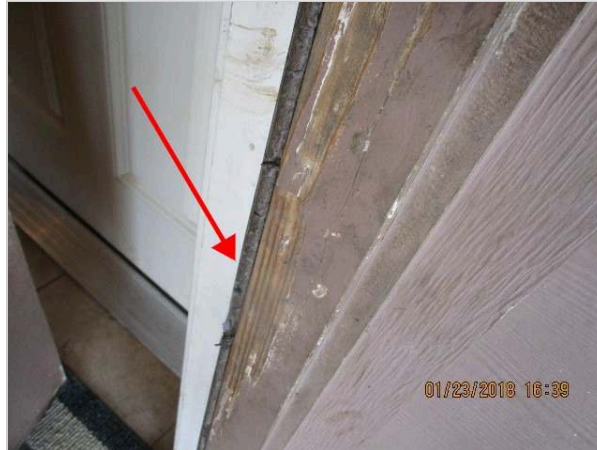
The weather stripping at the back exterior door was damaged.
The door to the left rear bedroom did not properly latch.
The deadbolt to the door going into the garage did not properly latch.

Damaged weather stripping

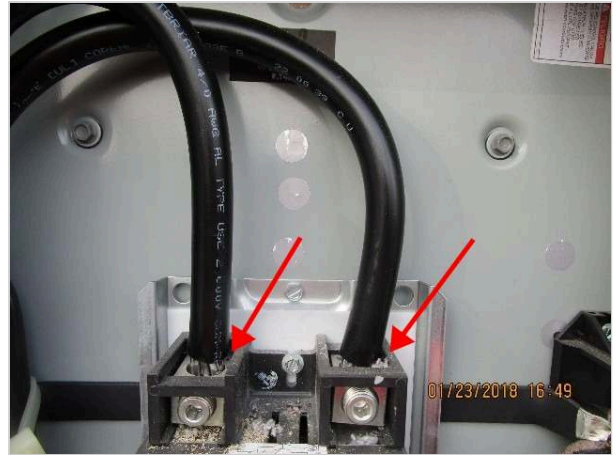
The aluminum service entrance wires ends did not have an anti-oxidant where they connect to the main breaker and the neutral bus.

No antioxidant

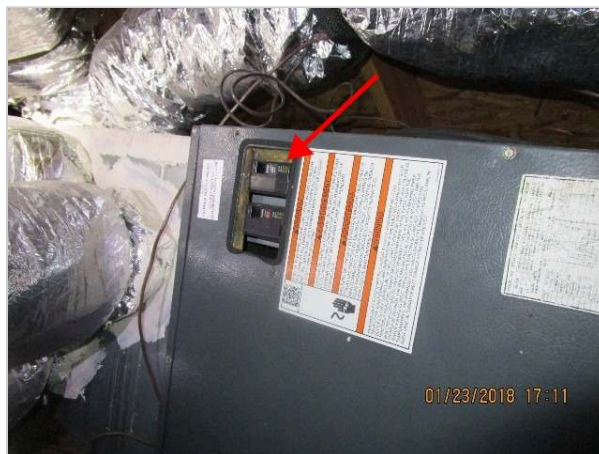
The faceplate for the disconnect panel on the heater was missing.

Faceplate missing

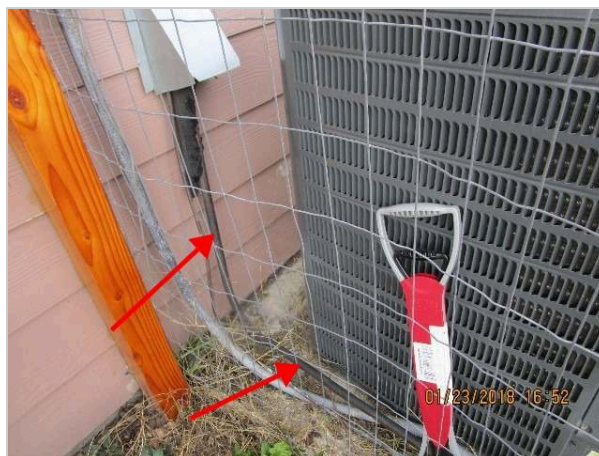
The refrigerant line at the outside unit needed insulation.

No insulation

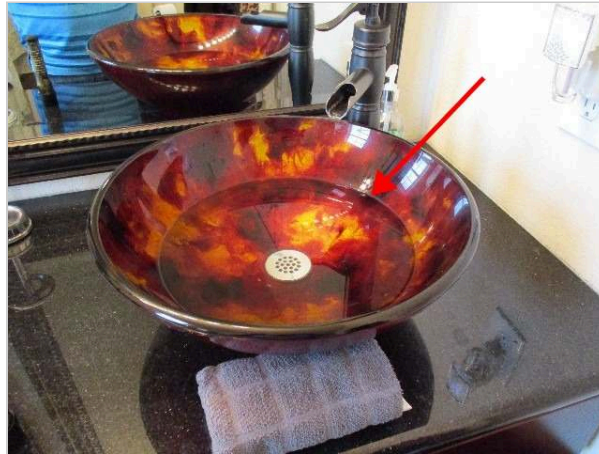
The right sink in the master bathroom had a slow drain.

Sink slow to drain

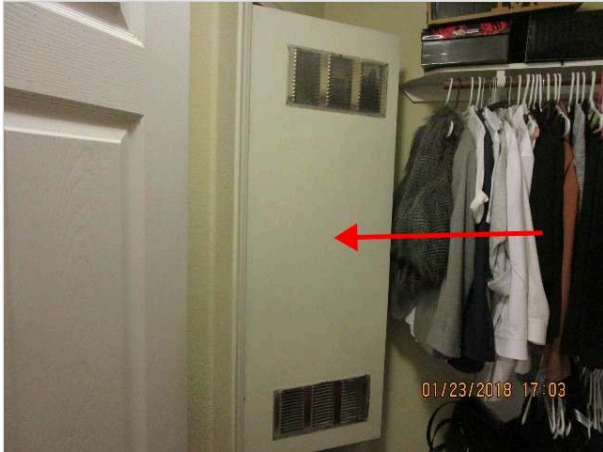
The water heater was located in a closet area. Industry practice recommends that gas appliances not be located in sleeping rooms or storage closets. We recommend a plumber to review appropriateness of the location.

Water heater closet

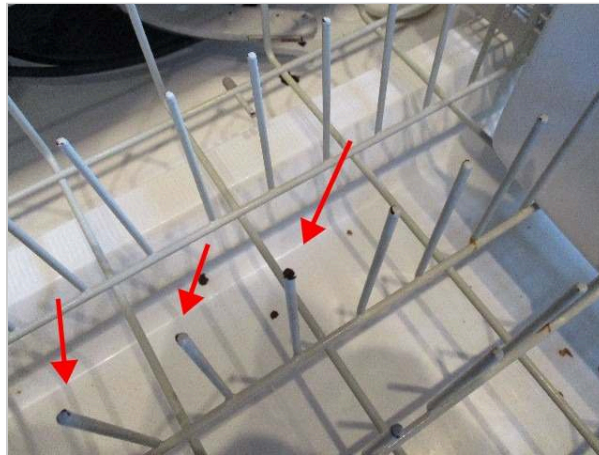
The dishwasher was run through a complete cycle, determining that the water loads, the soap dish opens, the spray arms rotate, and the water drains.
 BRAND: Kenmore
 The unit was functioning properly at the time of the inspection.
 There were several rusted areas on the bottom tray.

Rusted

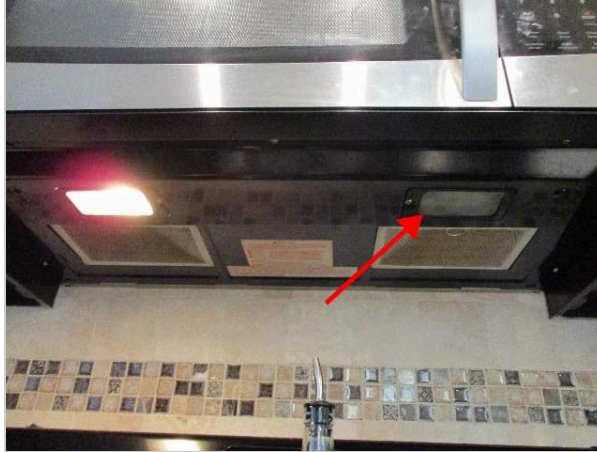
The Kenmore recirculating unit was functioning properly at the time of the inspection.
The right light was out (not tested).

Light not functioning
