## ENGINEER'S REPORT

28411 Peper Hollow Lane  
Spring, TX 77386

Inspection No. 2019271N  
Date of Inspection: December 2, 2019

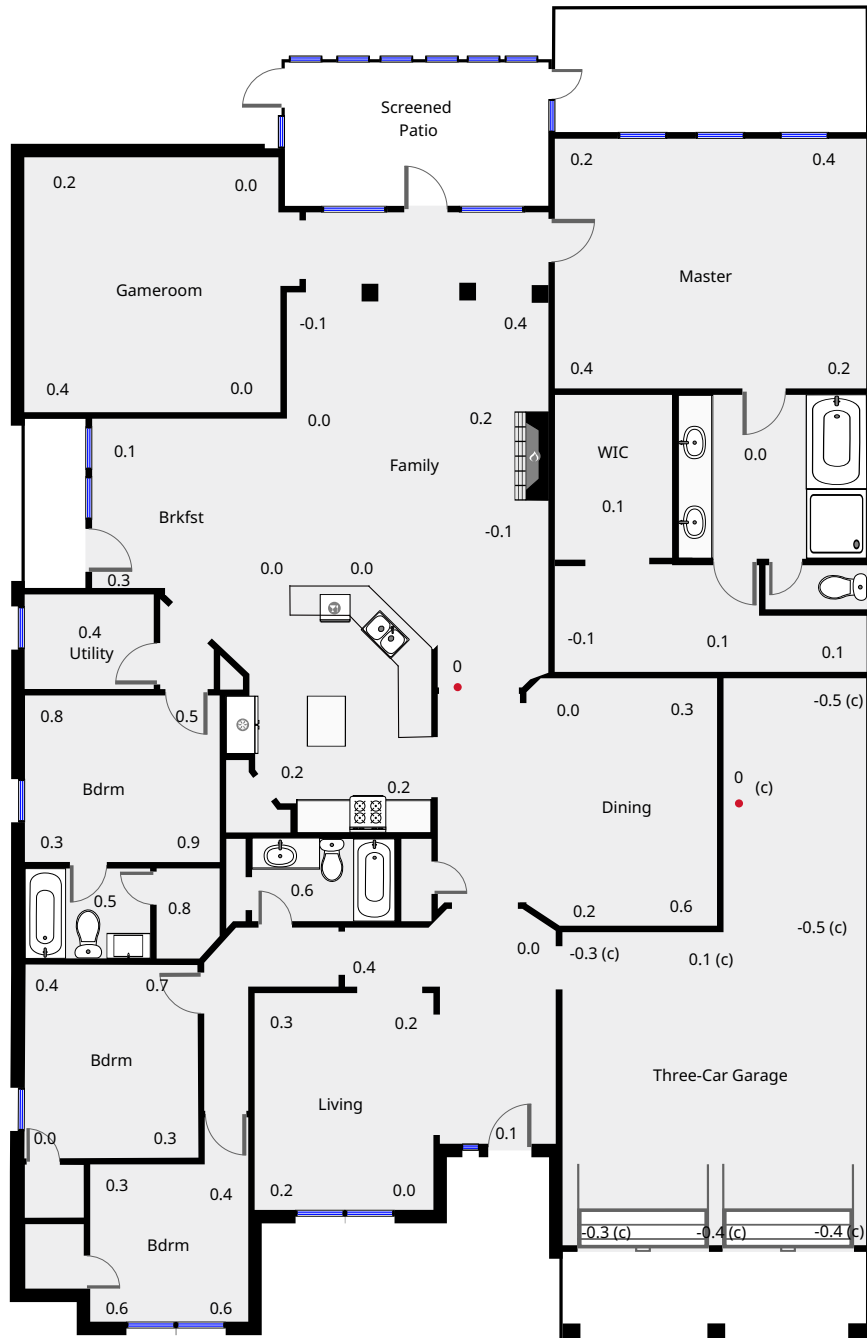
## 1st Floor Elevations

We noted minor elevation variance throughout much of the home. In general, we consider differentials of less than 1 inch in 10 feet to be acceptable. All measured differentials are well within that parameter.

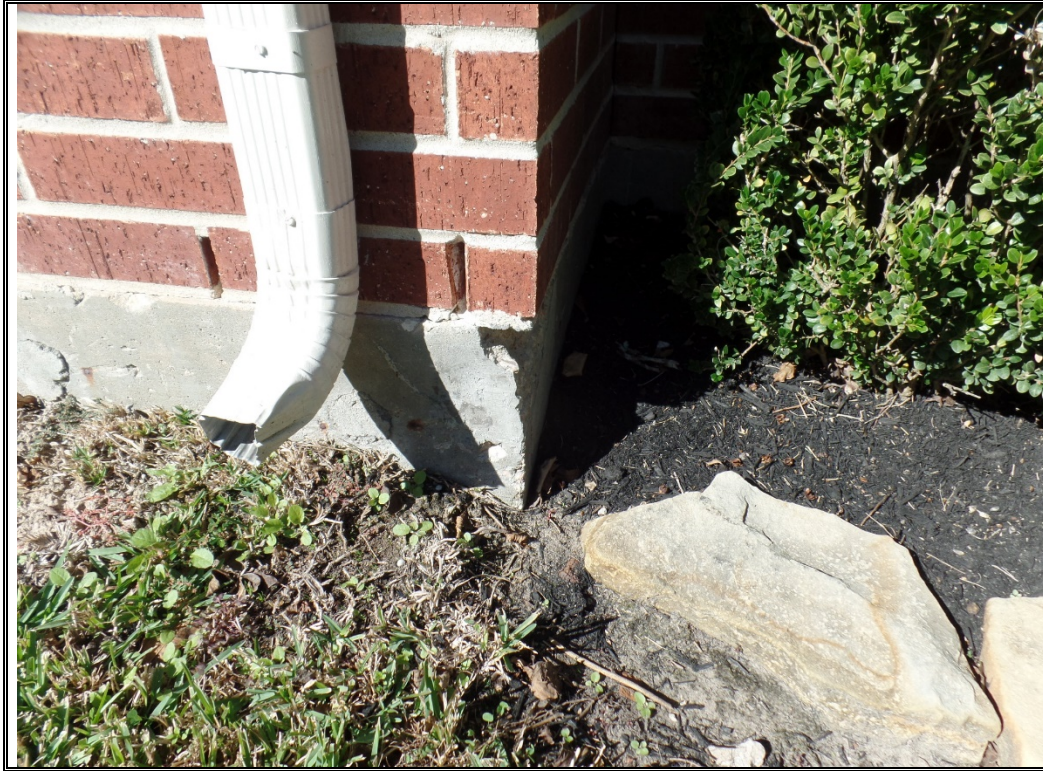
**Photo Number**  
**5**

- **The foundation corners were spalled/cracked at the front right, front left, right rear and left rear corners.** This is caused by thermal expansion of the walls and the tight connection between the veneer and concrete surface. The expanding veneer in the hot sun exerts a force sufficient to shear the corner from the foundation. This is common and is not considered a significant structural defect.

**Description:**  
Spall of the  
foundation grade  
beam at the front  
left corner

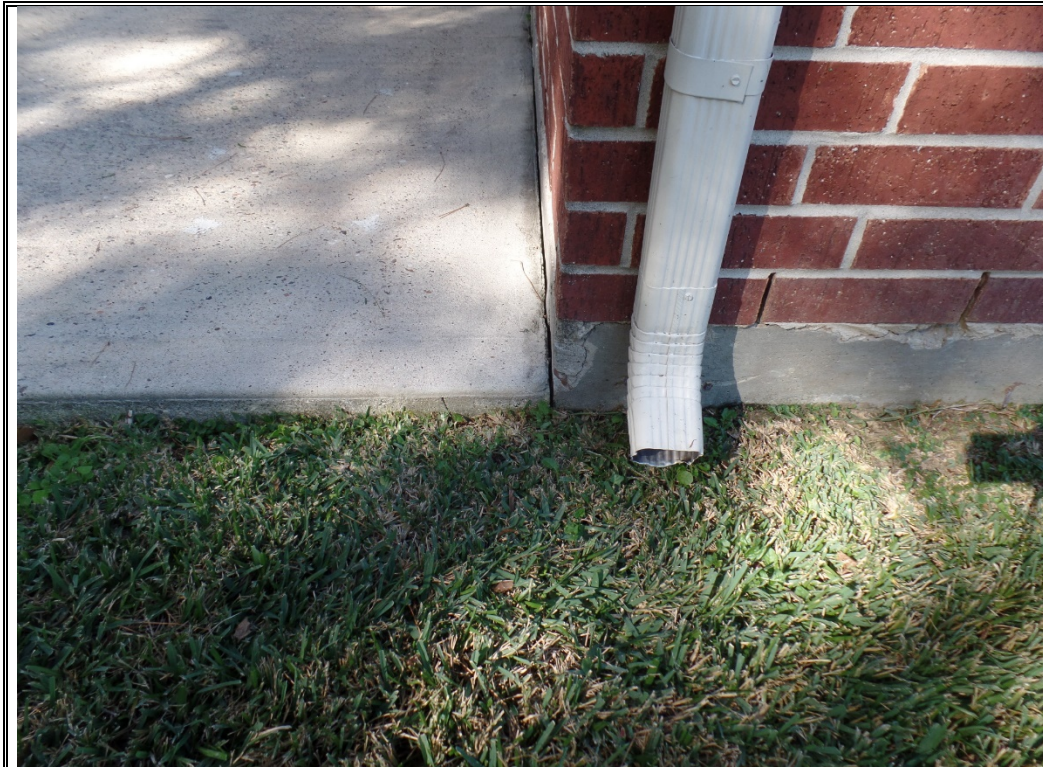
**Photo Number**  
**6**

**Description:**  
Spall of the  
foundation grade  
beam at the left  
rear (typical)

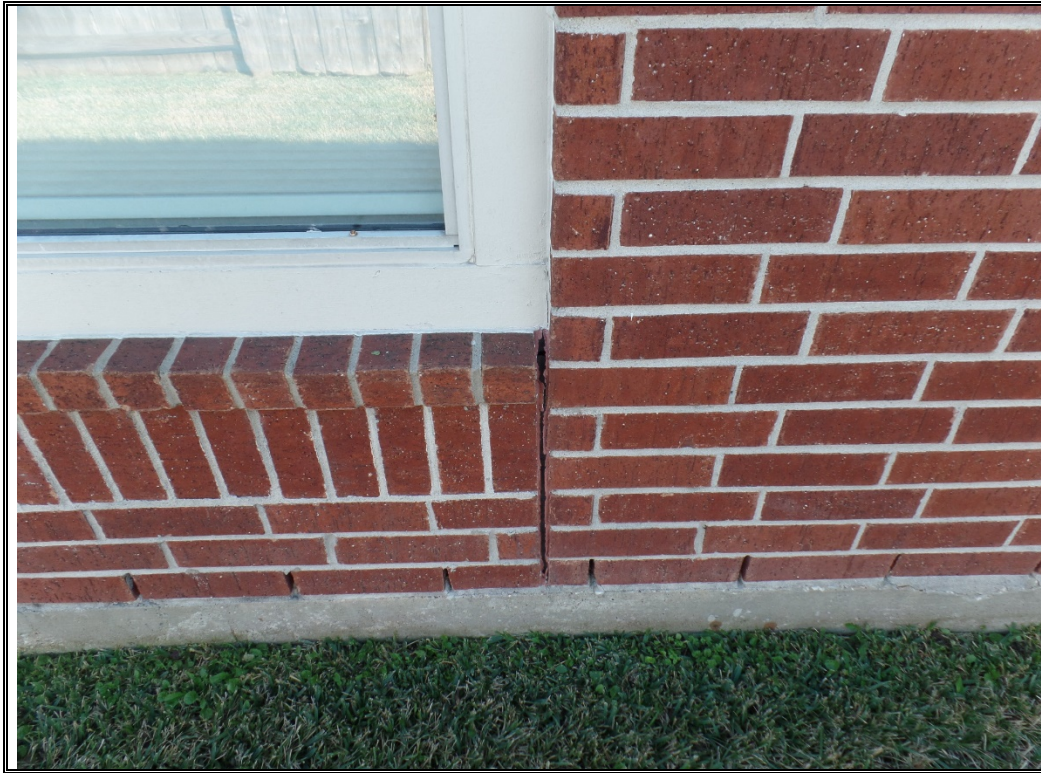
**Photo Number**  
**7**

- **We observed deteriorated caulking along the brick veneer expansion joints. Over time the sealant has degraded and should be repaired to help keep moisture from infiltrating this section. We recommend that the expansion joints be re-caulked with a flexible caulk to seal the joints.**

**Description:**  
Brick veneer  
expansion joints  
require caulking to  
seal (typical)

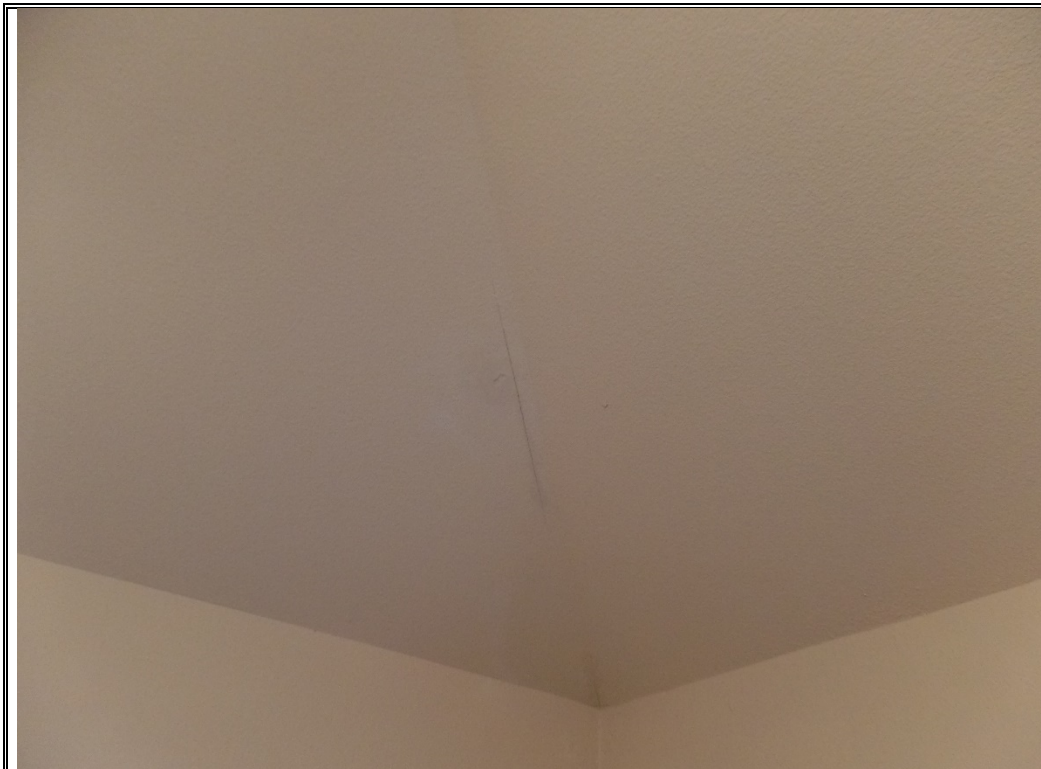
**Photo Number**  
**8**

While the amount of movement is within acceptable parameters, we observed drywall joint cracks in the game room and master bedroom and a sticking master bedroom door that, in our opinion, appear to be due to minor foundation movement. The movement appears to be caused by the downspouts discharging runoff directly at the foundation in the right rear and left rear corners. We recommend that extenders be installed on all downspouts that will discharge runoff away from the foundation or connect the downspouts directly to the underground drain system.

- **We noted drywall joint cracks in the game room and master bedroom vaulted ceilings. Small hairline cracks were also noted in the drywall at some game room and master bedroom windows. As previously mentioned (see Site section), in our opinion, the cracks are due to minor foundation movements and are considered**

**Description:**  
Drywall joint  
crack noted in the  
vaulted game  
room ceiling  
(typical)

cosmetic in nature. Cosmetic repairs and re-finishing of interior drywall and ceilings should be performed in accordance with industry standards by a qualified professional as a means of monitoring the foundation for future movement.

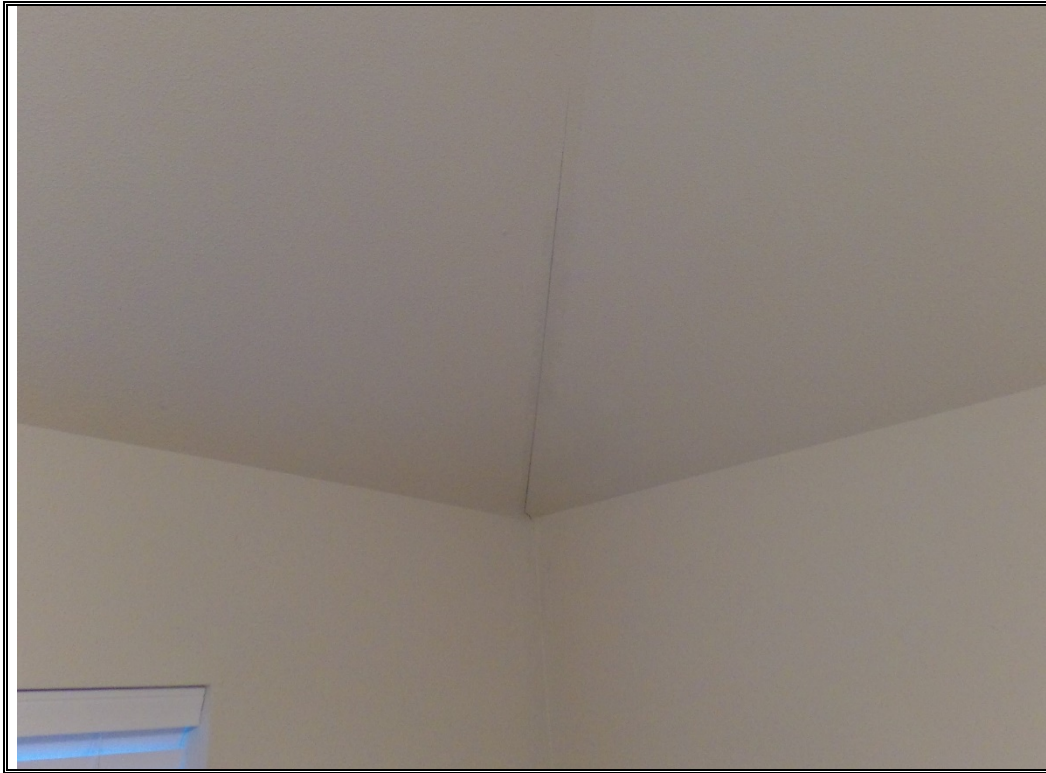
**Photo Number**  
**9**

**Description:**  
Drywall joint  
crack noted in the  
vaulted master  
bedroom ceiling

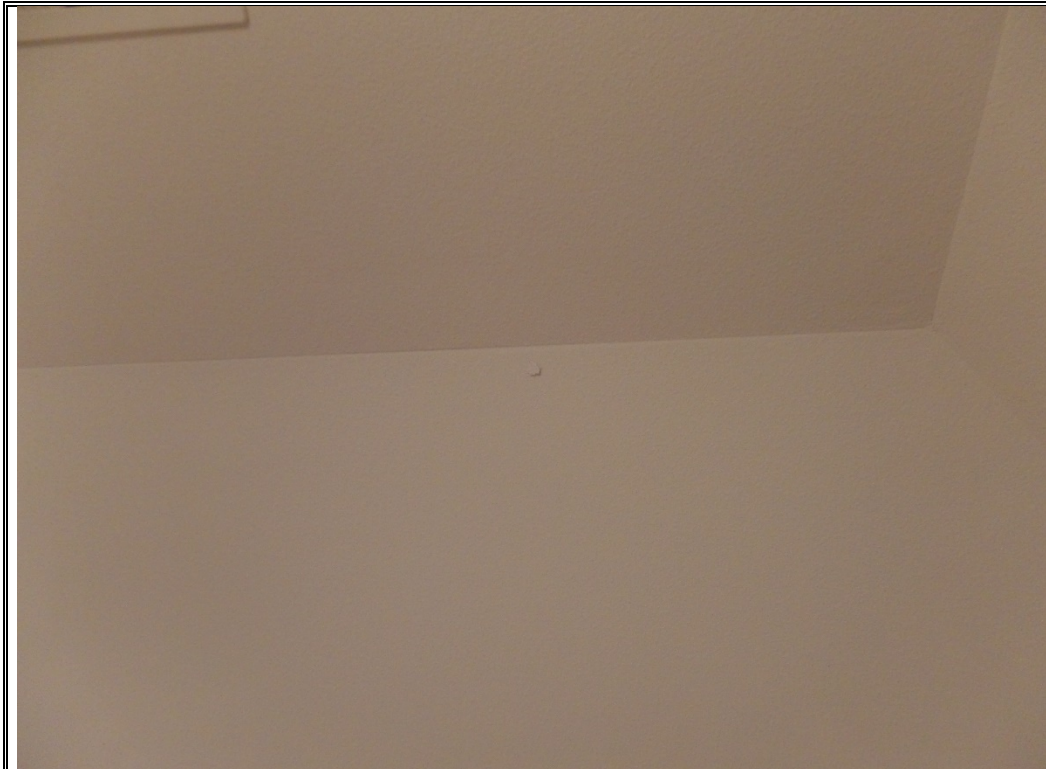
**Photo Number**  
**10**

- We observed drywall nail pops in the master bedroom ceiling. These are considered cosmetic in nature.
- We observed evidence of water damage on the middle bedroom ceiling. This appears to be due to a past overflow of the HVAC condensate pan in the attic and is not considered a structural deficiency.
- We noted the master bedroom door sticks. This also appears to be due to minor foundation movement. We recommend that the door be adjusted to open and close properly.
- We observed that the kitchen pantry door swings closed on its own. This appears to be due to minor foundation elevation differentials in this area. If this is a concern, we recommend that the door be adjusted for proper operation.

**Description:**  
Nail pops in the  
master bedroom  
ceiling (typical)
