Moisture Assessment Report

2719 Newman St.
Houston, TX 77098
04/24/2018

Prasad Ivaturi

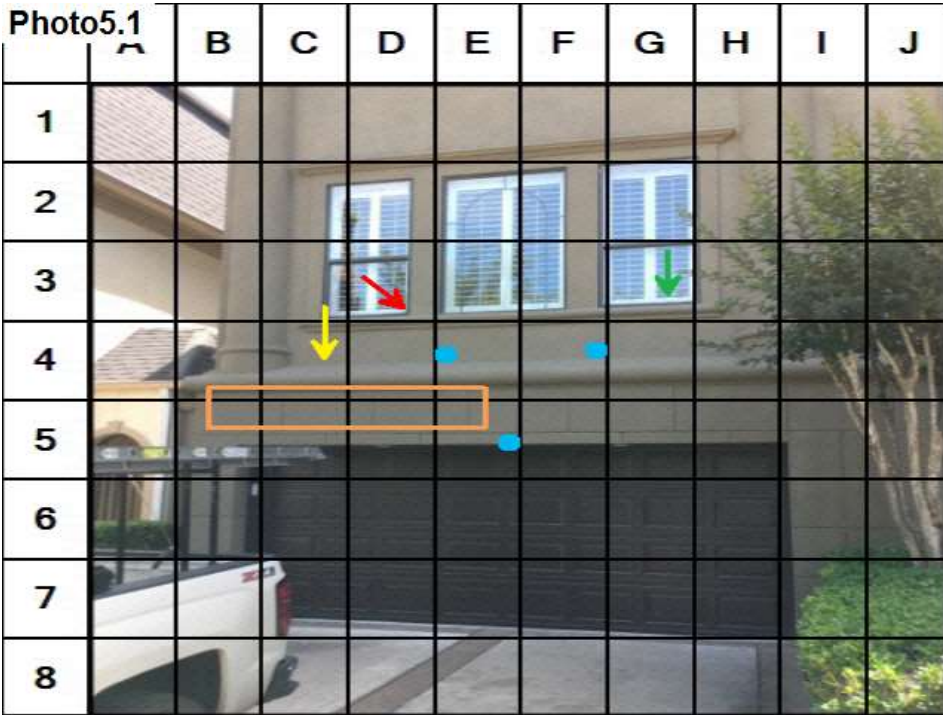
Grid Location	Item Description	Moisture Readings	Substrate Condition	Observations-Photo #5.1	Chapter Reference
				Always maintain sealants at windows, doors, penetrations and terminations.	Ch 3.1, 3.2
E4	Window Lower Left	11%	Firm	Moisture reading was made at window lower left.	
E5	Bottom of Wall	17%	Firm	Moisture reading was made at bottom of wall.	
F4	Window Lower Left	17%	Firm	Moisture reading was made at window lower left.	
Yellow Arrow	Semi-Flat Wall			Exposed semi-flat wall noted with hairline cracks. See detail #5.2. It is suggested to apply four coats of elastomeric coating on top of semi-flat wall to minimize moisture intrusion.	
Red Arrow	Impact Damage			Impact damage is present. See detail #5.3. Seal / Repair as needed.	Ch 3.6
Orange Box	Cracked Control Joints			Cracked control joints noted. See detail #5.4 and 5.5. Seal / Repair as needed.	Ch 3.6
Green Arrow	Alarm Sensors			Alarm sensors are present at windows. See detail #5.6. Always maintain silicone sealants at alarm sensors to minimize moisture intrusion.

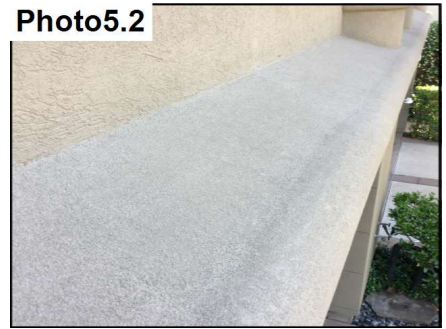
- Always maintain sealants at windows, doors, penetrations and terminations.
- Exposed semi-flat wall noted with hairline cracks. See detail #5.2. It is suggested to apply four coats of elastomeric coating on top of semi-flat wall to minimize moisture intrusion.

Apply four coats of elastomeric at semi-flat wall.

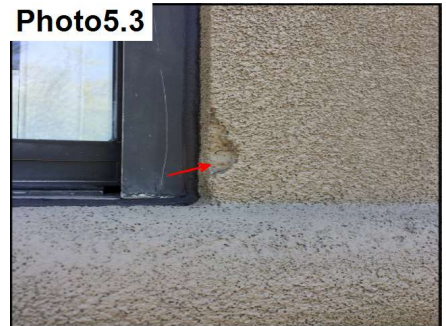
Impact damage is present. Seal / Repair as needed.

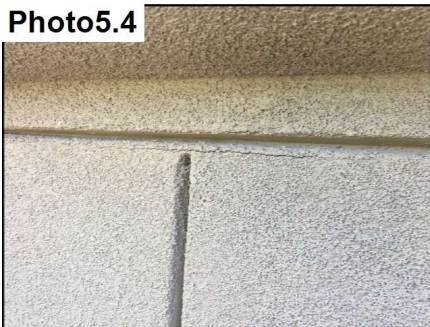
Cracked control joints noted. Seal / Repair as needed.

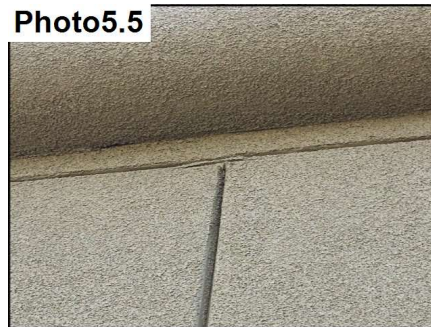
Cracked control joints noted. Seal / Repair as needed.

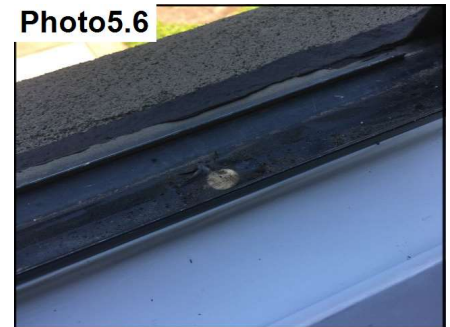
Alarm sensors are present at windows.

- Alarm sensors are present at windows. See detail #5.6. Always maintain silicone sealants at alarm sensors to minimize moisture intrusion.
- Crack is present. See detail #6.3. Seal / Repair as needed.

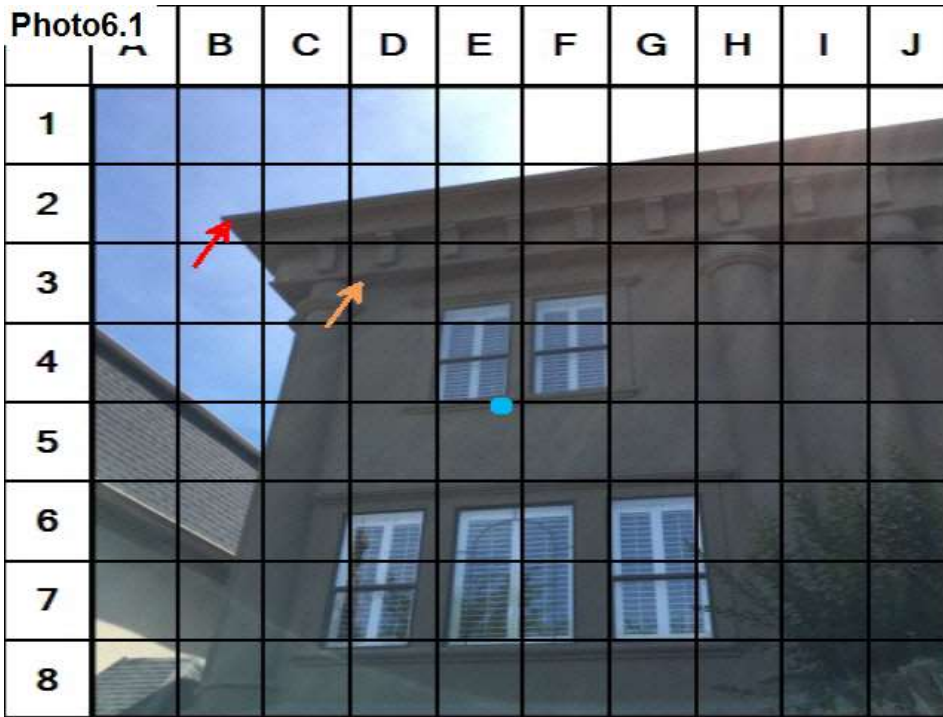
Grid Location	Item Description	Moisture Readings	Substrate Condition	Observations-Photo #6.1	Chapter Reference
				Always maintain sealants at windows, doors, penetrations and terminations.	Ch 3.1 3.2
E5	Window Lower Right	11%	Firm	Moisture reading was made at window lower right	
Red Arrow	Impact Damage			Impact damage is present. See detail #6.2. Seal / Repair as needed.	Ch 3.6
Orange Arrow	Crack			Crack is present. See detail #6.3. Seal / Repair as needed.	Ch 3.6

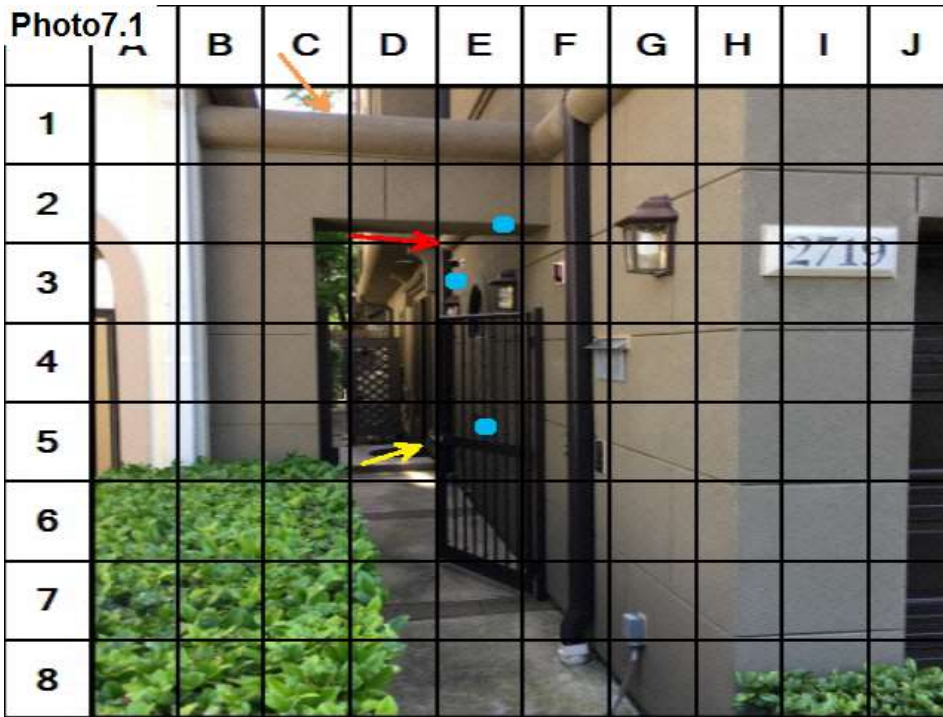
Grid Location	Item Description	Moisture Readings	Substrate Condition	Observations-Photo #7.1	Chapter Reference
				Always maintain sealants at windows, doors, penetrations and terminations.	Ch 3.1, 3.2
Yellow Arrow	Door Miters			Sealant separation noted at door miters. See detail #7.2 Reseal as needed.	Ch 3.2
Red Arrow	Hole behind down spout			Hole noted behind down spout. See detail #7.3. Assess and seal as needed.	Ch 3.6
Orange Arrow	Flat wall			Install a metal cap at flat wall above entry gate. See detail #7.4.	Ch 3.7
E3	Below Hole	15%	Firm	Moisture reading was made at below hole.	
E5	Window Lower Right	14%	Firm	Moisture reading was made at window lower right	
E2	Bottom of Wall	26%	Semi Firm	Elevated moisture reading was made at bottom of wall.

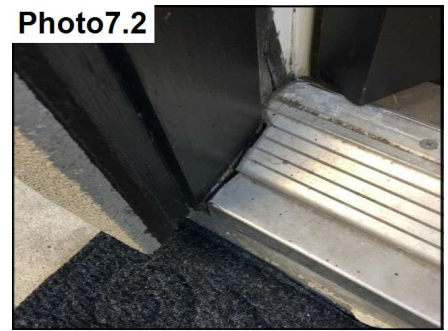
- Sealant separation noted at door miters. See detail #7.2 Reseal as needed.
- Hole noted behind down spout. See detail #7.3. Assess and seal as needed.

Photo7.2
 Reseal door miters as needed.

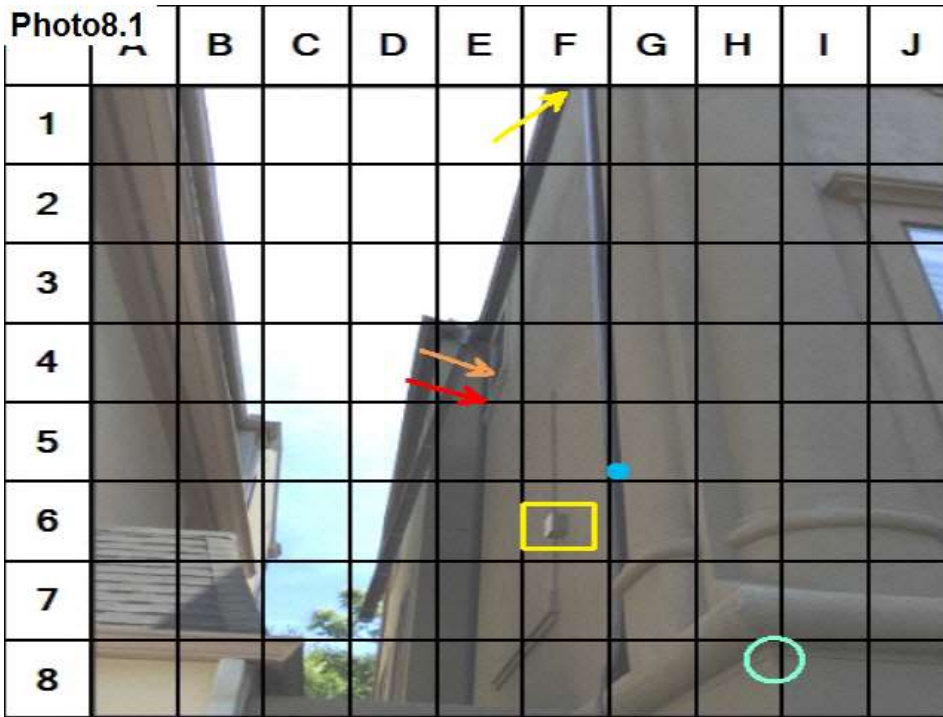
Grid Location	Item Description	Moisture Readings	Substrate Condition	Observations-Photo #8.1	Chapter Reference
				Always maintain sealants at windows, doors, penetrations and terminations.	Ch 3.1, 3.2
Yellow Box	Penetration			Some penetrations lack sealants. See detail #8.2. Assess and seal all penetrations that lack sealants.	Ch 3.1
Red Arrow	Foam accent			Impact damage noted at foam accent. See detail #8.3. Assess and repair / seal all damage to foam accents.	Ch 3.6
Orange Arrow	Rust			Rust noted from HVAC overflow. See detail #8.4. This is a cosmetic concern. Clean as needed.	
Blue Circle	Crack			Cracked corner noted. See detail #8.5. Assess and seal all cracked corners as needed.	Ch 3.6
Yellow Arrow	Soffit / fascia			Soffit / fascia at roof termination appears to be damaged / deteriorated. See detail #8.6. Have contractor assess and repair / waterproof area as needed.	Ch 3.4
G5	Below roof termination	17%	Firm	Moisture reading was made below roof termination.

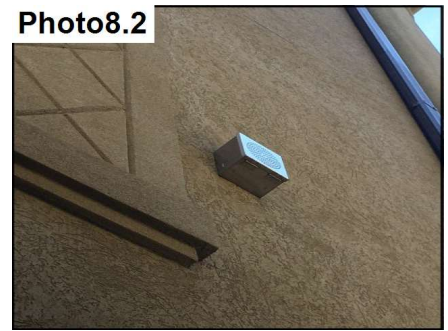
Penetration lacks sealants.

- Install a metal cap at flat wall above entry gate. See detail #7.4.
- Some penetrations lack sealants. See detail #8.2 and 10.2. Assess and seal all penetrations that lack sealants.

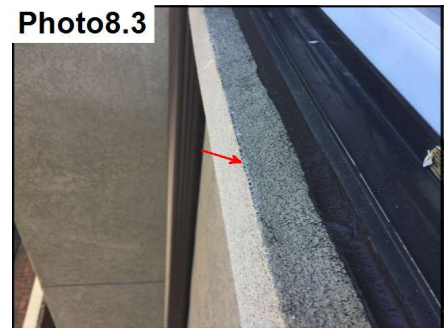
Impact damage noted at foam accent.

- Impact damage is present. See detail #5.3, 6.2, and 8.3. Seal / Repair all impact damage as needed.
- Cracked control joints noted. See detail #5.4, 5.5 and 12.3. Seal / Repair all cracked control joints as needed.

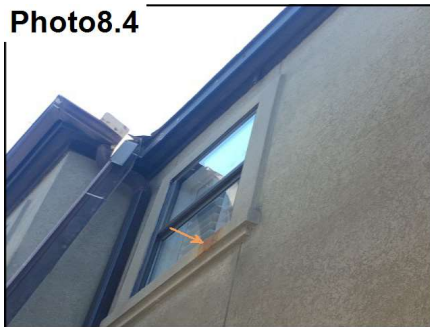
Rust staining from HVAC overflow noted.

- Rust noted from HVAC overflow. See detail #8.4. This is a cosmetic concern. Clean as needed.
- Cracked corner noted. See detail #8.5. Assess and seal all cracked corners as needed.

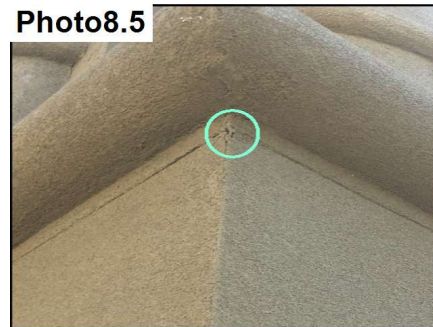
Cracked corner noted.

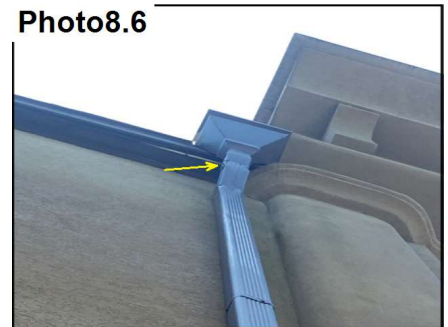
Fascia / soffit appears to be damaged / deteriorated.

- Soffit / fascia at roof termination appears to be damaged / deteriorated. See detail #8.6. Have contactor assess and repair / waterproof area as needed.

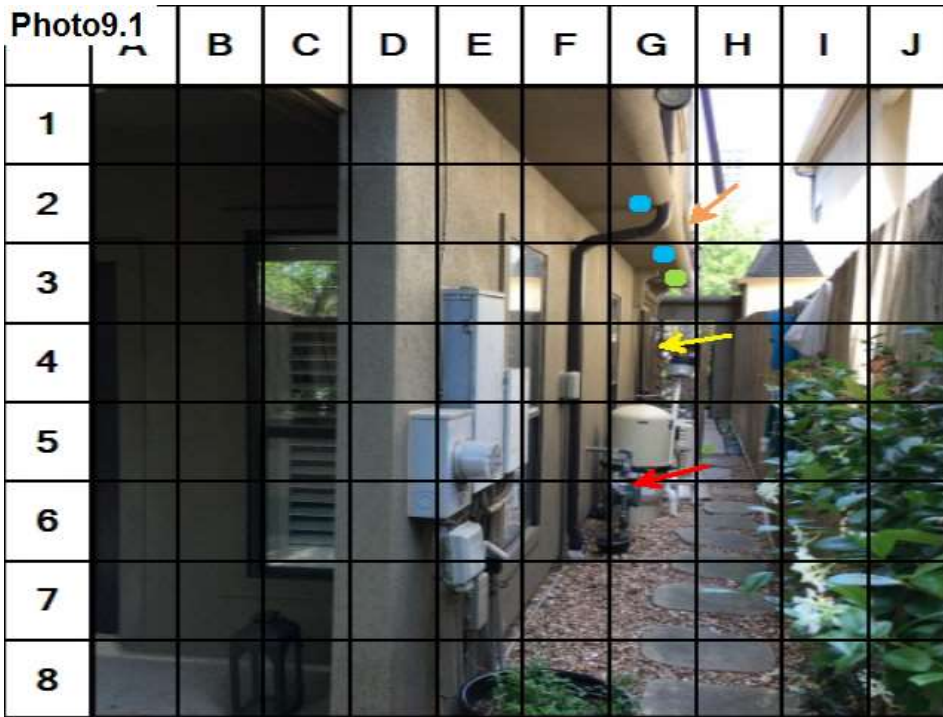
Grid Location	Item Description	Moisture Readings	Substrate Condition	Observations-Photo #9.1	Chapter Reference
				Always maintain sealants at windows, doors, penetrations and terminations.	Ch 3.1,3.2
G2	Bottom of wall below window	17%	Firm	Moisture reading was made at bottom of wall below window.	
G3 (Blue Dot)	Bottom of wall below windows	13%	Firm	Low moisture reading was made at bottom of wall below windows.	
G3 (Green Dot)	Bottom of wall below windows	15%	Firm	Moisture reading was made at bottom of wall below windows.	
Red Arrow	High soil			High soil noted. See detail #9.2. Assess and pull back soil away from home to minimize moisture and insect intrusion.	Ch 3.3
Yellow Arrow	Windows			Windows are adequately sealed. See detail #9.3. This is a proper detail.	Ch 3.2
Orange Arrow	Accent bands			Seal tops of all accent bands. See detail #9.4.	Ch 3.7

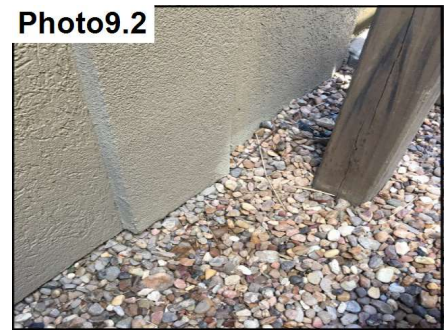
High soil noted.

- High soil noted. See detail #9.2. Assess and pull back soil away from home to minimize moisture and insect intrusion.
- Seal tops of all accent bands. See detail #9.4.

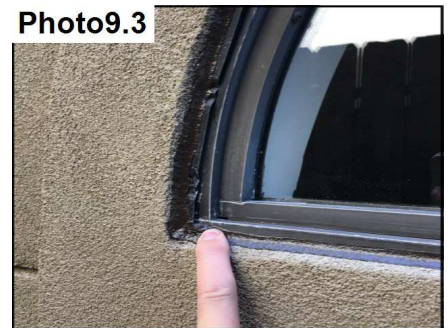
Windows are adequately sealed.

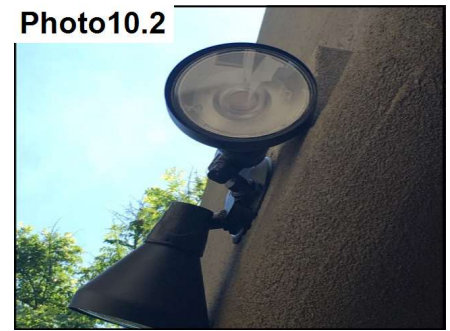
Light fixture lacks sealants.

Grid Location	Item Description	Moisture Readings	Substrate Condition	Observations-Photo #10.1	Chapter Reference
				Always maintain sealants at windows, doors, penetrations and terminations.	Ch 3.1, 3.2
Red Arrow	Light fixture			Light fixture lacks sealants. See detail #10.2. Assess and seal all light fixtures as needed.	Ch 3.1

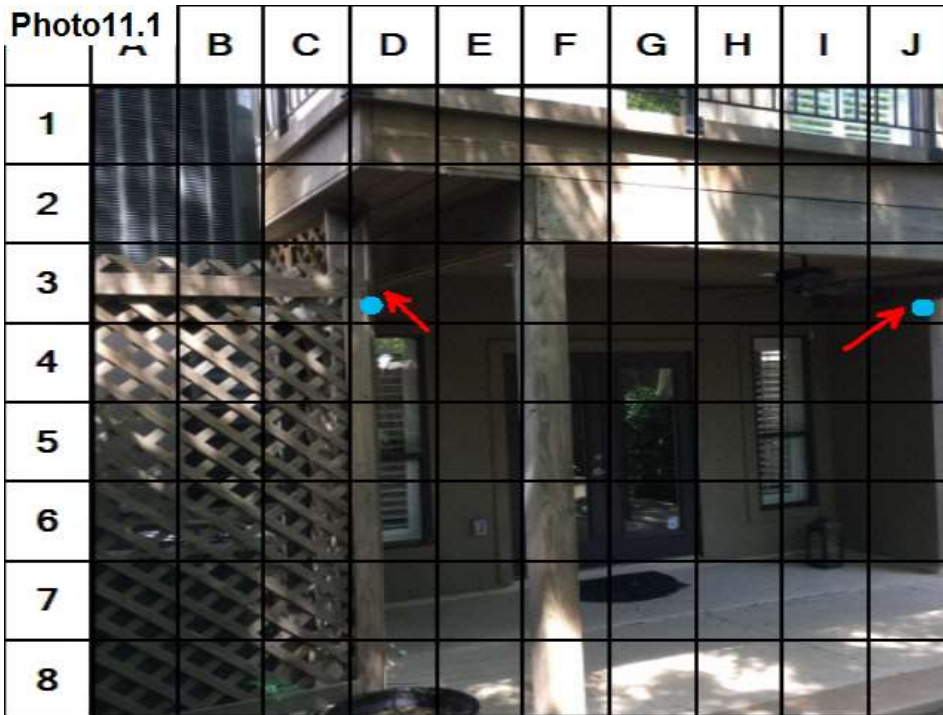
Grid Location	Item Description	Moisture Readings	Substrate Condition	Observations-Photo #11.1	Chapter Reference
				Always maintain sealants at windows, doors, penetrations and terminations.	Ch 3.1, 3.2
D3	Below Deck Termination	12%	Firm	Moisture reading was made at below deck termination.	
Red Arrows	Deck Terminations			Assess all deck terminations and seal as needed. See detail #11.2 and 11.3.	Ch 3.5
J3	Below Deck Termination	15%	Firm	Moisture reading was made at below deck termination.	
Please Note:	Touch up all noticeable Probe Holes			Touch up all noticeable probe holes.

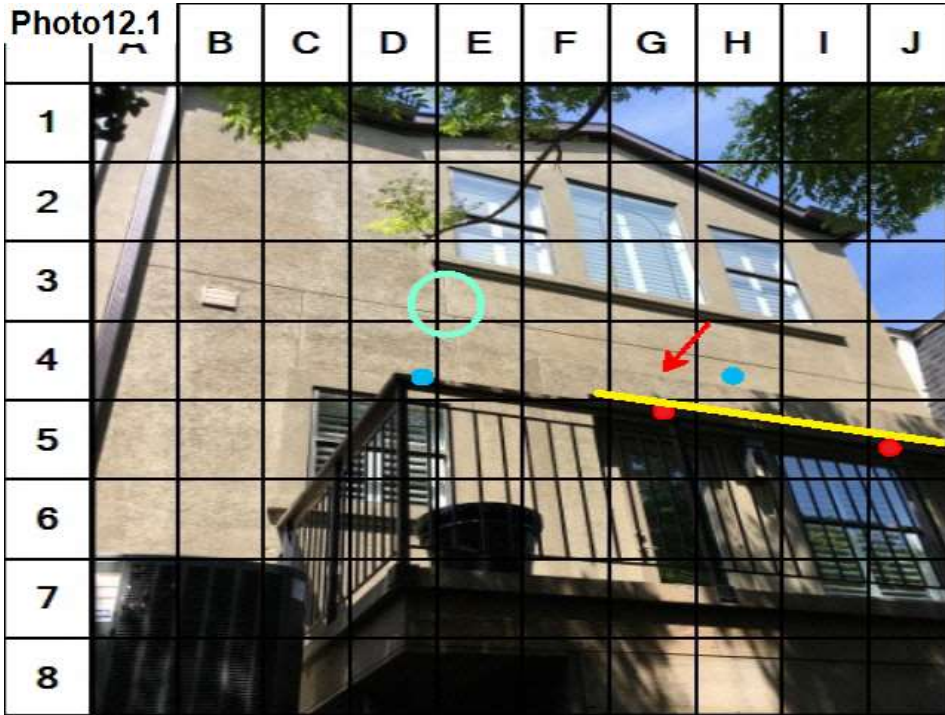
Grid Location	Item Description	Moisture Readings	Substrate Condition	Observations-Photo #12.1	Chapter Reference
				Always maintain sealants at windows, doors, penetrations and terminations.	Ch 3.1, 3.2
D4	Window Upper Right	13%	Firm	Moisture reading was made at window upper right.	
G5	Bottom of Wall	40%	Soft	High moisture reading was made at bottom of wall. Soft substrate noted.	
J5	Bottom of Wall	35%	Semi Soft	High moisture reading was made at bottom of wall. Semi soft substrate noted.	
H4	Window Lower Left	11%	Firm	Moisture reading was made at window lower left.	
Red Arrow	Pitched wall			It is suggested to install a metal cap at pitched wall to minimize moisture intrusion. See detail #12.2.	
Blue Circle	Control joints			Cracked control joints noted. See detail #12.3. Assess and seal all cracked control joints as needed.	
Yellow Line	Bottom of wall			Upon stucco repairs it is suggested to provide relief at bottom of wall to allow proper drainage of stucco system.

- Please Note: Touch up all noticeable probe holes.
- Previous probe holes noted by another stucco inspection company.
- Upon stucco repairs it is suggested to provide relief at bottom of wall to allow proper drainage of stucco system. See Elevation #12.1.

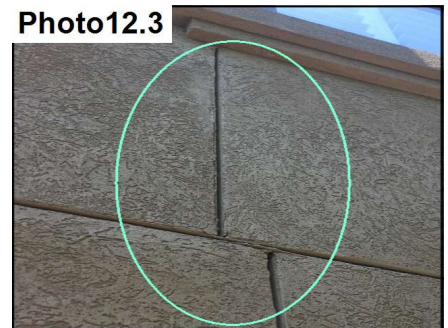
Cracked control joints noted.
