April 21, 2018

PROPERTY INSPECTION REPORT

Concerning: 2719 Newman St, Houston, TX 77098
(Address or Other Identification of Inspected Property)

By: Brendan Hirshey, Lic #22135 04/21/2018
(Name and License Number of Inspector) (Date)

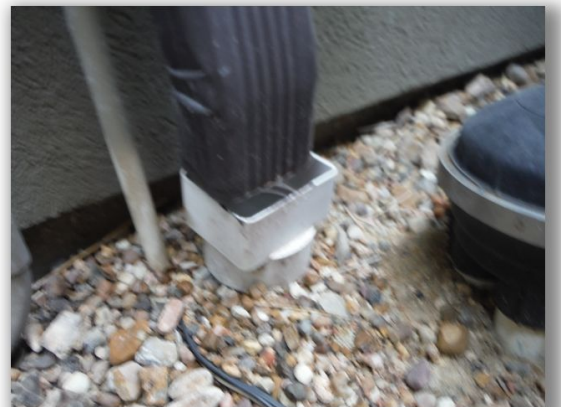
- Some of the guttering is pulling loose on the west side of the roof structure.

Note: The gutter downspouts should discharge water at least thirty-six inches (36") away from the foundation perimeter beam. Storm water should be encouraged to flow away from the structure at the points of discharge.

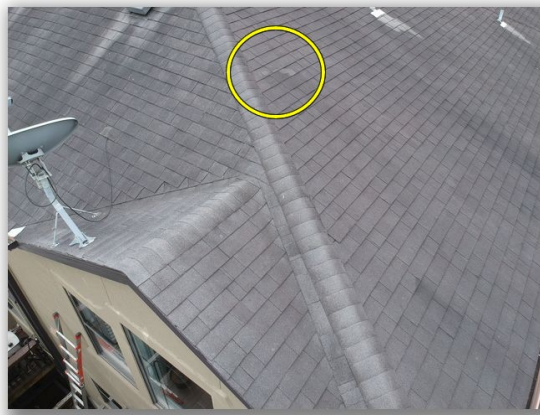
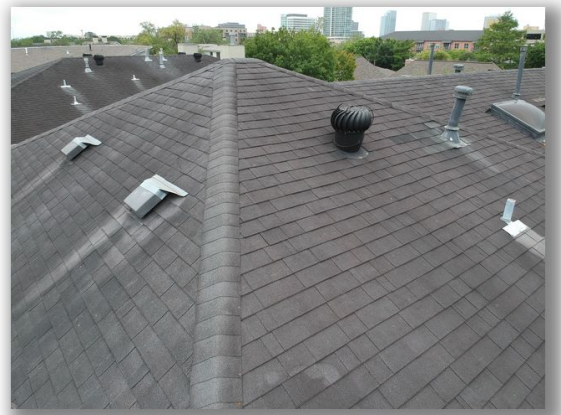
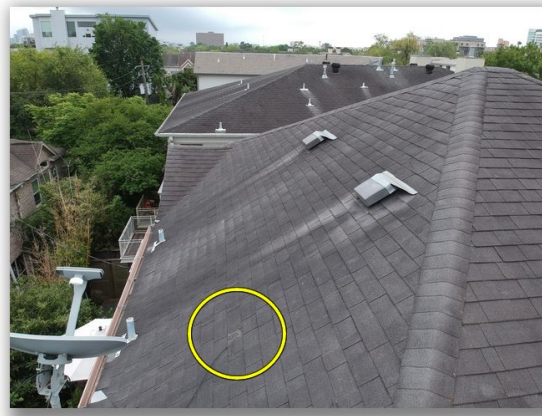
- Damaged shingles were observed on the north side, south side of the roof structure.
- The composition roofing material has experienced considerable granular loss in various locations throughout the roof.

Note: Some discoloration of the roofing material was observed.

Note: The tree and shrub branches should be trimmed away from the roofing material at all times.

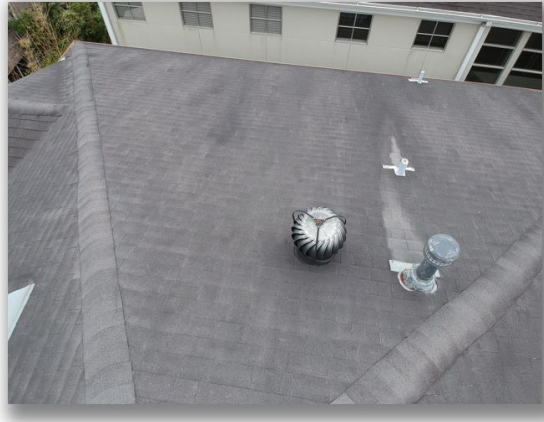
- Some of the metal flashing details were observed to be rusted and should be corrected as necessary.
- One or more of the flashing detail flanges are not properly set into the roofing material. This condition needs to be corrected to help prevent water intrusion at this points.
- The storm collar(s) at the roof level gas equipment vent pipe(s) need to be properly sealed to help prevent water intrusion into the structure.

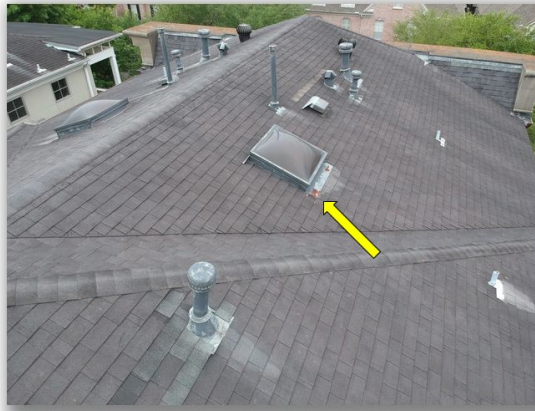
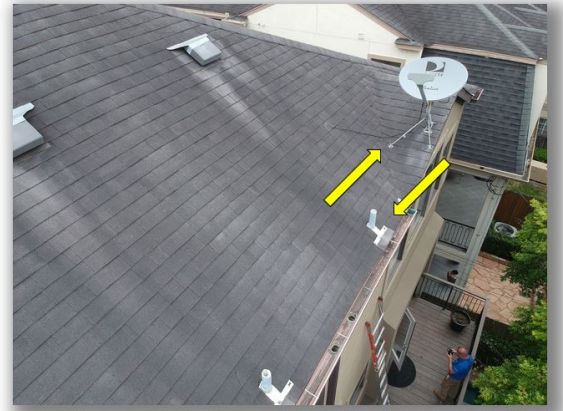
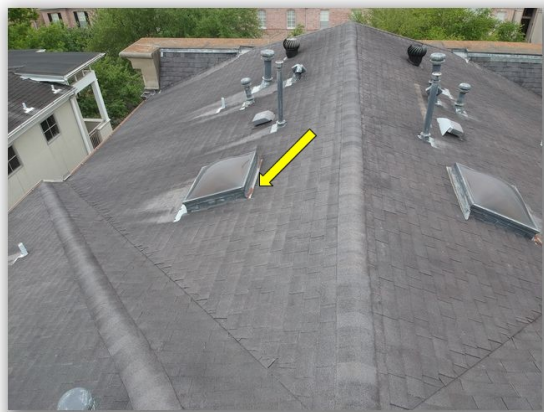
Skylight(s)

- The exterior surface (lens) of the skylight has some damage.

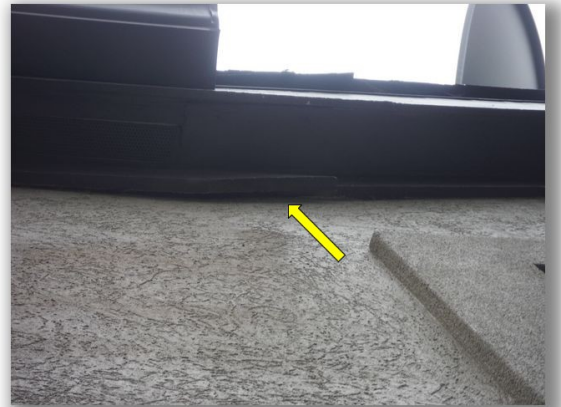
- There are visible water stains/damage on a hip rafter in one or more locations.
- The fascia board material is pulling loose on the north side of the roof structure.

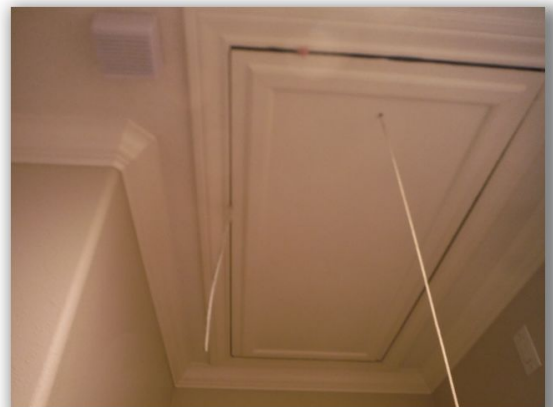
Attic Ladder

- One or more of the attic ladder components were observed to be damaged. This condition should be corrected for reasons of safety.

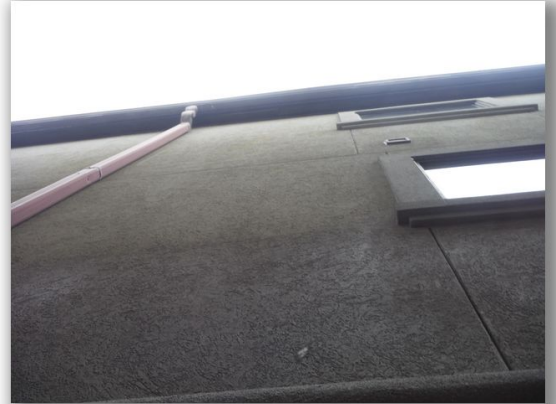
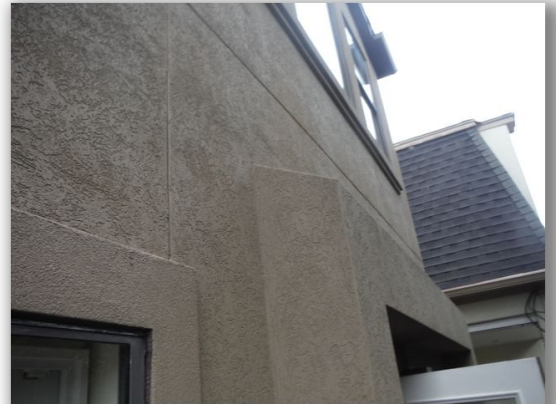
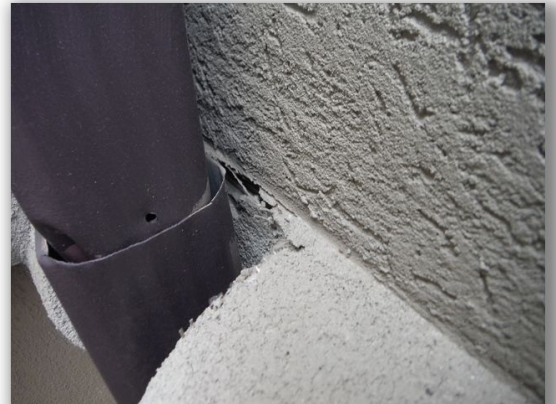
- The exterior stucco type veneer/cladding has inadequate clearance from the finished grade (ground). Most manufacturers require a minimum of 4- to 6-inches of clearance from the finished grade (ground).
- Some discoloration and/or staining of the stucco type veneer/cladding was observed on the west side of the structure.
- Some deterioration and/or damage to the stucco type veneer/cladding was observed on the west side of the structure.

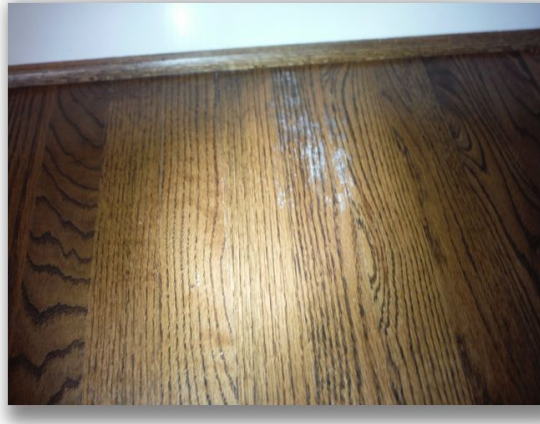
- The floor covering was observed to be damaged in the master bedroom.
- The floor tile(s) were observed to be cracked and/or damaged in guest bathroom.

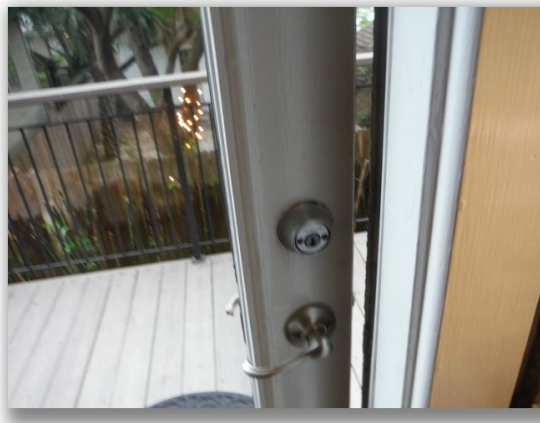
- Double cylinder locks were observed on one or more of the exterior exit (egress) doors. All exterior egress doors should be readily operable from the side from which egress is to be made without the use of a key or special knowledge or effort.

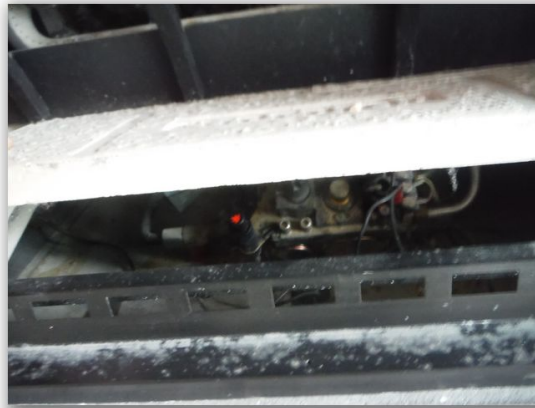
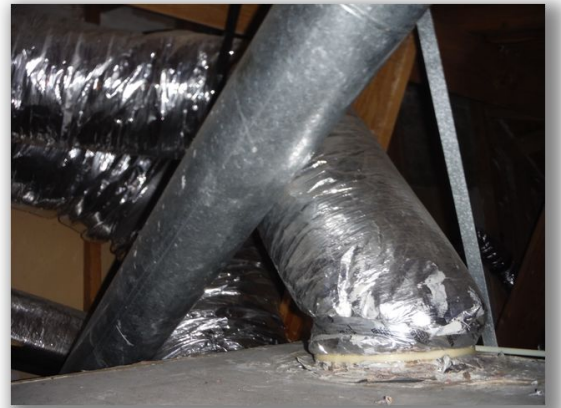
- The gas log assembly appears to be inoperative at the time of this inspection. I was unable to get the gas logs to respond to the pilot assembly / controls. This condition needs to be further evaluated and corrected as necessary.
- The fireplace chimney / vent pipe has inadequate clearance from combustible materials. Fireplace chimneys should have a minimum 2-inch of clearance (air space) from combustible material.

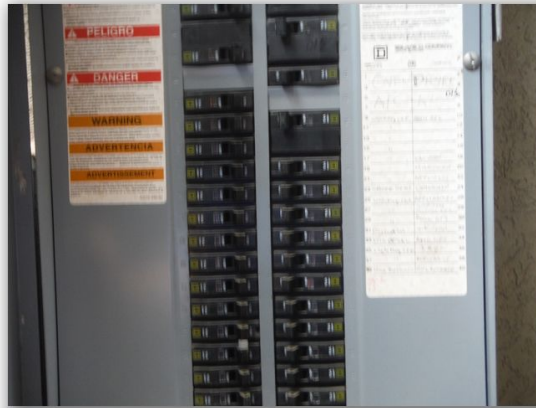
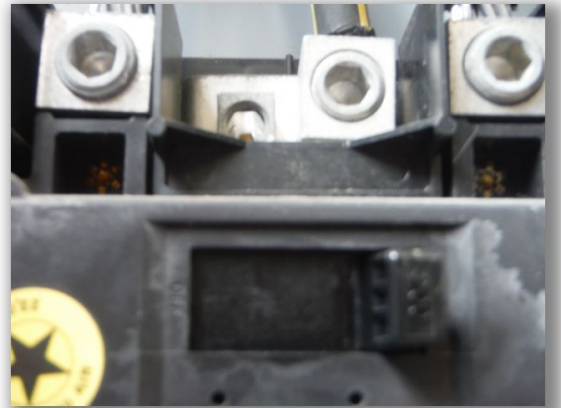
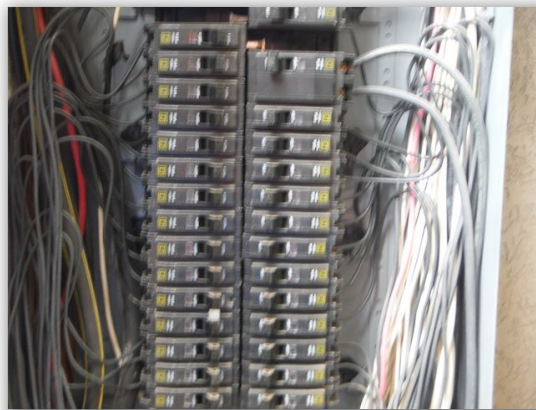
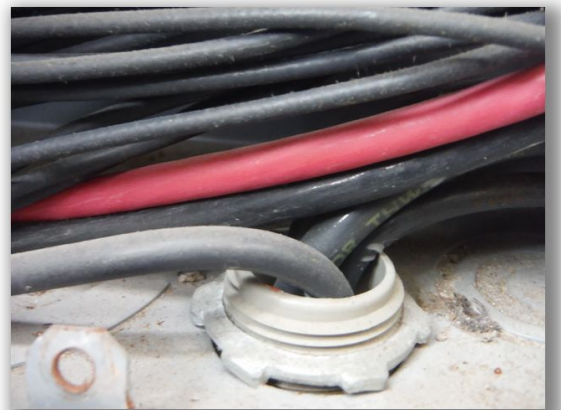
- One or more of the cabinet cover plate screws are missing and need to be replaced.
- There was no anti-oxidant gel observed on the exposed aluminum conductor terminations.
- The wires entering the electrical cabinet are not properly secured or protected from the sharp edges of the cabinet.

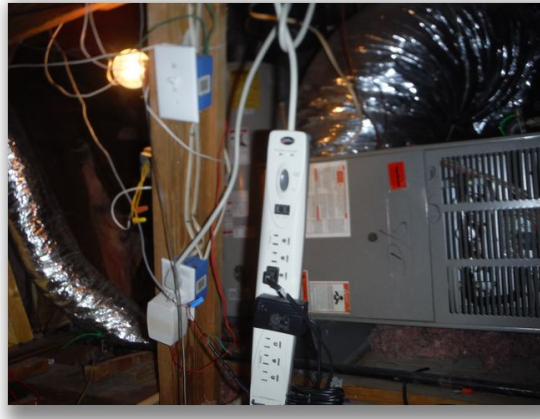
- Electrical flex extension cords should not be used for permanent wiring or pass through walls or ceilings. The improper use of extension cord was observed in or around the attic area.

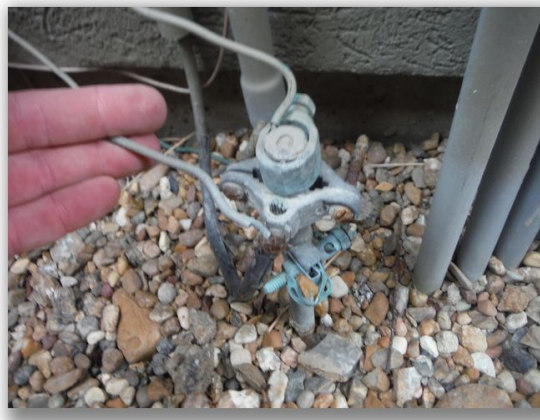
- The bonding wire connection to the ground electrode rod has pulled loose and needs to be repaired as necessary.

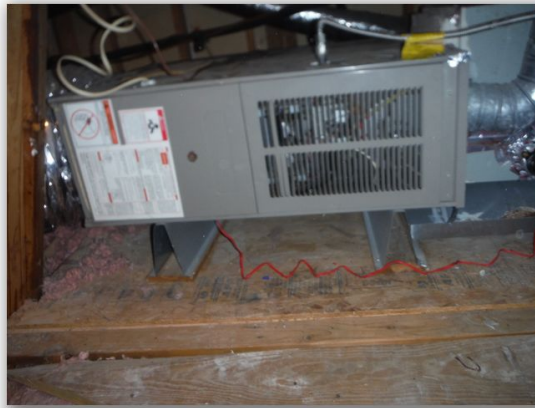
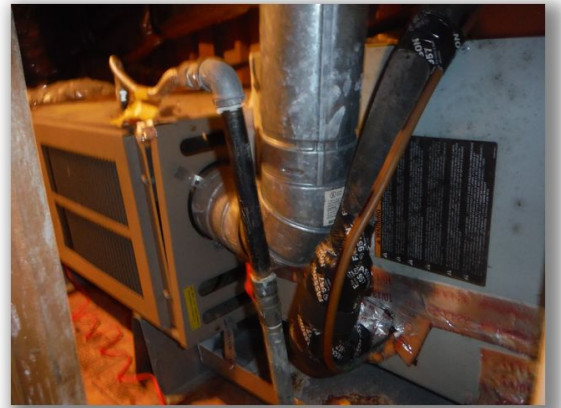
- The heater gas supply line is not equipped with a sediment trap just before the gas appliance connector. This condition does not meet current installation requirements and should be corrected.
- The roof level flue storm collar needs to be properly sealed to help prevent water intrusion into the structure.
- The heating unit flue (vent pipe) has inadequate clearance from combustibile materials. Double walled vent pipes should have at least 1-inch of clearance and single walled vent pipes should have at least 6-inches of clearance from combustibile material.

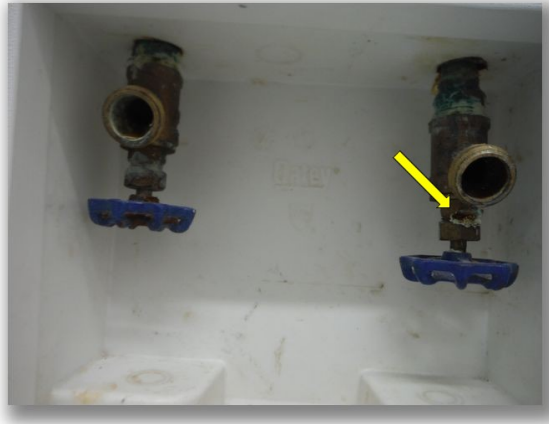
- Some rust and/or corrosion was observed at the laundry connection hose bibbs.

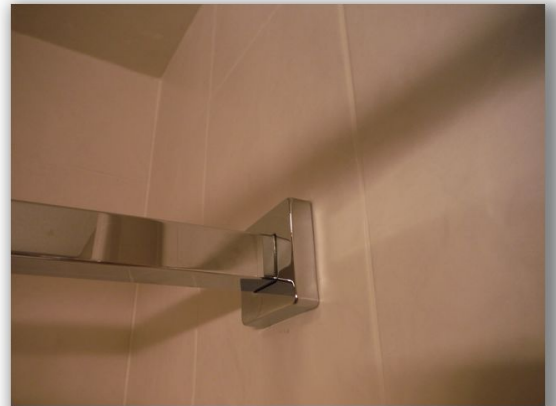
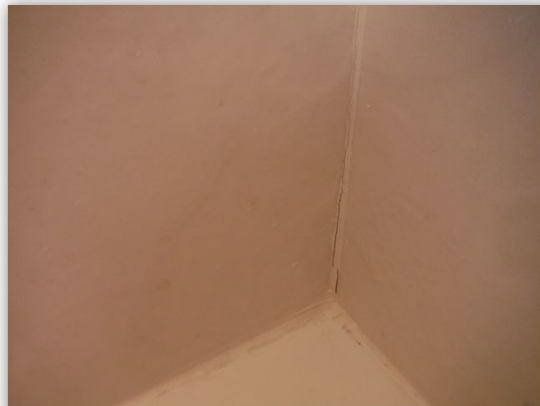
- The faucet assembly is not sealed at the wall. This condition has the potential to allow water to leak back into the wall cavity.
- The faucet has a slow leak when off.
- Cracked, deteriorated and/or missing shower stall grout and/or caulking should be repaired or replaced as necessary.

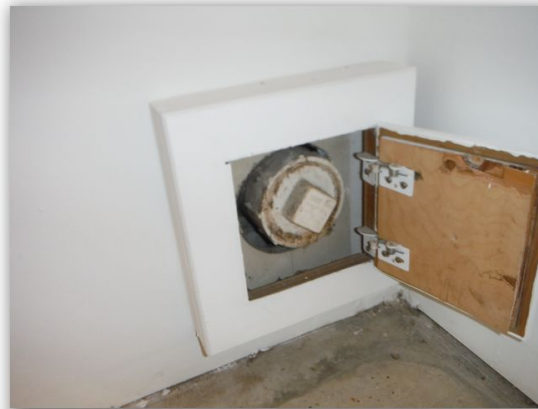
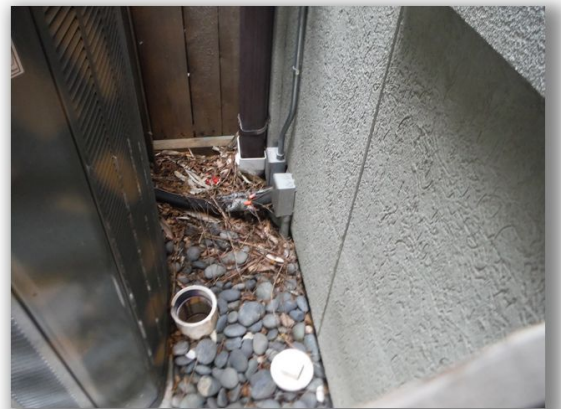
The plumbing cleanout cover(s) located in the yard were observed to be missing on the north side of the structure.

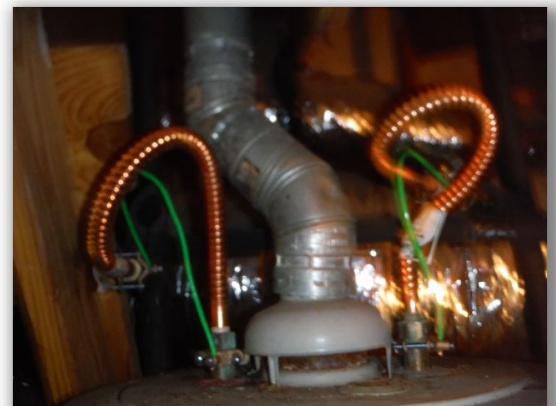
- The water heater is making a rumbling noise when operated. This is a good indicator that there is a lot of sediment in the bottom of the water heater tank. Cleaning and servicing is recommended.
- The water heater gas supply line is not equipped with a sediment trap just before the gas appliance connector. This condition does not meet current installation requirements and should be corrected.
- The roof level flue storm collar needs to be properly sealed to help prevent water intrusion into the structure.
- There is a surface damage on the water. This condition needs to be further evaluated and corrected.

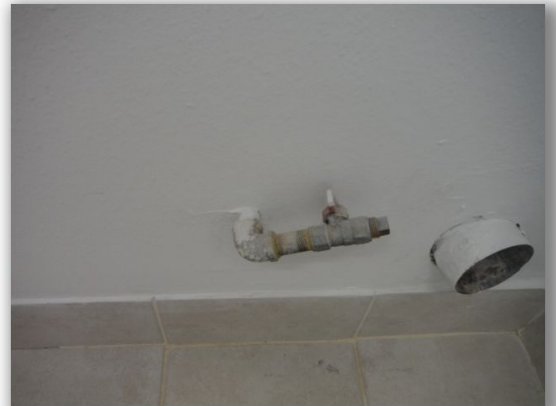
- All unused gas valve ends should be capped off for safety purposes.

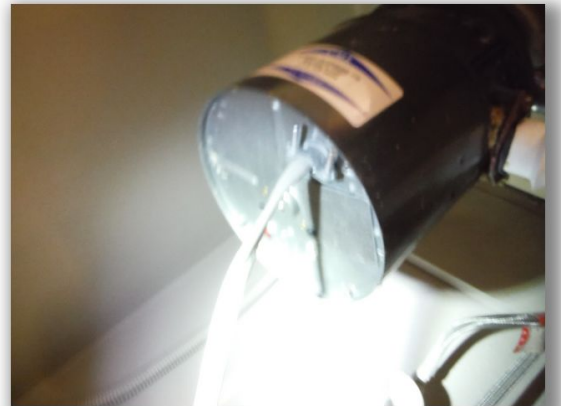
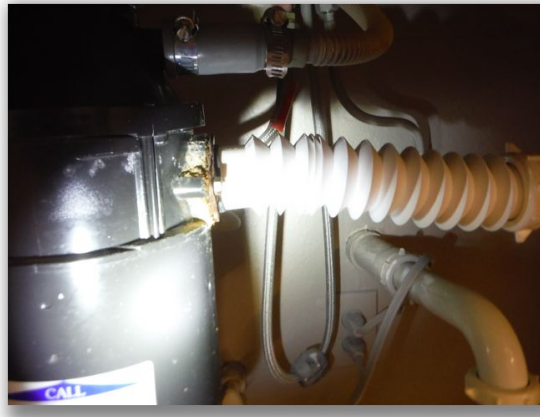
- The food waste disposer is leaking water into the cabinet area. This condition should be further evaluated and corrected as necessary.
- The electrical wiring to the disposal is exposed and should be enclosed in conduit.
- The disposer housing is corroded.

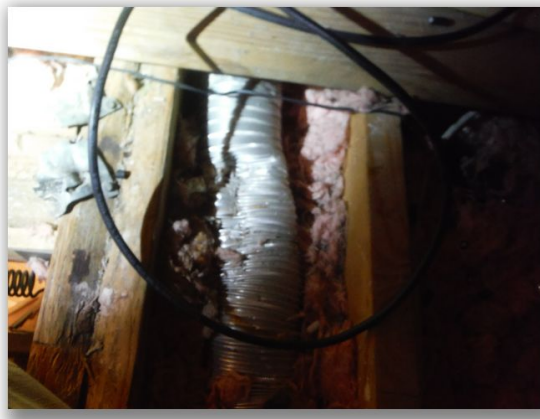
- The mechanical exhaust vents were observed to be venting into the attic area. Under current building standards, all mechanical exhaust vents should vent to the exterior of the structure. This is an “**as-built**” condition.
- The ducting to one of the mechanical exhaust fans was observed to be damaged in the attic area over the bedroom hallway.

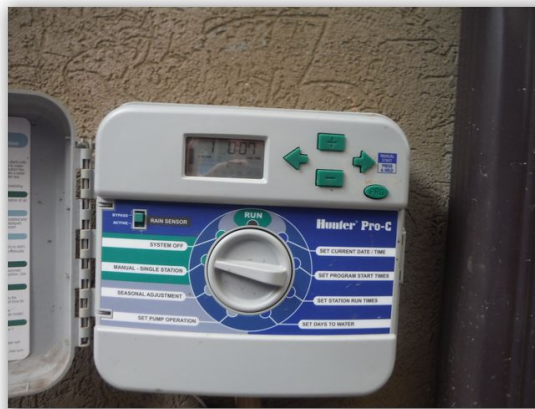
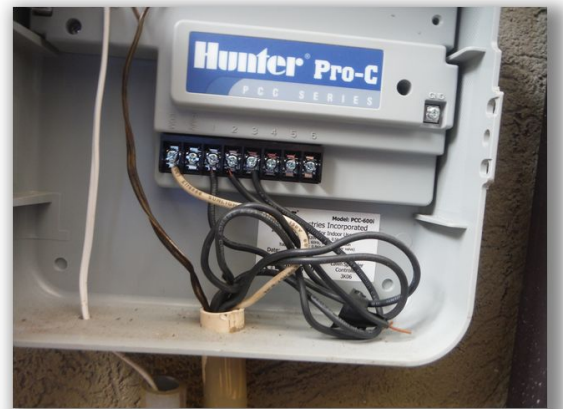
- One or more of the sprinkler heads need to be adjusted so not to spray water onto the exterior walls, surfaces or windows in stations; **1, 2, 3.**
- I was unable to locate a moisture (rain / freeze) sensor device for the sprinkler system. This is an **“as-built” condition**, but Per TREC standards of practice we are required to report this condition as a deficiency.
- There appears to be a sub-surface leak or damaged water lines in station(s); **2, 3.** The cause and remedy should be further evaluated and corrected as necessary.
- One or more of the sprinkler heads need to be adjusted so not to spray water into the pool in stations **3.**
