## **HEDDERMAN ENGINEERING, INC.**

REF: CONDITION OF PROPERTY SURVEY

At your request, a visual survey of the house located at 3211 Seminole Peak Lane, Katy, Texas, was made by Mr. Dennis Polk and Mr. Anthony Long.

**3211 Seminole Peak Lane**

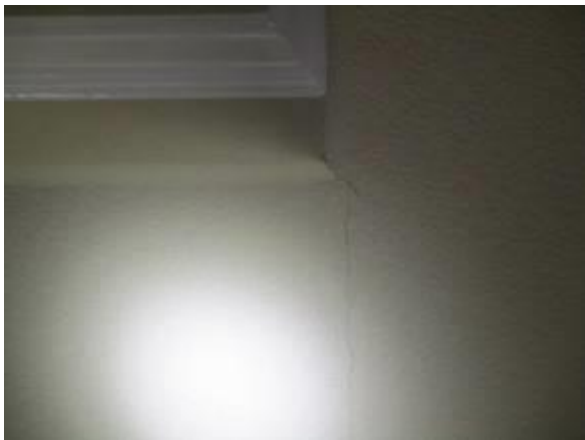
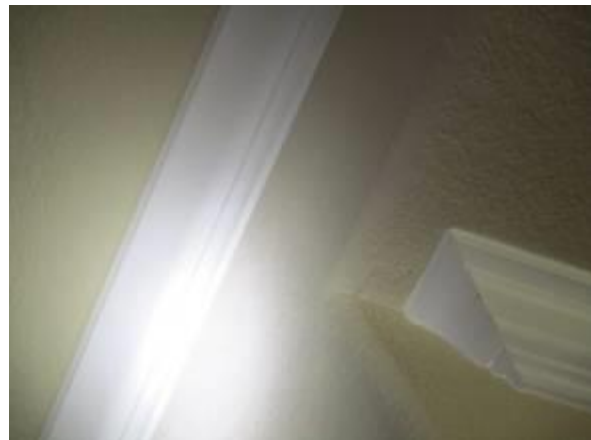
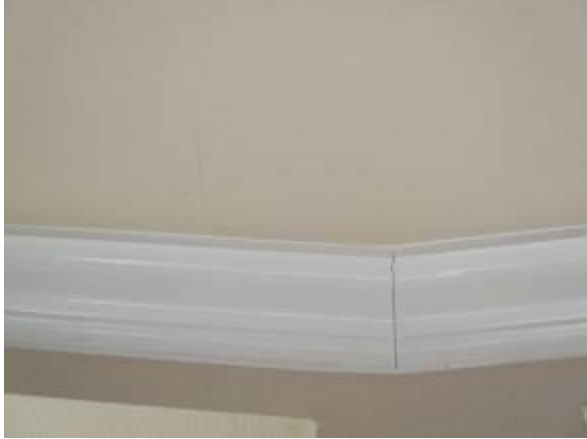
Sheetrock cracks, patches, and/or compression ridges were observed, including at: living room and master suite.

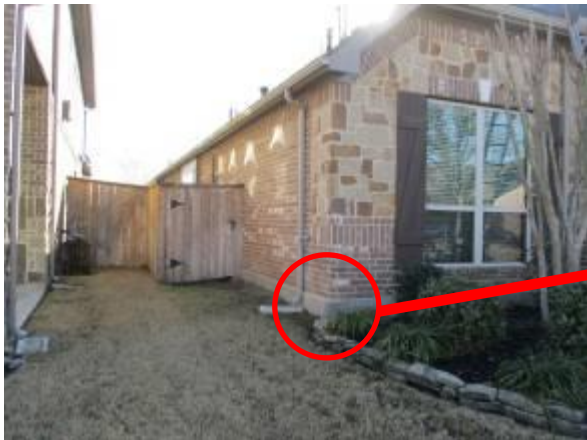
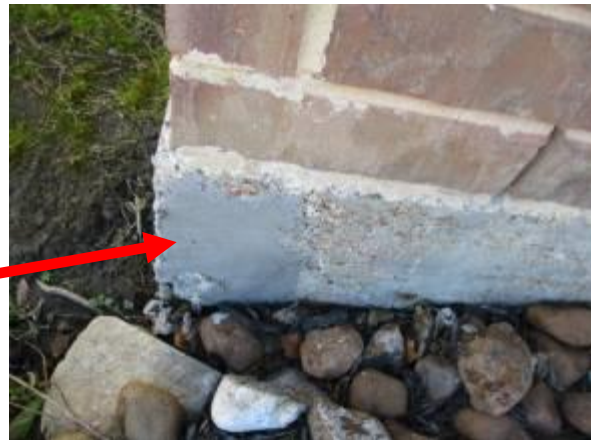
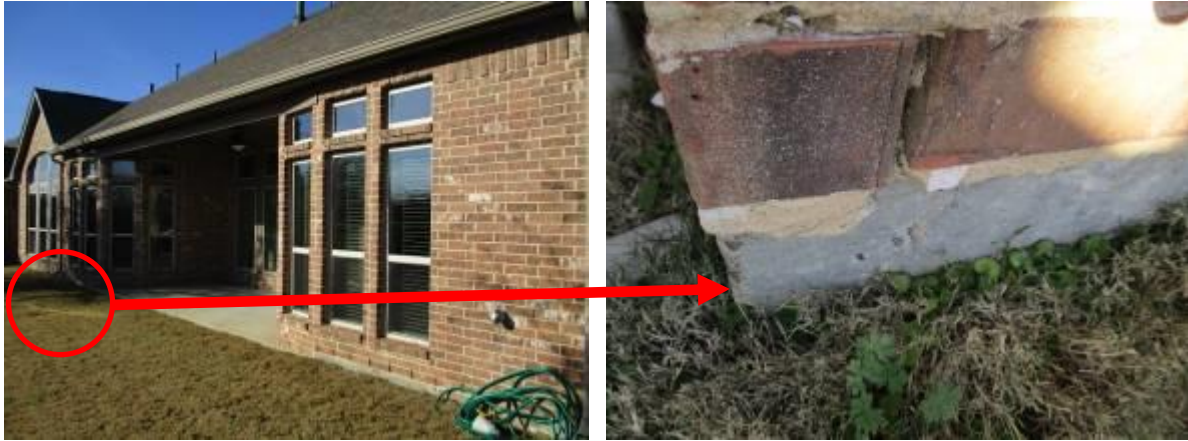
The corner of the foundation was observed to be chipped. This condition is typically caused by differences in thermal expansion between the brick veneer and the concrete foundation. Also, this condition can be caused by a lack of reinforcement in the corner of the foundation during original construction. In our opinion, this condition does not affect the overall structural integrity of the foundation. Locations included: northwest and southeast

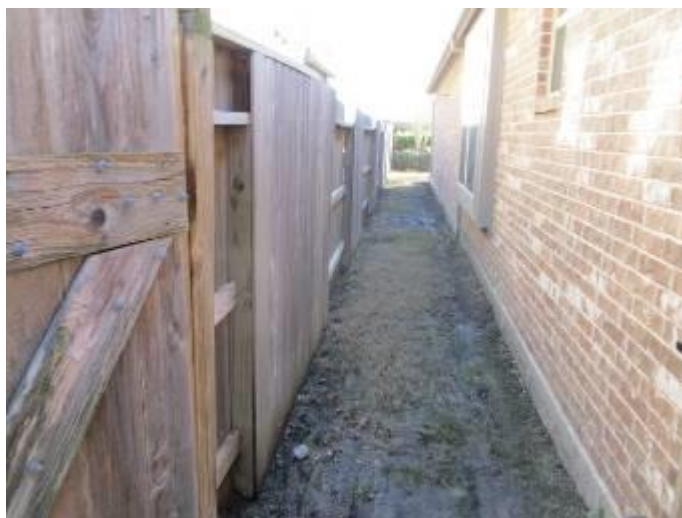
Location included: North house perimeter

The perimeter drainage was observed to be poor at some areas where the lot is not sloped away from the house (6 inch drop in the first 10 feet) and water will pond. Poor drainage conditions near the foundation can contribute to foundation movement. It is recommended that a company specializing in drainage solutions be contacted to provide a recommended solution, along with a cost estimate to provide proper drainage.

**Obtain Cost Estimate**

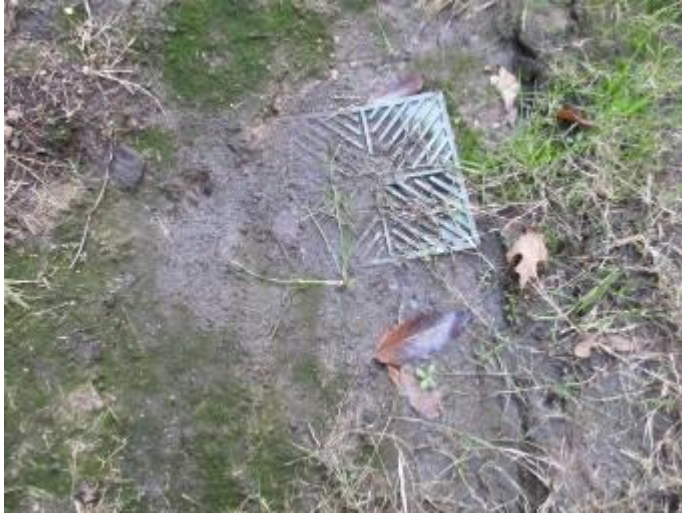
The underground drainage system was clogged at the north side of the house, and will not drain properly. It is recommended that the drain inlet be cleared of debris.

**Obtain Cost Estimate**

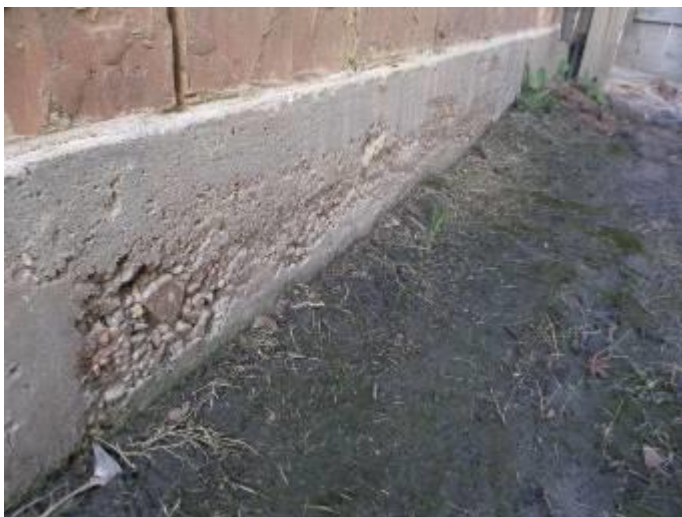
Locations included: North perimeter grade beam

The foundation concrete was observed to be honeycombed due to poor original construction workmanship. The honeycombed area should be grouted to present a smooth surface finish.

**Obtain Cost Estimate**

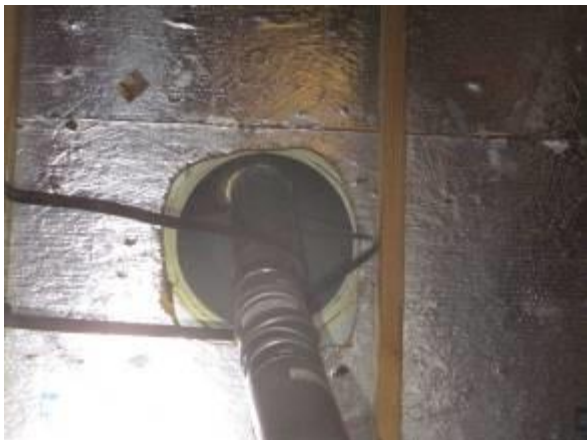
Locations included: Furnace vent pipe

After observing the interior of the structure, evidences of roof leaks were visible in the attic, where the roof decking and/or roof framing members were water stained. It is recommended that a roofing contractor be contacted to find the source of the leaks, and to make any needed repairs.

**Obtain Cost Estimate**

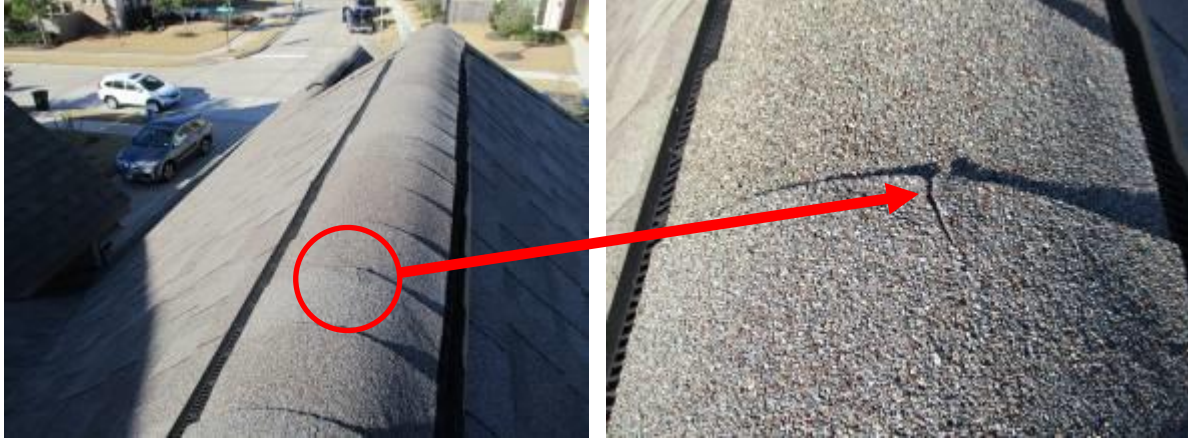
We observed shingles with cracked tabs.  
Location included: front low roof ridge

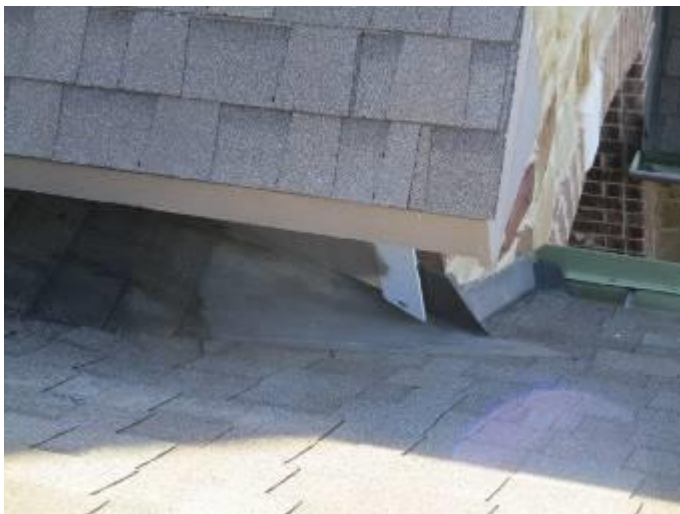
Location included: Front roof elevation

There was a narrow valley in the roof, where the valley narrows down and will be susceptible to the accumulation of leaves and other debris. This can cause a damming of water running down the valley, possibly causing a roof leak. It is recommended that this valley be monitored, and cleaned on a regular basis.

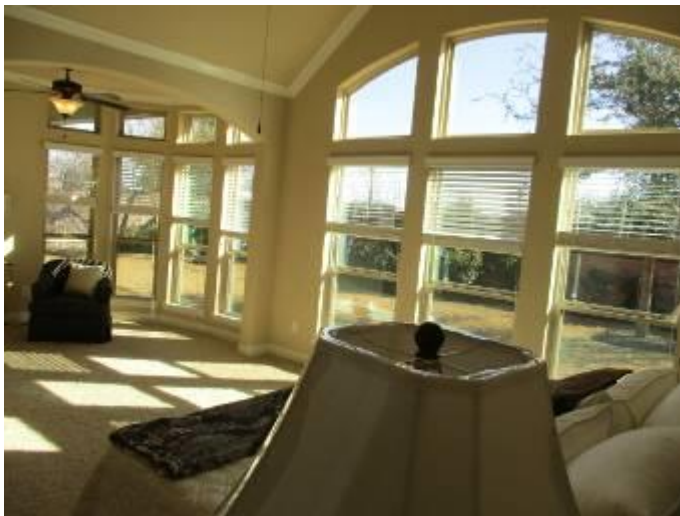
Locations included: Master suite windows

The window(s) did not bear any markings to indicate that it is safety glass. This window meets the requirements of windows that are required to be safety glass, including:

Therefore, this window should be safety glass, and it is recommended that you obtain a cost estimate to replace the window.

### **Obtain Cost Estimate**
