PROPERTY INSPECTION REPORT

Concerning: 3211 Seminole Peak Lane, Katy, TX 77494

By: Anthony Long # 22304

1/22/18

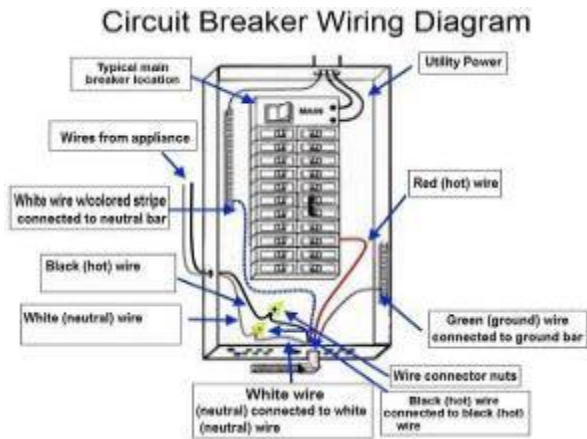
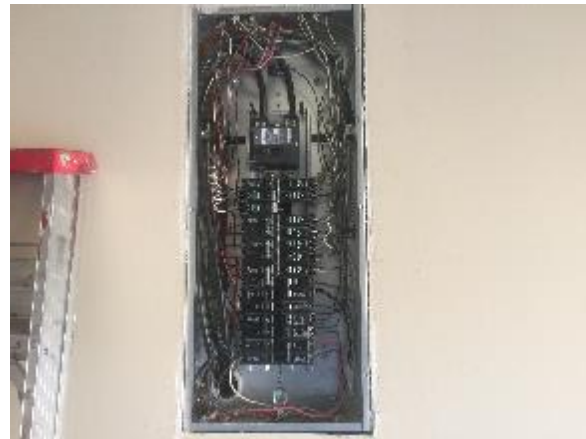
Breaker Panel Box

Foreign matter was observed in the panel box, which can be a safety hazard, and it is recommended that the panel be cleaned

Obtain Cost Estimate

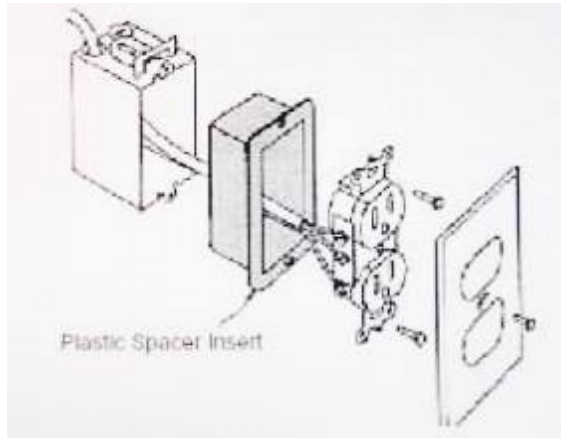
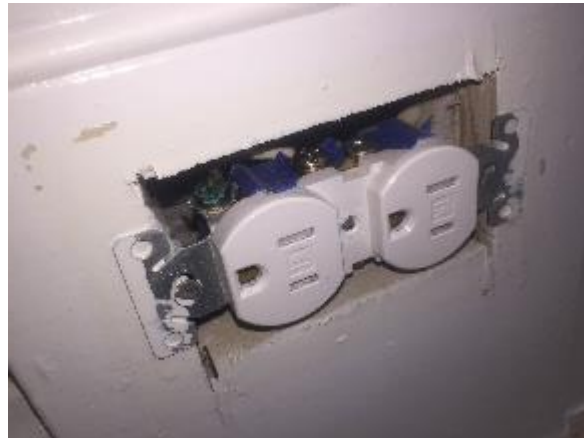
We observed an outlet located in the breakfast room baseboard that was not protected by extender boxes. This is considered to be a fire hazard, and it is recommended that the extender boxes be installed.

Obtain Cost Estimate

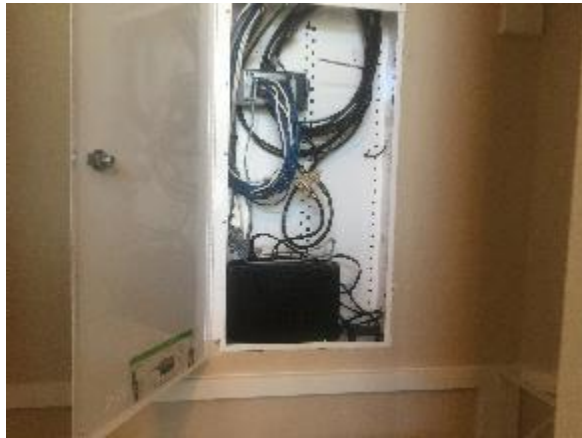
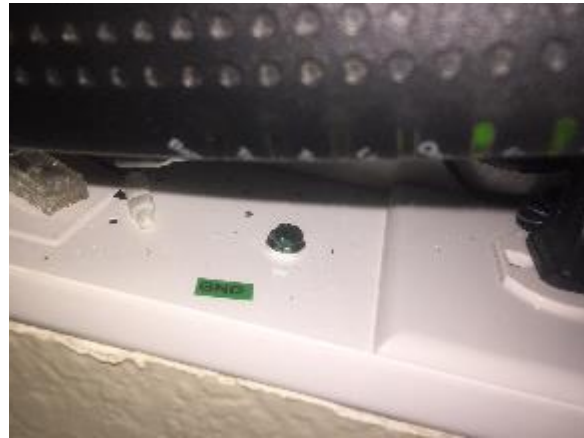
The networking panel was not bonded to a grounding source. A copper wire needs to be attached to the grounding lug on the panel, and properly attached to a grounding source.

Locations included: SW bedroom closet

Obtain Cost Estimate

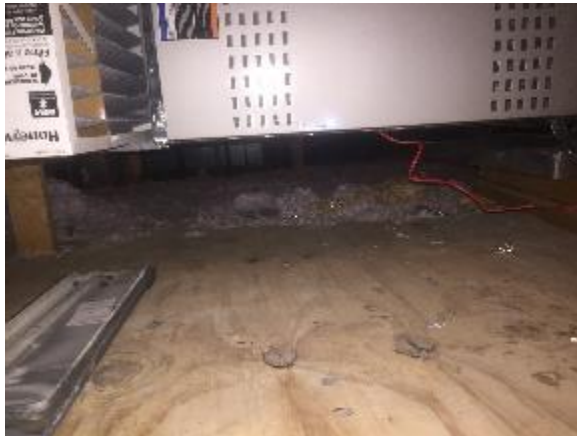
The furnace was not properly supported underneath the equipment.

Obtain Cost Estimate

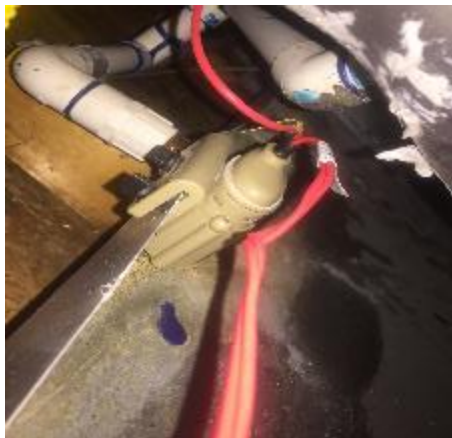
The overflow pan under the evaporator coil had rust in the pan, apparently from water overflowing the condensate drain line into the overflow pan. No water was in the pan at the time of the inspection, but, since we only ran the unit for a few minutes, it is recommended that the drain line be checked by an air conditioning service company.

Obtain Cost Estimate

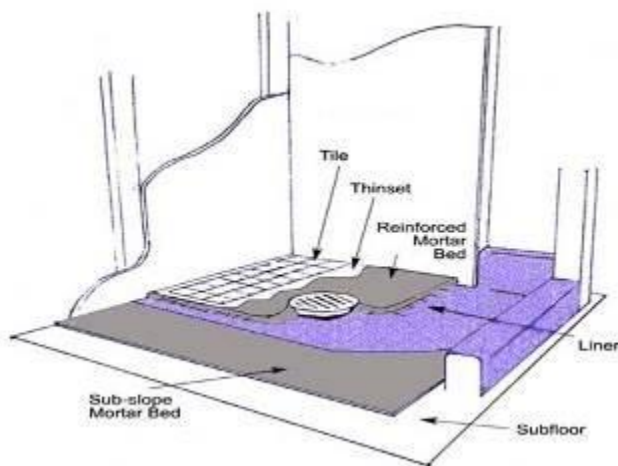
The shower head was partially clogged, and needs to be cleaned/replaced.
Locations included: Master shower

Obtain Cost Estimate
