Home Inspection Report

PROPERTY INSPECTED:
618 Aulia Lane
Spring, TX 77386

DATE OF INSPECTION: 05/27/2019
Inspection No. 52288-137

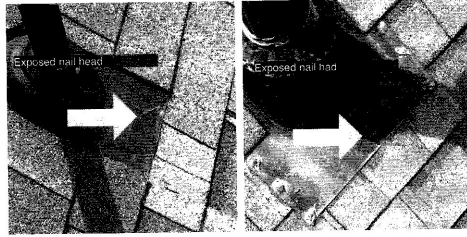
• Exposed nail heads on the roof need to be properly sealed over with roof cement to reduce chance of roof leak issues.

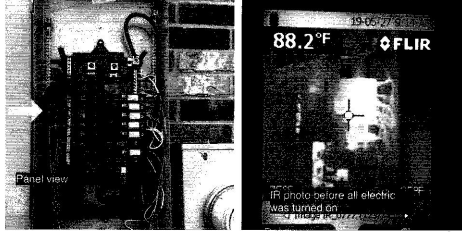
- Main service wire is aluminum. Main breaker is 125 amps, panel rating is 200 amps. Panel is located on the exterior north side of the house. The infrared camera evaluation of the panel before and after all of the electric was turned on did not show any anomalies, issues.
