## PROPERTY INSPECTION REPORT

Concerning: 1335 Outrigger, Tiki Island, TX 77554  
(Address or Other Identification of Inspected Property)

By: Joey Vrana, Lic #24551 07/27/2021  
(Name and License Number of Inspector) (Date)

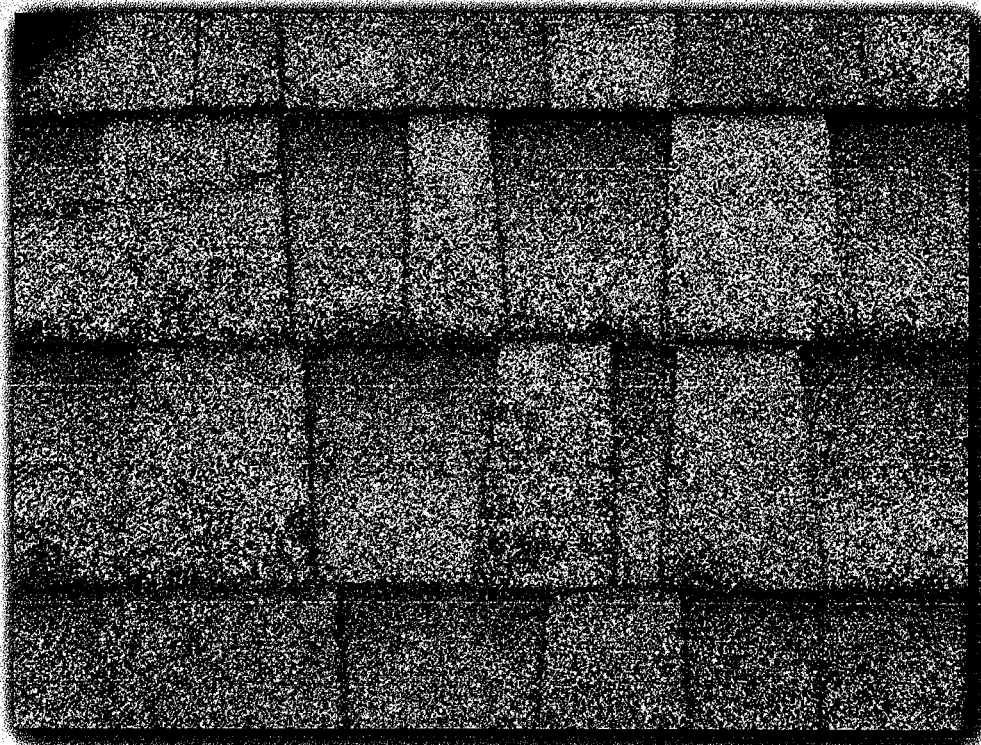
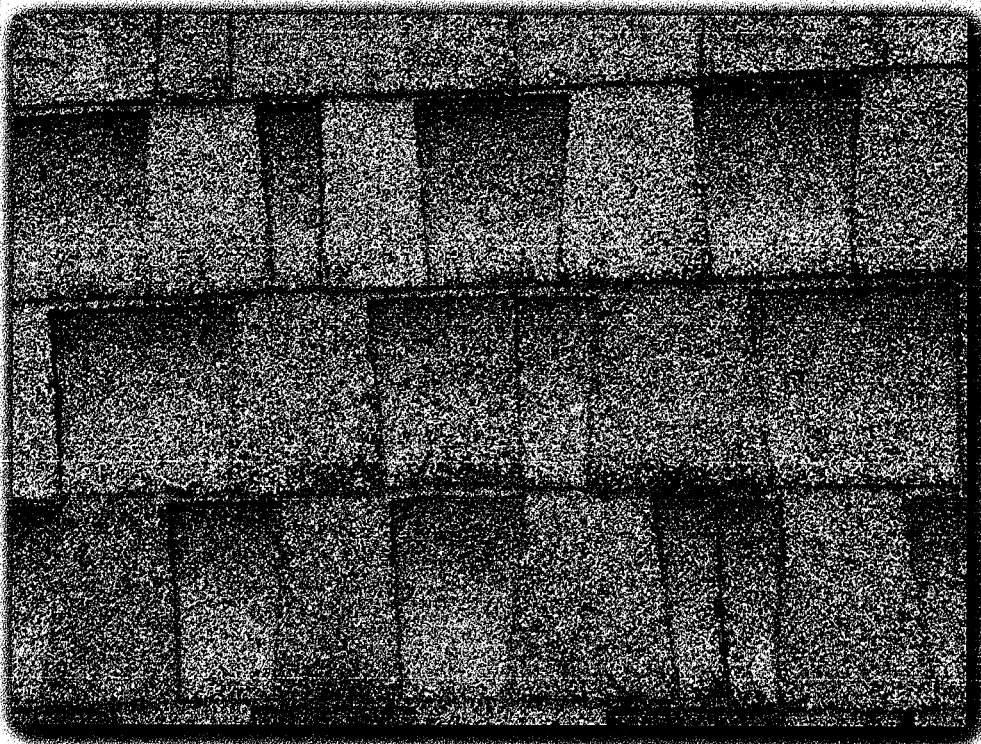
Older roof, nearing end (last 1/3 to 1/4) of serviceable life. Observed one or more of the following conditions: brittle, cracked, curled ends, and/or excessive granular loss of shingles.

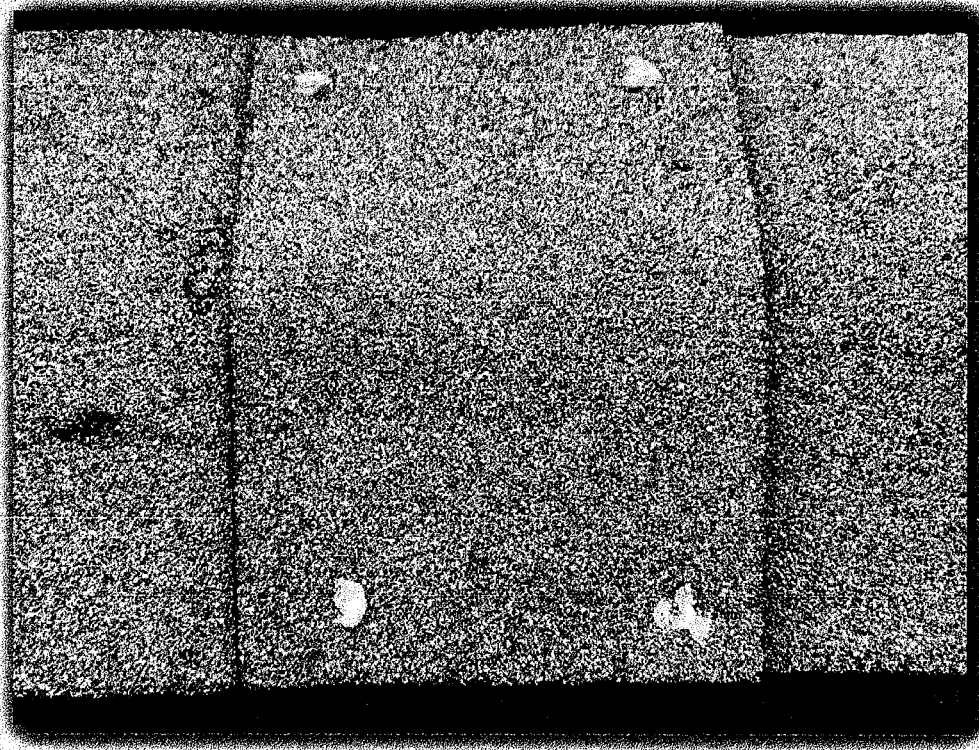
It is recommended that exposed nail heads be caulked or sealed appropriately.

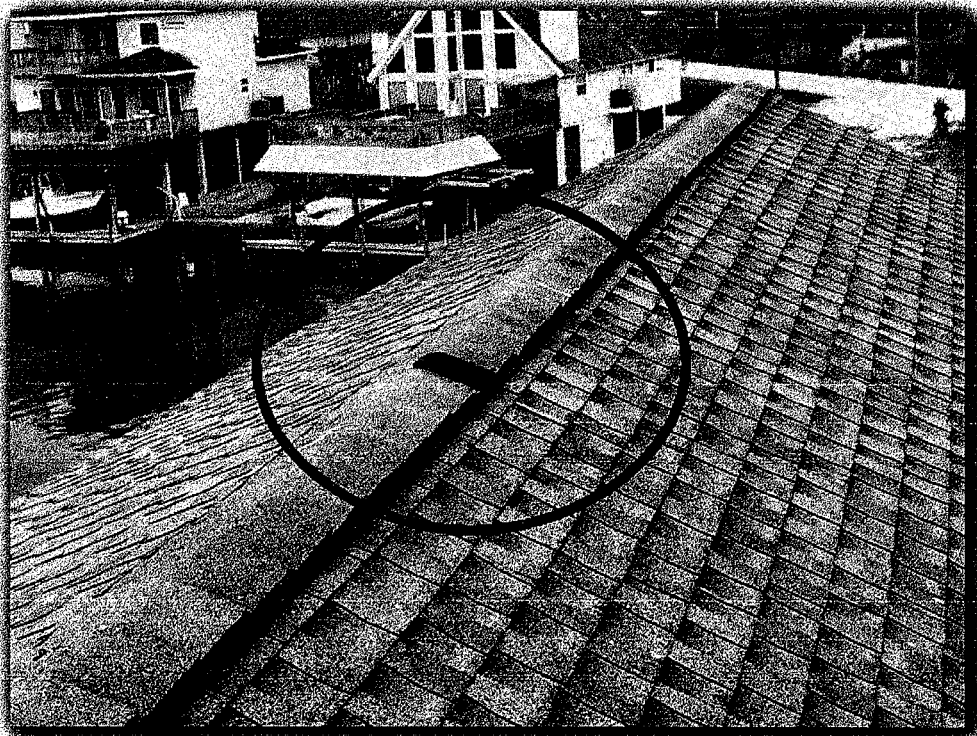
Prior repairs to the roofing are evident. This would suggest that problems have been experienced in the past. This area should be monitored.

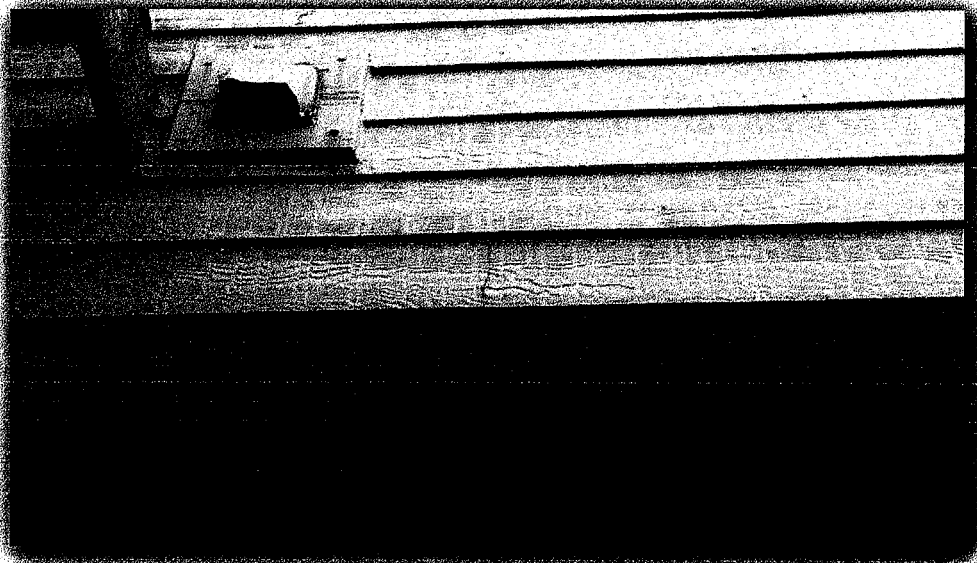
Damage to the siding at the exterior of the home was observed and should be repaired.

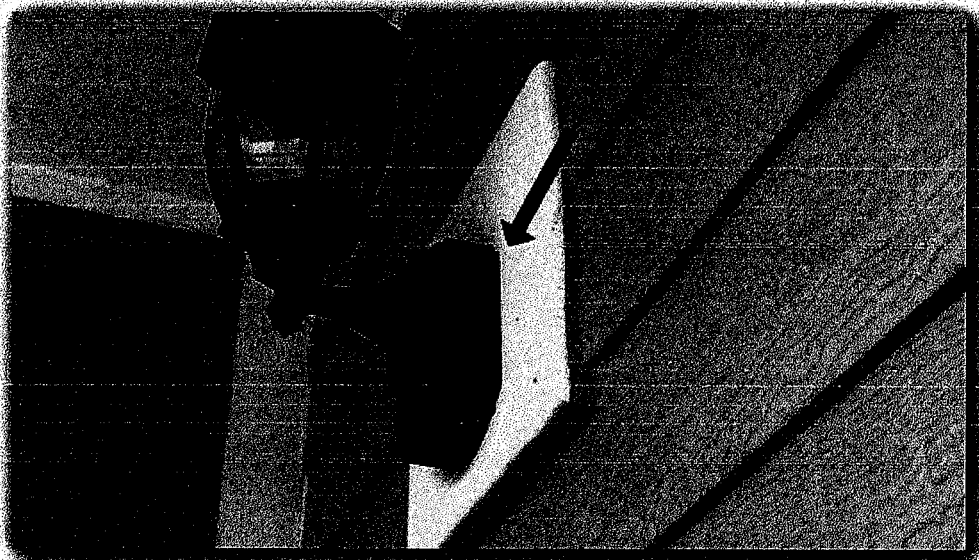
Exterior wall penetrations should be examined and sealed as necessary.

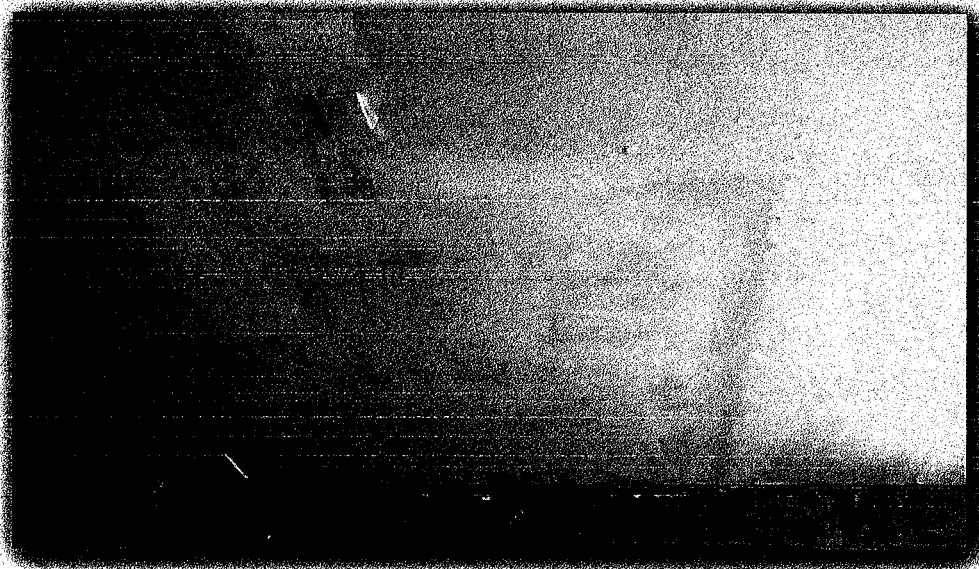
Patching was noted on the ceiling in the garage.

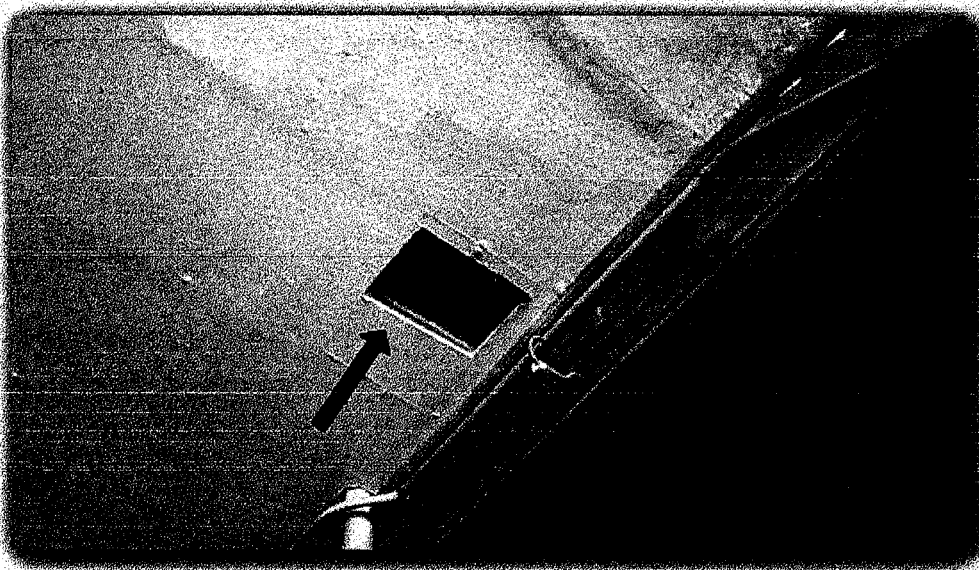
The opening in the garage should be properly sealed to prevent pest infiltration.

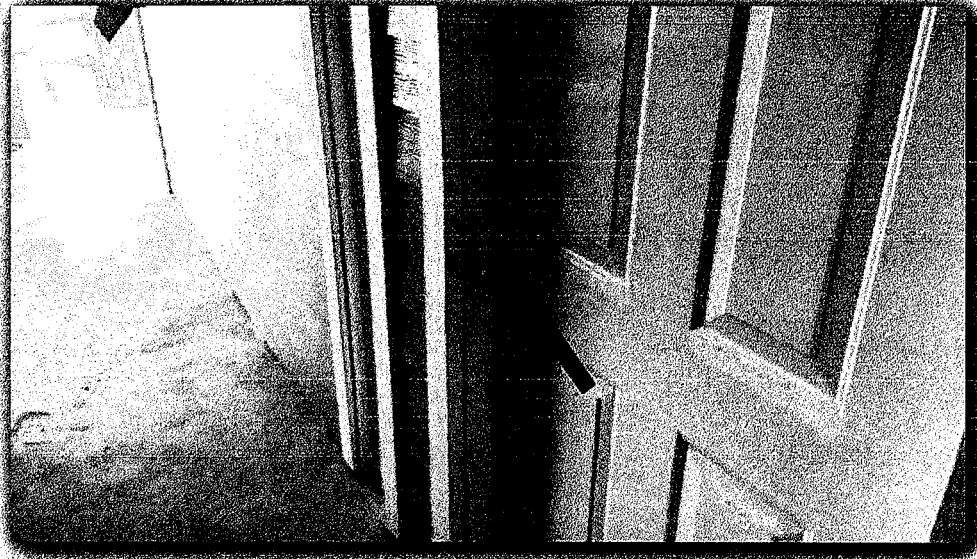
The hardware and/or striker plate on the side entry door requires adjustment in order to function properly.

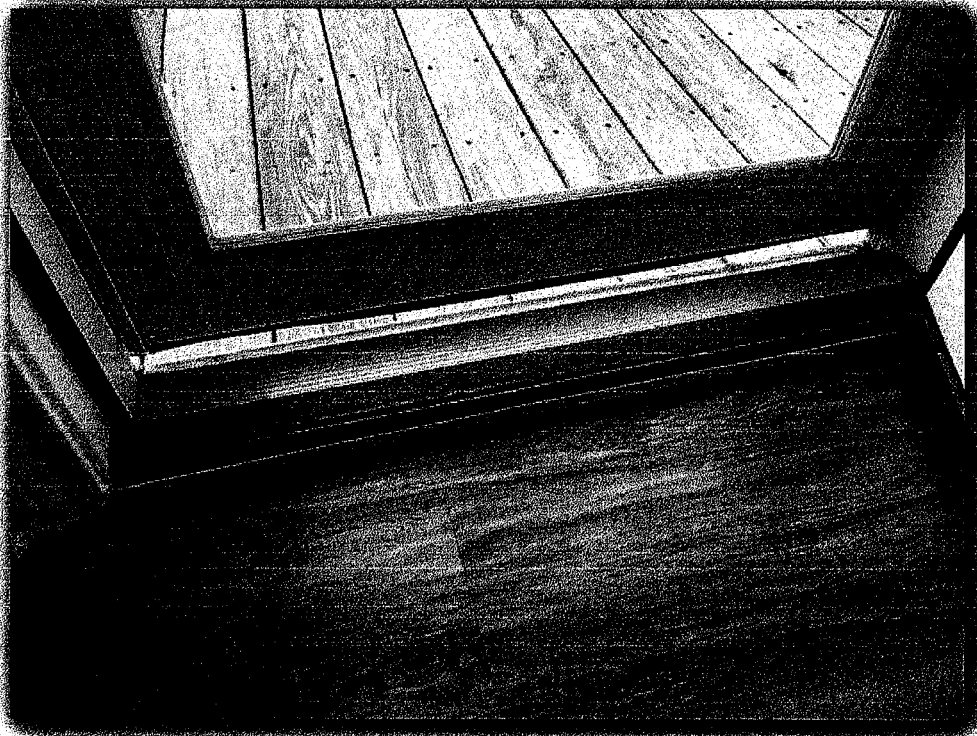
The exterior doors should be better sealed to promote energy efficiency.

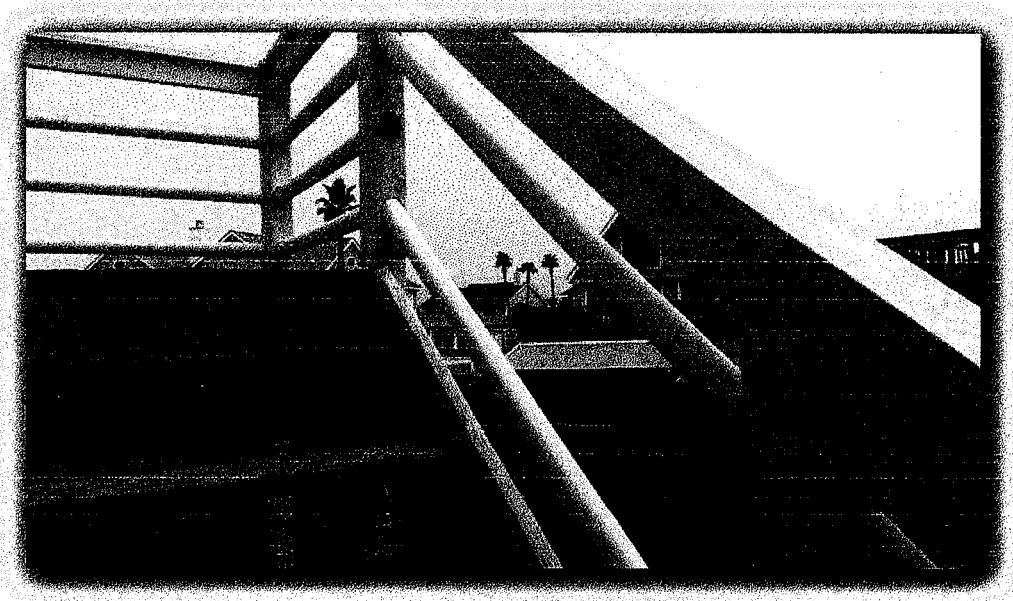
Missing railings should be replaced.

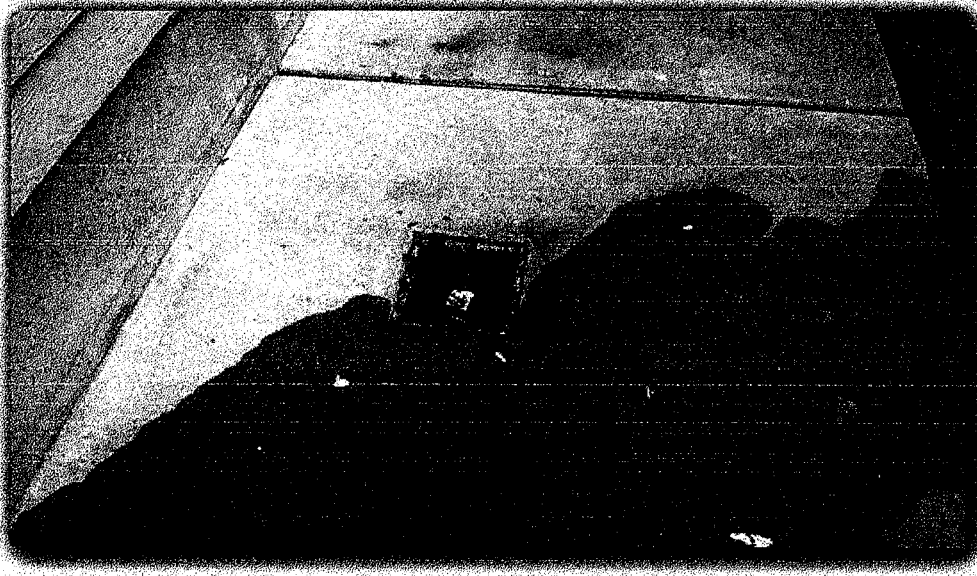
Loose deck boards should be resecured as necessary.

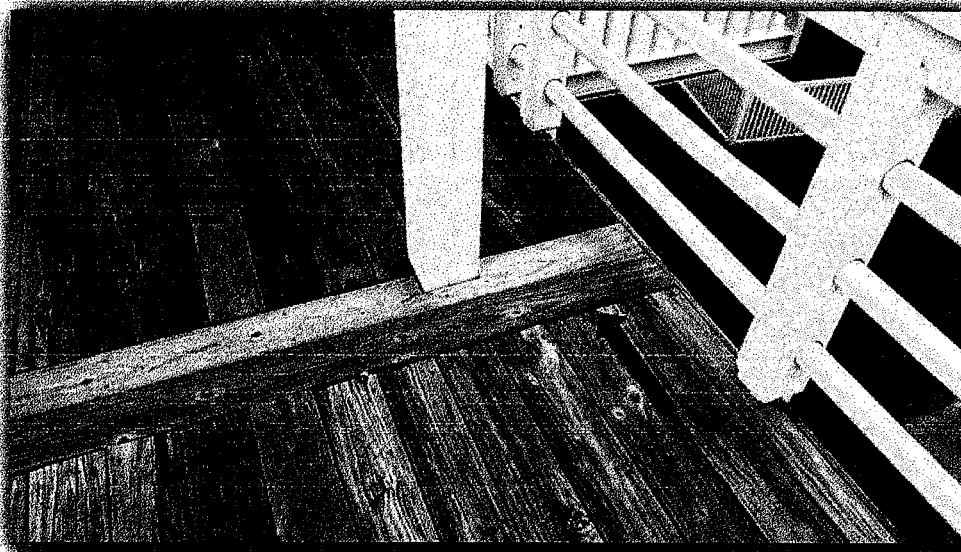
The boat dock/deck is damaged (board and beams are loose, slipping and sagging). Further investigation and repairs should be made as necessary.

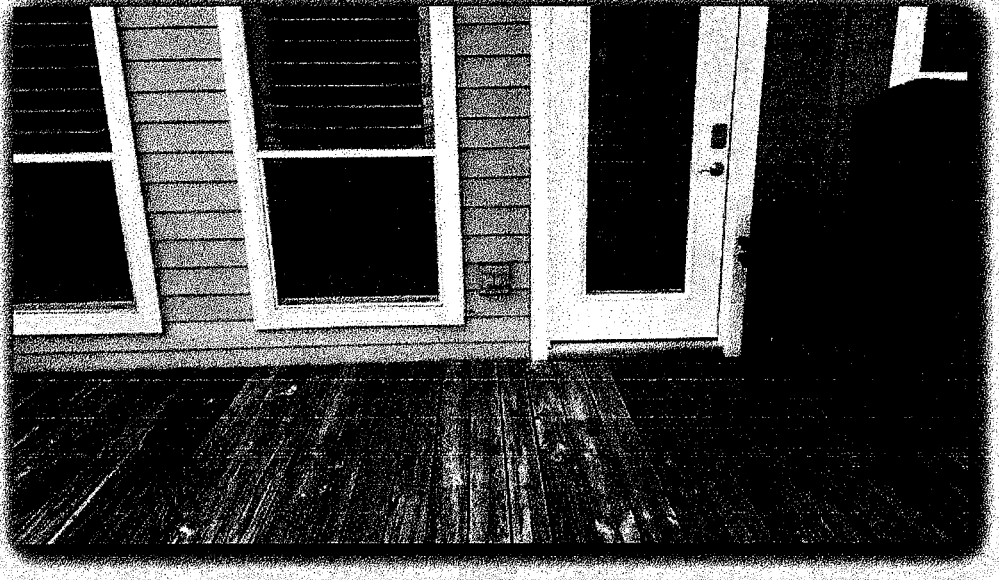
The installation of a ground fault circuit interrupter (GFCI) is recommended at the exterior of the home. A ground fault circuit interrupter (GFCI) offers protection from shock or electrocution.

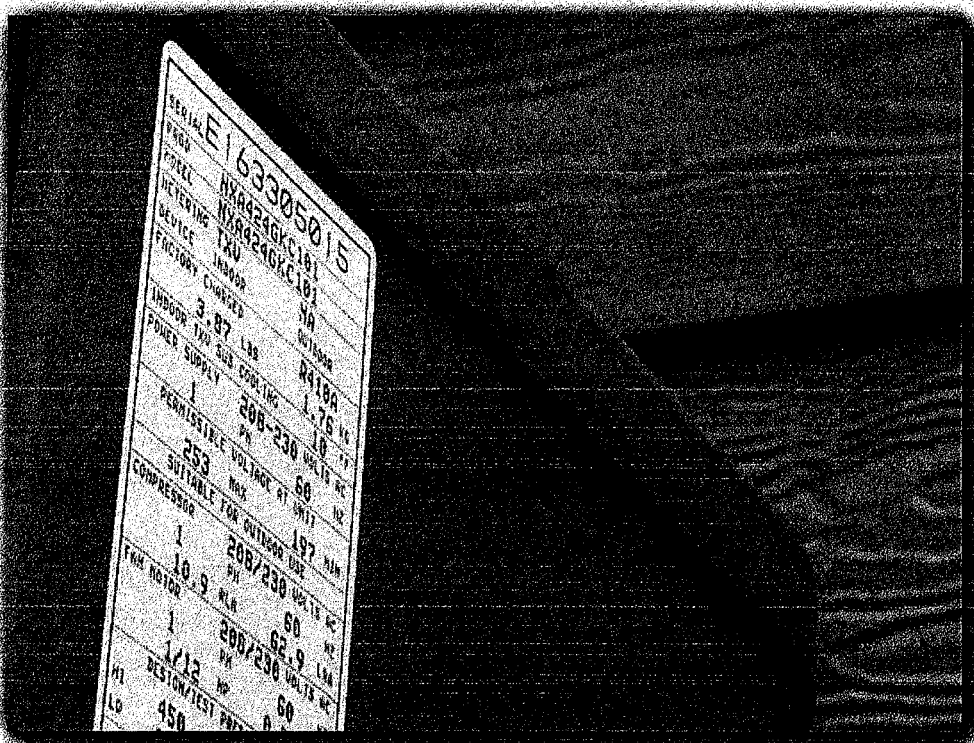
The discharge location of the condensate line for the air conditioning system should be improved so it protrudes well past the wall penetration. The current configuration is flush and drips down the wall.

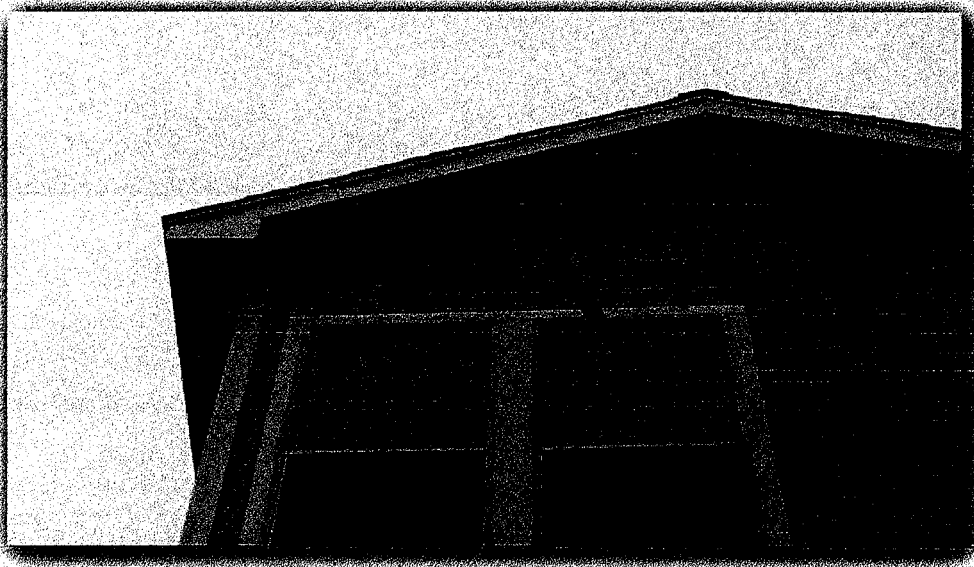
Damaged insulation on refrigerant lines should be repaired.

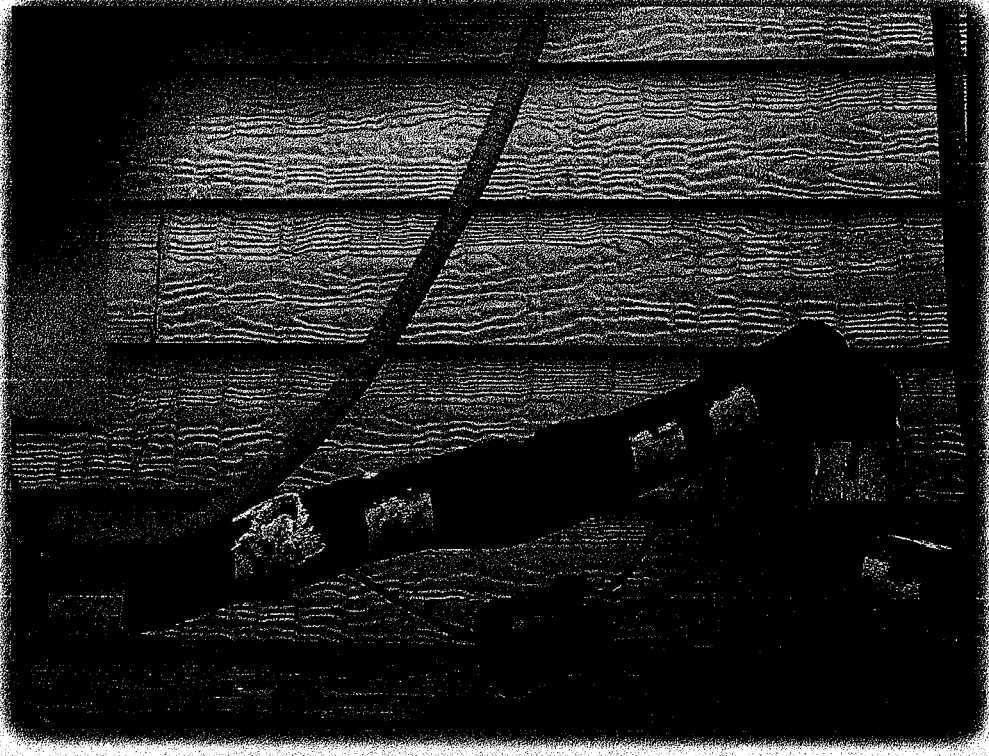
The auxiliary drain pan installed below the evaporator coil of the air conditioning system contains water and debris. This should be emptied and cleaned.

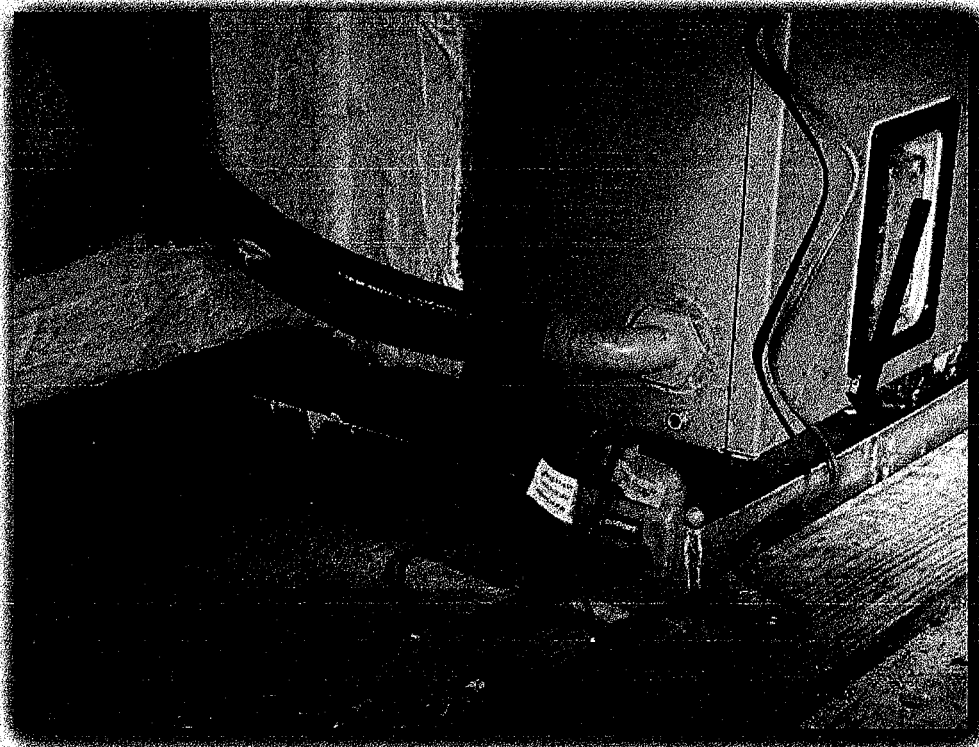
Missing insulation on secondary condensation drain line should be replaced to prevent water damage.

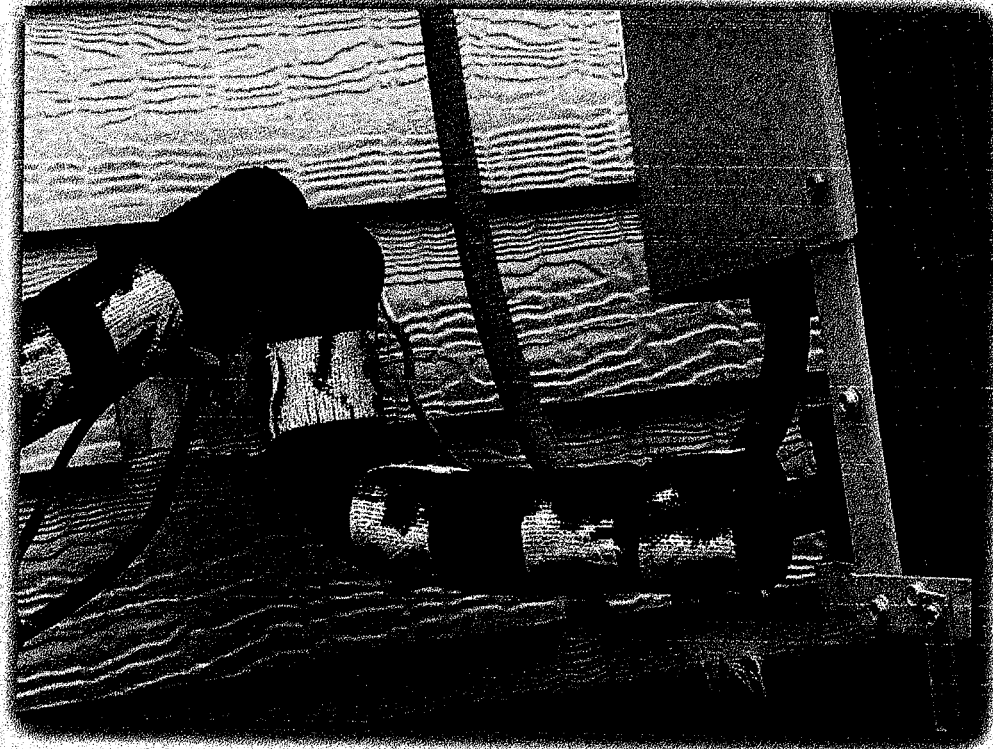
2 ton 2016 unit servicing the upstairs-

The air conditioning system was inoperative at the time of the inspection. A qualified heating and cooling technician should be consulted to further evaluate of this condition and the remedies available for correction.

Damaged insulation on refrigerant lines should be repaired.

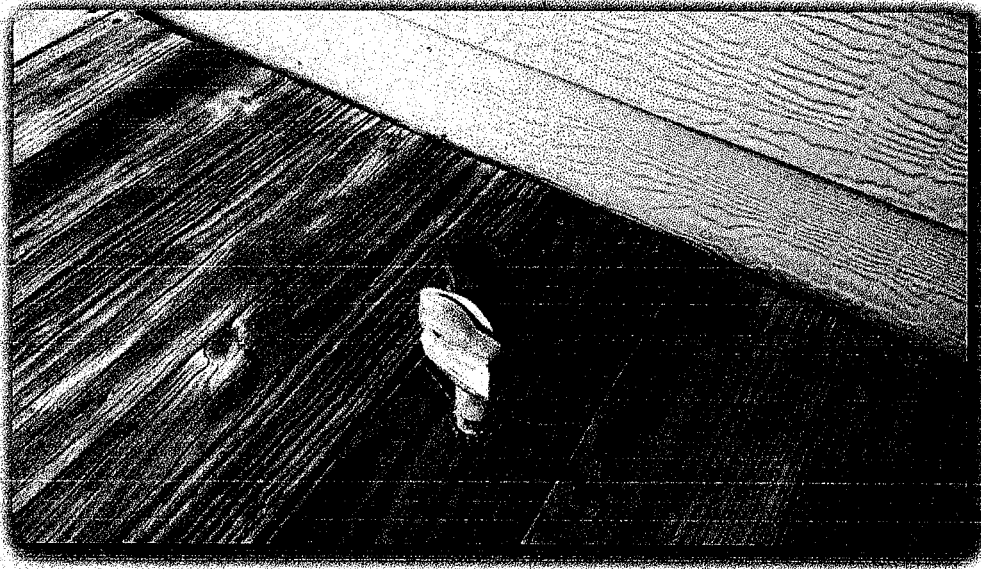
If the gas line for the clothes dryer is to remain unused, it would be recommended to cap or plug the gas line in the laundry room.

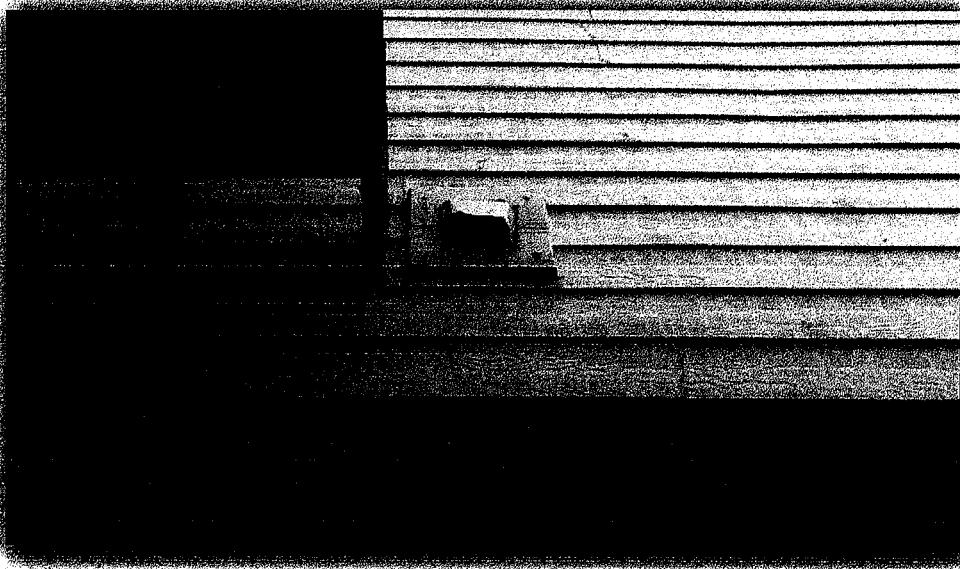
A damper should be installed (and/or repaired) on the dryer vent to prevent pest infiltration. The damaged damper cover should also be repaired or replaced as necessary.
