Wood Destroying Insect Report

Inspection Performed by Juan Mireles TPCL #838092 7/7/2021

201 Vanderpool Ln. #13

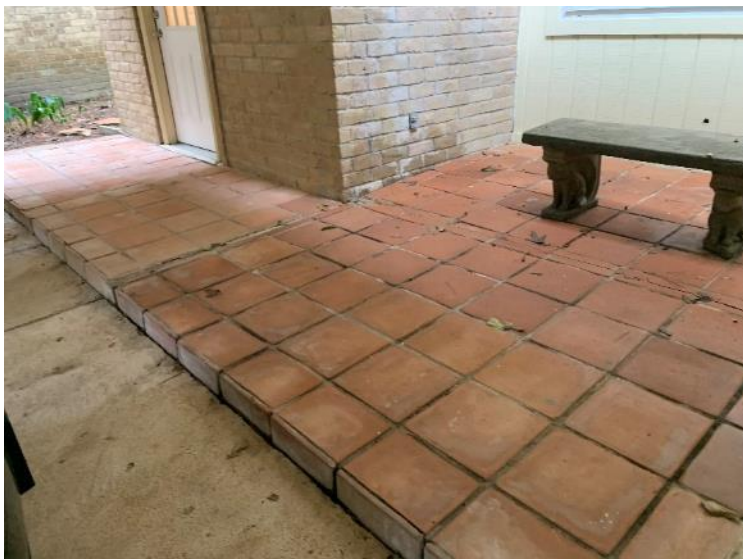
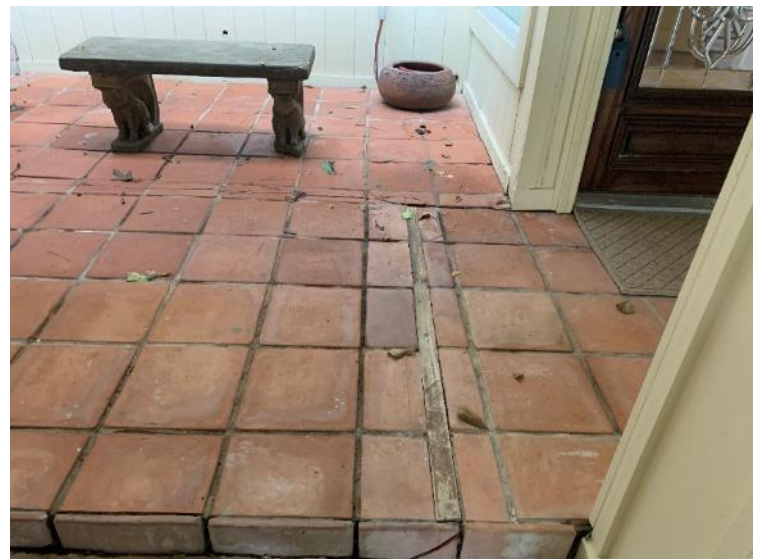
Obstructed View

Pavers obstructing view of the foundation

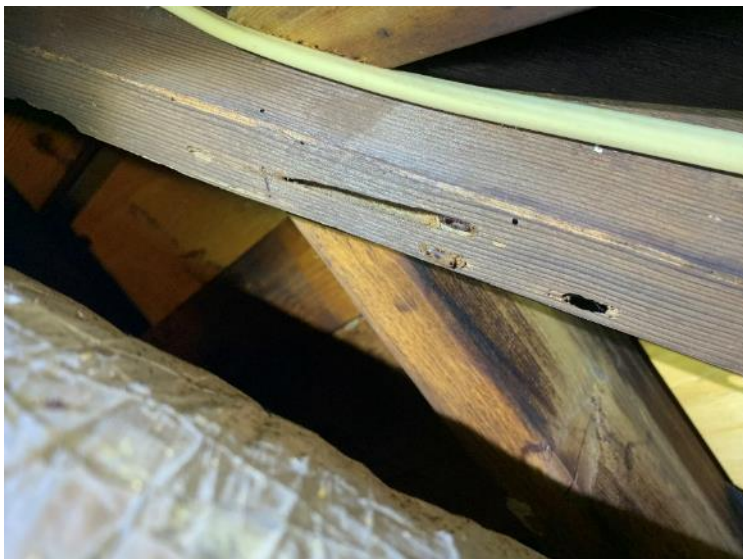
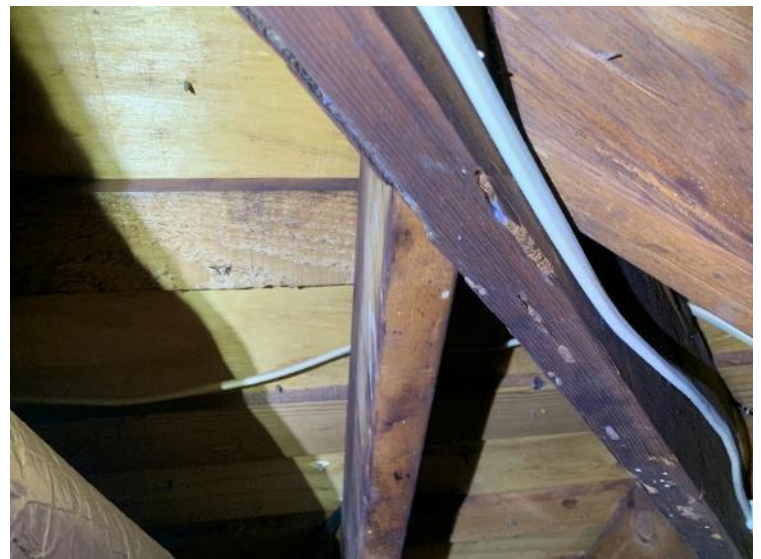
Evidence of Wood Destroying Insects

11G. Visible evidence of: **Wood Boring Beetles** has been observed in the following areas: **In the attic.**

(PB) Wood Boring Beetles - Evidence of previous infestation. Condition appears inactive - No treatment is recommended.

Evidence of wood boring beetles

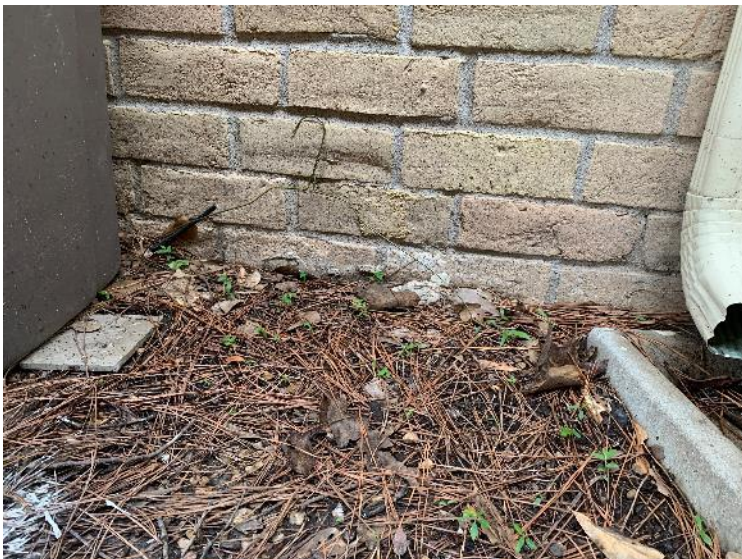
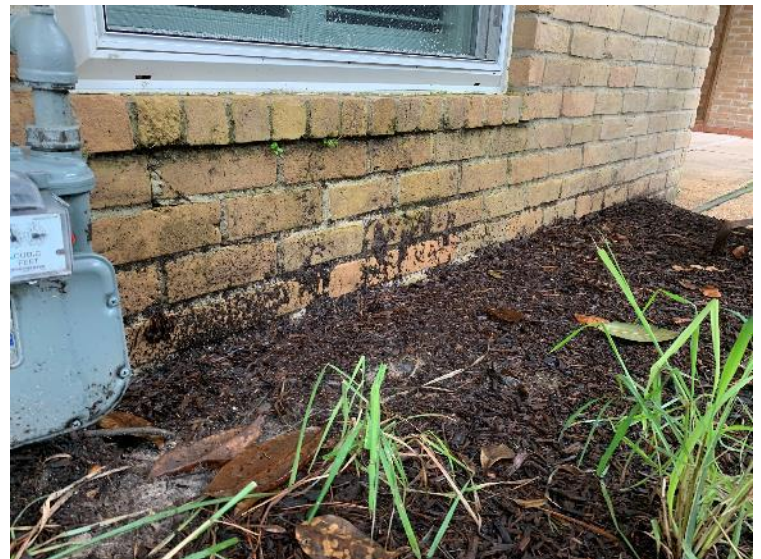
Debris observed near the structure and should be removed

(K) Debris - Debris should be cleared from around the structure.

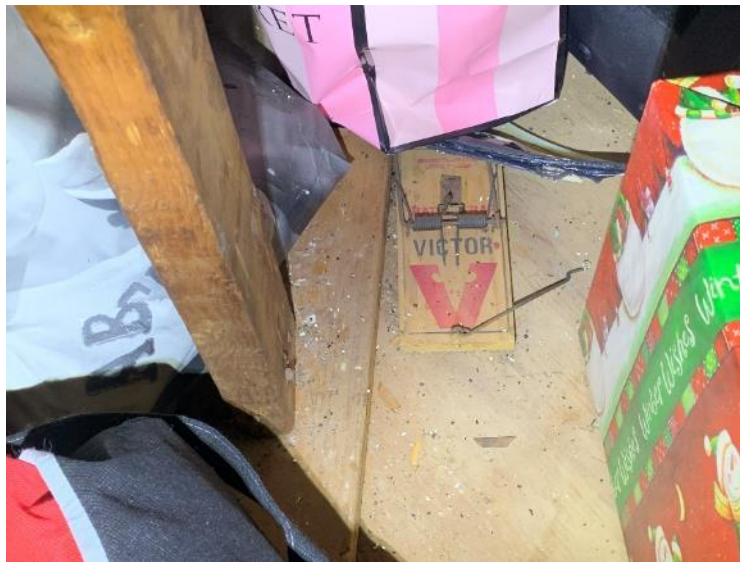
Rodent traps and droppings observed in the attic

Although this report does not include pest infestations, we noticed evidence of pest infestation during the course of our inspection. The following conditions were observed that indicate current or previous pest activity. Further investigation is recommended with the owner regarding the condition(s) and with a pest control company to obtain a cost estimate for any needed treatment to resolve the issue.
