STRUCTURAL INSPECTION

201 Vanderpool Ln #13
Houston TX 77024

JULY 7, 2021

REF: CONDITION OF PROPERTY SURVEY

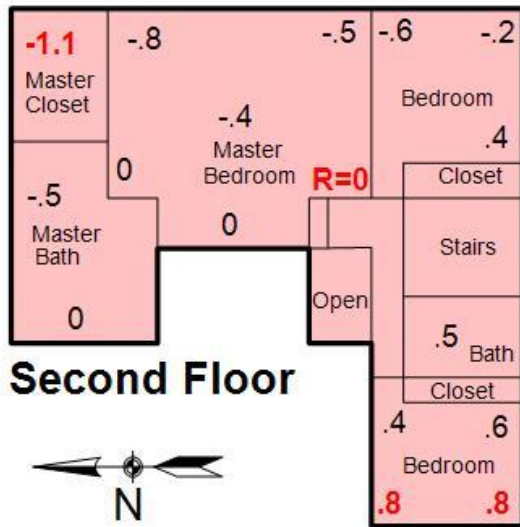
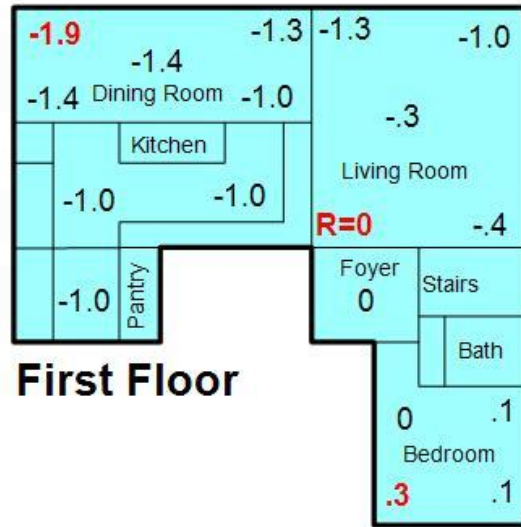
Elevation Readings 201 Vanderpool Lane #13

The floors were checked with an electronic level, and were observed to be sloping towards the northeast corner of the house. The difference in elevation between the high point and low point was 2.2 inches on the first floor; and 1.9 inches on the second floor. The first floor high point was located at the front bedroom, and the low point was located at the dining room. The unlevelness takes place over a horizontal distance of approximately 50-60 feet.

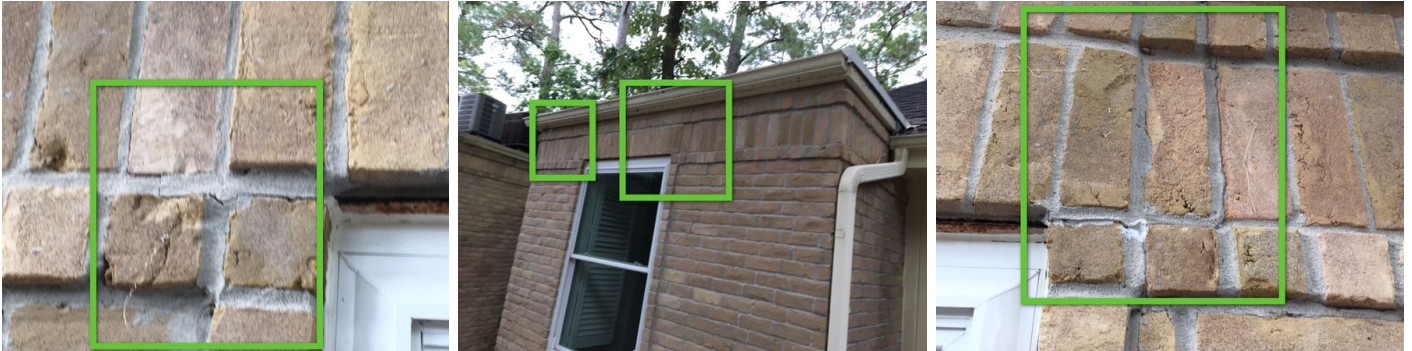
Differential Movement: Veneer Cracks - Minimal

We observed that cracks in the exterior veneer were minimal in number and degree at the time of the inspection. It is recommended to repair the cracks.

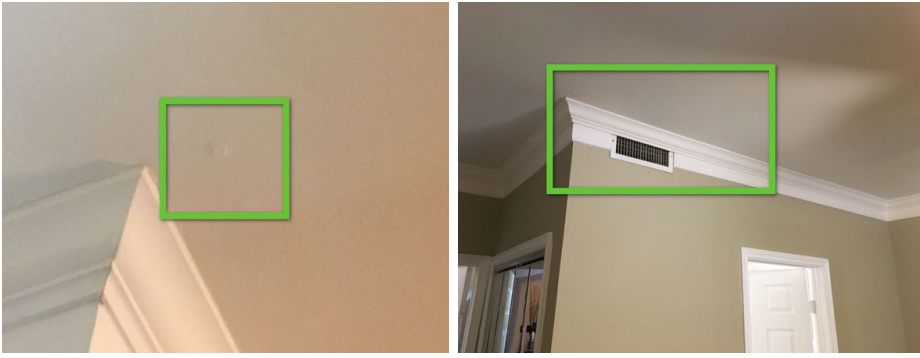
Differential Movement: Sheetrock Cracks - Minimal

Living room, dining room, and the kitchen.

We observed that sheetrock cracks were minimal in number and degree at the time of the inspection. It is recommended to repair the cracks.

First floor bedroom

Nail pops were observed in the surface of the sheetrock at the time of the inspection including at the above locations.

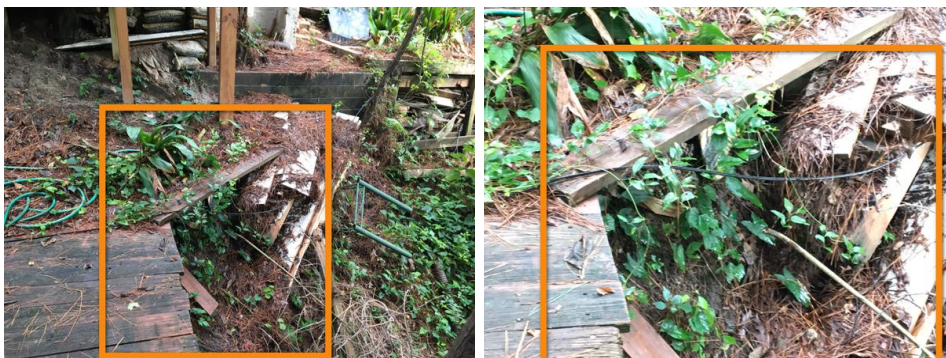
A section of the retaining wall was damaged or missing and needs to be repaired to avoid erosion.

Contact a qualified professional.

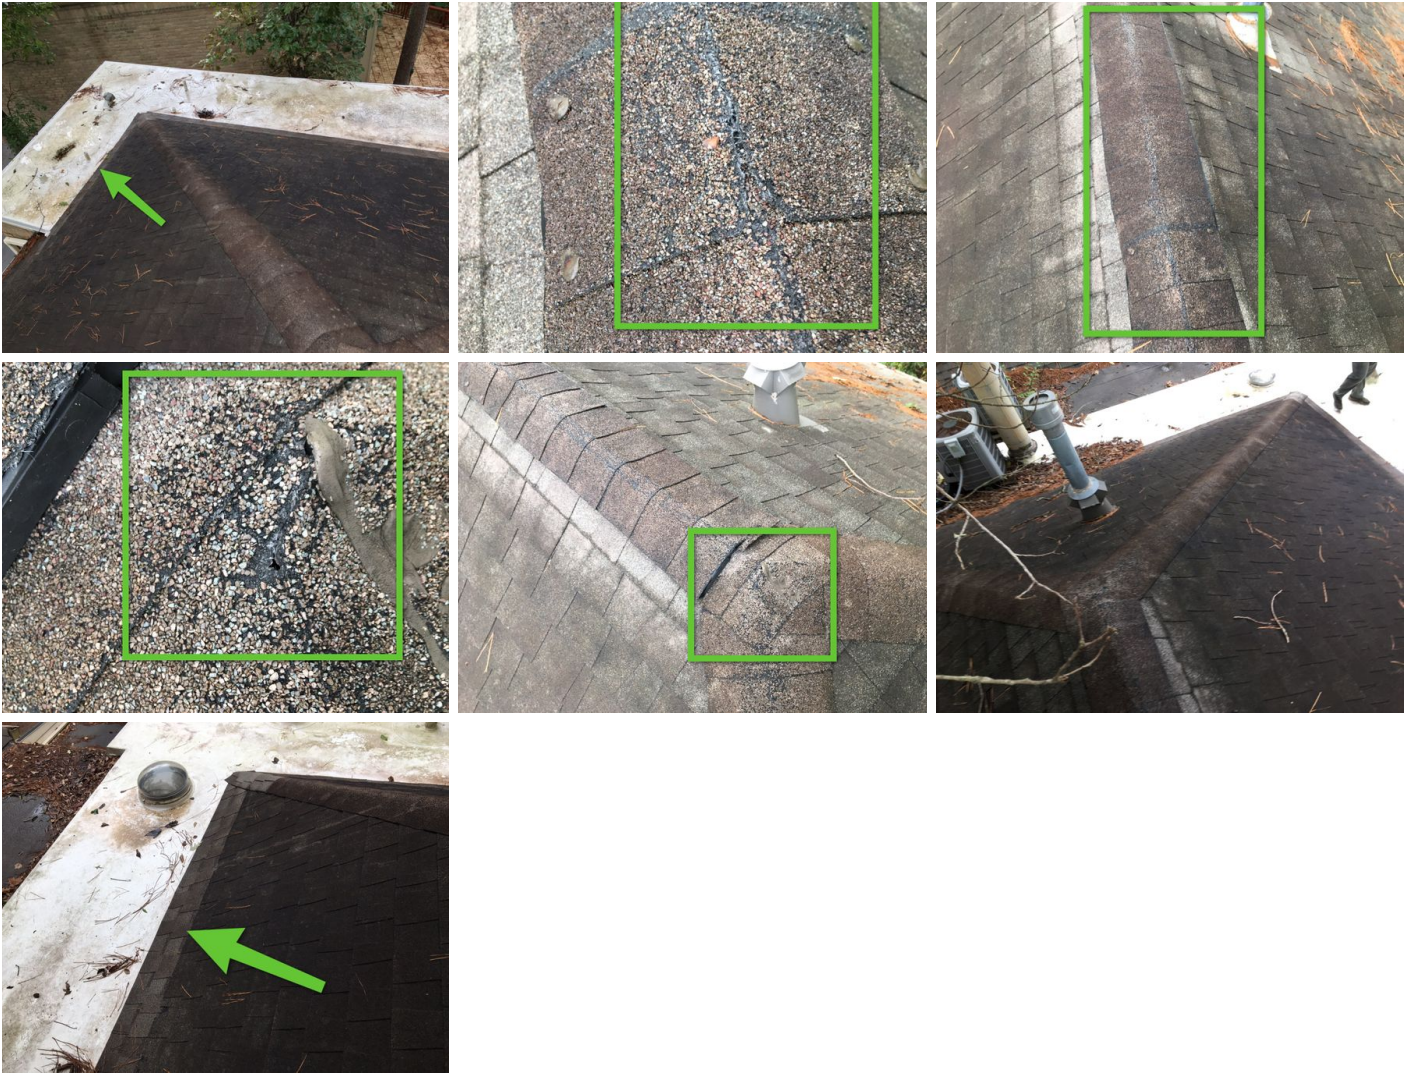
Wear and Deterioration: Composition - Some

Discolored, Aggregate Missing, Cracked, Patched

The composition roof surface was showing evidences of some deterioration of the roof surface as described above and shown below.

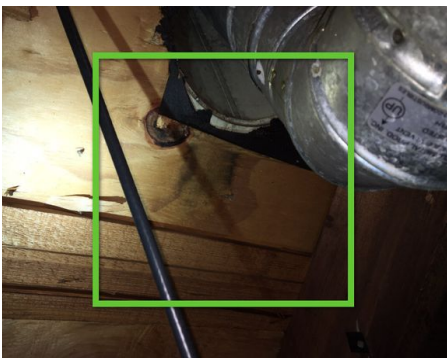
Furnace flue pipe

Roof Leaks: Stains appear to be from previous leaks

After observing the interior of the structure, evidences of current roof leaks were not visible. The absence of evidences of roof leaks does not guarantee that roof leaks were not present; rather, that no evidences of leaking were visible at the time of the inspection. Some stains were visible, but the stains appeared to be related to previous roof leaks. It is recommended that you check with the owner and/or a service company concerning the stains.

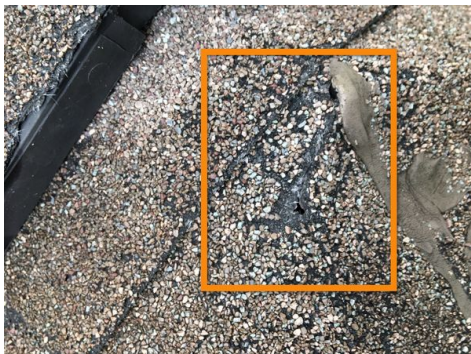
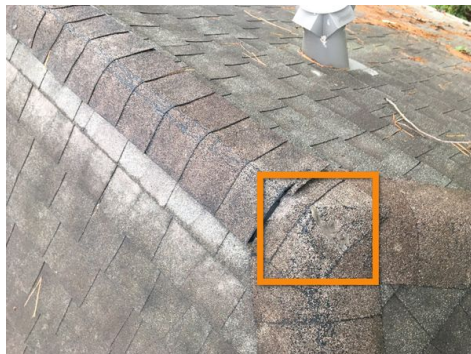
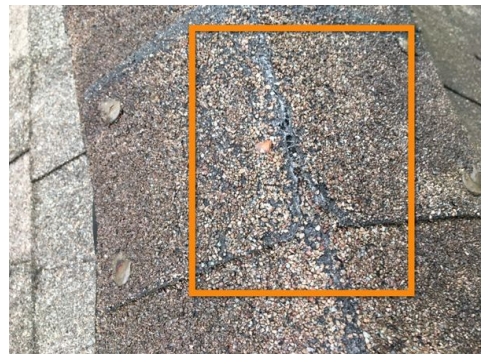
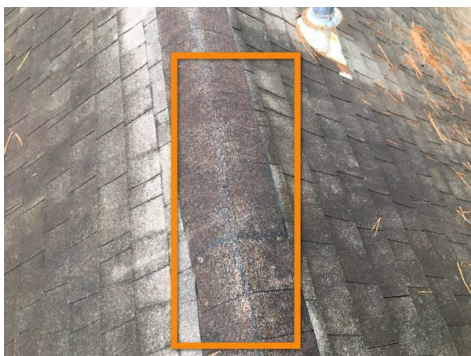
SHINGLE DAMAGE

Some of the shingles were observed to be damaged and the roof is in need of repair. Contact a roofing contractor to obtain a cost estimate for repairs.

Contact a qualified professional.

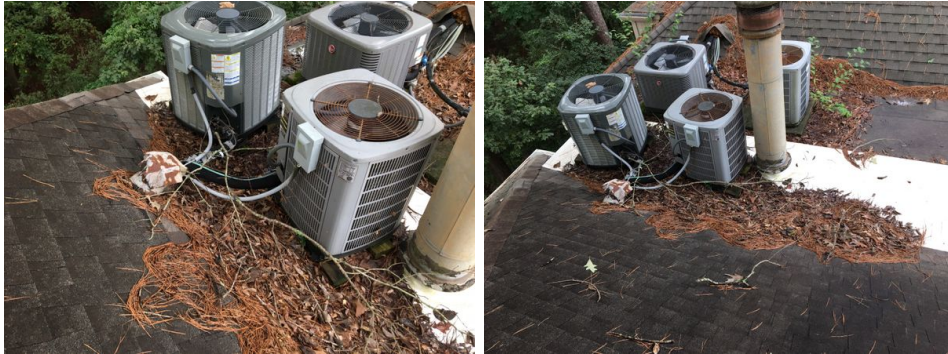
ROOF: MISCELLANEOUS

We observed some miscellaneous items related to the surface of the roof, including the items listed above. Have a roofing contractor provide a cost estimate to make any needed repairs.

Contact a qualified professional.

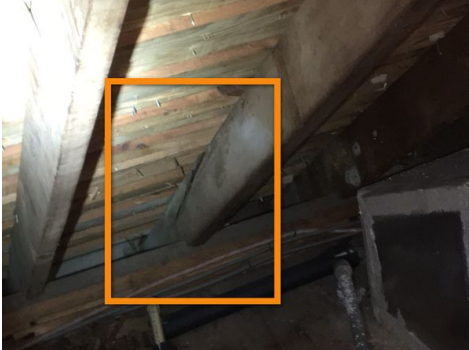
West side of the attic

One or more rafters in the attic were observed to be split, and need to be repaired.

Contact a qualified professional.

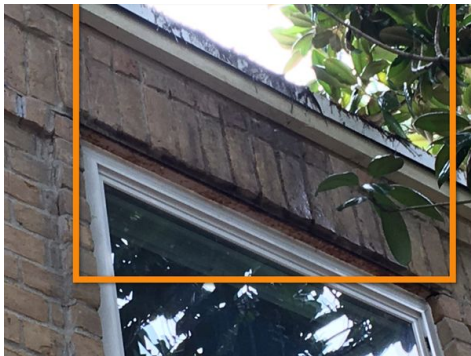
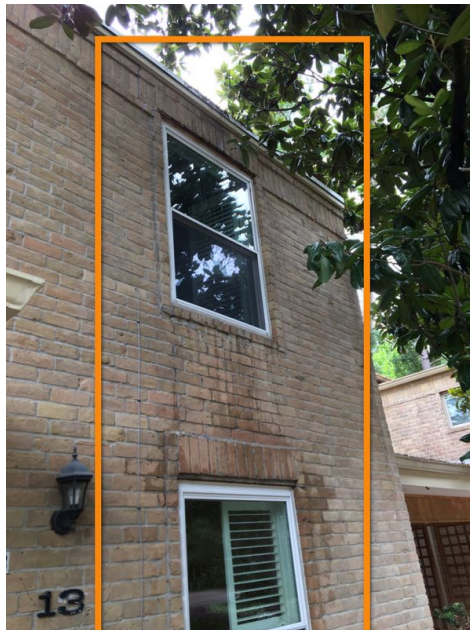
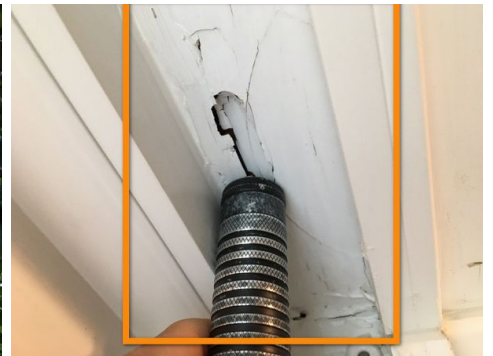
MOISTURE METER - HIGH READING

Evidences of water penetration to the interior of the structure were observed, including the following conditions and locations shown below. Further investigation is recommended with service companies to determine the source(s) of the water penetration along with any secondary damages, and also to provide a cost estimate for any needed repairs.

Our moisture meter showed a higher than normal reading around the windows. Also, water damage and water stains were observed near the windows. The source of the water penetration appears to be related to a lack of proper sealant around the windows, and cracks/gaps on the brick veneer. Also, the water from the roof runs over the brick walls. It is recommended to install gutters, caulk the windows, seal the cracks/gaps on the brick veneer and to repair all the secondary damages. Further investigation is recommended to determine the extent of the secondary damages.

Contact a qualified professional.

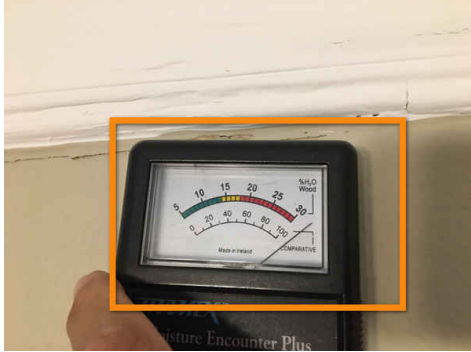
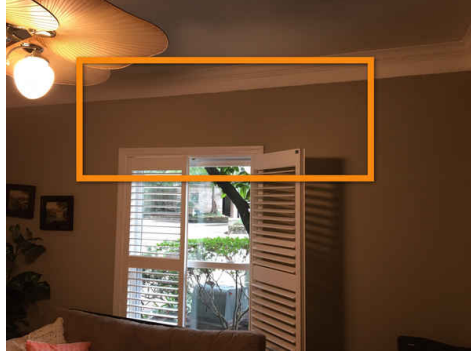
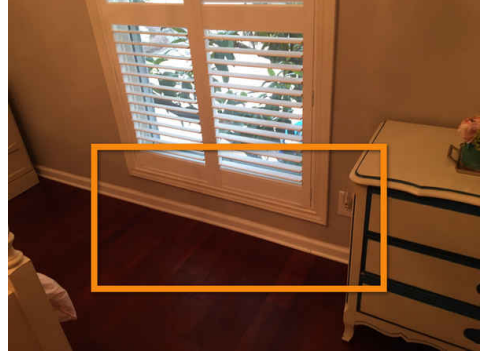
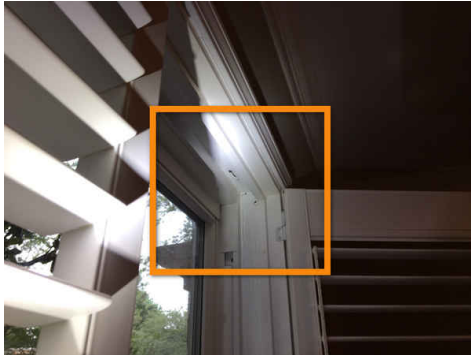
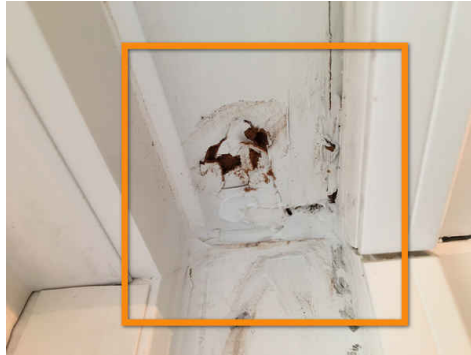
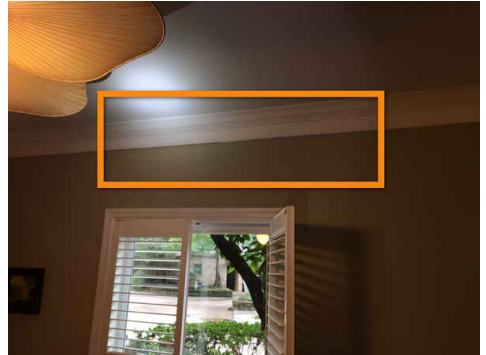
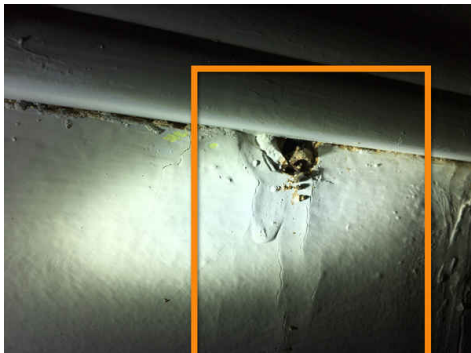
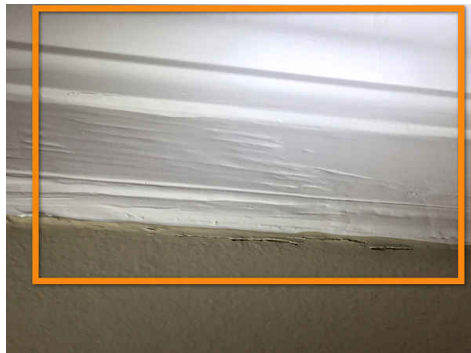
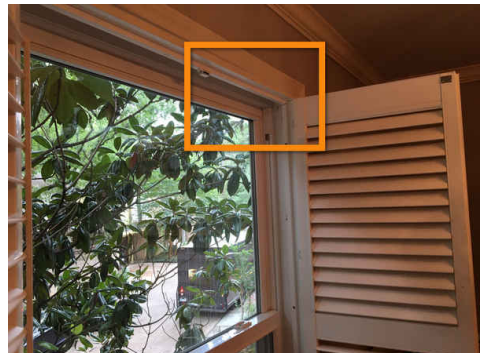
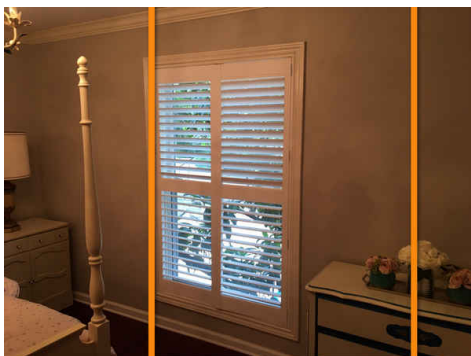
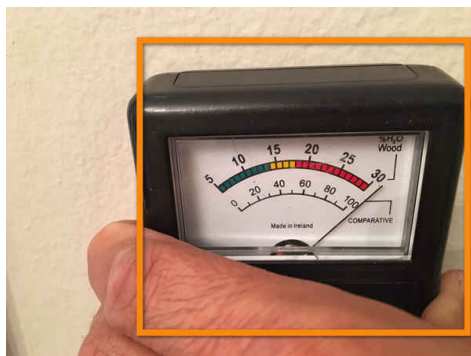
7.1.2 Water Penetration

MOISTURE METER - ADDITIONAL PHOTOS OF HIGH READINGS

Contact a qualified professional.

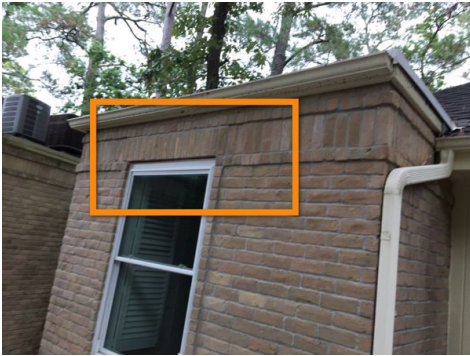
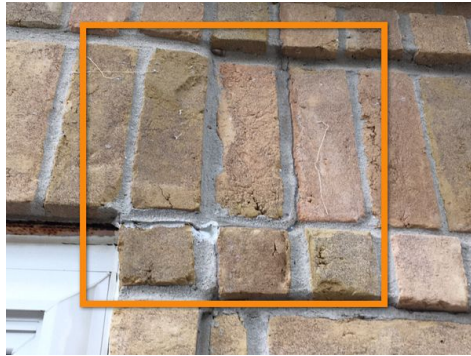
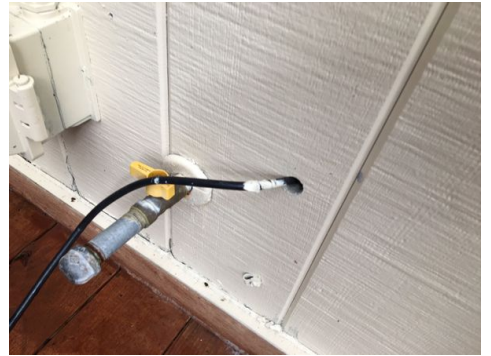
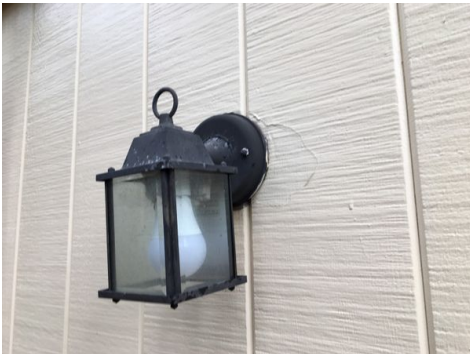
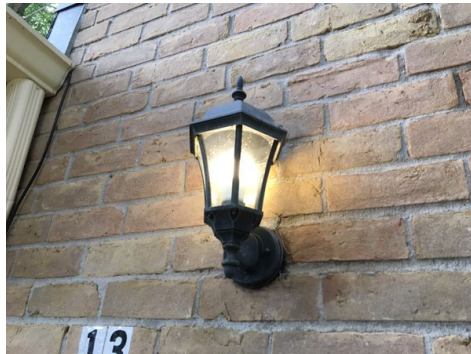
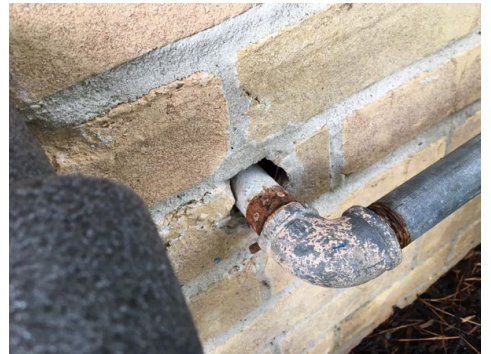
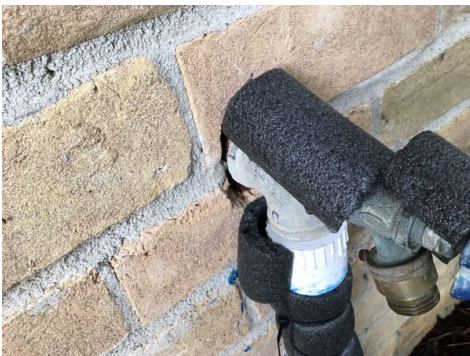
7.1.3 Water Penetration

VULNERABILITY TO WATER PENETRATION

Sealants deteriorated/missing, Window sealants, Light Fixtures, Hose Bibb, Piping, Wires, Cracks/separations on the brick veneer

A substantial vulnerability to water penetration was observed at penetrations/openings through the exterior building envelope, and it is recommended that all penetrations/openings be sealed against water penetration. Typical examples on a structure may include light fixtures, air conditioning refrigerant lines, water piping, gas piping, vent caps, windows, doors, expansion joints, etc. Below is a representative sample of locations and/or photographs showing some, but not necessarily all, locations where there is a vulnerability to water penetration. Have a contractor provide a cost estimate to seal all vulnerable areas on the exterior building envelope against water penetration and/or open up any clogged weepholes in the veneer.

Contact a qualified professional.

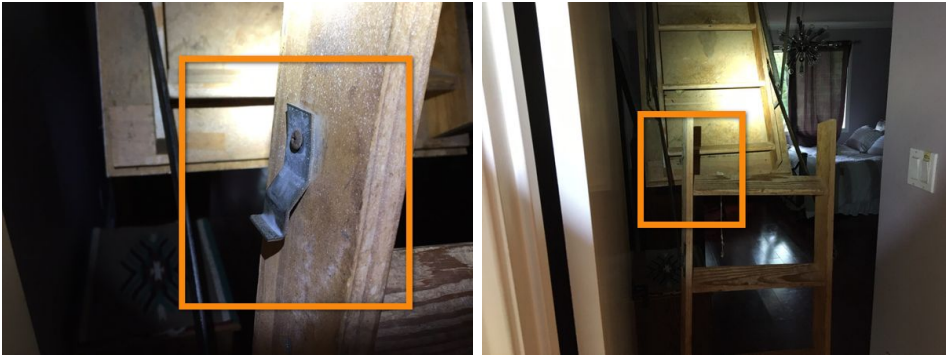
LADDER ATTACHMENT IMPROPER

Hardware loose

The stair assembly was not properly installed or secured to the framing members, and repair is needed for safety purposes. The condition(s) can be a safety hazard, and repair is needed, as an improperly installed stair assembly can possibly collapse.

Contact a qualified professional.

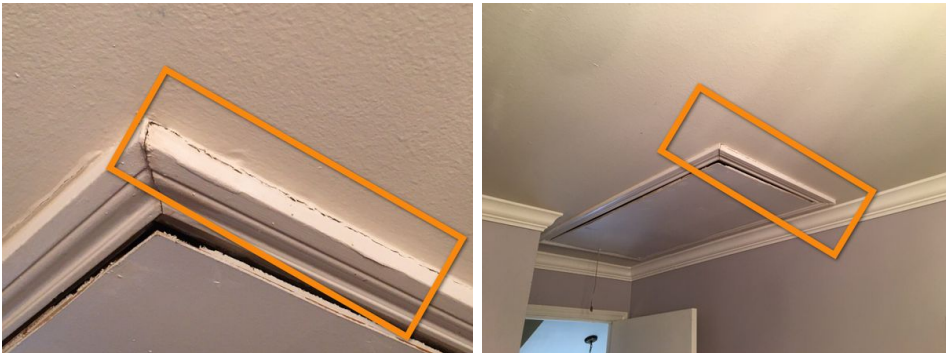
9.1.2 Ladder

LOOSE TRIM

Some of the trim around the ladder opening was loose and needs to be secured/sealed.

Contact a qualified professional.

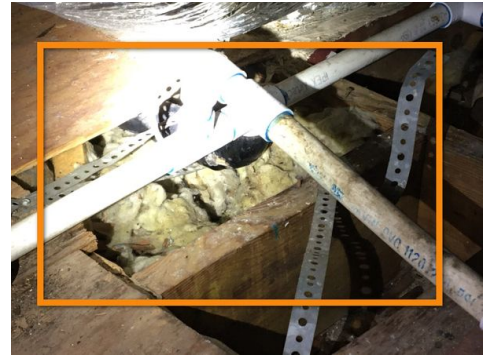
9.4.1 Insulation

THIN 3-5 INCHES

The insulation in the attic was thin by today's standards. This attic appeared to have approximately 3-5 inches of insulation in the ceiling. It is recommended that consideration be given to installing additional insulation. Current construction standards for new homes have insulation that is a minimum of an R-38 rating.

Contact a qualified professional.

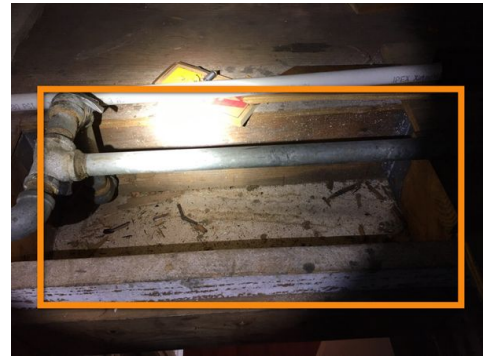
9.4.2 Insulation

INSULATION MISSING - BETWEEN JOISTS

The insulation in the attic was missing from between some of the joists. Have a service company provide a cost estimate for repairs.

Contact a qualified professional.

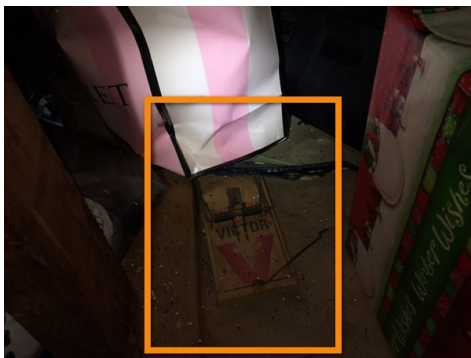
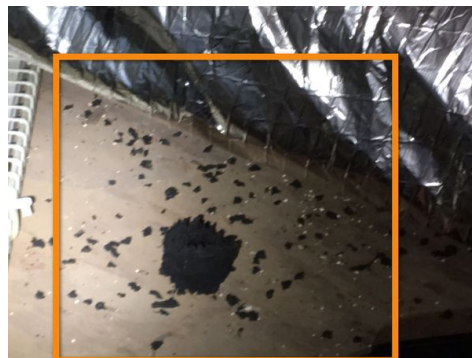
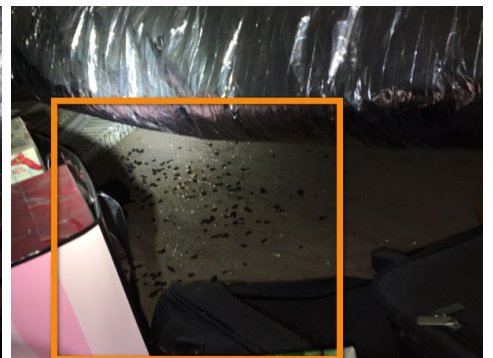
9.7.1 Miscellaneous

RODENTS

Rodent traps, Damaged piping insulation

We observed evidence of rodent infestation in the attic. Although HEI disclaims inspections for rodents and other pests, it is recommended that further investigation be done to find the source of entry of the pests into the attic, and to make all needed repairs to remove the pests, clean and sanitize the attic from any fecal/urine material and nesting materials. It is recommended that you contact a pest control company concerning this condition.

Contact a qualified professional.

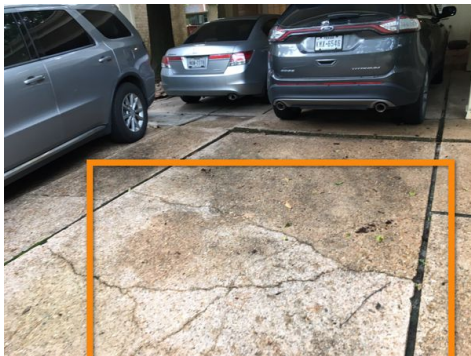
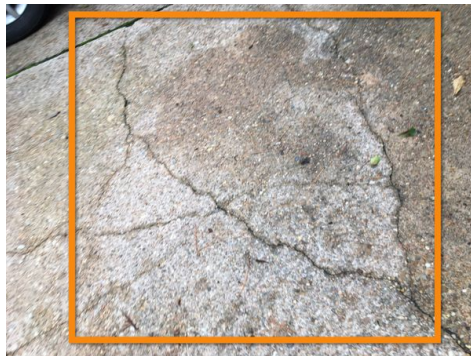
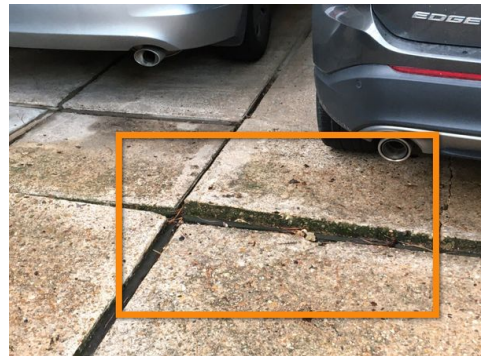
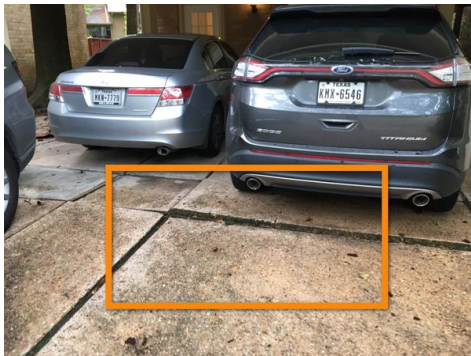
DRIVEWAY REPAIR

The driveway concrete was slightly cracked, and severely uneven and the damaged portion presents a tripping hazard. It is recommended that a contractor be contacted to provide a cost estimate to make the needed repairs.

Contact a qualified professional.

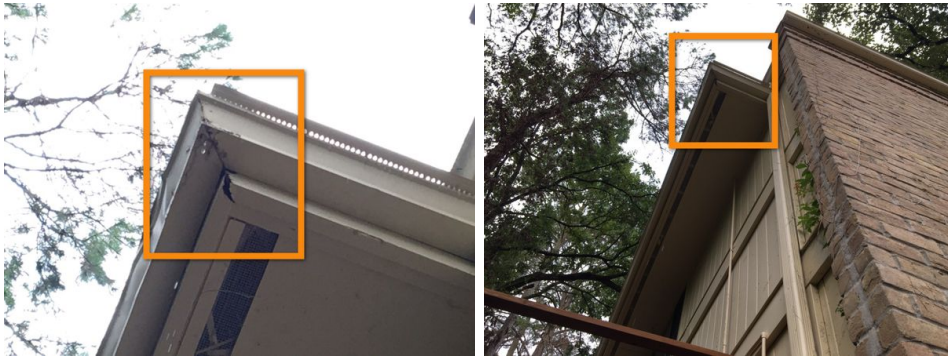
LEAKING

The gutter was leaking at the joints and needs to be sealed and made watertight.

Contact a qualified professional.

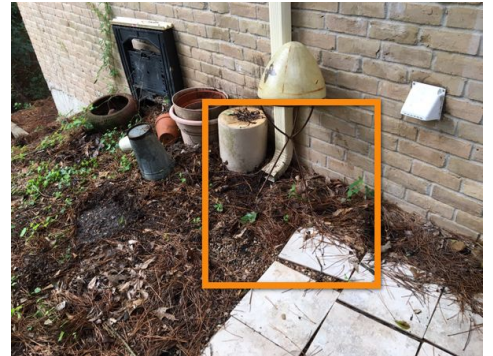
10.2.3 Gutters and Downspouts

DS SPLASH BLOCK

The downspouts were missing splash blocks.

Contact a qualified professional.

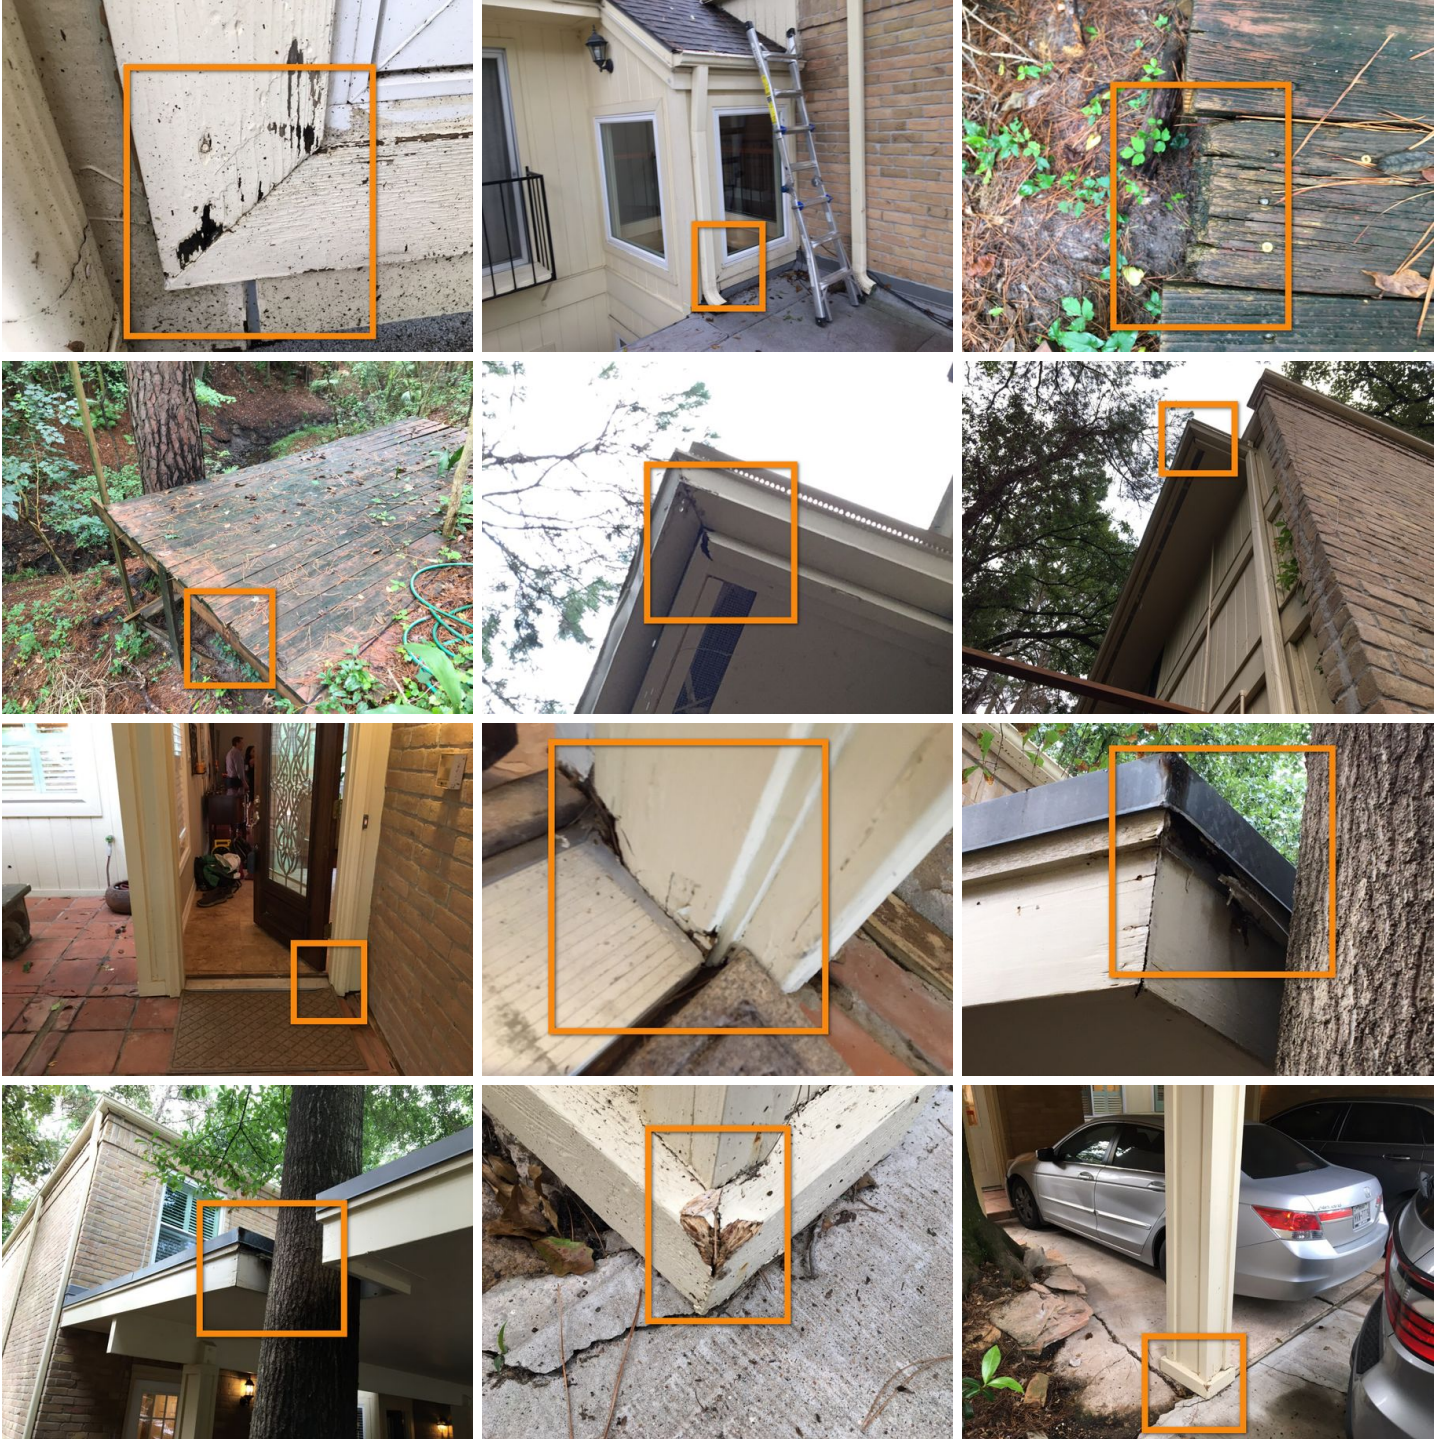
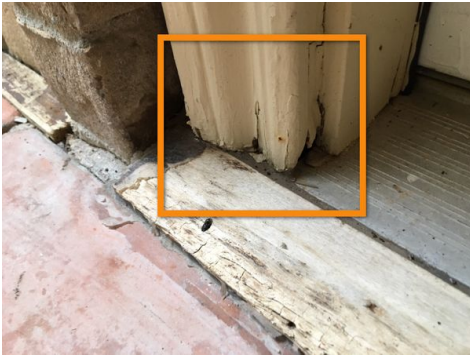
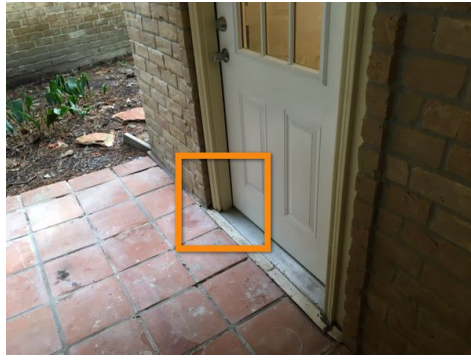
10.4.1 Wood Rot

WOOD ROT

Wood rot was observed and needs to be replaced. Have a contractor provide a cost estimate to determine the entire scope of the wood rot, and provide a cost estimate to replace all rotted wood in the house.

Contact a qualified professional.

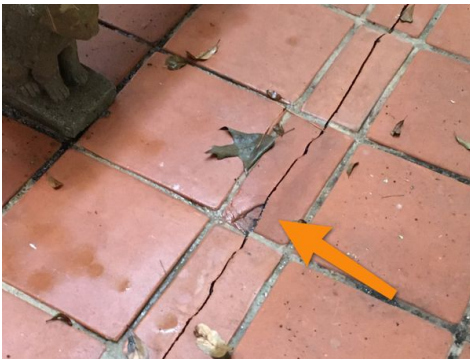
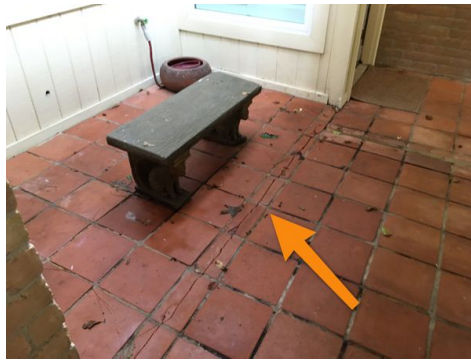
10.9.1 Miscellaneous Exteriors

FLOOR TILES CRACKED

Floor tiles were cracked and it is recommended they be replaced.

Contact a qualified professional.

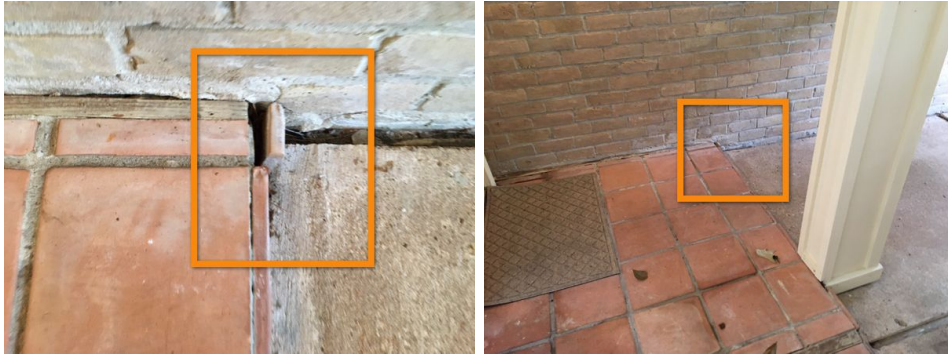
10.9.2 Miscellaneous Exteriors

LOOSE TILES

Floor tiles were loose and need to be repaired.

Contact a qualified professional.

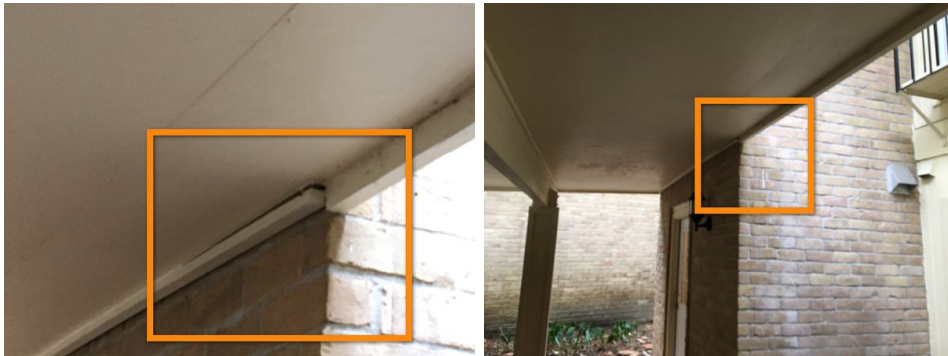
10.9.3 Miscellaneous Exteriors

SOFFIT LOOSE/DAMAGED

A piece of trim was loose and needs to be repaired. Have a service company provide a cost estimate for repairs at the above locations.

Contact a qualified professional.

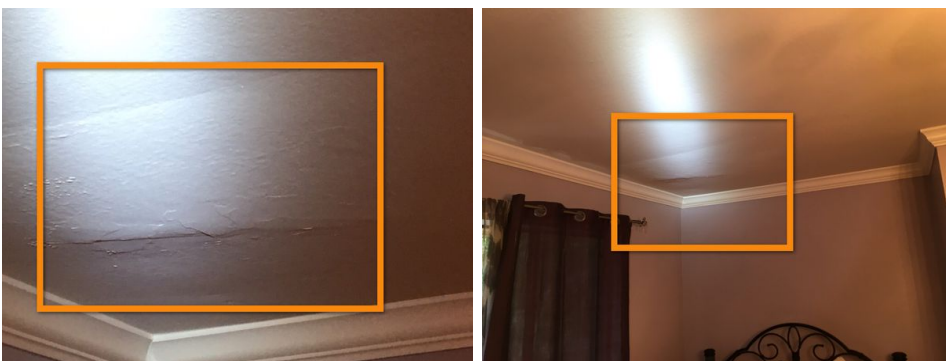
11.4.1 Sheetrock

PATCHES, FURTHER INVESTIGATION

Contact a qualified professional.

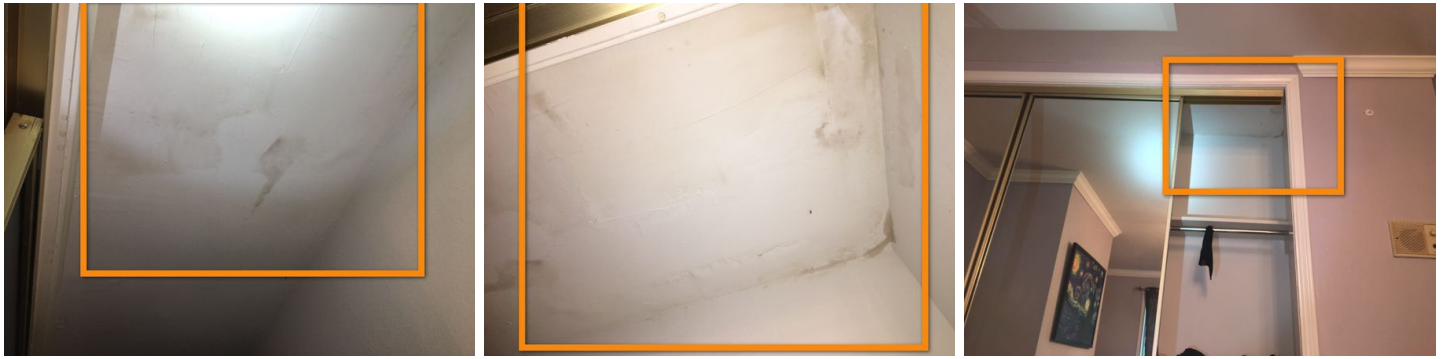
11.4.2 Sheetrock

WATER STAINS UNDER ATTIC HVAC EQUIPMENT

Contact a qualified professional.

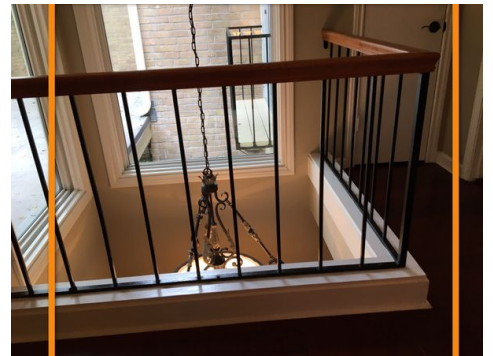
11.7.1 Stairs/Handrails/Guardrails

HANDRAIL BALUSTERS > 4"

The handrail was not constructed according to the current building code standards (obviously, given the age of the house). Therefore, the width between the balusters is greater than four inches. If this condition is of a concern to you, then further investigation with a contractor is recommended.

Obtain Cost Estimate
