MECHANICAL INSPECTION

201 Vanderpool Ln #13
Houston TX 77024

PROPERTY INSPECTION REPORT

Concerning: 201 Vanderpool Ln #13, Houston TX 77024
(Address or Other Identification of Inspected Property)

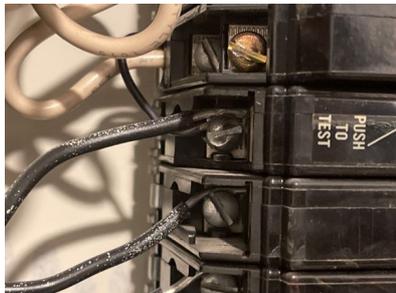
6: Panel - Acoustical material

Foreign matter was observed in the panel box, which can be a safety hazard. The interior of the panel was covered with sprayed on acoustical material, and the breaker panel needs to be cleaned, or completely replaced.

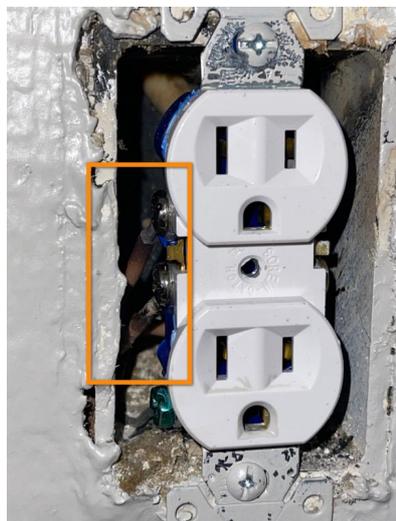
7: Outlet - Wiring Damaged/Burned

The wiring on the side of the outlet was damaged/melted/burned. This an extremely hazardous condition as aluminum wiring is know to cause electrical fires at these connections. Have a service company determine the source of the problem and make any necessary repairs.

Obtain Cost Estimate

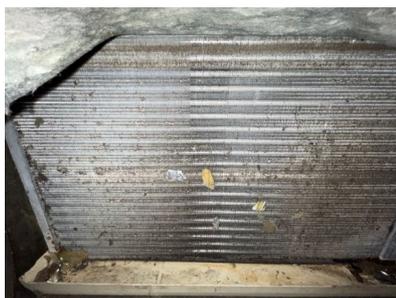
The coil was dirty and needs to be cleaned and serviced at this time. Have a service company clean the coils to allow for proper operation.

Obtain Cost Estimate

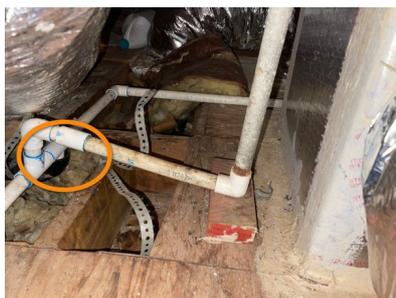
6: Primary Drain - Open/Stains Below

The primary drain line was not sealed in the attic and water stains were observed on the ceiling below in the bedroom closet. Have a service company make any necessary repairs to the drain line and any water damage.

Obtain Cost Estimate

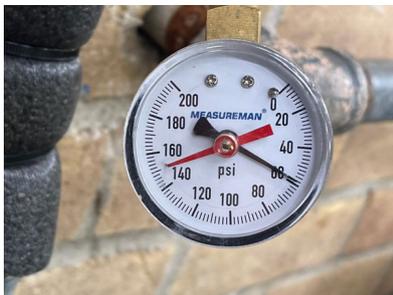
The static water pressure to the house at the time of the inspection was measured with a pressure gauge at the hose bibb nearest the shut off valve, and the static pressure was observed to be 58 psi.

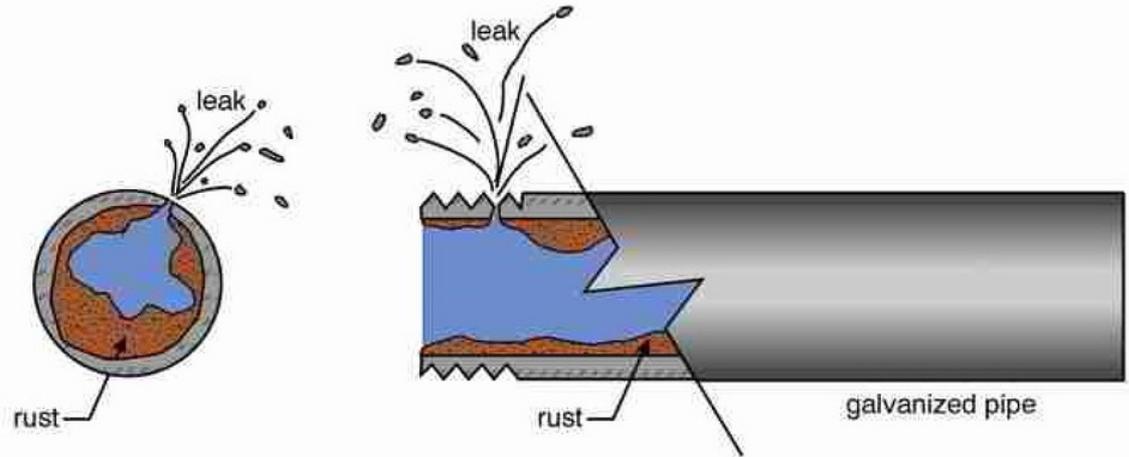
All or portions of the water piping for the property was observed to be the original galvanized piping. It is pointed out that the galvanized piping will deteriorate with time, and will corrode on the inside of the piping, thereby reducing the inside diameter of the pipe, and restricting the flow of the water through the pipe. In addition, the piping will corrode through to the outside of the pipe and will eventually deteriorate to where the pipe will start leaking. It can be anticipated that the galvanized water piping

throughout the house will need to be replaced when it is causing reduced water pressure or is corroded enough to start leaking.

rusting of galvanized pipe can greatly reduce water pressure and will eventually cause leaks as rust creates holes in the pipe walls

problems are likely to occur soonest on pipes carrying hot water, horizontal pipes and at threaded (thinner) sections

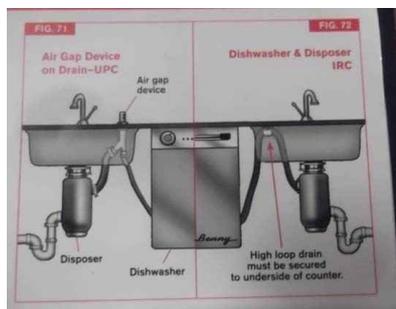
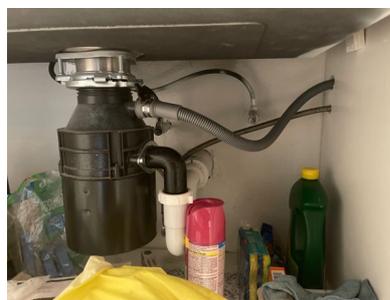
The drain line under the sink was not equipped with an anti-siphon device, nor was it looped up so that the top of the loop is at least six inches above the entrance of the drain line into the disposal. It is recommended at least that the drain line be looped to prevent the water from the garbage disposal from siphoning back into the dishwasher, or an anti-siphon device installed.

Obtain Cost Estimate
