## PROPERTY INSPECTION REPORT

**Prepared For:** Jody Norris  
(Name of Client)

**Concerning:** 6018 Bridgeside Lane, Missouri City, TX 77459  
(Address or Other Identification of Inspected Property)

**By:** Jim Messina, Lic #TREC #288 TPCL # 13562 04/04/2017  
(Name and License Number of Inspector) (Date)

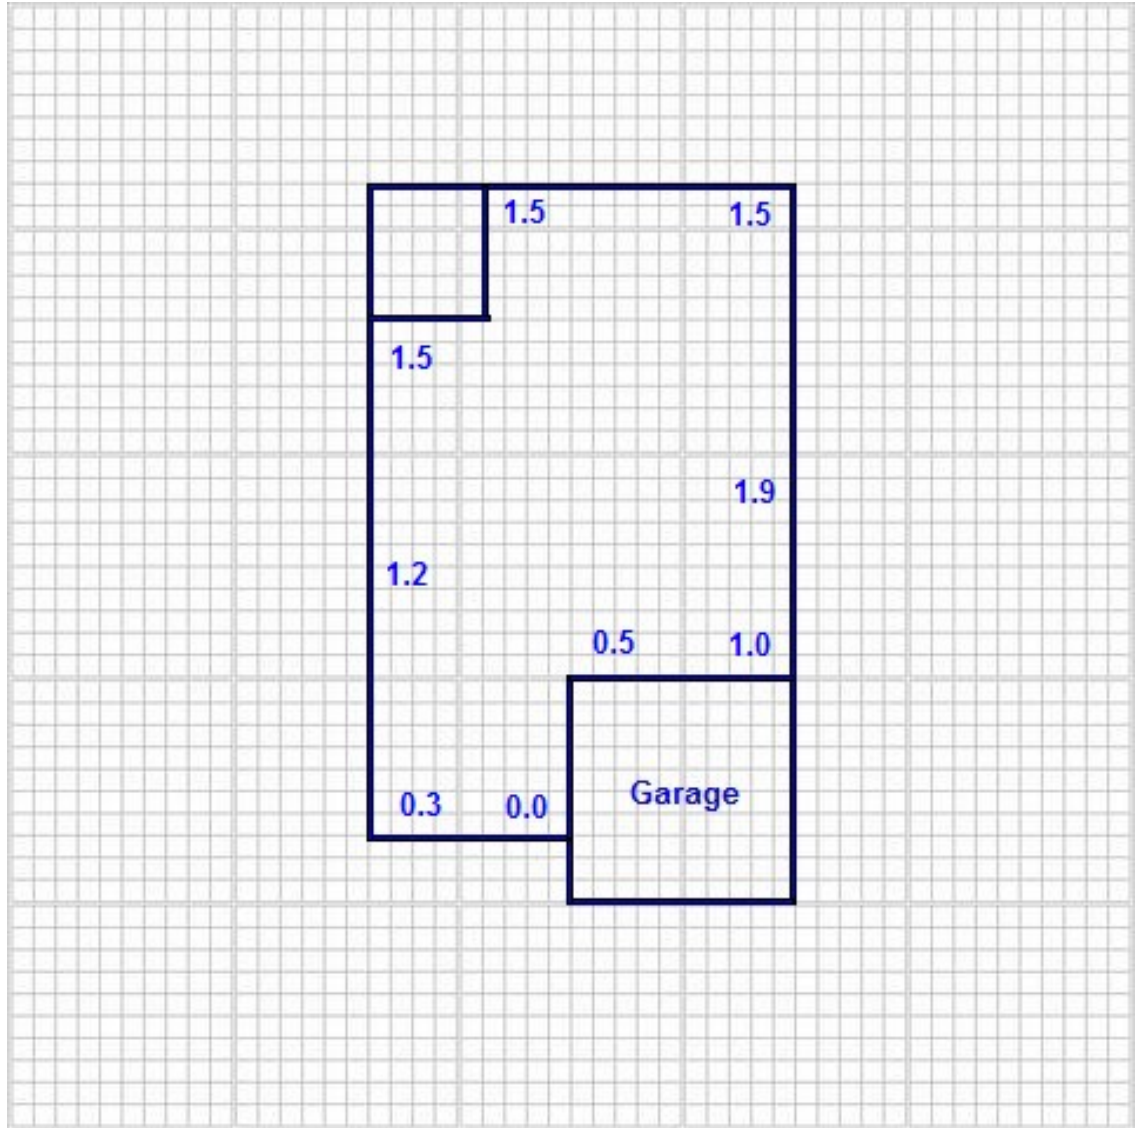
**Foundation Elevations Readings**

Foundation slopes approx 1.5" from high elevations along rear wall to low elevations at front wall

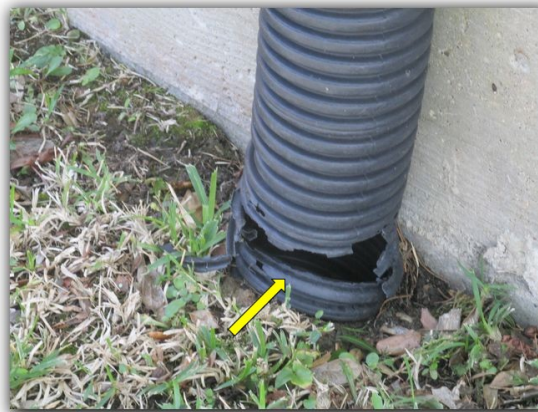
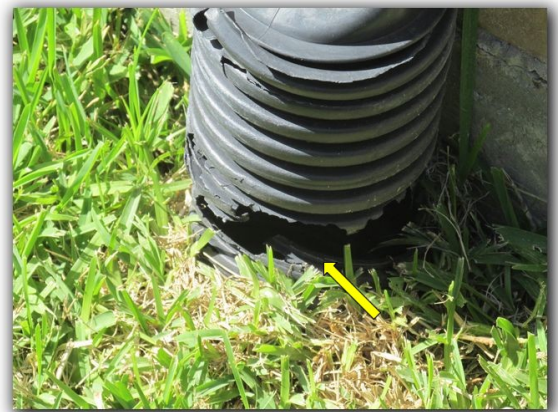
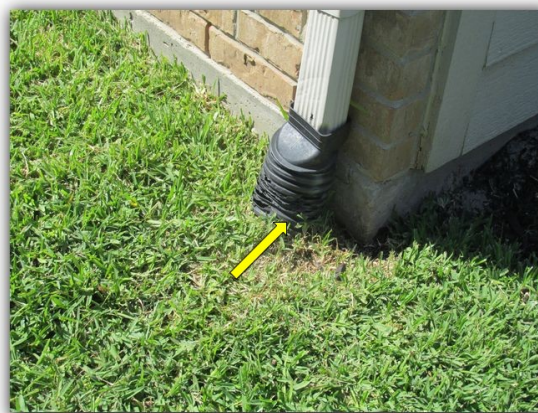
Damaged downspouts were observed at front corner, and rear corner

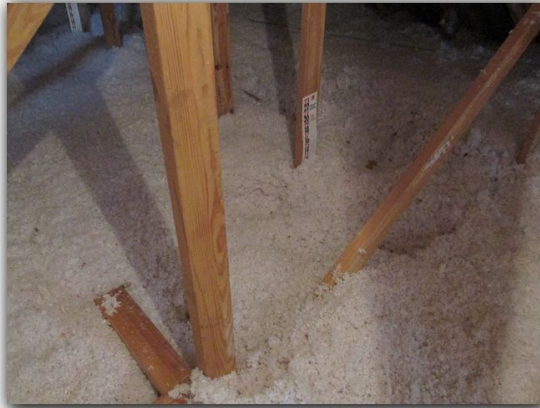
Attic insulation appears to be adequate, good condition, and performing as intended

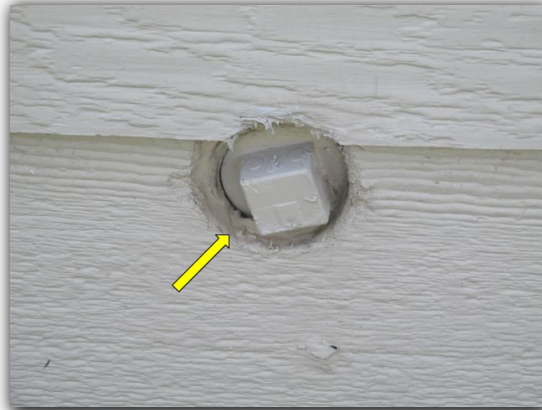
- Piping not sealed at exterior wall penetration

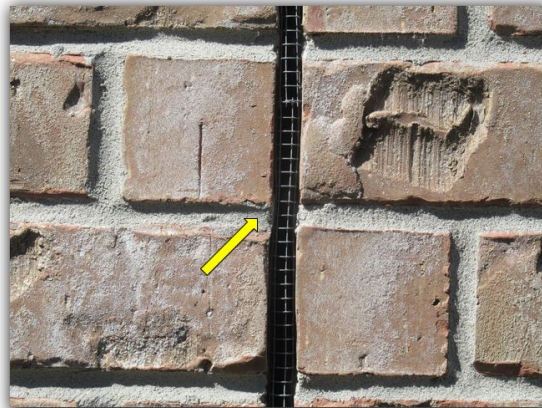
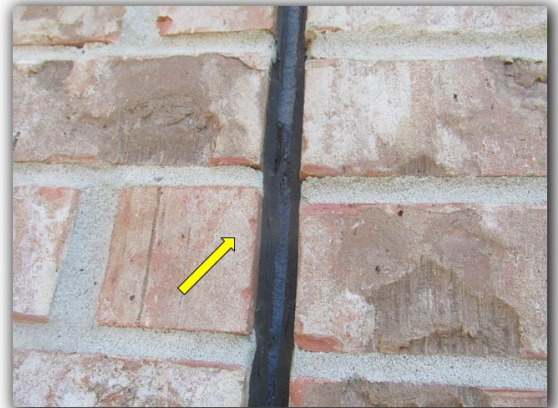
- Brick expansion joints not sealed at north + south walls

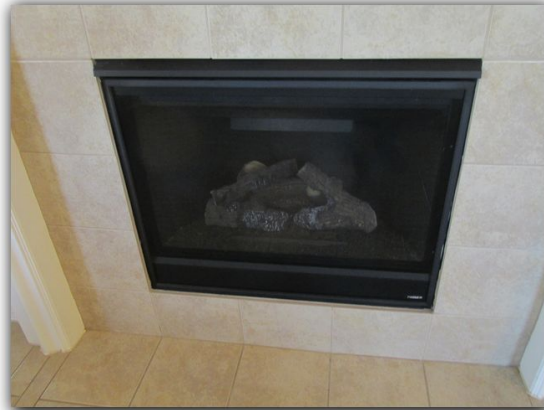
- Unit not tested - Further evaluation recommended
- Gas fireplace does not come on - Further evaluation recommended

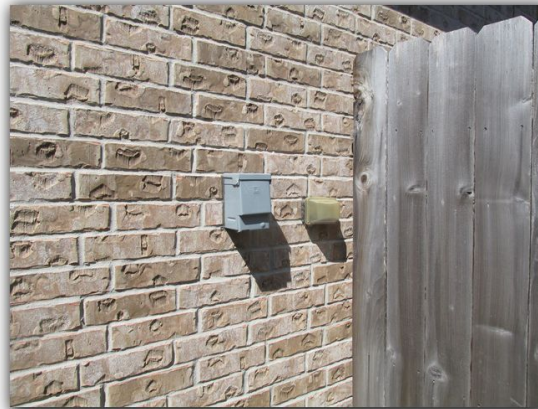
No electric disconnect within sight of unit - Wrong side of fence

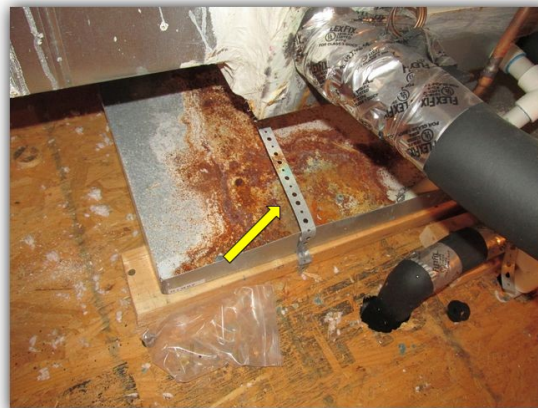
Lack of GFCI near unit for technician

Secondary drain pan is rusted

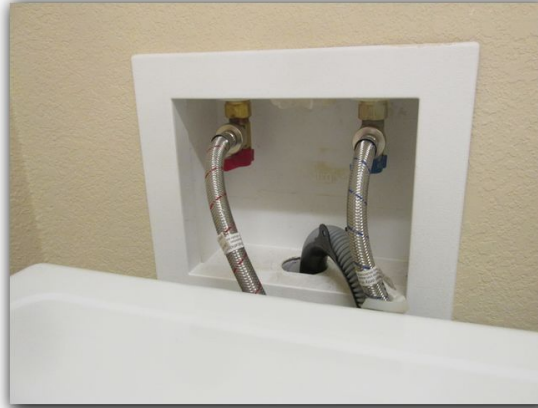
Washing machine were connected - leakage not inspected

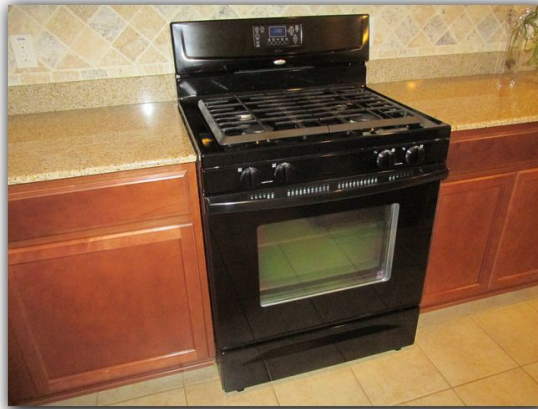
- Absence of anti-tilt device
