PROPERTY INSPECTION REPORT

“AROUND THE HOUSE” HOME INSPECTIONS

Concerning: 38 Twin Valley Drive, Sugar Land, TX 77479

By: David J. Stiles Inspector Lic. #7308 8/11/2020

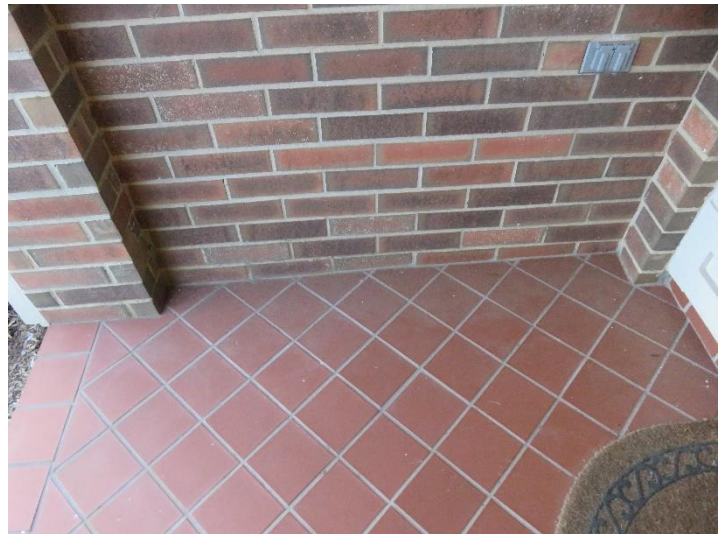
Required example and current installations

- The front porch lacks weep holes at the wall/foundation.

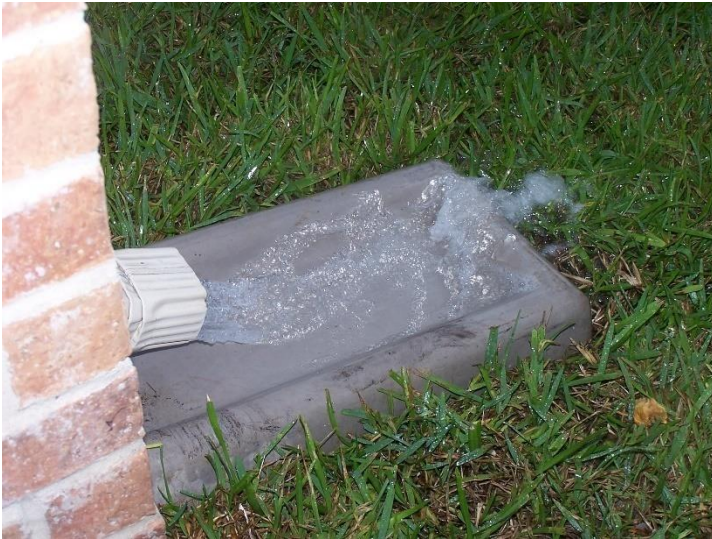
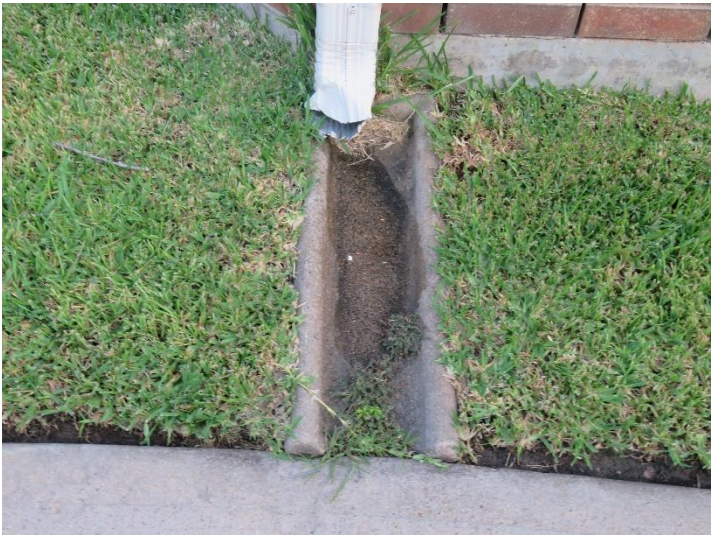
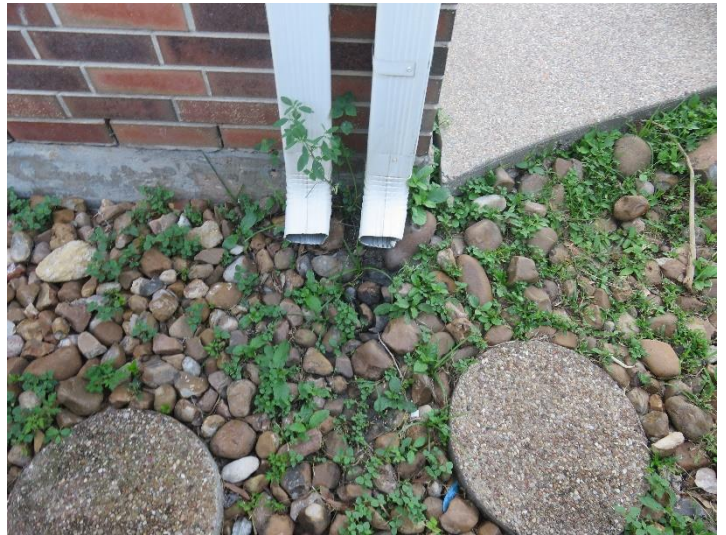
Example of a downspout splash back in action and current installation examples

- Downspout splash backs should be installed at the delivery point of each rain downspout. Splash backs should be positioned so that the high side or “block” is positioned away from the home and not against the foundation. They prevent rushing water from eroding the soil and provide an increased directional flow of water away from the home and foundation.

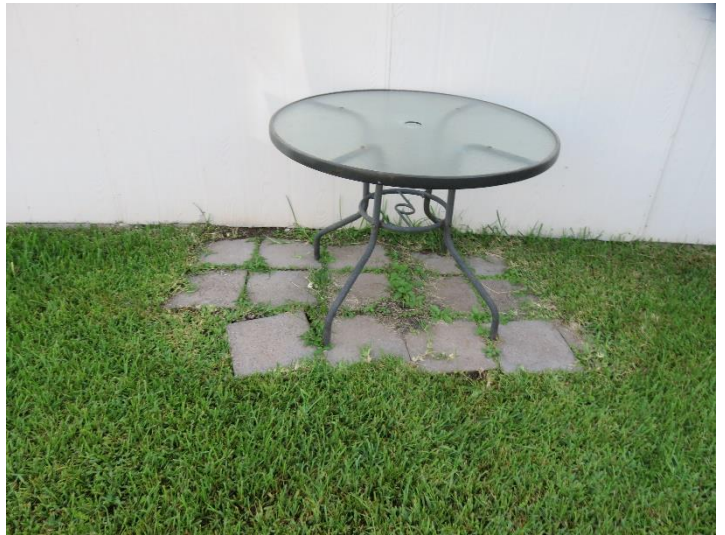
- At the rear of the garage soils are installed too high against the rear framing and wall surfaces. Dirt and moisture is penetrating into the garage.

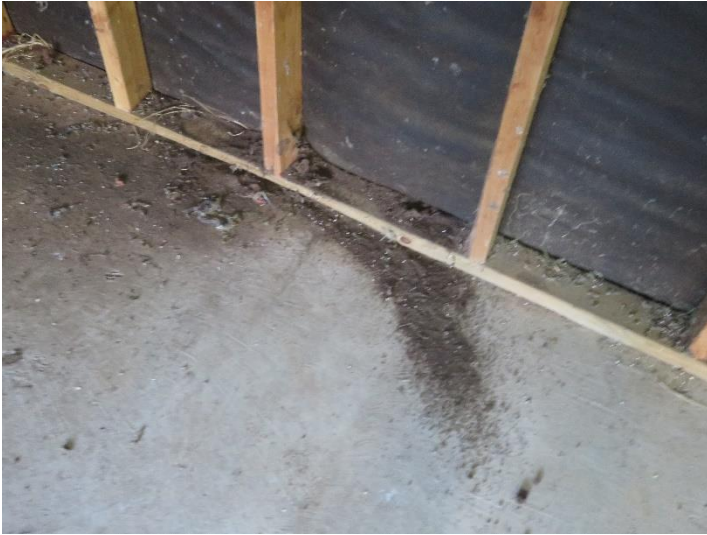
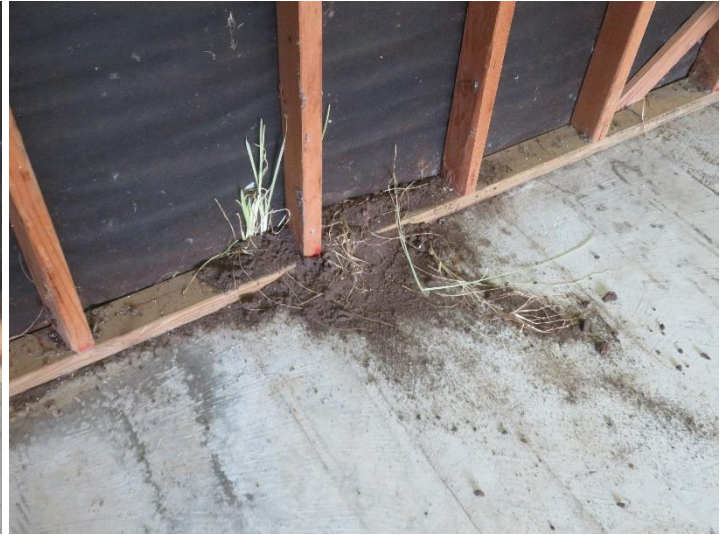
➤ Drainage at the left side of the garage requires improvement.

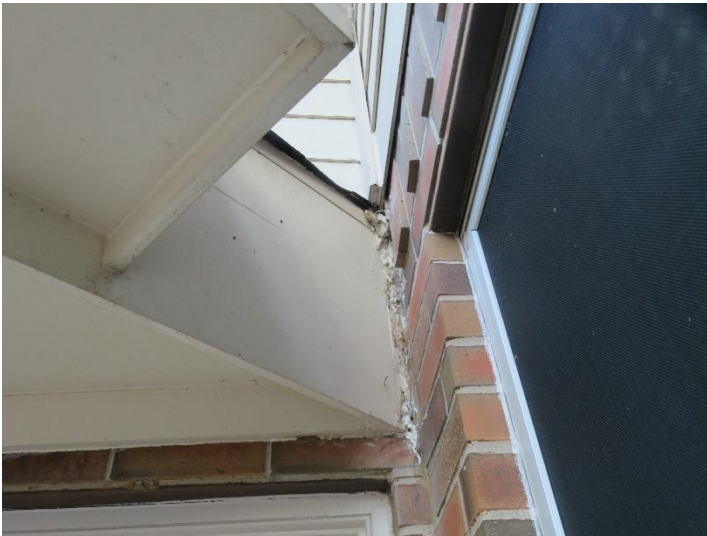
- At the rear breezeway to the right of the rear entry door water draining from the roof is posing a troublesome area. Heavy caulk has been applied to try and correct the problem.

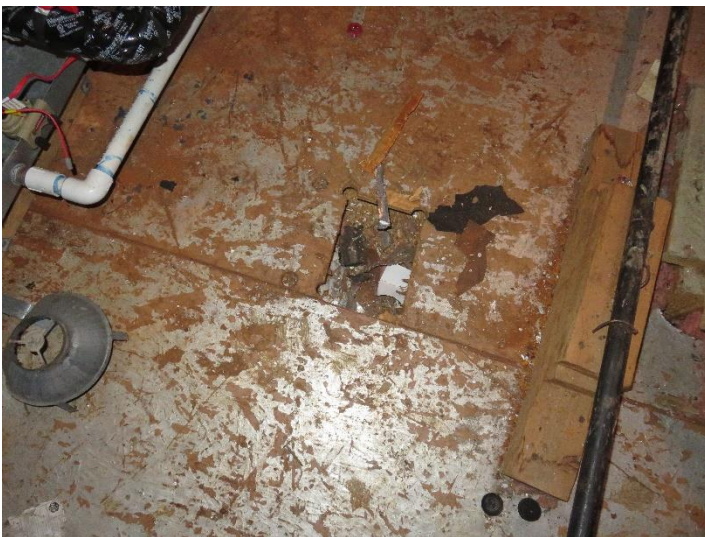
- The main attic floor displays a hole creating a safety hazard.

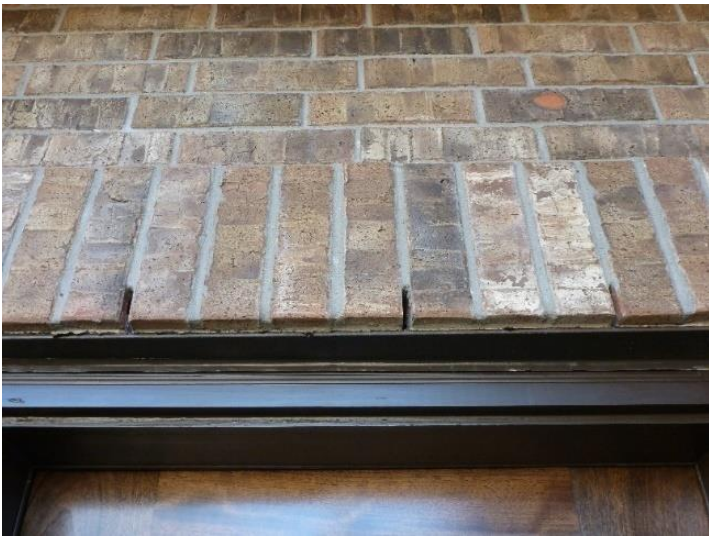
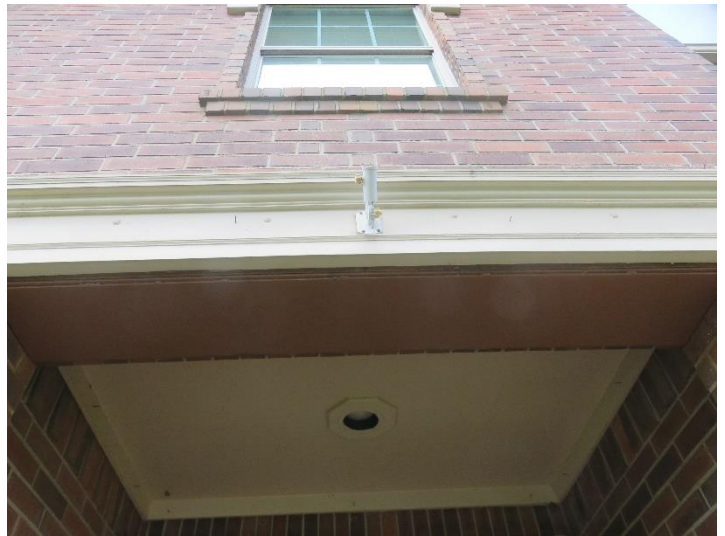
Weep hole example and current installation example at the front porch

- Walls with arches supported by steel lintels will rust if condensation/water is allowed to accumulate or penetrate behind the wall of brick. The top of the lintel should be installed with flashing between the bottom of the first row of brick and the lintel. **[IRC - 703.7.5]**.It could not be ascertained to what degree, if any, flashing is installed in this manner. Weep holes can be provided by drilling/removing a portion of the mortar between bricks at the top of the lintel. Weep holes are required to be 3/16” in width and installed in pairs above aa arch and/or at least within 33” of each other. **[IRC - 703.7.6]**. Rusting lintels should be scraped and painted with a rust preventing paint.

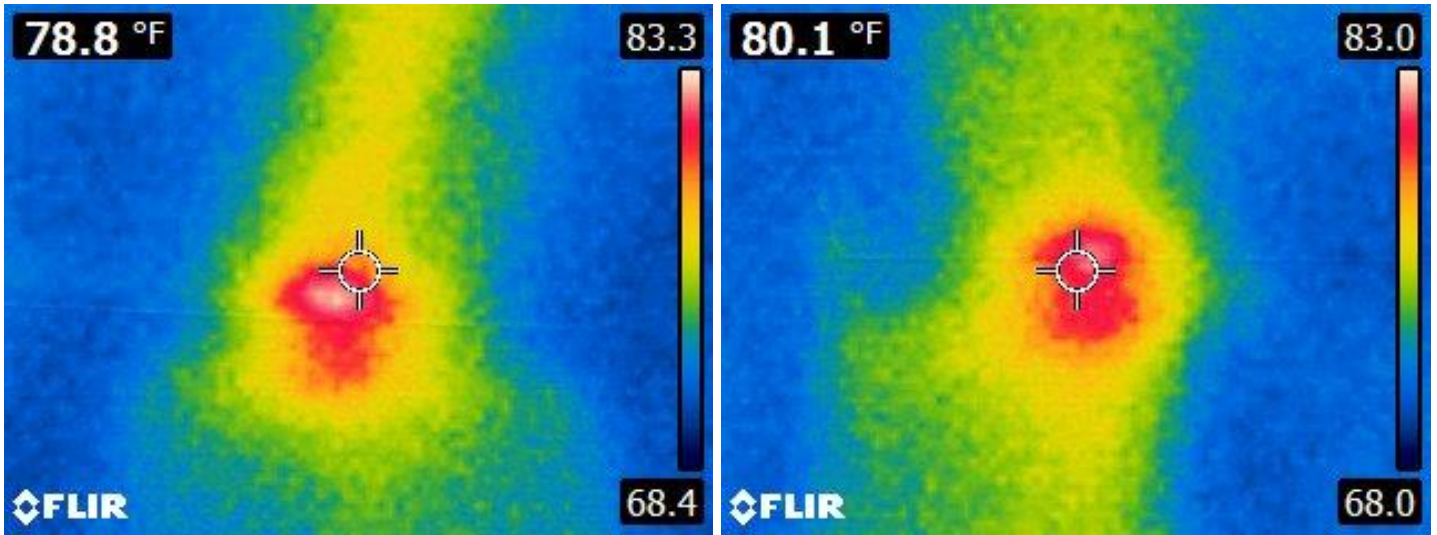
Examples in the left side 2nd floor bathroom – wall above sink and opposite wall

- Employing a thermal camera hot spot were not on the 2nd floor in the left side bathroom, left rear game room extension and front left bedroom. Possible attic insulation is deficient.

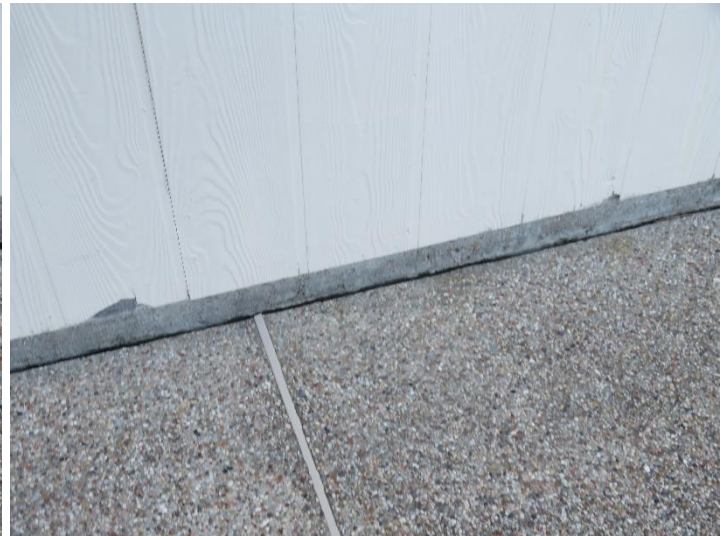
Examples

- Siding at the garage displays damage.

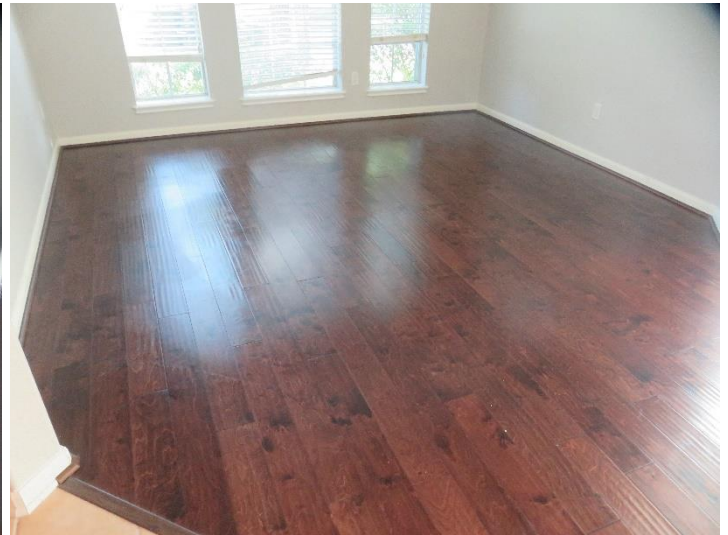
- The ceiling between the kitchen and 1st floor family room displays a ridge.
- Wood flooring in the front left and center 1st floor rooms creak under foot.

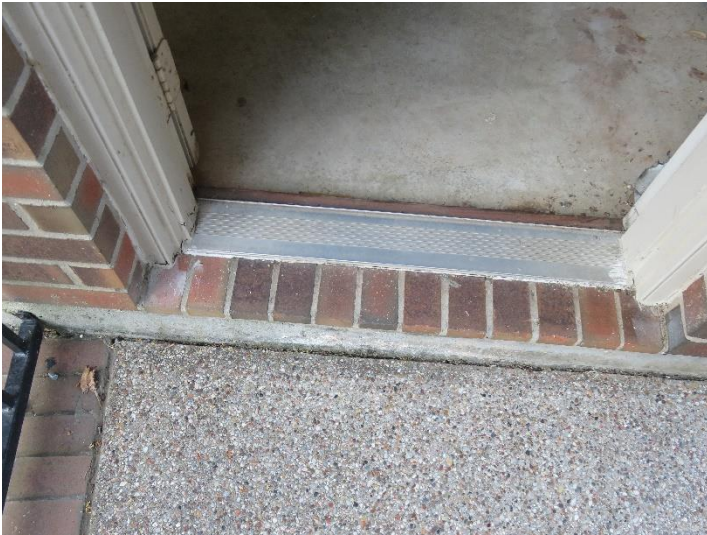
- The garage door/trim displays deterioration.

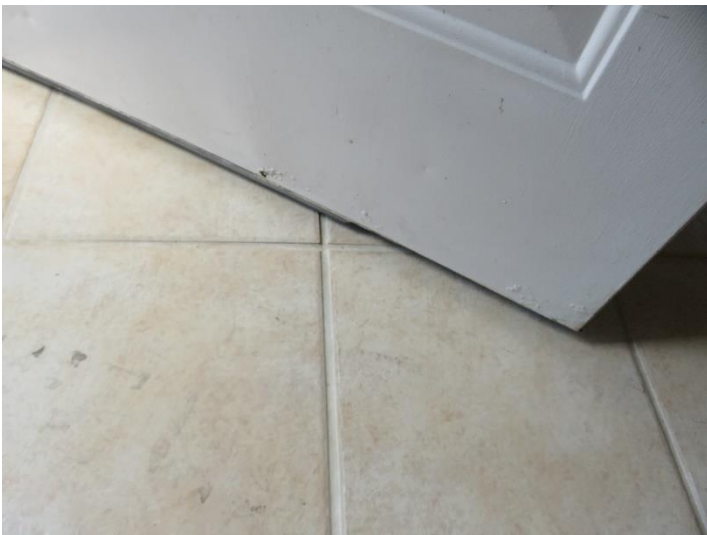
- The rear kitchen/house exit door displays rust.

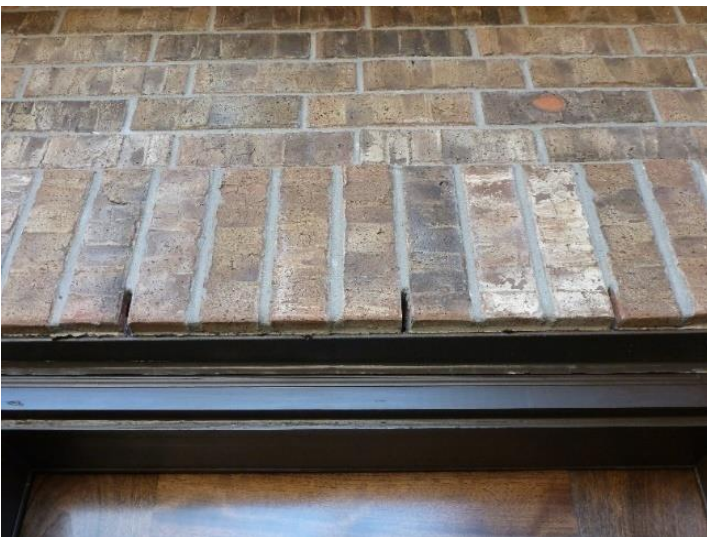
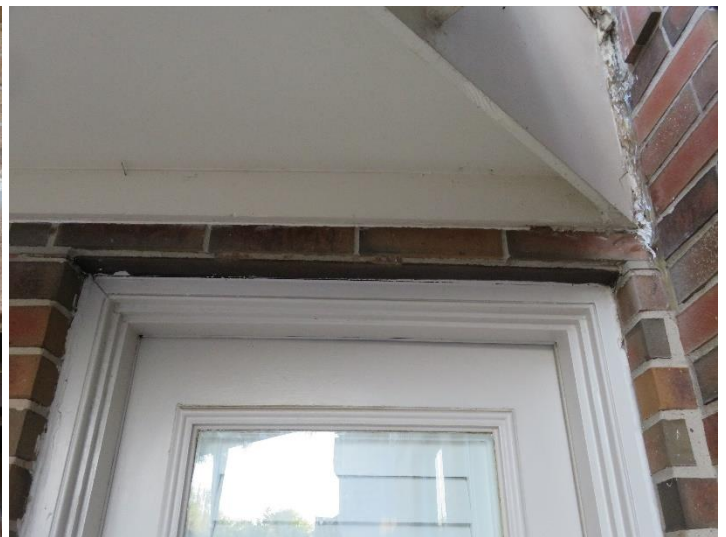
Weep hole example and current installation example at the front porch

- Doors with brick walls supported by steel lintels will rust if condensation/water is allowed to accumulate or penetrate behind the wall of brick. The top of the lintel should be installed with flashing between the bottom of the first row of brick and the lintel. [IRC - 703.7.5]. It could not be ascertained to what degree, if any, flashing is installed in this manner. Weep holes can be provided by drilling/removing a portion of the mortar between bricks at the top of the lintel. Weep holes are required to be 3/16" in width and installed in pairs above a door and/or at least within 33" of each other. [IRC - 703.7.6]. Already rusting lintels should be scraped and painted with a rust preventing paint.

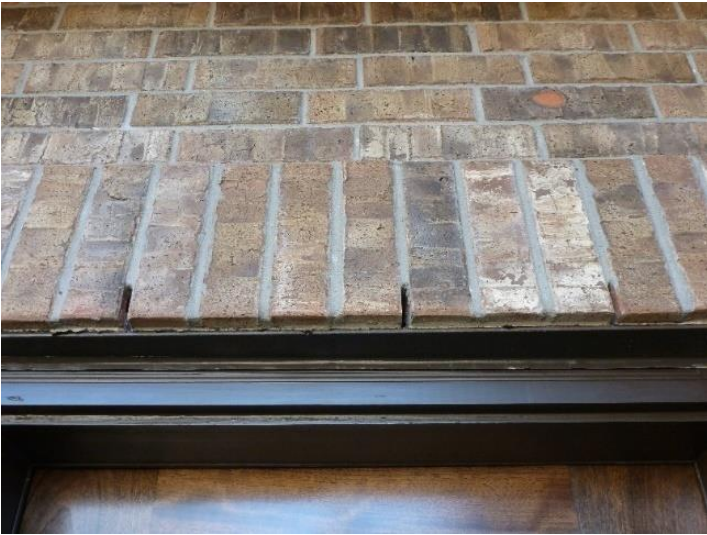
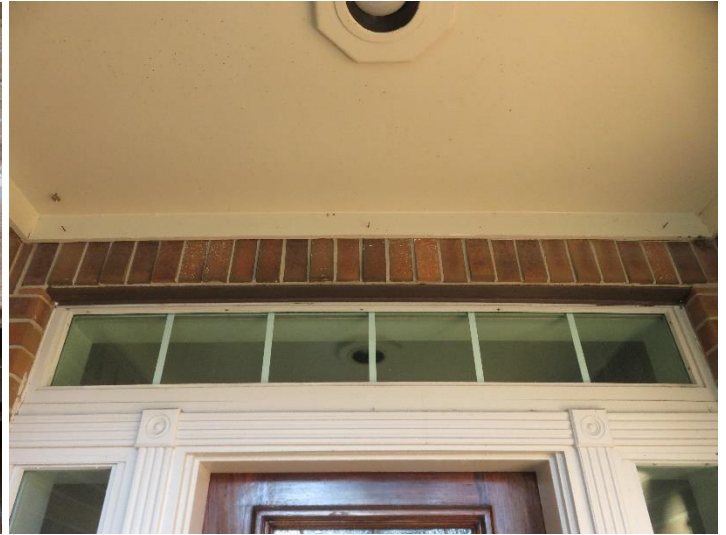
Weep hole example and current installation examples

- Windows with brick walls supported by steel lintels will rust if condensation/water is allowed to accumulate or penetrate behind the wall of brick. The top of the lintel should be installed with flashing between the bottom of the first row of brick and the lintel. [IRC - 703.7.5]. It could not be ascertained to what degree, if any, flashing is installed in this manner. Weep holes can be provided by drilling/removing a portion of the mortar between bricks at the top of the lintel. Weep holes are required to be 3/16" in width and installed in pairs above a window and/or at least within 33" of each other. [IRC - 703.7.6]. Already rusting lintels should be scraped and painted with a rust preventing paint.

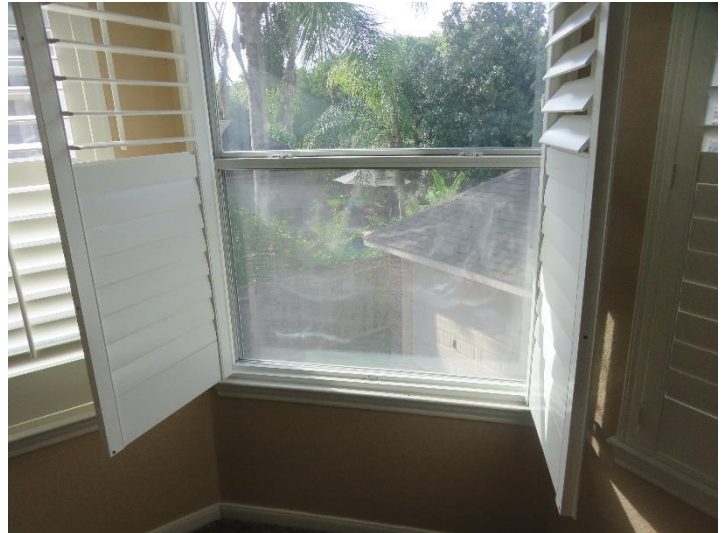
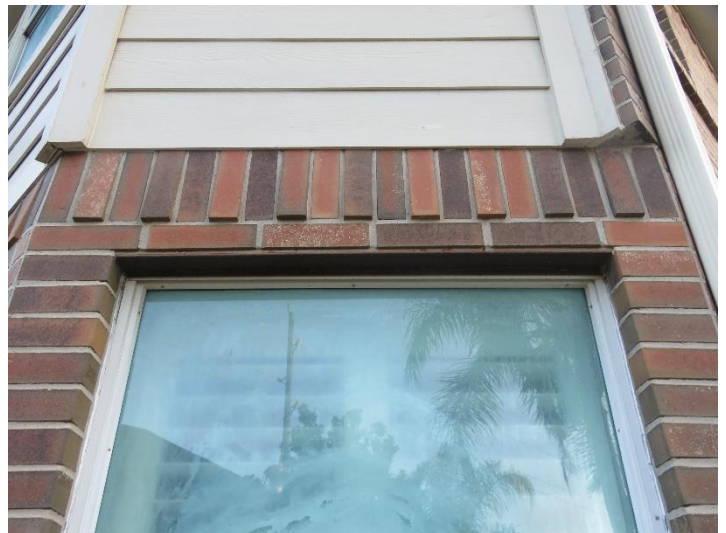
Examples

- Several windows in the home displayed broken insulating seals and condensate that has formed/stained the area of glass between window panes.

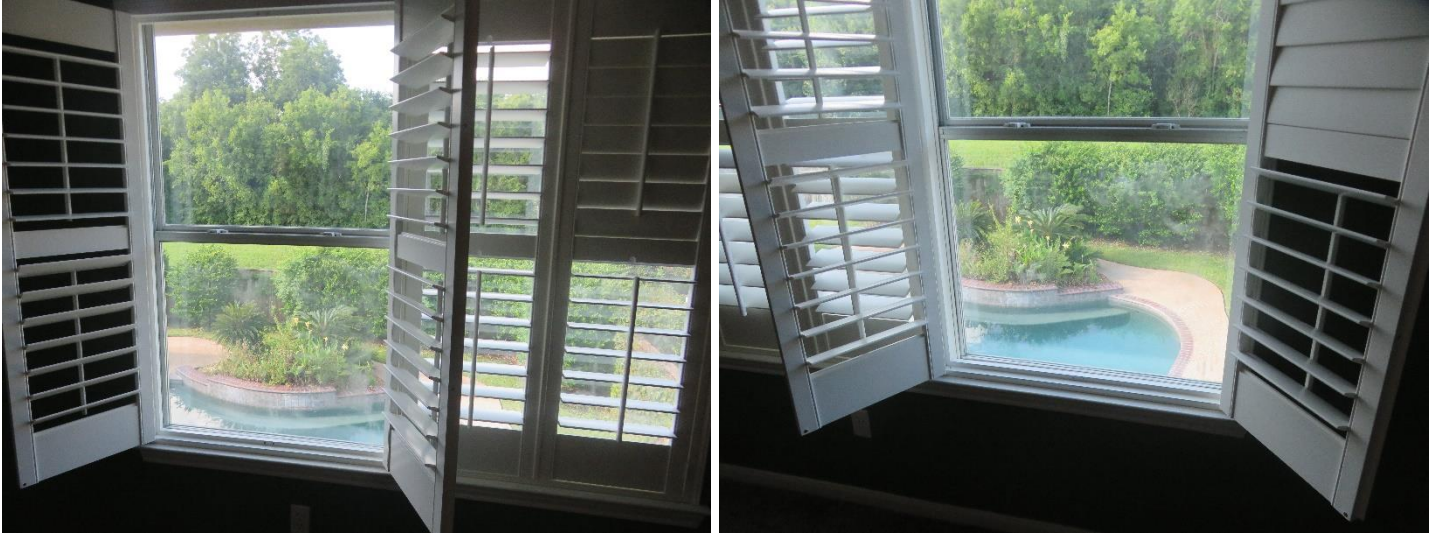
Examples

- Several windows have loosened safety straps causing windows to fall immediately upon opening.

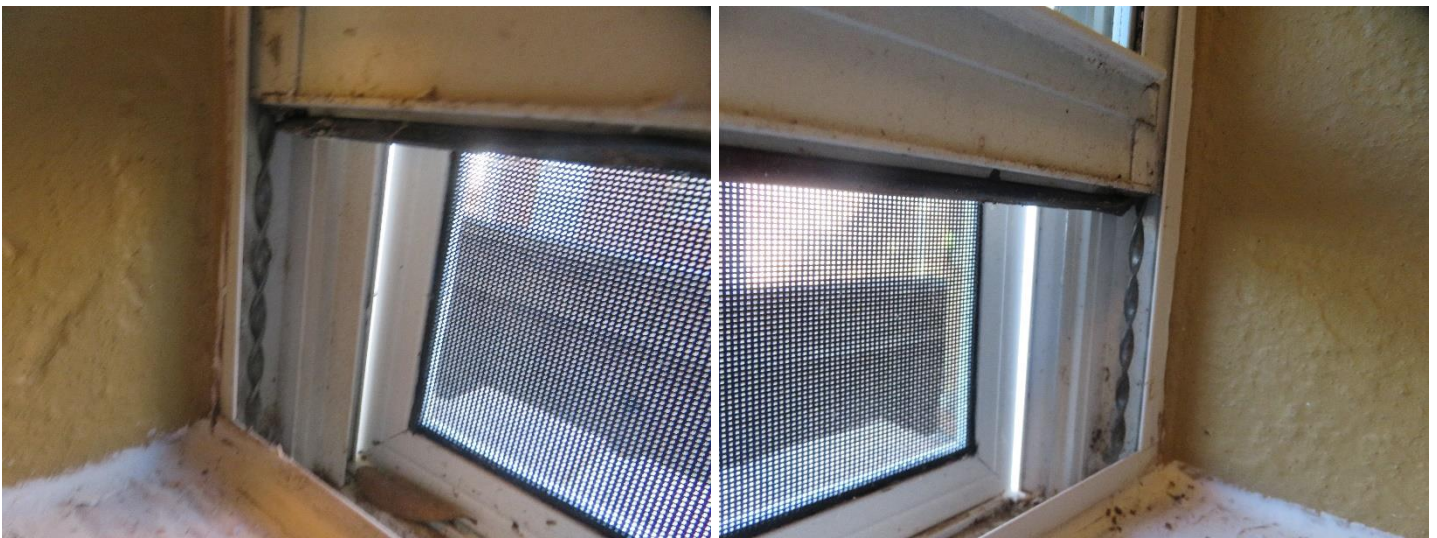
- Primary bathroom toilet area window falls with broken/loosened safety straps. Window falls when elevated.

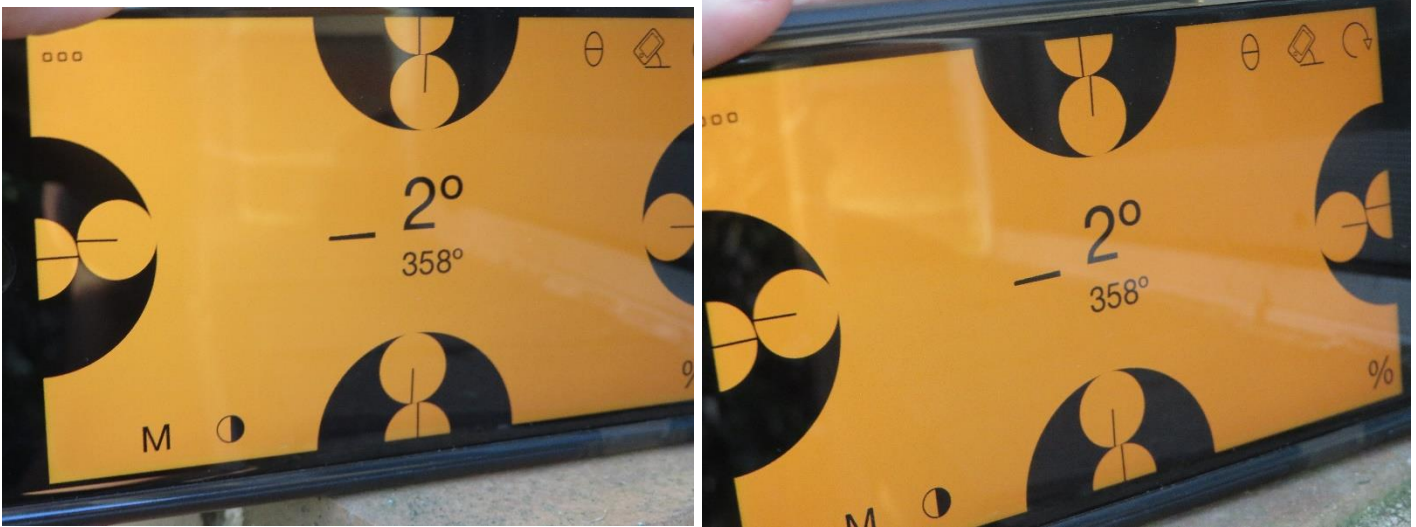
Examples

- Exterior window sills are required to be installed to slope at least at a 15* angle away from the home/window to properly drain/shed water away from the home. Maintain window caulk/sealant to assist in preventing window leakage.

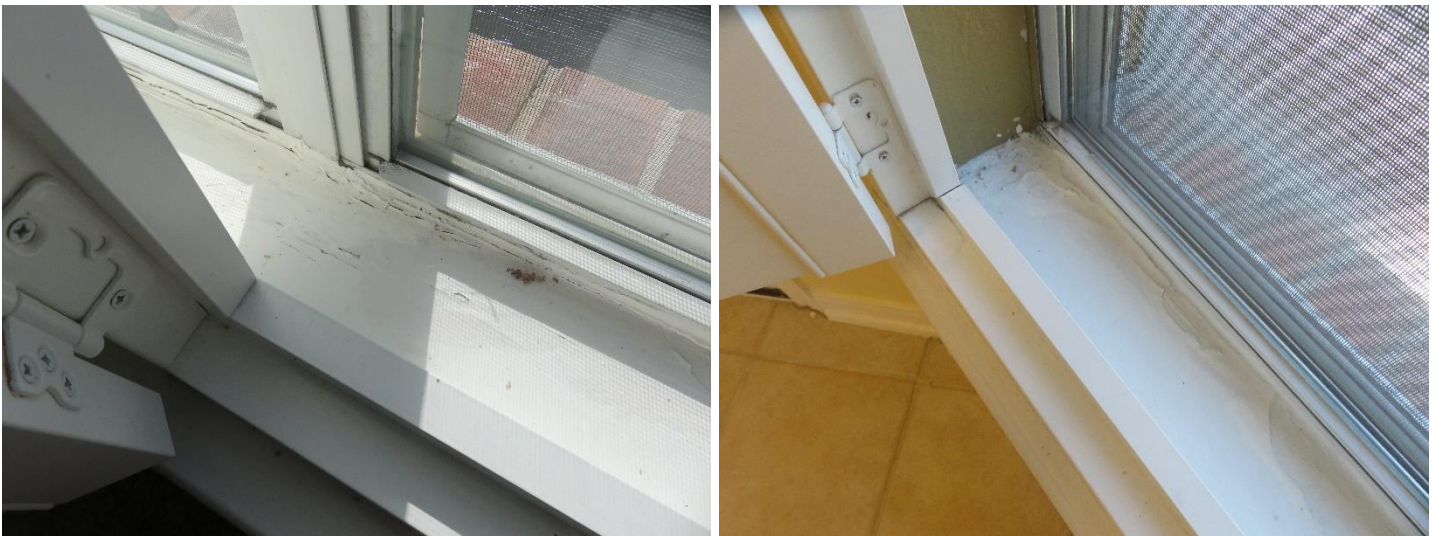
Examples

- Several interior windows display leakage and/or condensate damage on their sill.

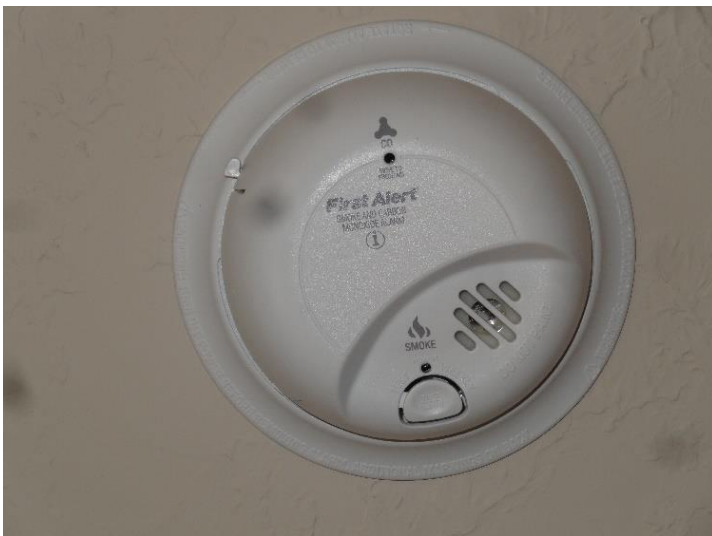
Example

- Carbon Monoxide detectors provide advance warning of this colorless, odorless gas just as smoke detectors provide advance warning of smoke and combustible conditions. Placement of these detectors in the hallway of the home immediately outside each bedroom, on each floor and in accordance with manufacturer recommendations is a required fire safety precaution. The CO detectors are required to be interconnected with the smoke detectors. IRC {315.1}

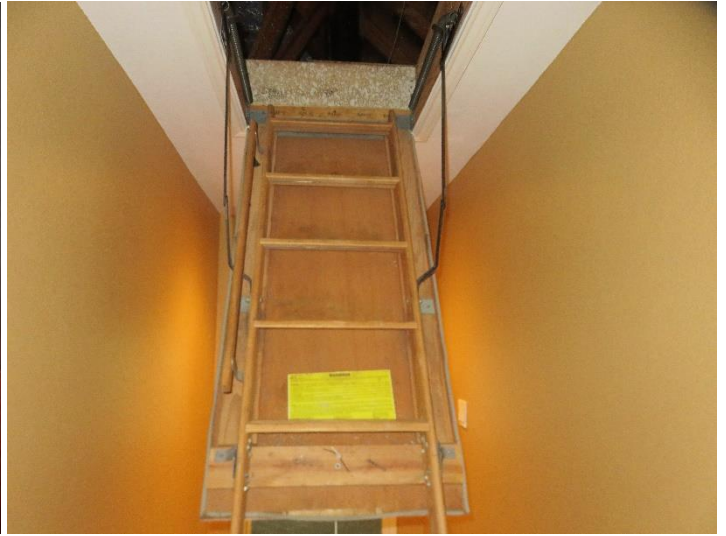
Example of a fire rated/insulated attic pull down stairs include and current installation

- Pull down attic stairs in the home are required to be clad with insulation to form a barrier between the attic and living area of at least R-30 equal to the rating of currently required attic insulation at living area attic fronting ceilings. It is advisable to install fire rated stairs to provide a fire barrier between the attic and living space.

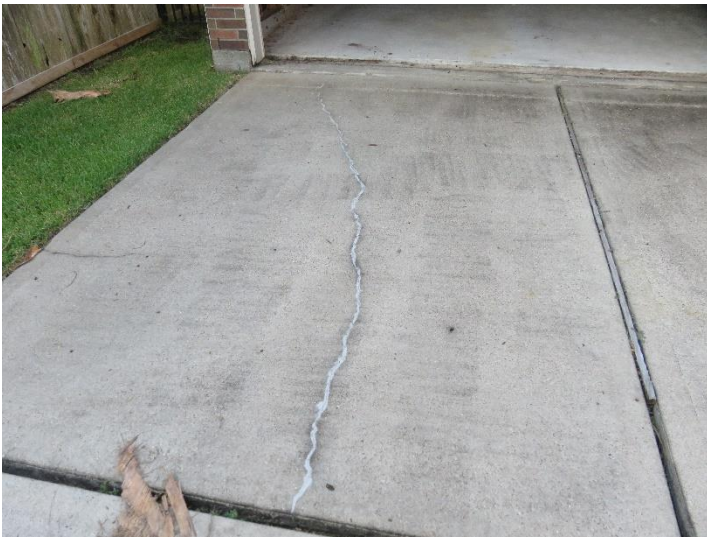
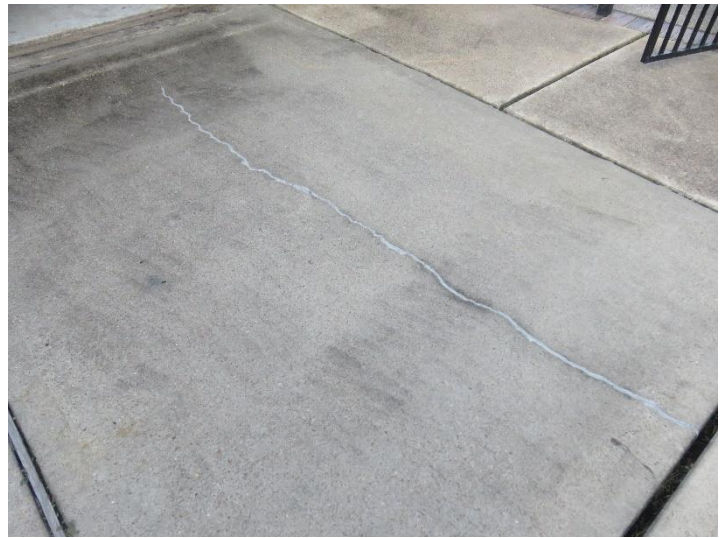
- The driveway displays a section recently improved by arched and cracked as well as cracks in the upper pads.

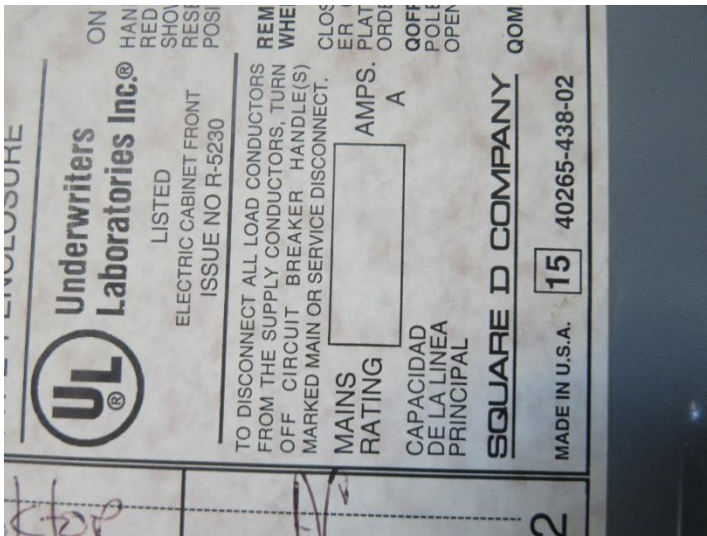
- The Main service entrance panel box is not labeled for AMP capacity. The panel should be further inspected and rated by a professional electrician. The service entrance panel box should be at least the size of the incoming service to the Main breaker.

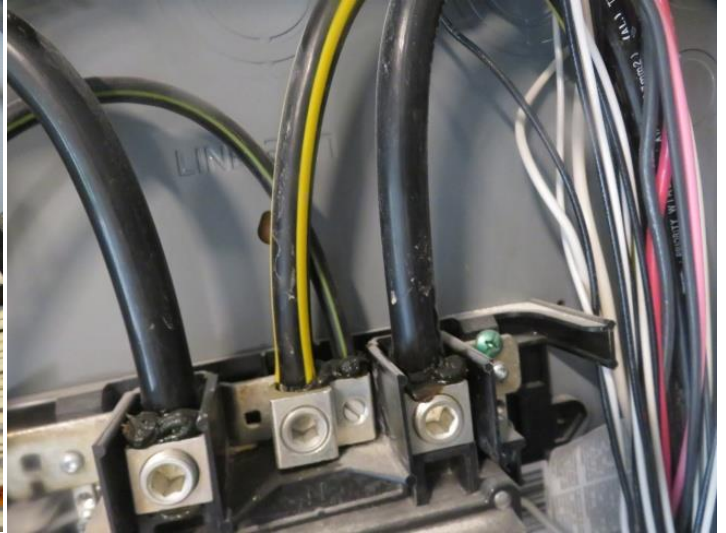
Current and required installation

- Aluminum service wiring requires anti-oxidizing agent at entry points to the main breaker and neutral bar.

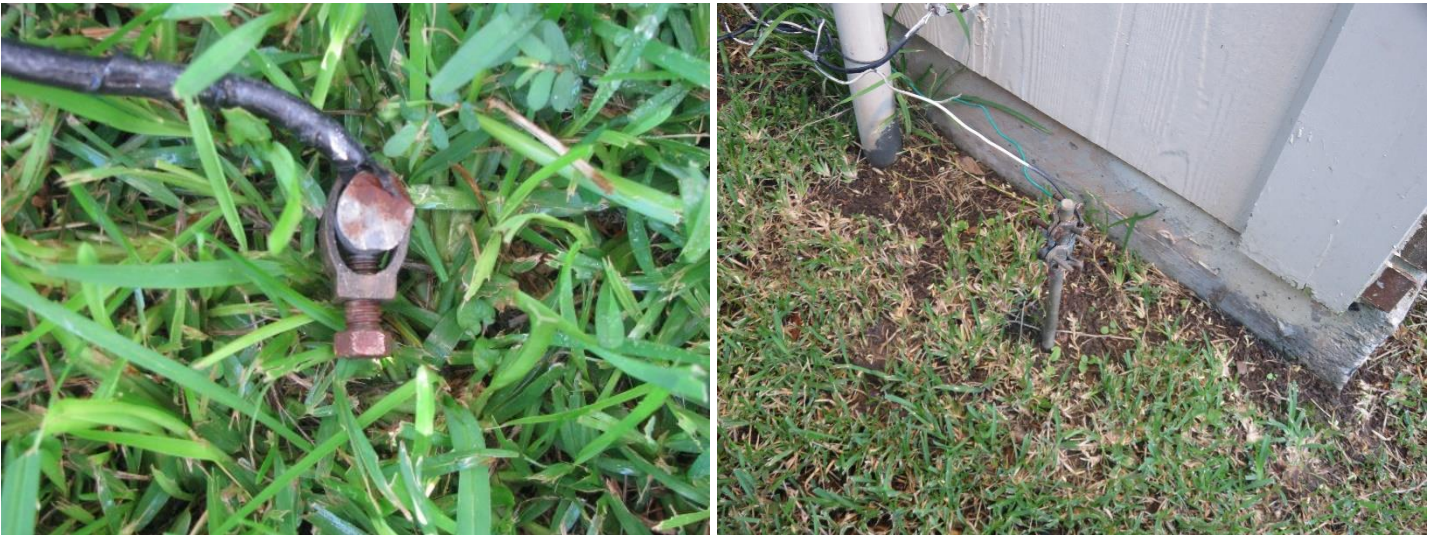
Example of an acorn clamp and current installation

- The installed grounding clamp at the ground rod is for use in a natural gas pipe application. Grounding rods are required to have an acorn grounding clamp.

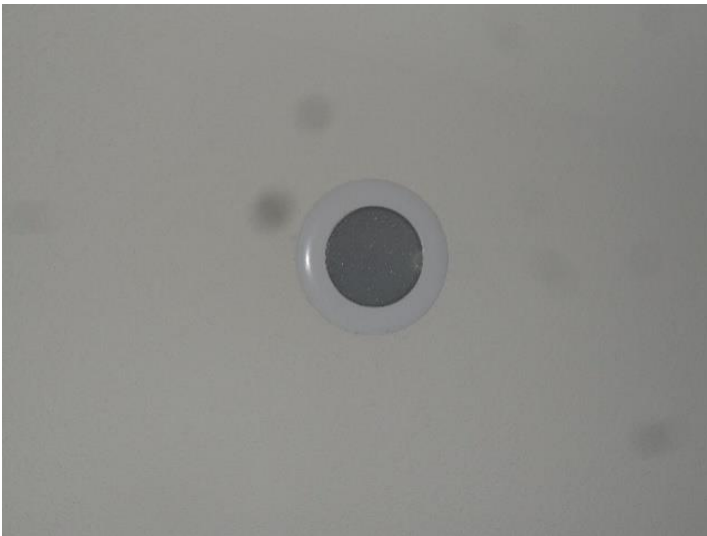
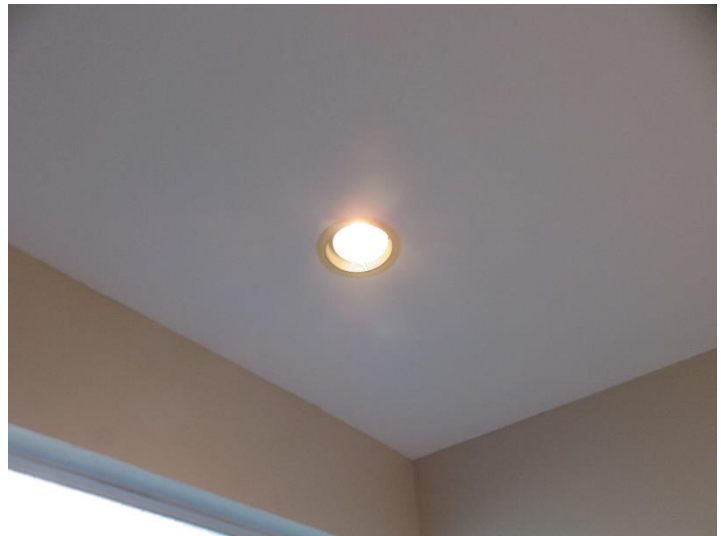
- Unprotected/open light fixture at bathroom tub/shower ceilings are prohibited due to the accessibility of water to persons using the facility. An electrocution hazard is present. A sealed lens fixture is required at the ceiling light above the Primary bathroom bathtub.

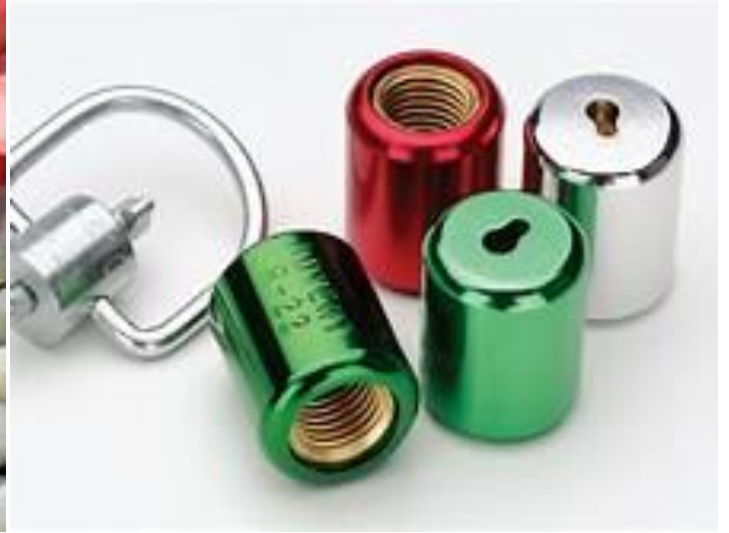
- As of 2009, locking caps for HVAC Freon ports are required and only a licensed HVAC company/contractor can install and/or remove.

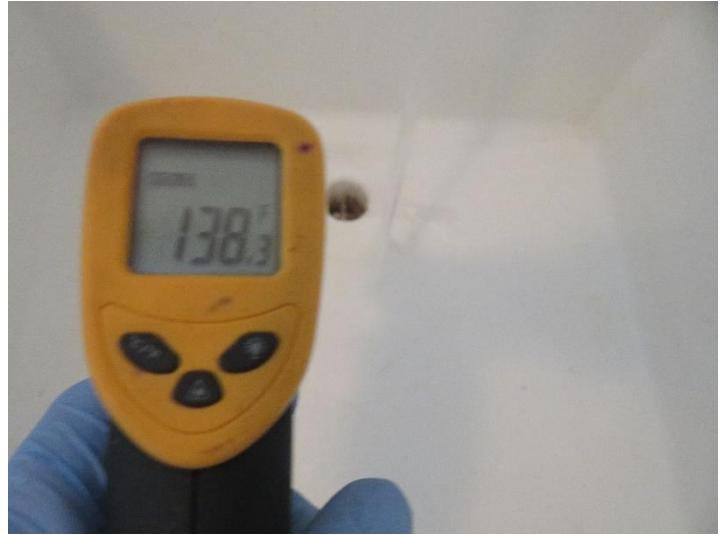
- The water temperature as recorded at sinks was too hot. Temperatures in excess of 120°F can cause severe burns and scalding.

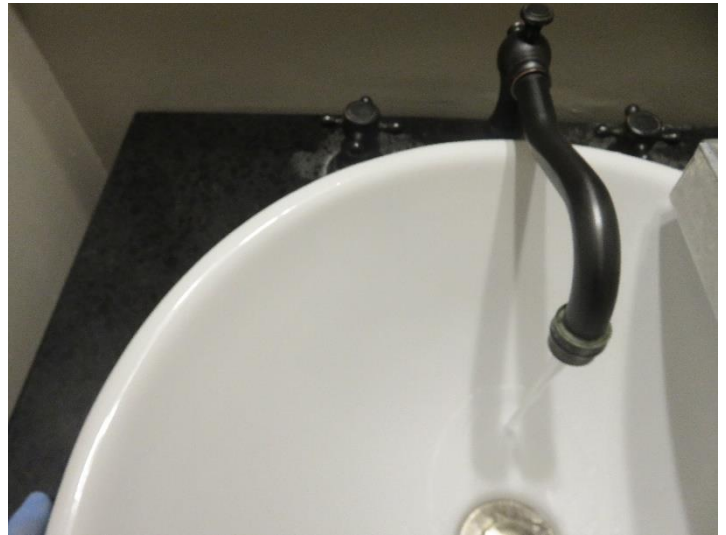
- Water pressure at the 1st floor half-bath lacked adequate water pressure and the hot water handle is loose/wobbly.

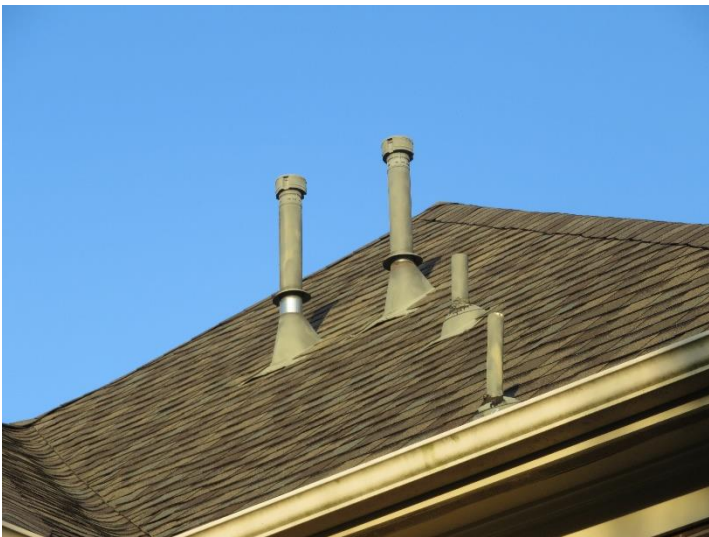
➤ The rain collar on the flues are elevated and should be lowered to the top of the roof boot/hood.

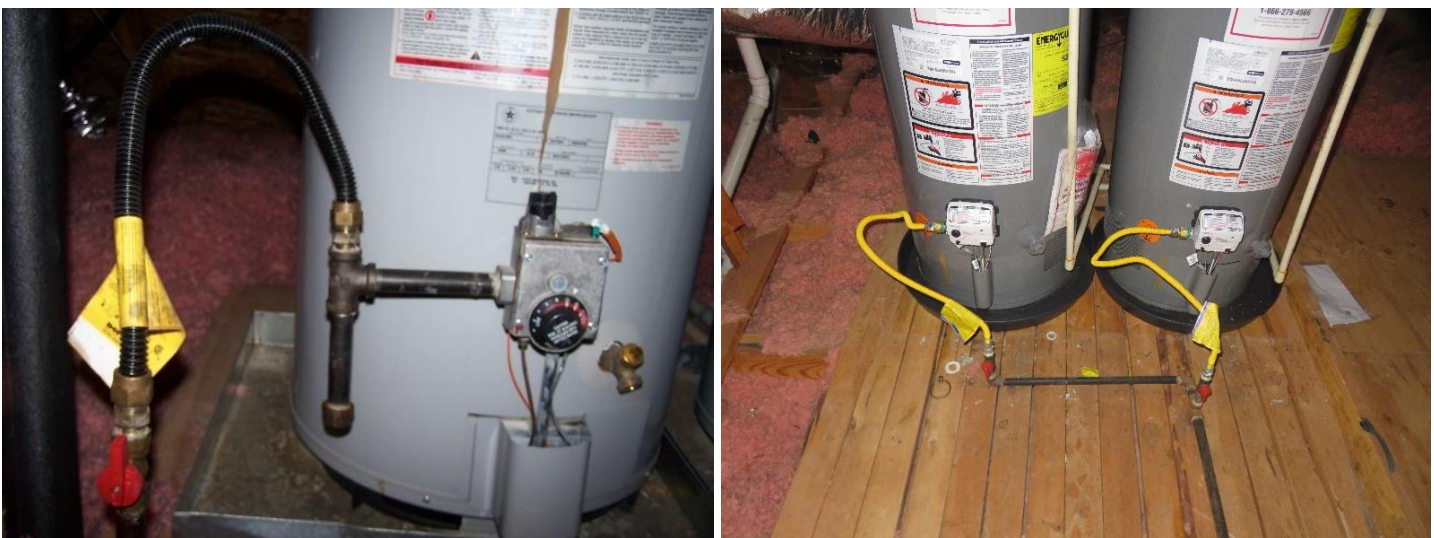
Example of a gas line dirt leg/sediment trap and current installations

- Standards for natural gas line/pipe installations at water heater(s) should include natural gas supply lines that are installed with a dirt leg/sediment trap inserted at a point in the supply line just before the regulator and burners. The installation requires a change in direction of the natural gas flow. This dirt leg/sediment is intended to trap condensate and any wayward metal shavings, dirt and dust that could interfere with the normal operation of a water heater employing natural gas as fuel.

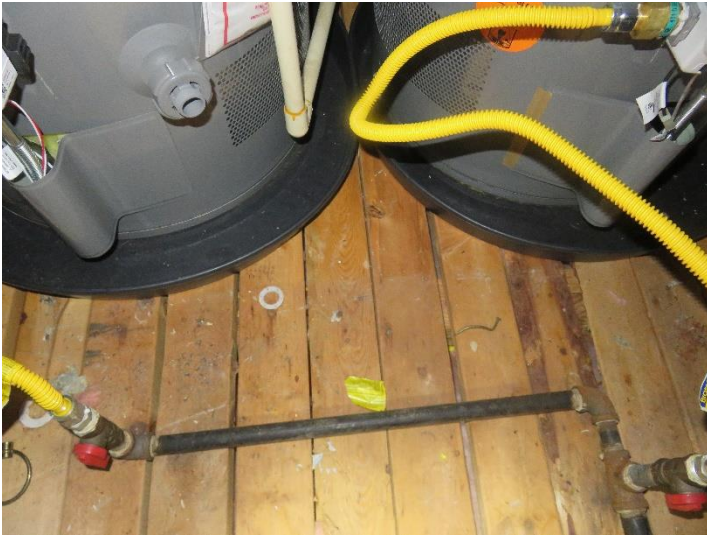
- Water heaters are required to be equipped with a drain pan (natural gas – metal and electric – plastic/metal) beneath the water heater having a drain line that allows the flow of water that would leak from the heater to the exterior of the home. **Natural gas water heaters are prohibited from having a plastic drip pan. {IRC P2801.6}**

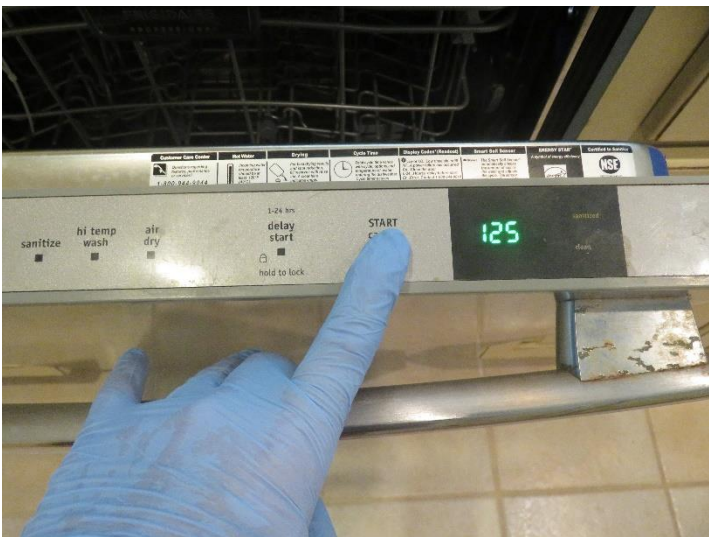
- The START button was not functioning to energize the appliance.

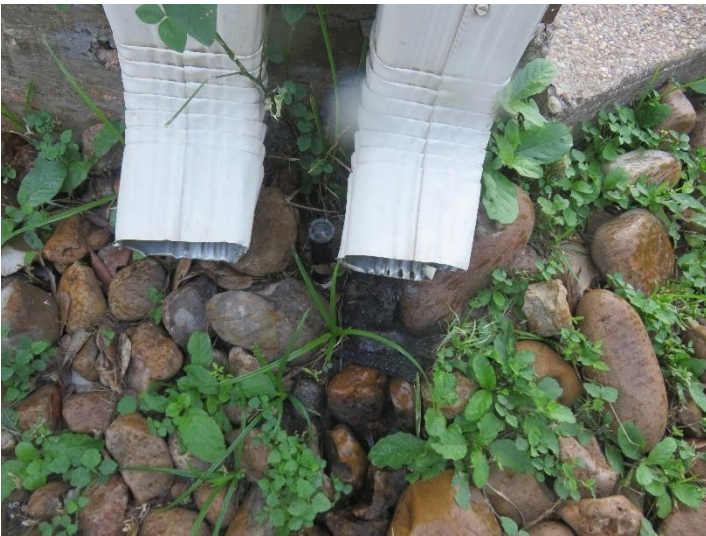
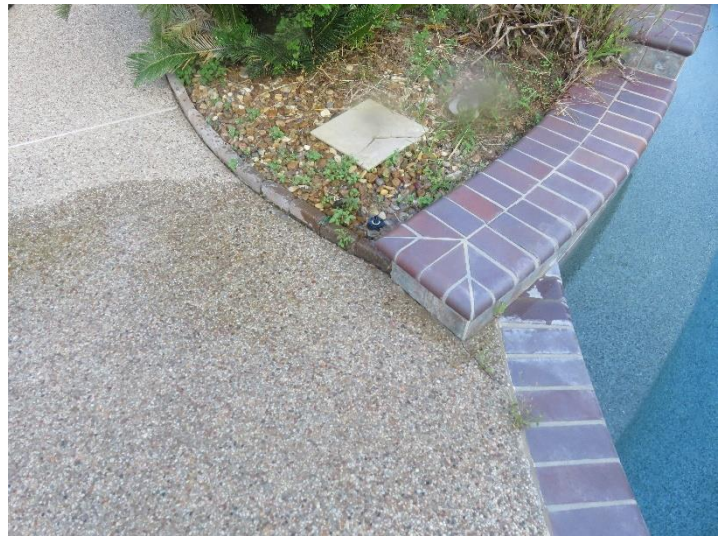
- Sprinkler heads in Zone 3 (right rear home corner) and at the rear flower bed behind the pool lacked water spray and displayed leakage.

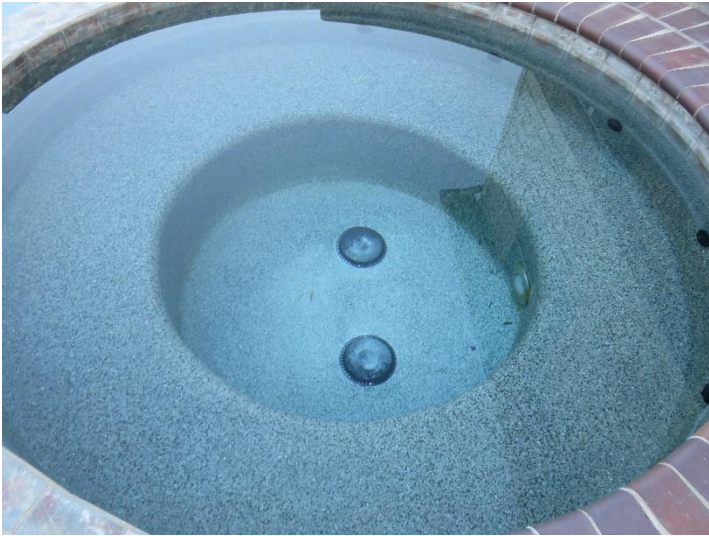
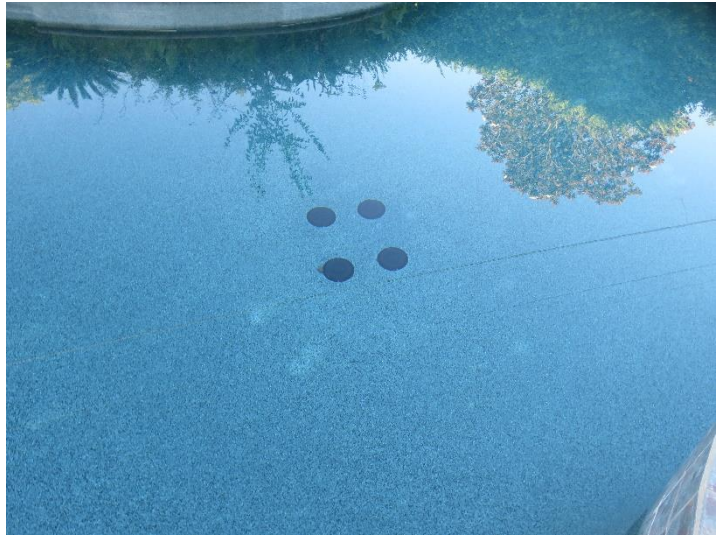
- Two Anti-vortex drains in the pool and spa are required to be installed at least 3’ apart for safety. The drains in the pool and spa are too close together.
