PROPERTY INSPECTION REPORT

“AROUND THE HOUSE” HOME INSPECTIONS

Concerning: 38 Twin Valley Drive, Sugar Land, TX 77479

By: David J. Stiles Inspector Lic. #7308 8/11/2020

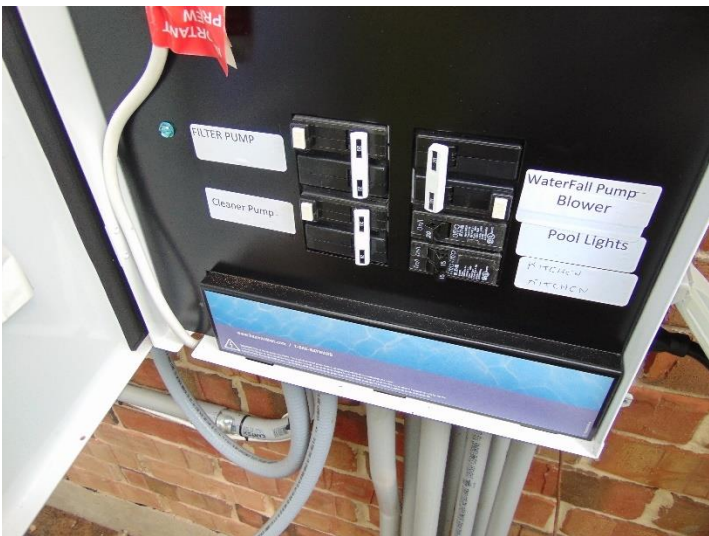
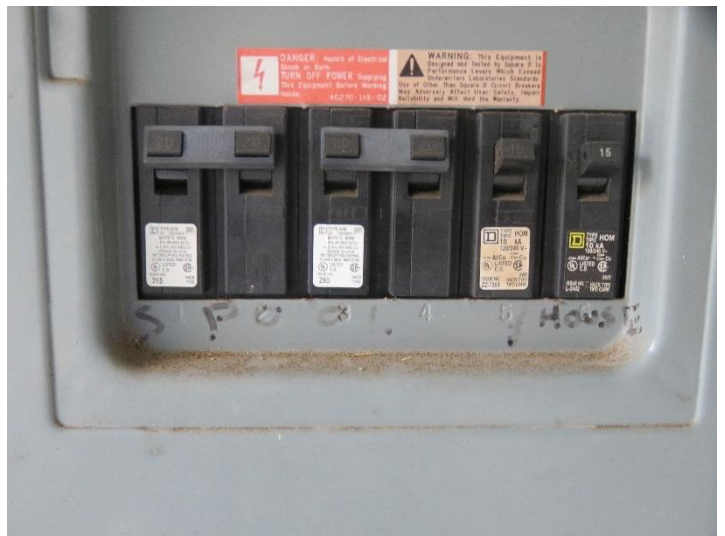
Example and current installation

- Swimming pool electrical equipment are required to have breakers to act as a disconnect should electrical failure(s) occur.

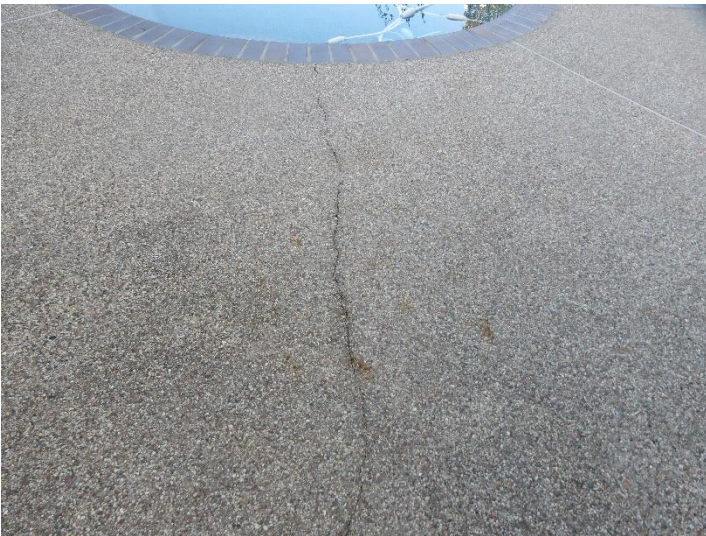
- The pool deck displays a crack(s).
