ENGINEERING OPINION
INVESTIGATION OF FOUNDATION PERFORMANCE
RESIDENCE AT 4216 ELI STREET, HOUSTON, TEXAS, 77007
Date of Inspection: March 12, 2021
Date of Report: March 15, 2021

SLAB SURFACE ELEVATIONS AND OBSERVATIONS

4216 Eli Street, Houston, Texas, 77007

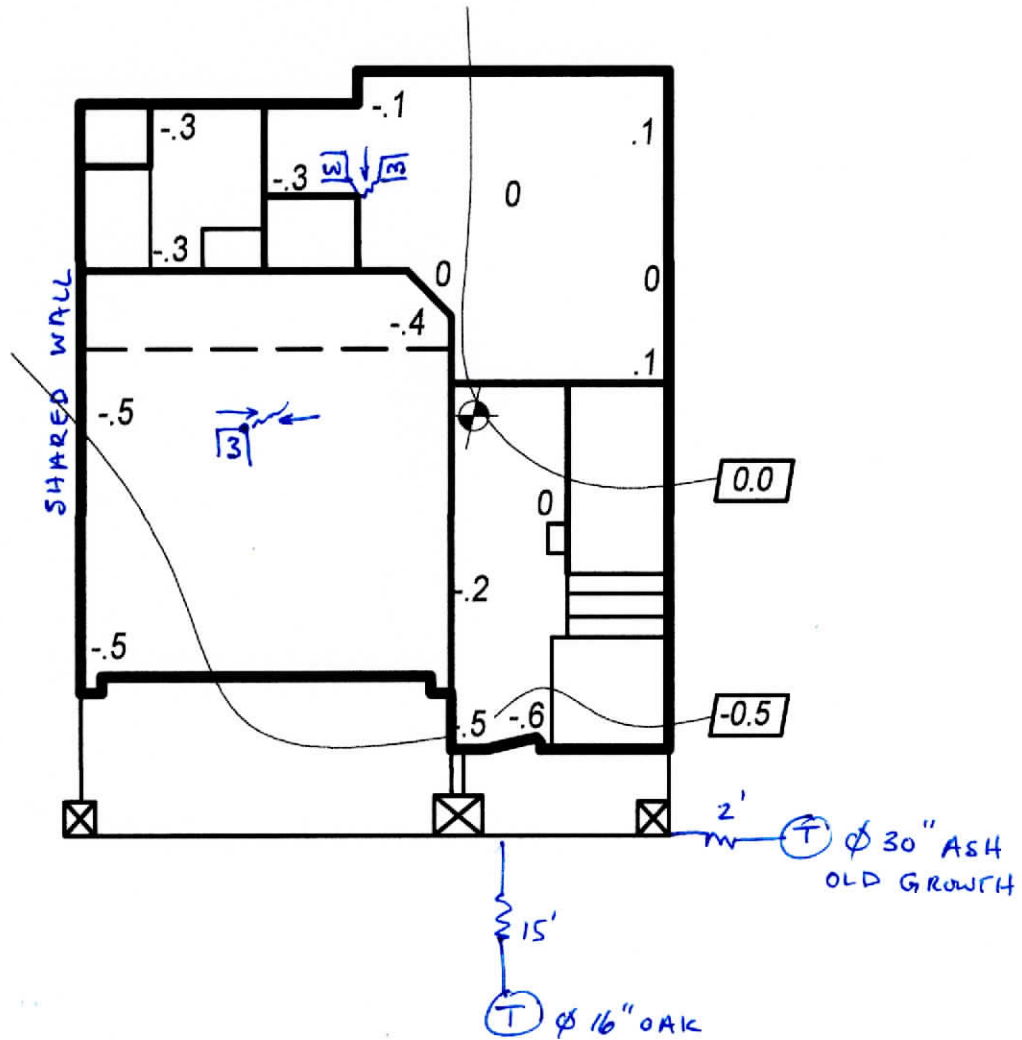
Damages and conditions at the interior are shown on the attached Elevation survey sheet. Two doors at the 3rd story show diagonal wall cracks. The door to the master bath binds at the top.

An elevation survey throughout the house was performed using a Technidea Zipline. The reference zero was the foyer. The elevations have a range of 0.7 inches, highest at the 1st floor bedroom, lowest at the entrance. The foundation generally is flat and level with a slight slope downward towards the front and left.

See attached elevation survey.

DISPOSITION: The cracks and binding of the 3rd story doors are presently not due to any foundation movement. They are attributable to minor framing deflections of floor spanning the open floor living area below where these damages have occurred.
