PROPERTY INSPECTION REPORT

Concerning: 1148 Arlington St, Houston, TX 77008
(Address or Other Identification of Inspected Property)

By: Scott Osborne, Lic #20555 12/30/2019
(Name and License Number of Inspector) (Date)

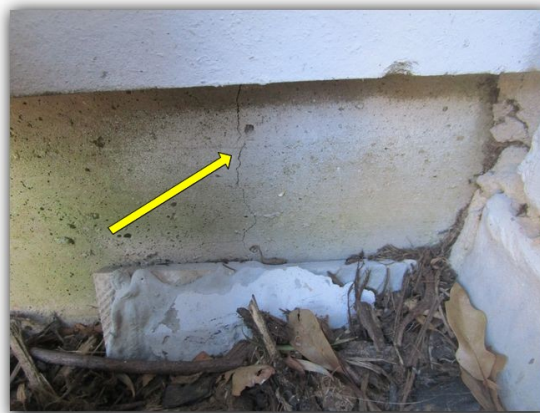
There is a hairline crack on the side of the garage near the fence / gate area (leading to the back yard / side of the garage).

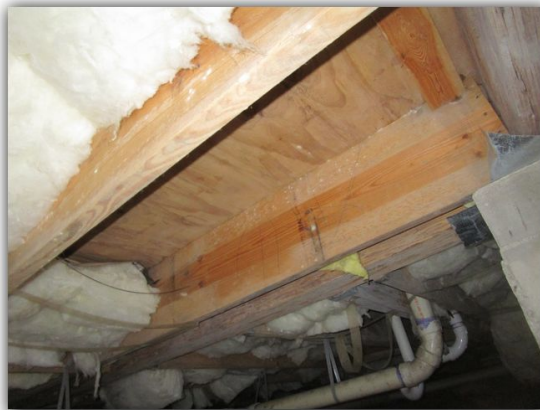
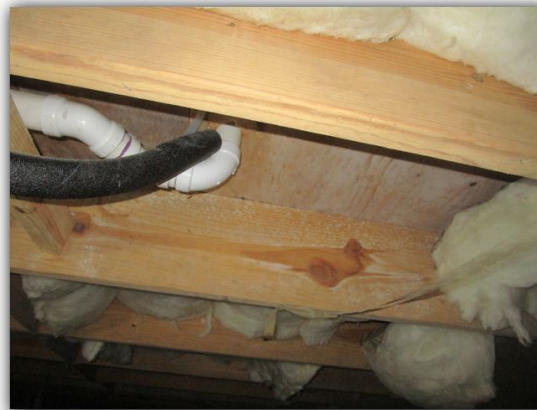
The insulation is loose along the underside of the home in the crawl space at more than one location. The insulation may need to be re-installed / re-secured.

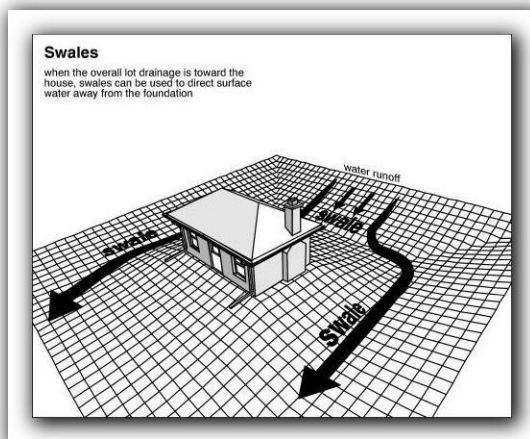
There are flat / low spots in the yard (front and back) that may hold water. The lot did not appear to have the proper slope for drainage at all points around the perimeter of the home. The grading should slope at least 6" in the first 10' around the home. Inadequate slope may allow water to stand against the foundation and may lead to excess foundation movement.

NOTE: I recommend monitoring the drainage after rain to determine if there is an additional need for drains.

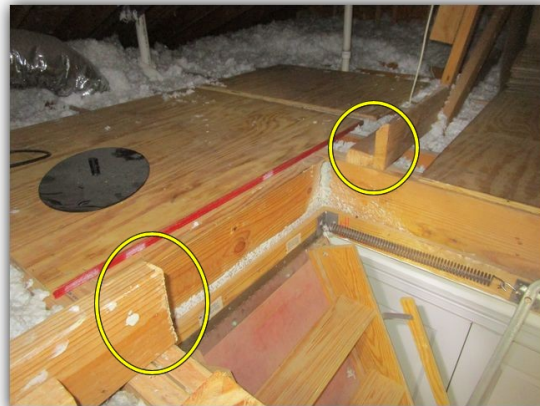
The strong back has been cut in the attic above the garage apartment to make room for the attic ladder.

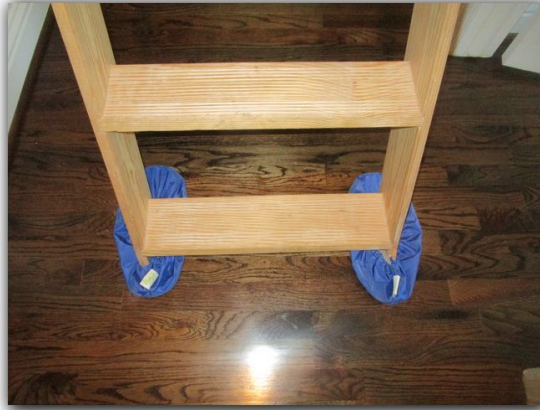
The attic access ladder is very shaky and may need to be reviewed by a qualified contractor for safe access to the attic.

NOTE: I recommend protecting the bottom of the attic ladder in order to help protect the floors in the upstairs hall.

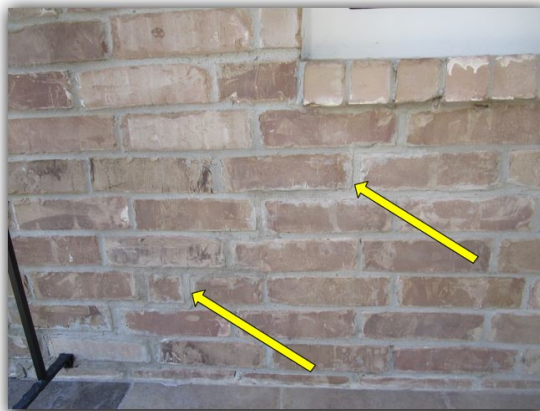
There is a mortar joint crack at the bottom front left corner (at the front left window on the front porch).

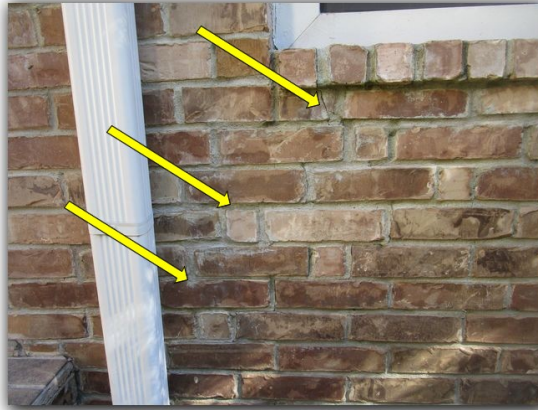
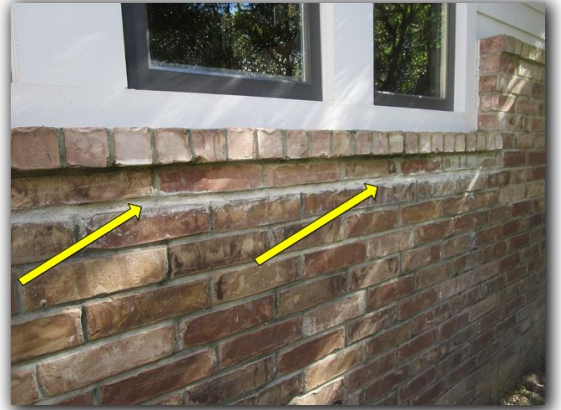
There is evidence of a mortar joint crack and prior repair to the brick / mortar on the front of the home at the front right windows (formal living room).

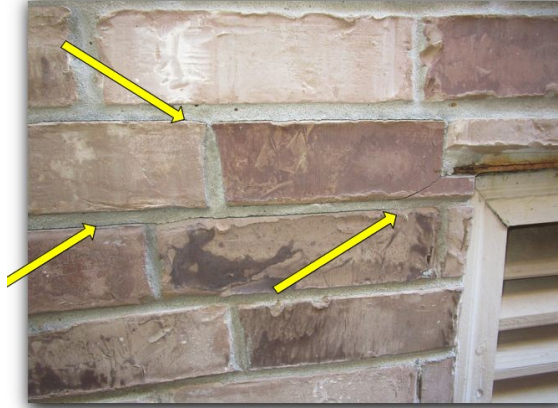
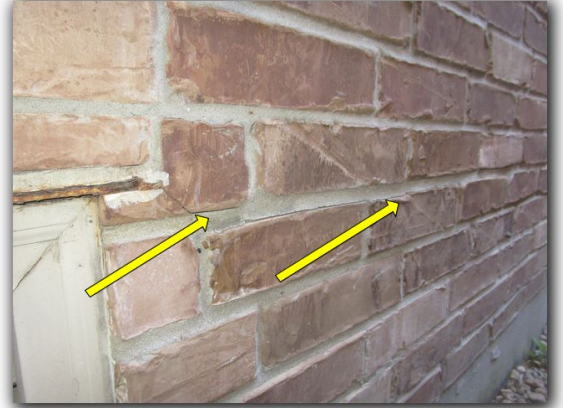
There is a horizontal mortar joint crack on the right side of the home at the middle crawl space vent.

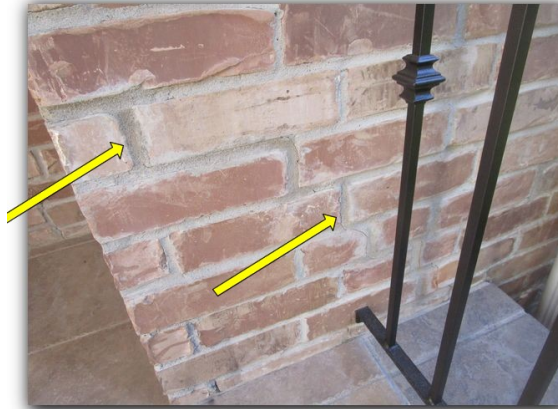
There is a mortar joint crack at the front right corner of the front porch.

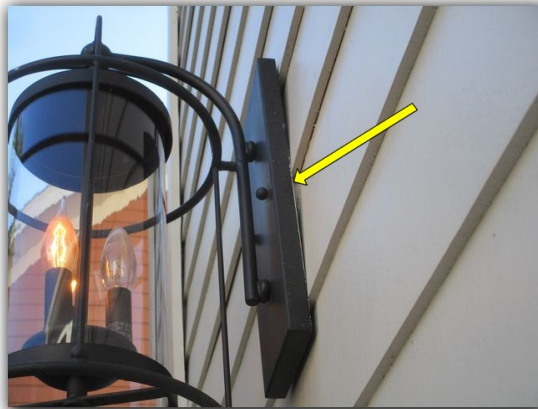
The exterior light fixtures are not properly sealed or secured to the wall. This is a potential moisture penetration point.

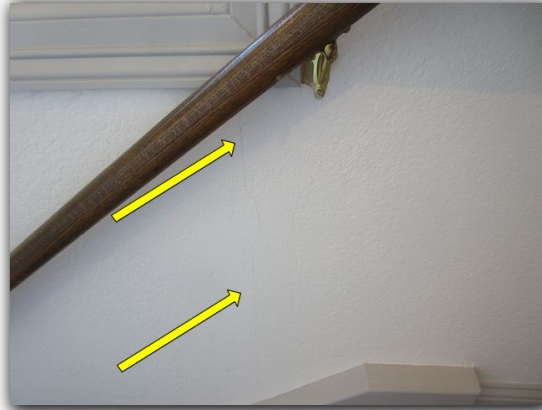
There is a hairline crack on the wall at the top of the stairs leading into the garage apartment at the windows.

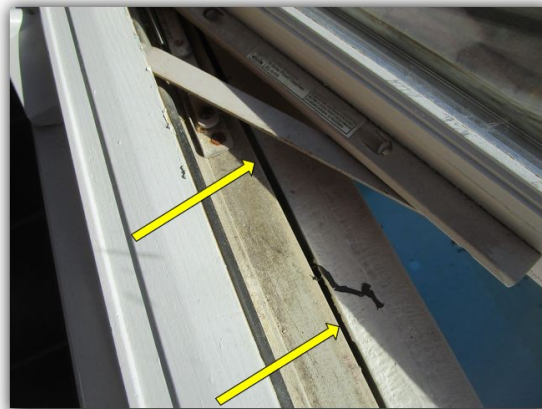
There are gaps at the window frame / trim at the apartment windows.

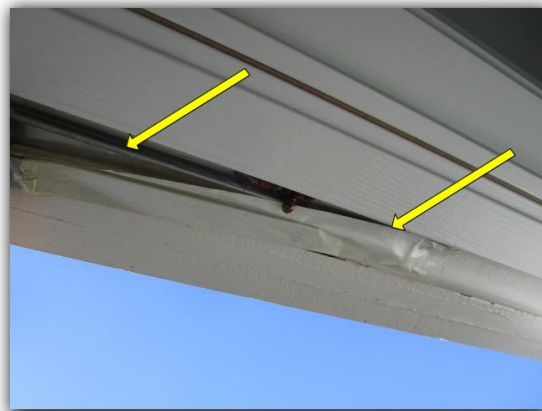
There is evidence of wood rot / deterioration at the front right bedroom window. There are signs of a multitude of ladybugs at this location.

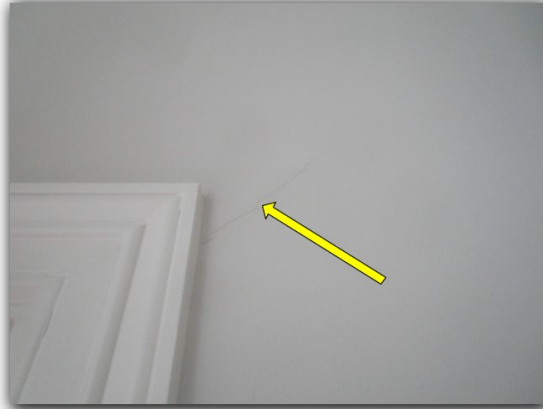
There is a crack on the wall in the front right bedroom at the doorway to the bathroom.

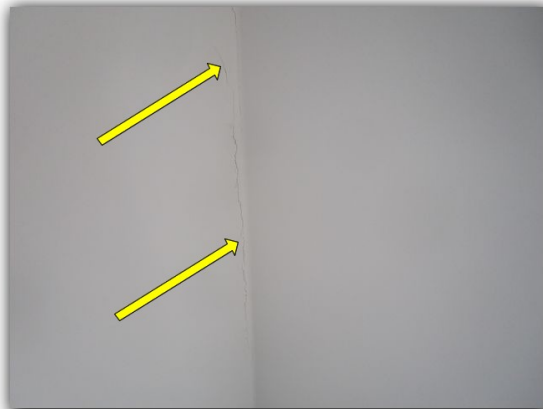
There is a crack along the inside corner in the front left bedroom at the corner to the right of the windows.

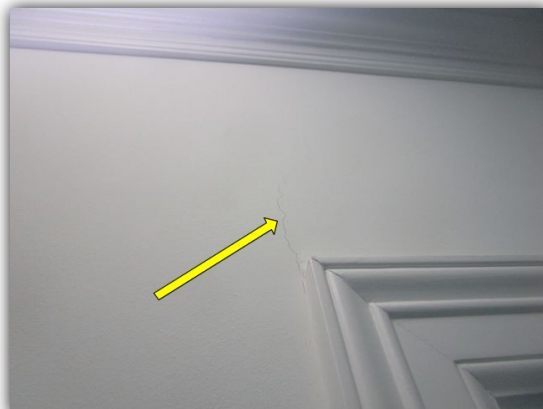
The interior walls (including closets) and garage walls are obstructed by storage and furniture. Not all of the walls are accessible / visible for inspection. There is a crack on the wall in the master bedroom at the bathroom door.

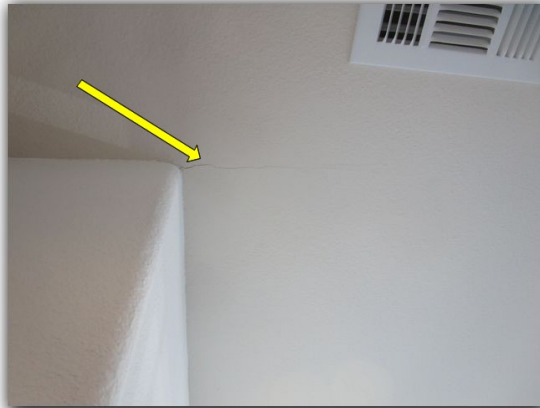
There is a hairline crack on the ceiling at the top of the stairs at the entry to the garage apartment.

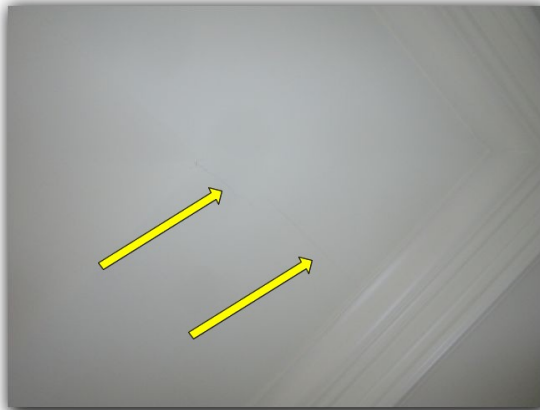
There are cracks at the corners of the tray ceiling in the dining room.

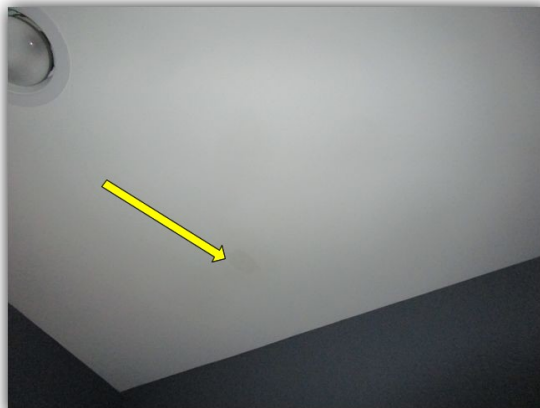
There is a stain on the ceiling in the master bathroom above the entry door.

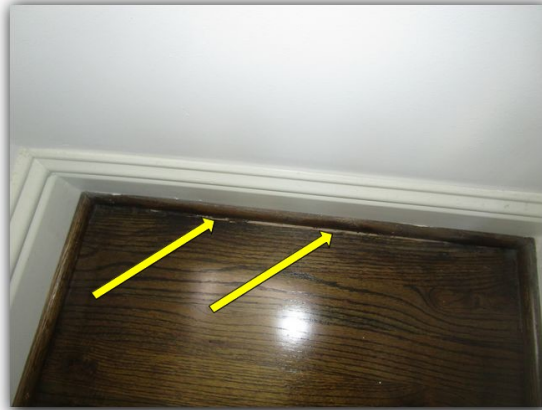
There is a gap along the floor board and trim / quarter round in the master closet at more than one location.

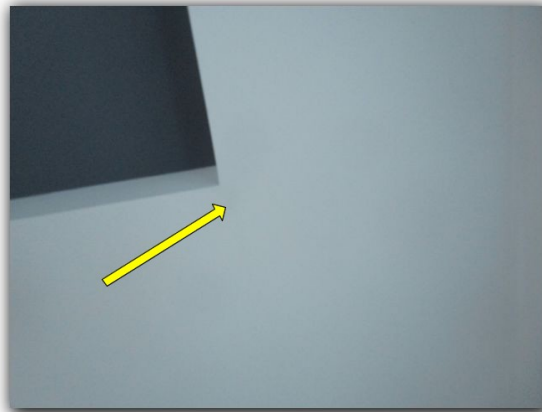
There are cracks beginning to form at the corners of the tray ceiling in the master bedroom.

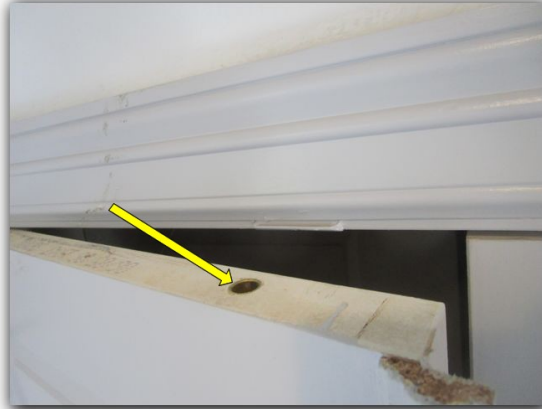
There are missing bullets at the top of the doors at more than one location, including the top of the left water heater closet door in the garage apartment, and the left closet door inside the garage apartment.

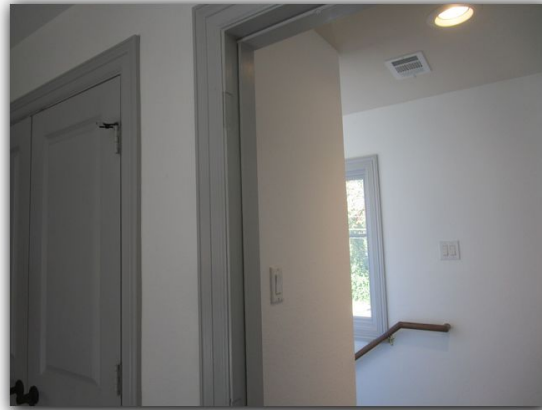
The garage apartment entry door is missing.

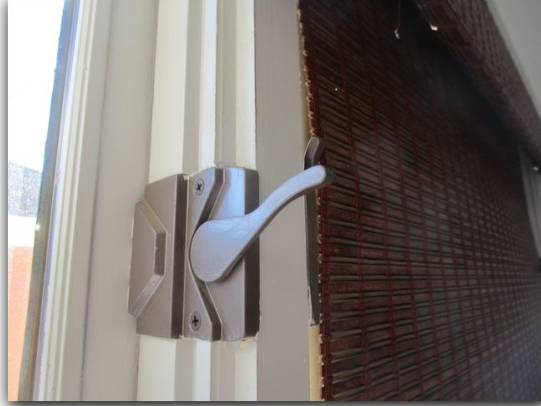
The top window lock / latch is loose at the left apartment window.

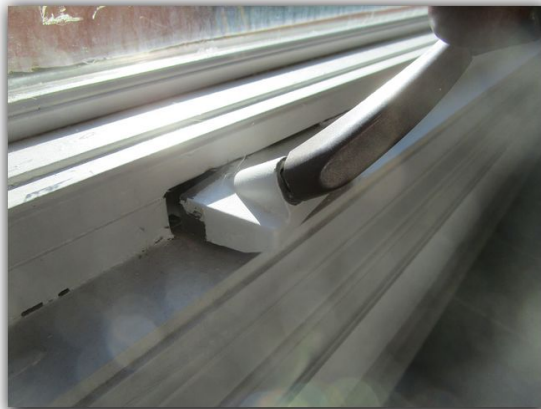
The left window crank is loose at the left apartment window.

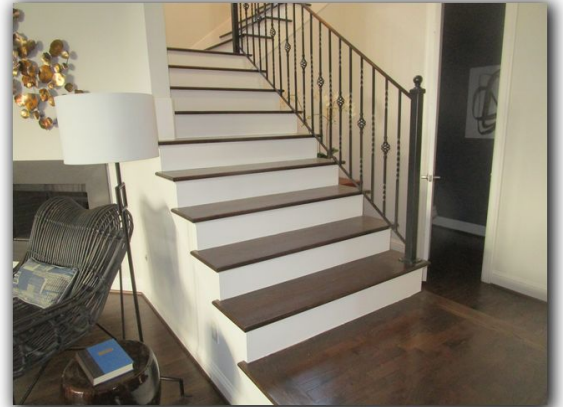
Where there are three or more stairs, a handrail is required. This requirement is not being met at the garage entry stairs, or along the left side of the stairs in the home. This may pose a potential safety hazard.

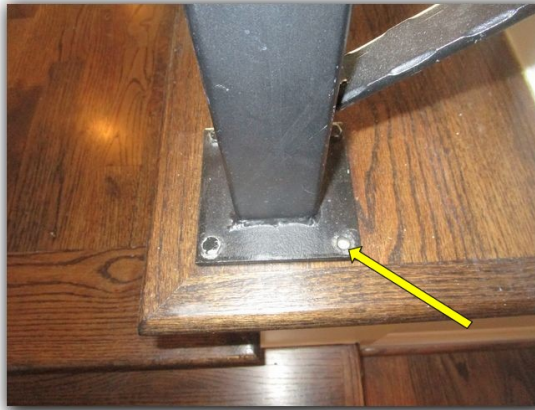
There is a missing bolt at the bottom rail / post at the base of the stairs in the home.

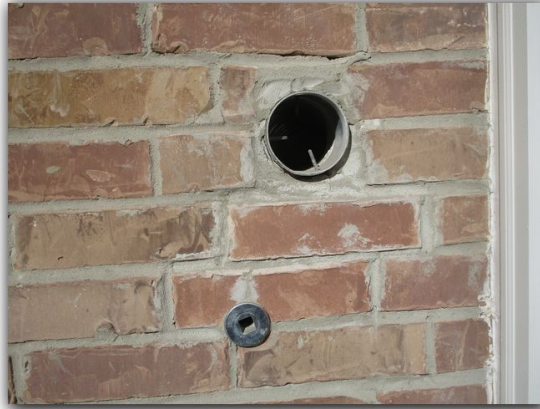
There is a missing cover on the vent at the outdoor fireplace.

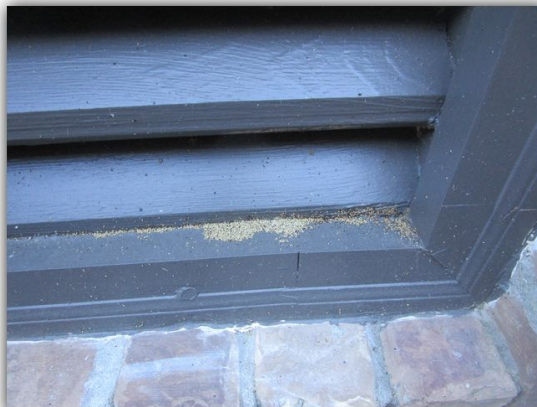
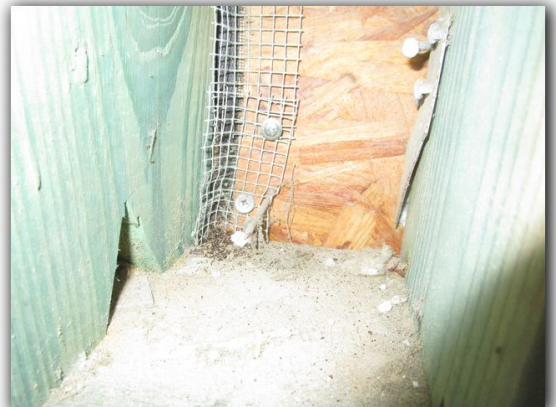
There is evidence of drywood termite activity at the left side of the home at the crawl space vent (both exterior and interior sides of the vent). I recommend a complete treatment by a qualified contractor.

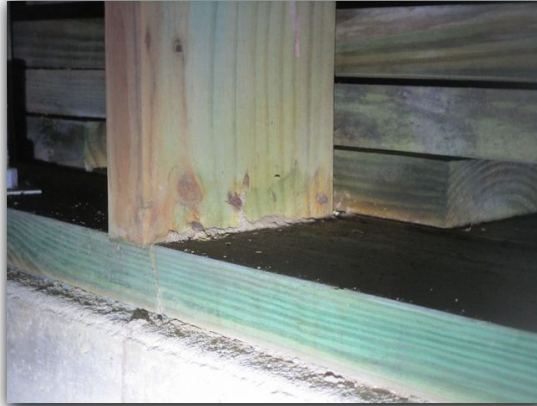
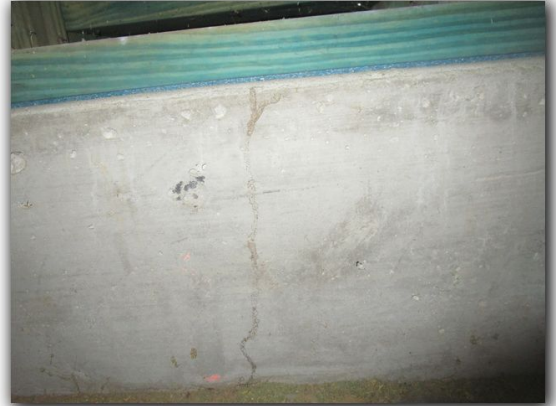
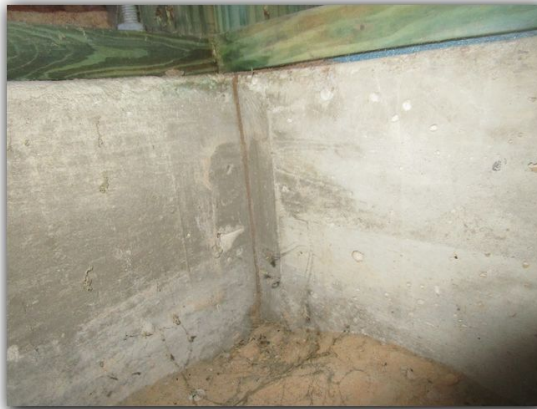
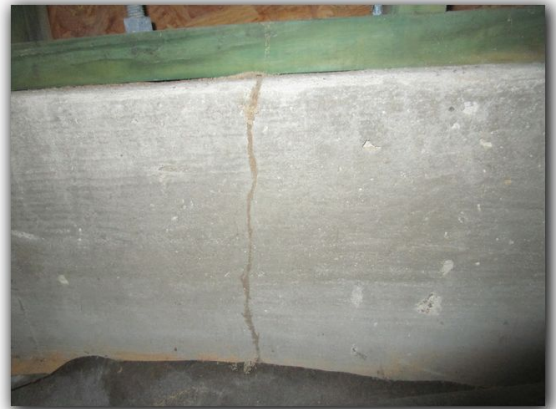
There are signs of prior subterranean termite activity in the crawl space at the rear of the home at more than one location. I recommend asking for any additional information.

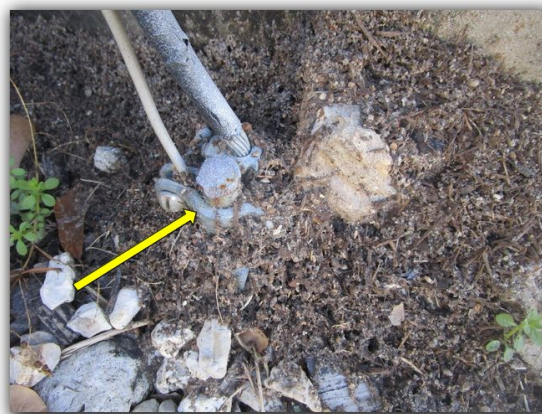
The wrong clamp has been used to secure the ground wire to the ground rod. The clamp should be an acorn style clamp.

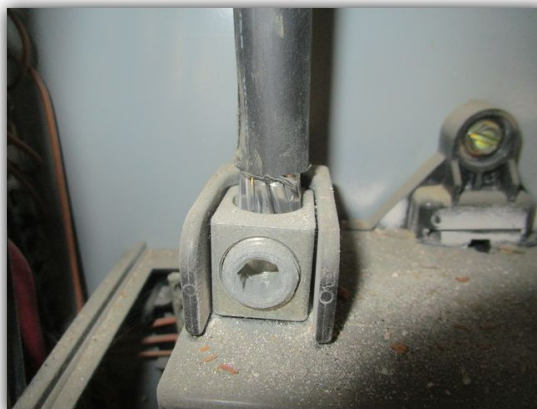
There is no anti oxidant paste on the aluminum service wires at the main lugs in the garage panel.

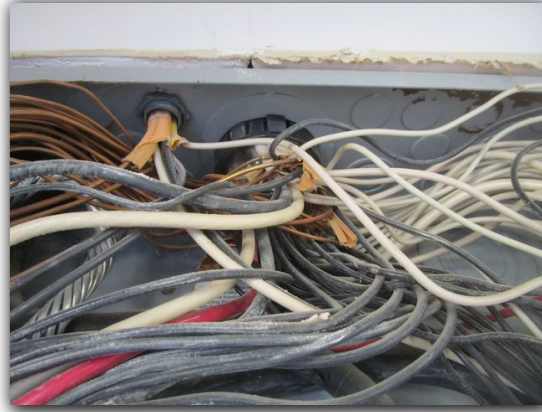
Newer codes state that electrical panels cannot have their wiring bundled, unless it is an exterior electrical panel. There are bundled wires in the garage panel.

I recommend a complete review by a licensed electrician to review and repair any and all deficiencies.

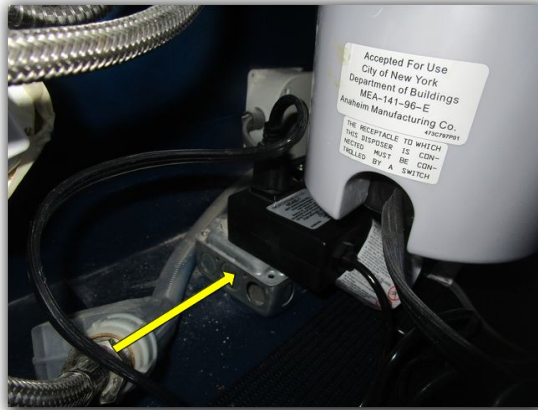
There is an outlet face up in the kitchen cabinet below the kitchen sink that is not GFCI protected.

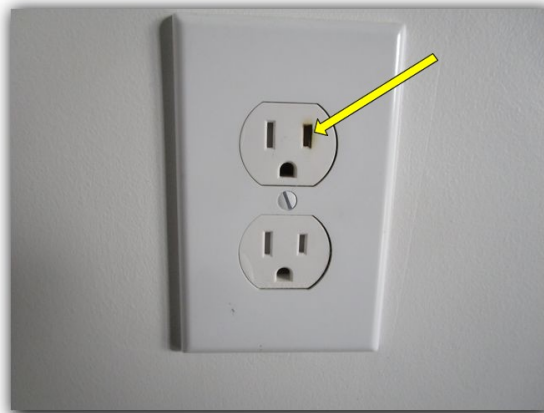
There are bulbs missing or burned out in more than one location around the home.
NOTE: This is an occupied home. The arc fault breakers were not tested as I did not want to risk damage to any item that may be connected to those breakers.
There is a missing outlet cover in the cabinet below the sink in the garage apartment kitchen.
There are loose outlets in the apartment by the entry and at the top of the stairs in the home.
The three way light switch servicing the overhead lights at the rear patio area is not wired properly and does not allow the light to be turned off or on at either switch unless one of the switches is in a specific position.
There are char marks at the top outlet opening in the dining room at the front left corner.

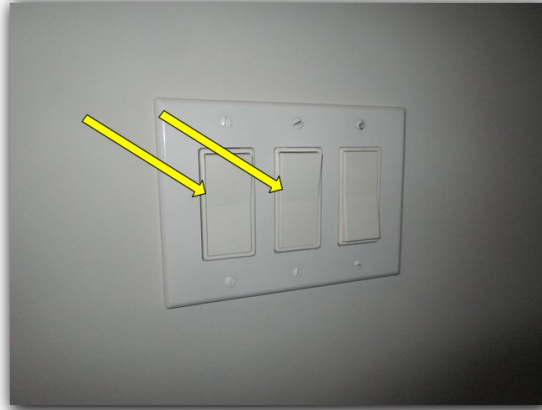
There are light switches in the upstairs hall in the home that do not have an obvious purpose. I recommend asking the seller for any additional information.

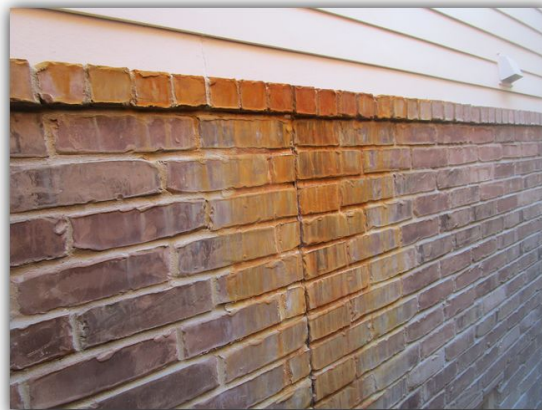
There is rust at the secondary drain line and on the house on the right side of home.

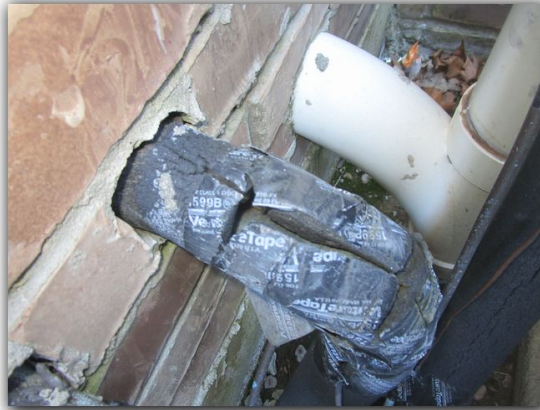
The insulation on the copper lines at the exterior condenser unit is deteriorated and may need to be replaced or repaired.

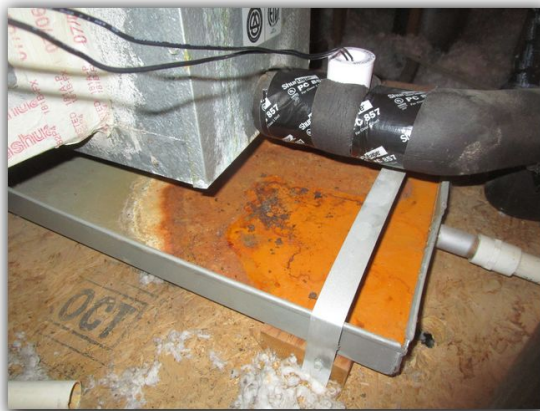
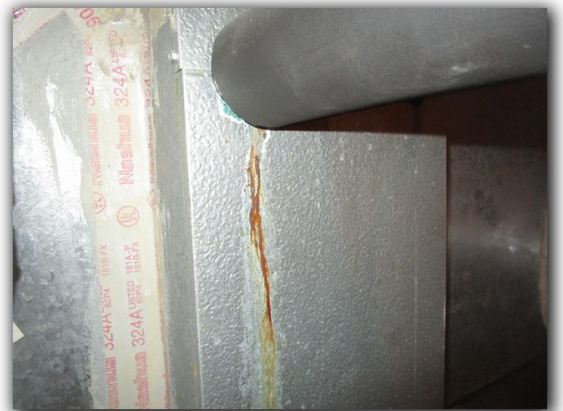
There is rust in the overflow pan and on the evaporator coils cover in the attic.

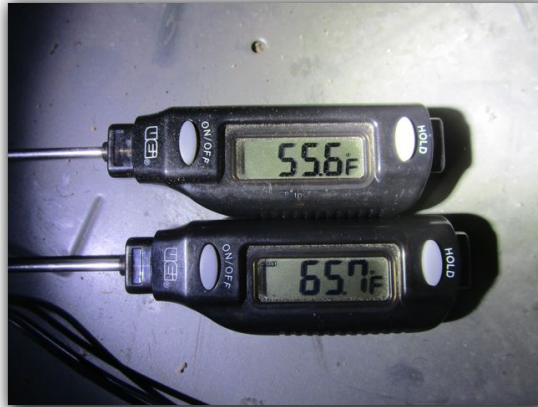
The temperature differential between the supply and return registers should be at least 15 degrees. The unit did not produce a temperature differential that meets this minimum requirement. This could be symptomatic of other issues inside the system.

I recommend a complete review of the entire HVAC system by a qualified HVAC technician prior to closing.

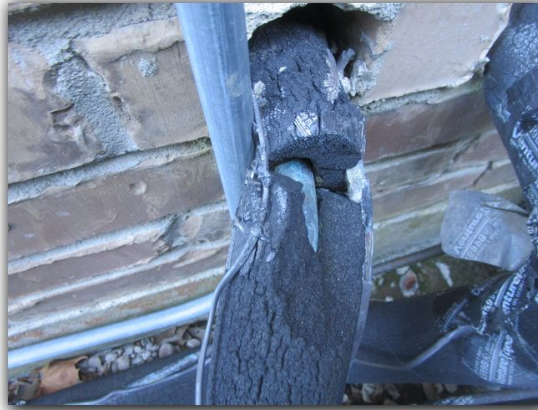
The insulation on the copper lines at the exterior condenser unit is deteriorated and may need to be replaced or repaired.

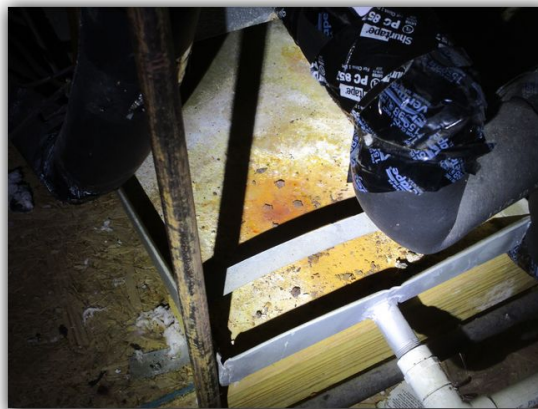
There is rust in the overflow pan.

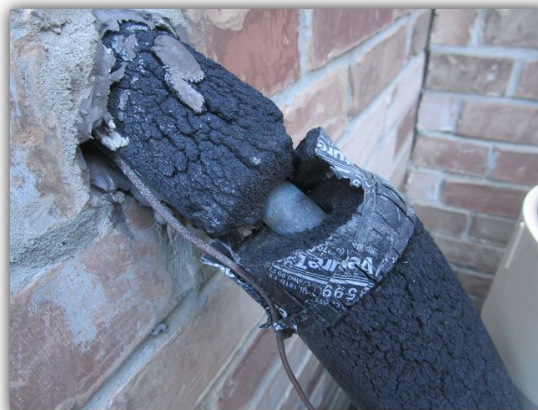
The insulation on the copper lines at the exterior condenser unit is deteriorated and may need to be replaced or repaired.

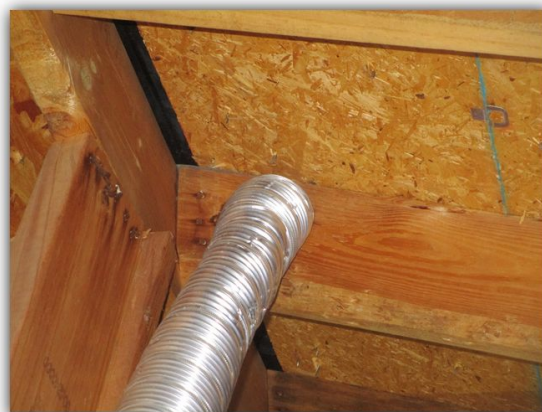
There is an exhaust vent that terminates in the attic instead of the exterior.

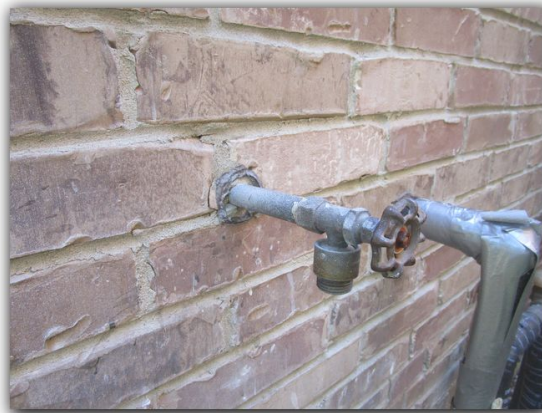
The hose bibs are not fully / properly insulated.

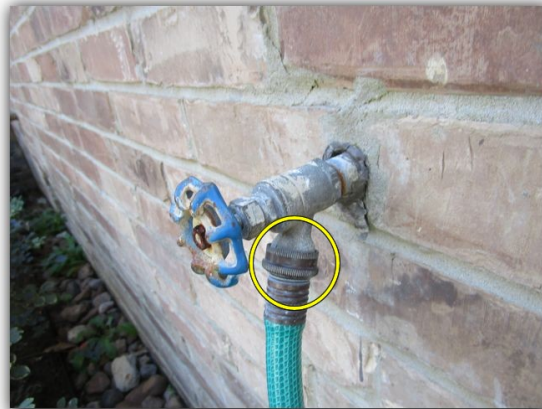
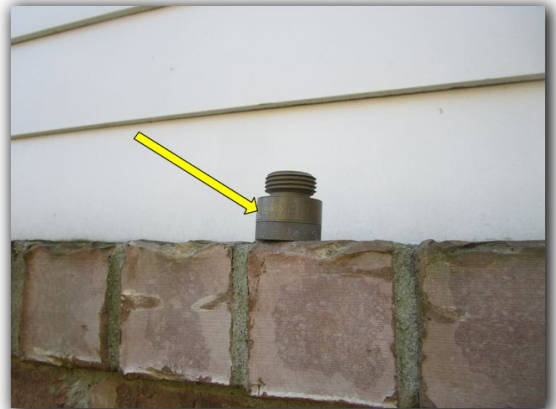
There are anti siphon devices missing at the hose bibs around the home.

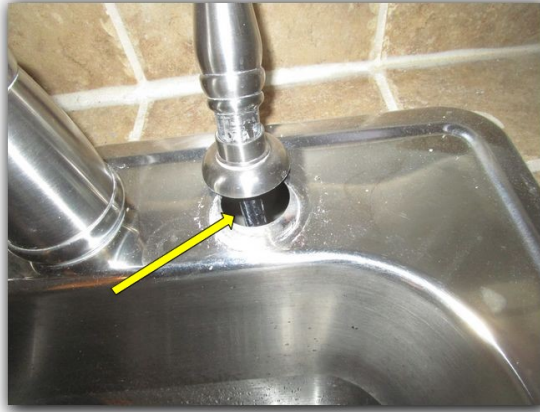
The cover is loose at the base of the sink faucet sprayer, creating an exposed opening to the interior of the cabinet.

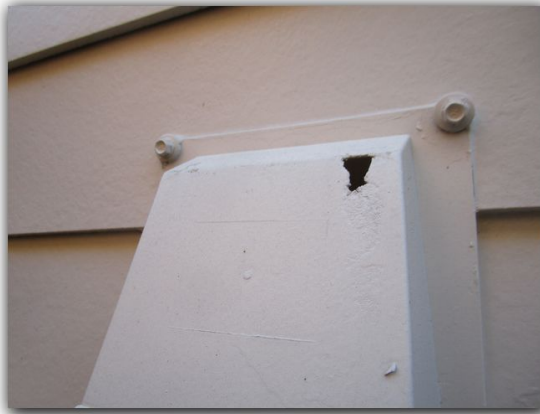
There is damage to the deflecto on the right wall of the home near the rear corner.

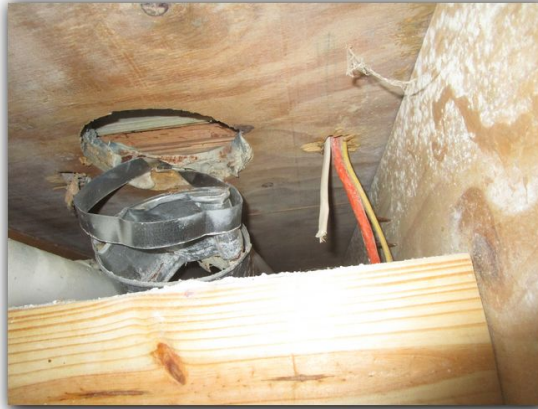
NOTE: There is evidence of a downdraft vent in the crawl space that is not connected to anything in the home, including wiring that is not contained in conduit or a junction box. I recommend asking the seller for any additional information.

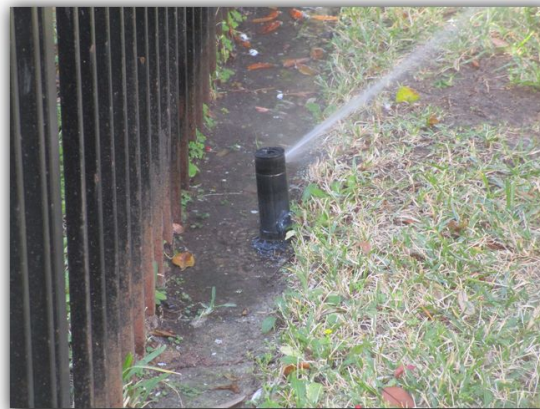
There is a leak at the base of the sprinkler head in zone 1 by the fence.
