12169 MAJEN Inspected Address

1A EXLEY BUTSIT Name of Inspection Company
1B 133297 SPCS Business License Number
1C 312 CEDAR LAKE DR, LIPSBY, TX 77583 Address of Inspection Company
1D NADI BASHIR Name of Inspector (Please Print)
1E Certified Applicator (check one) Technician
2 N/A Case Number (VA, FHA, Other)
3 7-1-19 Inspection Date
4A MLS Mills Name of Person Purchasing Inspection
4B N/A Owner/Seller

TEXAS OFFICIAL WOOD DESTROYING INSECT REPORT

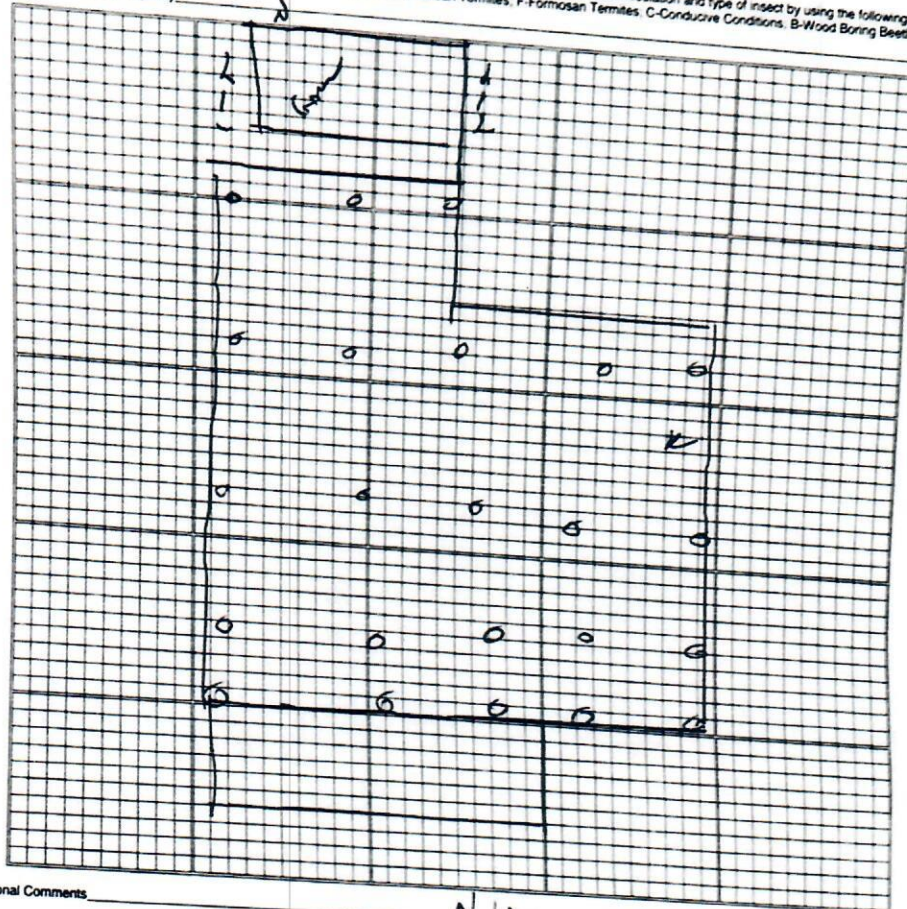
Diagram of Structure(s) Inspected

- 7B. Conducive Conditions include but are not limited to:
Debris under or around structure (K) [] Wood to Ground Contact (G) [] Formboards left in place (I) [] Excessive Moss
Planter box abutting structure (O) [] Footing too low or soil line too high (L) [] Wood Rot (M) [] Heavy Foliage
Insufficient ventilation (T) [] Wood Pile in Contact with Structure (Q) [] Wooden Fence in Contact with the Structure (R) []
Specify: Very low crawl

8G. Visible evidence of: N/A has been observed in the following areas: No Activity AT The time
