J. T. Engineering, Inc.

REFERENCE: CONTRACTOR PERFORMANCE INSPECTION

1714 Seven Maples

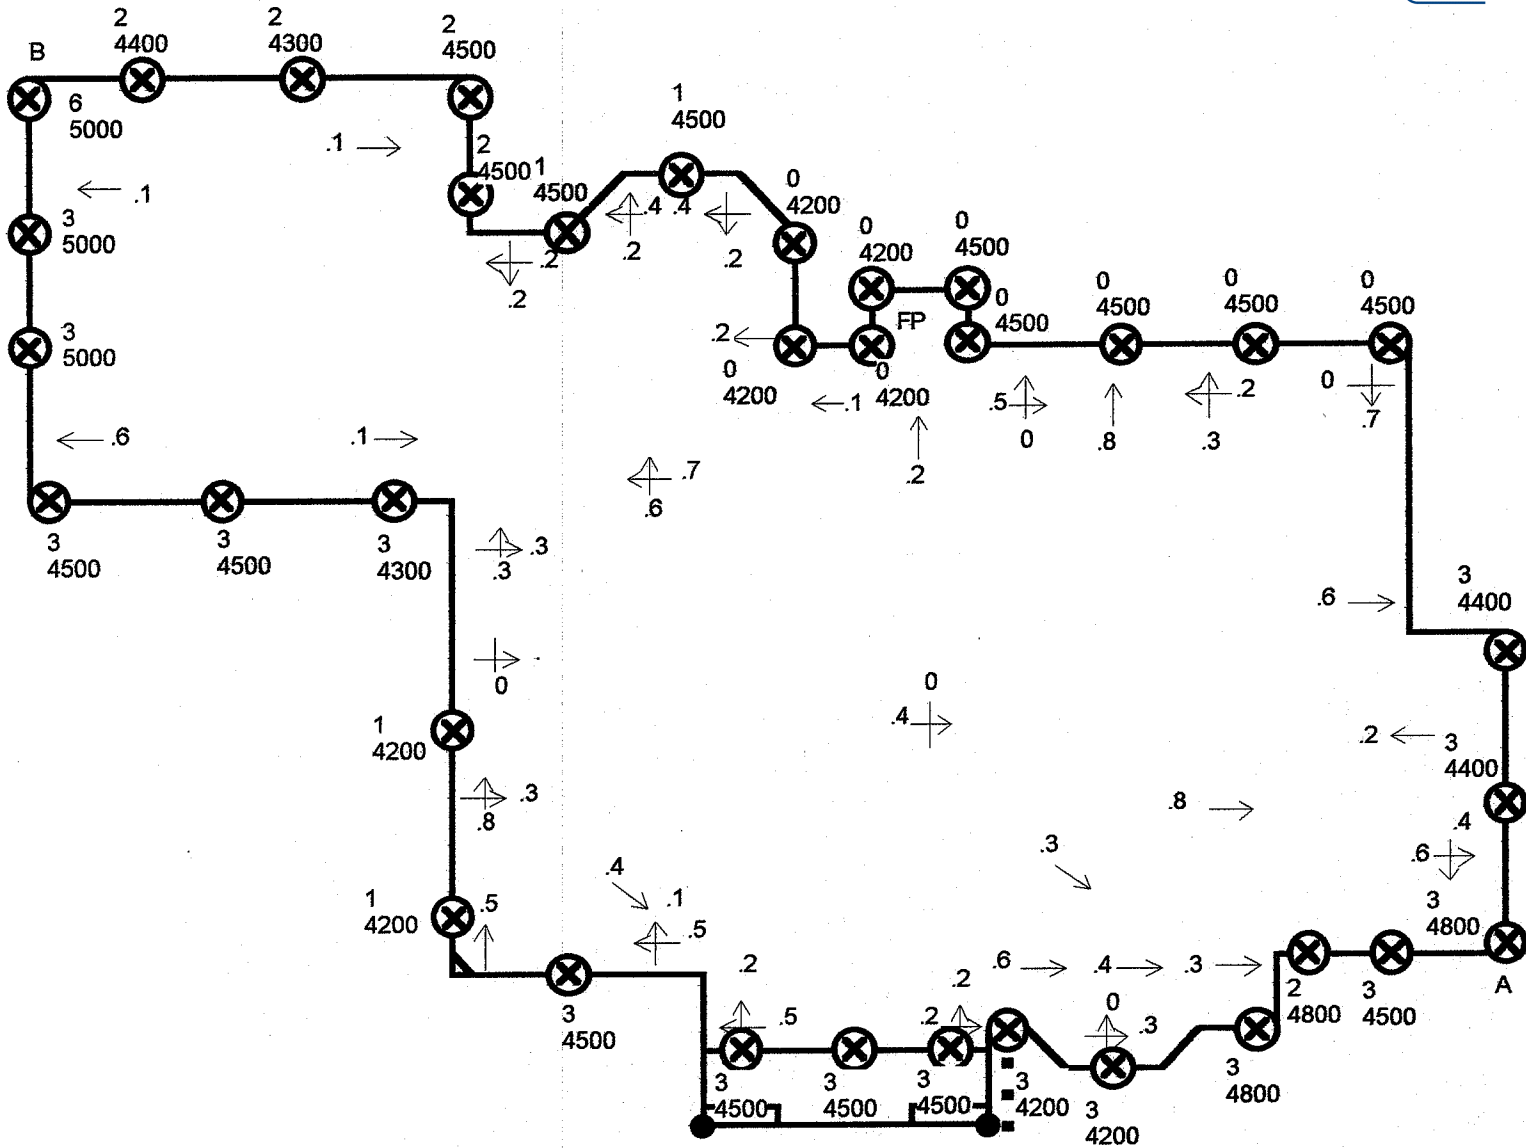
J.T. ENGINEERING		
SCALE: 1"=10'	APPROVED BY:	DRAWN BY: AT
DATE: 7/3/2014		REVISED:
1714 SEVEN MAPLES DR.		
PIER DIAGRAM	DRAWING NUMBER : 2

Medrano Foundation probed the ground to find the location of the existing piers. Thirty-five piers were located. Each pier was excavated so the vertical blocks and the transition block were exposed. The presence of pushed piers was documented. Their locations are on Drawing 2. There is a significant void under the house. A drain line from the center of the house is to be installed.

Two piers, one on the front right corner (A on the Drawing 2) and the other at the rear left of the garage (B on the Drawing 2) were excavated to find the depth of the penetration of the pushed piles. The soil at the front excavation was a very stiff grey clay. The rear however had softer clay stiff gray clay. At both locations there were three

concrete pushed cylinders for a total penetration of 4'8" A twenty ton hydraulic jack was installed and pressure applied to see if the house would move upward at that penetration. The front right pushed up holding the load. The rear garage did not. Additional piers were pushed till refusal of the jack to push any further in and the house would rise. The number of cylinders added and the hydraulic jack pressure reading at refusal is shown on Drawing 2. Upon re-driving a new transition block was added because the existing ones were not acceptable and two cylinders were added above the transition block (the previous foundation installation had only one which is not acceptable. Two new piers were installed under the two columns on the front porch.

The concrete slab was level as close to level as the structure of the house would permit. This has reduced the stress on the superstructure. The house is now structurally sound. Final slope readings are shown on Drawing 2 and are within acceptable tolerances

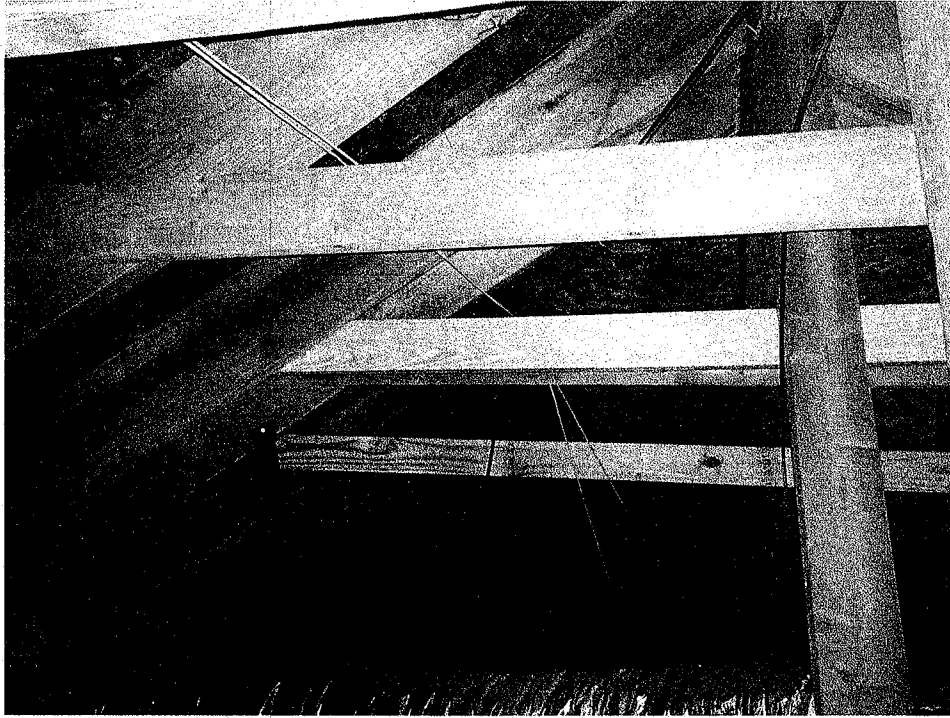
Photo 1: New Collar Beams Installed.

Photos 1 and 2 shows the collar beams that were installed to return the structural integrity of the roof structure. Photos 3 and 4 shows where sheetrock cracks had been taped and floated. The void under the house was drained by installing a 4" drain line from the center of the house, under the lawn, and to the street

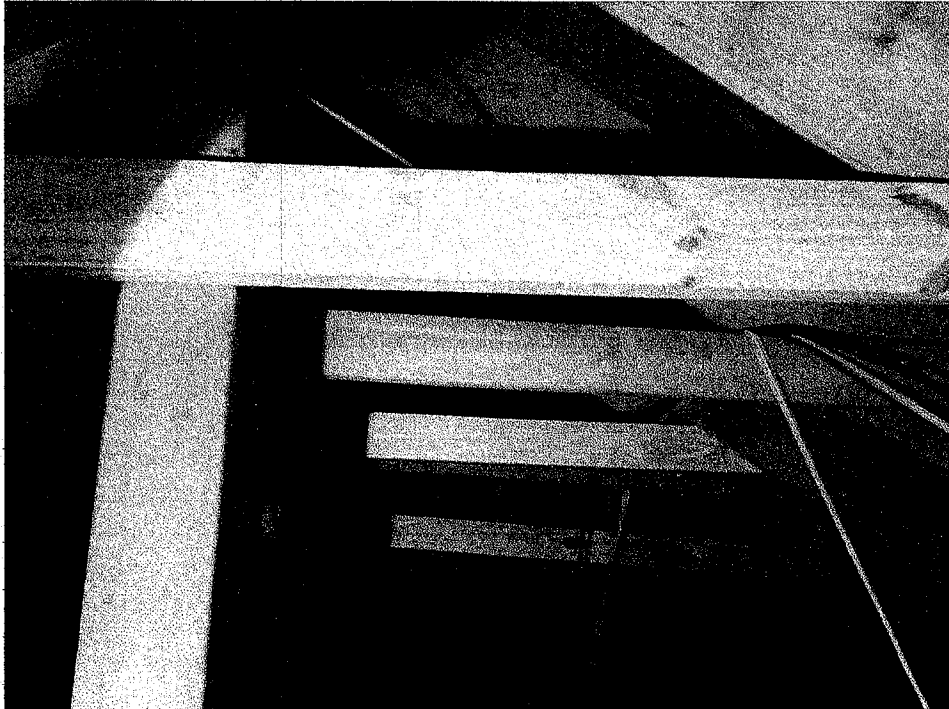
Photo 2: New Collar Beams Installed.

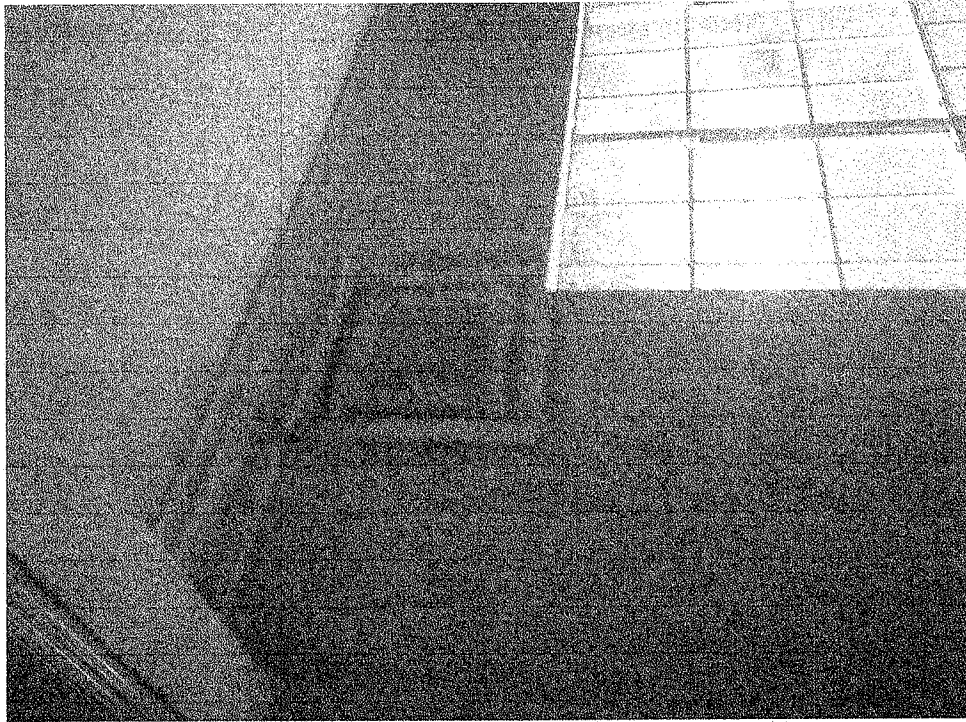
Photo 3: New Tape and Floating of Sheetrock.

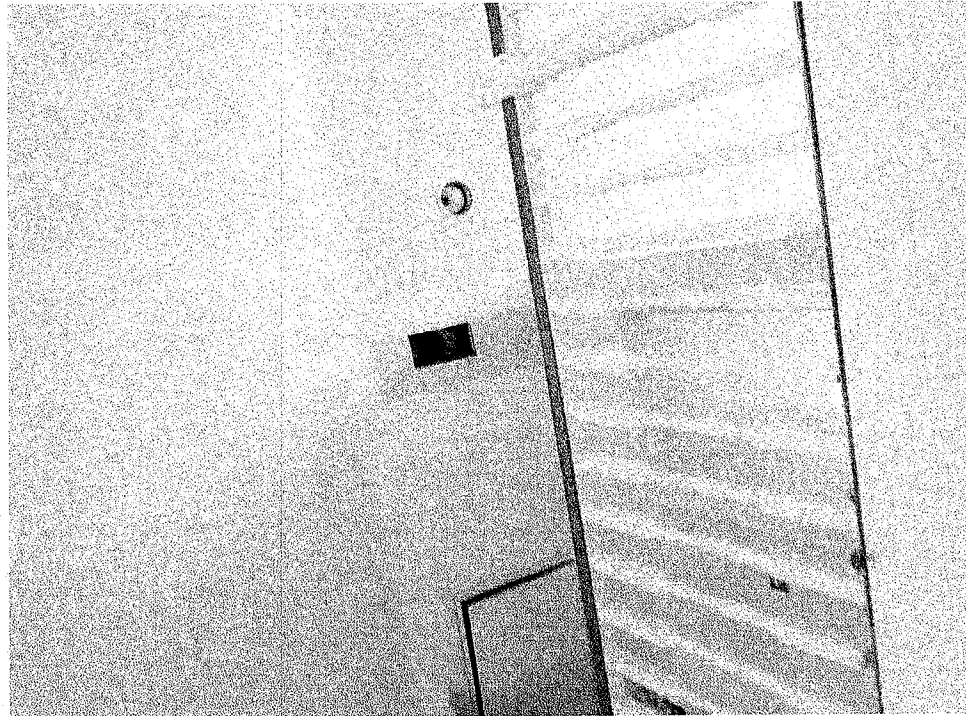
Photo 4: New Tape and Floating of Sheetrock
