PROPERTY INSPECTION REPORT

Prepared For:	Eloise Palomares	
r roparou r or.	(Name of Client)	
Concerning:	g: 803 Grand Plains Drive , Houston, TX 77090 (Address or Other Identification of Inspected Property)	
Ву:	Dale Hall Lic.#: TX #21144 (Name and License Number of Inspector)	07/17/2021 (Date)
	(Name, License Number of Sponsoring In	nspector)

Report Identification: 521082-583

PROPERTY INSPECTED: 803 Grand Plains Drive Houston, TX 77090

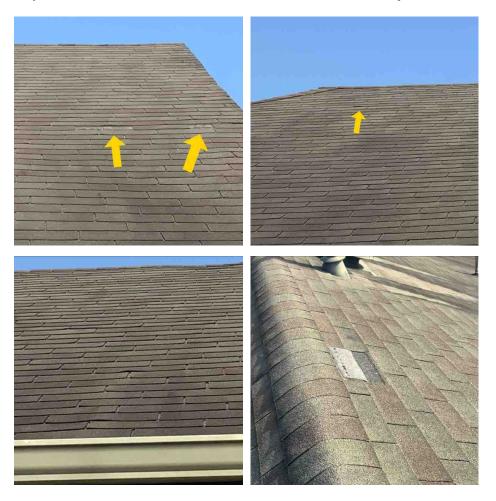
- Request receipt / paperwork from sellers regarding any re-shingling for Your insurance and warranty purposes.
- There are some raised shingles or flashing, some times called nail pops or a lack of adhesion. These all should be sealed down to help prevent wind/ water damage. Minor repairs to the roofing are recommended, examine and seal roof as required.

Replace missing shingle tabs.

A qualified roofer/ contractor should be consulted to rectify.

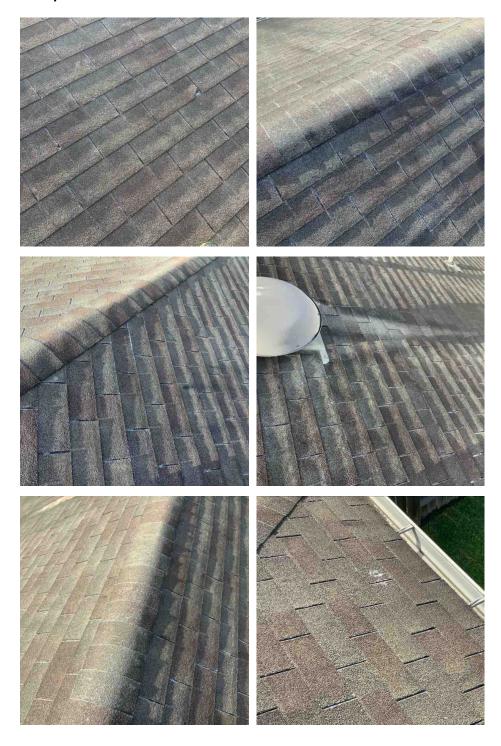
Roofing is older. Nearing end of life expectancy, There are spots missing granules (these are for uv protection) Misc types of damaged noted.

If you contact a roofing contractor. Please use a trusted one. Get multiple bids.

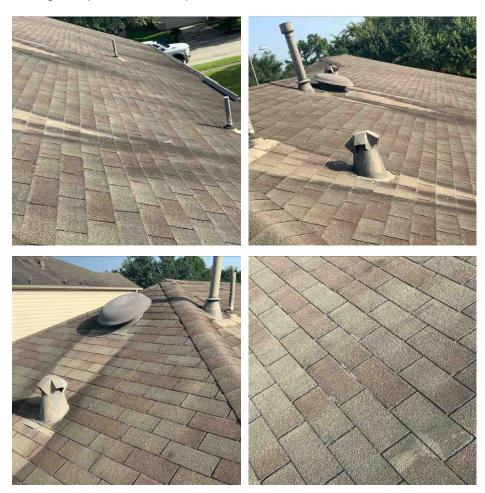
Make sure that roof valleys and gutters are kept clean seasonally from leaves & debris. Also, ensure that tree branches are not rubbing against walls, eves and roof. Monitor the roof and attic on a seasonal basis for leaks and (wind) damage. Repair as soon as possible.

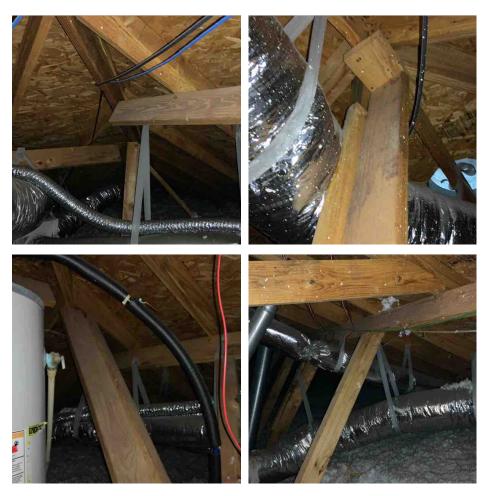
• Roof structure is conventional wood framed, supported by the interior and exterior walls. It appears stable and to be performing as intended at this time. This is a standard method of construction. (Exceptions will be noted)

Ventilation: Roof and soffit vents appears to be of the time period. There is no evidence of excessive moisture in the attic. Insulation in attic appears to be adequate. (exceptions will be noted)
