PROPERTY INSPECTION REPORT

Prepared For: Andrew Michon
(Name of Client) File Name CS-8917

Concerning: 24722 Double Lake Dr., Missouri City TX 77459
(Address or Other Identification of Inspected Property)

By: Clint Simon TREC 5550 2-27-2020
(Name and License Number of Inspector) (Date)

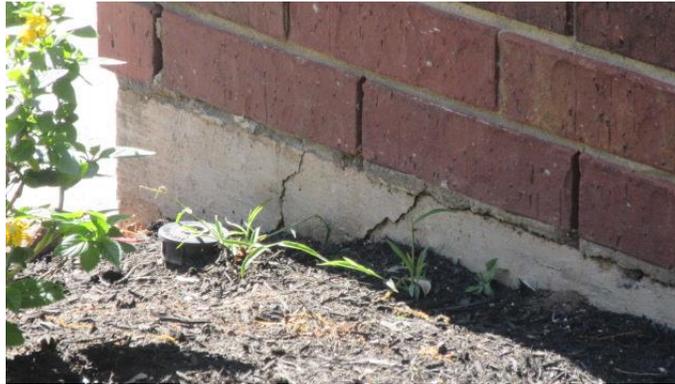
- Slab has experienced signs of settlement as evidenced by cracks in the grade beam, brick veneer.
- Foundation cracking was observed.
- This implies that structural movement of the building has occurred. The rate of movement cannot be predicted during a one-time inspection.
- A structural engineer should be consulted to further evaluate this condition and the remedies available for correction.
- Corner cracks were observed and should be repaired.

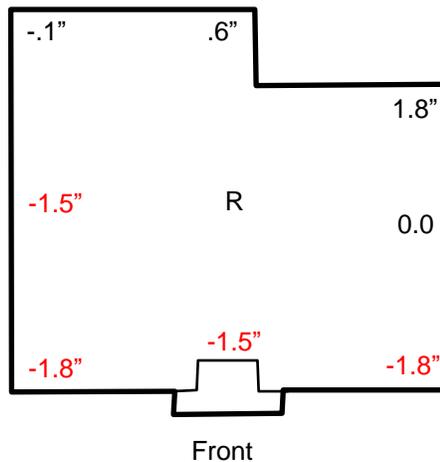
- See measurements below of the slab at the time of the inspection.

R is reference point = Zero

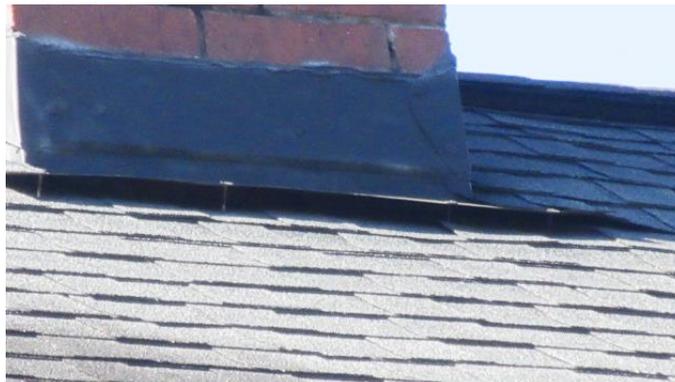
- Missing aggregate noted on shingles throughout rooftop.
- Raised flashing at the chimney, recommend repair.

- Repairs are recommended in the short term to maintain the weather tightness of the roof.
- Observed no active water penetration at the time of the inspection.

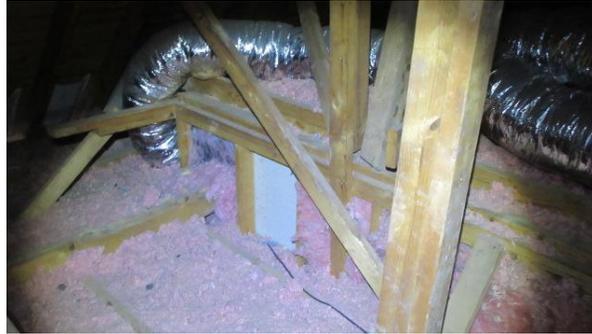
- Size purlins (2x6) installed at (2x6) rafters.
- Adequate attic ventilation at house noted.
- **Missing and / or displaced attic insulation noted (exposed sheetrock).**

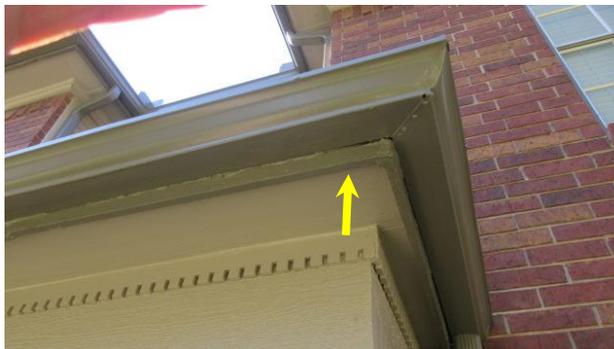
- **Observed damaged wood trim at the front of the house behind the gutters, replacing all damaged wood trim is recommended to prevent further damaged to structure.**

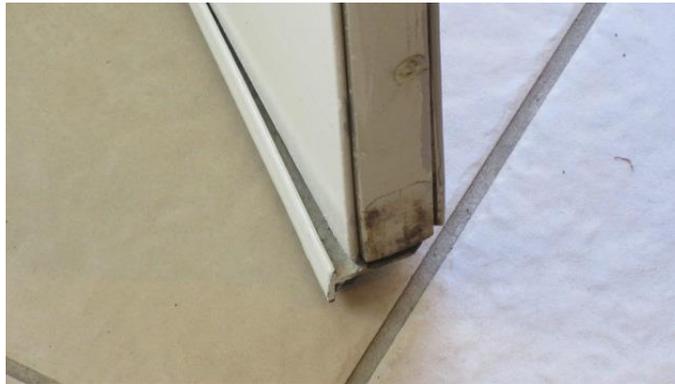
- Bottom seal at the rear patio door is loose and should be repaired.

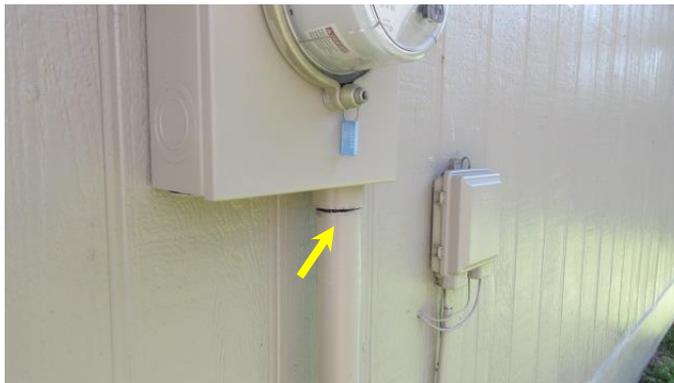
- Conduit at the main meter on the back side of the garage is loose and should be securely mounted, recommend repair.

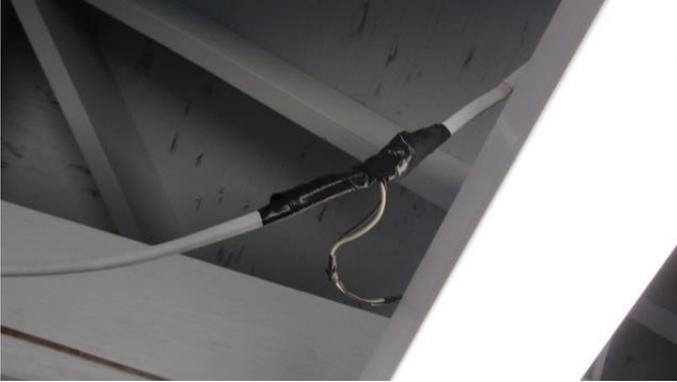
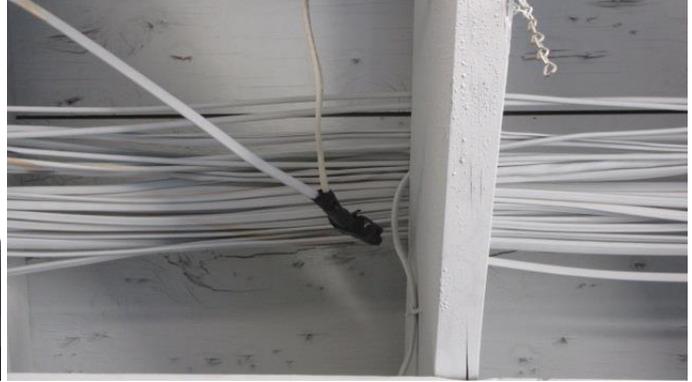
- Improper termination of wires noted in the garage, all electrical connections should be in J-boxes, recommend repair.

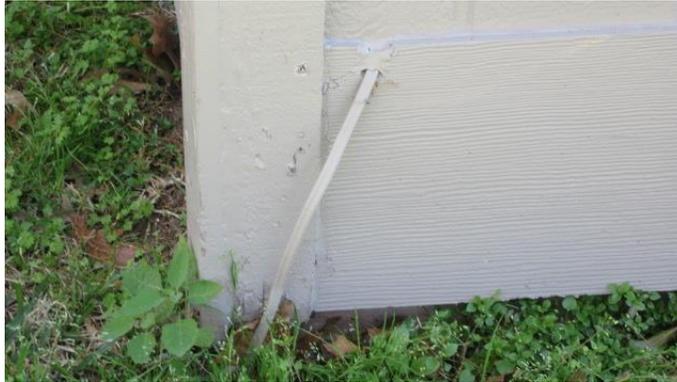
- Improper termination of wiring noted at the back side of the garage to the gazebo, all electrical connections should be in conduit / J-boxes, recommend repair.

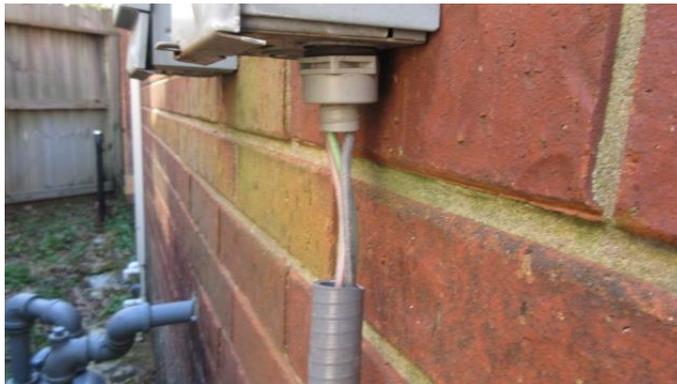
- Exposed electrical noted at the rear condensing unit shutoff j-box, recommend repair.

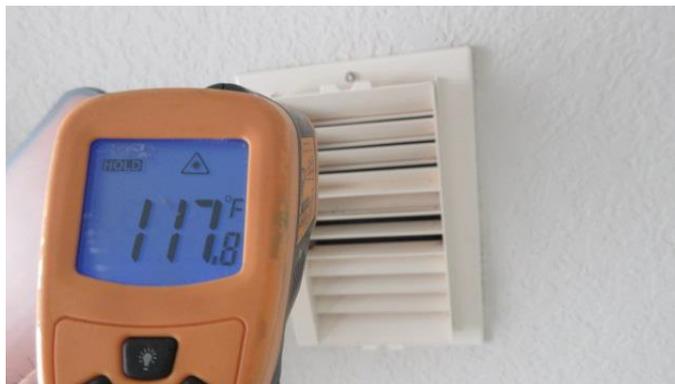
- Rust in burner compartment noted, recommend repairs, service, and a complete inspection of the Heating System / **exchanger** by a licensed Heating & Cooling service.
- Heating Unit appeared to be functioning as intended at the time of the inspection.
- Observed 117 degrees at supply registers.

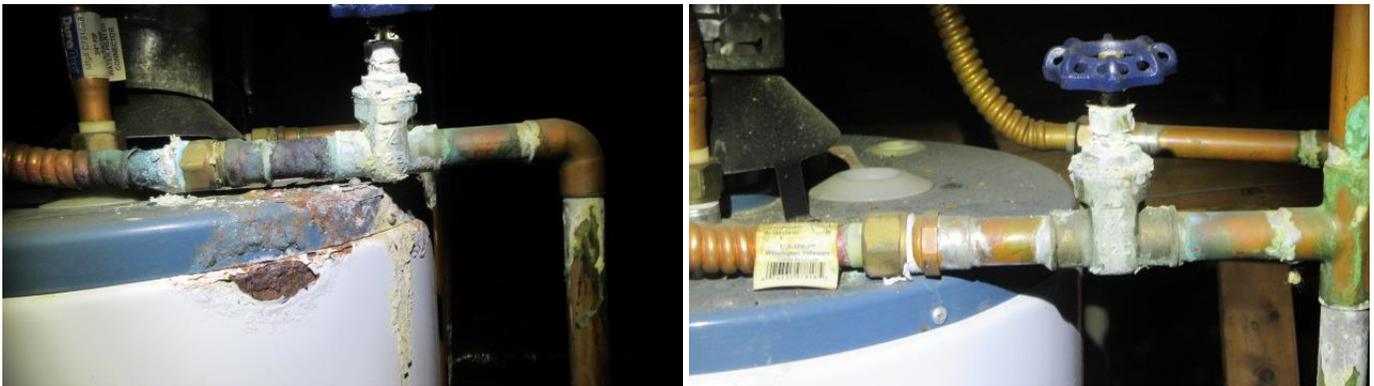
- 2 - 40 Gal. Units / 2006 & 2007 model
- Located in attic
- The water heaters are older units that could be approaching the end of its useful life. It would be wise to budget for new units in the future. One cannot predict with certainty when replacement will become necessary.
- The supply piping shows evidence of corrosion at the top side of the water heaters. This should be repaired.

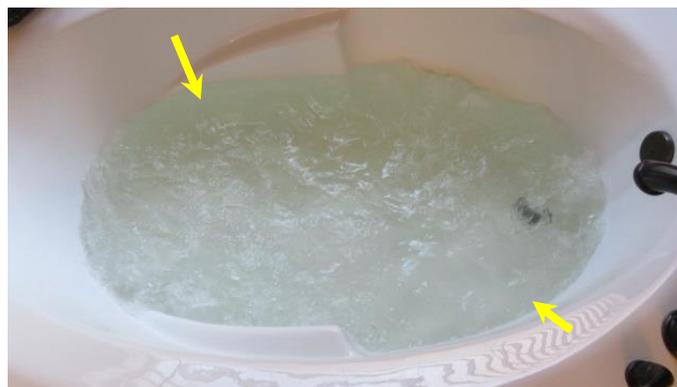
- Unit was not functioning properly, air should be blowing around the entire tub, recommend repair.

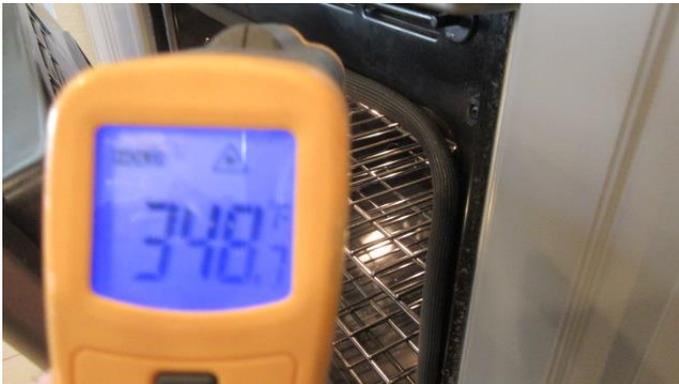
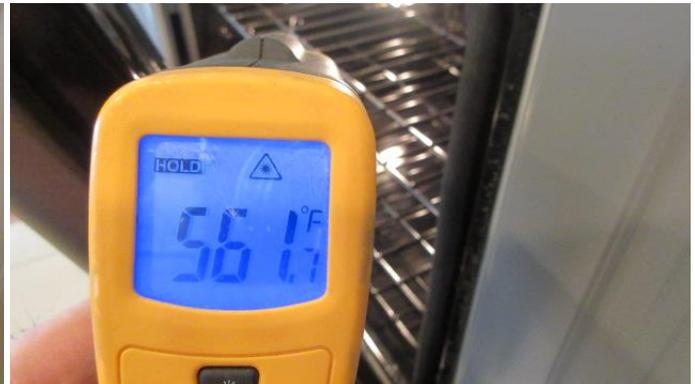
- Electric range top & electric oven.
- Baking mode set at 350 degrees - plus or minus 25 degrees / Broiler mode set at 500 degrees.
- **Oven:** Baking mode reads 348 degrees. Broiler mode reads 561 degrees.
