# PROPERTY INSPECTION REPORT

**Concerning:** 7534 Rosepath Ln., Richmond, TX 77407  
(Address or Other Identification of Inspected Property)

**By:** Sam Hestand, Lic #24118 06/11/2021  
(Name and License Number of Inspector) (Date)

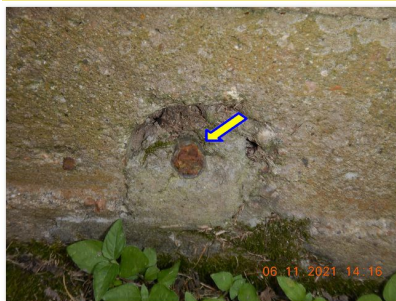
Exposed or deteriorated slab reinforcing or rebar observed

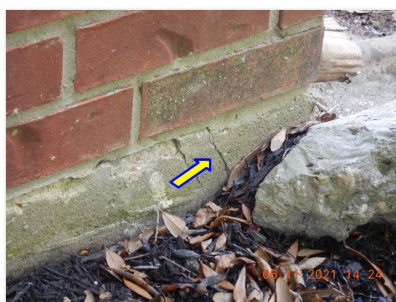
Corner fractures (possible insect penetration)

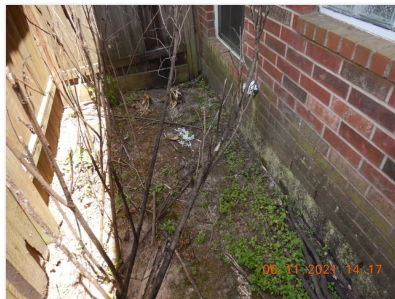
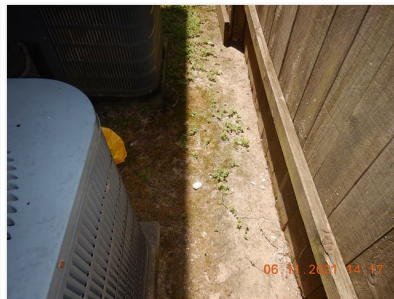
Evidence of ponding water was noted.

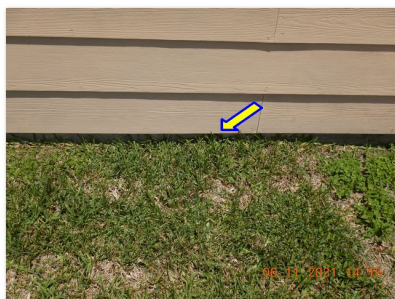
High soil levels exposed under wood surfaces.

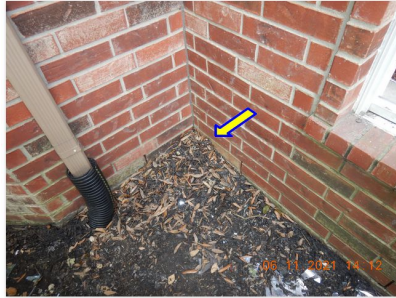
Lower mulch levels at the planting beds

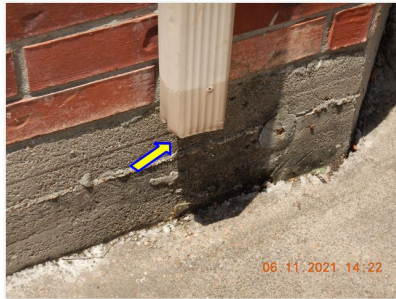
Gutter downspout directional diverters missing

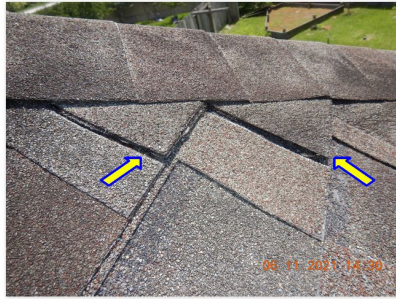
Scuffed and/or damaged shingles were noted at various locations.

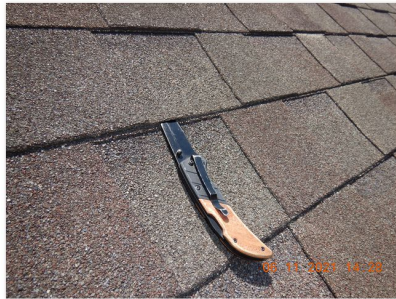
Lifted shingles were noted at various locations.

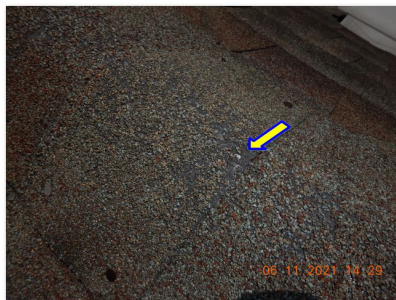
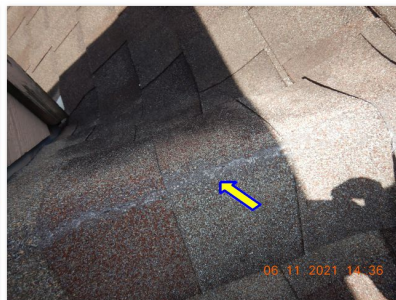
Excessive aggregate loss observed at ridge cap shingles was noted.

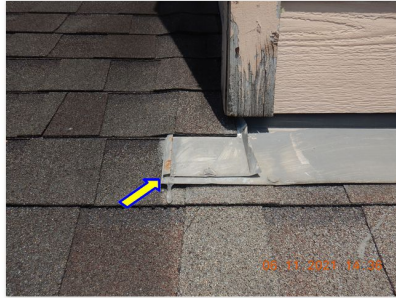
J flashing was used to seal the junctions between the roof's surface and the side walls. Step flashign should have been installed.

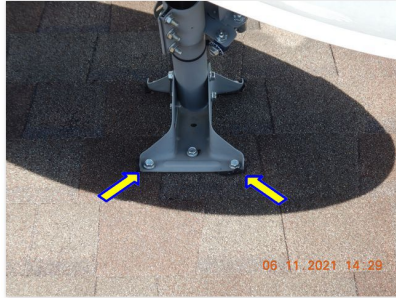
Satellite dishes have been installed on the roof. These penetrations should be caulked at the fasteners.

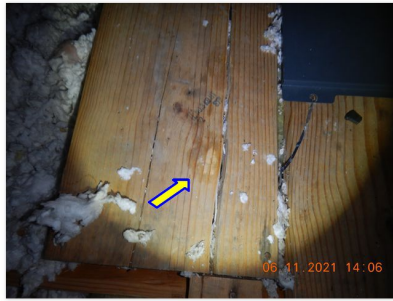
Evidence of moisture stains was noted.

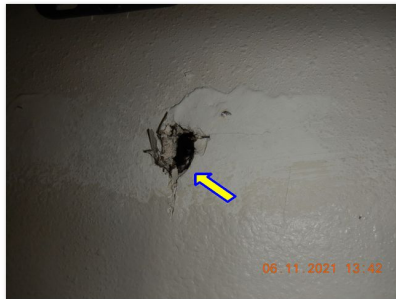
Cracks/damage/repairs in the drywall observed were noted. Some Examples: Master bedroom, Master bathroom, Back right addition, Back left addition, Laundry room, 2nd floor back left bedroom.

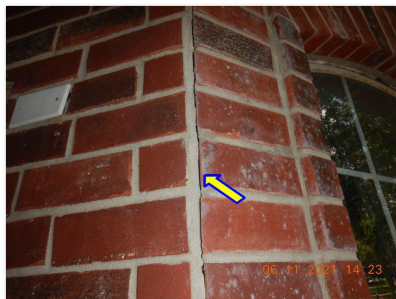
Cracks observed in the brick veneer and/or mortar.

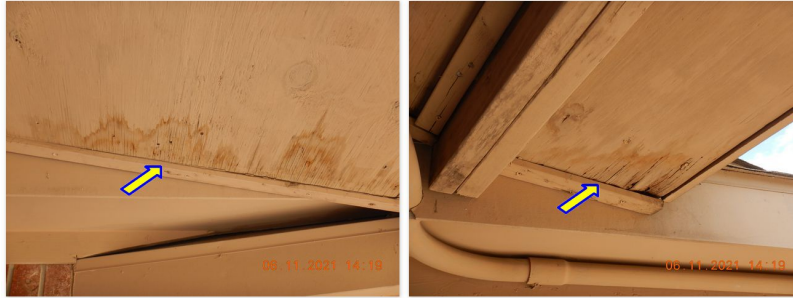
Moisture stains/damage were noted at the back patio ceiling covering.

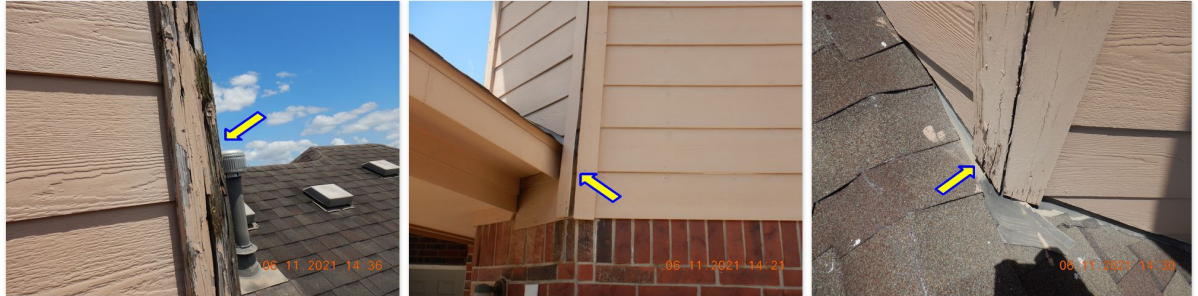
Cement board siding and/or trim damaged at various locations.

Exterior siding did not meet the current standard of 4 - 6 inch clearance from grade at the time of the inspection.

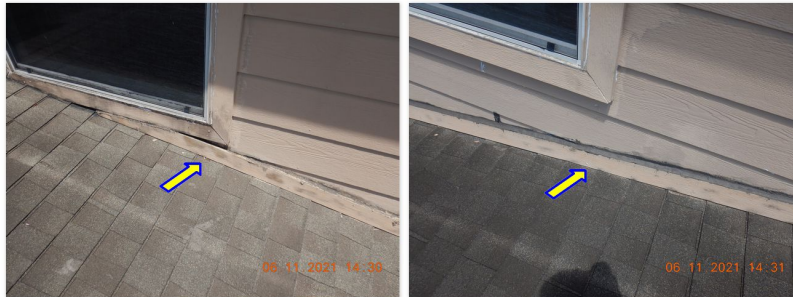
Exterior siding is in contact with the roof. Separation between the siding and roof covering will minimize moisture entrapment and deterioration of the siding.

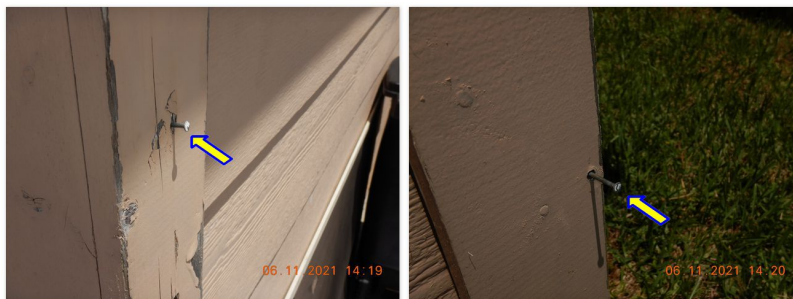
Several nails are backed out. All nails should be pitted and caulked over.

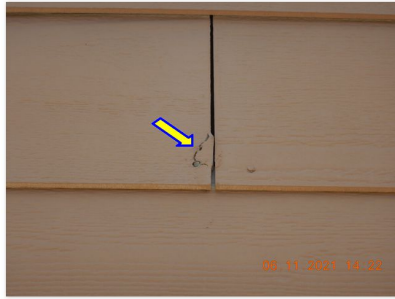
Cement board siding damaged at corner fasteners.

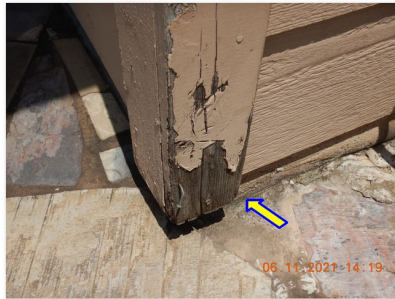
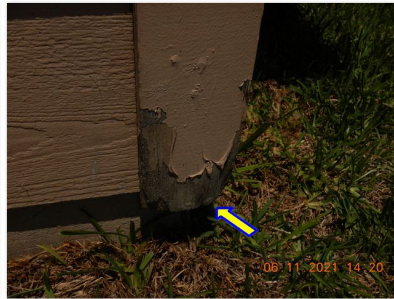
Peeling paint observed was noted.

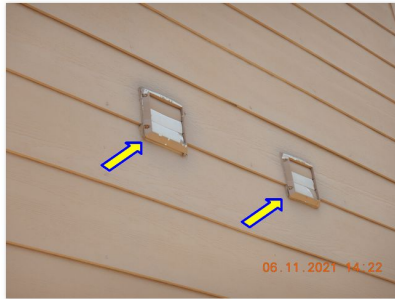
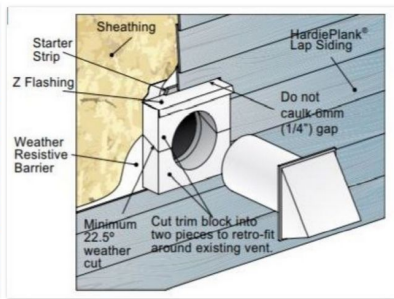
Holes and penetrations in the cement board larger than 1.5 inches are required to have flashed mounting blocks. For example: dryer vents – kitchen fan vents.

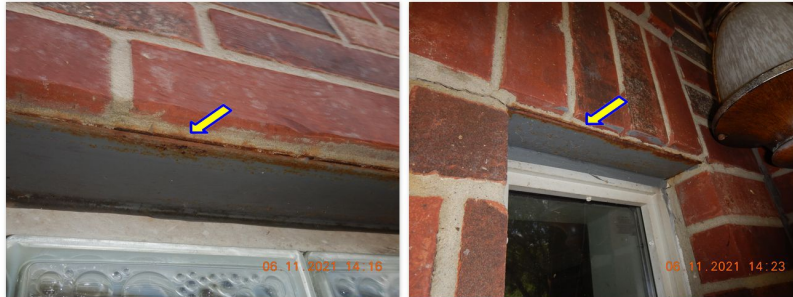
Metal lintels are rusting above the doors and windows.

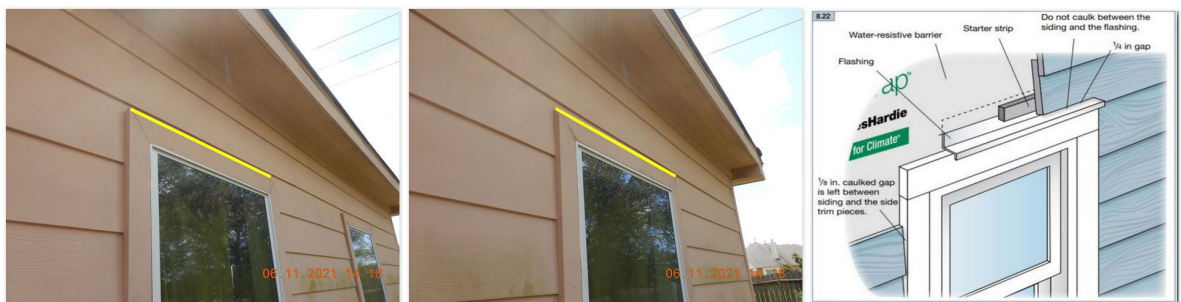
The window and/or door and/or other wall penetrations installed through the wood fiber products siding were not properly flashed.

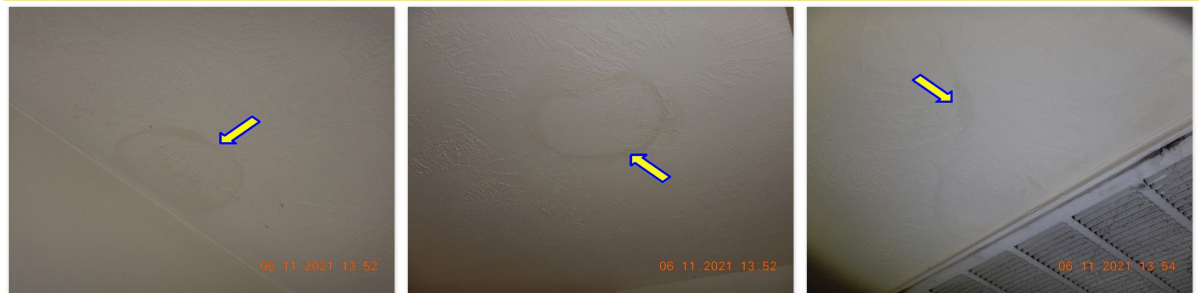
Evidence of moisture stains observed. Some Examples: Kitchen, 2nd floor game room, 2nd floor left hallway.

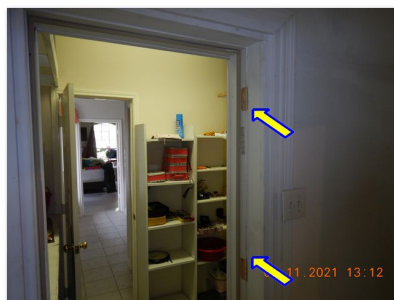
- Door missing at the following locations: Back right addition.

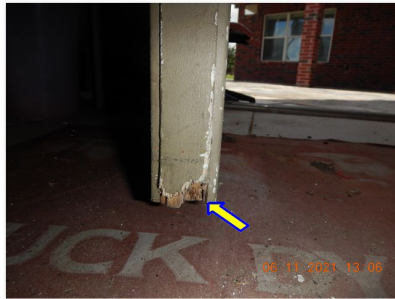
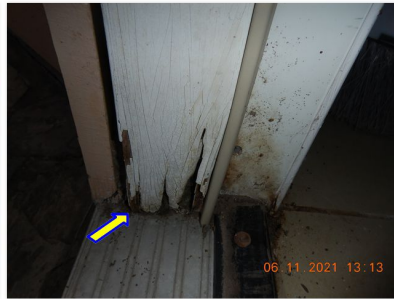
Door and/or door jamb damage was noted at the following locations: Garage entry, Back door.

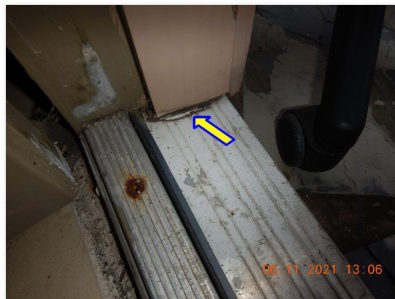
Caulking around the door missing or deteriorated was noted. Some Examples: Garage entry, Back door, Front entry door, Back addition door.

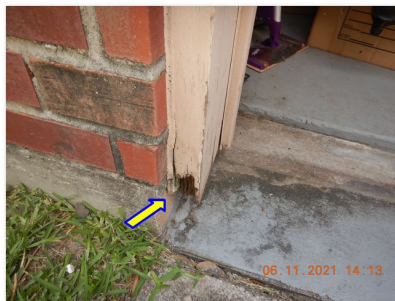
Garage door jambs deteriorated from weathering.

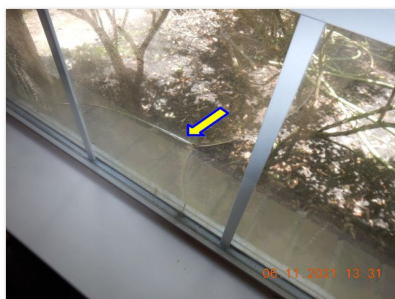
Broken windows observed at the following locations: Master bathroom.

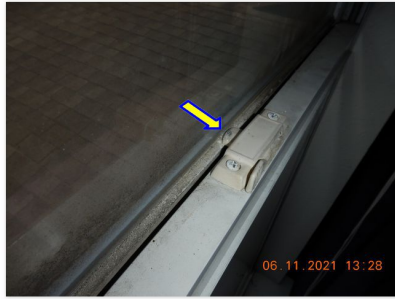
Window locks misaligned at various locations.

Window springs inoperable or detached at various locations.

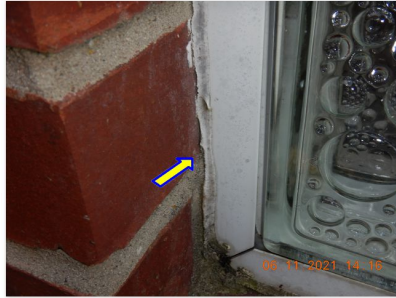
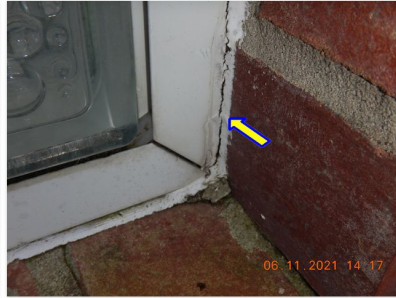
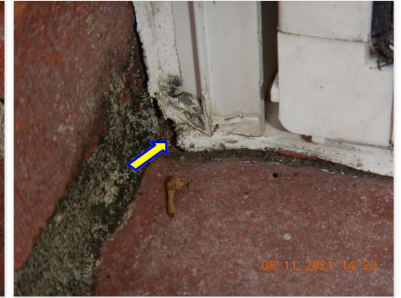
- Caulking around exterior windows deteriorating.
- Window screens missing at various locations.

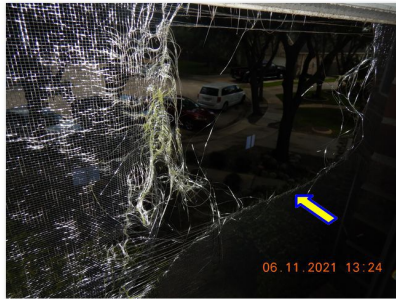
- Holes in the window screens observed at various locations.

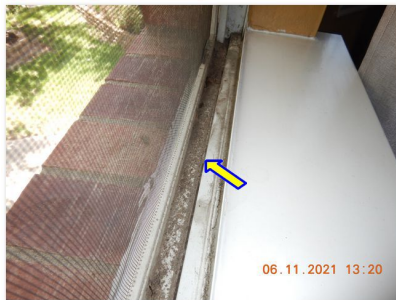
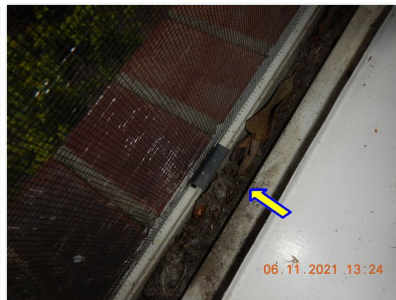
- Window drainage ports obstructed with dirt and debris. Window drainage ports and other components should be cleaned on an annual basis. Otherwise, drainage ports can be blocked allowing water to back up into the wall area below the windows.

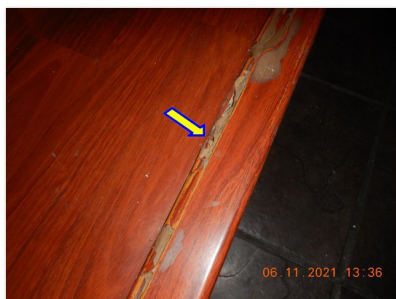
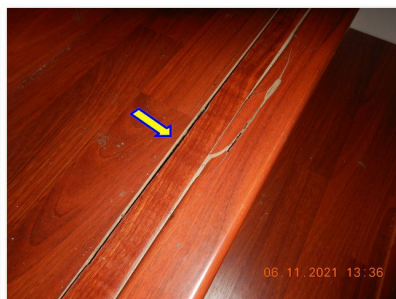
- Several of the stair treads are damaged.

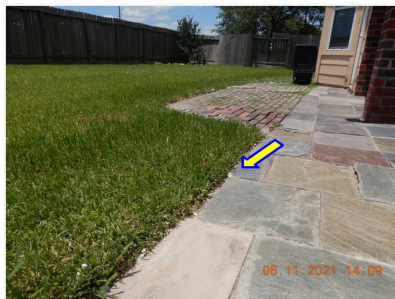
The back patio's floor is near grade (soil level).

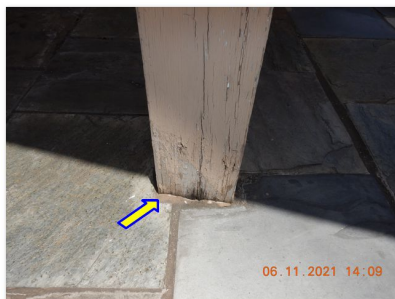
Base of the columns are in direct contact with the flatwork. These can deteriorate over time due to water accumulating around them.

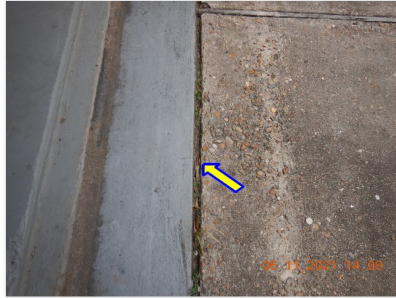
The expansion joints in the driveway and walk way are open. Open expansion joints can allow water to get under the concrete surface and expand or wash away the soil causing lifting or settling of the concrete. I recommend filling the expansion joints with an approved expansion joint material.

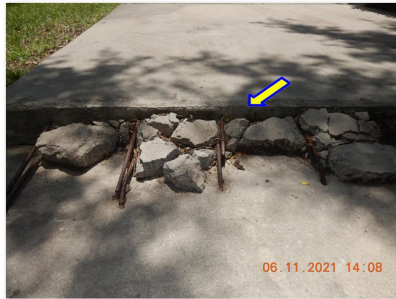
The front driveway concrete is deteriorated and the reinforcement bars are visible.

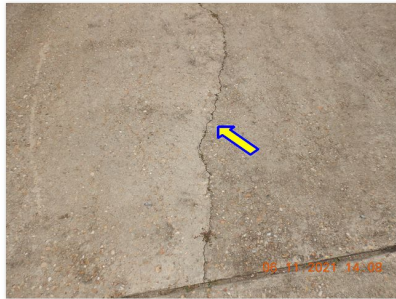
Settlement cracks observed at the flatwork at the following locations: Driveway.

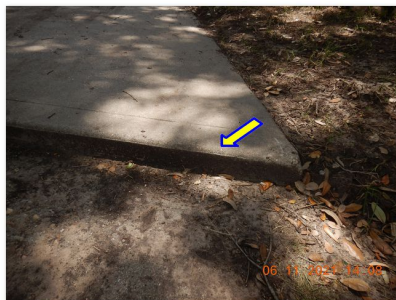
Flatwork joints offset at the following locations: Driveway, Back patio. This poses a possible tripping hazard.

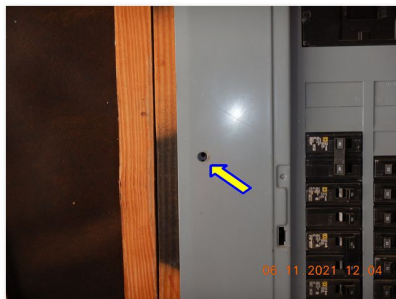
The service equipment disconnecting means panel board dead front cover is missing one or more set screws.

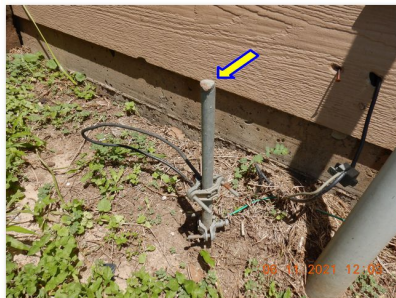
The grounding electrodes should be driven to below top surface of the soil.

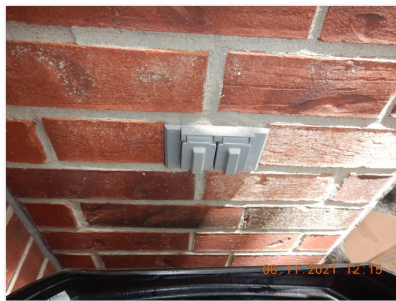
☑ Receptacles are not GFCI protected at the following required locations: Laundry room, Front exterior, Back exterior, Garage.

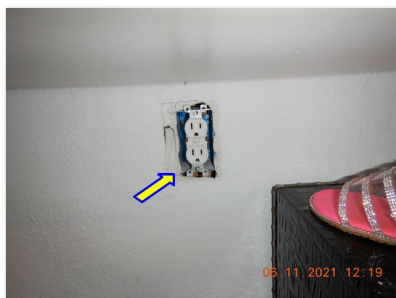
☑ Receptacle cover plates observed missing at the following locations: Back right addition closet, Back patio, Garage.

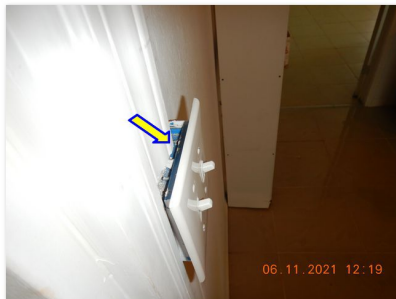
The back right addition switch is not flush mounted on the wall.

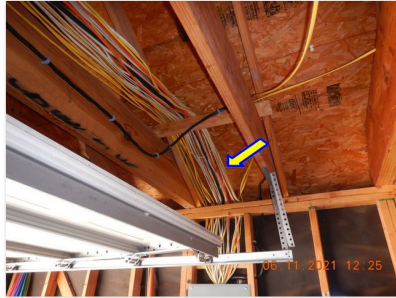
Branch circuits are bundled at the following locations: Garage. Bundling of conductors for more than 24 inches without maintaining spacing and are not installed in raceways, the allowable ampacity of each conductor shall be reduced as shown in IRC Table E3605.3.

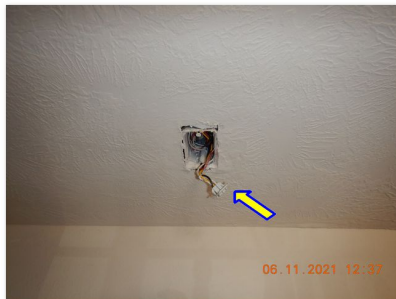
Smoke alarms missing at the following locations: 2nd floor left hallway.

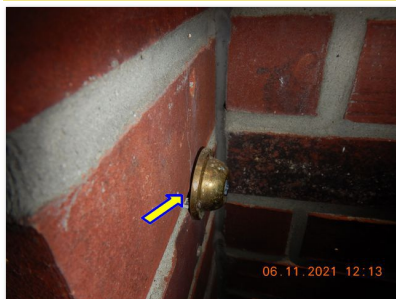
Door bell button is loose at the interior.

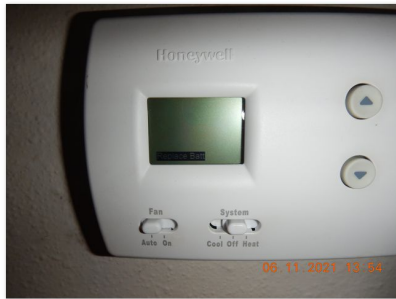
The 2nd floor unit could not be tested due to the batteries being dead in the thermostat.

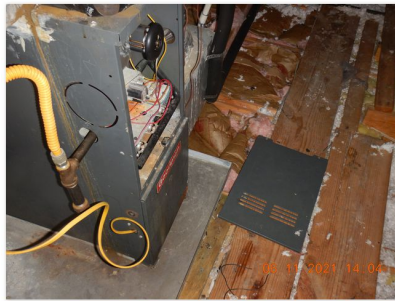
- One of the HVAC covers was removed at the time of inspection. Rust was noted at various locations on the equipment.
- HVAC systems should be inspected and serviced by a licensed technician per manufactures recommendations or on a bi-annual basis. If unable to obtain service records from current owner, buyer should consider having units serviced by a qualified and licensed professional.

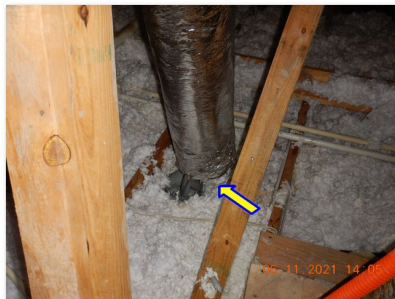
☑ Ductwork damaged or disconnected and blowing into the attic.

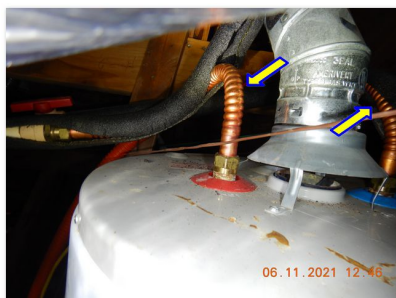
Hot and cold water lines should be insulated within 5' of the unit.

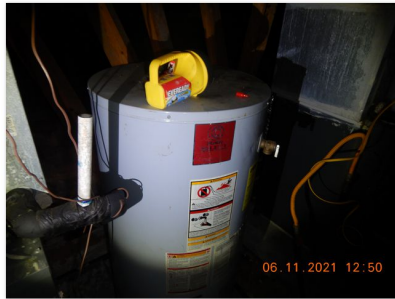
The old water heater should be removed from the attic.

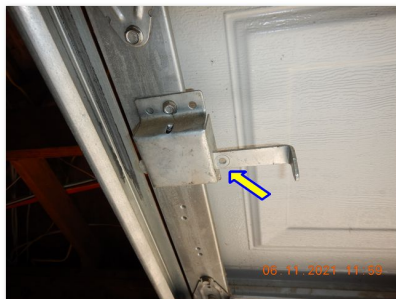
Disable or remove the garage door manual lock.
