## RESIDENTIAL INSPECTION REPORT

2380 Marina View Way  
League City TX 77573

# PROPERTY INSPECTION REPORT

Concerning: 2380 Marina View Way, League City TX 77573

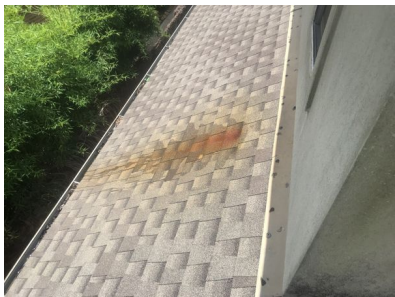
Roof shingles were discolored, which can be caused by moisture, rust or soot. Evaluation and/or repair by a qualified roofing professional.

Recommendation: Contact a qualified roofing professional.

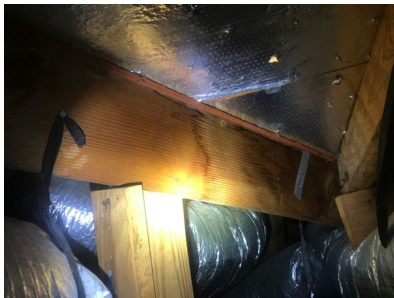
**1: Sheathing: Evidence of Prior Moisture**  
➔Recommendation  
Evidence of prior moisture intrusion was observed. Evaluate and remedy as needed.  
Recommendation: Contact a qualified roofing professional.

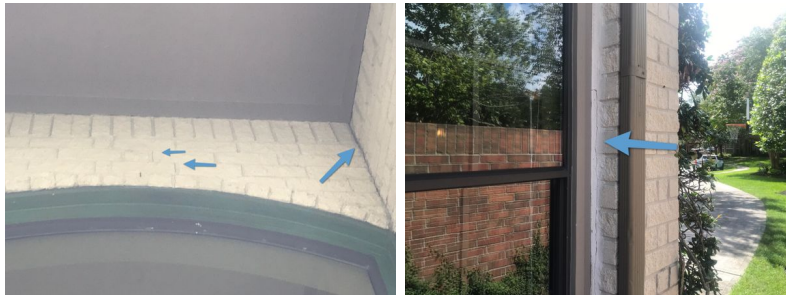
#### **2: Exterior Masonry: Minor Brick Cracks**

Cosmetic hairline cracks were observed in the masonry siding. Hairline cracks may be a result of thermal expansion of the veneer and/or normal structural movement. Monitoring is recommended.

Recommendation: Recommended DIY Project

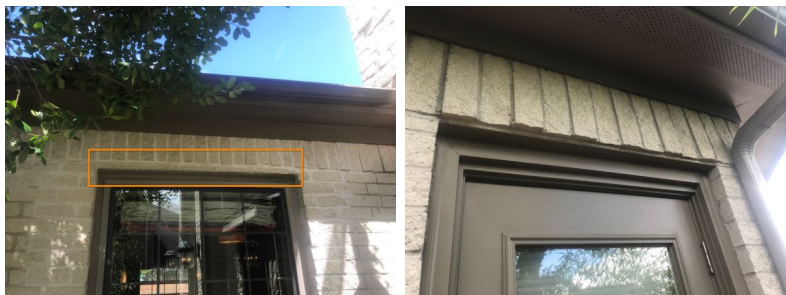
### 3: Exterior Masonry: Weep holes not present over openings

Weep holes were not installed in brick above steel lintels over windows and/or doors. Modern practices often utilize weep holes to prevent rusting of steel lintels supporting brick. If there is visible moisture damage to steel lintels or other building materials around these openings then this condition should be evaluated by a brick mason for possible correction. Otherwise the area should be monitored periodically.

Recommendation: Contact a qualified professional.

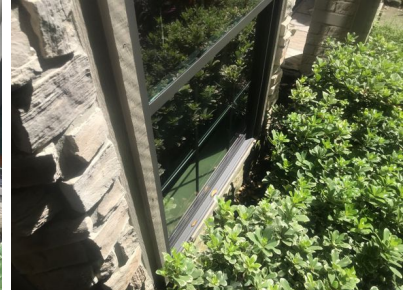
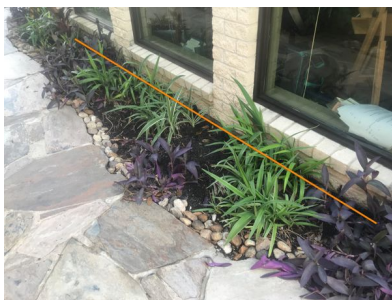
A high soil level was observed. The foundation should have at least 4 inches of exposure. Remedy as needed.

Recommendation: Contact a qualified landscaping contractor

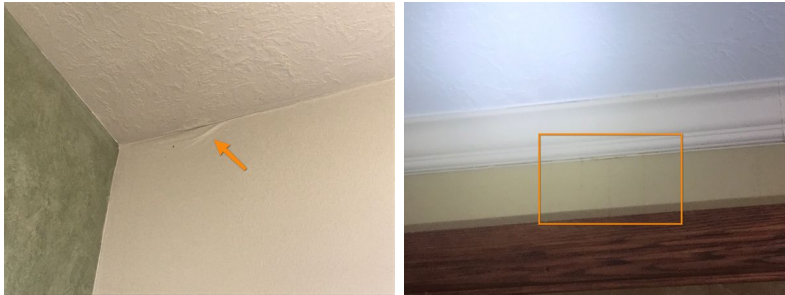
**7: Interior: Evidence of Previous Moisture Contact**

Wall structure showed signs of previous water intrusion. Tested negative for moisture at the time of the inection. Evaluate and remedy as needed.

Recommendation: Contact a qualified professional.

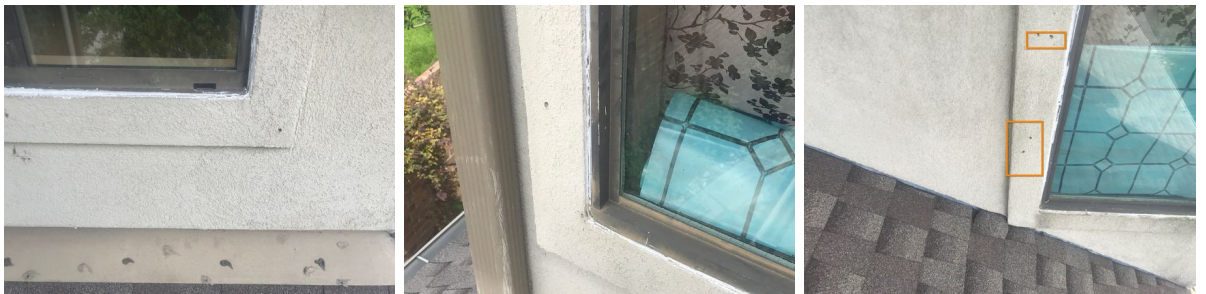
#### 8: Stucco: Multiple Stucco/EIFS Deficiencies are Present

Caulking Damaged, Surface Damage -

Due to deficiencies identified with the Stucco and/or EIFS siding on the home, further evaluation by a qualified party is recommended. Bryan & Bryan offers invasive inspections of these products using inspection methods and tools not available during a standard home inspection. This type of inspection is known as a Building Envelope Moisture Inspection, and can be scheduled through our office. By not investigating these deficiencies further, you release Bryan & Bryan Inspections from all future liability due to deficiencies with the Stucco/EIFS siding, both identified and not identified within the Inspection report.

Recommendation: Contact a stucco repair contractor

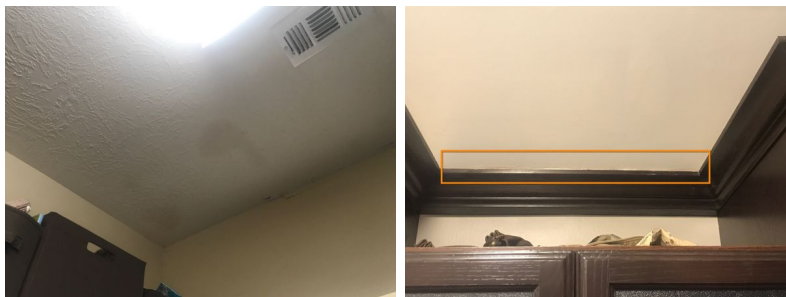
## 2: Ceiling: Evidence of Previous Moisture Contact

Wall structure showed signs of previous water intrusion. Tested negative for moisture at the time of the inspection. Evaluate and remedy as needed.

Recommendation: Contact a qualified professional.

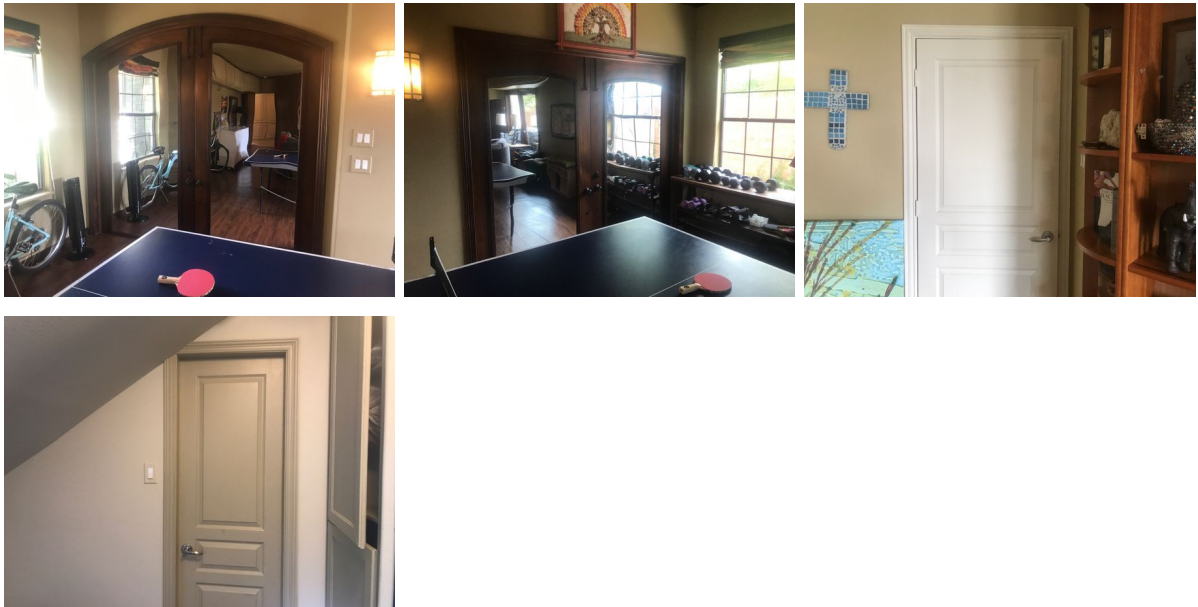
**4: Door: Sticks/Difficult to Operate**

Door sticks and is tough to open. Remedy as needed.

Recommendation: Contact a handyman or DIY project

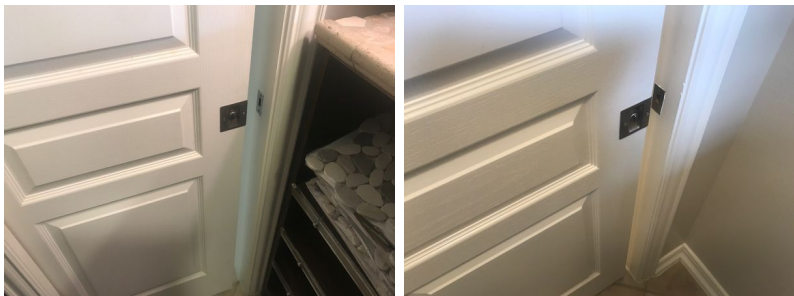
**5: Door Hardware: Doesn't Latch**

Door did not latch properly. Handyman repair of latch and/or strike plate is recommended.

Recommendation: Contact a qualified handyman.

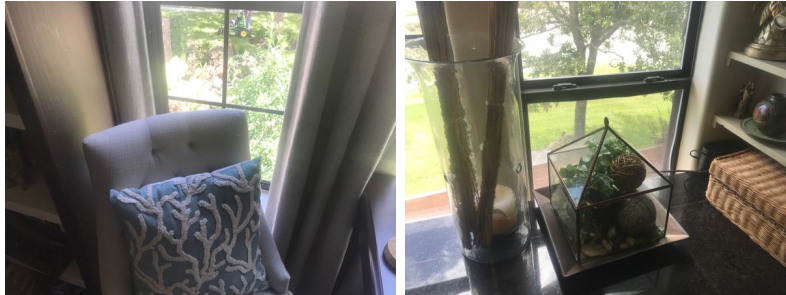
Windows were not operating properly. Evaluation and remediation by a window professional is recommended.

Recommendation: Contact a qualified window repair/installation contractor.

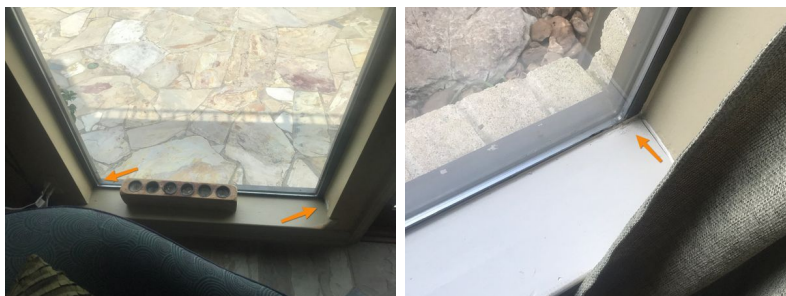
### 6: Evidence of Previous Moisture Contact

Wall structure showed signs of previous water intrusion. Tested negative for moisture at the time of the inspection. Evaluate and remedy as needed.

Recommendation: Contact a qualified professional.

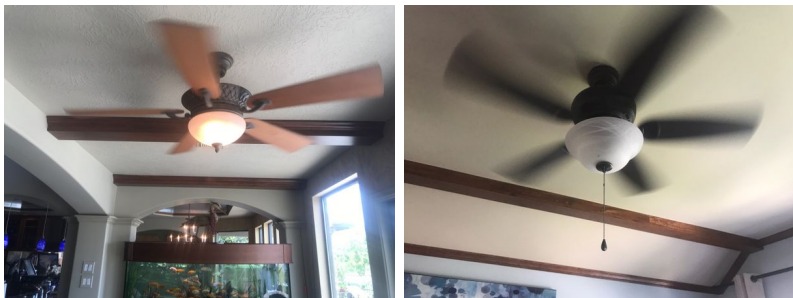
**1: Ceiling Fan Defects**  
👉Recommendation  
Multiple Locations  
Out of balance, Light out -  
Further evaluation is recommended.

Recommendation: Contact a qualified professional.

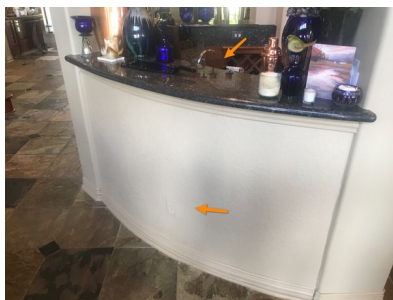
GFCI protection was not present in one or more of these locations. Evaluate and remedy as needed.

Recommendation: Contact a qualified electrical contractor.

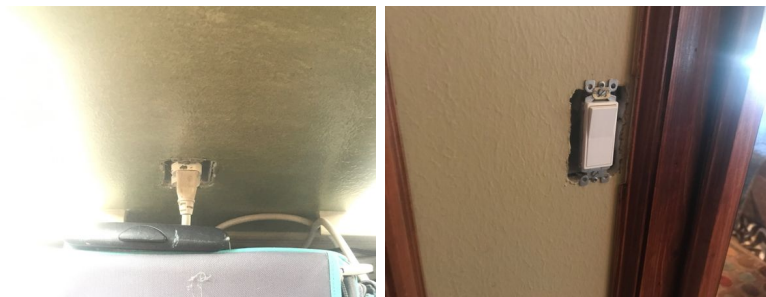
## 3: Receptacle/Switch Covers: Missing or Damaged

One or more receptacle/switch cover plates were missing or damaged. Replacement of cover plates is recommended for safety. Evaluation and remediation by a qualified electrical contractor is recommended.

Recommendation: Contact a qualified electrical contractor.

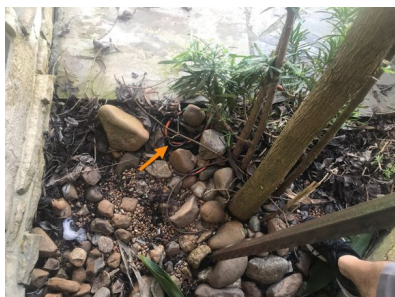
Extension cord are not intended to be used as permanent wiring. Evaluate and remedy as needed.

Recommendation: Contact a qualified professional.

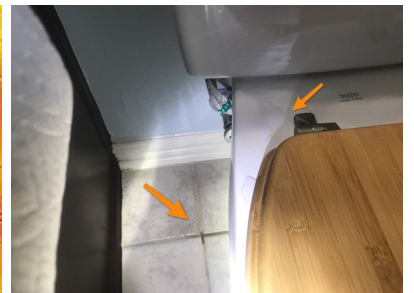
Toilet is leaking. Evaluation and/or repair by a qualified handyman or licensed plumber is recommended.

Recommendation: Contact a qualified plumbing contractor.

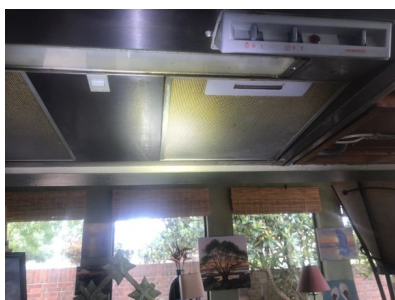
Kitchen exhaust filter had excessive grease build-up. Clean and/or replace as needed.

Recommendation: Contact a qualified professional.

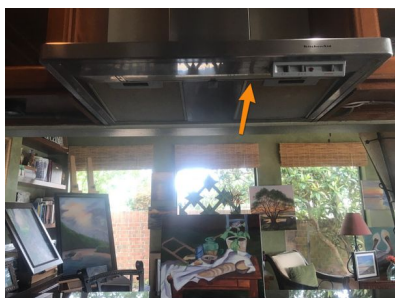
**2: Exhaust Light Out**

The light did not function at the kitchen exhaust. This may be the result of a bad bulb. Replace and test or remedy as needed.

Recommendation: Contact a qualified professional.

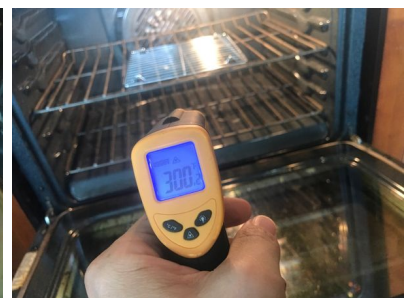
The oven thermostat is inaccurate. A variance of more than 25 degrees F was noted when set at 350F. Evaluate and remedy as needed.

Recommendation: Contact a qualified professional.

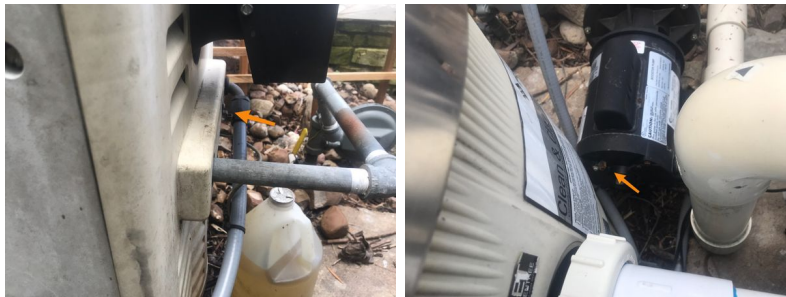
A bonding connection is missing at the pool equipment.

Recommendation: Contact a qualified electrical contractor.

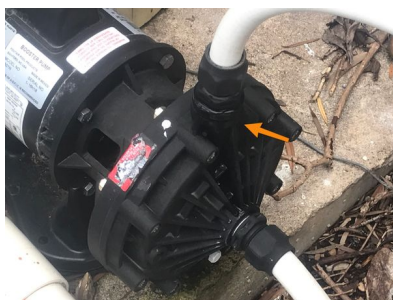
Equipment leaked. Leaking equipment and/ or pumps should be fully evaluated by a qualified pool contractor.

Recommendation: Contact a qualified Swimming Pool Contractor
