HVAC Inspection Report

Performed a visual HVAC inspection at **1501 #60 Stallings, College Station**. All visual accessible components of the HVAC system were evaluated and found to be in serviceable condition at the time of inspection with exception of service recommendations below:

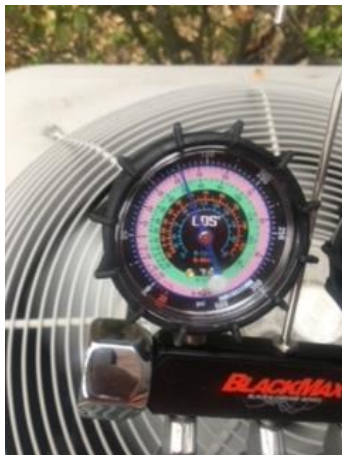
2010, 2.5-ton Payne condenser
2010, 2.5-ton Payne air handler

Freon pressure: 126 psi

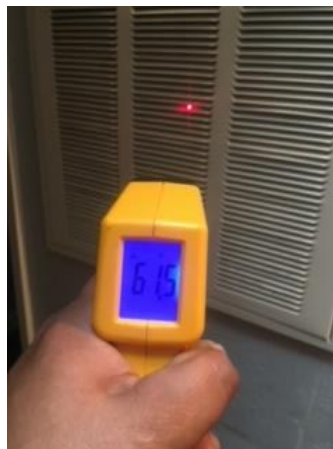
61° return air
Evaporator coil split: 19°
Normal split: 15 degrees and over

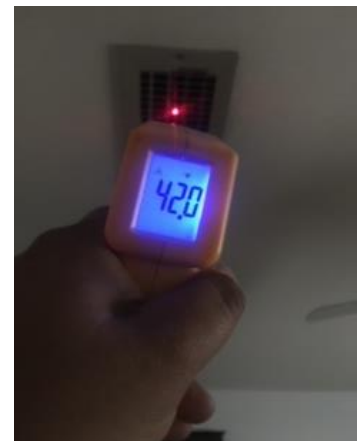
42° supply air

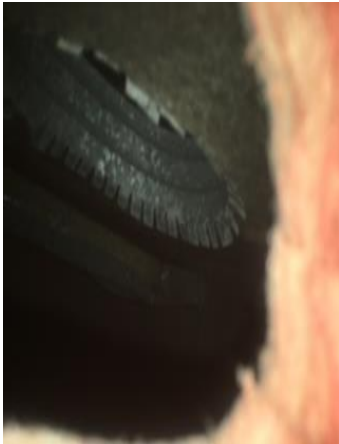
Black growth present in the supply plenum. Consult with an air duct cleaning contractor to evaluate the plenum, flex and/or duct board, and equipment panel for cleaning.
