# Inspection Report

**Property Address:**  
1501 STALLINGS DRIVE #60  
COLLEGE STATION TX 77840

# PROPERTY INSPECTION REPORT

**By:** Tom Rike TREC 20478 / Tucker Inspections 4/5/2021

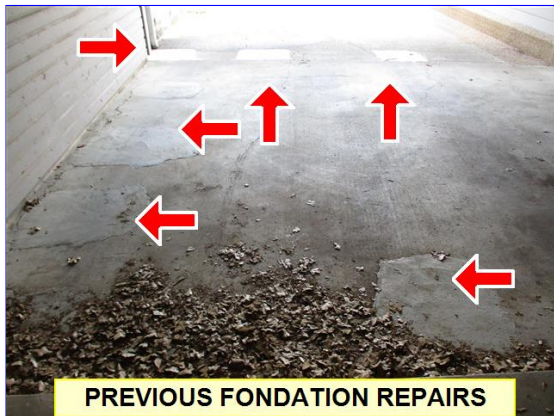
A. Item 1(Picture)

This foundation has had some pier work performed. No significant problems were observed, only signs of what is considered typical movement for the area. As a buyer you should be given all paperwork pertaining to this work and also find out if any warranty is in place for this work.

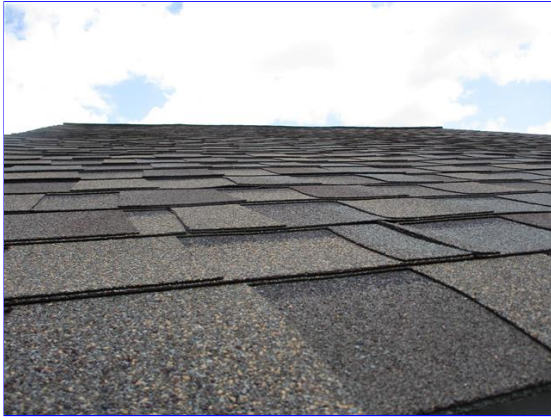
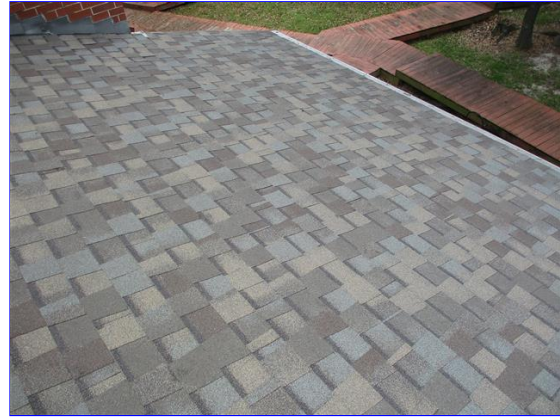
This is a composition shingled roof that was found in good condition at the time of this inspection.

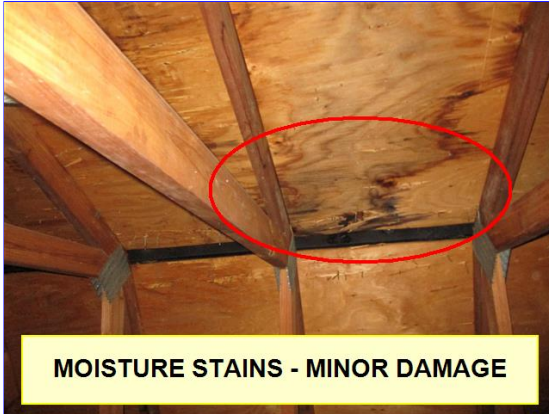
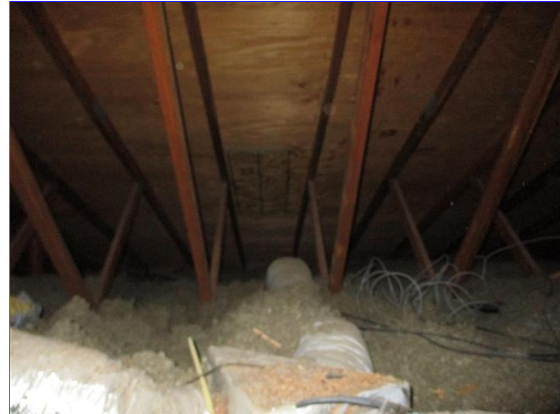
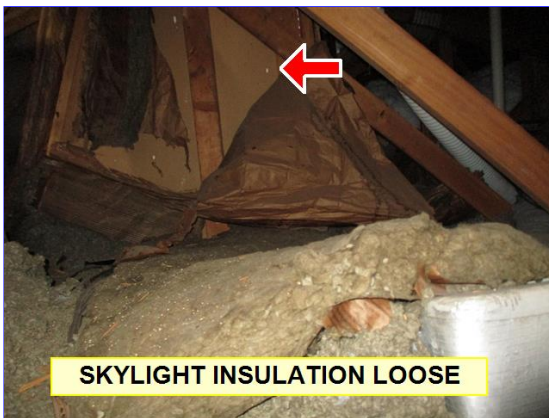
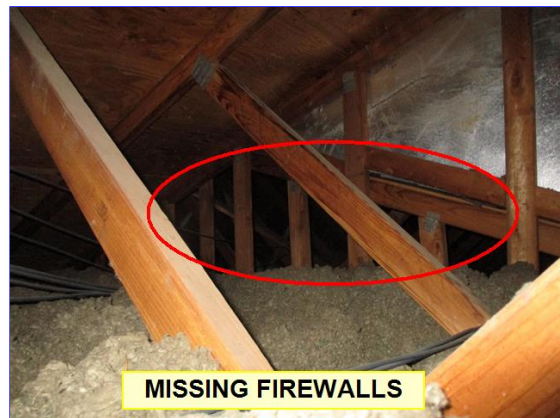
The insulation in the attic does not meet the current building standard of R30 value.

Fire block was missing between the units in the attic.

There were moisture stains-minor damage to the upper roof deck.

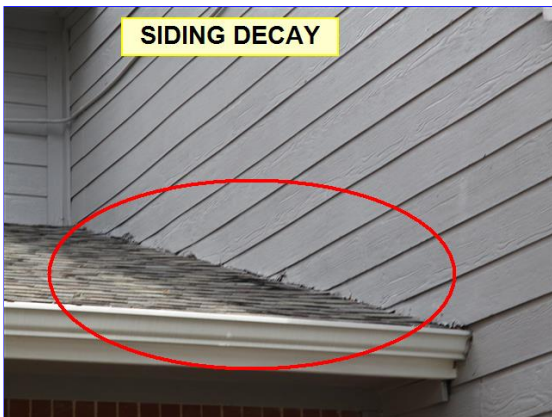
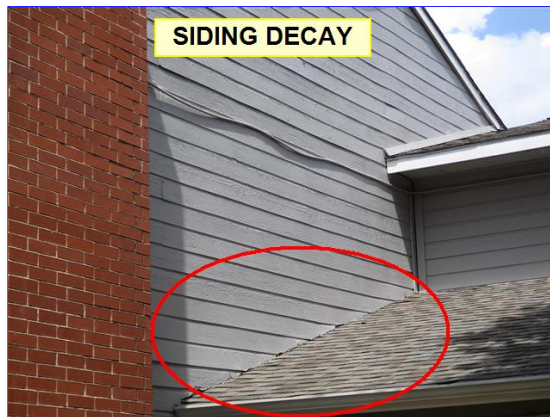
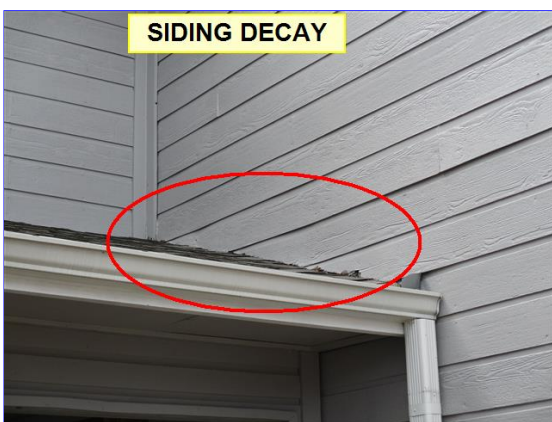
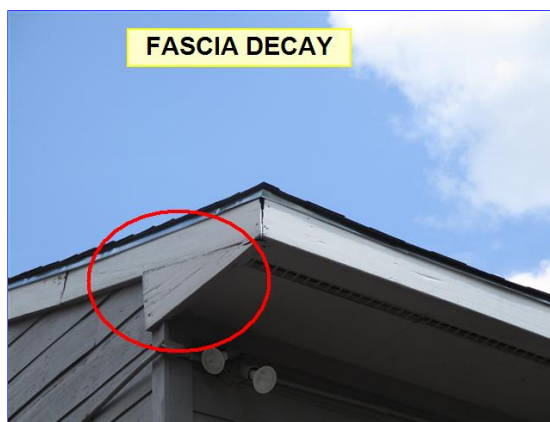
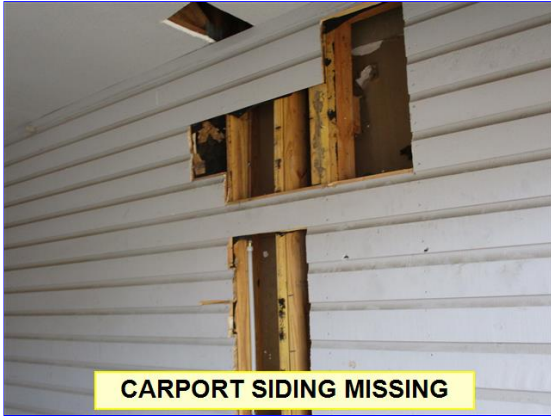
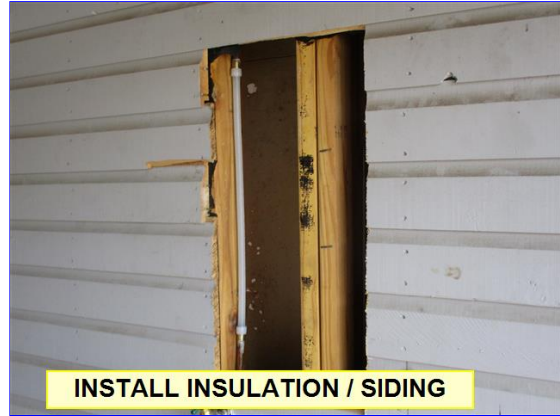
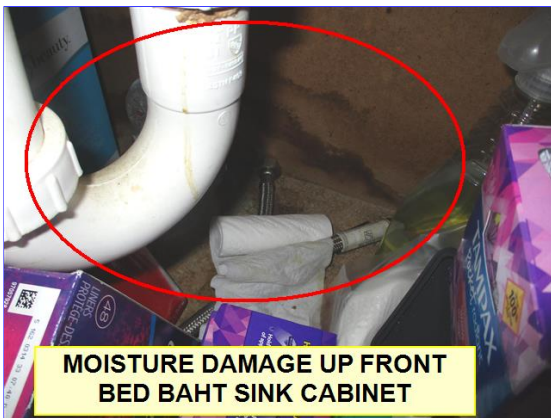
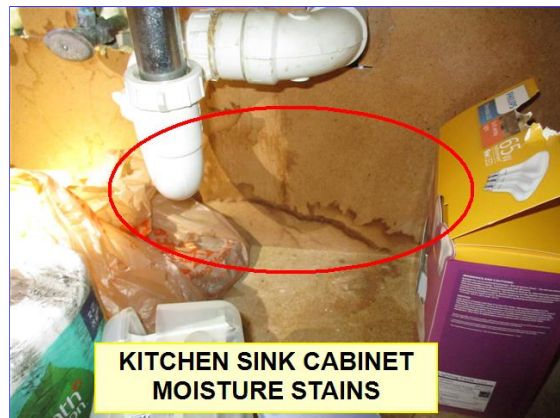
There was a section of carport siding missing. Recommend installing insulation and covering with siding.

There was siding/fascia decay in multiple areas.

There was moisture damage to the upstairs front bedroom bathroom sink cabinet.

There were moisture stains in the kitchen sink cabinet.

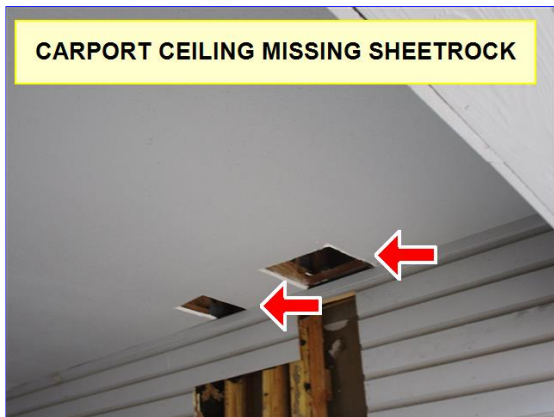
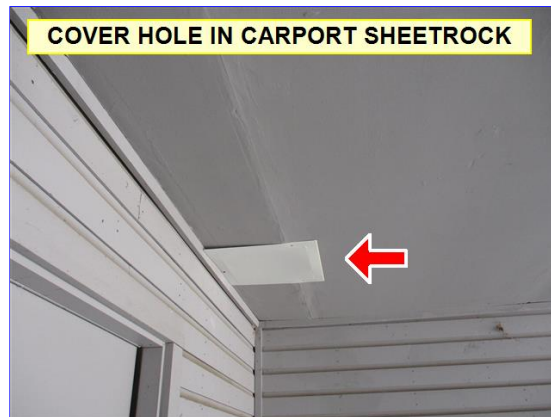
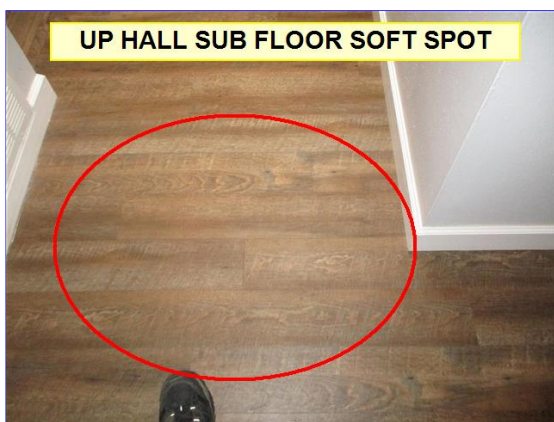
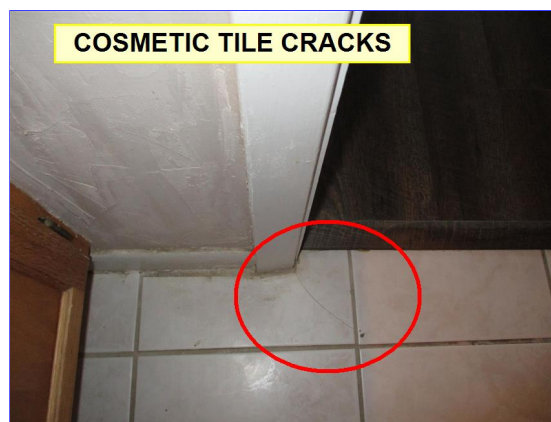
Note: There was a soft spot in the upstairs hall sub floor.

Note: There were tiles with cosmetic cracks.

There were holes in the carport ceiling. These need to be covered with sheetrock as the ceiling servers as a firewall. (Plastic is not an approved firewall material)

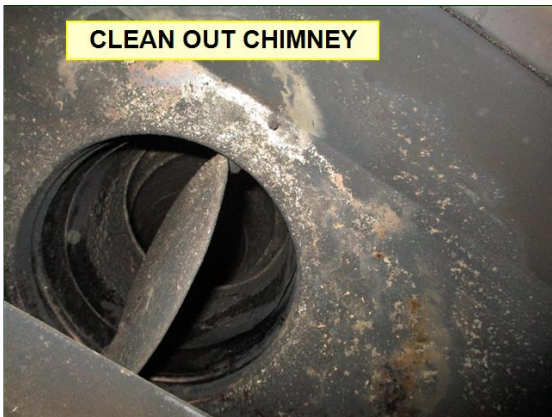
J. Item 1(Picture)

The fireplace and chimney need to be cleaned.

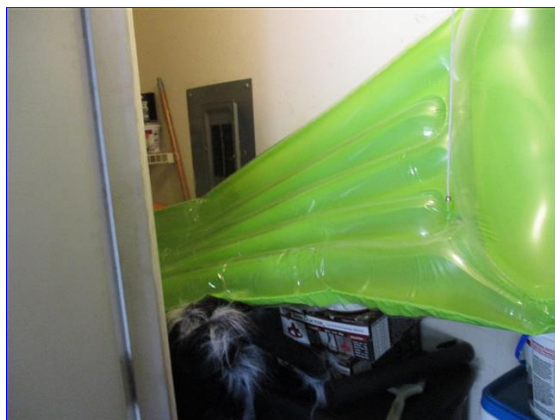
A. Item 1(Picture)

The main panel is located in a closet. This was common installation when this home was built. However, the current building standards does not allow this. The panel was found in good condition and does not need to be relocated.

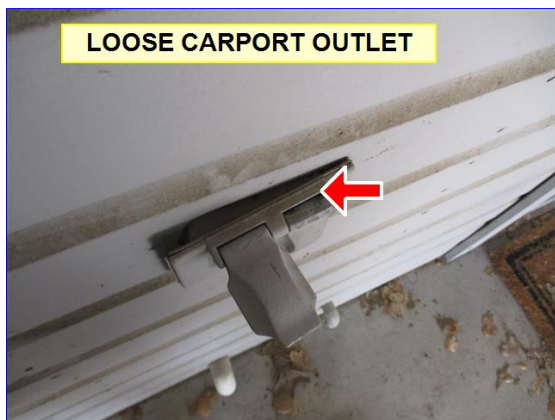
B. Item 1(Picture)

There were no fire protective covers over the closet light bulbs. *This would not meet current building standards.*

The bathroom outlets were wired hot/neutral wires reversed. The outlets still tripped when tested for ground fault protection. The GFCI reset outlet was located in the half bathroom.

The carport outlet was loose from the wall.

There was not a labeled carbon monoxide detector outside of the sleeping areas.

There were multiple smoke detectors that were not operating. Recommend installing new batteries in all units. Replace units as necessary.

Not all of the bedrooms had a smoke detector present. *Recommend installing detectors for safety.*

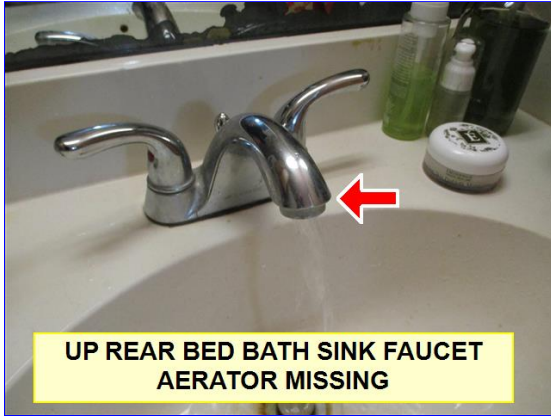
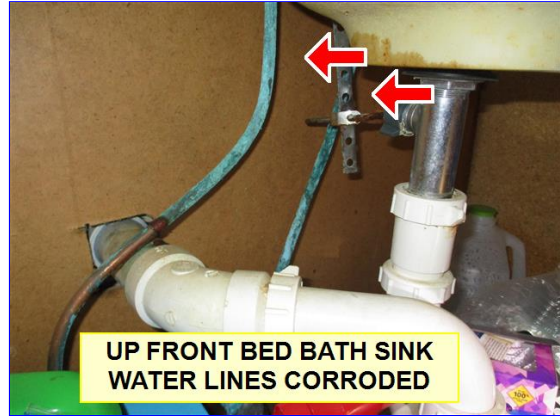
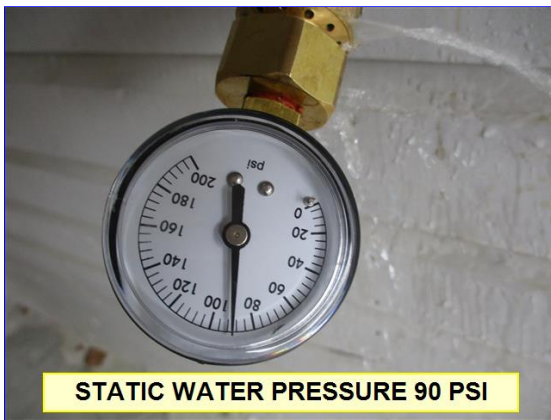
There were missing back flow preventer on the exterior hose bibs.

The upper rear bedroom bathroom sink faucet aerator was missing.

The upstairs front bedroom bathroom sink water lines were corroded.

The static water pressure should range between 40-80 PSI. The static water pressure was over 80 PSI at the time of this inspection. **Recommend installing a pressure regulator at the meter.** *There is a higher risk for leaks at the plumbing fixtures and/or water supply lines when the water pressure exceeds 80 PSI.*

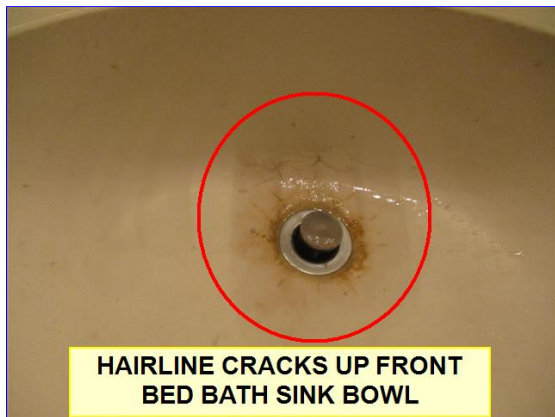
B. Item 1(Picture)

The upstairs front bedroom tub stopper was missing.

The upstairs front bedroom bathroom toilet flush mechanism needs to be replaced.

There were hairline cracks in the upstairs front bedroom bathroom sink bowl.

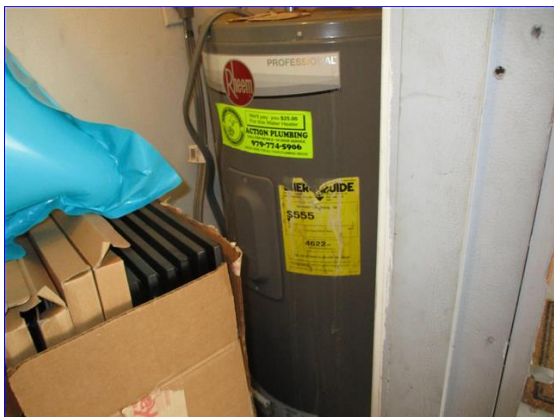
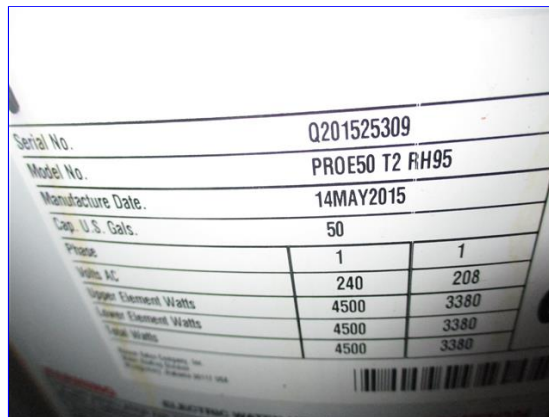
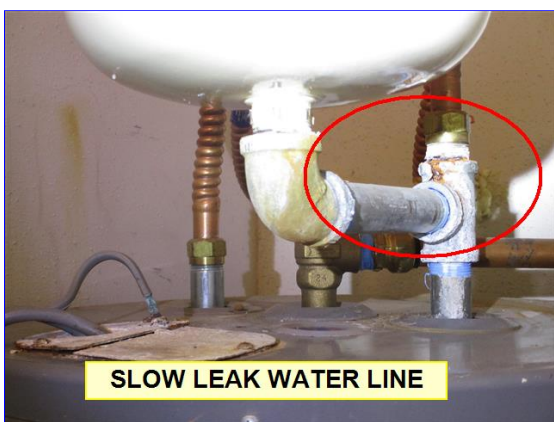
There was a slow leak in the water supply line. Recommend further review by a professional plumber.

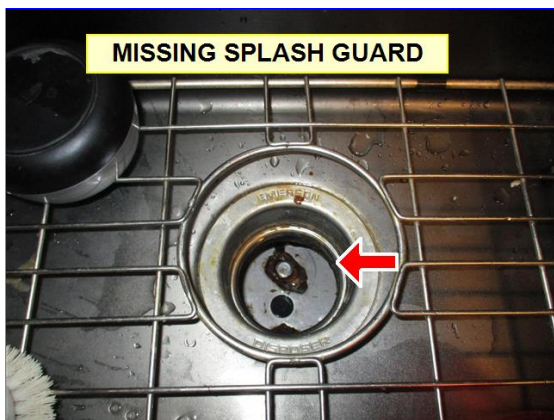
B. Item 1(Picture)

The rubber splash guard at the drain is missing.

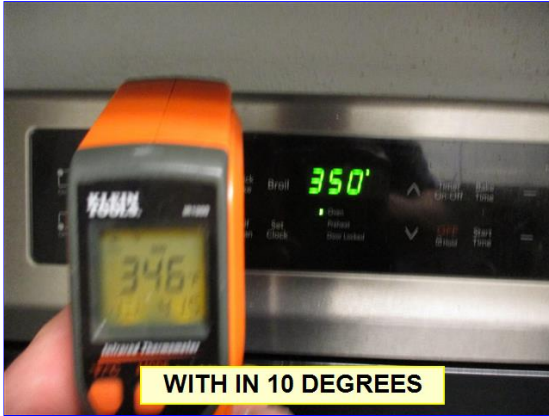
D. Item 1(Picture)

This is a stand alone range. There was not an anti tip brace in stalled. *This is a safety hazard.*

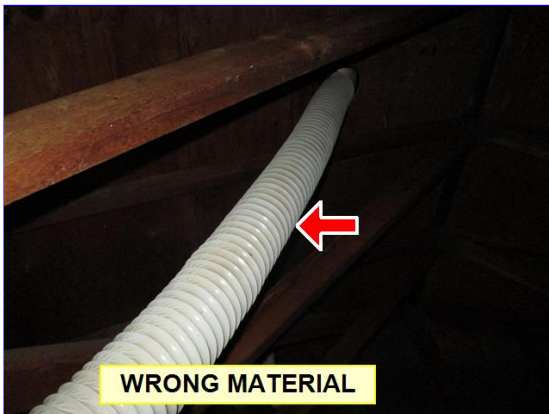
H. Item 1(Picture)

The dryer vent through the roof. If the seller can not verify the vent pipe has been cleaned in the last 12 months, recommend having the vent pipe professionally cleaned. The dryer vent through the roof. If the seller can not verify the vent pipe has been cleaned in the last 12 months, recommend having the vent pipe professionally cleaned.

The dryer vent was flexible plastic pipe. *Current building standards would require a solid metal vent pipe.*
