A & L PROFESSIONAL  
HOME INSPECTIONS, PLLC  
TREC LICENSE# 21647  
HOME INSPECTION REPORT

**11723 Dorrance Ln, Meadows Place, TX 77477**

7/22/2021

# PROPERTY INSPECTION REPORT

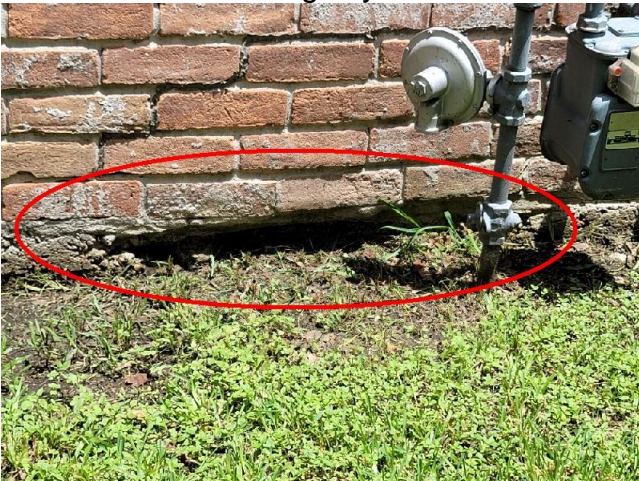
More than one location of spalling was observed on the foundation. Spalling occurs when inner forces such as corroded rebar expands and cracks the concrete or surface cracks occur allowing water to seep in and freeze in the winter which expands and causes sections of concrete to pop off.

Exposed and corroding rebar on the foundation may be the cause of the spalling in the concrete at this location and other locations.

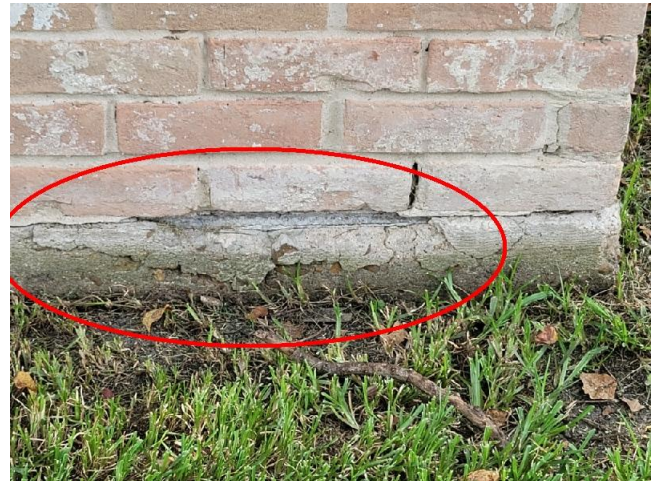
Another example of the multiple locations of spalling on the foundation.

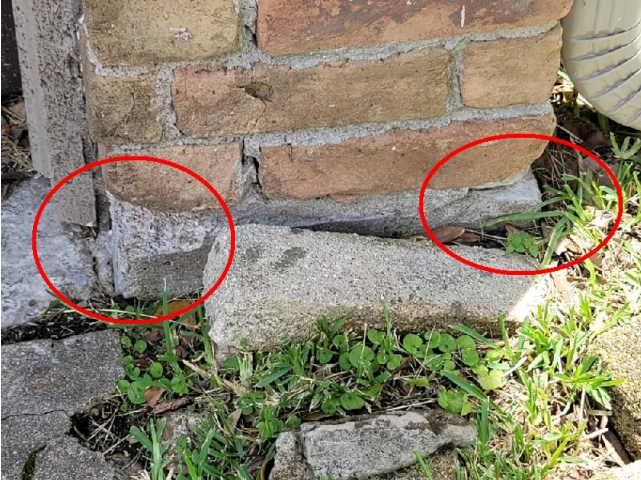
Corner cracks/corner pops were observed on the foundation and are stress fractures from the weight of the brick veneer on top of the foundation. As the walls expand and contract from temperature variations the foundation doesn't causing the weakest point on the foundation (the corners) to fracture. This item should be repaired/sealed to prevent further deterioration. In colder months moisture can penetrate these cracks, freeze, expand and cause the corner to fall off leaving no support for the brick or stone veneer above. This inturn could cause the mortar in the brick or stone above to crack. Recommend repair to prevent further deterioration.

Corner pops/corner cracks were observed on the foundation.

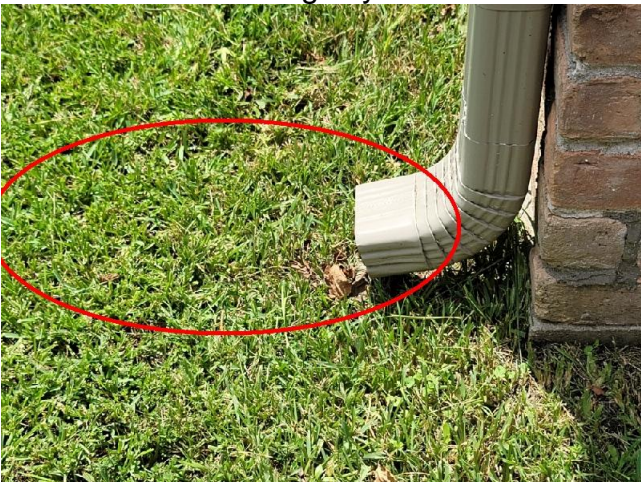
Multiple locations of missing splash blocks were observed. See the comments above.

Splash blocks should be installed under the downspouts in a manner that promotes storm water runoff to flow away from the foundation, ideally diverters could be installed to carry storm water runoff atleast five feet away from the foundation.

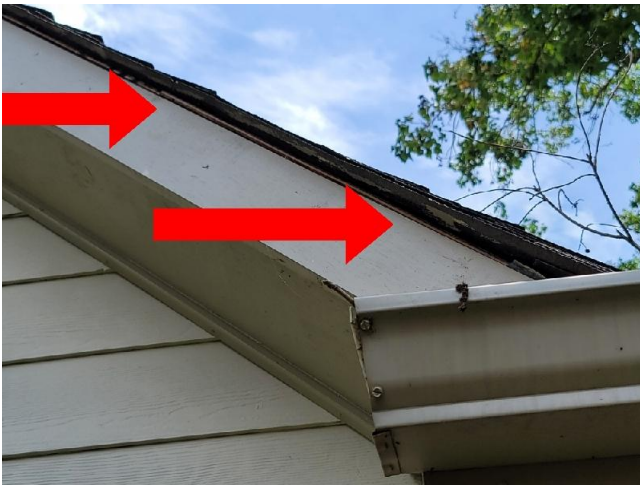
Missing rake edge flashing was noted on the roofs edge. Drip edge/rake edge flashing protects the structure from water damage. Recommend repair to prevent costly damage to fascia boards and soffits and possible water penetration into the structure.

There is no drip / rake edge flashing installed around the west side of the roofs edge. See the comments above and the following illustration.

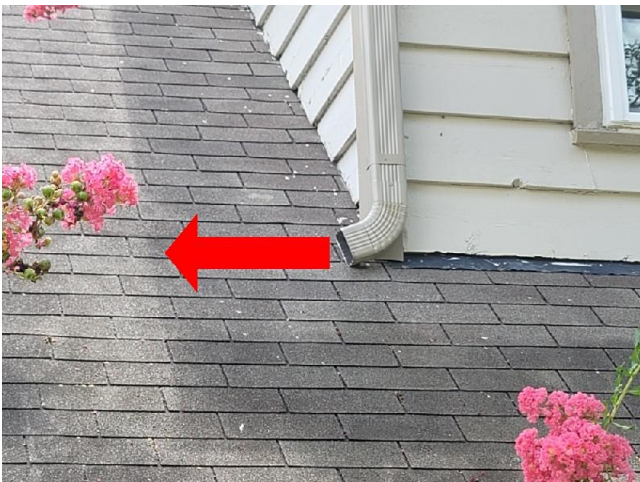
One or more down spouts were observed to be discharging storm water runoff at a 90 degree angle to the flow of the shingles. Shingles are designed to shed stormwater run off in a downward direction not stormwater discharging on them from a 90 degree angle. This area has a potential for future leaks and should be repaired.

A downspout was observed to be discharging stormwater runoff at a 90-degree angle to the lay of the shingles. See the comments above.

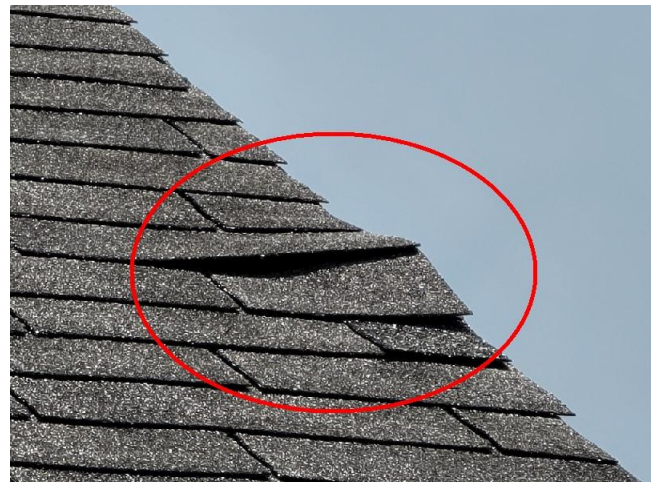
Multiple locations of buckled, uplifted or deficient shingles were observed. These and other indicators such as excessive granule loss are indications that this is an older roof.

Multiple locations of buckled, uplifted or deficient shingles were observed.

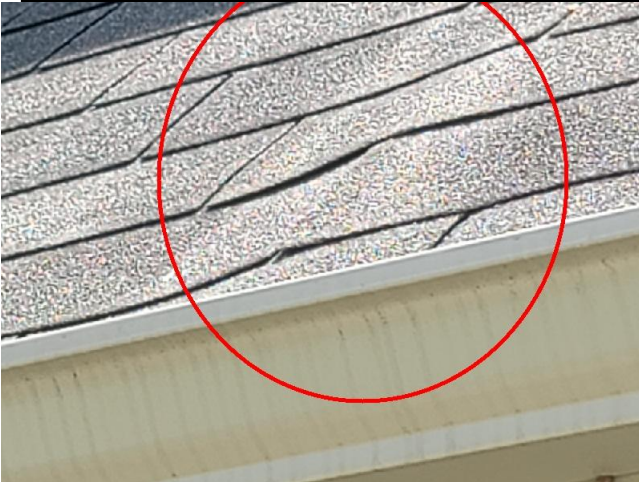
Buckled shingles were observed.

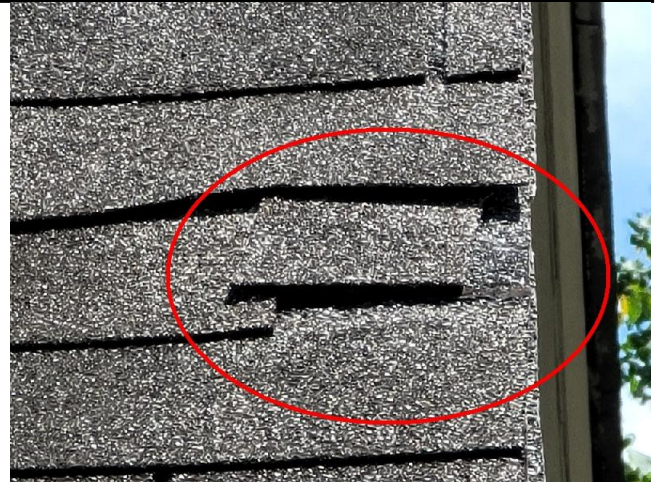
Torn shingles were observed.

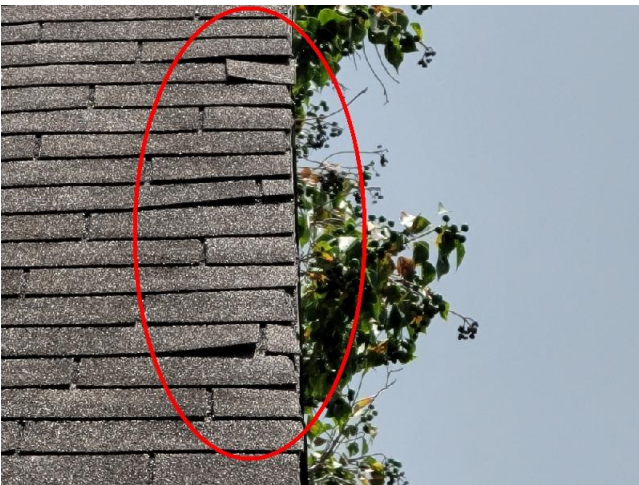
Another example of deficient shingles that were observed on the roof.

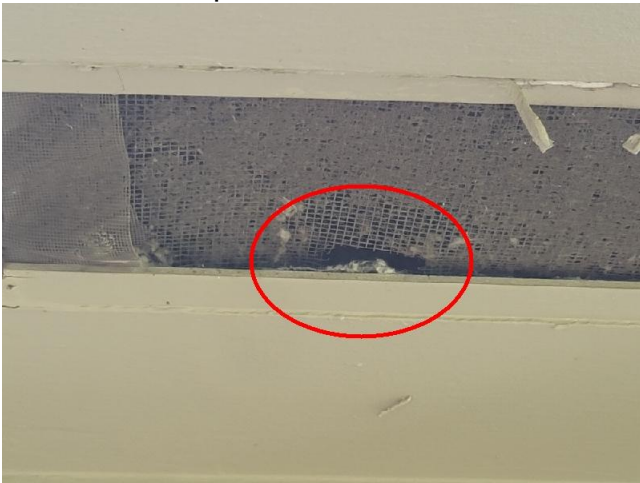
Damaged screens on the soffit were observed. Recommend repair to prevent vermin access into the structure.

Damaged screens on the soffit were observed. See the comments above.

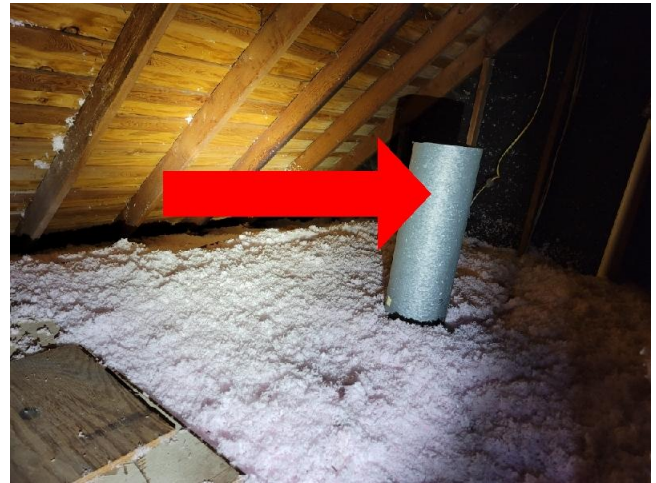
The kitchen exhaust vent was observed to be discharging directly into the attic. This deficiency is allowing moisture to be discharged directly into the attic which can cause problems such as but not limited to delamination of the decking. Recommend repair by extending the vent

The exhaust fan in the ceiling of the kitchen was observed to be discharging directly into the attic. See the comments above.

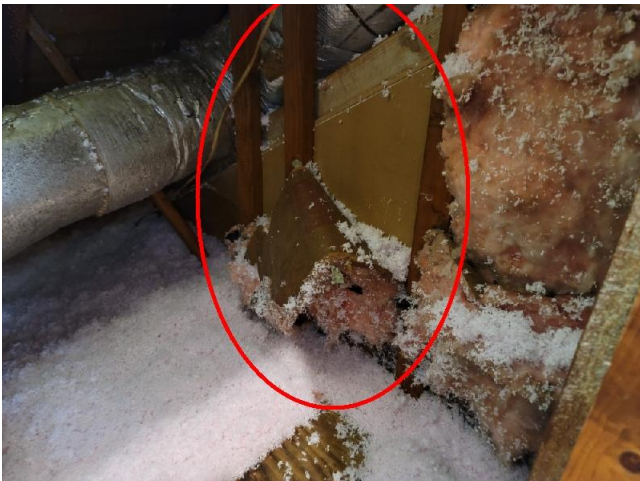
Insulation in the attic was observed to be falling off the sidewalls. Recommend repair for increased energy efficiency.

Insulation in the attic was observed to be falling off the sidewalls. See the comments above.

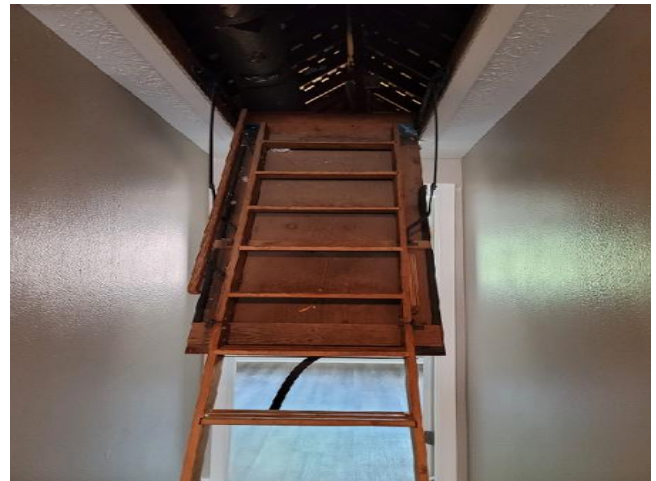
The attic access ladder should be insulated for increased energy efficiency.

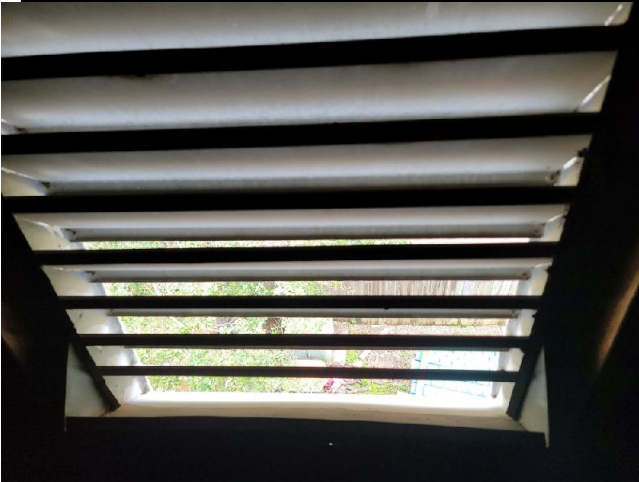
Missing or damaged screen(s) on the gable vent(s) need to be replaced to prevent vermin access into the structure.

Missing screens on the gables were observed. See the comments above.

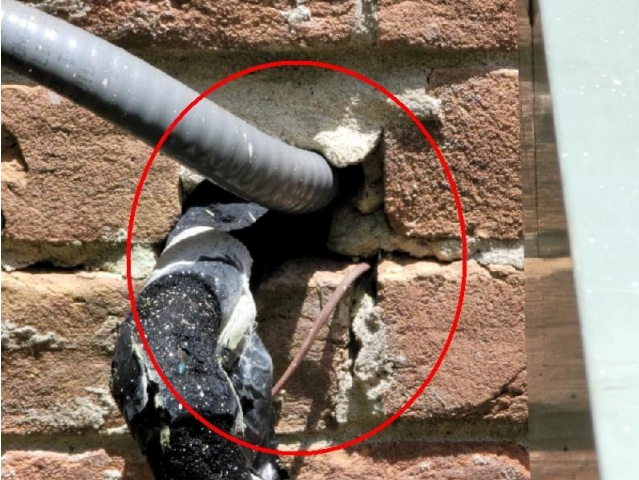
All holes and access points on the exterior walls need to be sealed/repared to reduce the risk of rodent and water penetration into the structure.

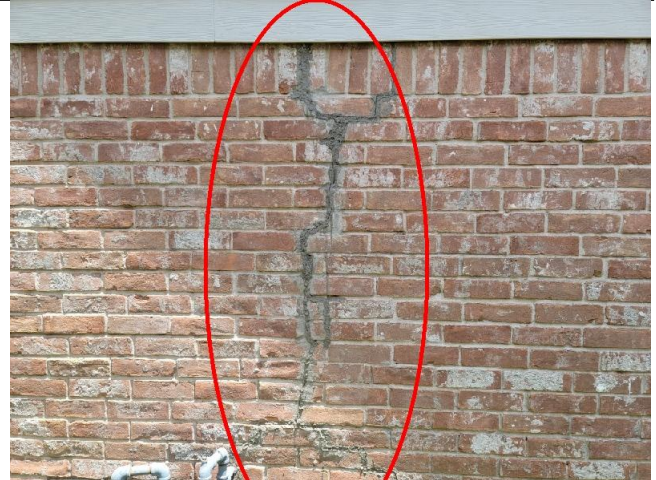
Multiple locations of various types, sizes and degrees of cracks that both have and have not been patched were observed on the exterior walls, these cracks need to be sealed/repared to prevent water penetration into the structure and possible structural damage. If not sealed the cracks may continue to deteriorate.

Multiple locations of various types, sizes and degrees of cracks that both have and have not been patched were observed on the exterior walls.

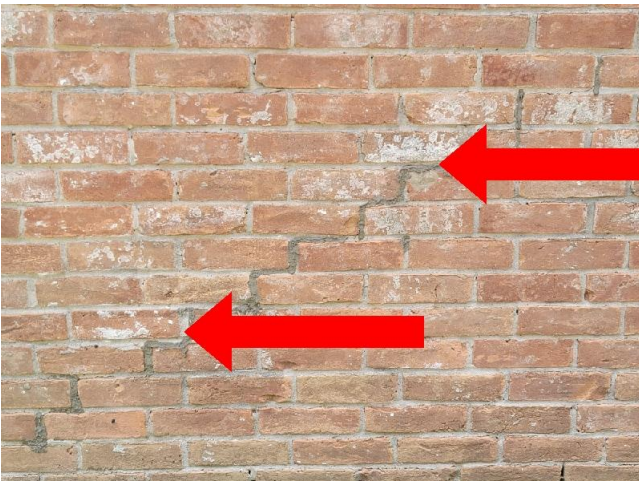
Another example of the multiple locations, types and sizes of cracks on the exterior walls that have and have not been patched.

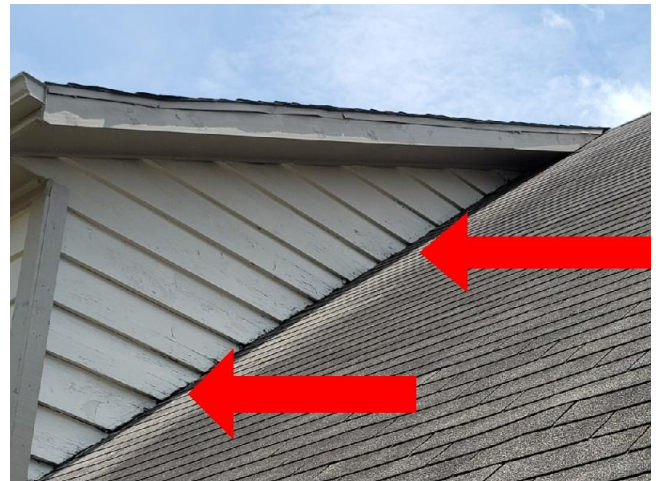
The siding should have been installed in accordance with the 2" rule. The siding should be installed a maximum of 2" inches or a minimum of 1" inch above the shingles to prevent wicking moisture into the siding. Usually repairs are made the next time the roof or the siding is repaired or replaced. The NRCA suggests using 7 inch by 8 inch step flashing with a 4-inch leg onto the asphalt shingles and a 4-inch leg up the vertical surface with a 1" minimum space between the siding and the roofing shingles.

Multiple locations of siding were observed to be in contact with the shingles. See the comments above and the following illustration about the 2" rule.

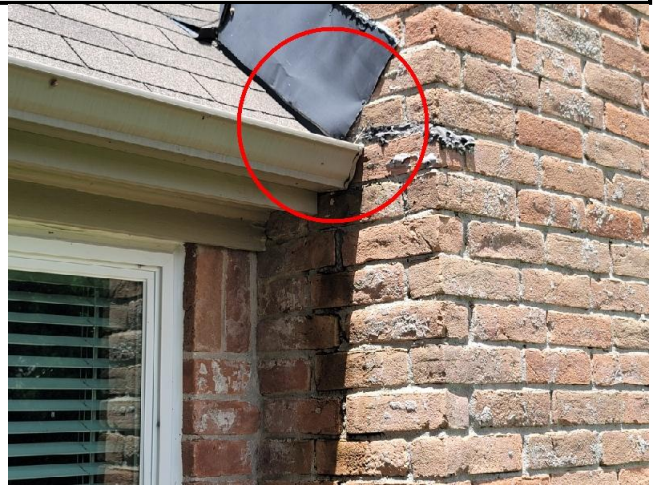
Missing kick out flashing was observed. Kick out flashing protects the exterior walls from water damage. Recommend repair.

Missing kickout flashing around the chimney were observed. See the comments above and the following illustration.

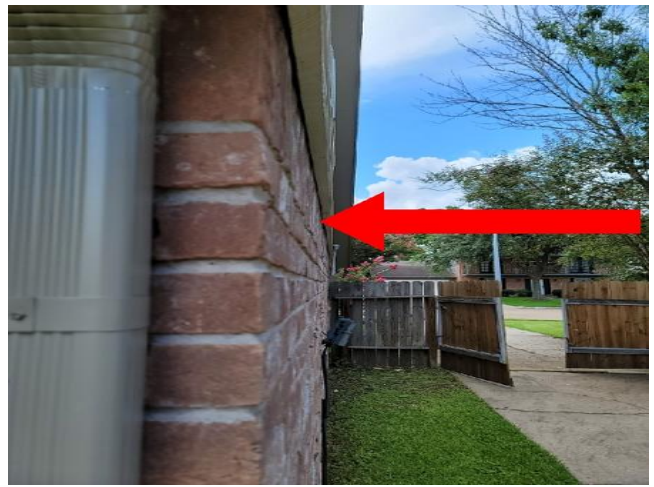
The east facing exterior wall was observed to be bowing. This could be indications of a moving Foundation or could be structural movement which is common in homes of this age. Further evaluation by structural engineer may be necessary.

This east facing exterior wall was observed to be bowing.

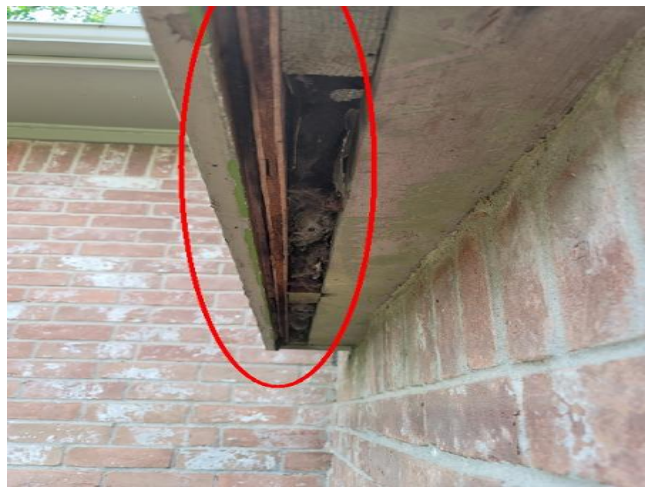
There is no soffit/bottom board installed under the box on the exterior wall beside the back door that houses shelving on the interior wall. Recommend repair to prevent rodent access into the structure.

There is no soffit/bottom board installed under the box on the exterior wall beside the back door that houses shelves on the interior wall. See the comments above.

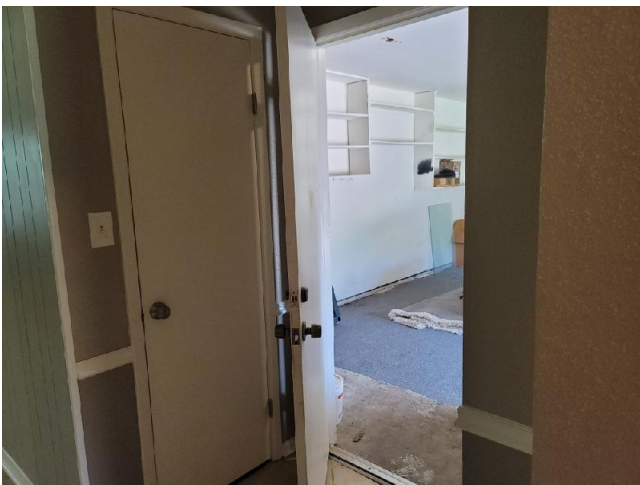
The garage door to the house is not self closing or does not properly close all the way as required by today's standards. This is a safety hazard as it poses a risk of carbon monoxide entering the home from the garage. Recommend repair with the addition of at least one self closing hinge as soon as possible.

The garage door to the house is not self-closing. This is considered to be a safety hazard. See the comments above.

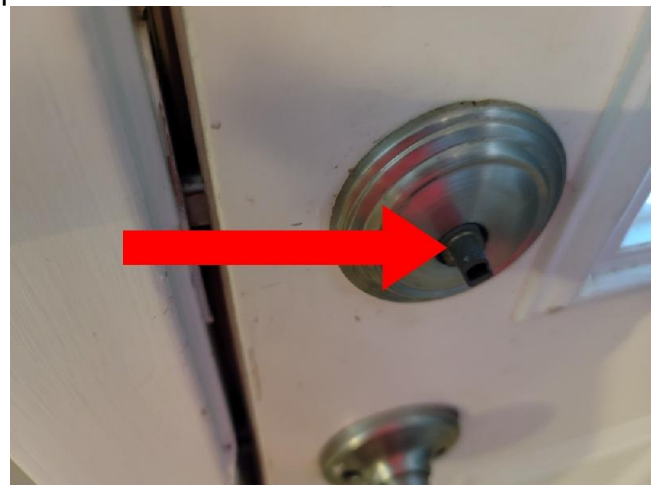
Damaged, missing or non-functional door hardware should be repaired or replaced.

Damage or missing door hardware was observed and needs to be repaired.

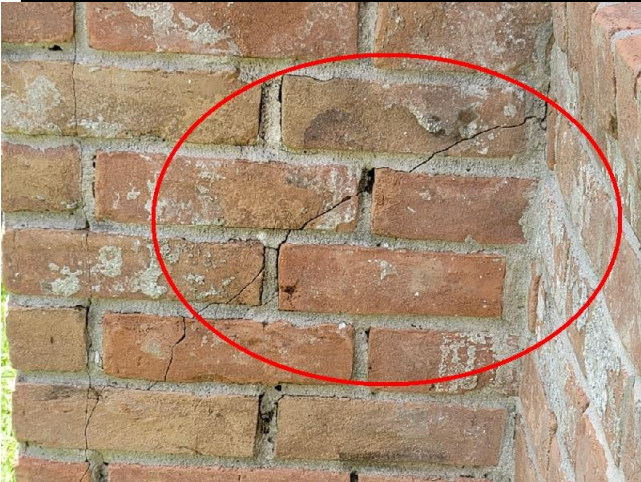
Cracks were observed on the exterior of the chimney. See the comments above.

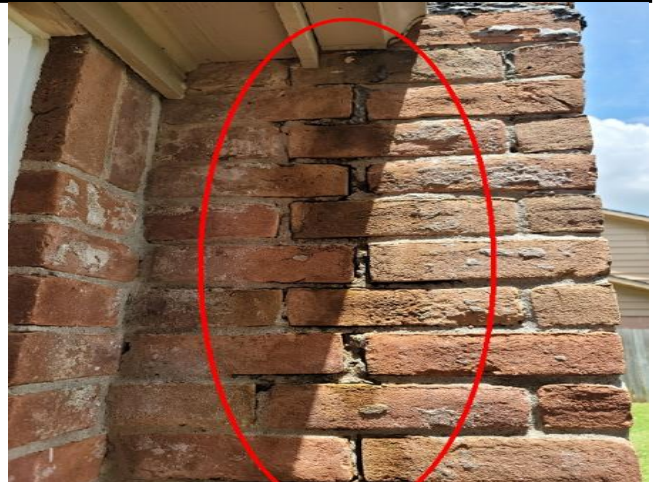
Deteriorated mortar was observed on the chimney below a missing kickout flashing on the roof. See the comments above.

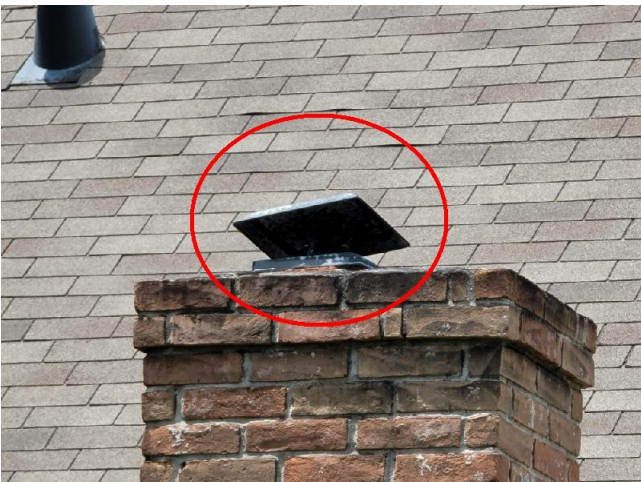
The chimney cap on top of the chimney was observed to be loose and there is no spark arrestor installed.

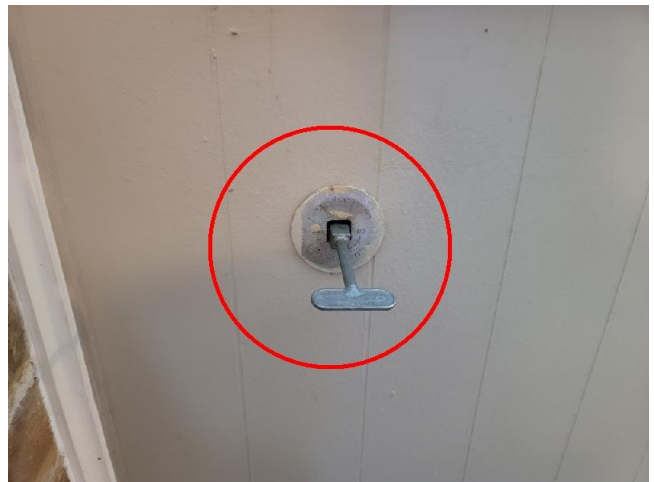
Inoperative gas valve. The gas control valve for the fireplace will not turn; therefore, it cannot be determined whether it is stuck in the on or off position.

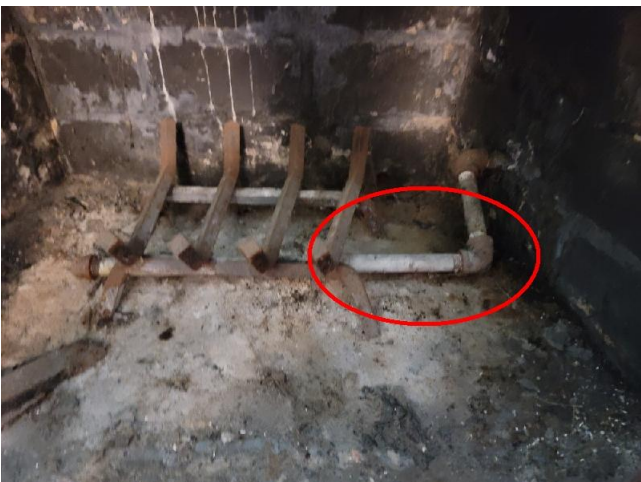
There is no air/fuel mixer installed on the gas pipe in the fireplace. See the following illustration.

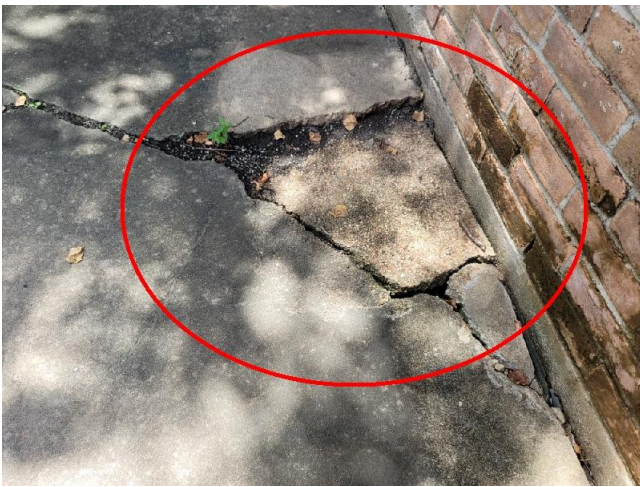
Multiple locations of trip hazards were observed on the back patio.

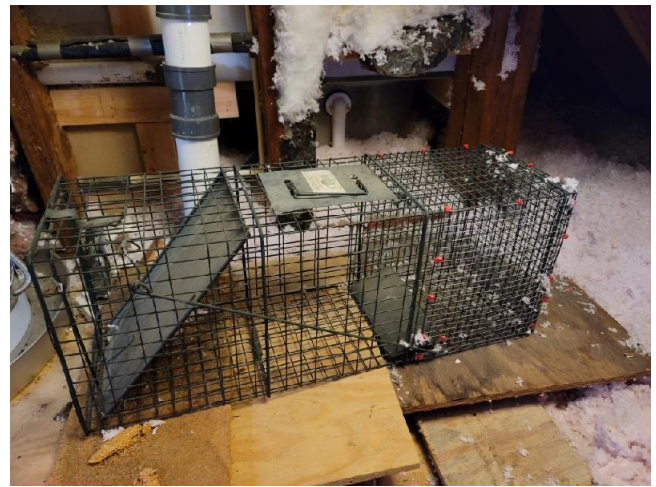
A live catch trap was observed in the attic and is an indication that rodents were or are present in the structure.

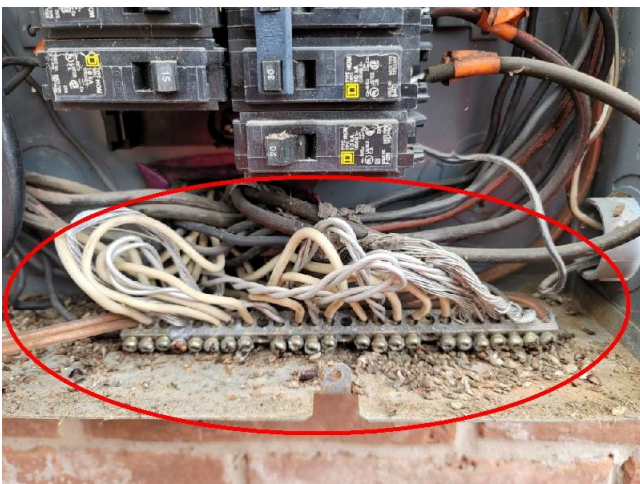
The neutral buss is laying in the bottom of the service panel unconnected to the panel and not bonded to the panel in anyway. See the comments above.

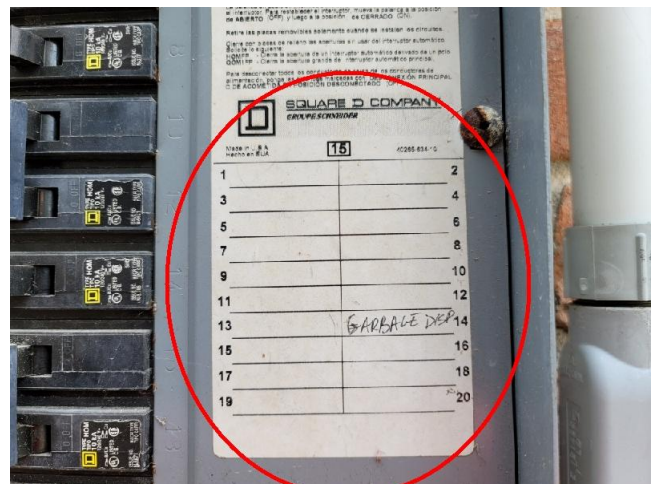
Multiple locations of missing or unreadable labels on a circuit breakers were observed. This is considered a safety hazard. See the comments above.

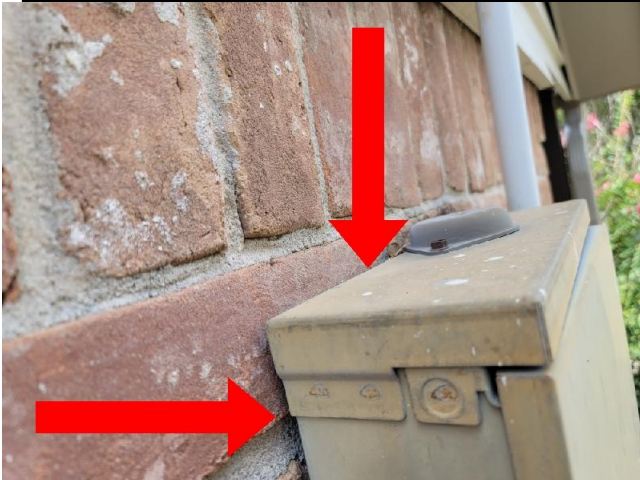
The service panel should be caulked around its perimeter to reduce the risk of water penetration into the service panel.

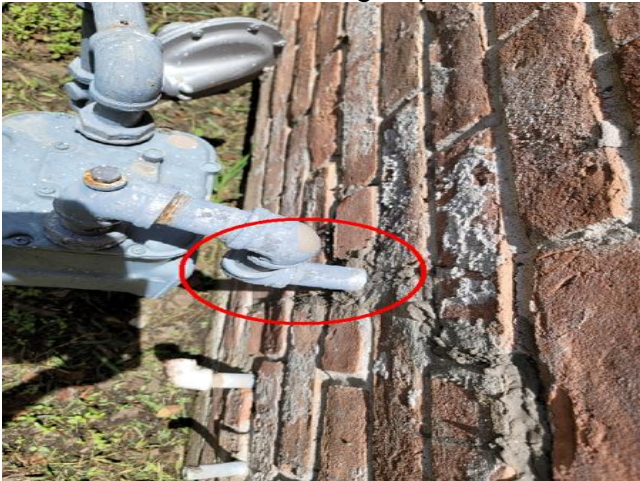
This photograph confirms the statement above that the gas meter was not bonded at the time of this inspection.

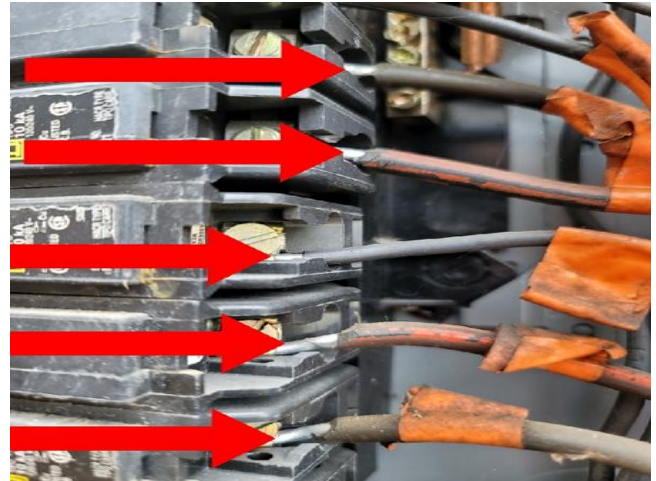
Single strand aluminum wiring was observed to be connected to the circuit breakers in the panel. This is considered a deficiency. See the comments above.

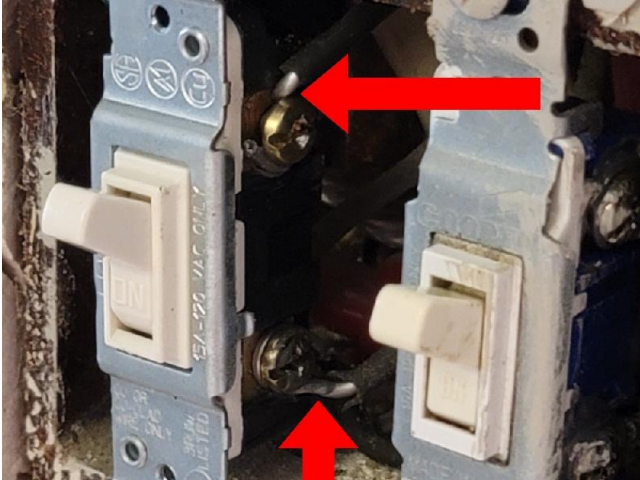
One or more outlets or switch covers were removed and it was determined that aluminum branch wiring was used in the home.

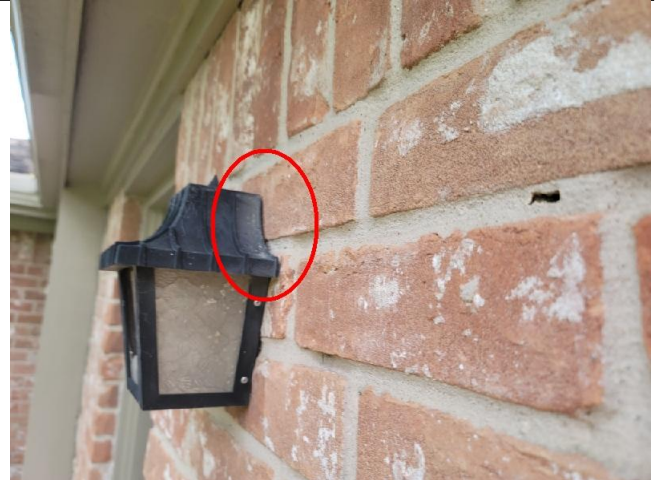
All exterior light fixtures need to be caulked at their base to prevent water penetration into the fixture or structure.

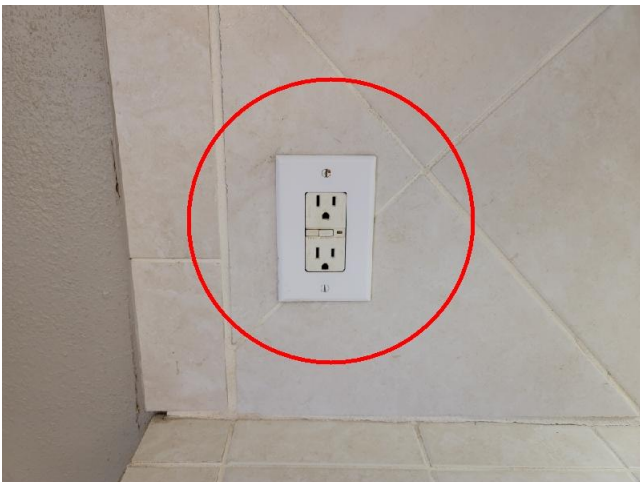
The GFCI outlet beside the kitchen sink is improperly wired. It will not trip when tested and even when manually tripped it still functions. This is a safety hazard. See the comments above.

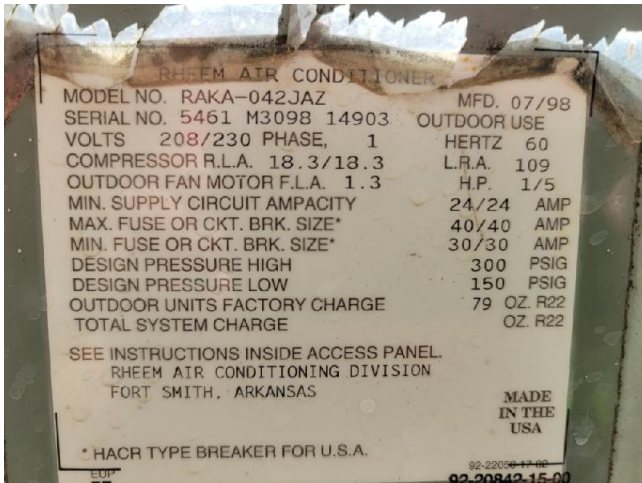
This outdoor condensing unit for the Rheem air conditioner was manufactured in July of 1998 making it about 23 years old. See the comments above.

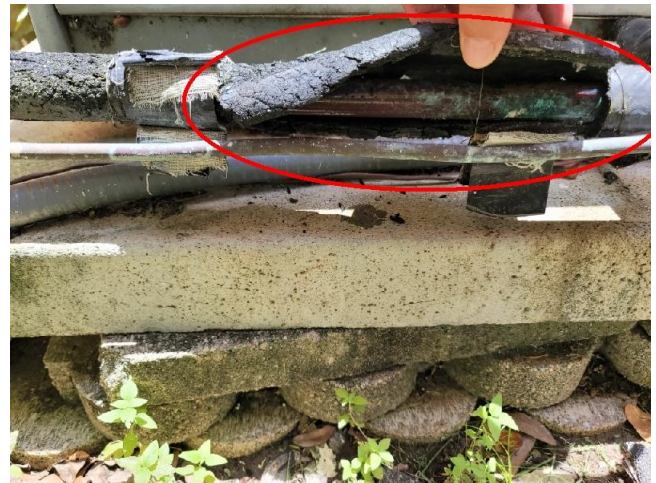
Damaged or missing insulation on the AC refrigerant lines at the condenser were observed. See the comments above

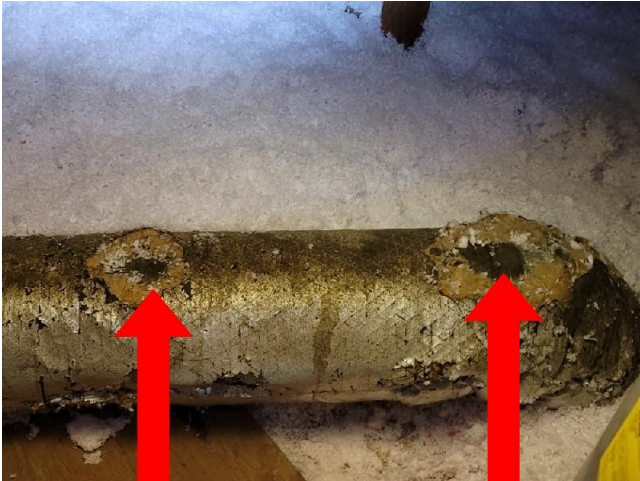
The insulation on the HVAC ducts in the Attic appears to have been chewed away by rodents to access moisture / condensation to drink.

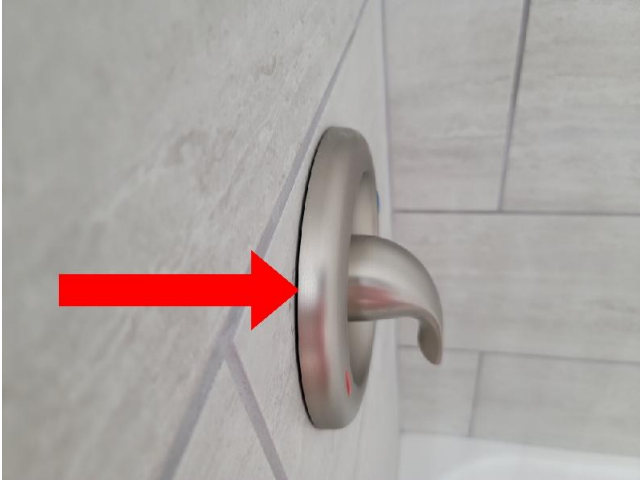
All Plumbing fixtures installed in a shower or bathtub enclosure need to be caulked at their base to reduce the risk of water penetration into the structure and possible structural damage.

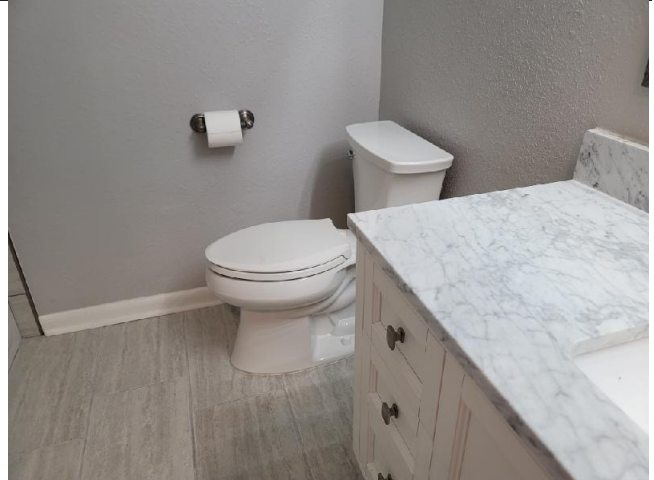
The downstairs toilet continues to run after being flushed. See the comments above.

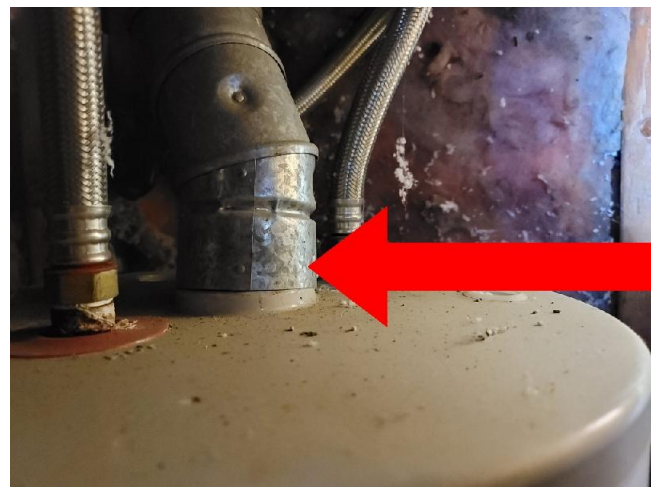
There is no draft hood installed on the exhaust vent on top of the water heater.

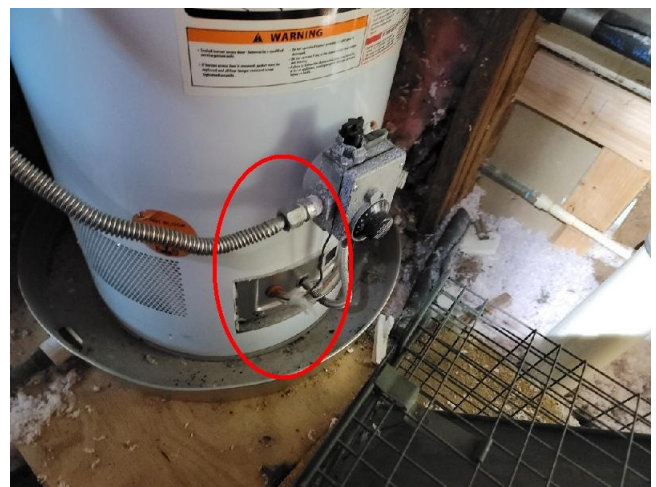
There is no sediment trap installed on a gas supply line to the water heater. See the comments above and the following illustration.

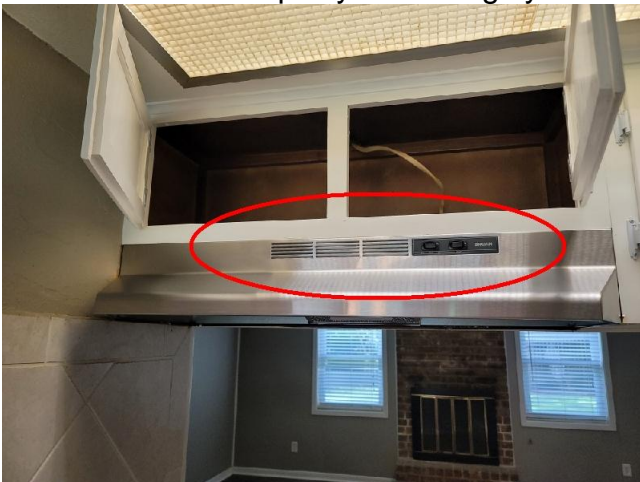
The range hood exhaust vent does not exhaust to the exterior as required by today's standards. See the comments above.

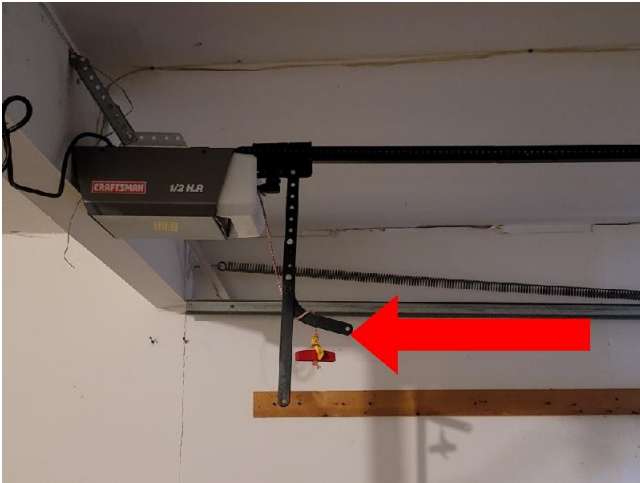
Both automatic garage door operators have been disconnected.

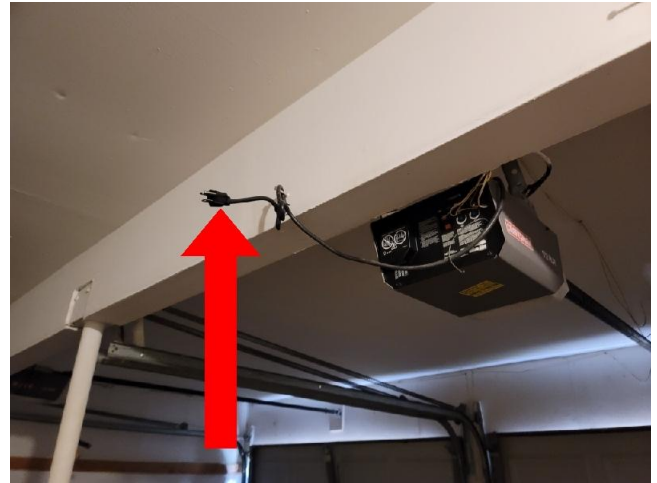
Both automatic garage door openers were unplugged at the time of this inspection.

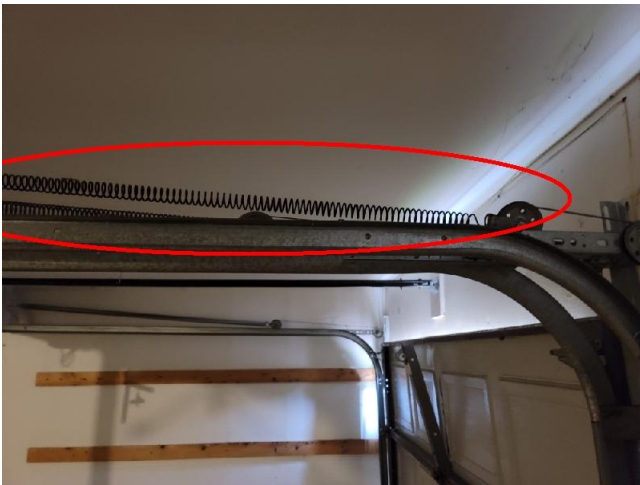
Unprotected Springs were observed on the garage doors. See the comments above.
