PROPERTY INSPECTION REPORT

Prepared For: Shane Lampard and Candise Juarez
(Name of Client)

Concerning: 2421 Parkview Dr. Pearland, TX 77581
(Address or Other Identification of Inspected Property):

By: Giovanni Angel, 22909 3/10/2019
(Name and License Number of Inspector) (Date)

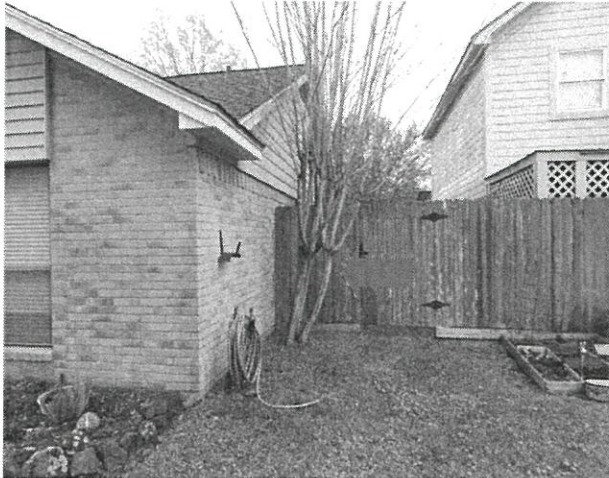
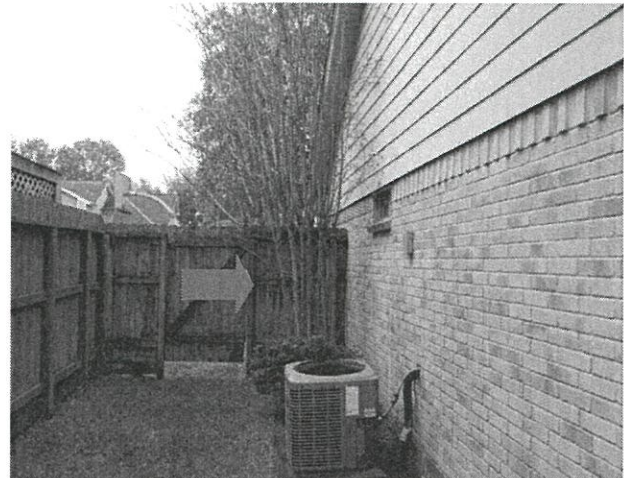
- Inspector was not able to inspect the front left and rear side of the foundation due to storage building, mulch, and siding preventing inspection of same.
- Recommend the removal of mature trees in close proximity to the structure or the installation of root barriers to prevent possible damage to foundation. **Note:** Some types of mature trees can cause damage when these are too close to the structure.

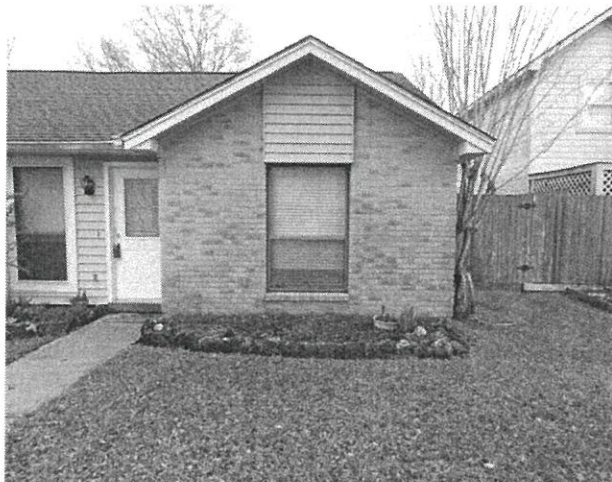
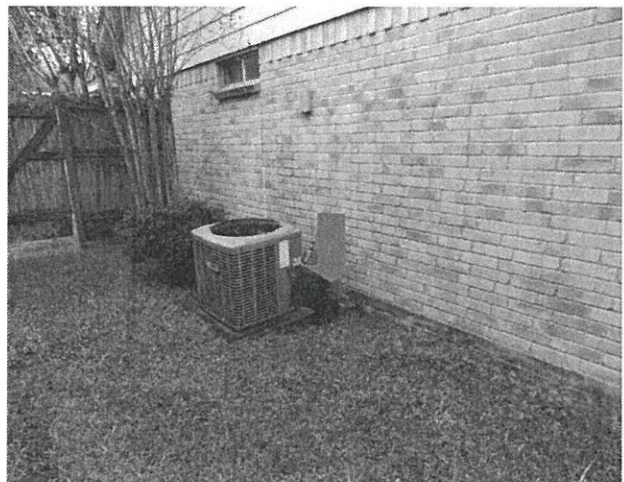
- The soil level was high on the front side of the house. When soil levels and vegetation are high against the face of the foundation it promotes water penetration, siding rot and insect infestation. Brick veneer wall cladding should have about *4" of clearance between the soil and the first of bricks*, and other materials should have *6" of clearance between other materials and the soil*. We recommend lowering the grade. See illustration in this document's Addendum
- Soil overall is of reverse grade (low spots, negative slope, etc), creating vulnerability to the accumulation of standing water at the foundation wall, a condition known to be a factor in foundation failure. Re-grading is required for a more positive drainage

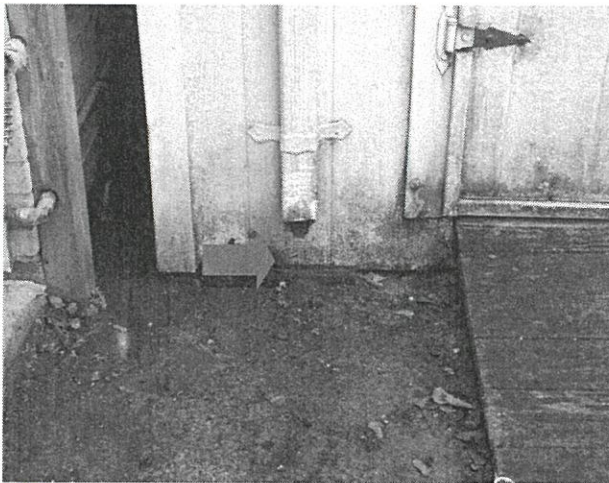
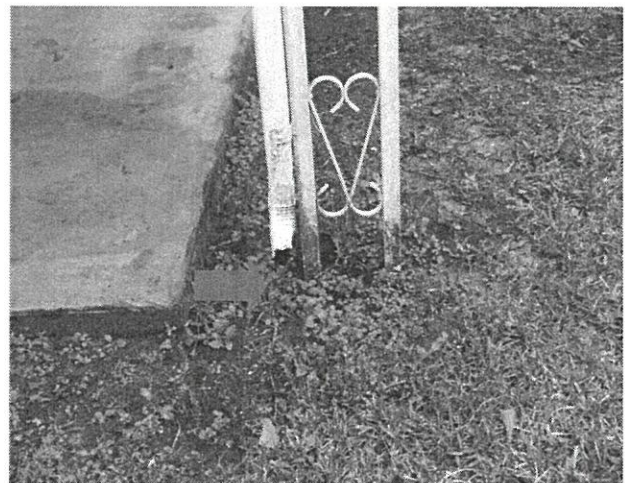
- Install missing splash blocks at all gutter spouts to prevent erosion of soil.

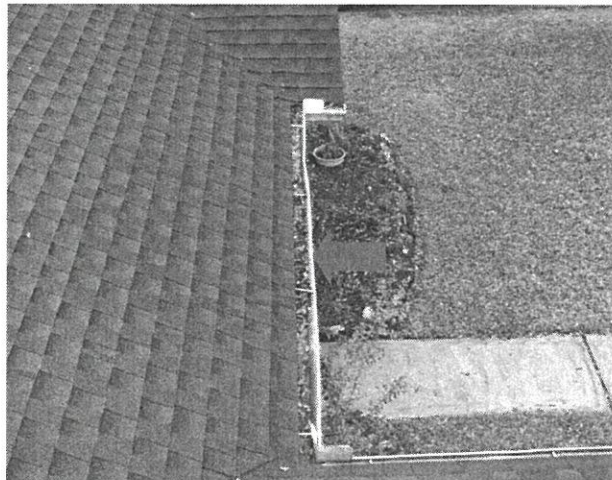
- Routinely clean gutters and spouts for a more positive drainage and to prevent damage to gutters.

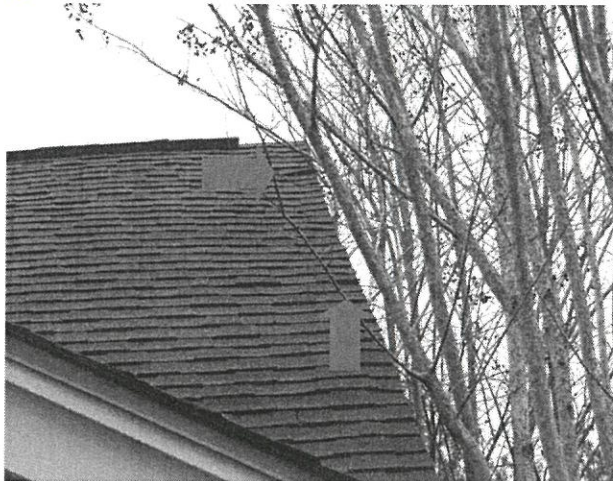
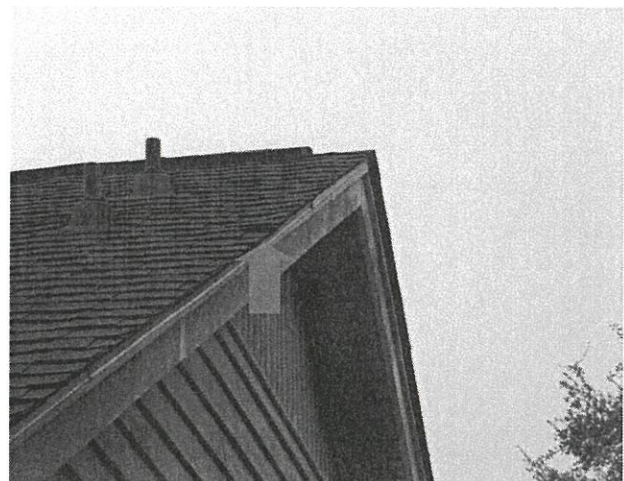
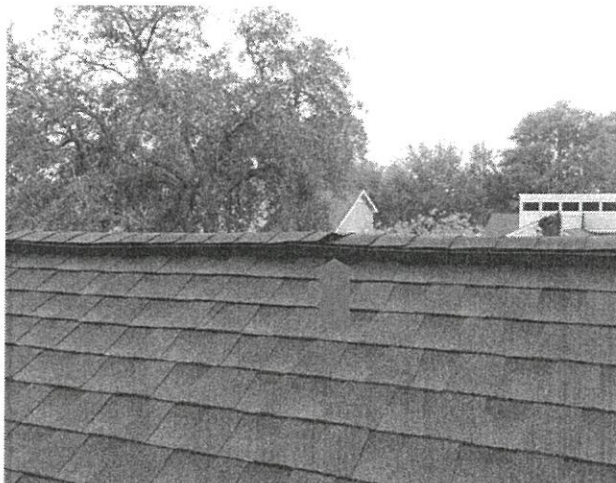
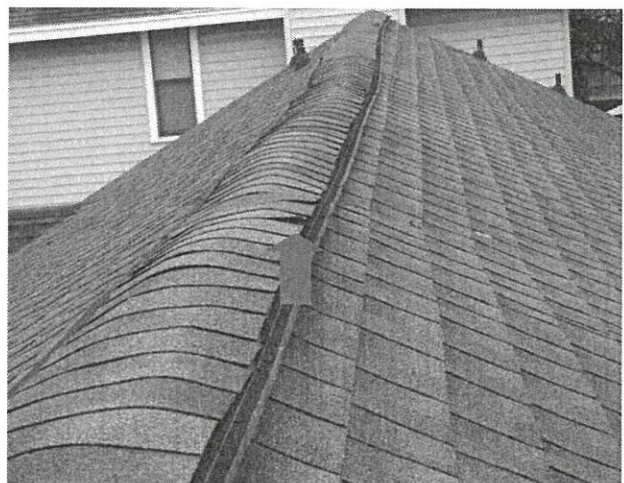
Observed lifting shingles on front, rear, and roof ridge. Repair to avoid further deterioration and possible water intrusion. Samples below.

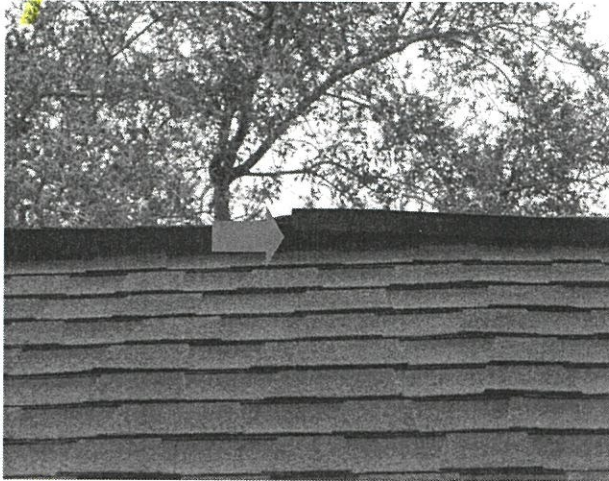
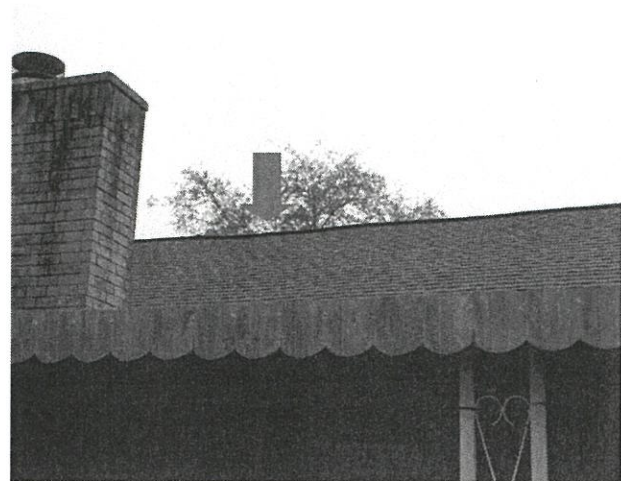
- Noted lifting and sag in ridge vents. Sag may be caused by the damaged roof decking. Further investigate root cause and repair as needed.

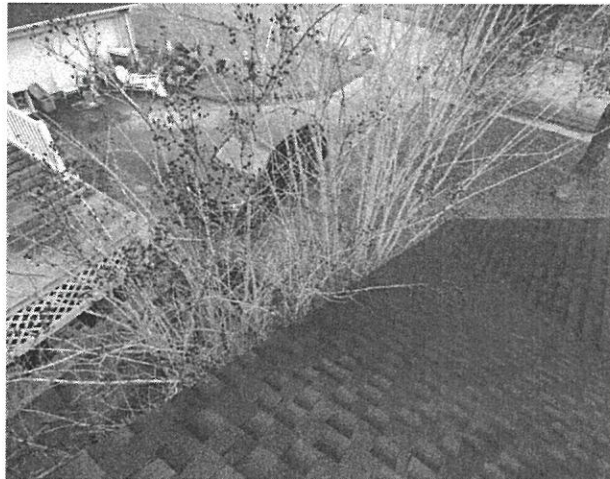
- Recommend to maintain tree limbs trimmed on the right side of the house to prevent from contacting and damaging roof shingles.

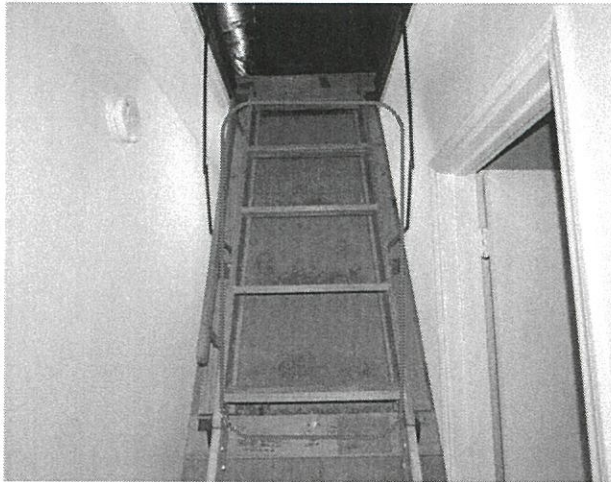
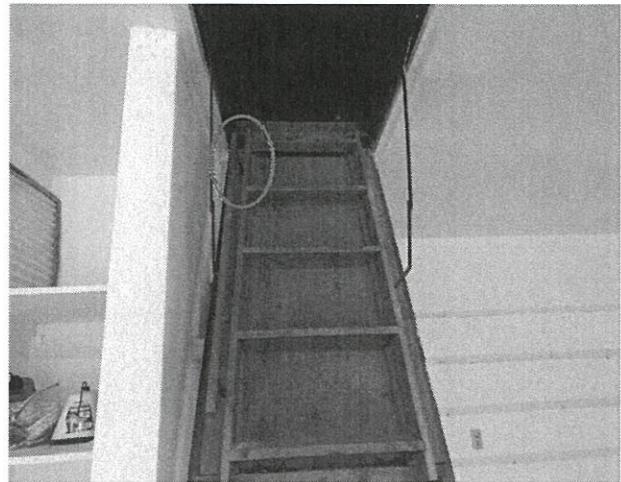
- Recommend to insulate ladder rungs for insulating value, install weather stripping on attic door edges or on access frame for energy efficiency
- The garage attic access handrail is loose due to a missing a fastener on the top side of ladder. Replace for safety.

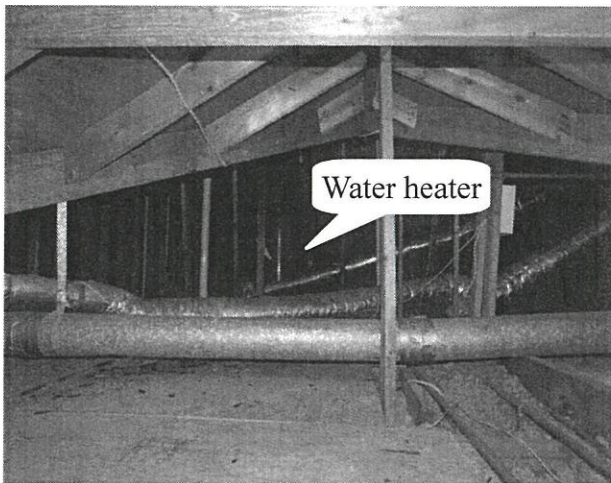
- Inadequate attic walkway/platform to mechanical equipment. Standards require 30" head clearance and a minimum of 24" wide solid with no gaps or obstructions

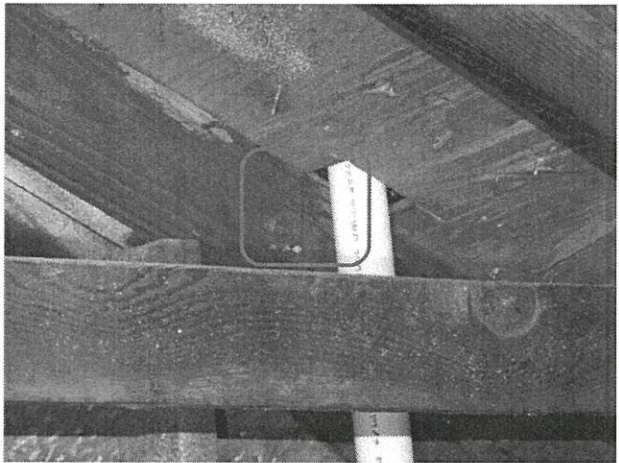
- There is evidence of previous water intrusion at plumbing vent penetrations visible through the garage attic access. Stains appear to be prior to installation of existing shingles. Further investigate condition as needed.

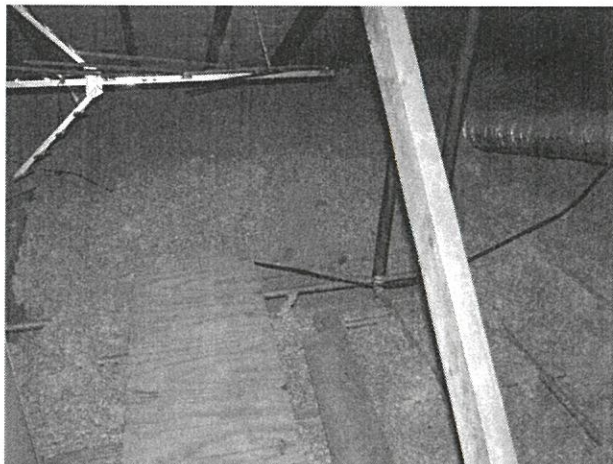
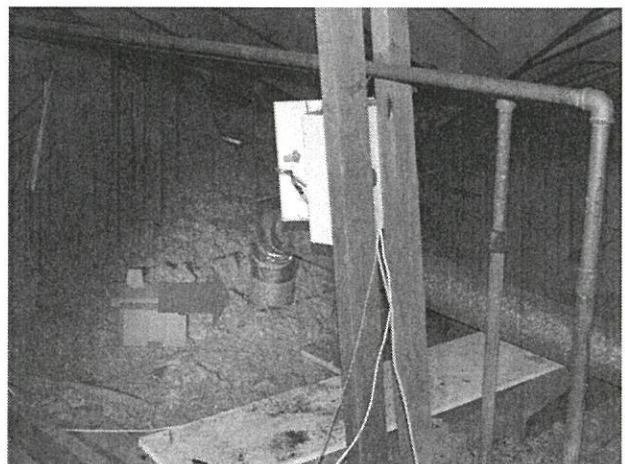
- Insulation missing near water heating equipment. Install required amount of insulation for energy conservation.
- Observed insulation in contact with range hood exhaust. There should be a min clearance of 1" for double wall/type "B" and 3" for single wall exhausts.

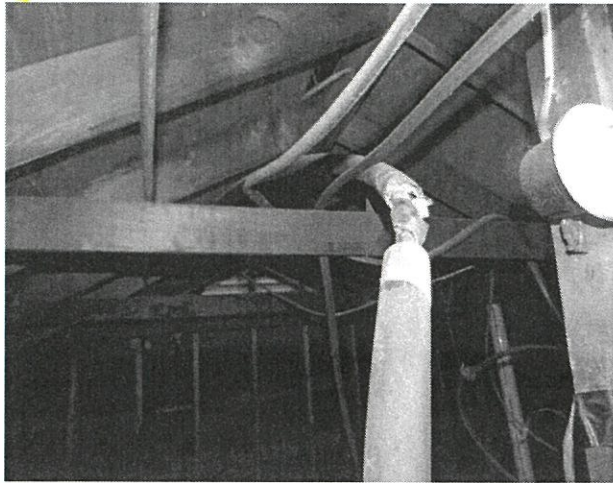
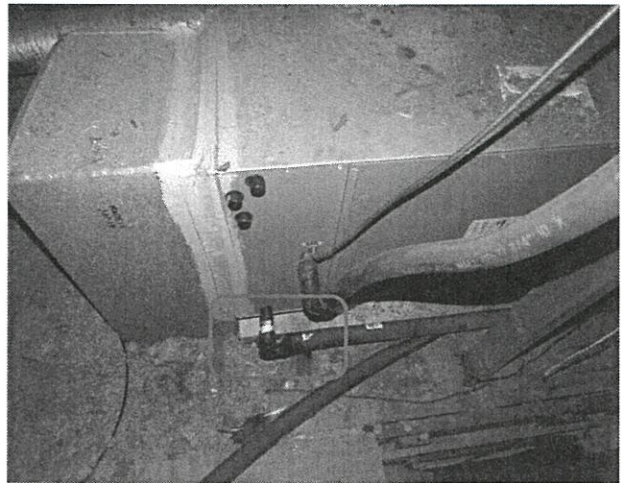
- Repair missing/damaged insulation on A/C refrigerant and primary drain lines to prevent possible damage from condensation.

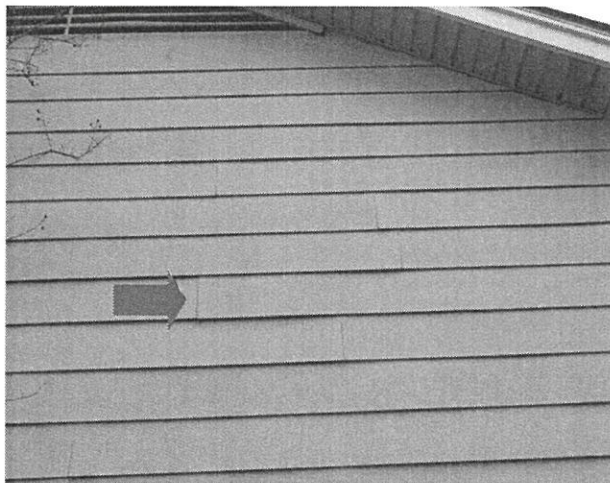
- Properly seal gaps at siding joints to prevent deterioration and moisture/water intrusion

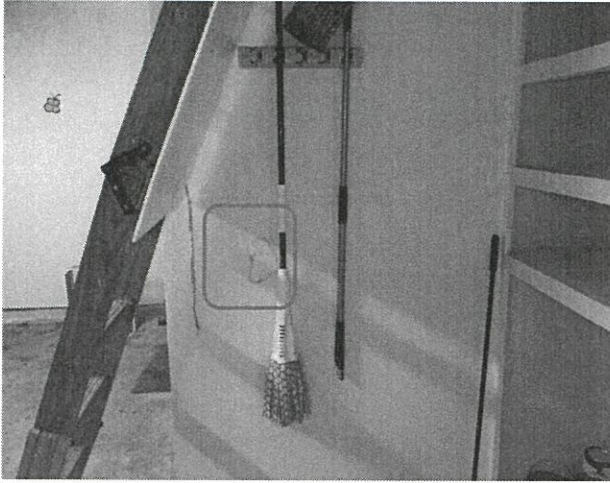
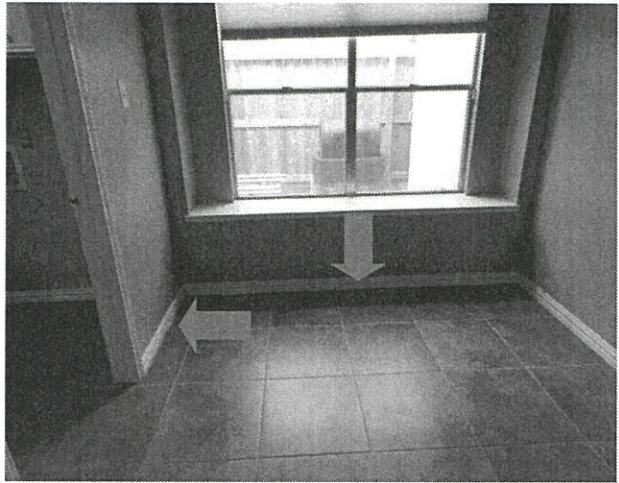
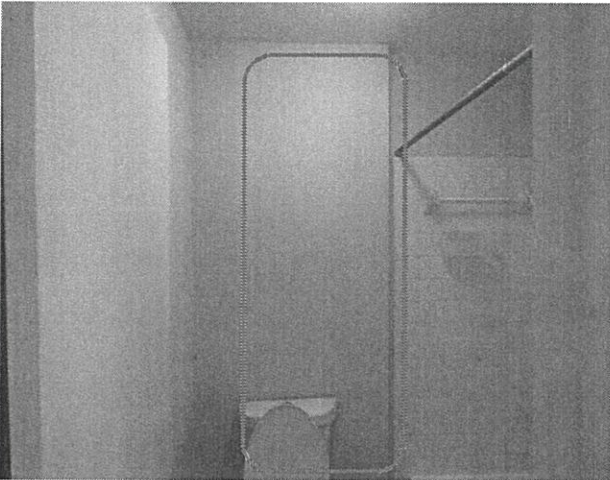
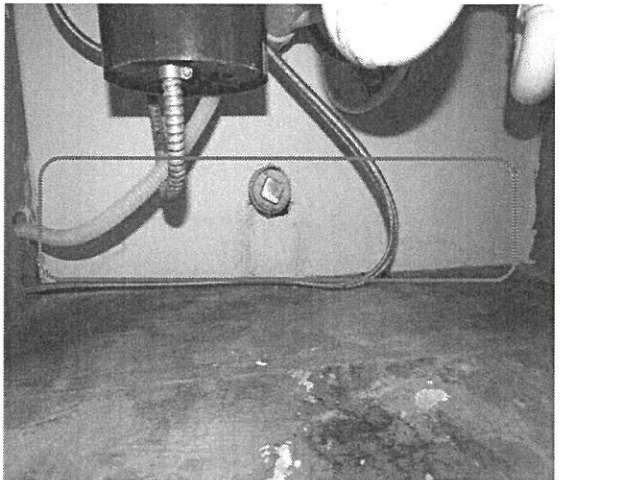
- Noted previous moisture damage in garage, kitchen, master bathroom and breakfast area baseboards. Moisture did not appear to be recent. Further investigate root cause and repair as needed.

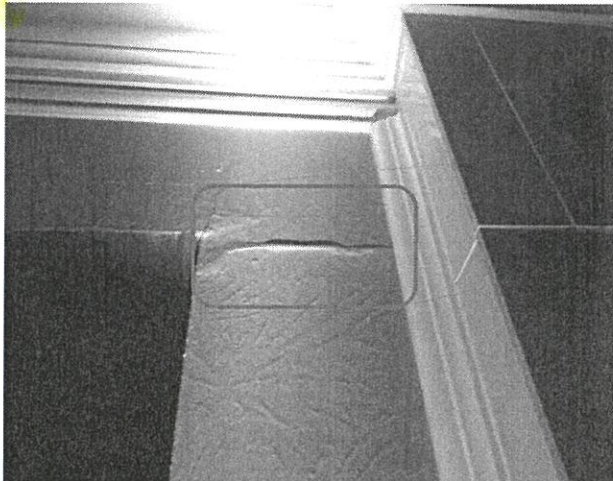
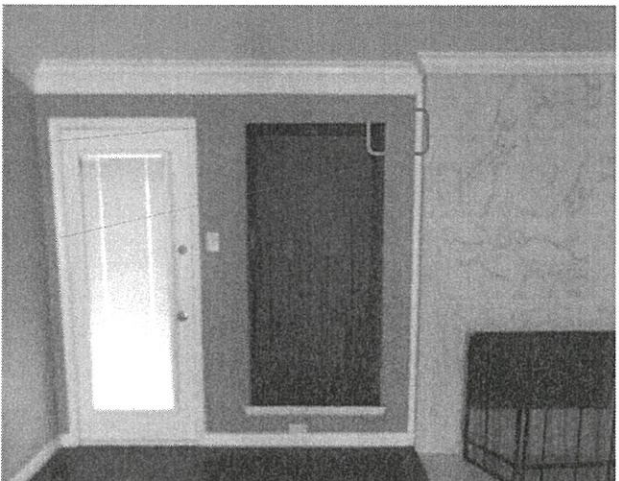
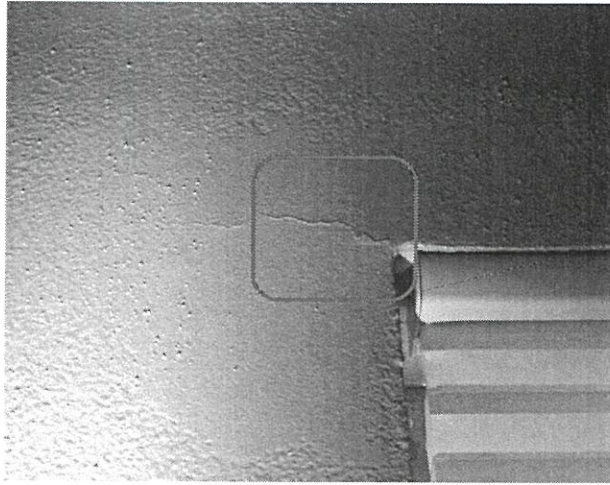
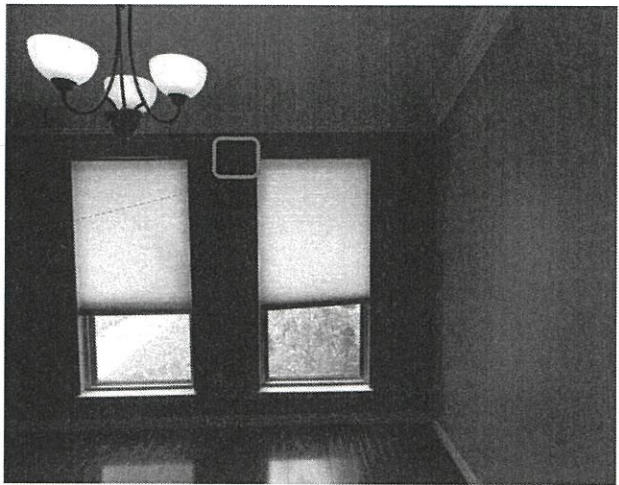
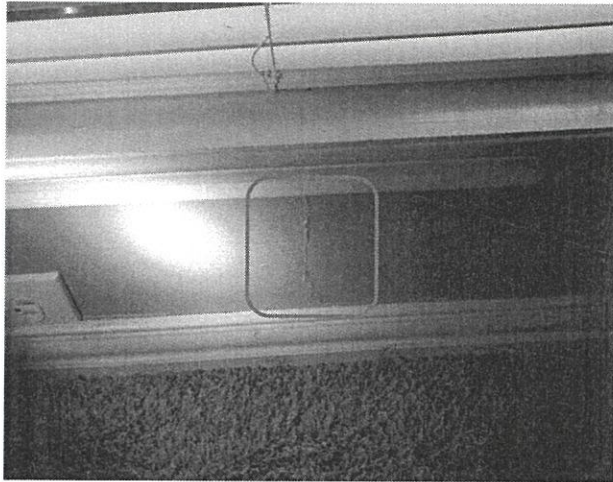
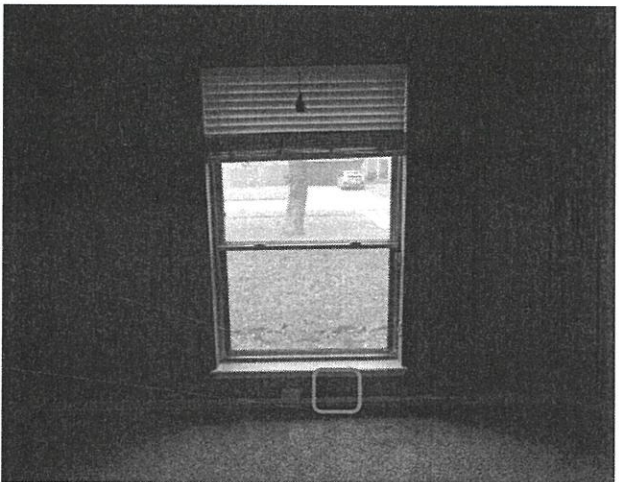
- Noted cracks on several walls that may be associated with settlement of the home. Recommend to monitor cracks over time. If concerned at this time, or should the condition continue to deteriorate, we recommend to consult with structural engineer to further assess the integrity of the foundation slab.

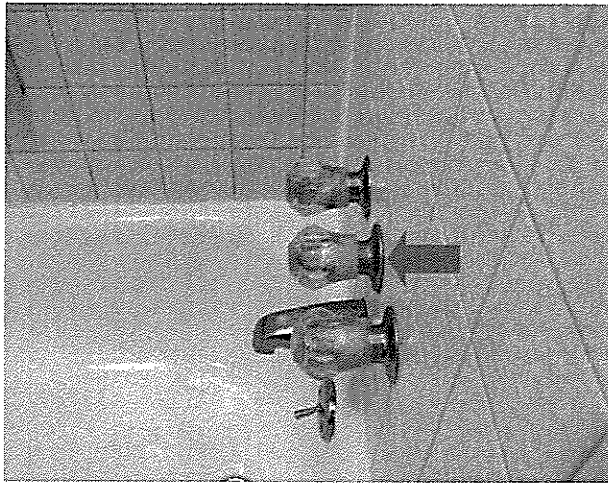
- Properly seal gaps in shower enclosures to avoid water infiltration and damage to property

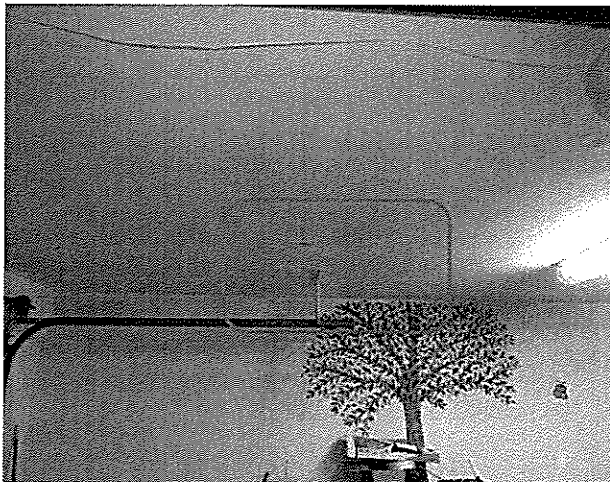
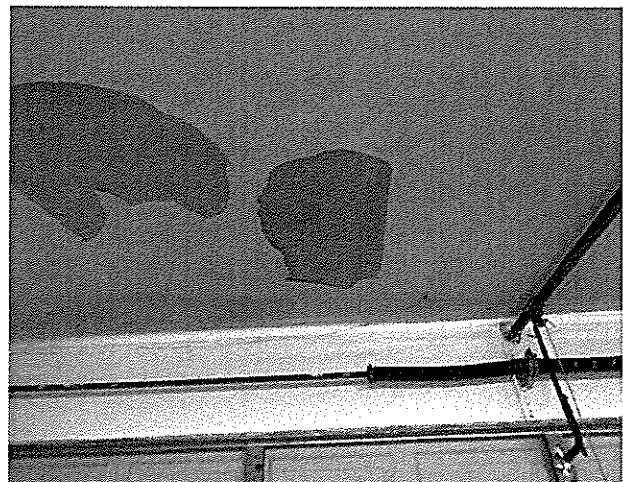
- Bubbled/blistered paint on multiple areas of the garage ceiling. This condition may be caused by excessive moisture/humidity. Further investigate root cause and repair as needed.

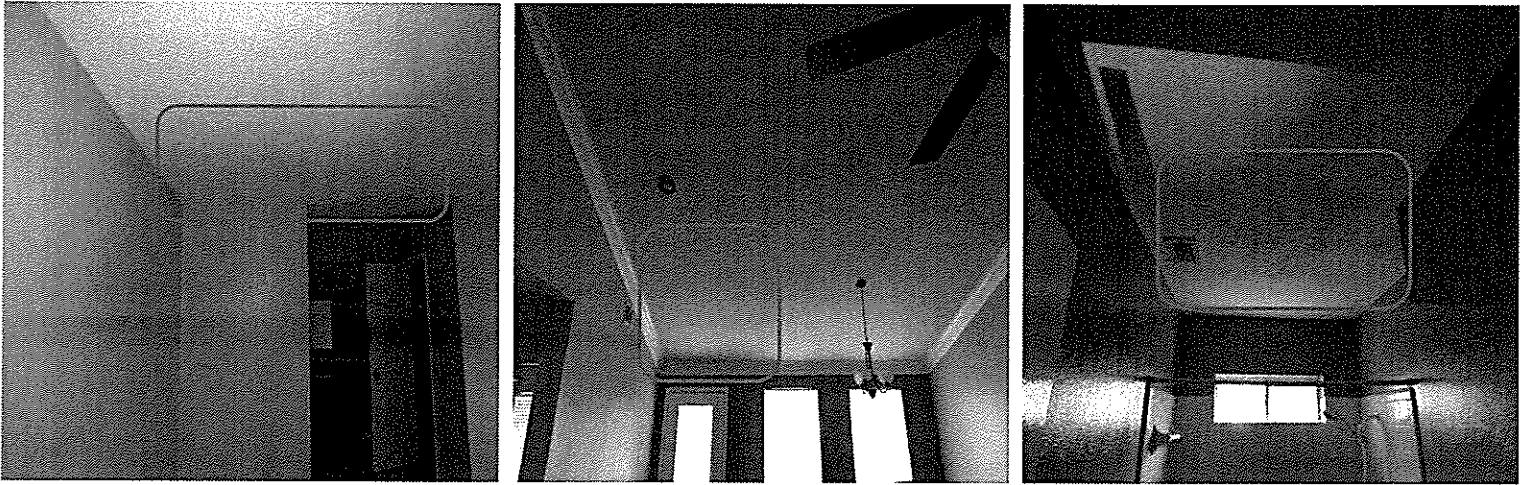
- Evidence of repairs on master bedroom, living room, and hallway bathroom. Further investigate root cause as needed.

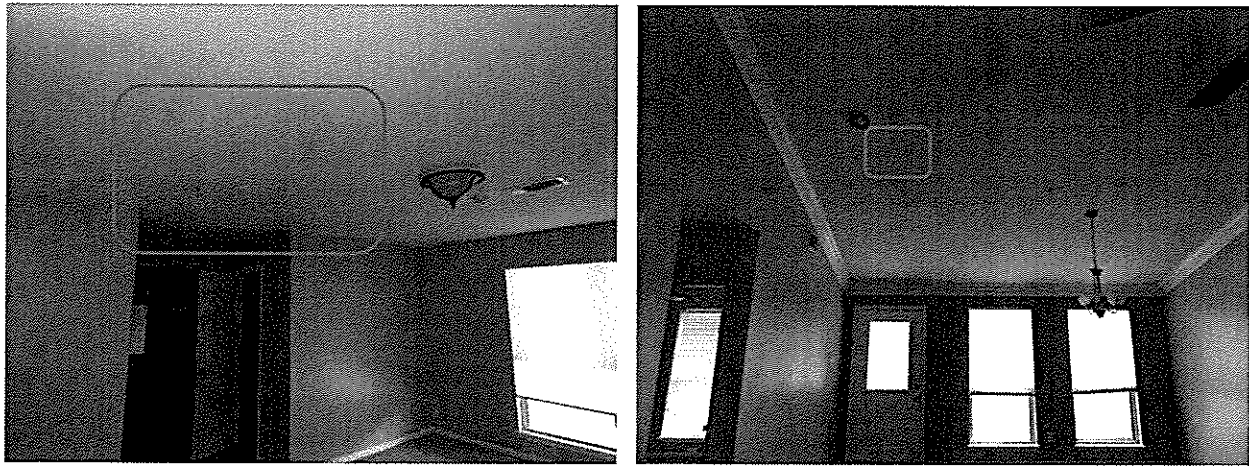
- Water/moisture stain noted on master bedroom and living room ceiling. Stains do not appear to be recent. Investigate root cause and confirm that all affected areas such as but not limited to: sheetrock, insulation, joists, etc, have been properly repaired/treated by a qualified contractor. Note: If not properly repaired and or treated, it can lead to microbial growth

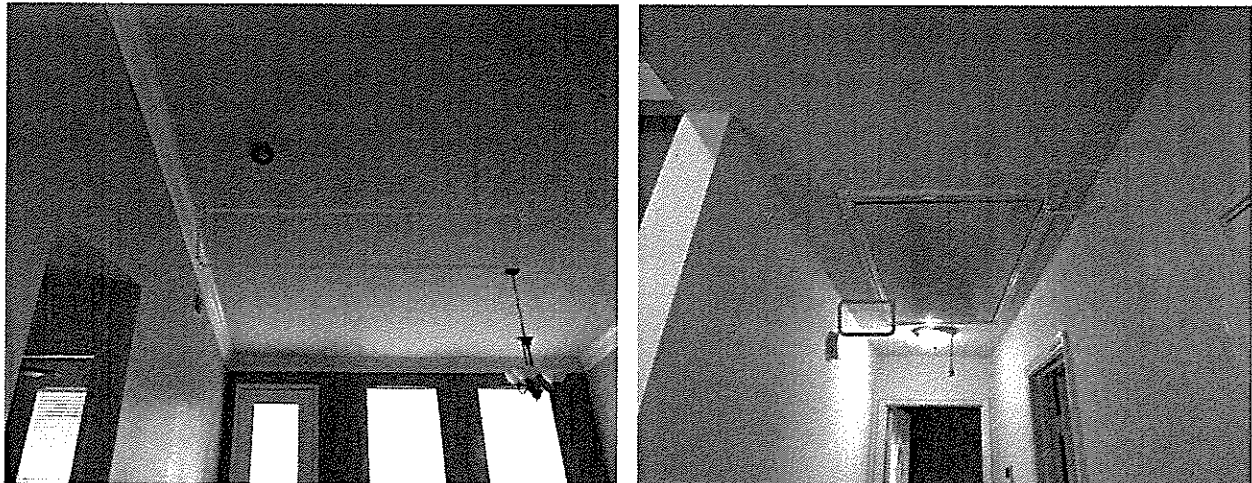
- Hairline cracks noted on living room ceiling and around attic access. Repairs may be desirable.

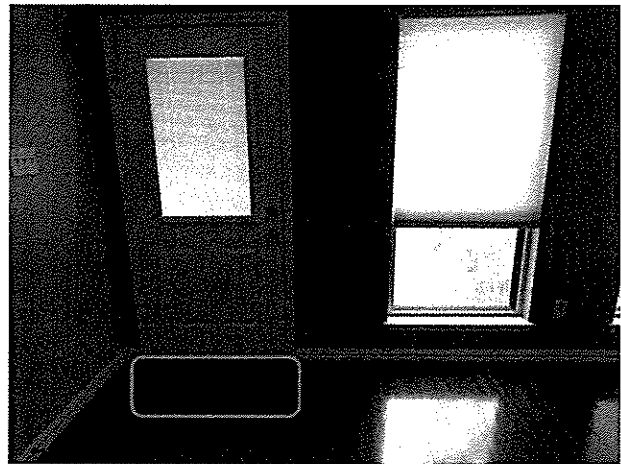
- Lifting flooring in front of the front right bedroom and also noted possible evidence of water damage on flooring at the entrance door. Repair as needed.

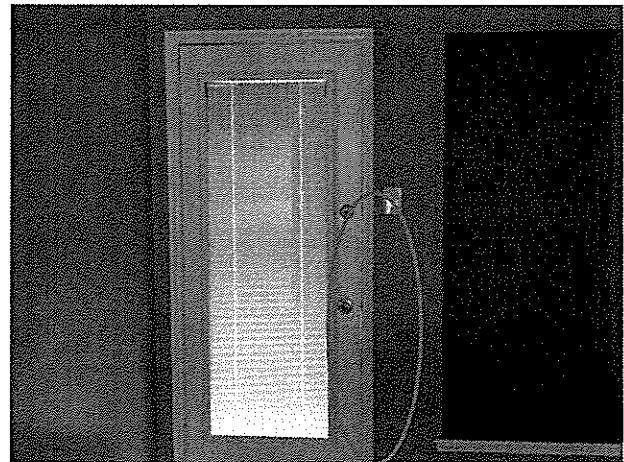
- Double key deadbolt observed at the front and rear exterior doors. **Note:** while this feature improves security, it may also hinder access/egress in an emergency. Recommend single key deadbolt for safety
- Observed daylight on rear exterior door. Properly seal for energy efficiency

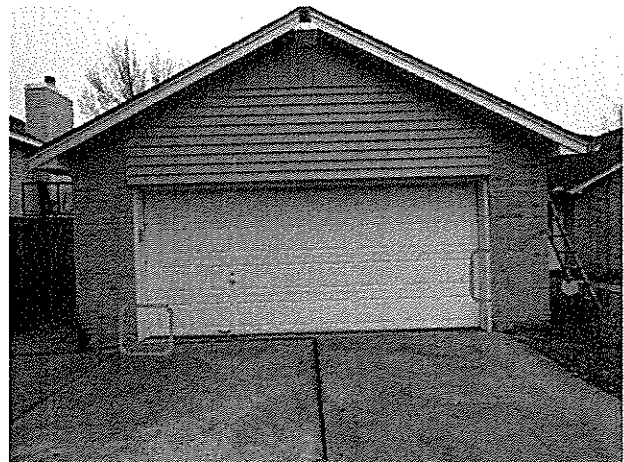
- Front right bedroom door sticks and garage door trim is damaged. Repair as needed.

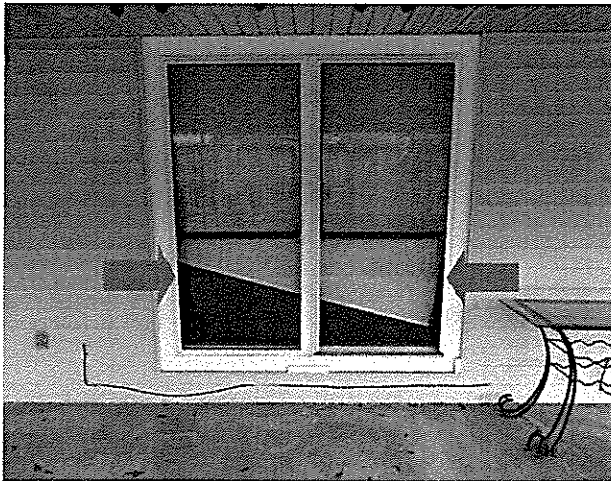
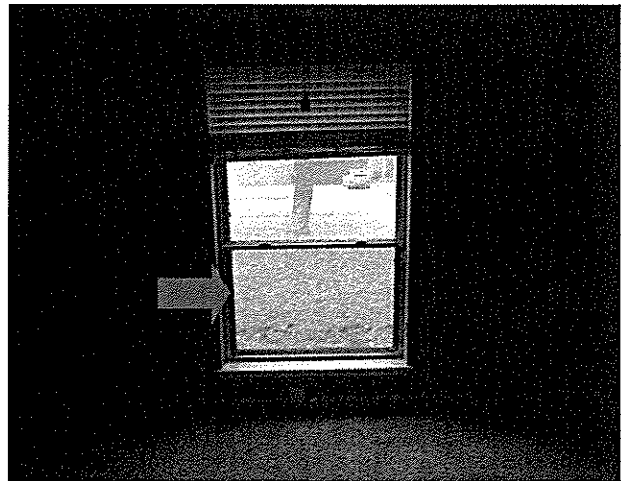
- Rear exterior storm windows appear to be missing. Replace as needed.
- Window in the front right bedroom did not stay open. Repair for safety.

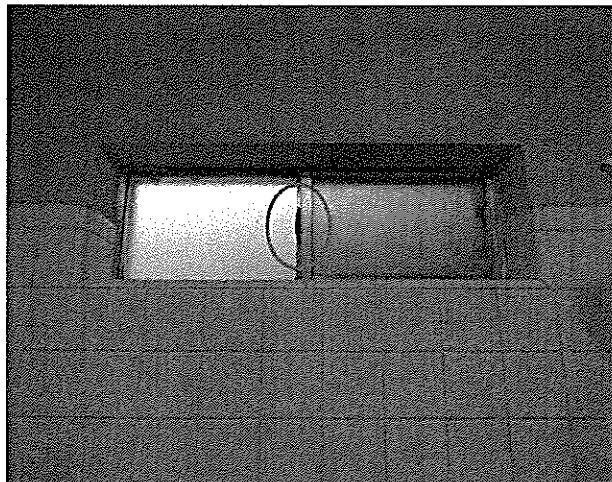
- Master bathroom window lock is stiff. Repair as needed.

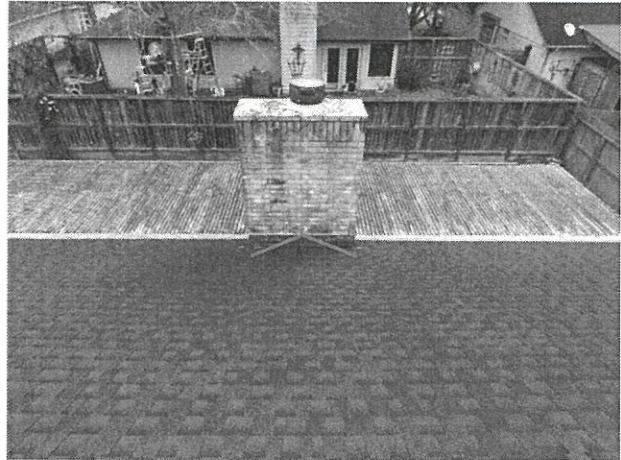
- Repair cracks in the firebox to prevent the escape of gases/ashes into the cavity.
- Chimney cricket is missing. **Note:** Chimneys shall be provided with crickets where the dimension parallel to the ridge line is greater than 30 inches. Repair as needed.

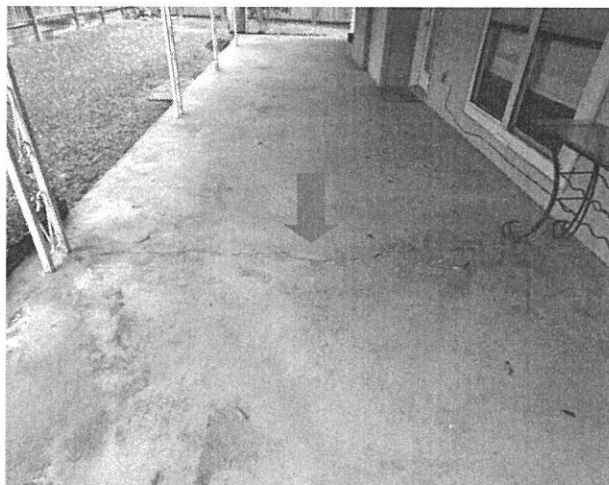
- Multiple Cracks on rear porch cement slab. Repair as needed. Sample below.

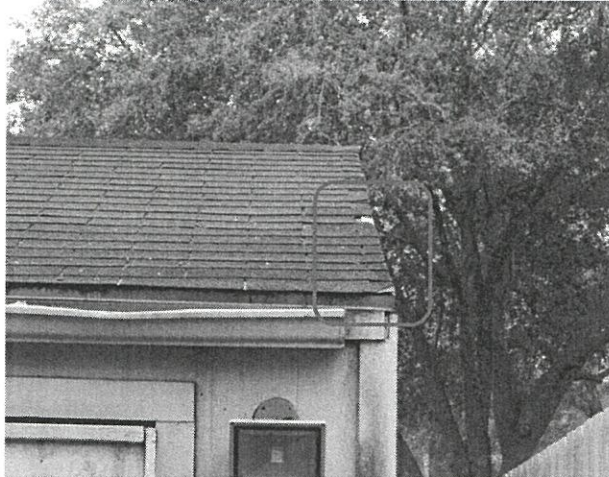
- Missing/damaged shingles on the right side of storage shed roof covering. Repair/replace to prevent further water penetration.

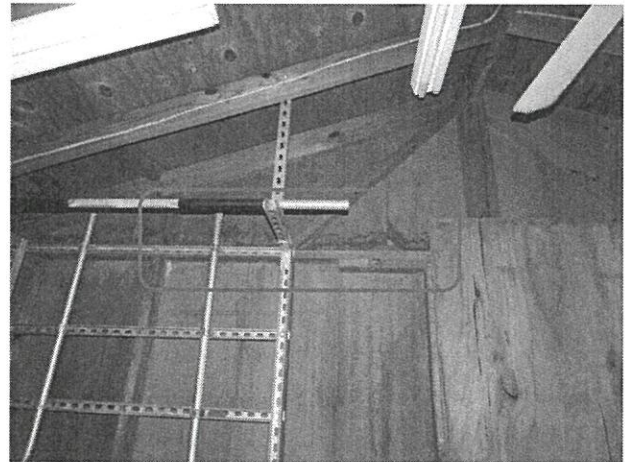
- Water damaged noted on storage shed roof structure and walls. Investigate root cause and repair as needed. Samples below.

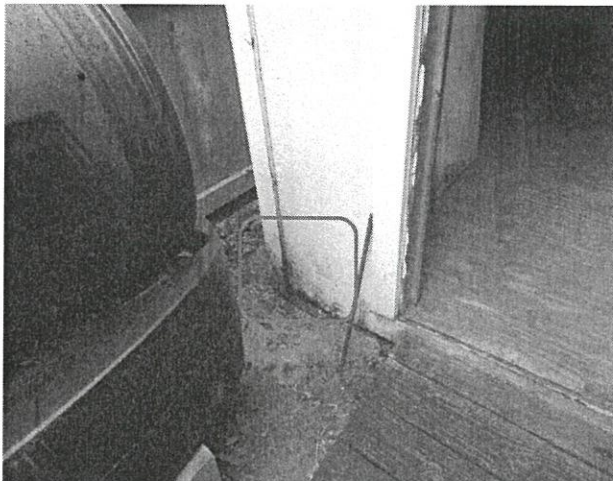
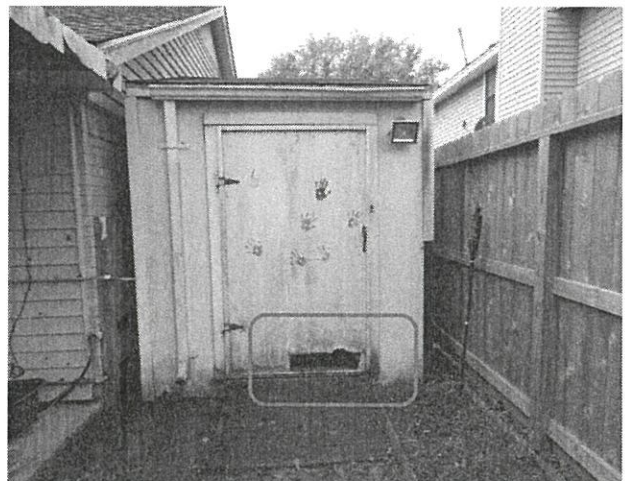
- Rotted/damaged siding on storage shed. Replace as needed. Samples below.

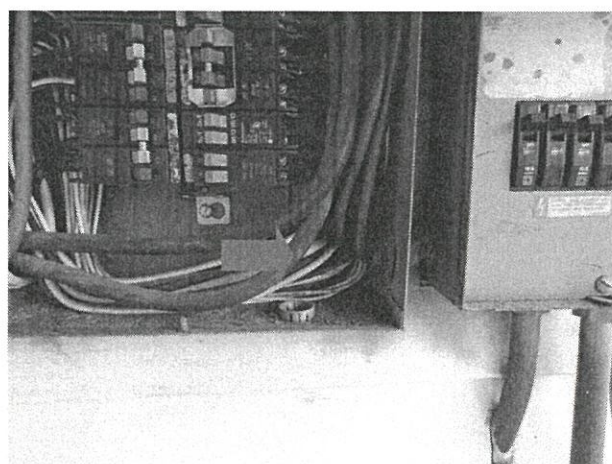
- Main feeder and sub panel feeder cables are double tapped. This condition is hazardous and may cause overheating. Consult with a licensed electrician for proper repairs for safety.
- No anti-oxidant compound on feeder aluminum cables. As oxide builds and continues to build on aluminum wires, it also builds up resistance. Recommend Alnox or Penetrox A13k
- Branch conductors were bundled and pass through a single penetration in the panel cabinet. Such constriction of conductors may generate excessive heat and de-rate the amperage of the cables.

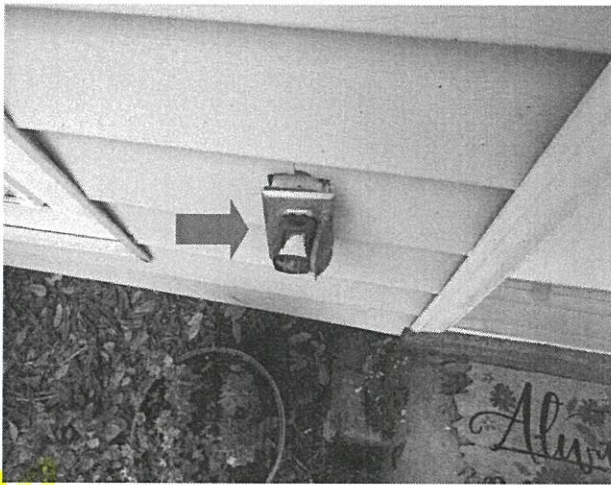
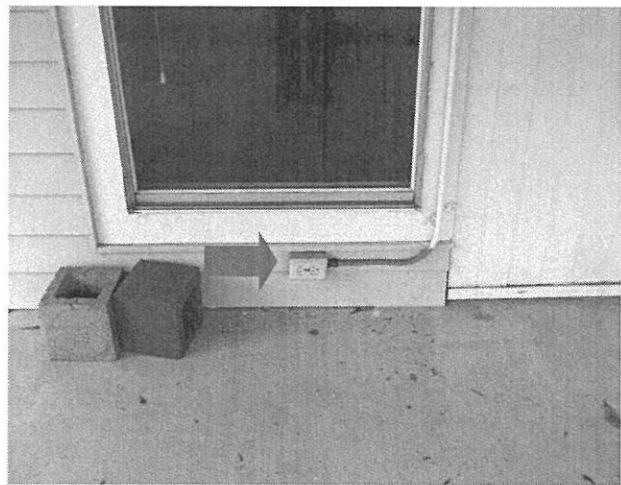
- There are missing GFCI outlets at required locations: Note: GFCIs are intended to protect persons from accidental electrocution in areas susceptible to moisture. Installations of these devices in the locations specified are recommended as safety upgrades. These locations include: All kitchen countertop receptacles, and bathroom receptacles, receptacles within 6' of water, all outdoor receptacles and all garage receptacles, including ceiling receptacles for any overhead garage door operators, except those dedicated to a fixed appliance. These devices should be tested monthly for safe and proper operation per the manufacturer.
- Properly install outlet on the front exterior side of the house to prevent possible moisture/water entry.
- Debris in outlet prong inserts on the rear side of the house. In need of repair.

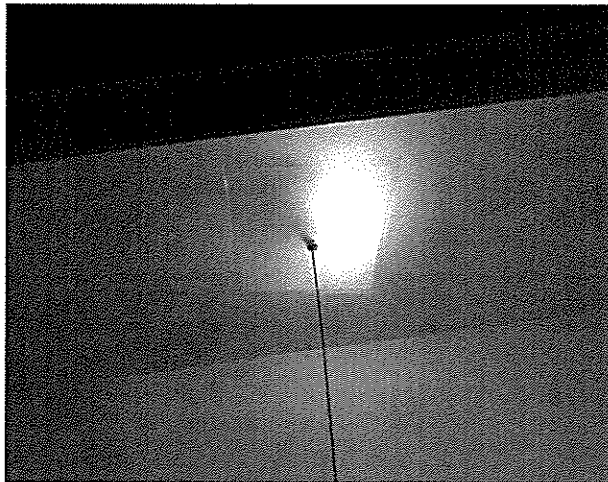
- Light fixture cover in the front right bedroom is cracked. Replace for safety.

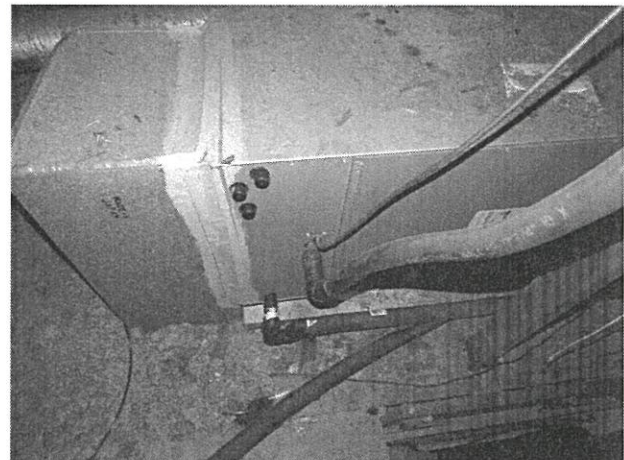
- Air leaking from plenum. Properly seal to prevent the escape of air/moisture.
- Recommend to unplug secondary drain line and elbow it down to drain pan using pvc.

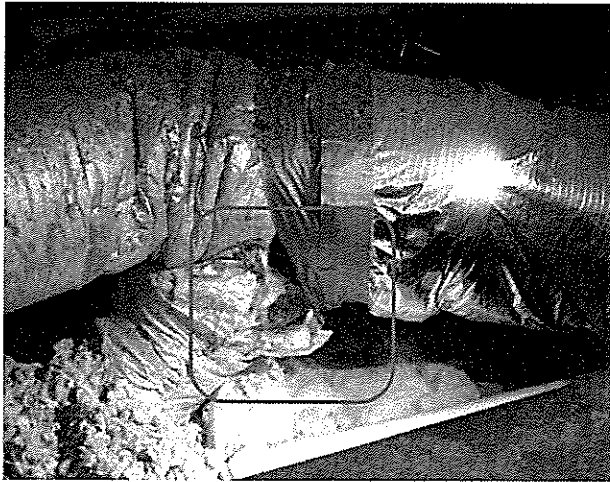
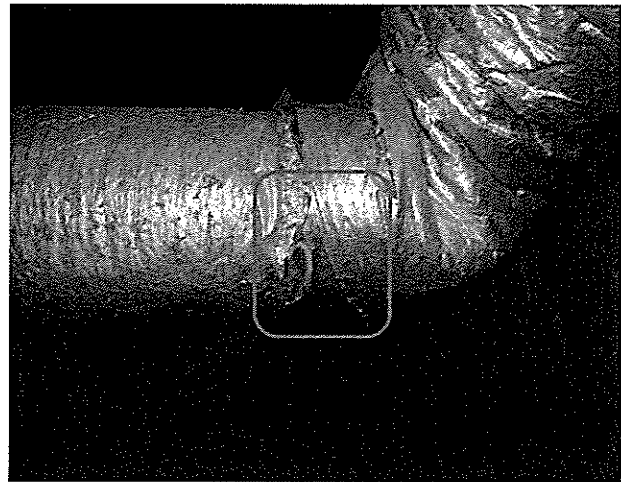
- Corrosion on ducts located on the right side of the house. Recommend to consult with a qualified HVAC tech to further assess the integrity of the duct system and properly repair/replace as needed.

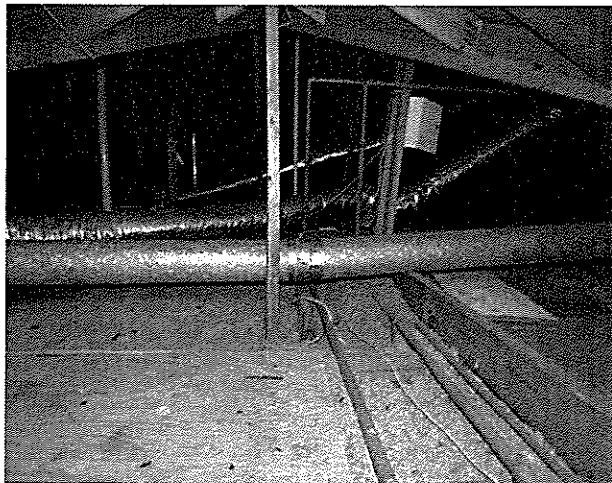
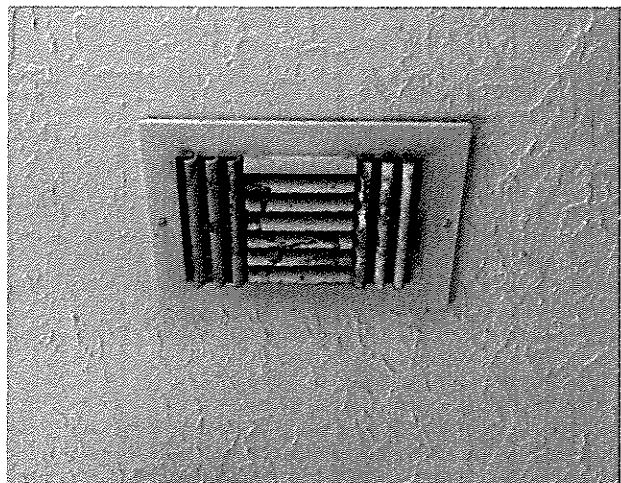
- Ducts are to be suspended using 1 1/2" straps at every 4ft
- Possible evidence of microbial growth on multiple vents throughout the house. This condition may be caused by condensation and/or leaking air ducts. Further investigate root cause and properly repair as needed

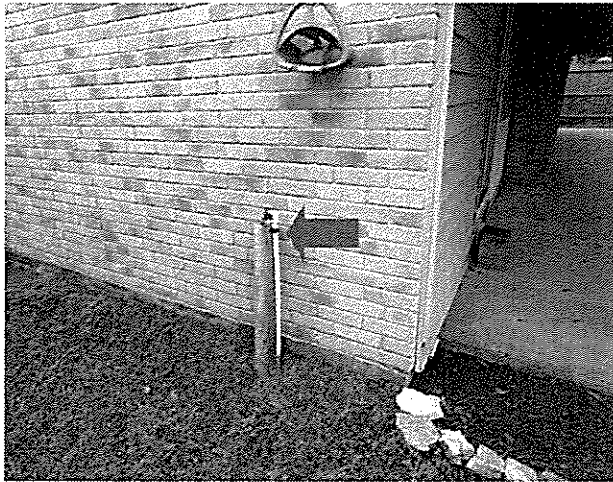
- Hose bib on the rear right side of the house did not have water supply. Consult with a qualified plumber to further investigate condition and repair as needed.
- Noted missing "Back Flow Prevention" device on hose bibs. This prevents contaminants such as sewage etc from being siphoned into the water supply. Recommend installation of device for safety

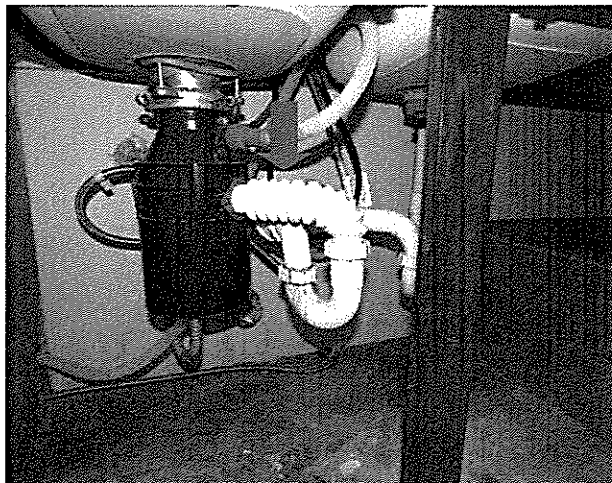
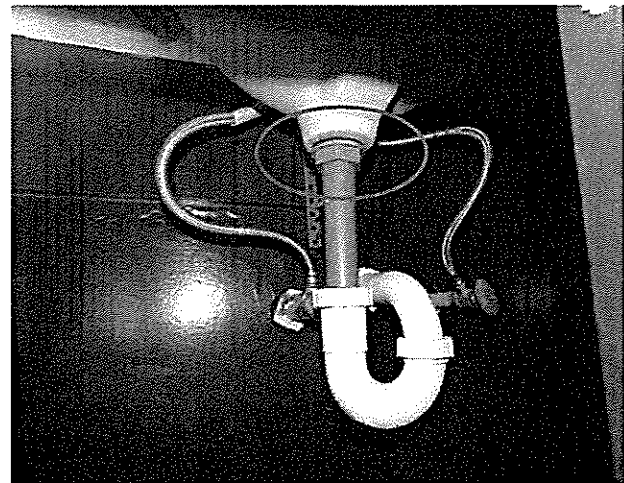
- Observed non-approved drain connector in upstairs bathroom plumbing. Note: Drainage fittings shall have a smooth interior waterway of the same diameter as the piping served. All fittings shall conform to the type of pipe used. Drainage fittings shall have no ledges, shoulders or reductions which can retard or obstruct drainage flow in the piping. Any configuration other than smooth interior will cause solids to catch and begin to clog the pipe
- Leak at master bathroom sink connection. In need of repair.

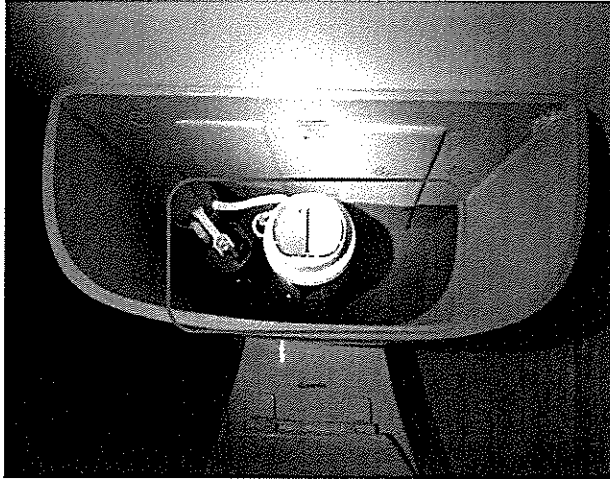
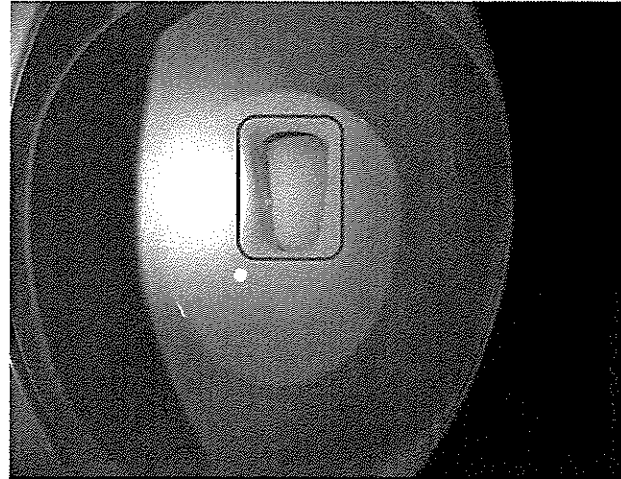
- Sediment in both toilet tanks and also noted debris in the hallway toilet bowl when flushed. This condition may be indicative of corrosion in plumbing and/or water heating equipment. Recommend to consult with a licensed plumber to further investigate root cause and properly repair as needed.
- Observed loose toilets in both bathrooms. Properly secure to avoid water leaks **Note:** If excessive movement of toilet is noticed, we recommend that the seal be replaced.
