PROPERTY INSPECTION REPORT

Prepared For: Shane Lampard and Candise Juarez
(Name of Client)

Concerning: 2421 Parkview Dr. Pearland, TX 77581
(Address or Other Identification of Inspected Property):

By: Giovanni Angel, 22909 3/10/2019
(Name and License Number of Inspector) (Date)

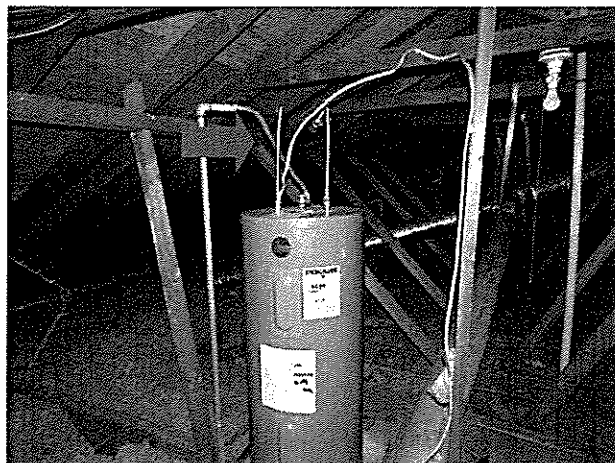
- Inspector was not able to verify bonding of the metal water supply piping. **Note:** The metal gas water supply piping should be grounded or bonded to the electrical system. Recommend verification and/or installation of same for safety precautions.
- The temperature/pressure relief discharge pipe should be as short and as straight as possible so as to avoid undue stress on the valve and be installed so as to drain by flow of gravity. In need of repair.
- The water heating equipment is missing the required in-sight direct disconnect or lockable switch. Install same for safety precautions.

The disconnect must be within sight of the appliance, or it must be capable of being locked in the open position, and the provision for locking remains in place whether locked or unlocked.

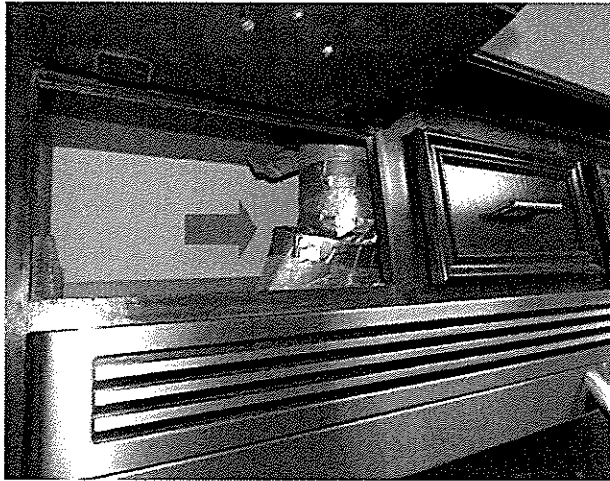
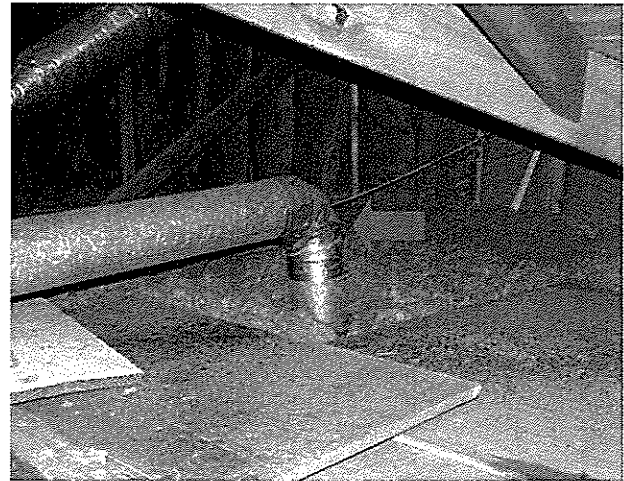
- Noticed duct tape (flammable) being used on connectors. Recommend replace duct tape for aluminum tape

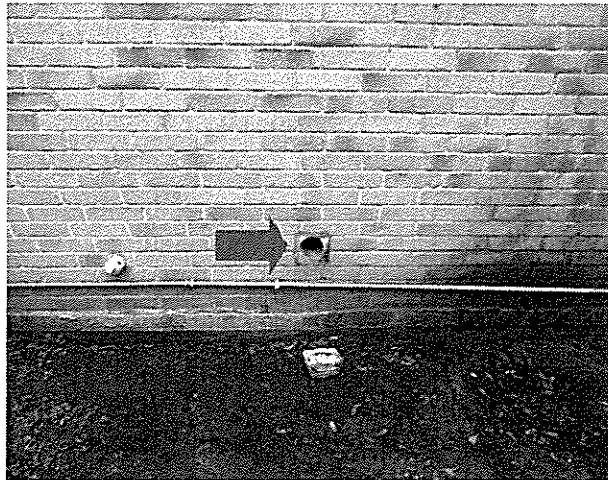
- The dryer vent cap is not installed. In need of repair. **Note:** recommend checking dryer hoses and cleaning ducts approx. every six months. Hoses should be replaced every five years. A dryer can erupt in flames if lint builds up inside the machine or its ducts. **Note:** Exhaust duct terminations shall be equipped with a back draft damper. Screens shall not be installed at the duct termination
