BRUCE ' S

Date: 07/16/2020 Report Number 2020-Ashford Meadow-Goldman-82

Address: , Houston, TX 77082

PROPERTY INSPECTION REPORT

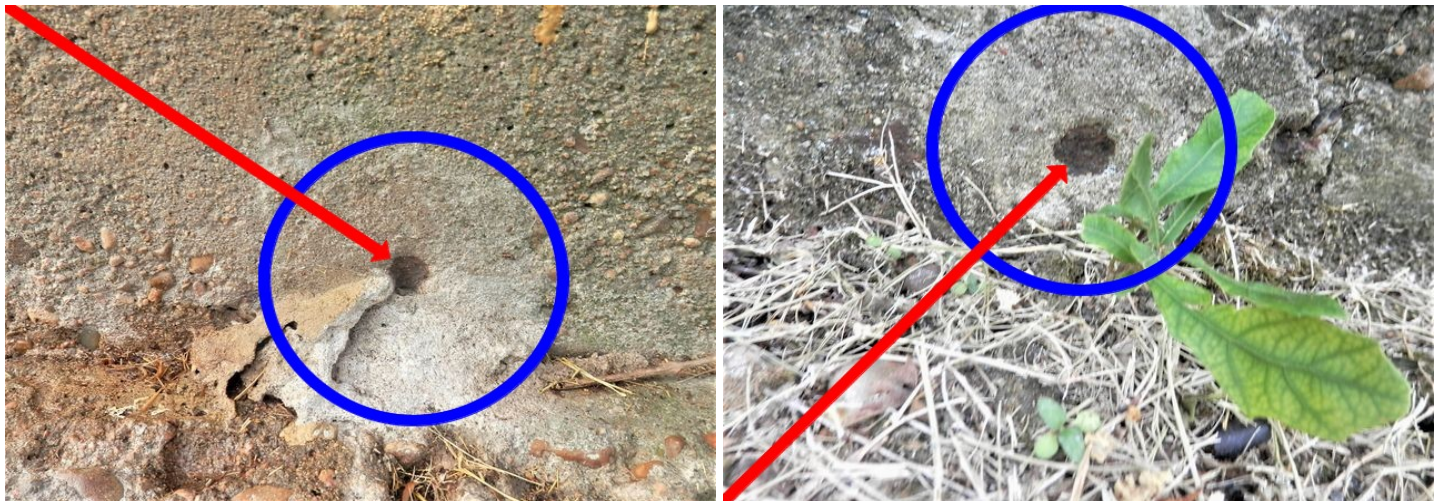
- One or more of the Post-tension cable ends was observed to be exposed at the face of the foundation. At this time, the remedial work needed is considered to be a maintenance issue.

sample of exposed cable ends

Plastic end cover (if present) is for "temporary construction protection", and not intended for long term exposure to the elements Patch should be of a non shrink, epoxy / cement type mix. Do not use bagged cement or any product containing calcium chloride or other material harmful to pre-stressed steel.

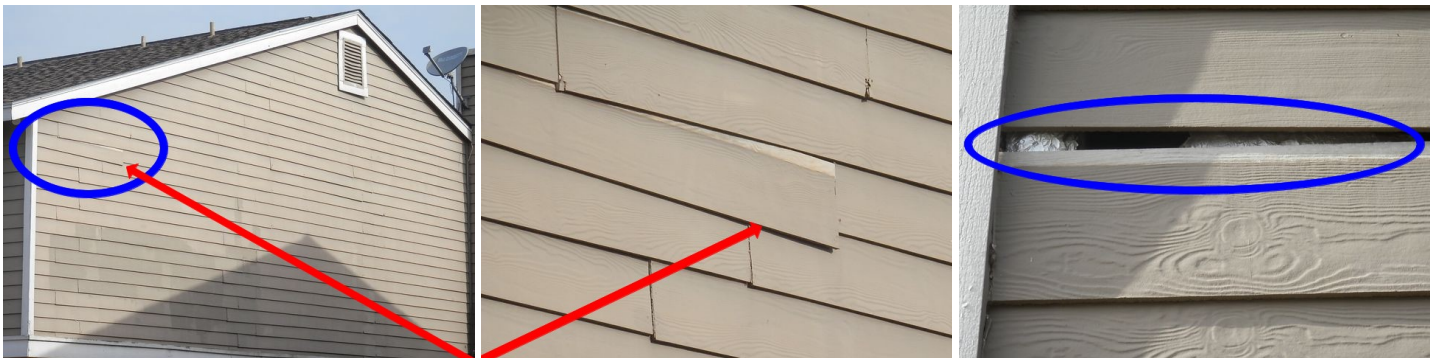
- The siding material was observed to be loose and spacing at one or more areas. It was disclosed that the HOA takes care of the exterior. Check with the Home Owners Association as to when repairs are scheduled for this unit. Some voids or spacing is such that water penetration could occur. Repairs are recommended.

sample of loose siding and voids in the exterior veneer

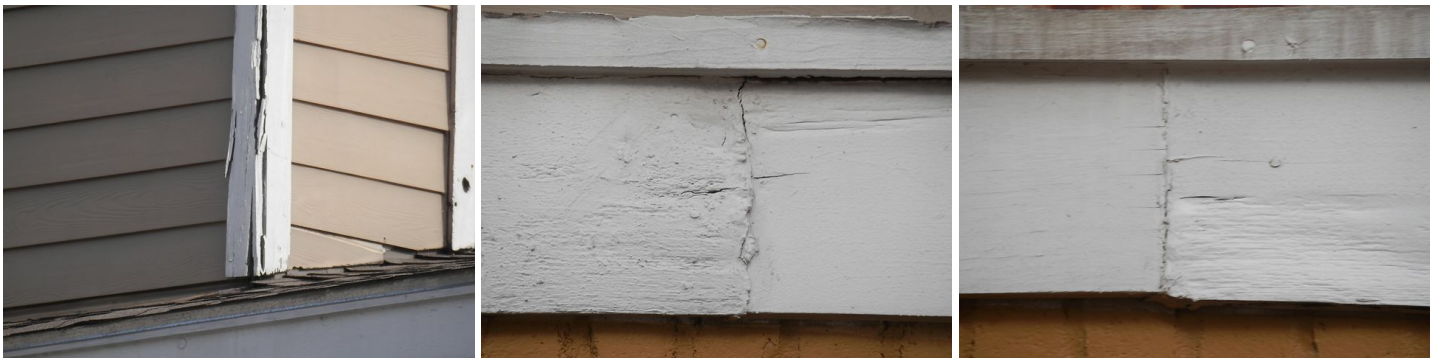
- Deteriorated wood and loose trim was observed at the outside at one or more areas. It is not the purpose of this report to point out every such area; however, to recommend that the outside veneer and trim be repaired or replaced as needed.

sample of loose trim and/or soft, deteriorated wood

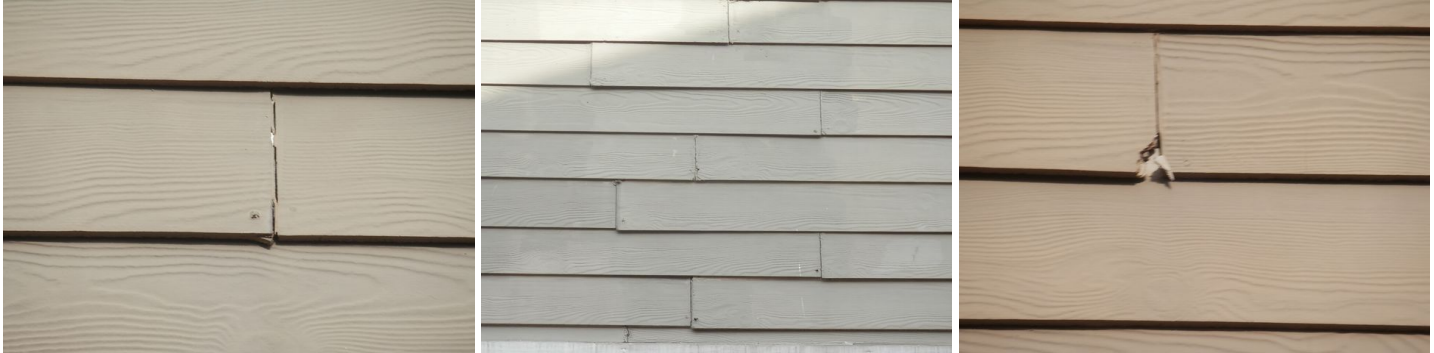
sample of siding end joints that are recommended to be caulked or sealed

- INFORMATION - MAINTENANCE:** Siding material has spacing at the end or butt joints. It is recommended that this space be caulked and kept caulked to help prevent water penetration and help protect the sub-material.

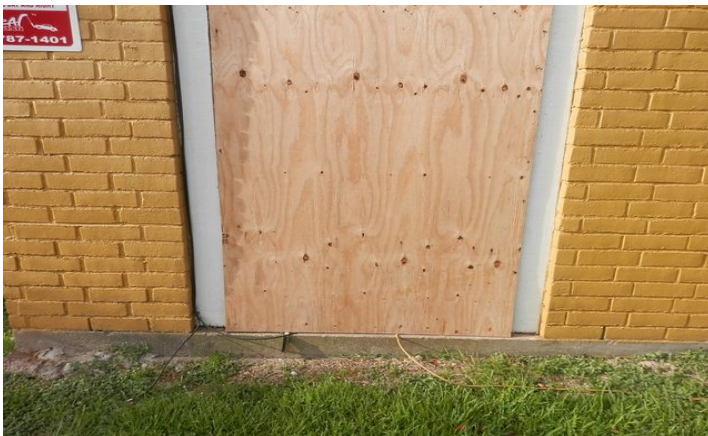
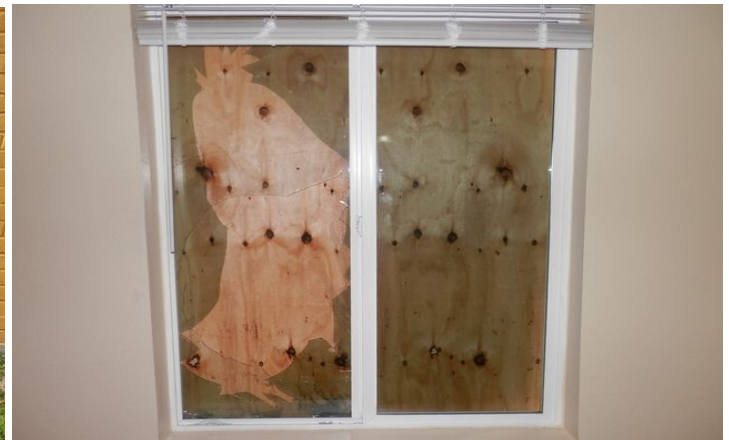
- One of the windows was observed to have broken glass at the front, first floor, of Unit A. Reglaze as needed for normal function and safety reasons.

window covered at the outside, broken glass observed inside

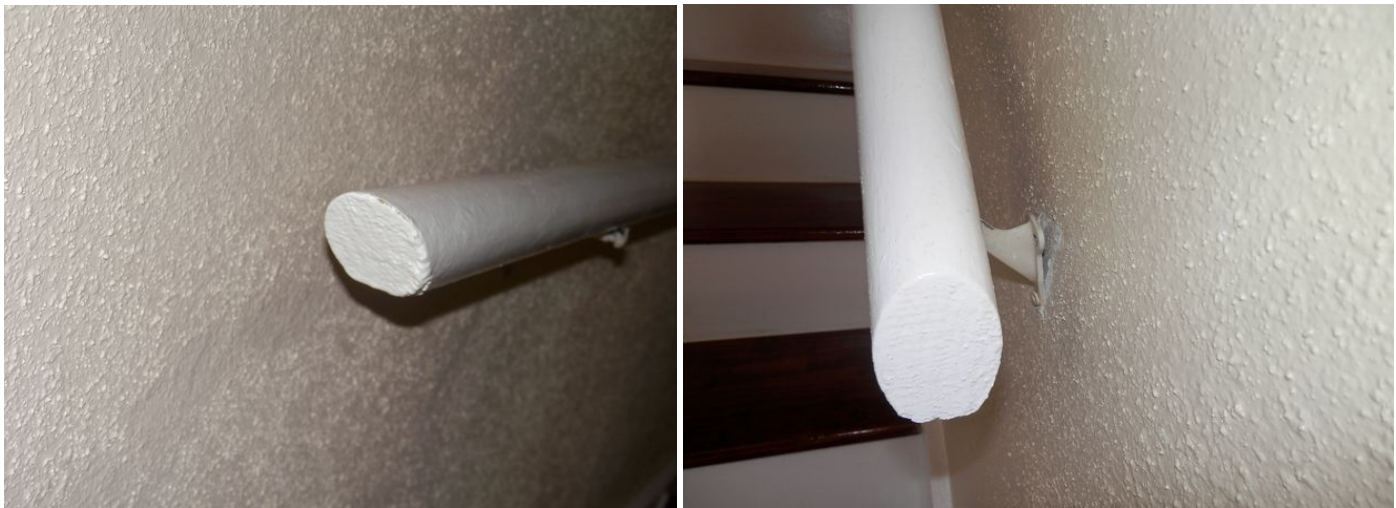
- The hand rail, such as at the stairs in unit A, did not terminate to the wall. The open end of the rail is a hazard, clothing can catch and cause a person to trip or fall (as per current standards). You may want to up-date this for safety reasons. Tenants should be advised about this in their lease. The hand rail was loose at unit A.

sample of hand rail not terminated to the wall (safety note) - hand rail was loose at wall in unit A

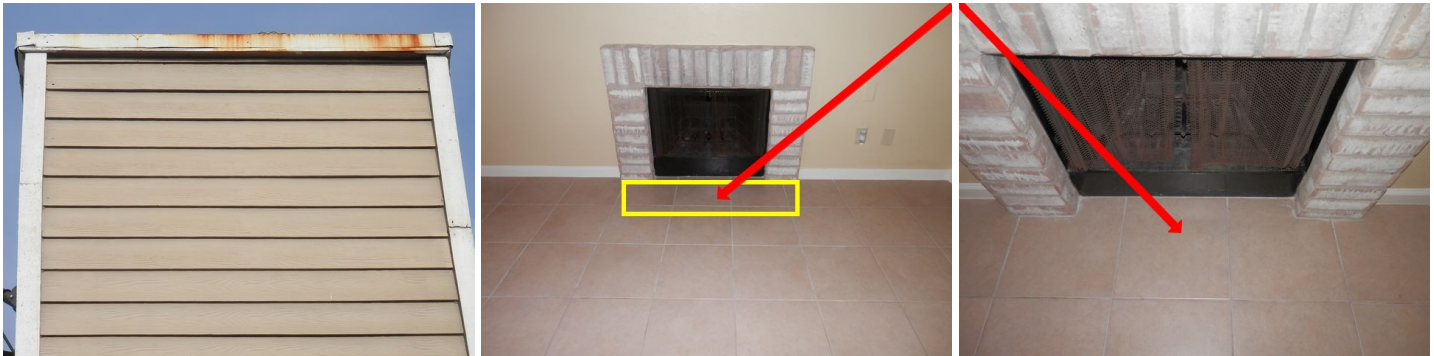
The flooring next to the fireplace is non-combustible (tile flooring), however, the International Residential Code for One & Two Family Dwellings, states "Hearth extensions of approved factory built-fireplaces shall be installed in accordance with the listing of the fireplace. The hearth extension shall be readily distinguishable from the surrounding floor area." (A hearth extension would serve as a reminder to not place anything that could be flammable too close to the fireplace.)

A non-combustible hearth is required for a fireplace, that is capable of burning solid fuel, because of popping embers and shifting logs that can spill from the firebox. I point out the lack of a hearth when a wood-burning fireplace is equipped with a gas log appliance and the hearth subsequently removed, because the equipment can still be restored to its original condition.

chimney cap appeared to be rusted - no discernable hearth at front of the fireplace firebox at unit A

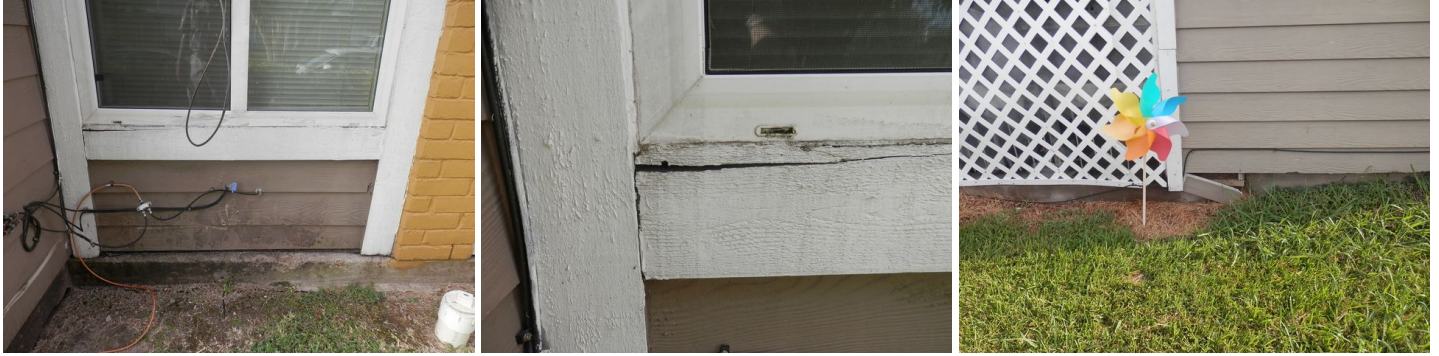
additional sample of voids in trim or loose trim

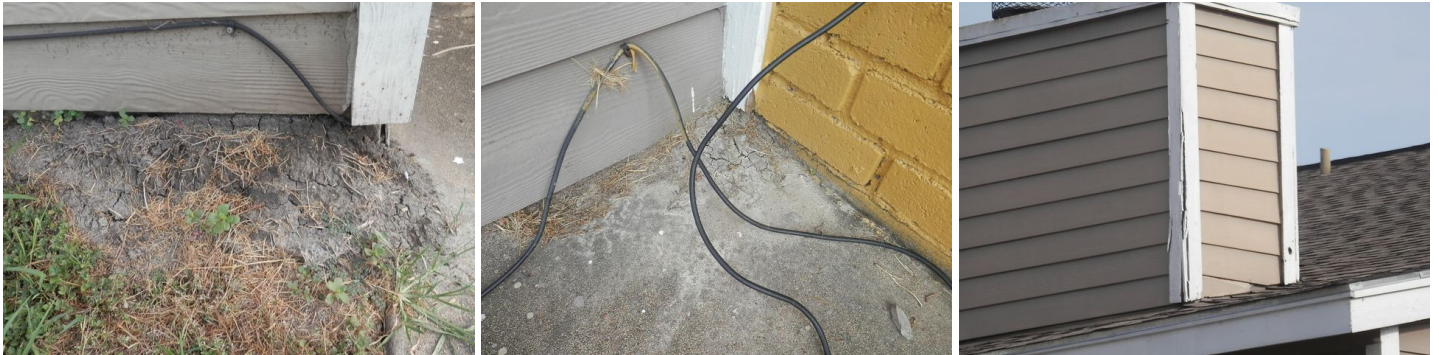
sample of ant beds at the back of unit C - void in trim at fireplace chimney housing

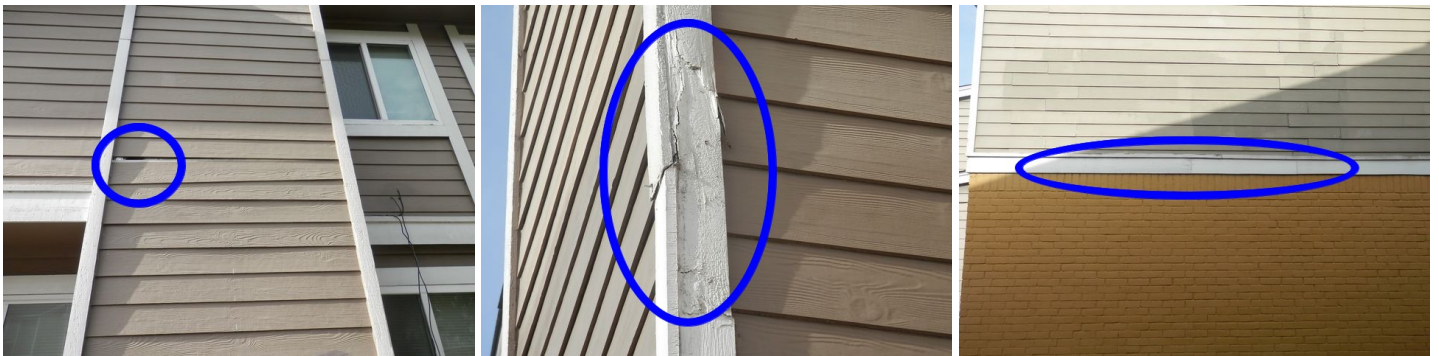
loose siding - deteriorated / soft wood

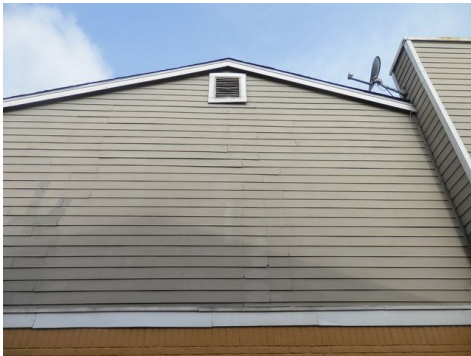
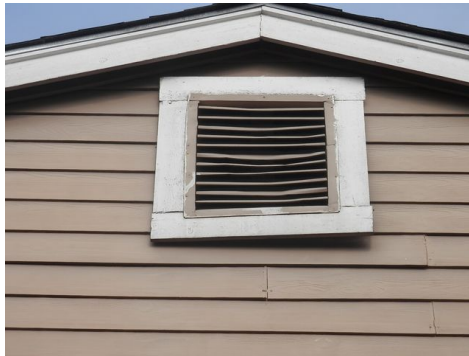
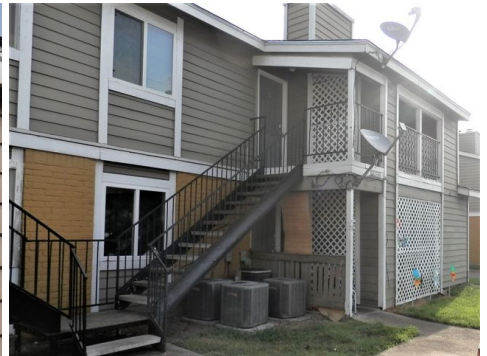
loose trim around the gable vent - general view of the back of the units

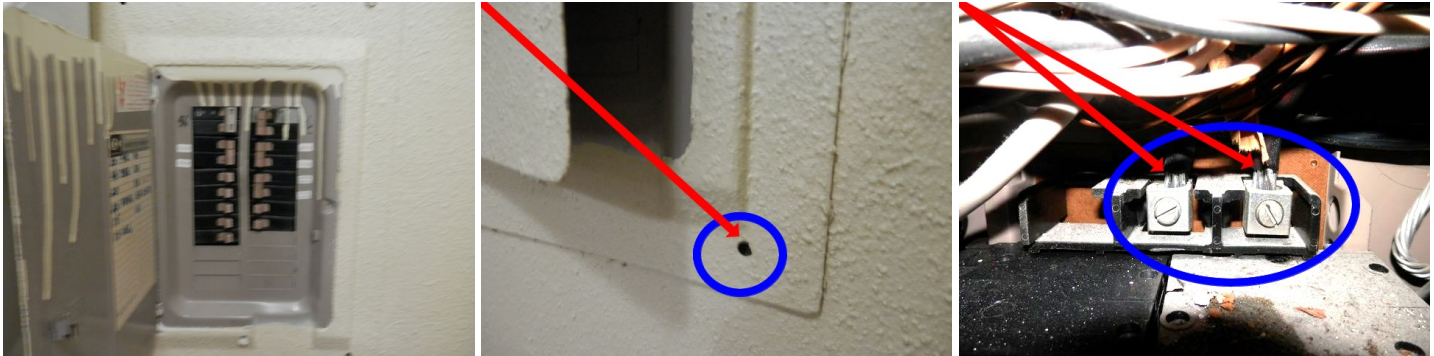
general view of panel box - fasteners missing at the front cover - no anti-oxidant on the aluminum wires

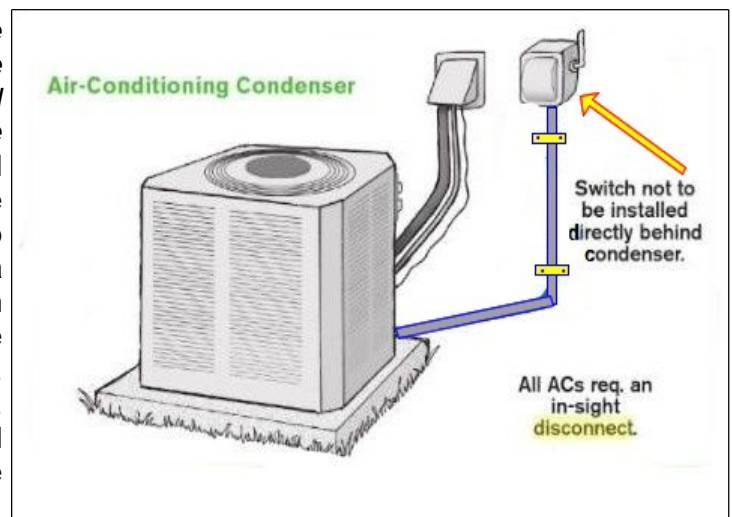
INFORMATION: The a/c service disconnect for the four outside a/c units is not recommended to be behind the outside a/c units. Use caution if you need to deactivate the power to the outside a/c units. The metal cabinet may have become energized. All energized electrical equipment and panelboards are required to have unobstructed access 36 inches deep in front of the equipment and 30 inches wide, at a minimum as per current standards. This may be an "update" depending on the prevailing code at the time of installation; however, this is not a code inspection. This comment is listed as a safety recommendation.. Proper access for the mechanic's disconnect should be considered according to Section E3305.2 of the IRC and Section 110.26(A) of the NEC.

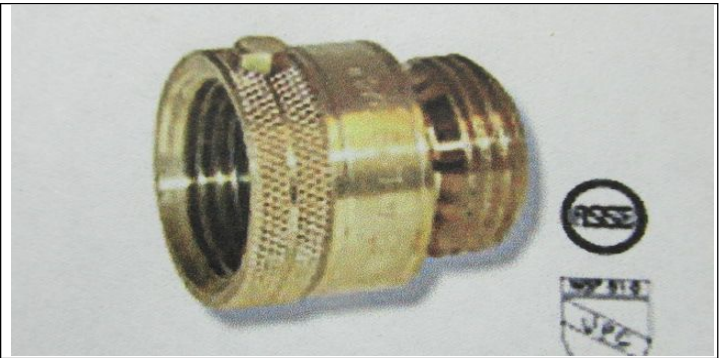
- Back-flow device was missing at one or more of the outside faucet / hose bibs. Install as per current standards for safety reasons.

Vacuum breakers (AKA - Back-flow device) were missing from one or more of the outside hose bibs. Sill cocks, hose bibs, wall hydrants and other openings with a hose connection shall be protected by an atmospheric-type or pressure-type vacuum breaker or a permanently attached hose connection vacuum breaker for protection of the potable water supply.

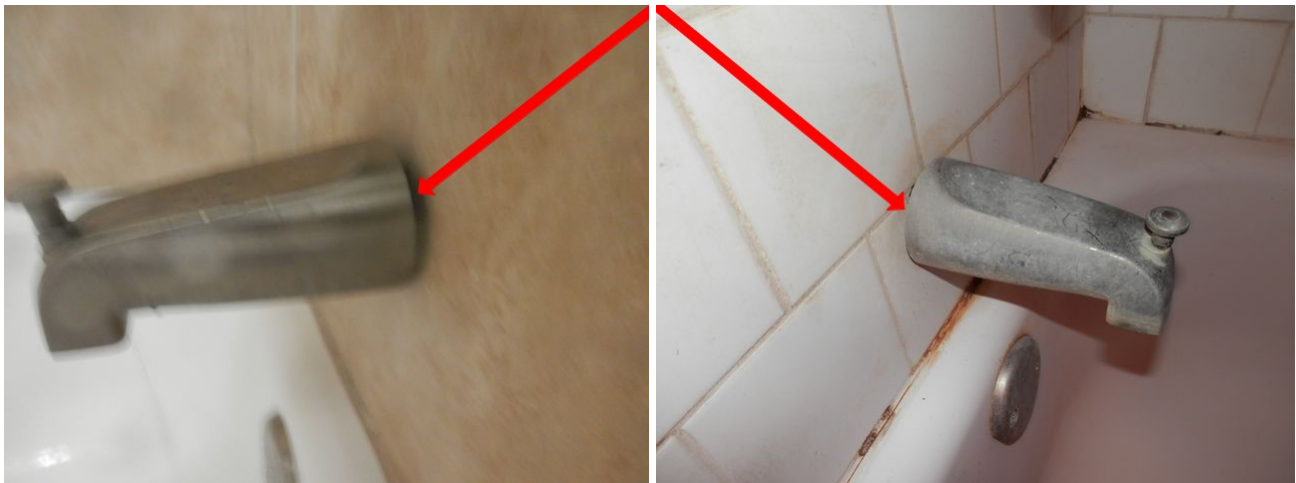
- Unit A and C: One or more of the bath fixtures was not sealed at the tile or surface, e.g. at the tub. Repairs are required to prevent undue water penetration to the sub-material.

sample of faucet not sealed at the wall in unit A and C

Keep all plumbing fixtures caulked and sealed at the floor to prevent water penetration to the sub-material, and insect intrusion. The following codes require it, and so does homeownership. International Plumbing Code 2012 - Chapter 4 Fixtures, Faucets and Fixture Fittings - Section 405 Installation of Fixtures - 405.5 Water-tight joints. Joints formed where fixtures come in contact with walls or floors shall be sealed. Uniform Plumbing Code 2009 - Chapter 4 Plumbing Fixtures and Fixture Fittings - Section 407 Installation - 407.2 Joints. Where a fixture comes in contact with the wall or floor, the joint between the fixture and the wall or floor shall be made water-tight.

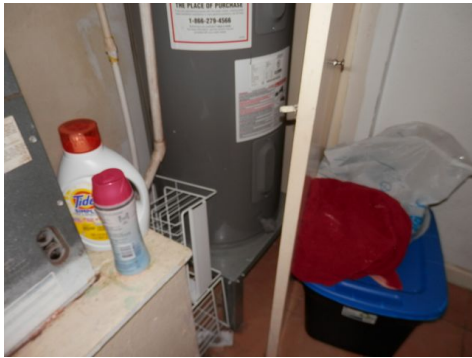
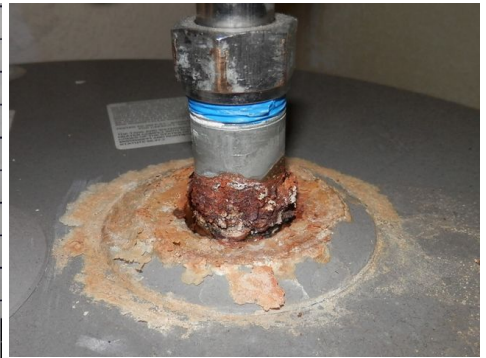
- *Unit C:* There was no safety pan beneath the water heater. A water heater should be placed in area that will prevent damage to floors, ceilings, and furniture if the heater leaks.
- Corrosion observed on the water heater supply lines, have evaluated for repair / replacement needs. Maintenance items should not be put off until they become an insurance claim.

water heater in the utility area - data plate dated 2017 - sample of corroded supply line at top of water heater

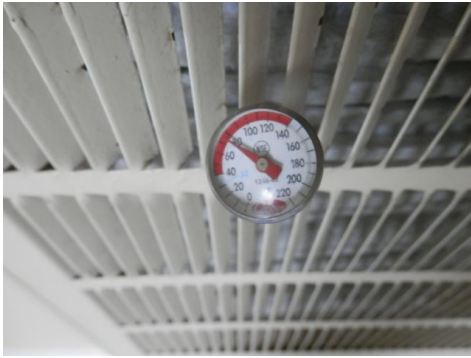
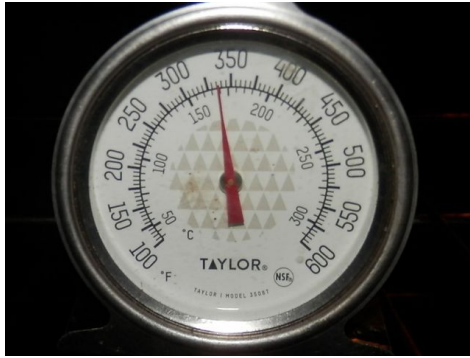
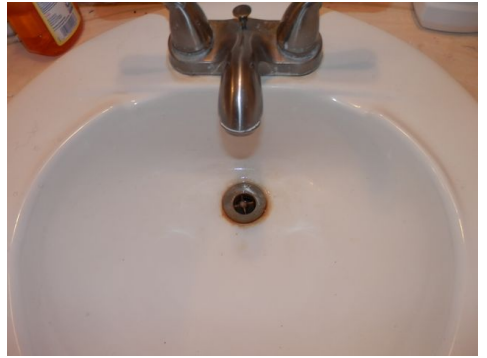
sample of thermometers used to check the HVAC and the ovens - sample of stopper parts missing (unit C and D)

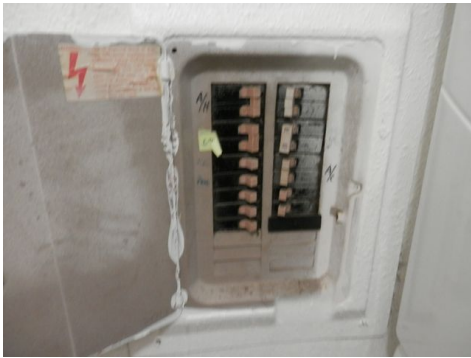
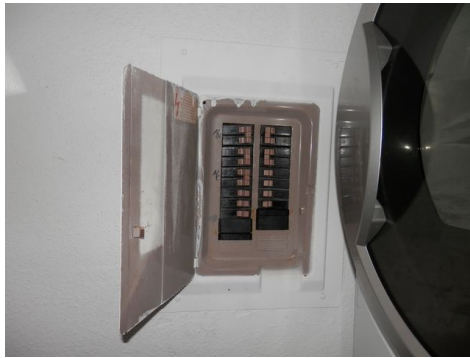
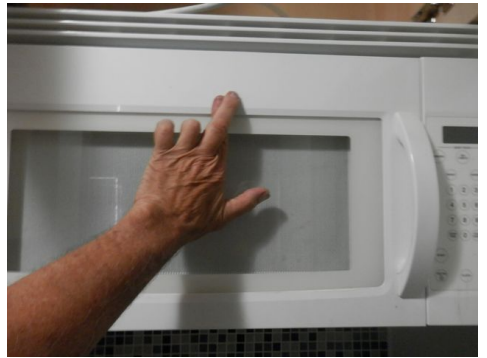
covers painted to the wall were not removed - outlet for microwave in unit D did not appear to work
