PROPERTY INSPECTION REPORT

Concerning: 5115 White Manor Drive , Pasadena, TX 77505
(Address or Other Identification of Inspected Property)

By: Mike Ash Lic.#: TREC 24404 08/24/2021
(Name and License Number of Inspector) (Date)

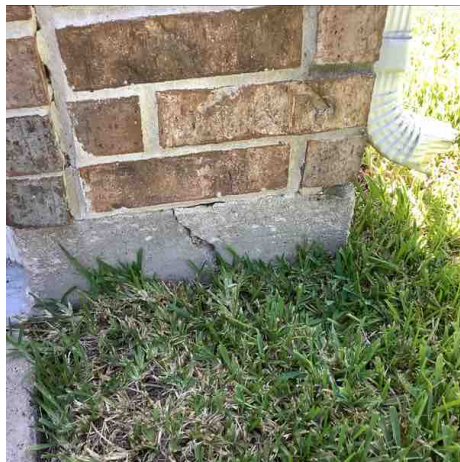
- **Corner cracks or “pops” were observed on several corners of the foundation. These do not impact the structural integrity of the foundation and are typical of most homes. Recommend repair to prevent possible water and/or pest penetration.**

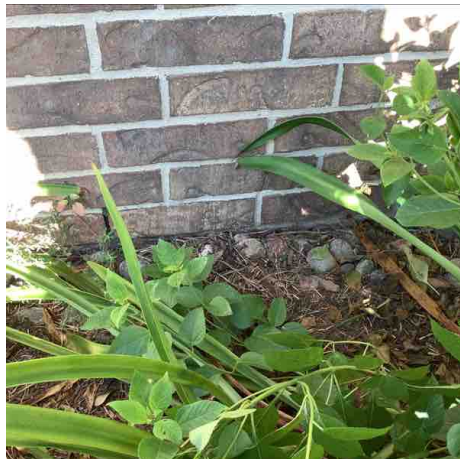
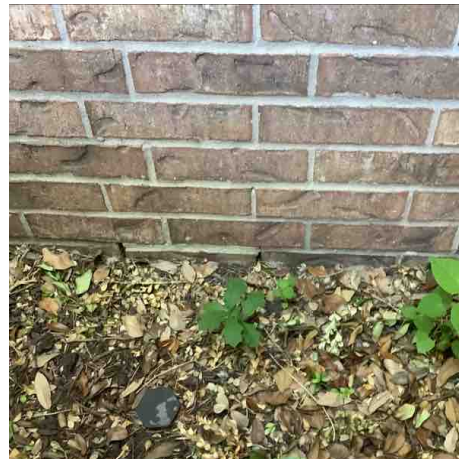
- **Areas of the landscaping and grading have inadequate clearance to the exterior siding / brick on the home. Recommend increasing clearance 4-6" to reduce risk of water and/or pest penetration.**

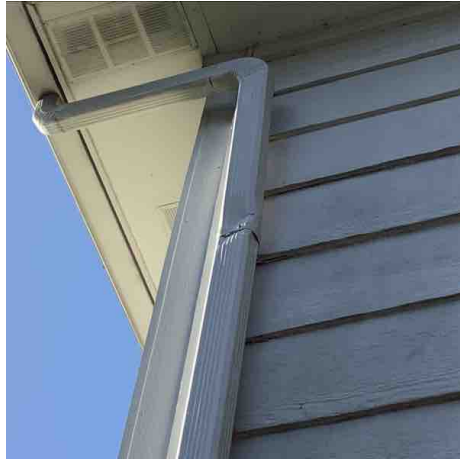
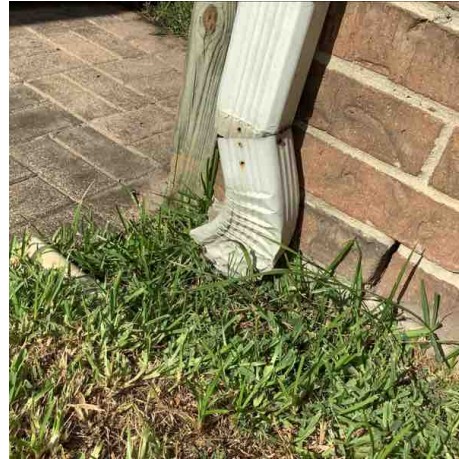
- **Multiple gutter downspouts around the home were noted damaged. Recommend making needed repairs to open these downspouts to promote proper waterflow.**

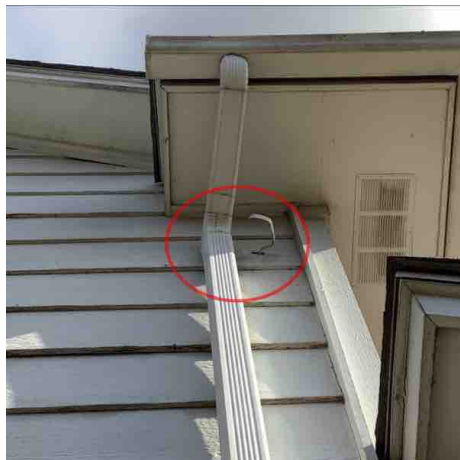
- **Gutter trough downspout at the back south corner of the home was noted loose at the exterior wall. Recommend securing the downspout to prevent possible damage and promote proper water drainage.**

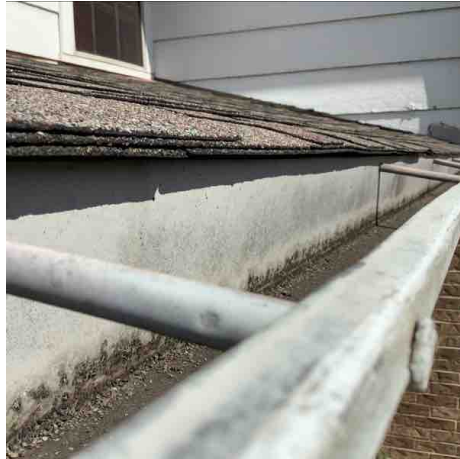
- Gutter troughs are installed on top of the drip edge flashing. This could allow water to drain between the gutter trough and fascia board. Gutter troughs should be installed under the drip edge flashing.

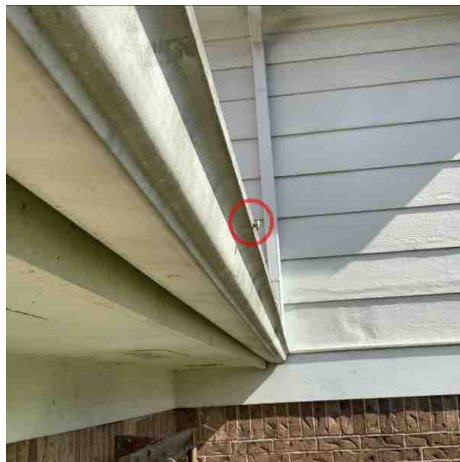
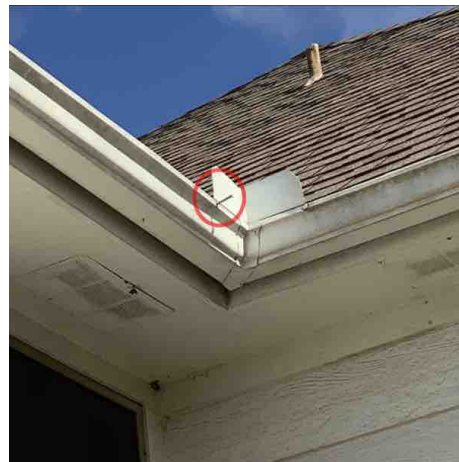
- Multiple gutter trough hanger nails, were noted backing out from the fascia board. Recommend securing the hangers for proper water drainage and prevent sagging in the troughs.

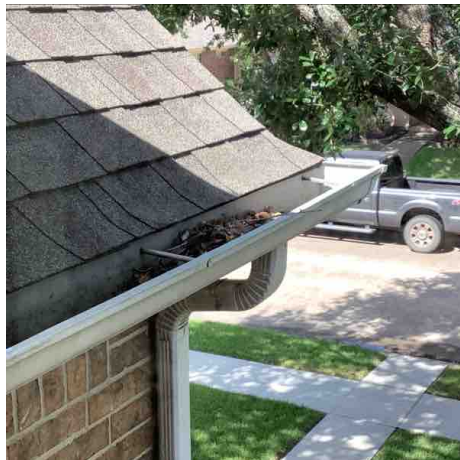
- Gutters troughs noted having debris / leaves in them, in multiple areas. Recommend cleaning to promote proper water flow.

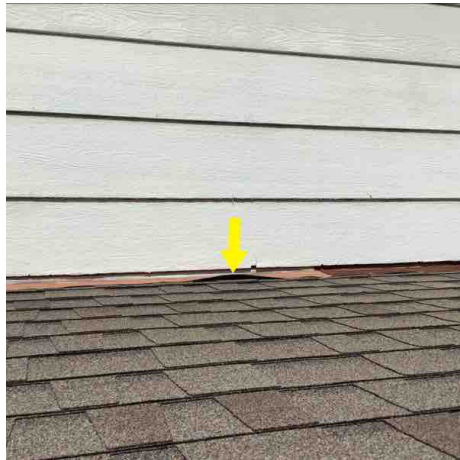
- **Minor lift was noted in areas of the sidewall flashing around the home. Recommend securing and sealing these areas properly to prevent possible water penetration under the flashing**

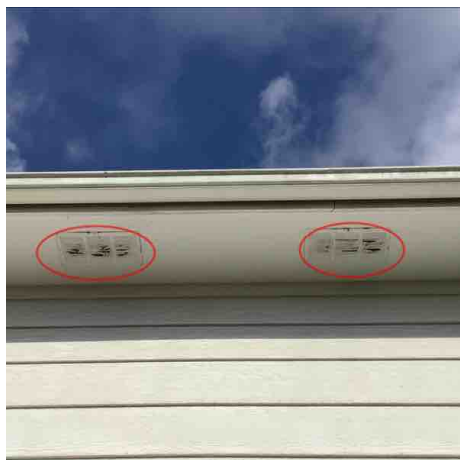
- **Soffit vent screen was noted open / damaged at the back of the home. Recommend sealing these areas to prevent pest penetration into the attic area.**

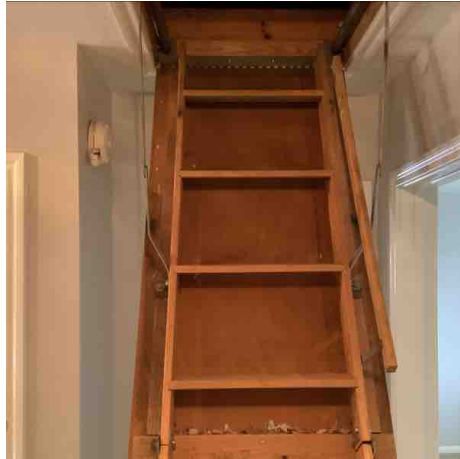
- Attic access stairs is missing insulation. Recommend installing insulation to prevent energy loss.

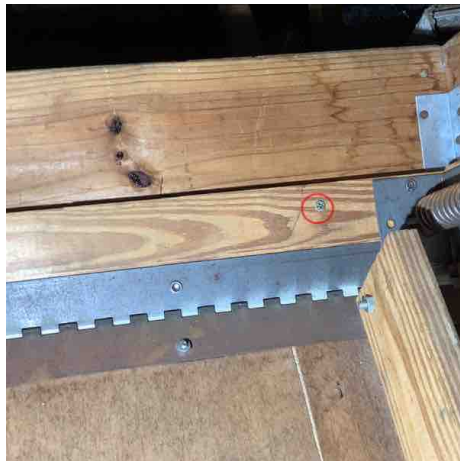
- Attic access has improper fasteners holding the stairs in the ceiling. Approved hardware such as lag bolts or 16D nails are required, not screws.

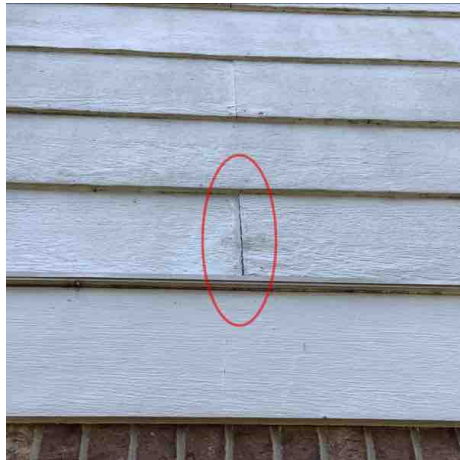
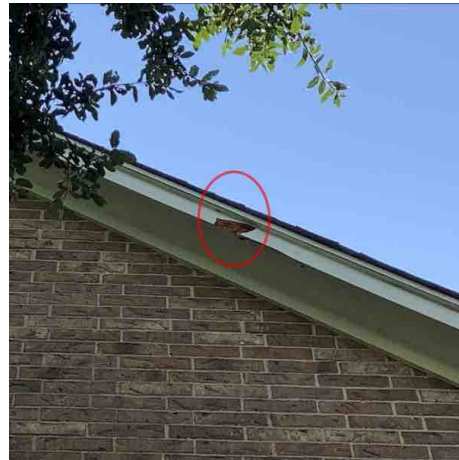
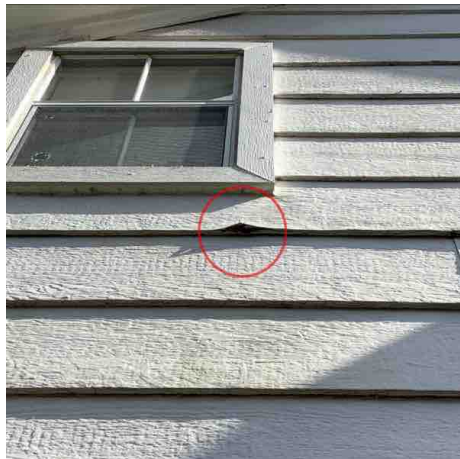
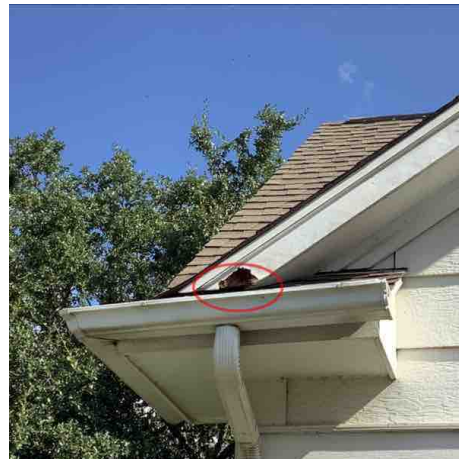
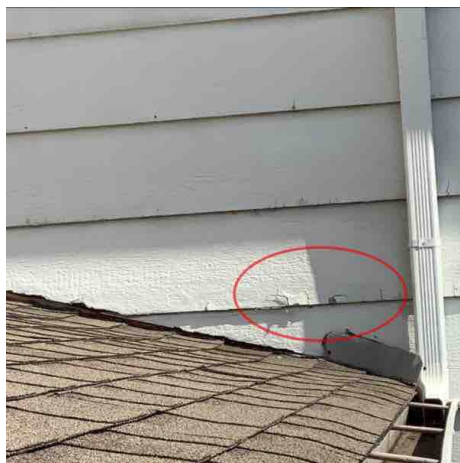
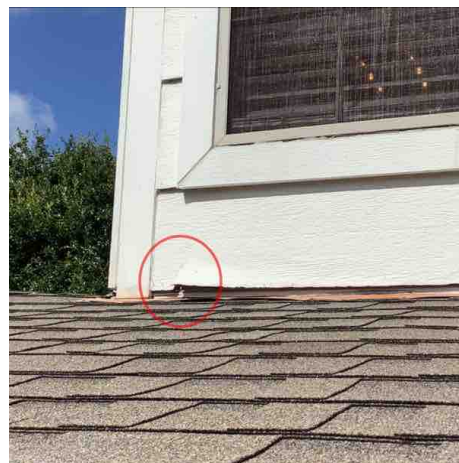
- **Damaged / deteriorated siding and trim were noted in multiple areas around the home. Recommend repairing and sealing to prevent further deterioration.**

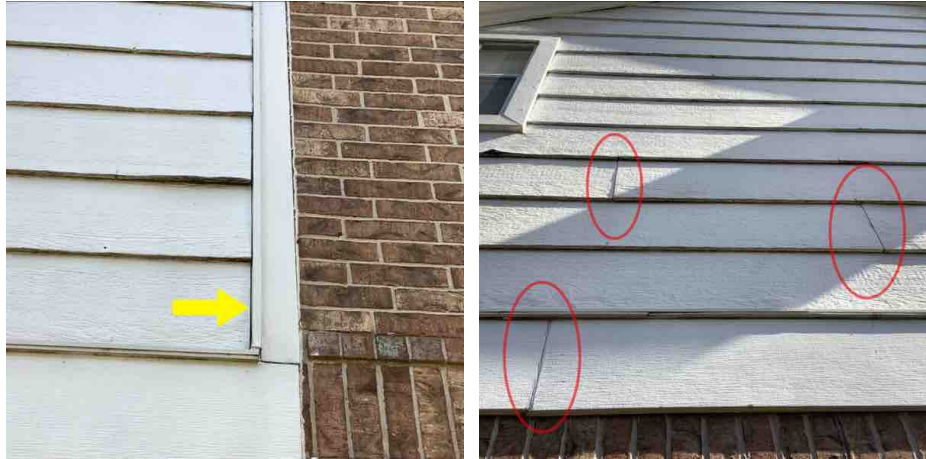
- Sealant was noted deteriorated and/or missing in multiple areas on the exterior siding and trim. Recommend removing old sealant and resealing to prevent water penetration and possible deterioration.

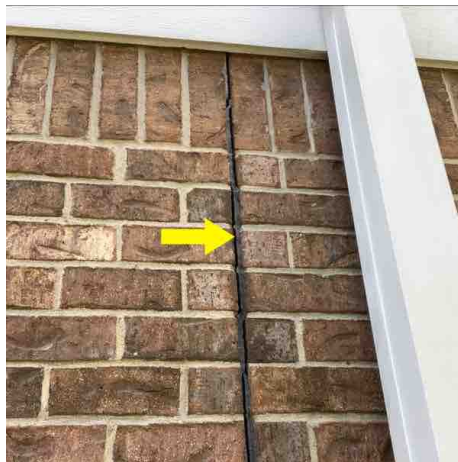
- Sealant in the expansion joints of the brick veneer is deteriorating / missing. Recommend removing old sealant and resealing to prevent possible water penetration into the wall.

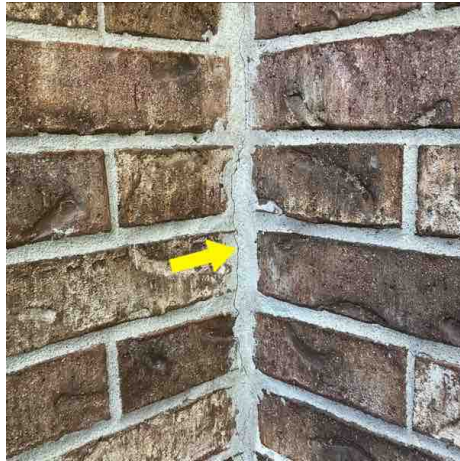
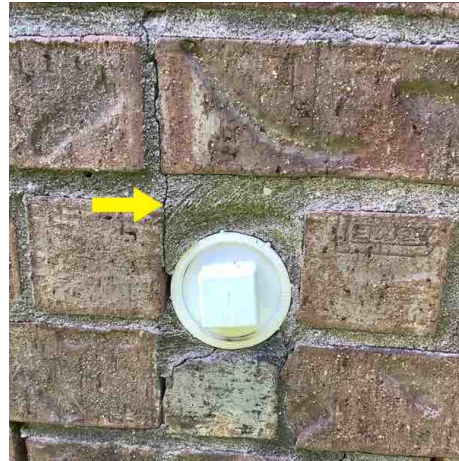
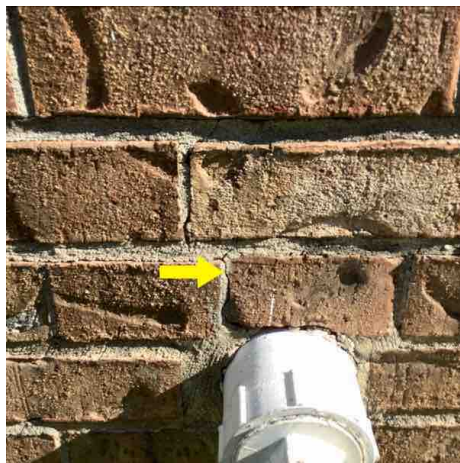
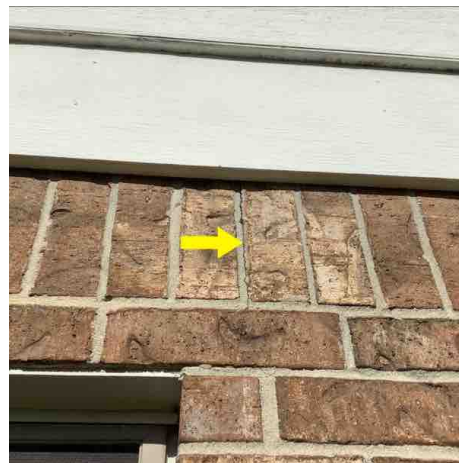
• Minor cracking was observed in the brick mortar at several locations around the home. These do not appear to be structural and are common of most homes. Recommend sealing these cracks to prevent water and/or pest penetration, and monitoring for any future movement.

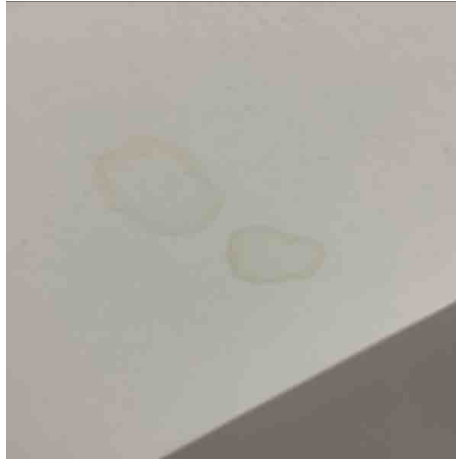
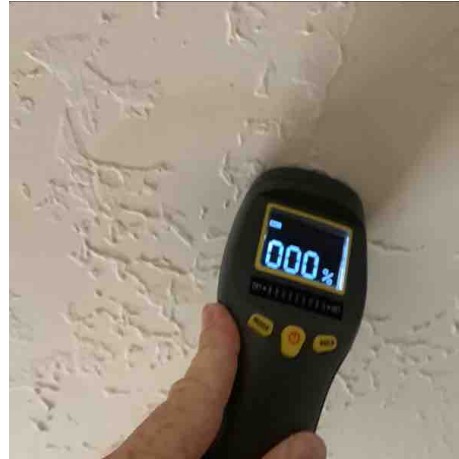
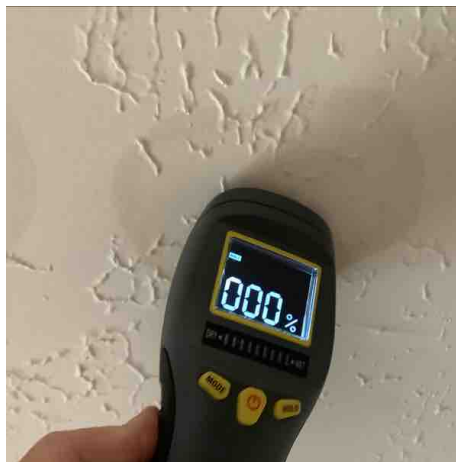
- **Water stains noticed on upstairs guest bedroom ceiling. Area was tested with a moisture meter and no moisture was detected at time of inspection.**

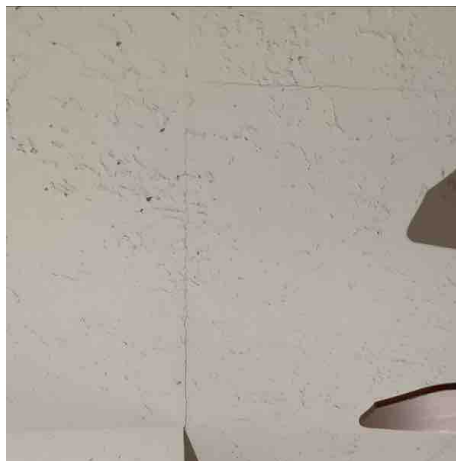
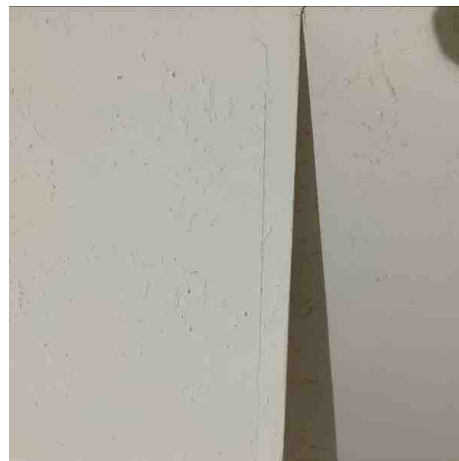
- **Minor drywall cracking/imperfections noted throughout the home. This is typical of most homes and is cosmetic.**

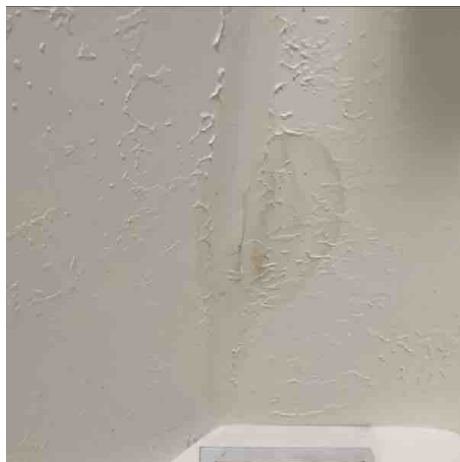
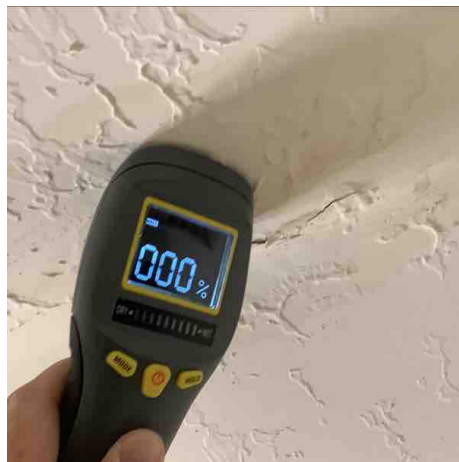
• Water stain was noticed in master bathroom closet ceiling. Area was tested with a moisture meter and no moisture was detected at the time of inspection.

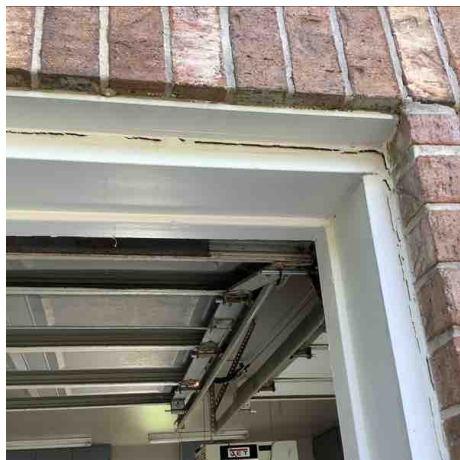
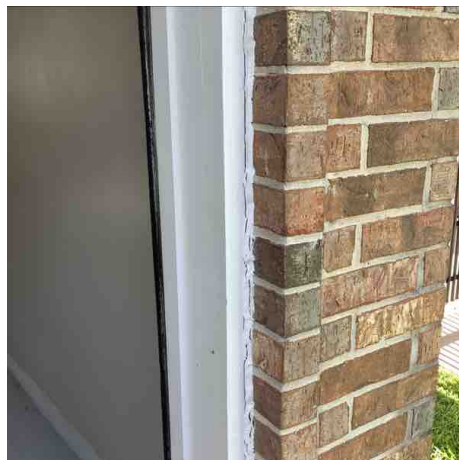
• Sealant is light or missing around the garage door. Recommend removing old sealant and replacing with new sealant to prevent water and/or pest penetration.

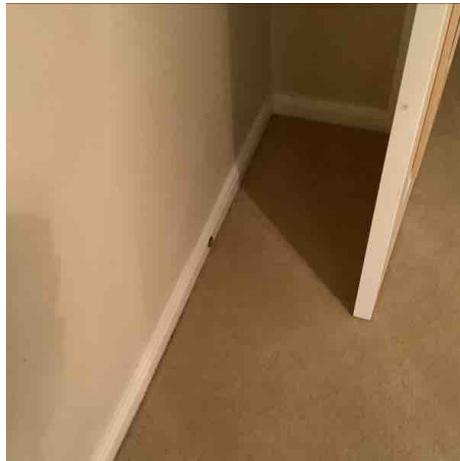
- **Door stops are missing and/or damaged in multiple location throughout the home.**

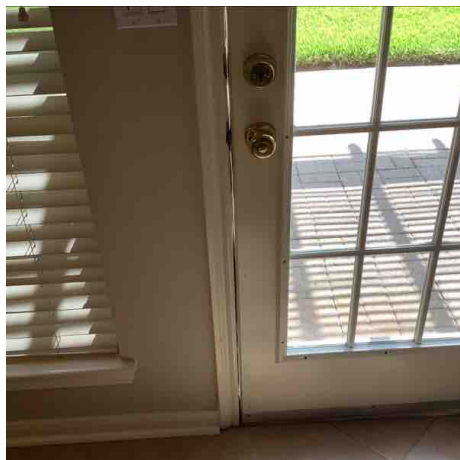
- **Back exterior door rubs the door jamb when attempting to open and close.**

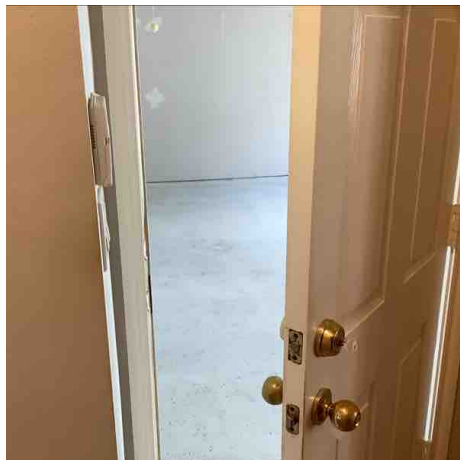
- **Garage pedestrian door does not have self-closing hinges. These hinges are required to make the door latch closed unassisted, and are required in todays safety standards.**

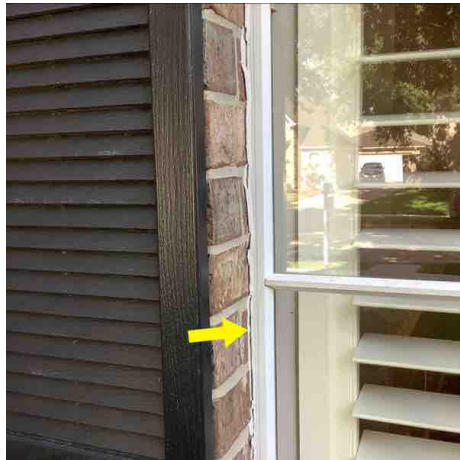
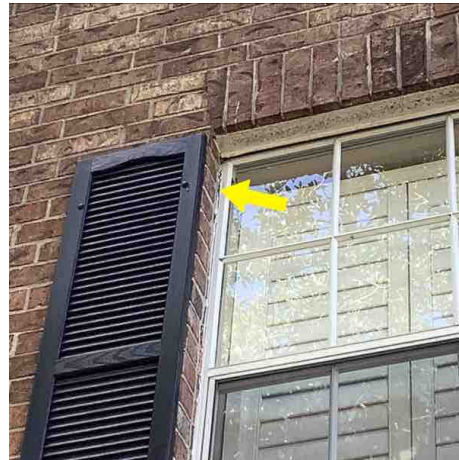
- Sealant is deteriorated and cracked around the exterior of multiple windows. Recommend removing old sealant and replacing sealant to prevent water and/or pest penetration.

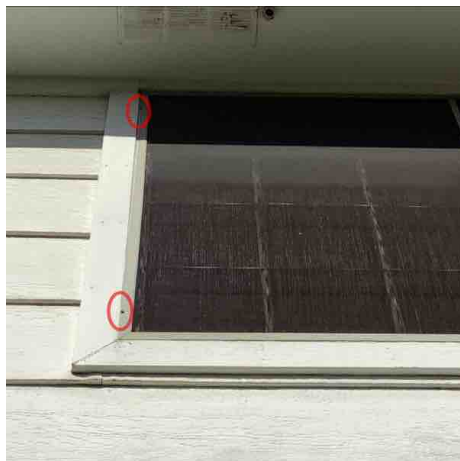
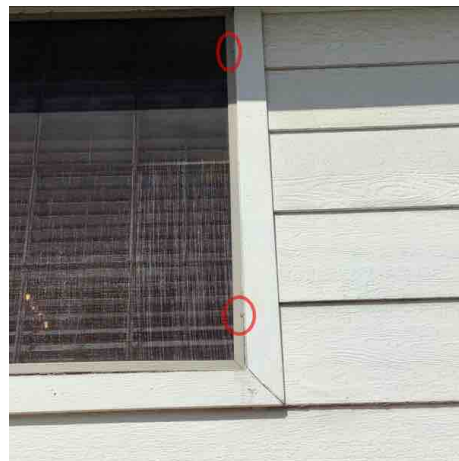
- Exterior screens were noted screwed to the bedroom windows. This impedes the egress through the window. Bedrooms are required to have one egress window that does not require special tools to use, for an emergency exit.

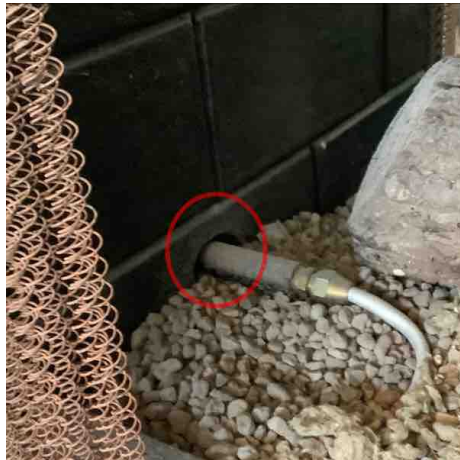
- Gas lighter/burner is missing sealant were the gas plumbing enters the firebox. This is required to be sealed with an appropriate sealant that is fire rated.

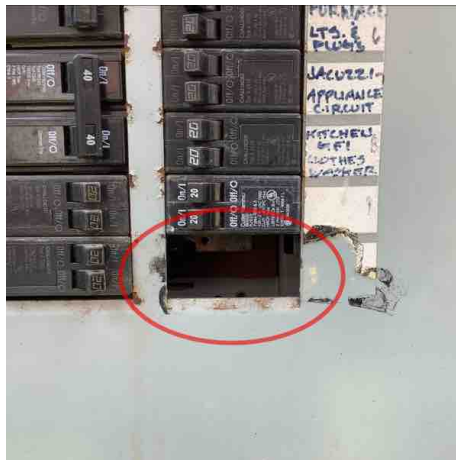
- Opening observed in the cover of the service panel. Breaker cover plate should be installed to cover the openings.

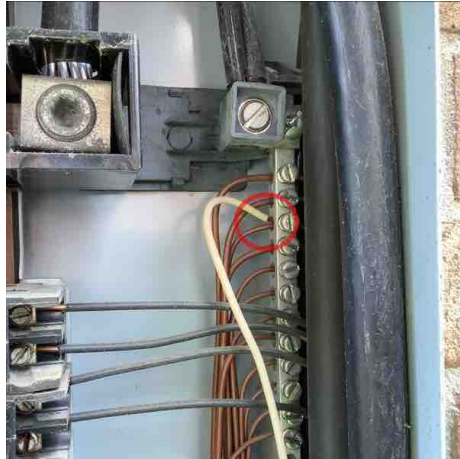
- Neutral and ground wires noted mixed on the bus bars. Neutral and ground wires should each be on their own bus bars, and only bonded by the bonding arm.

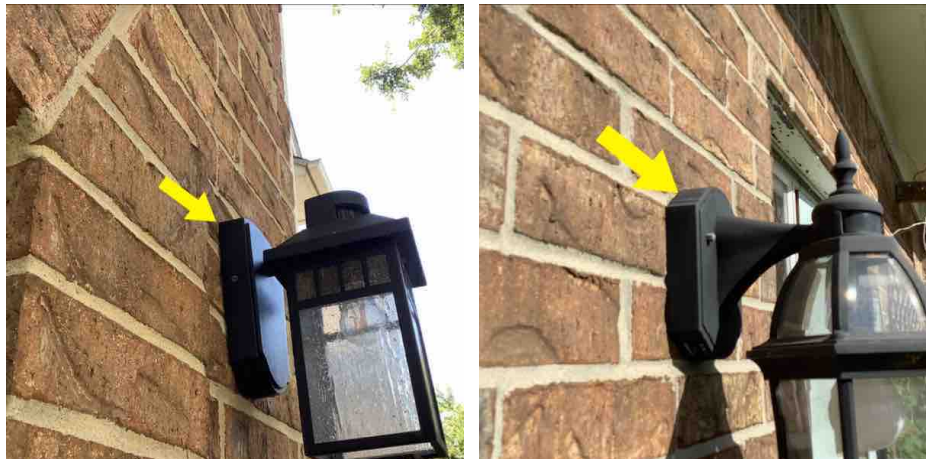
- Exterior light fixtures should be secured properly to the wall and sealed at the wall to prevent moisture and/or pest penetration.

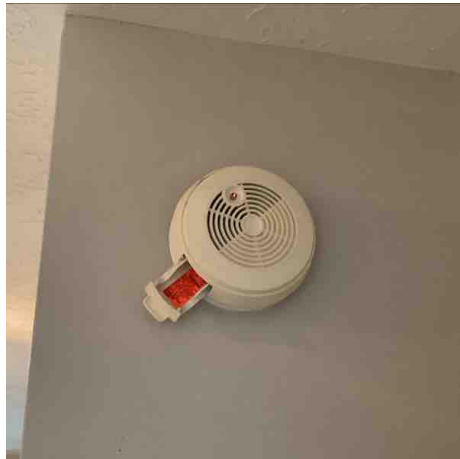
- Smoke detectors appear to be older units. Smoke detector alarms should be replaced every 10 years.

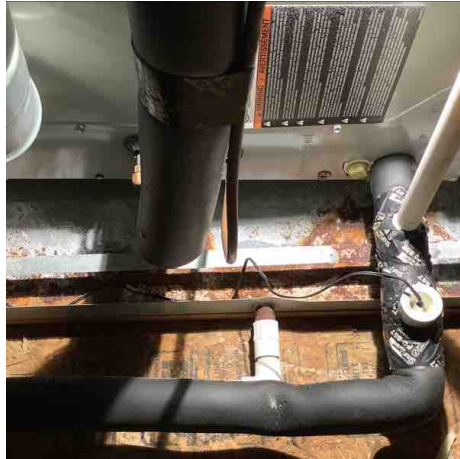
- **Minor areas of rust was noted in the AC pan in the attic area. No water was in the pan at the time of inspection. Recommend monitoring for any further deterioration and replace in the pan when needed.**

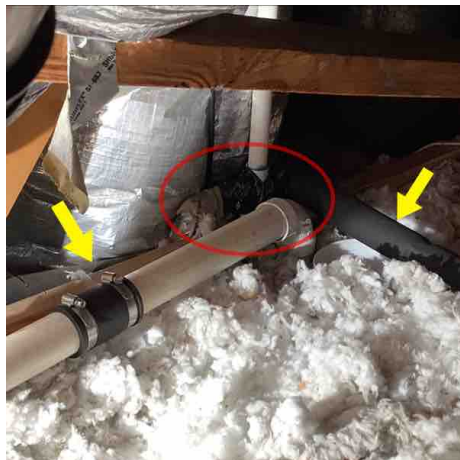
- **The main condensation lines for both units are plumbed together in the attic space. Single drains are required to be 3/4". After the drains are connected the pipe size should be sized to accommodate both drains. Verify the correct size pipe was use after the drains were connected.**

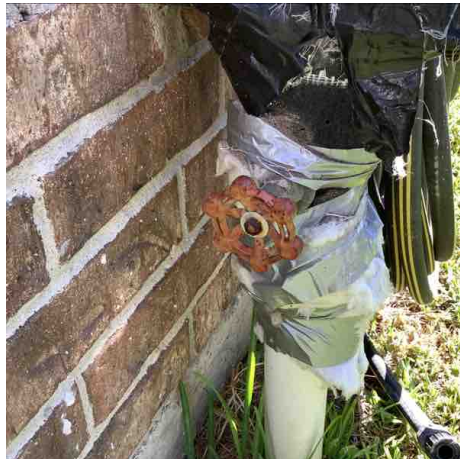
- Improper shut off valve noted at the main water pipe. Valve is required to be the lever type and not the knob type.

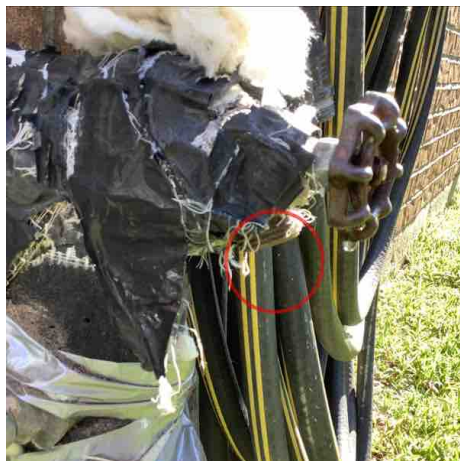
- Hose bibs are missing the anti-siphon device. Recommend adding these to prevent backsiphonage into the house water supply

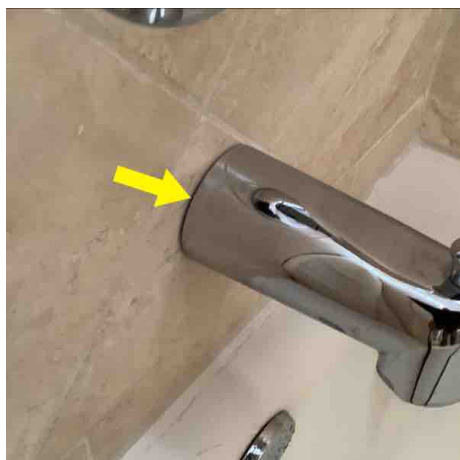
- Tub spouts in the showers/bathtubs should be sealed to prevent water penetration into the walls.

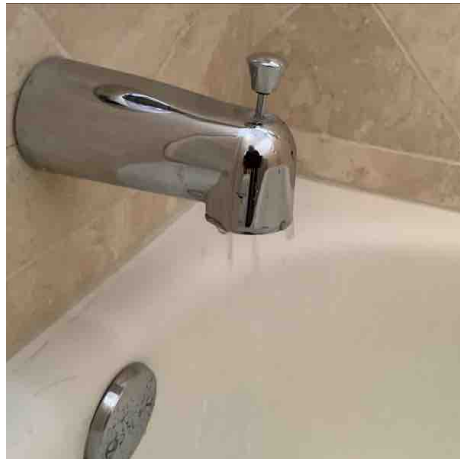
- **Tub spout diverter in upstairs guest bathroom doesn't seal completely when operated.**

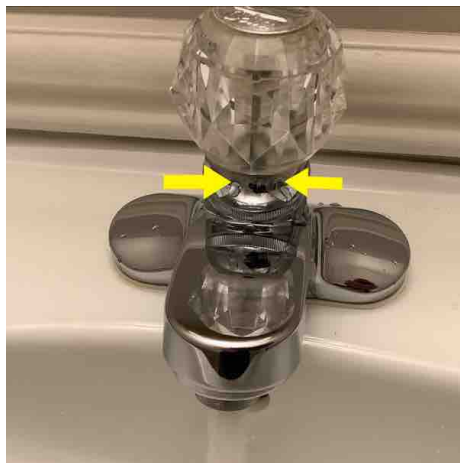
- **Downstairs half bathroom faucet handle was leaking when operated at the time of inspection.**

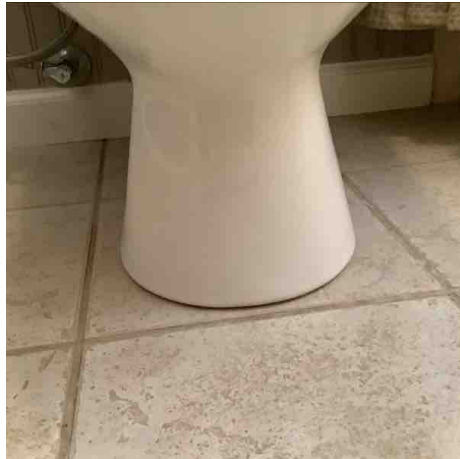
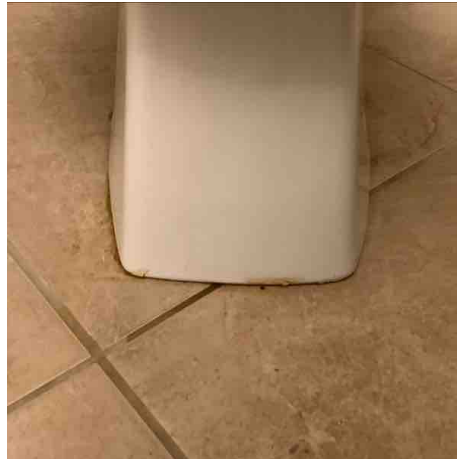
- Toilets were noted missing the sealant on the base at the floor. Recommend sealing to avoid possible leaks.

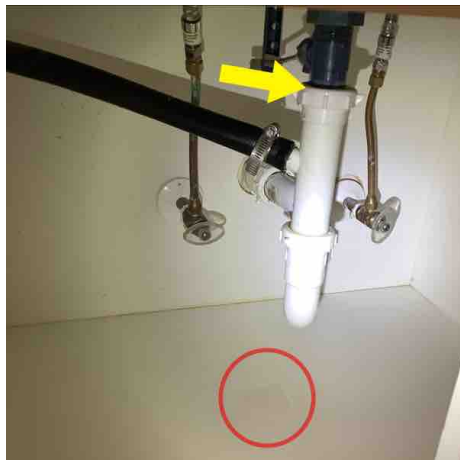
- Leak under upstairs guest bathroom sink was discovered at the time of inspection.

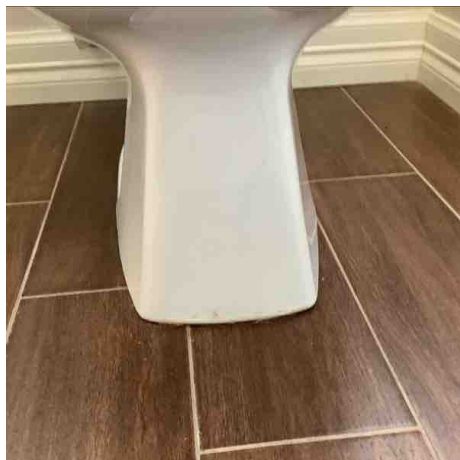
- The master bath toilet was noted loose at the floor. Recommend securing and sealing at the floor to prevent possible leaks.

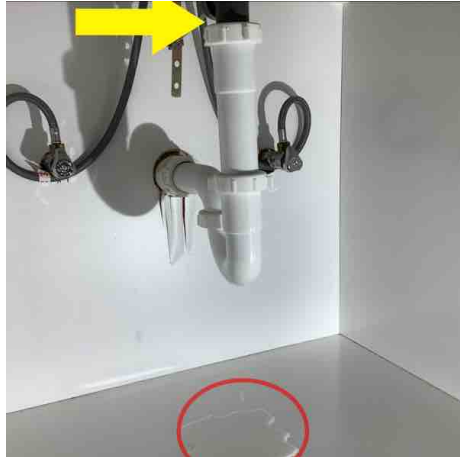
- The downstairs half bathroom toilet was noted loose at the upper tank. Recommend securing the tank to prevent possible leaks.
- Upstairs master bathroom sink on the right was noted leaking.

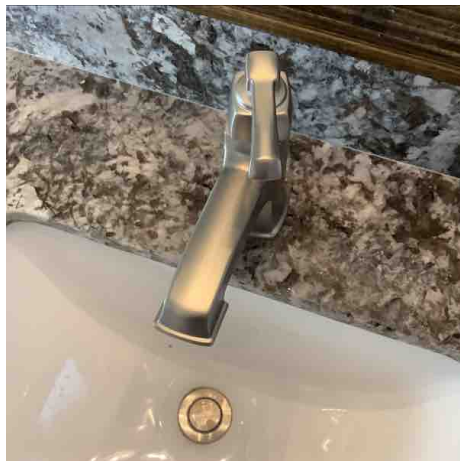
- Drain stopper at the left master bathroom sink failed to completely seal and hold water.

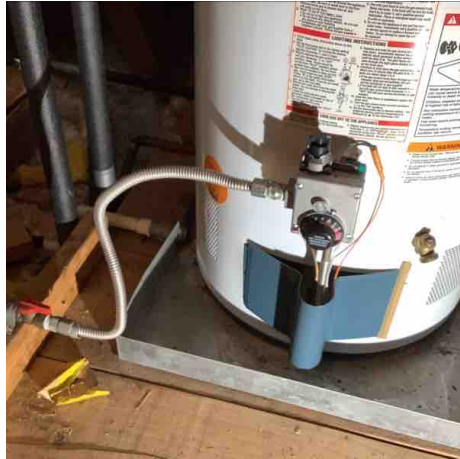
- Sediment trap is missing at the water heater. Sediment traps prevent sediment in the gas line from reaching the orifices in the appliance and clogging them.

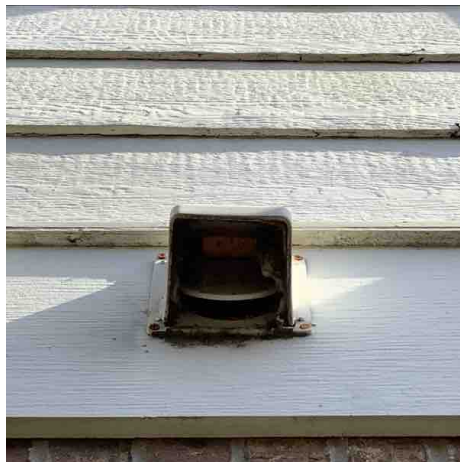
- Dryer vent door or “flap”, was noted staying open and not closing when not in use. Recommend repair to prevent possible pest penetration into the vent.
