Report Prepared For:
Mary Sharkey

5410 Navarro
Houston, Texas 77056
September 12, 2017

Stucco Inspection Report

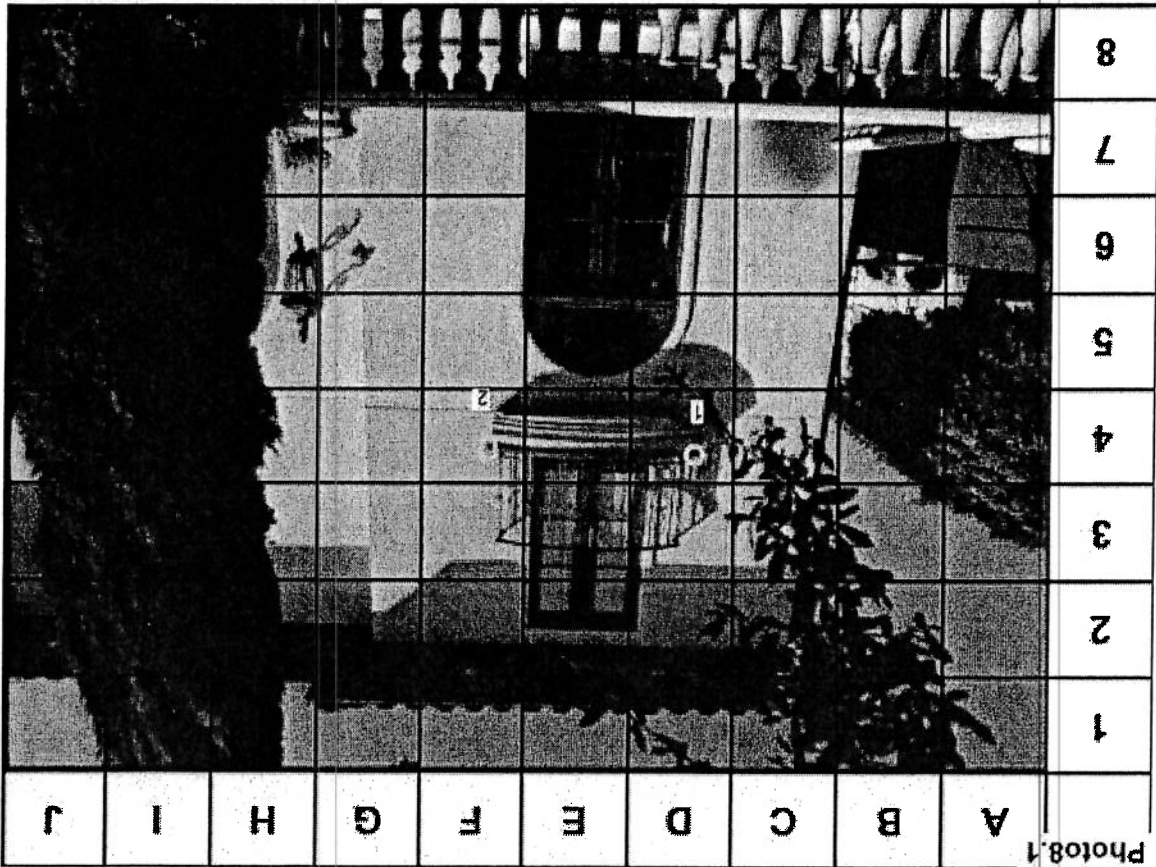
Photo 8.1

Item	Reading	Test Equipment	Observations / Comment
GENERAL			FOR COMMENTS REGARDING GENERAL CONDITIONS, REFER TO "OBSERVATION" AND "SUMMARY" PAGES
D/4, F/4			Insufficient diverter flashing at balcony to wall intersections
D/4-F/4			No provisions for drainage installed at stucco balcony overhang to cast stone balcony trim band
#1	7.5%; firm resistance	BD2100	Below left balcony to wall intersection
#2	8.7%; firm resistance	BD2100	Below right balcony to wall intersection

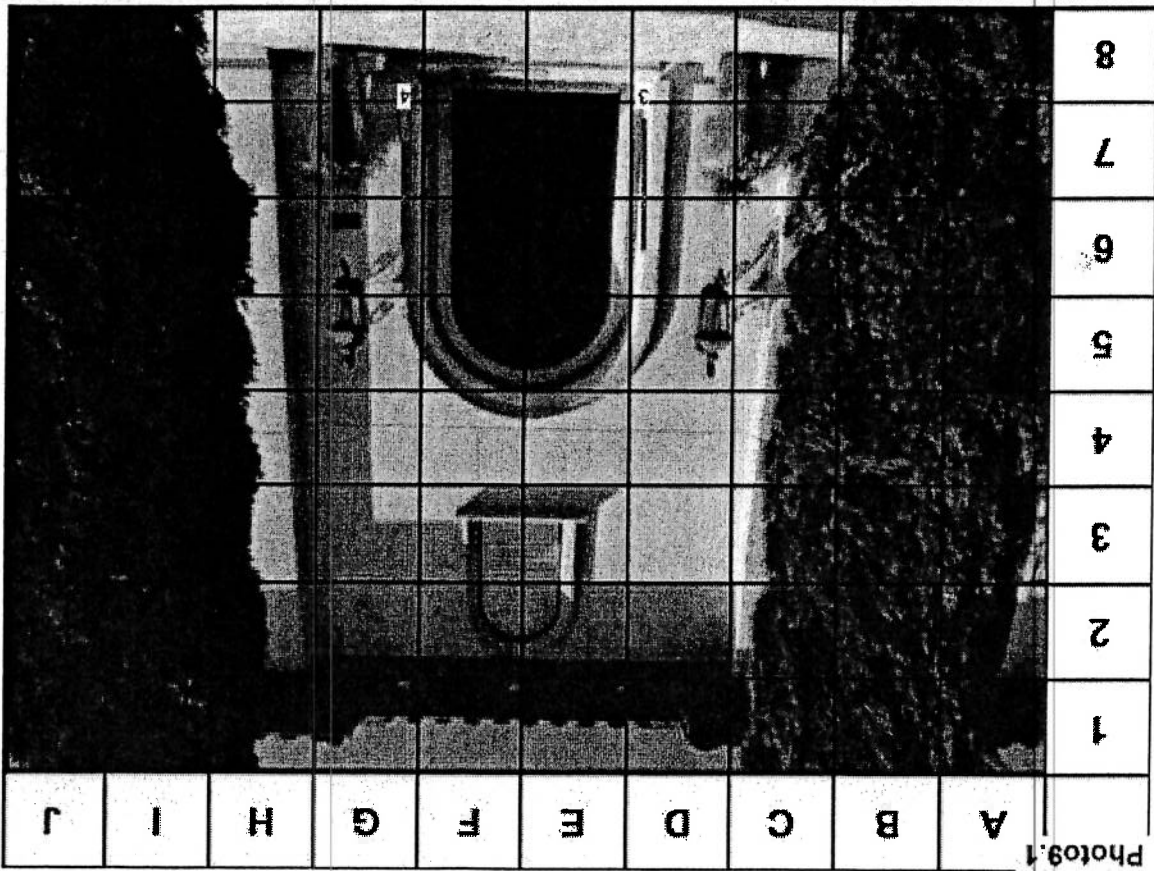
Item	Reading	Test Equipment	Observations / Comment
GENERAL			FOR COMMENTS REGARDING GENERAL CONDITIONS, REFER TO "OBSERVATION" AND "SUMMARY" PAGES /
D/6-D/7, G/6-G/7			Rust colored spots at corner of entryway walls
#3	14.4%, film resistance	BD2100	Inside left entry
#4	12.9%, film resistance	BD2100	Inside right entry

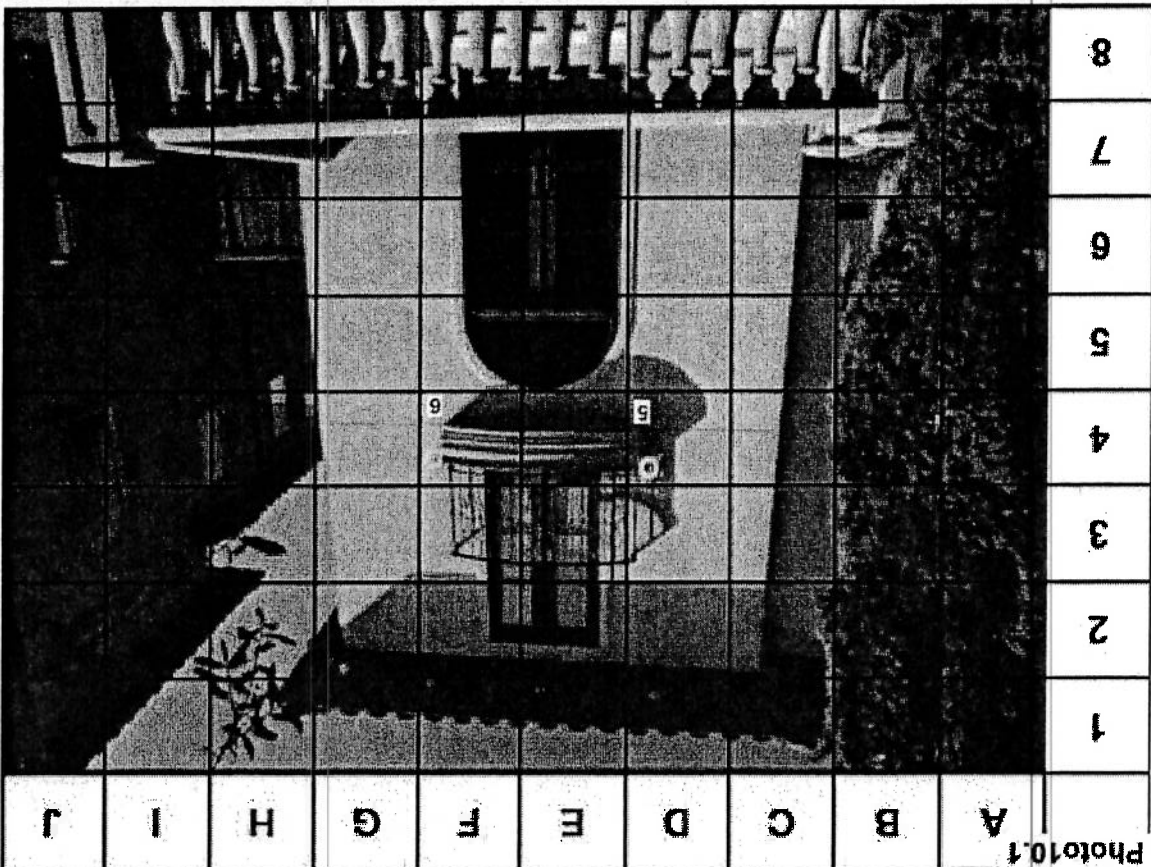
Photo 10.1

Item	Reading	Test Equipment	Observations / Comment
GENERAL			FOR COMMENTS REGARDING GENERAL CONDITIONS, REFER TO "OBSERVATION" AND "SUMMARY" PAGES
D/4, F/4			Insufficient diverter flashing at balcony to wall intersections
D/4-F/4			No provisions for drainage installed at stucco balcony overhang to cast stone balcony trim band
#5	6.2% firm resistance		Below left balcony to wall intersection
#6	9.4% firm resistance		Below right balcony to wall intersection

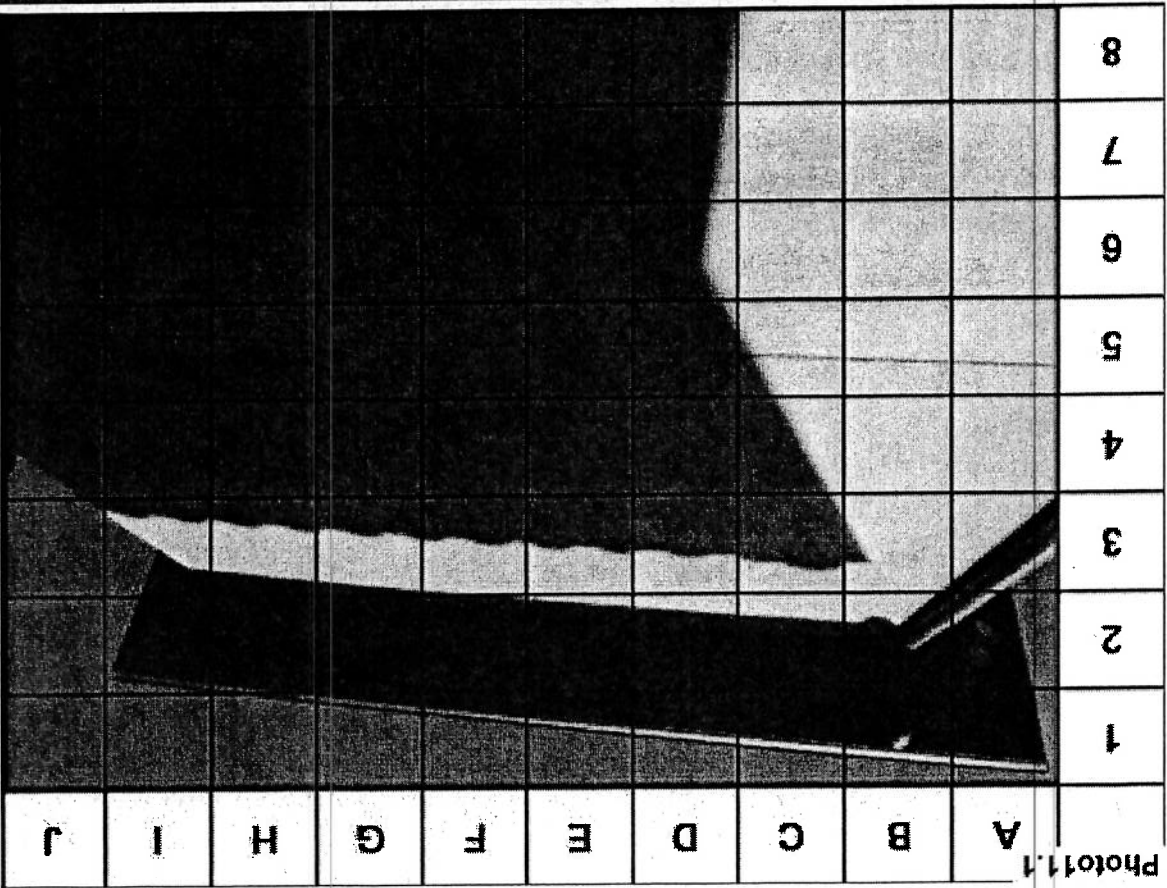
Photo 11.1

Item	Reading	Test Equipment	Observations / Comment
GENERAL			FOR COMMENTS REGARDING GENERAL CONDITIONS, REFER TO "OBSERVATION" AND "SUMMARY" PAGES
B/1-D/2			Diagonal crack in stucco panel
C/4,H/4			Kick out diverter flashing at roof to wall intersections
I/3			Insufficient diverter flashing at balcony to wall intersection
G/2-H/1			No provision for drainage at balcony beam
#7	8.5%; firm resistance	BD2100	Below roof to wall intersection
#8	10.2%; firm resistance	BD2100	Below roof to wall intersection
#9	11.6%; firm resistance	BD2100	Below balcony to wall intersection

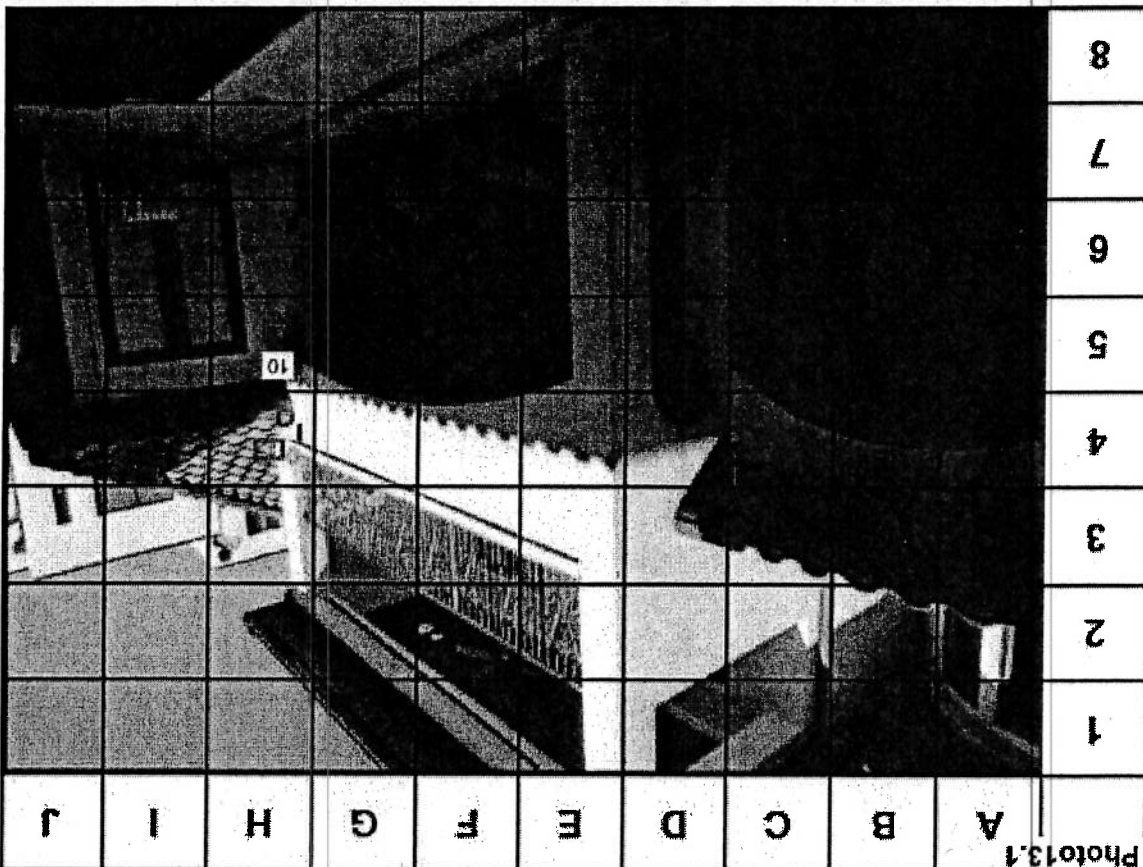
Photo 13.1

Item	Reading	Test Equipment	Observations / Comment
GENERAL			FOR COMMENTS REGARDING GENERAL CONDITIONS, REFER TO "OBSERVATION" AND "SUMMARY" PAGES
#11	7.9%: firm resistance	BD2100	Below left window jamb
#12	8.1%: firm resistance	BD2100	Below right window jamb

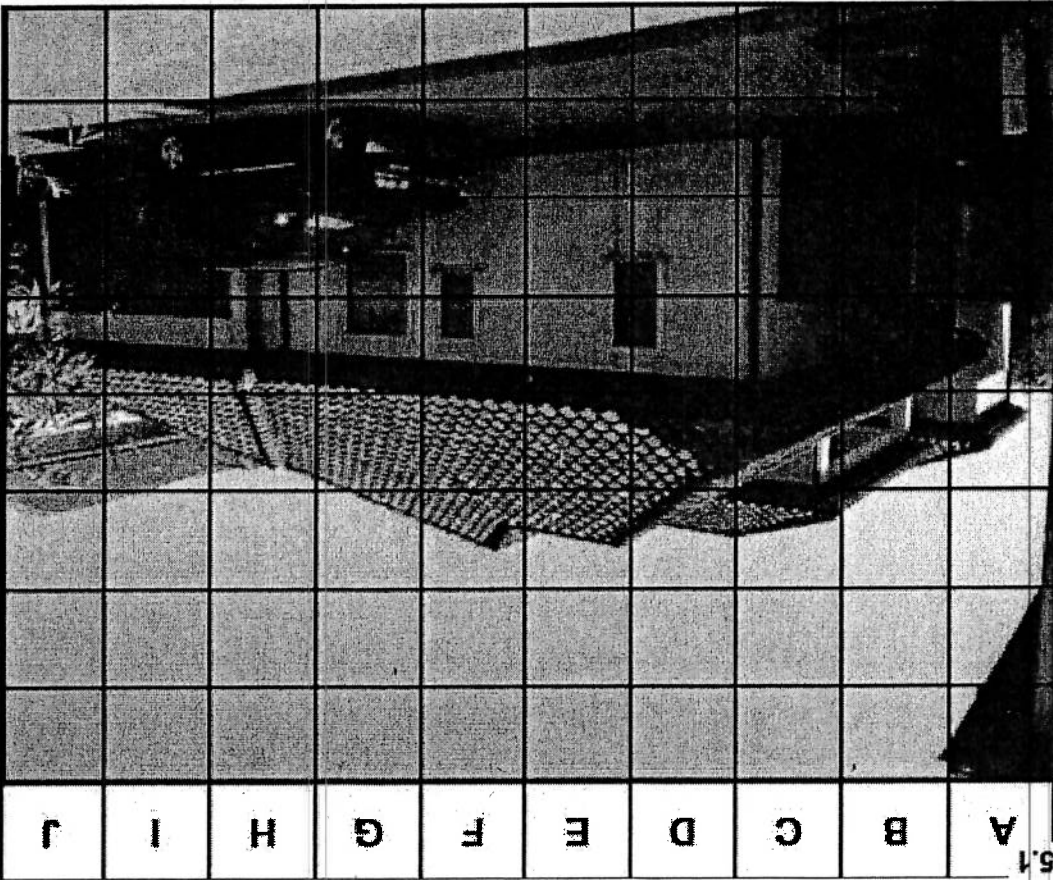
Photo 15.1

Item	Reading	Test Equipment	Observations / Comment
GENERAL			FOR COMMENTS REGARDING GENERAL CONDITIONS, REFER TO "OBSERVATION" AND "SUMMARY" PAGES
E/3			Kick out diverter flashing at roof to wall intersection, failed sealant with void below
#13	7.9%, firm resistance	BD2100	Left window jamb below trim
#14	7.7%, firm resistance	BD2100	Right window jamb below trim
#15	9.7%, firm resistance	BD2100	Left window jamb below trim

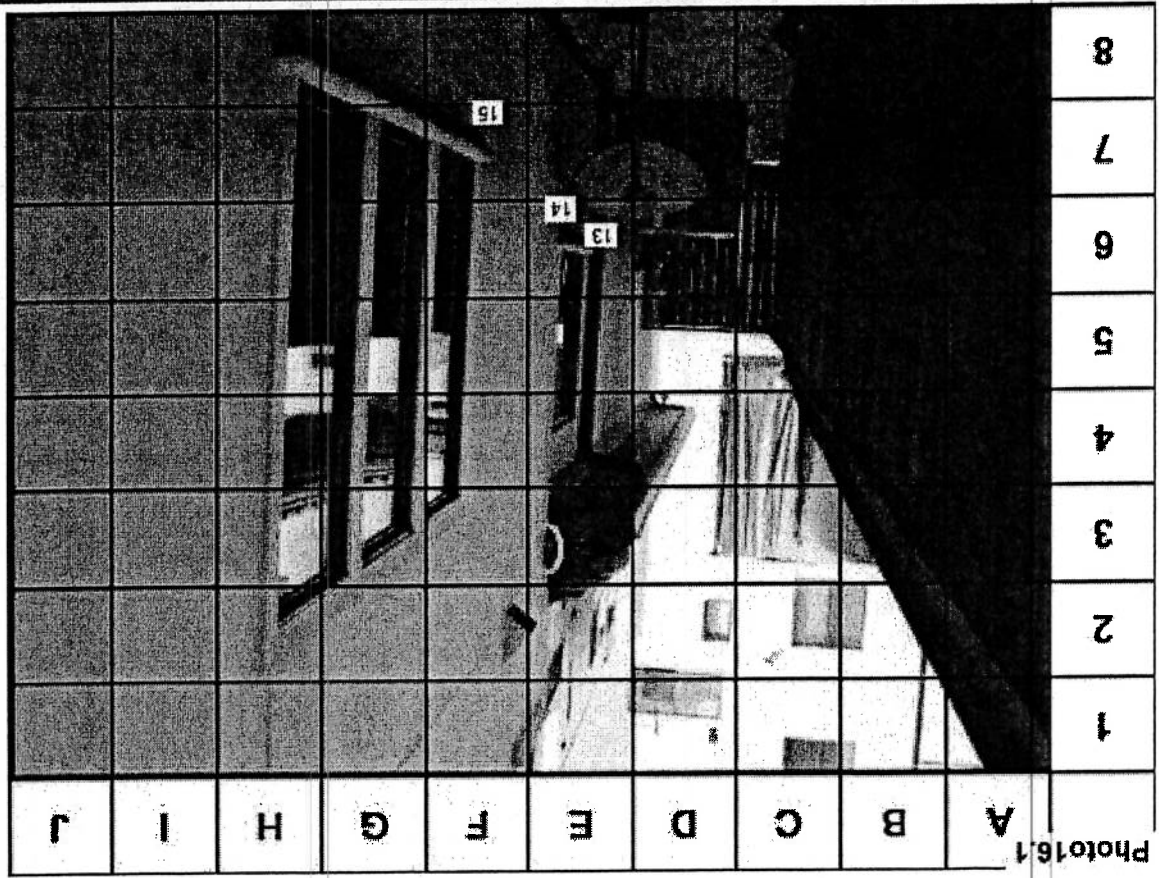
Item	Reading	Test Equipment	Observations / Comment
GENERAL			FOR COMMENTS REGARDING GENERAL CONDITIONS, REFER TO "OBSERVATION" AND "SUMMARY" PAGES
E/5			Split control joint
#16	11.5%: firm resistance		Right window jamb below trim
#17	7.2%: no resistance		Below roof to wall intersection, from firm framing
#18	8.0%: firm resistance		Above right window head, below split control joint

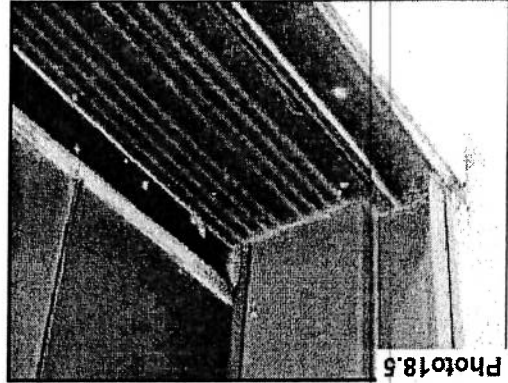
Door threshold, front elevation, no visible sealant

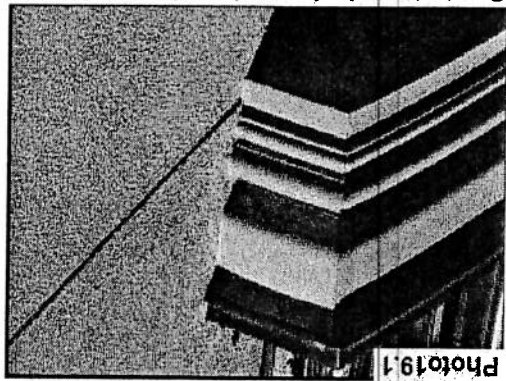
Cast stone balcony band to stucco wall transition, front elevation, no visible sealant

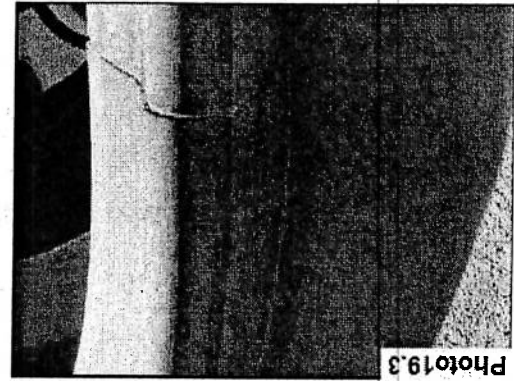
Cast stone trim to stucco wall transition, front elevation, no visible sealant

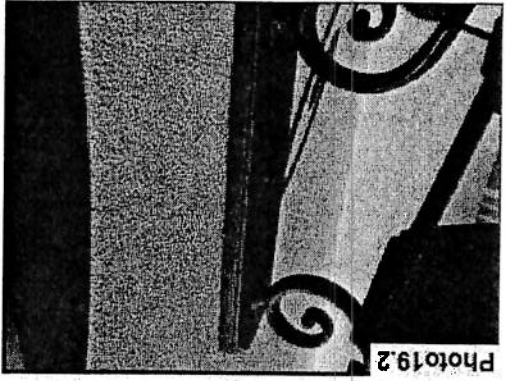
Light fixture penetration, front elevation, no visible sealant

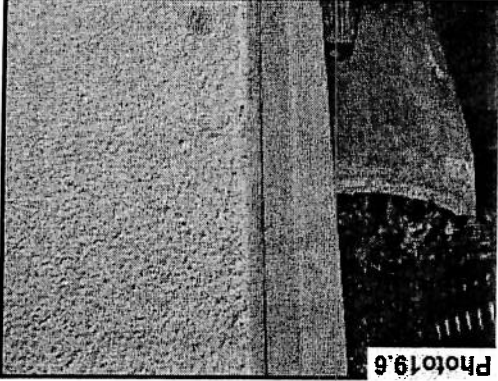
- Cracked stucco was observed on the right elevation in the courtyard area.
- Small areas of rust colored spots were observed at the corners of the entryway.

Left entry, front elevation, rust spots at corner (visible on both sides)

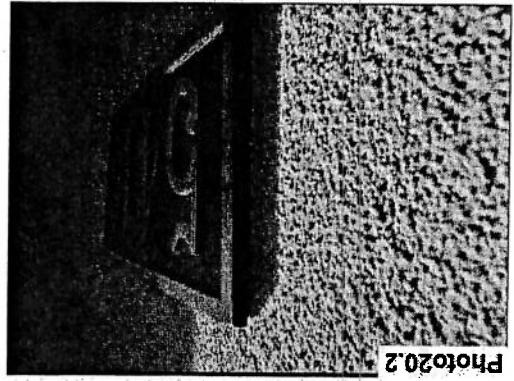
Miscellaneous penetration, front elevation, no visible sealant

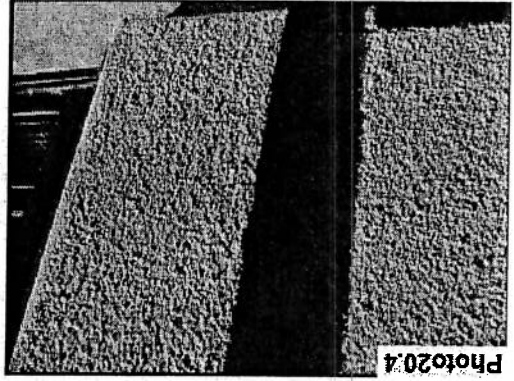
Casing bead trim to stucco panel transition, front elevation, sealant present but failing

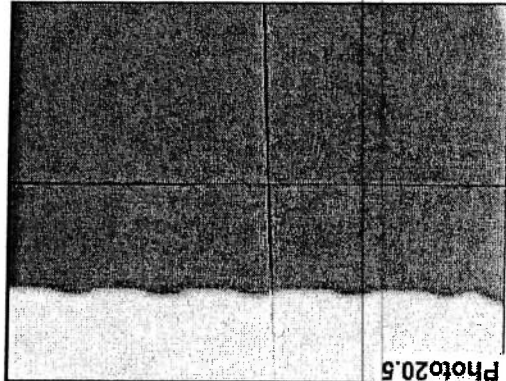
- Annual inspection of sealant conditions, with replacement as necessary, should be considered part of routine home maintenance.
- Expansion/control joint placement appear to conform with industry standard guidelines, although some vertical control joints were not continuous through horizontal control joints. A split vertical control joint was observed on the left elevation.

Control joint intersection, right elevation, vertical control joint not continuous through horizontal control joint

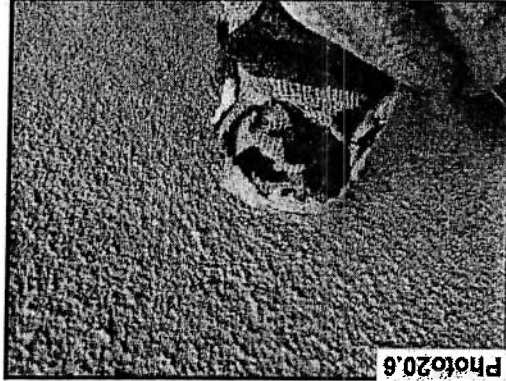
Hose bib, right elevation, sealant present but failing

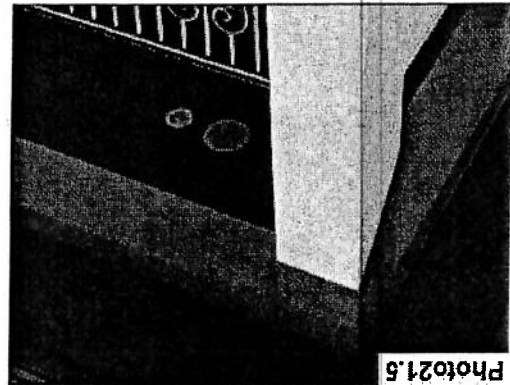
- No provisions for drainage were observed on the underside of balcony beams/overhangs. No provisions for drainage were observed between horizontal stucco overhangs and cast stone balcony trim bands.

Balcony beams, right elevation, no provisions for drainage

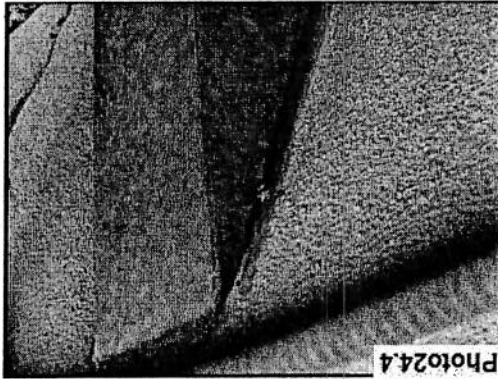
Air conditioning refrigerant line cover, left elevation, sealant present but falling

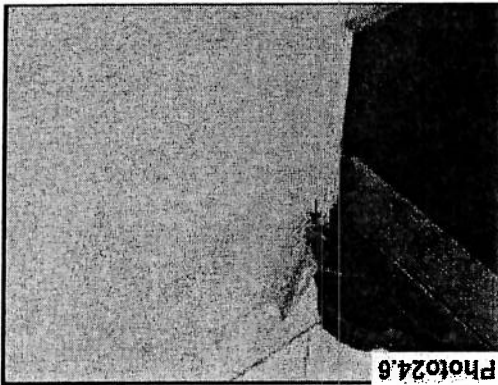
- Kick out/diverter flashing was installed at roof to wall/balcony to wall intersections that were visible. Missing, insufficient and/or failing sealant conditions were observed at some kick out/diverter flashings. Balcony flashings were turned back onto the face of stucco panels.

Kick out diverter flashing, left elevation, sealant present but falling. Void below flashing.

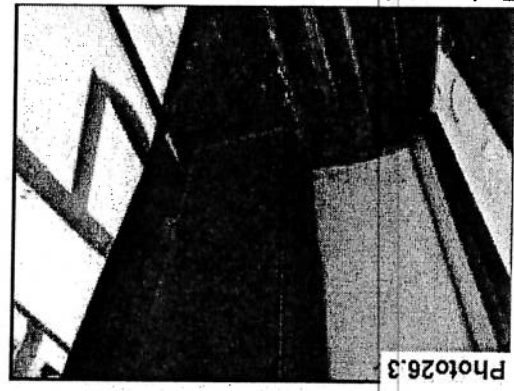
Balcony threshold, front elevation, no visible sealant

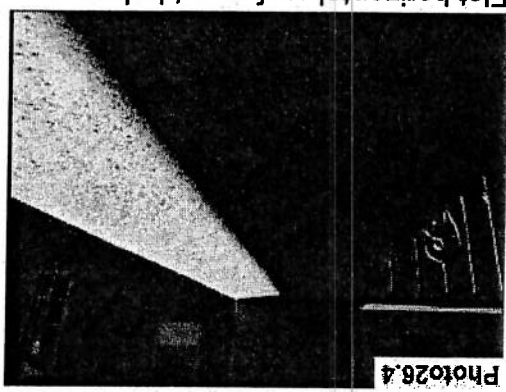
- No 6:12 slope is present on horizontal stucco/EIFS surfaces such as decorative trim bands and balcony walls. Large flat horizontal surfaces were observed.

Flat horizontal surface at balcony wall, right elevation

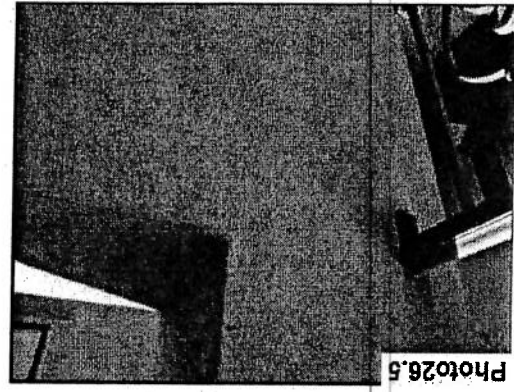
Hairline crack visible at balcony wall, right elevation

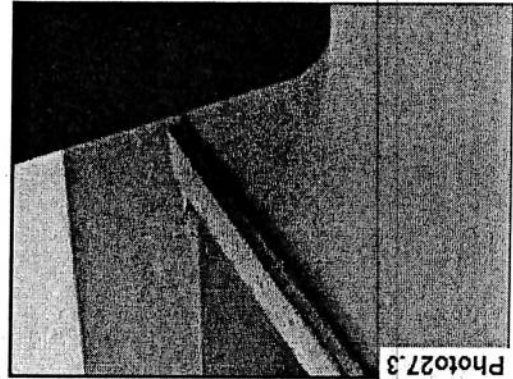
Crack below window and above roof to wall, right elevation

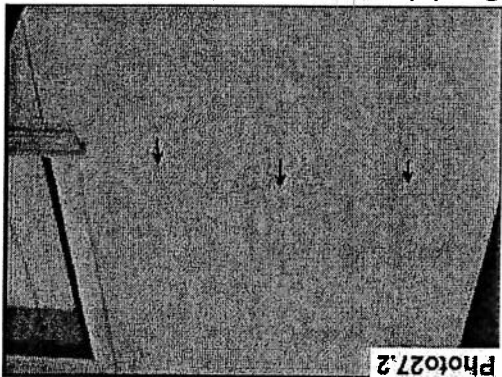
Crack in stucco panel at window, right elevation

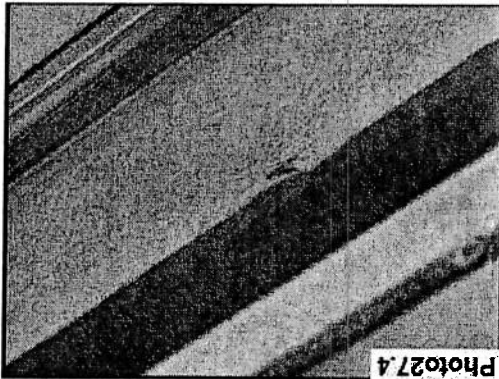
Exposed mesh at trim band, second level window, right elevation
