PROPERTY INSPECTION REPORT

217 11th Ave N
Texas City TX 77590

Prepared For: Robert Orfino
(Name of Clients)

Concerning: 217 11th Ave N, Texas City TX 77590
John Rugg - TREC #24488, TPCL FIRM #2017015000 (Inspector)
FIRM #ACO1162, LEAD FIRM #2110697, ASBESTOS
By: AGENCY #100576, TPCL FIRM #0761253 08/07/2021 9:30 am
(Name and License Number of Inspector) (Date)

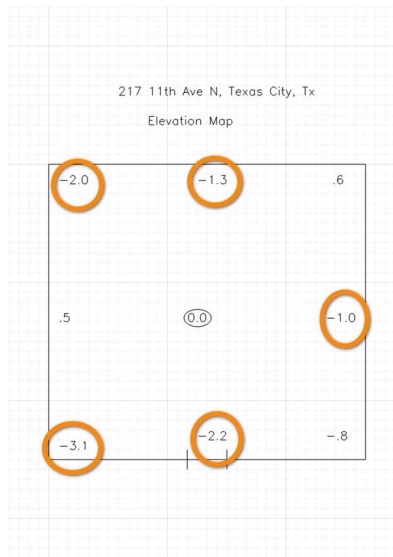
1: Foundation Levels - Out of Tolerances

Based on an elevation survey taken at time of inspection, the foundation appears to have moved beyond industry accepted tolerances and should be further evaluated by a professional engineer to determine if permanent repairs are needed.

Recommendation: Contact a qualified professional engineer

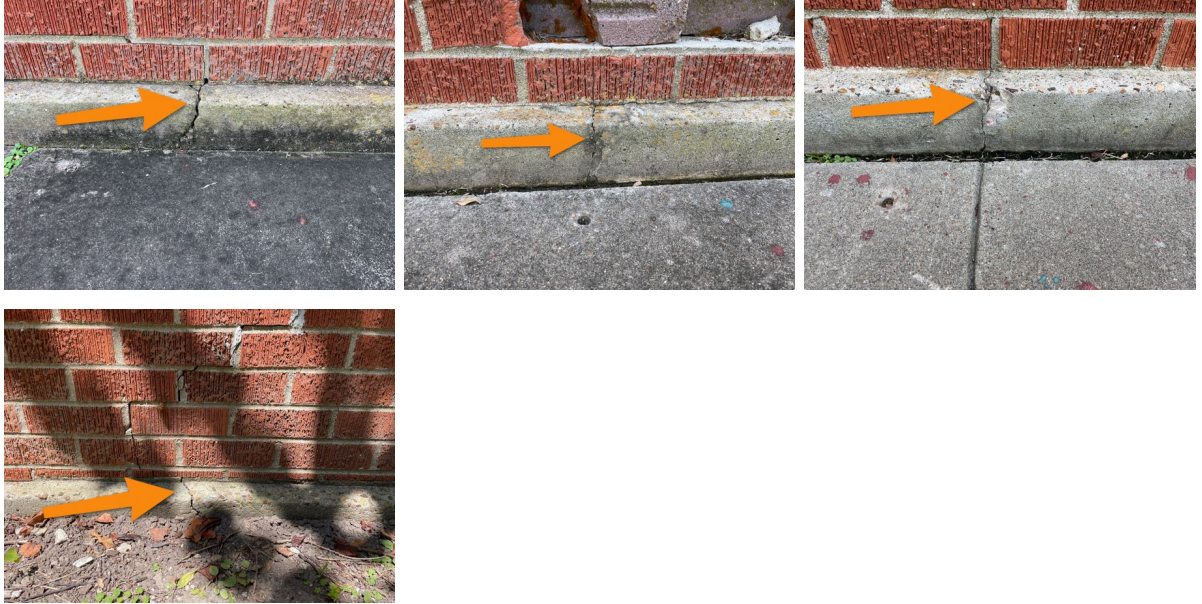
Cracks were observed in the foundation wall.

Recommendation: Recommend monitoring.

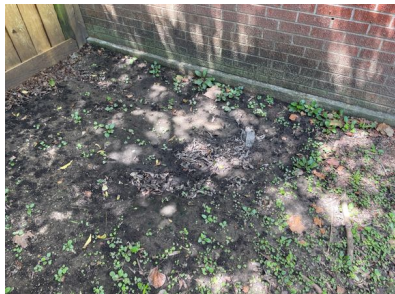
There are holes in the grade around the structure.

Recommendation: Contact a qualified professional.

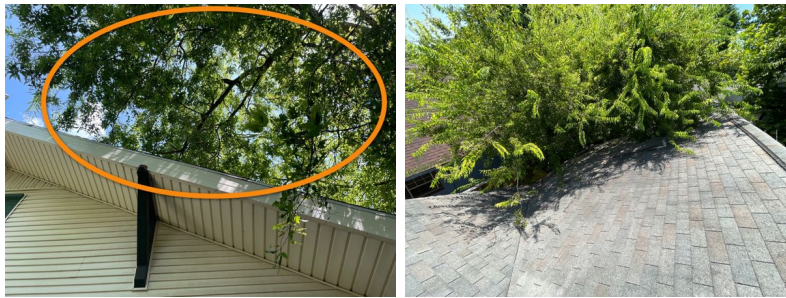
Trees observed overhanging the roof. This can cause damage to the roof and prevent proper drainage. Recommend a qualified tree service trim to allow for proper drainage.

Recommendation: Contact a qualified tree service company.

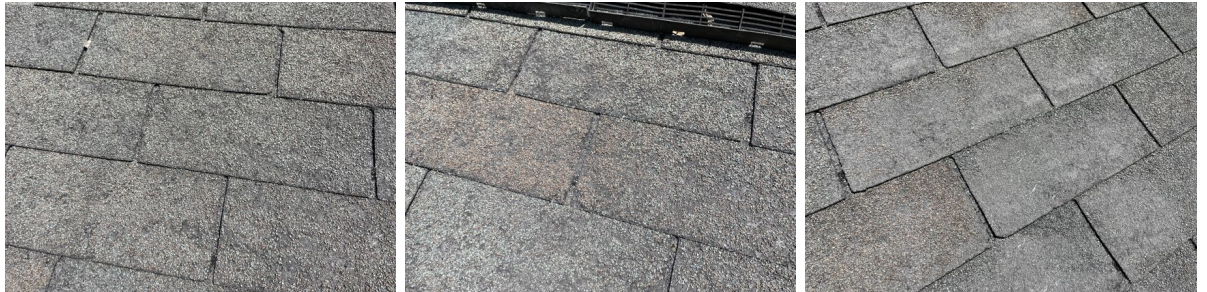
2: Aggregate Loss

Aggregate loss was observed at the roofing material.

Recommendation: Contact a qualified roofing professional.

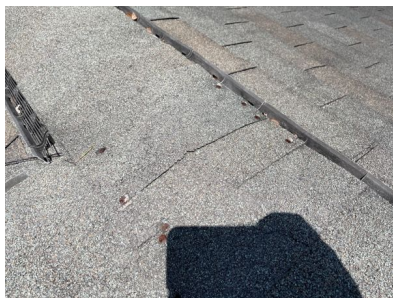
3: Fasteners - Exposed

Exposed fasteners. Fasteners should be sealed to prevent water penetration.

Recommendation: Contact a qualified roofing professional.

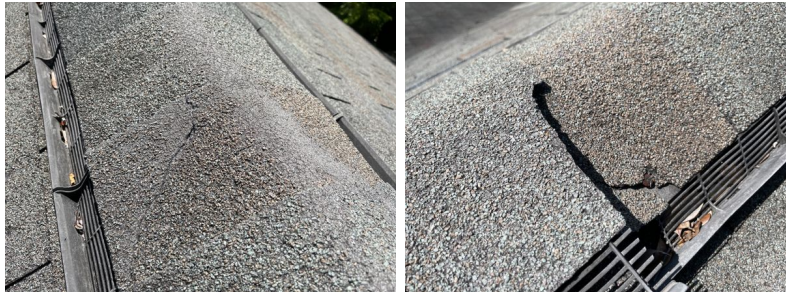
There are torn and damaged ridge shingles.

Recommendation: Contact a qualified roofing professional.

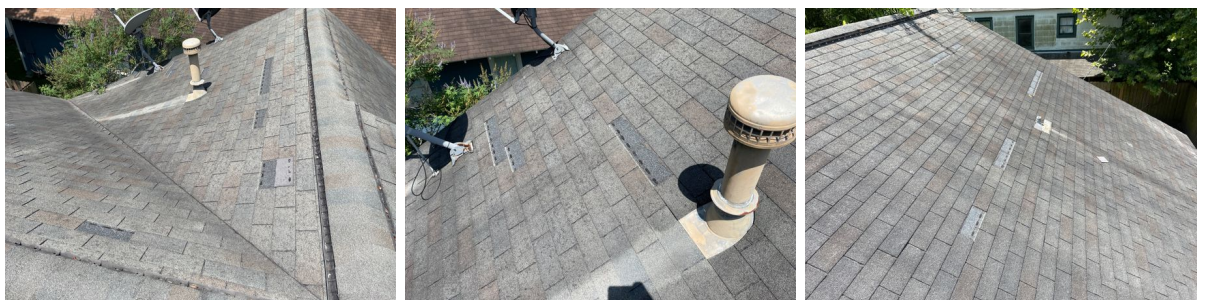
6: Missing Shingles

There were missing shingles on the roof. Replacement is recommended.

Recommendation: Contact a qualified roofing professional.

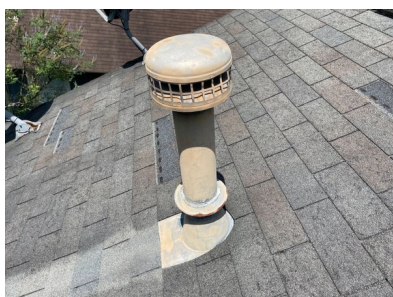
7: Furnace Rain Collar

The rain collar to the furnace chimney(s) should be pushed down to the roof flashing and sealed at the upper end with silicone caulk.

Recommendation: Contact a qualified roofing professional.

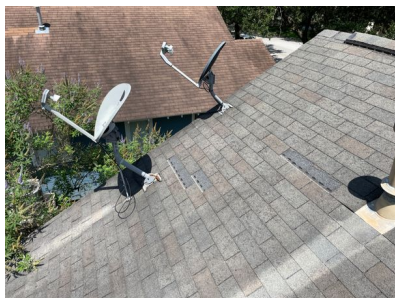
There was a satellite dish installed on the roof. Due to the penetrations in the roof this area is prone to future leaking.

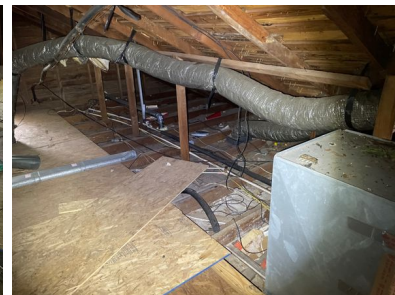
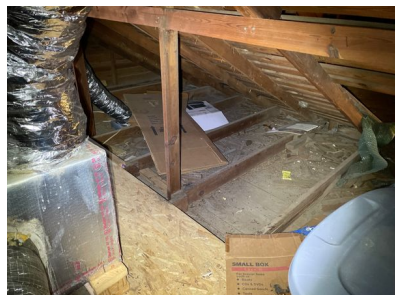
There were areas of missing insulation in the attic area. The Department of Energy currently recommends an insulation value of R-30 to R-49 for the attic area.

Recommendation: Contact a qualified insulation contractor.

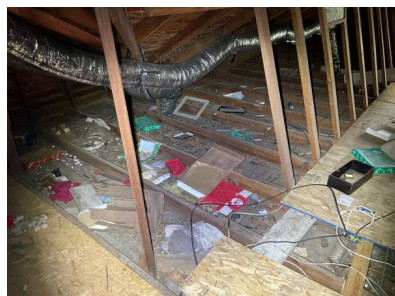
2: Missing Purlin Supports

There were missing purlin supports.

Recommendation: Contact a qualified professional.

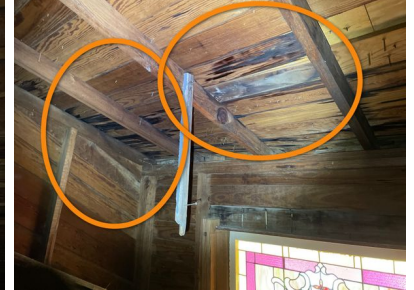
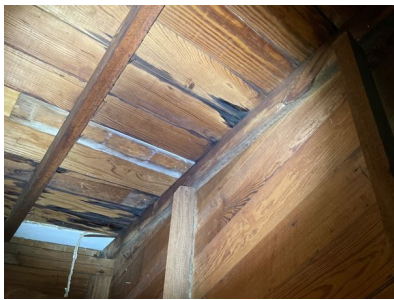
Areas of water damage and staining were noted on the roof decking and structural members in the attic.

Recommendation: Contact a qualified professional.

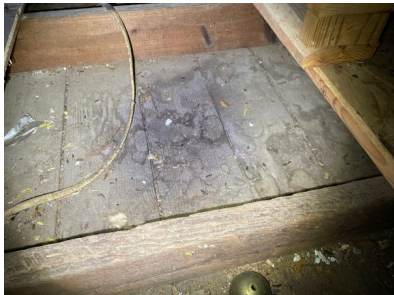
5: Water Stained Walkboards

There were areas of previous water staining noted on the attic walkboards.

Recommendation: Contact a qualified professional.

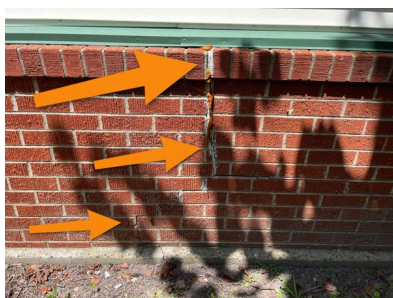
There were brick cracks noted at the time of inspection.

Recommendation: Contact a qualified professional.

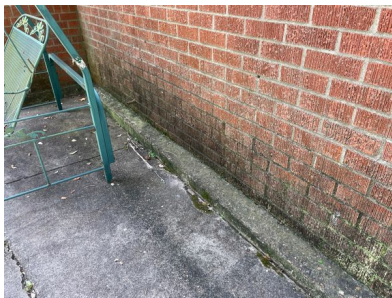
There are signs of algae and/or mildew on the siding. This is a cosmetic issue and is not uncommon especially on shaded portions of the home. Recommend that said areas be washed or cleaned on a regular basis.

Recommendation: Contact a qualified professional.

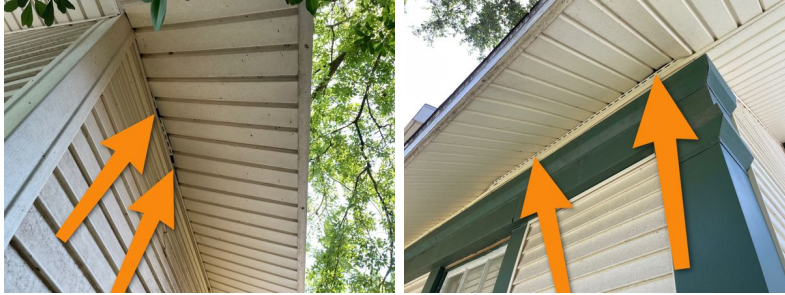
There were gaps and holes present at the exterior soffit boards.

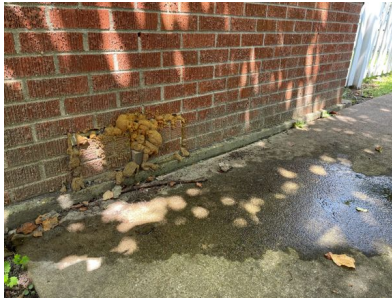
6: Previous Repair

There were incorrectly repaired bricks at the exterior of the home.

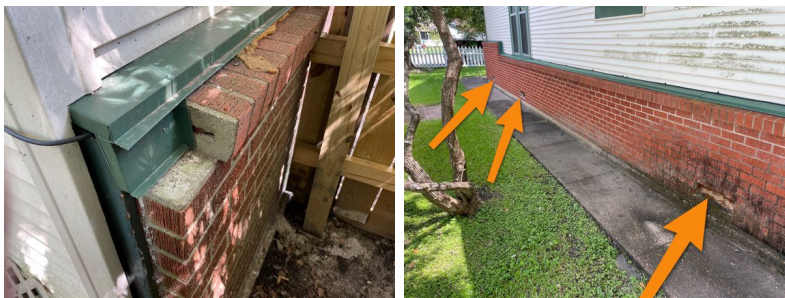
7: Missing Brick

One or more bricks were missing at the exterior walls. Repair by a qualified professional is recommended.

Recommendation: Contact a qualified professional.

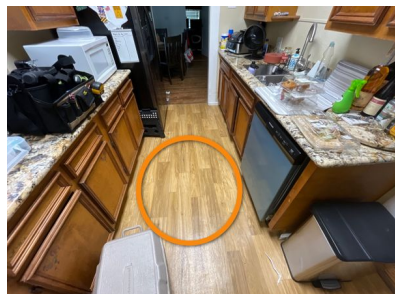
Hump was noted in the flooring. Repair is recommended.

Recommendation: Contact a qualified professional.

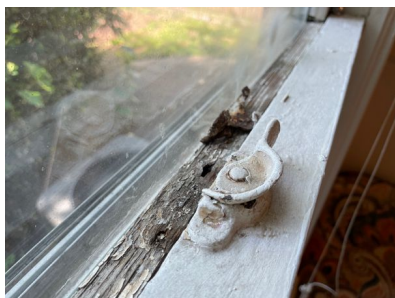
Various window locks within the home did not lock when operated.

Recommendation: Contact a qualified window repair/installation contractor.

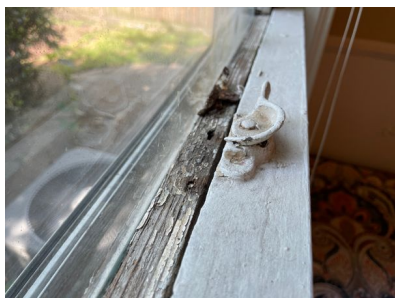
3: Wood Rot

Wood rot observed at the windows. Replacement is recommended.

Recommendation: Contact a qualified professional.

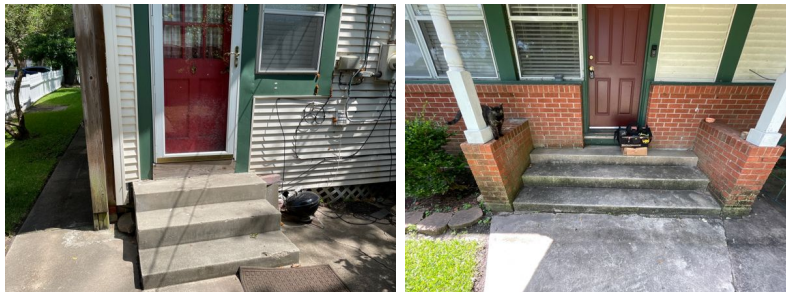
Railing is needed for the stairway.

Recommendation: Contact a qualified professional.

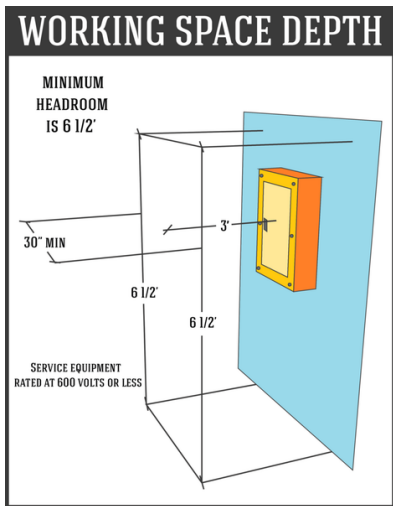
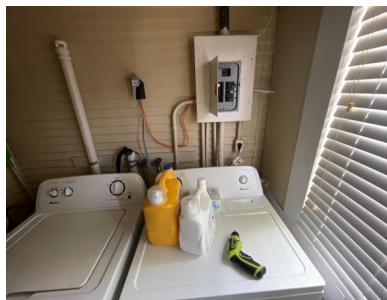
There was insufficient working clearance in front of the panel.

Recommendation: Contact a qualified electrical contractor.

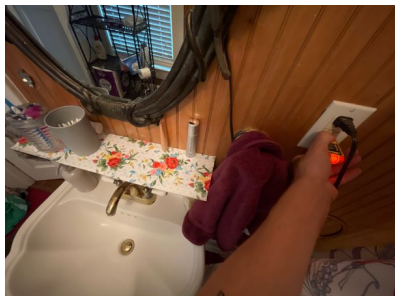
The GFCI outlet does not trip when tested with a handheld tester. Replacement is recommended.

Recommendation: Contact a qualified electrical contractor.

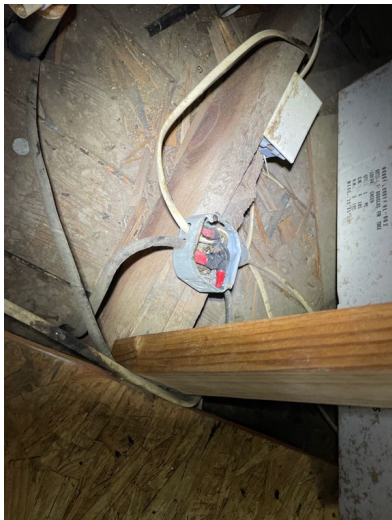
Visible electrical junction box observed that does not have a cover.

Recommendation: Contact a qualified electrical contractor.

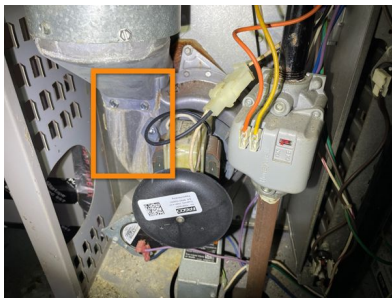
There were areas of rust present at the interior cabinet.
