DUPLEX INSPECTION REPORT

217 11th Ave N
Texas City TX 77590

PROPERTY INSPECTION REPORT

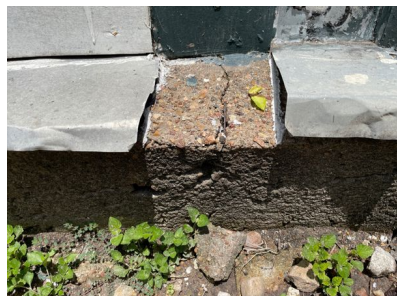
Cracks were observed in the foundation wall.

Recommendation: Recommend monitoring.

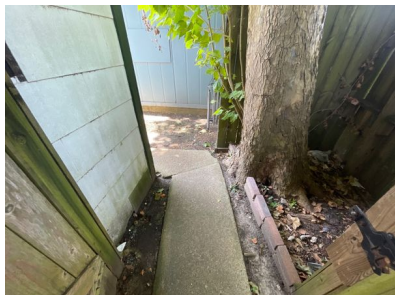
There are trees growing in close proximity to the foundation wall. Tree root systems can take as much as 50-60 gallons of water away from the foundation per day.

Recommendation: Contact a qualified professional.

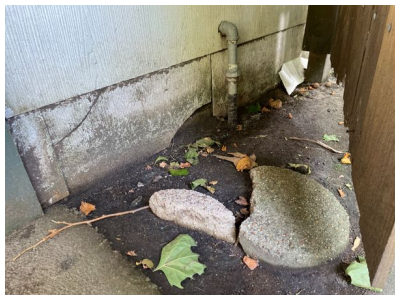
There were areas of insufficient exposure of the foundation wall. Preferably 6 to 8 inches of foundation exposure should be present around the perimeter of the home. The higher the soil level the more inviting it is for wood destroying insect activity and moisture intrusion.

Recommendation: Contact a qualified professional.

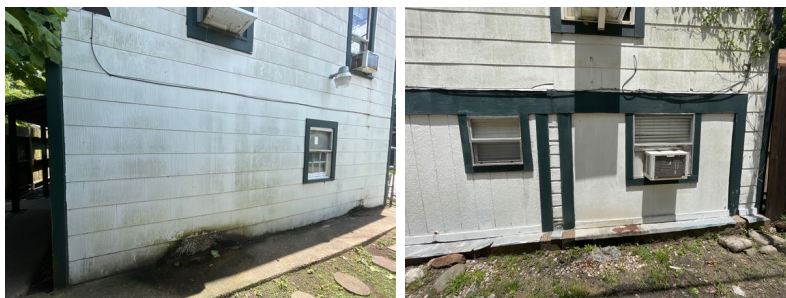
2: Excessive moisture

Excessive moisture is present in areas around the home. Further evaluation is recommended.

Recommendation: Contact a qualified professional.

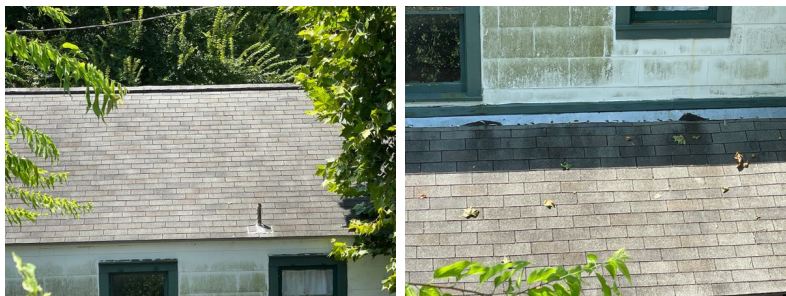
There were aged, worn, and damaged shingles and ridge.

Recommendation: Contact a qualified roofing professional.

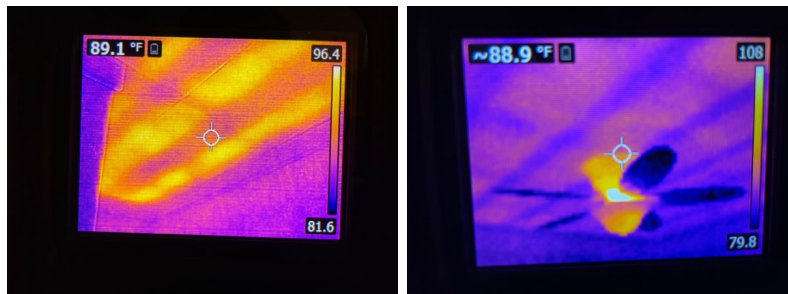
There were areas of low/missing insulation observed with the infrared camera.

Recommendation: Contact a qualified insulation contractor.

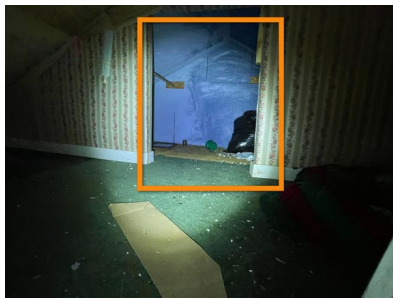
There is not a complete firewall installed between the units within the attic area.

Recommendation: Contact a qualified professional.

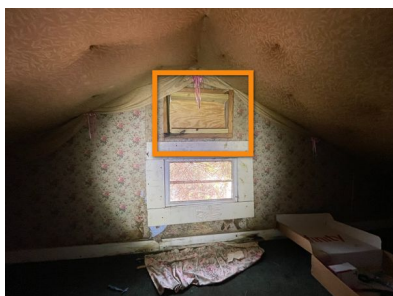
4: Gable Vents Not Working

The gable vents do not appear to be adequately ventilating air.

Recommendation: Contact a qualified professional.

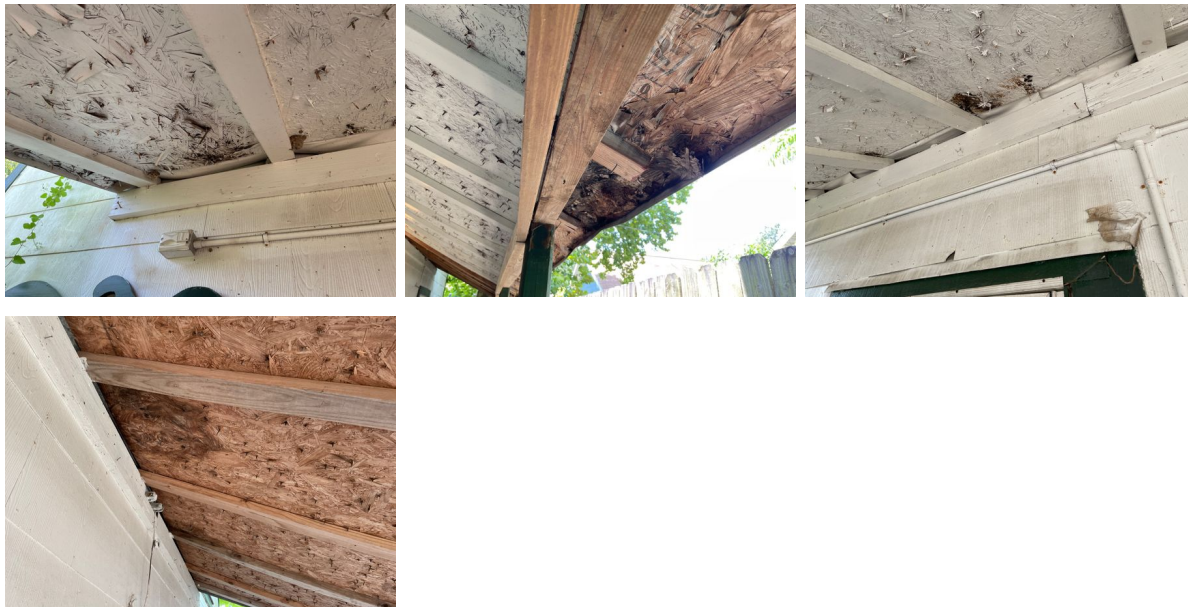
Areas of previous water damage and staining were noted on the roof structural members over the patio.

Recommendation: Contact a qualified professional.

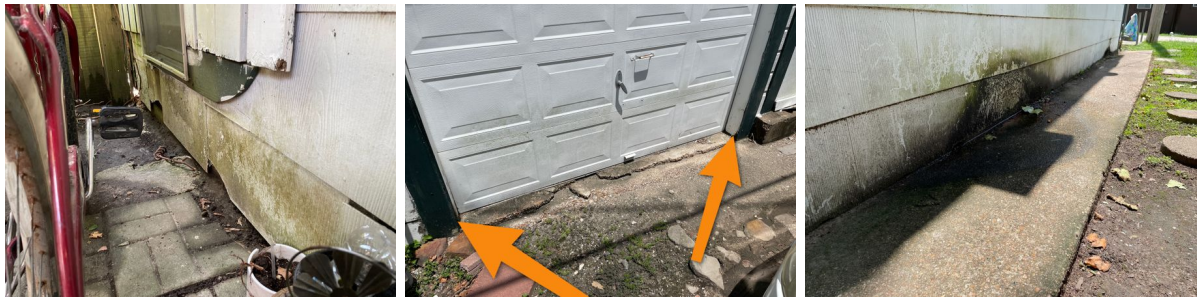
There were various areas of rot and damage to the exterior siding and trim materials.

Recommendation: Contact a qualified professional.

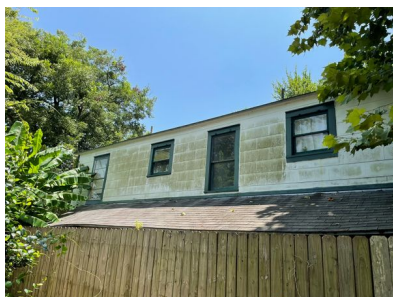
2: Mildew/Algae

There are signs of algae and/or mildew on the siding. This is a cosmetic issue and is not uncommon especially on shaded portions of the home. Recommend that said areas be washed or cleaned on a regular basis.

Recommendation: Contact a qualified professional.

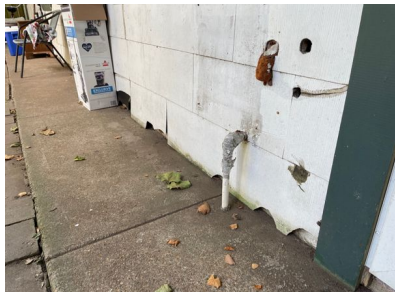
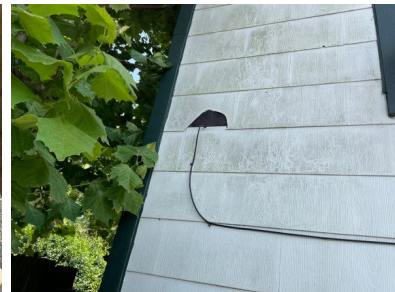
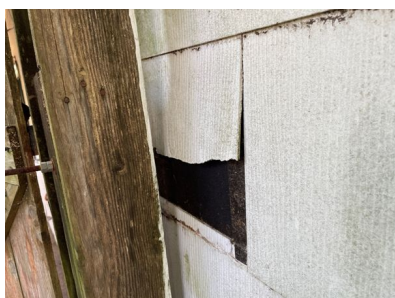
There were areas of damaged siding and trim materials.

Recommendation: Contact a qualified professional.

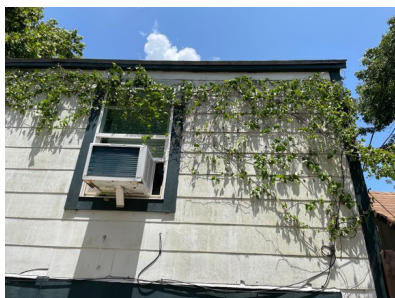
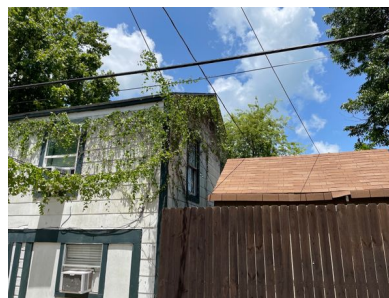
4: Vines on Wall

Vines were growing on the exterior veneer of the home. Vines can cause damage to brick, as well as deteriorate the wood trim, and wall pieces, due to the amount of water they hold. It is recommended that the vines be removed to ensure proper dryness of the wall, as well as to deter pests and insects from entering the home.

Recommendation: Contact a qualified landscaping contractor

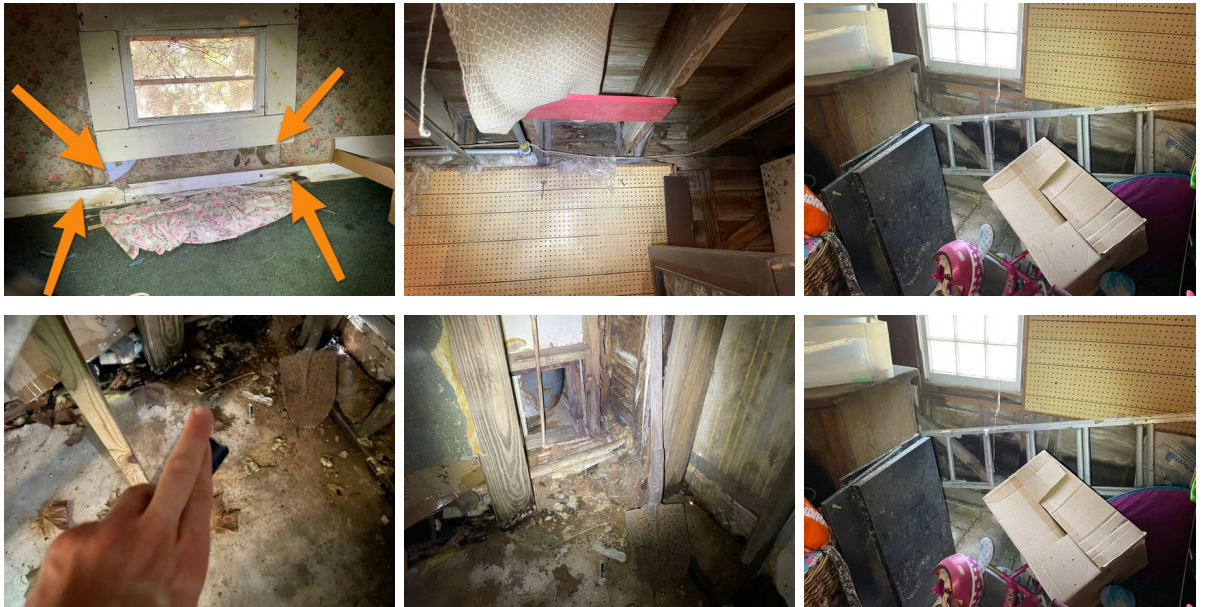
1: Water Damage

Stains on the walls visible at the time of the inspection appeared to be the result of water or moisture intrusion. The source of water/moisture may have been corrected. Recommend further examination by a qualified contractor to provide confirmation.

Recommendation: Contact a qualified professional.

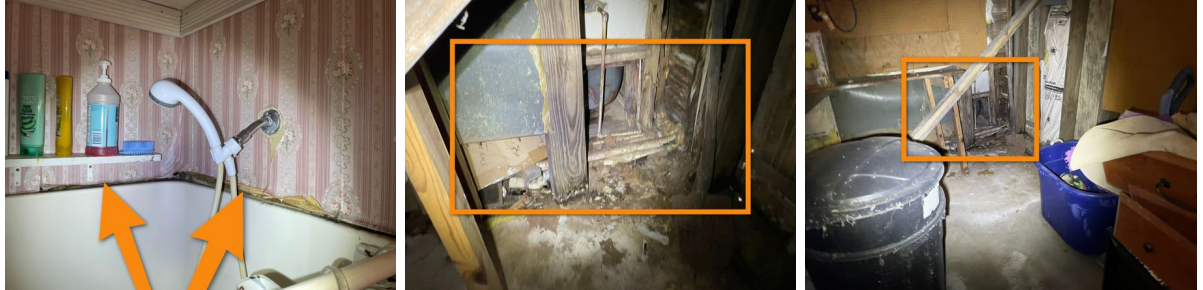
There was evidence of previous water loss at areas of the interior walls. Further evaluation recommended.

Recommendation: Contact a qualified painting contractor.

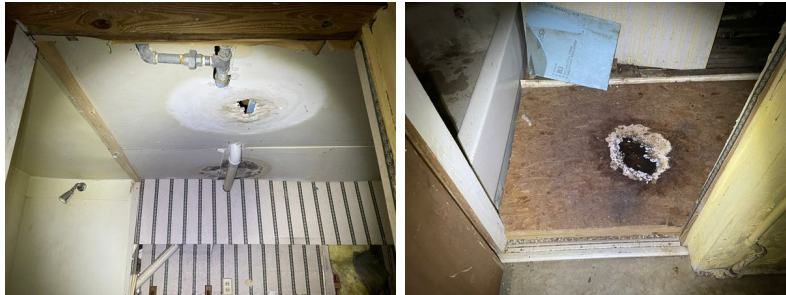
3: Interior Walls - Active Water Leak

There was an area of water penetration present at the interior walls. It is recommended that the source of the water be determined and all necessary repairs/replacements be made.

Recommendation: Contact a qualified professional.

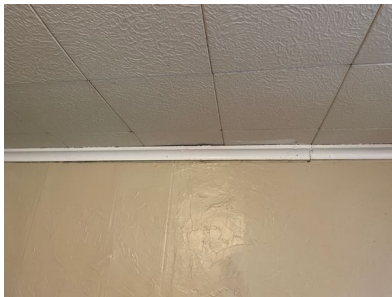
There was wall to ceiling cracking/separation present.

Recommendation: Contact a qualified professional.

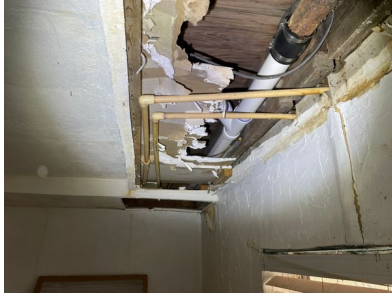
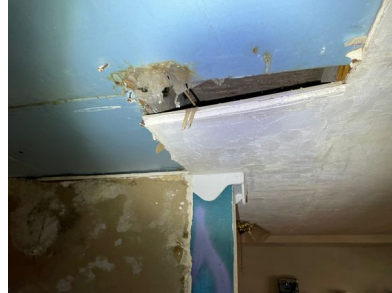
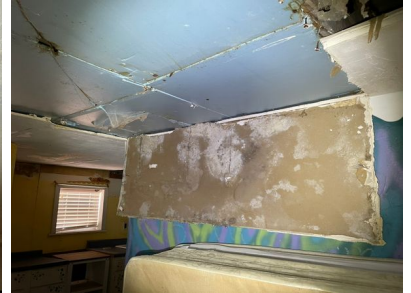
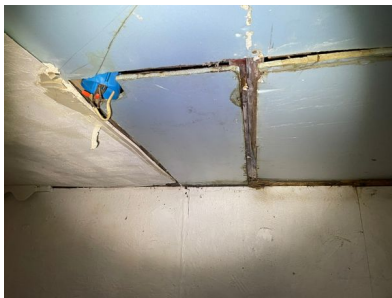
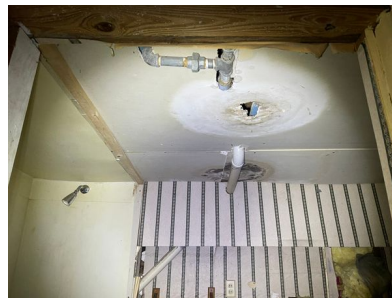
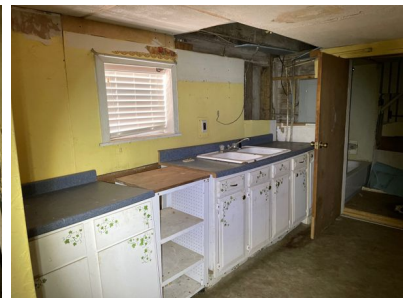
3: Ceiling Damage

There is damage to the ceiling. Recommend repair by a qualified professional.

Recommendation: Contact a qualified professional.

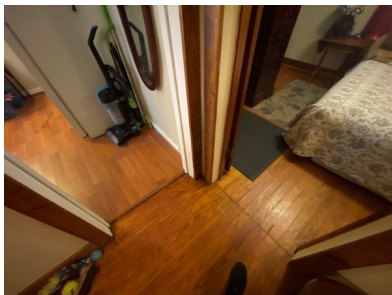
1: Floors Out of Level

The interior floors felt out of level in areas.

Recommendation: Contact a qualified professional.

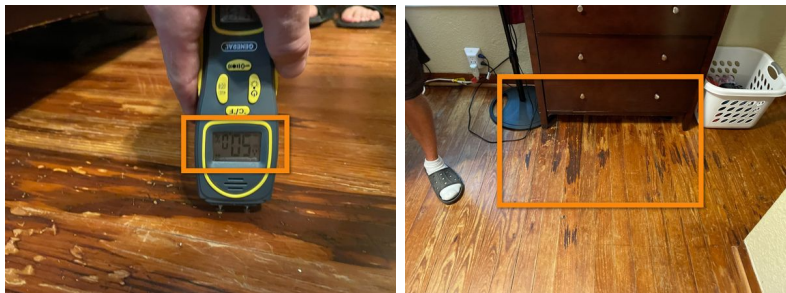
There was an area of moisture penetration present at the floor. Water penetration was confirmed with a moisture meter. Further evaluation is recommended to determine source of water penetration.

Recommendation: Contact a qualified professional.

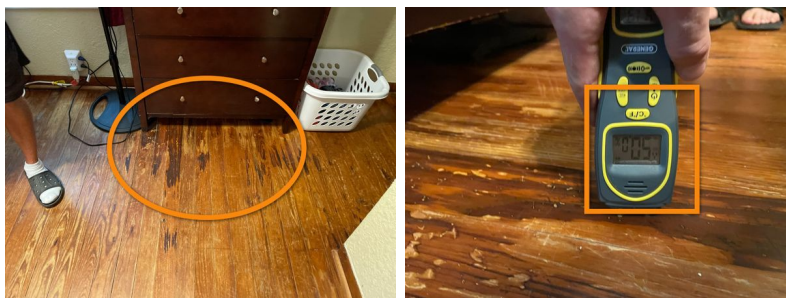
3: Elevated Moisture Readings

Elevated moisture readings on the floor.

Recommendation: Contact a qualified professional.

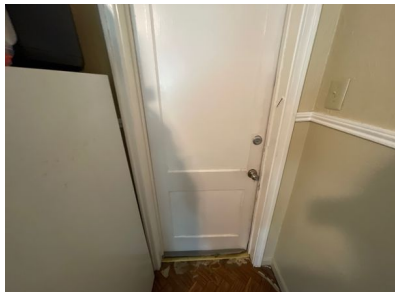
There were doors present that did not latch when shut.

Recommendation: Contact a qualified door repair/installation contractor.

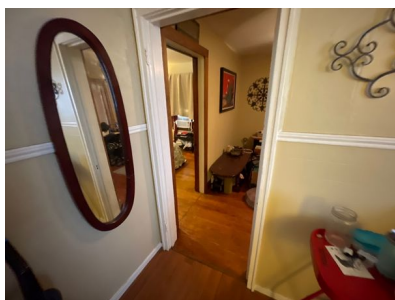
2: Missing Door

A door is not present at time of inspection.

Recommendation: Contact a qualified professional.

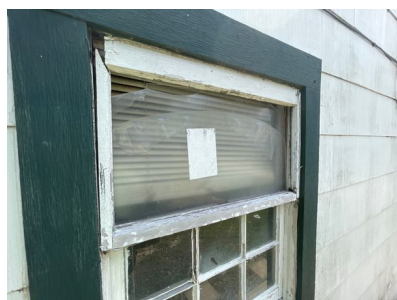
Broken, loose, and missing handles on windows in the home.

Recommendation: Contact a qualified window repair/installation contractor.

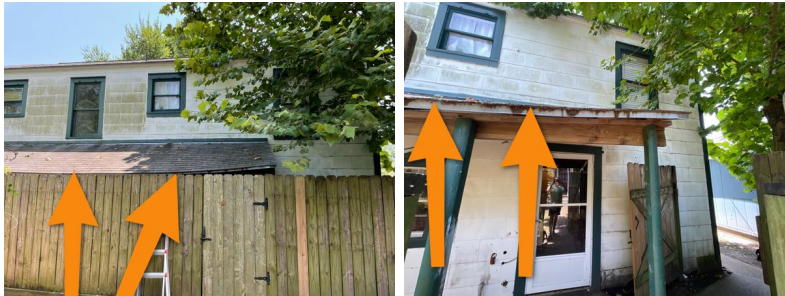
The patio covering was sagging. Repair is recommended.

Recommendation: Contact a qualified professional.

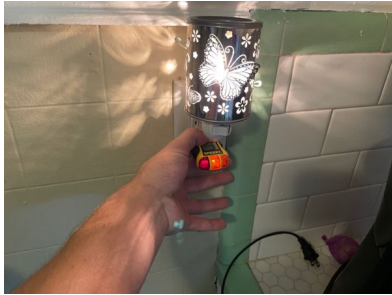
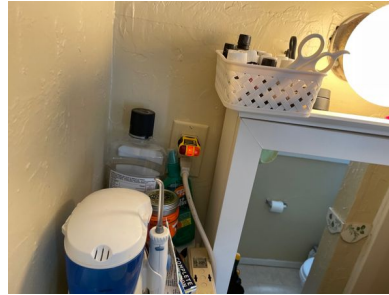
The GFCI outlet does not trip when tested with a handheld tester.

Recommendation: Contact a qualified electrical contractor.

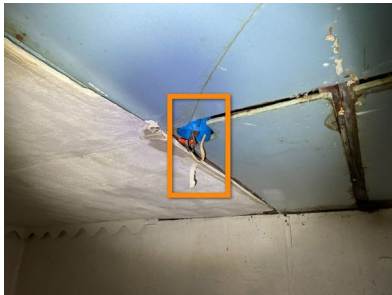
2: Junction Box Covers Missing

Visible electrical junction box observed that does not have a cover.

Recommendation: Contact a qualified electrical contractor.

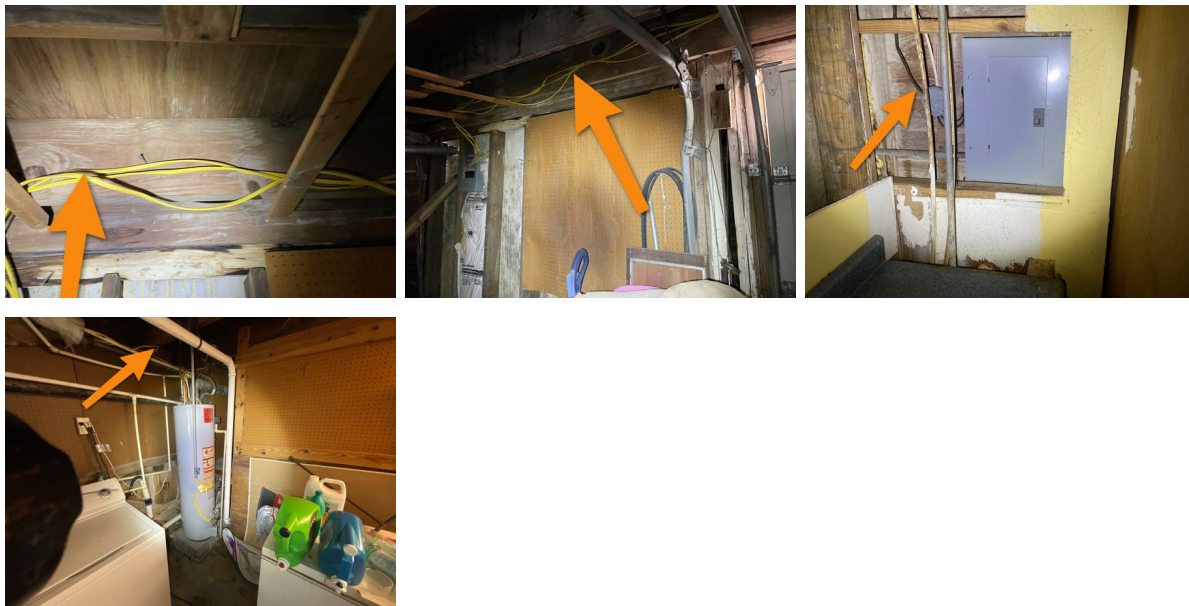
3: Exposed Interior Wiring

The exposed interior wiring should be relocated behind gypsum board or should be in protective electrical conduit.

Recommendation: Contact a qualified electrical contractor.

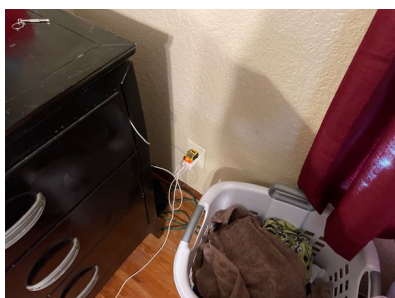
4: Open Ground Readings

Hand held tester had open ground readings.

Recommendation: Contact a qualified electrical contractor.

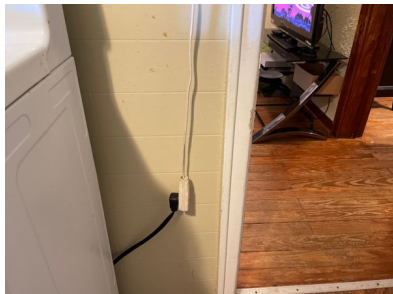
There was extension cord wiring used as permanent wiring.

Recommendation: Contact a qualified electrical contractor.

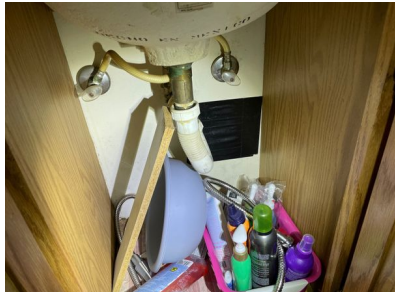
Accordion piping was present at the sink. Drainage piping should be smooth walled.

Recommendation: Contact a qualified plumbing contractor.

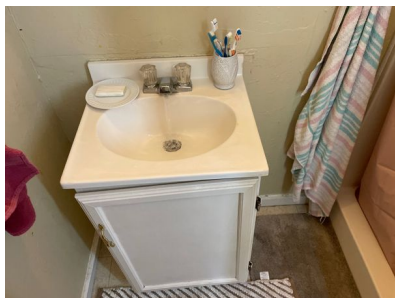
2: Slow Drain - Sink

The sink drains slowly and should be checked for possible blockage.

Recommendation: Contact a qualified plumbing contractor.

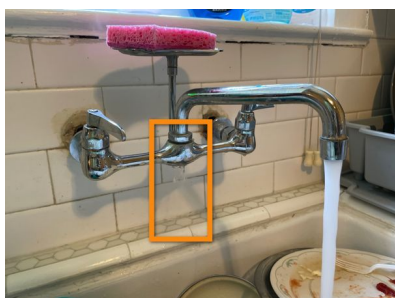
3: Leaking Faucet Handle

There is a leak at the faucet handle.

Recommendation: Contact a qualified plumbing contractor.

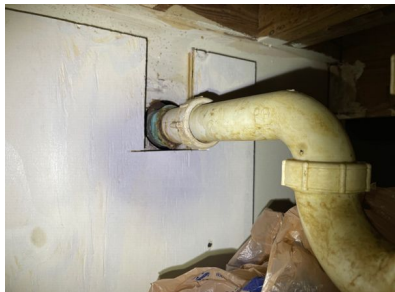
There was corrosion present at the bathroom sink drainage piping.

Recommendation: Contact a qualified plumbing contractor.

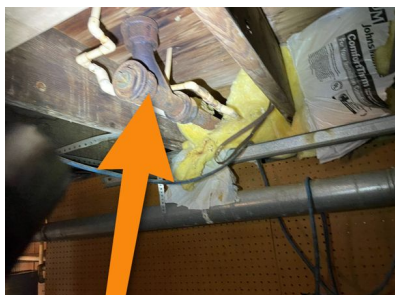
5: Cast Iron - Typical

The typical drainage piping for this age of home is cast iron. Cast iron piping has been associated with problematic conditions and buyer may wish to have the drainage piping further evaluated by a licensed plumber.

Recommendation: Contact a qualified plumbing contractor.

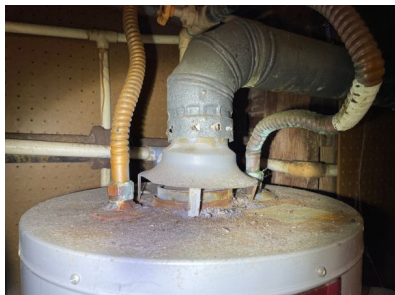
There is corrosion on the valves and fittings at the water heater.

Recommendation: Contact a qualified plumbing contractor.
