# PROPERTY INSPECTION REPORT

Concerning: 6511 Misty Creek, Missouri City, TX, 77459

By: Ning Xue 04/30/2021

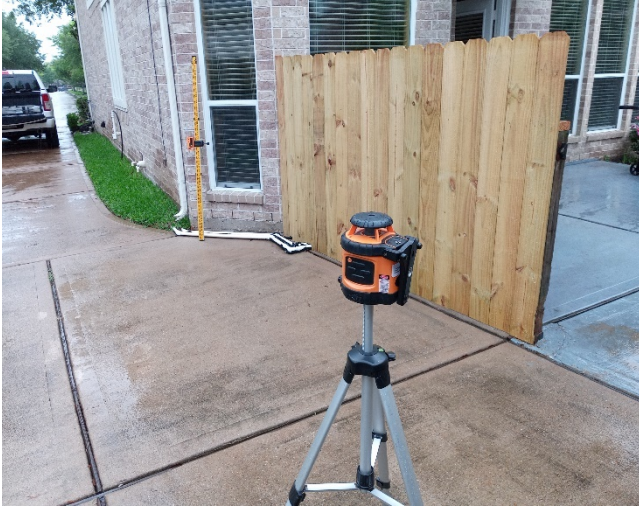
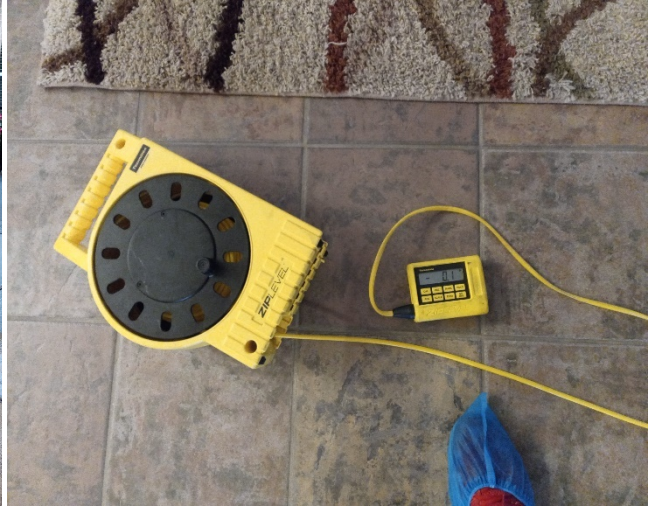
a. In my opinion, current foundation integrity appears to be performing the function intended; no significant differential movement was noted at the exterior and interior by using laser level and Ziplevel;

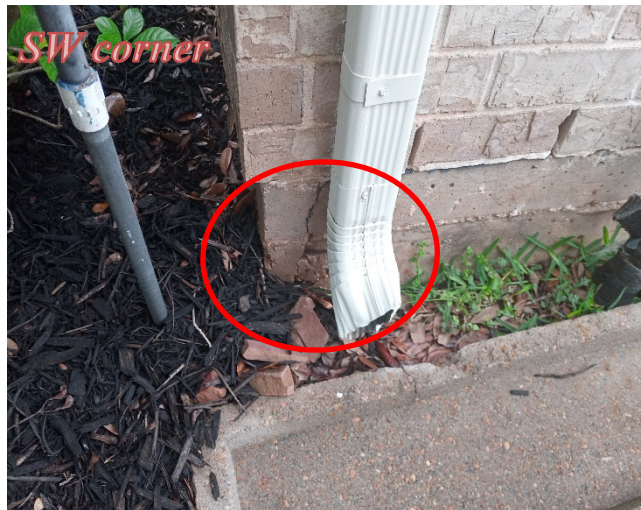
b. Cracks noted at various corners of the foundation slab; these are called corner pops and usually considered cosmetic nature unless other movement is noted, this condition can be caused by a lack of reinforcement in the corner of the foundation during original construction, and it is the inspector's opinion that it is not a structural issue at this time, but should be properly sealed to prevent further deterioration; Photo is representative of the issue and may not include all locations;

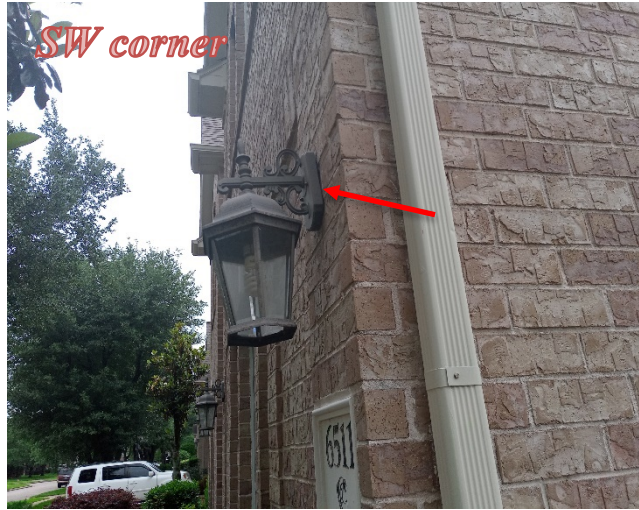
- a. Need sealing /caulking around all holes, openings (expansion joints, windows, door thresholds, etc.) and exterior wall penetrations to prevent water/critter entry; including but not limited to the above location, and all penetration for AC suction/refrigerant lines, electrical panel, dryer vent, bath and range top vents, light fixtures, etc.;
- Photo is representative of the issue and may not include all locations;

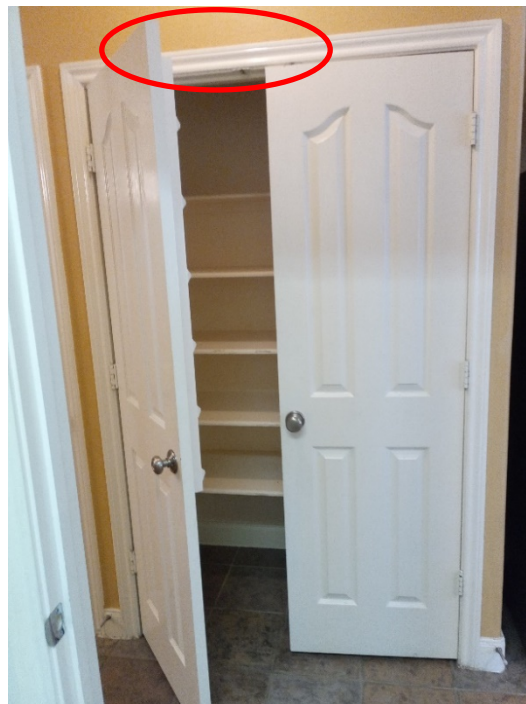
- a. The pantry's door could not be latched properly when closed; recommend repair/adjustment the ball catch at the marked location;

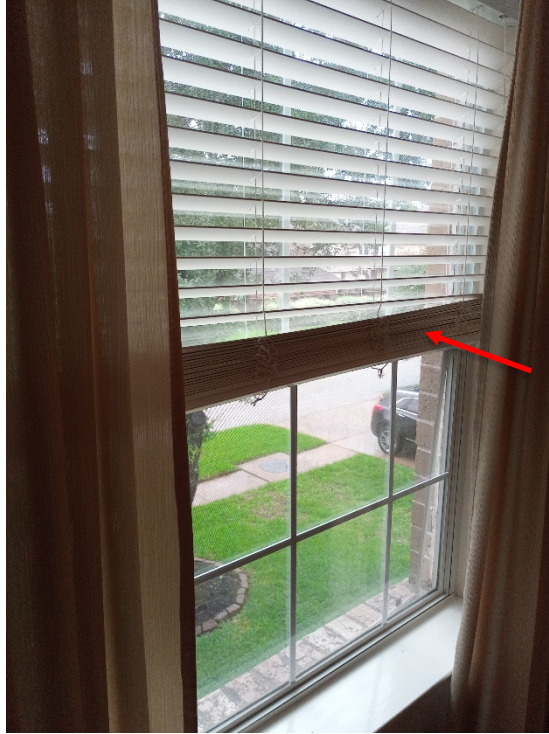
- a. The blind at above window (upstairs bedroom) was difficult to operate and the window screen was displaced; recommend adjusting or repairing as necessary;

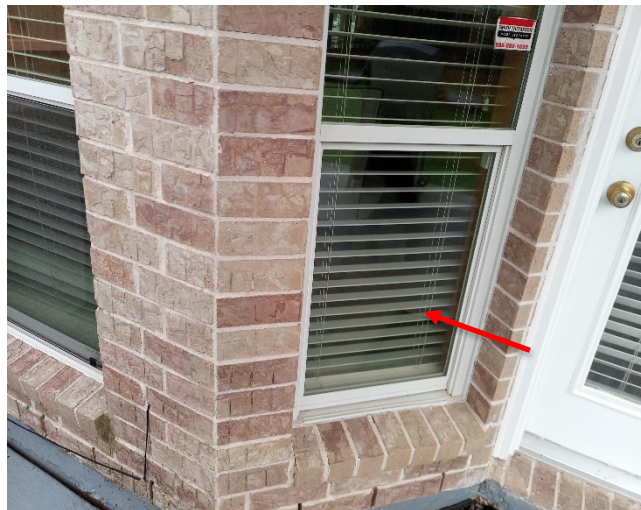
- b. Recommend installation of missing screens at certain windows; Photo is representative of the issue and may not include all locations;

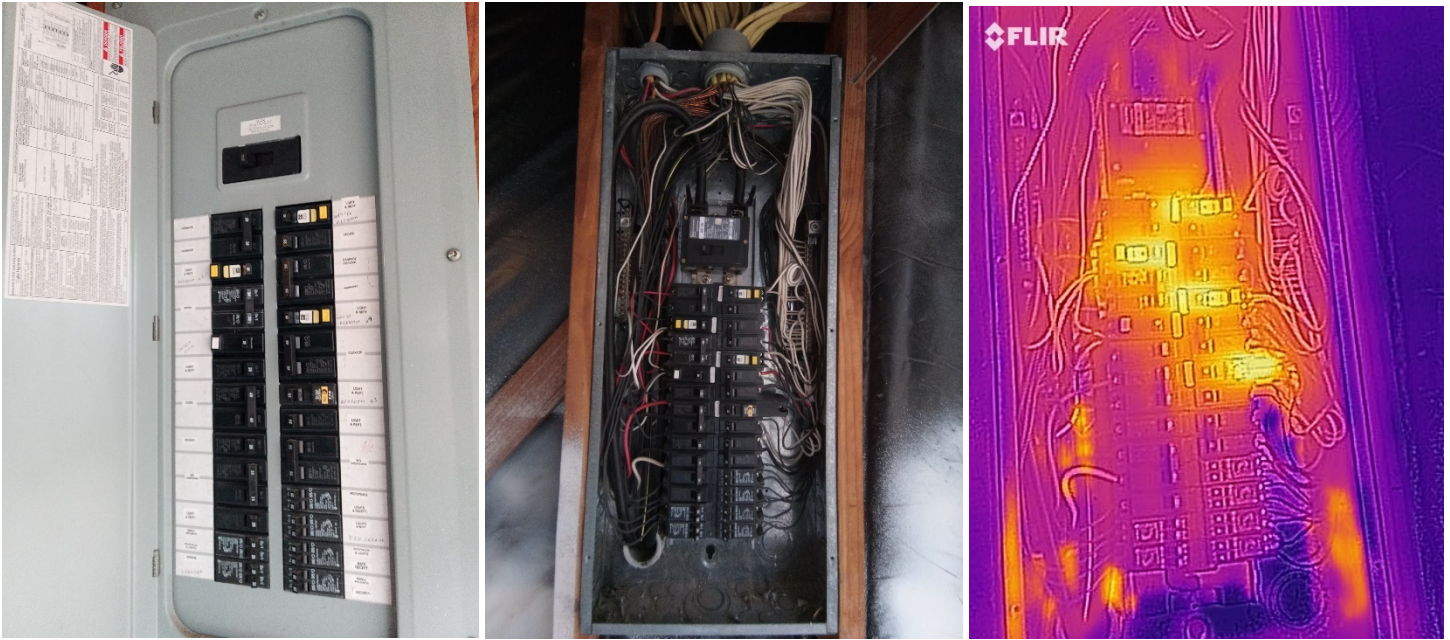
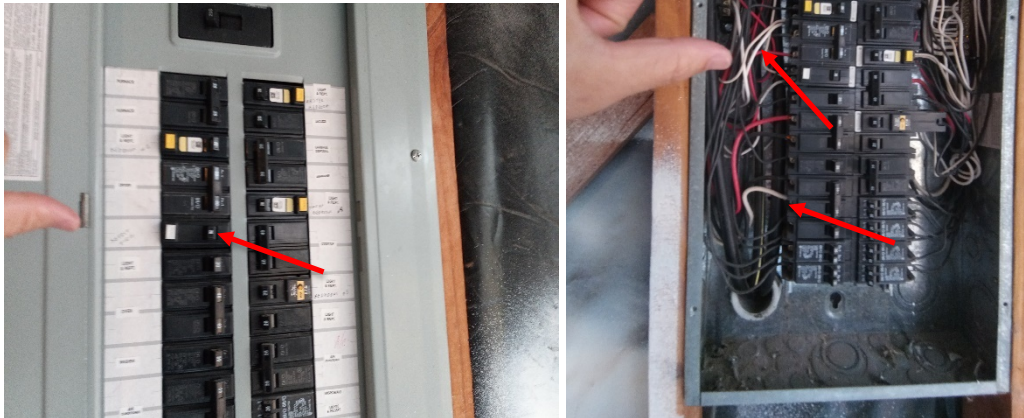
- a. One circuit breaker (labeled as “Soffit Plug”) repeatedly trips when tested; in addition, white (neutral) wires should be marked black when used as a live wire; It is recommended that a licensed electrician be contacted to further evaluate and repair as needed;

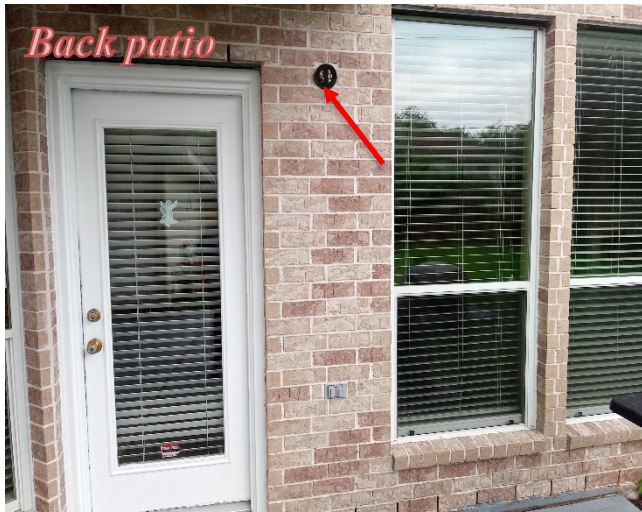
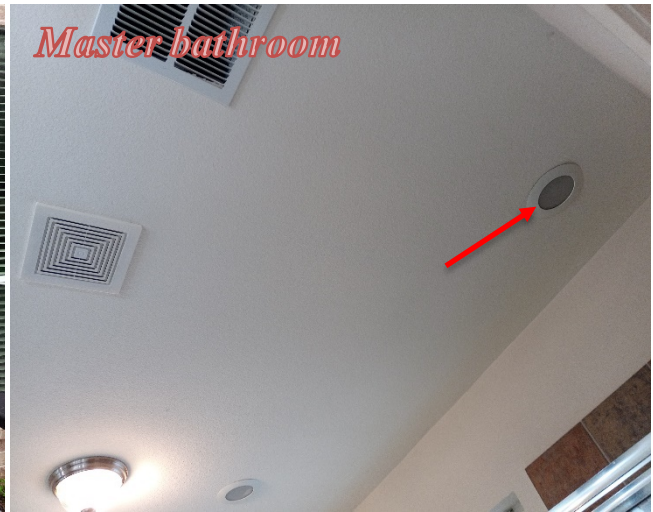
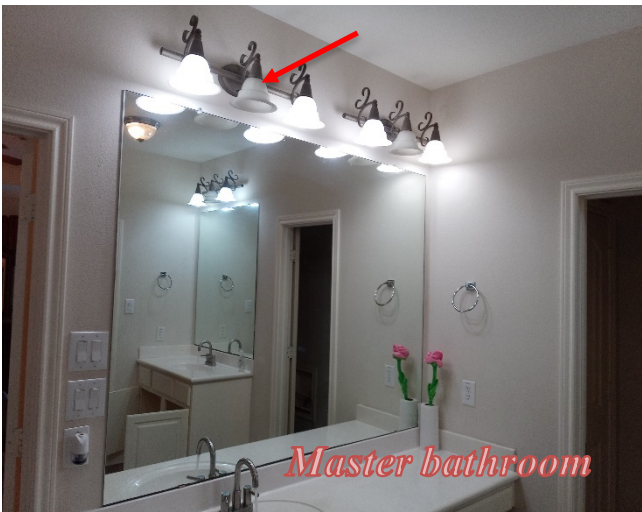
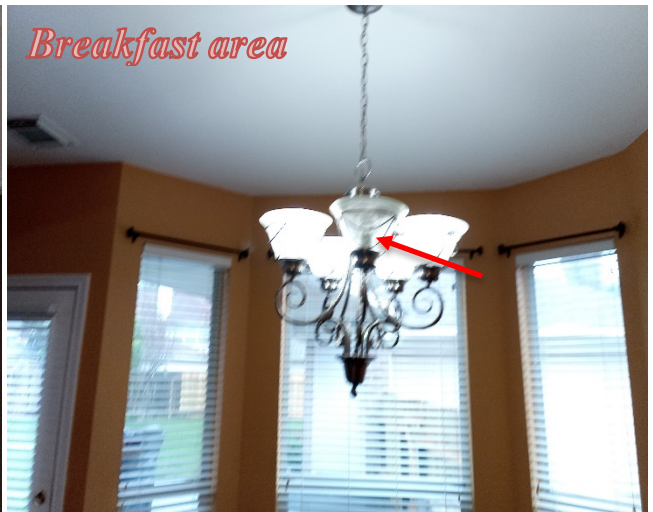
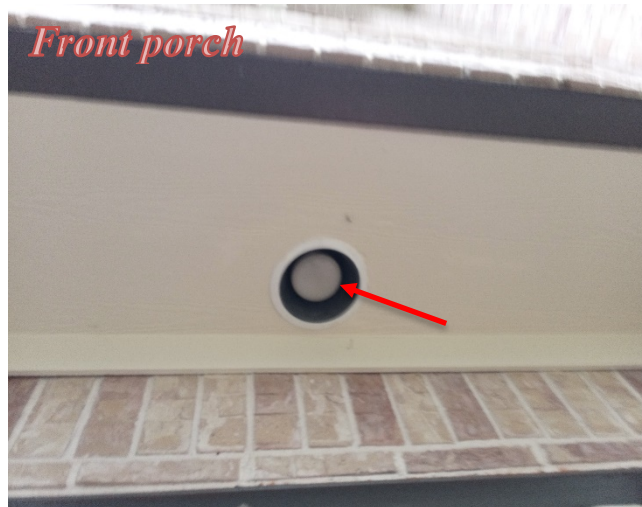
- a. The lights at above locations were faulty at time of the inspection; suggest replacing light bulbs and verifying fixture for proper operation prior to closing;

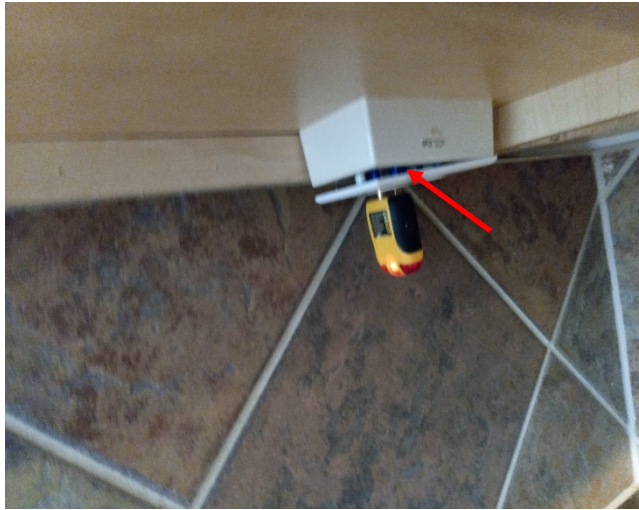
- b. *The receptacles under the kitchen cabinets were loose; suggest correction by a licensed electrician for safety reason; Photo is representative of the issue and may not include all locations;*

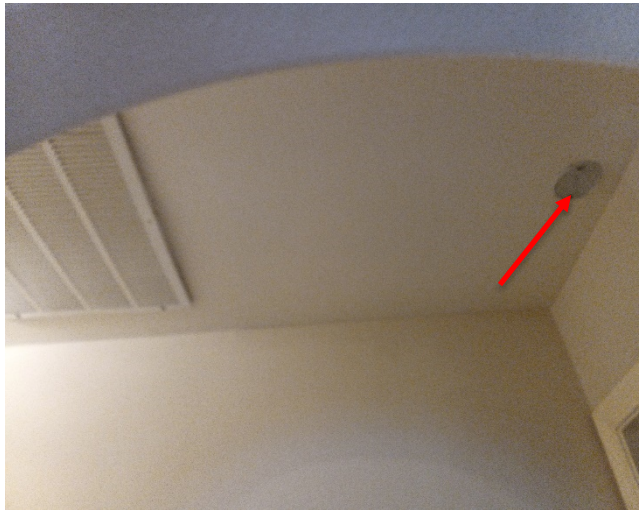
- c. *Smoke detectors were removed at various locations for unknown reason; recommend proper installation by a qualified contractor and having it tested on a regular basis based on manufacturer's recommendations; Photo is representative of the issue and may not include all locations;*

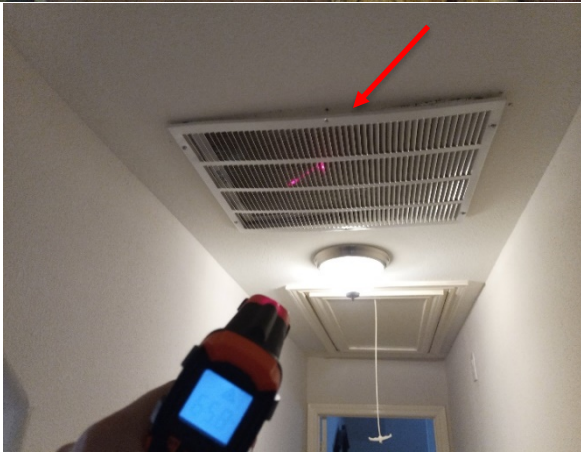
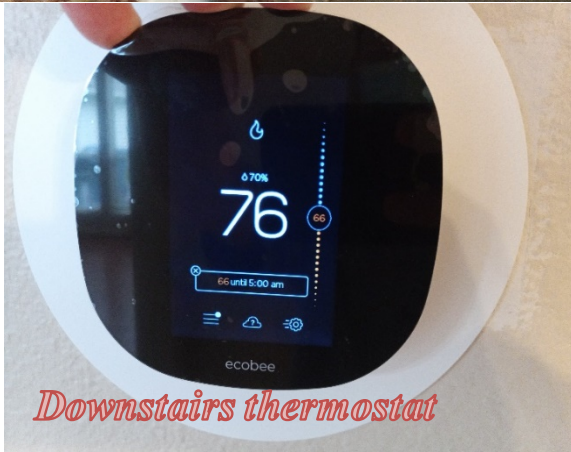
*Downstairs thermostat*

- a. The furnace serving downstairs could not be tested as the thermostat (ECOBEE brand) seems to be restricted to start the furnace until the ambient temperature reach 66 degree or lower; recommend obtaining the operation manual of the thermostat and/or further evaluation by a qualified A/C contractor before the close of escrow; The AC air return louvered ceiling grill (serving upstairs) is loose; recommend correction; The furnace serving upstairs areas were tested and functioning as intended;

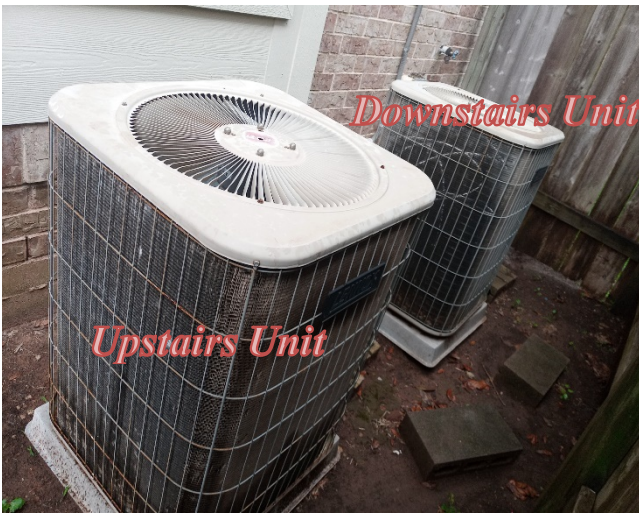
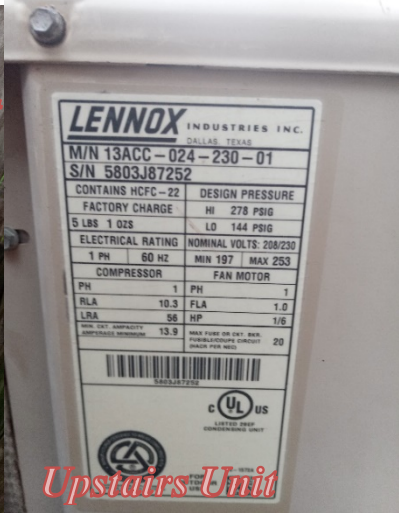
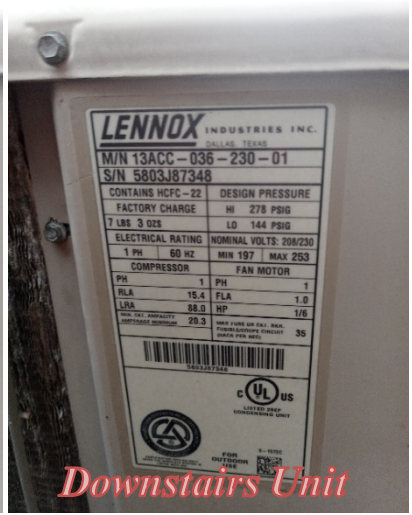
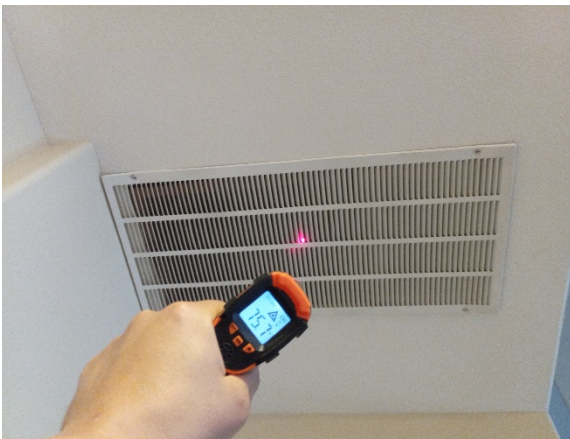
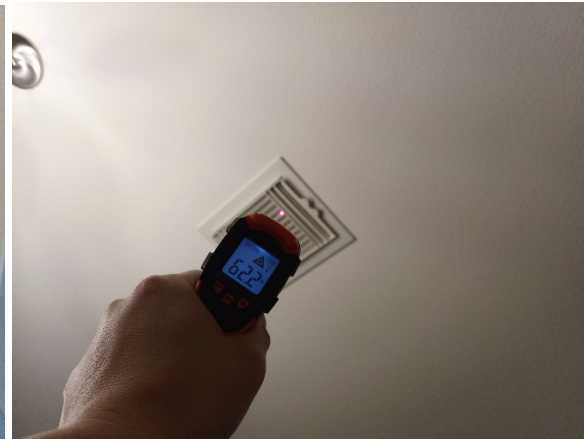
- a. System has two thermostats, one at each floor; The temperature drops measured in downstairs were not within considered typical (14-21 degrees °F) which is supposed to be measured between the return air and supply air within close proximity of the related coils of the system being evaluated; cooler ambient temperature, low freon, or dirty air filters may contribute to this problem; recommend to have an HVAC specialist to further evaluate the whole downstairs A/C system before the closing; The upstairs A/C is functioning properly at time of the inspection; the temperature drops were within considered typical (14-21 degrees °F);

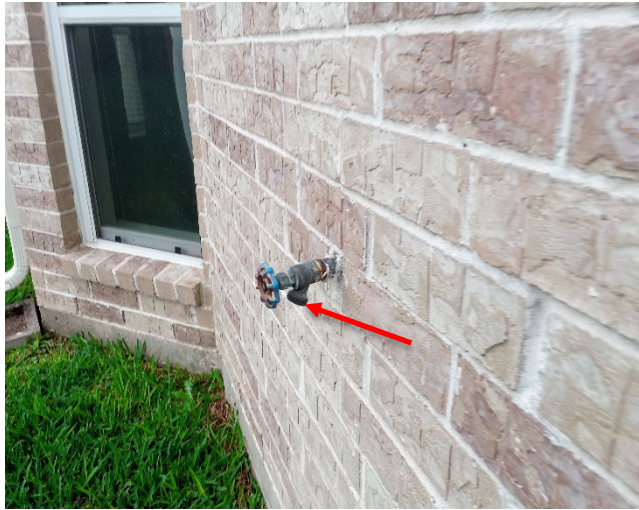
- a. *Recommend adding insulations on all exposed water pipes and adding vacuum breakers to exterior hose spigots/faucets;  
Photo is representative of the issue and may not include all locations;*

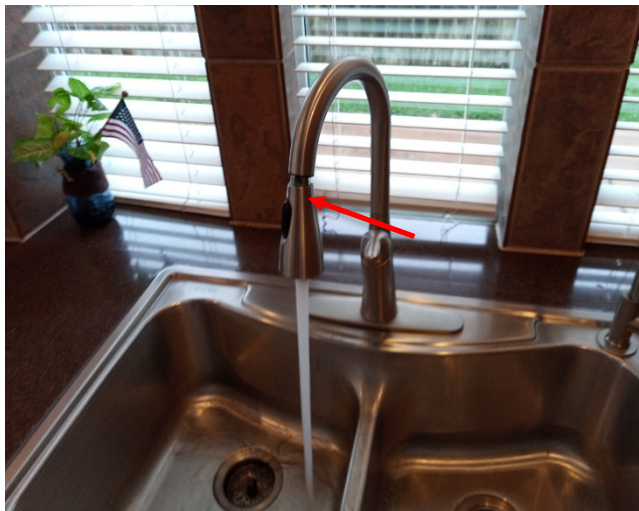
- b. *The kitchen pull-out faucet will not retract fully when tested; it is recommended that a qualified plumber be contacted to further evaluate and repair/replace as needed;*

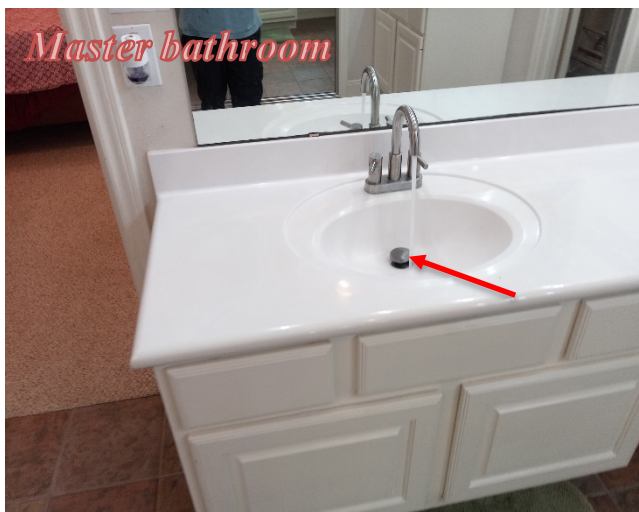
- c. *The inspector noted an inoperable drain stopper at above sink; recommend further evaluation by a licensed plumber and repair as needed;*

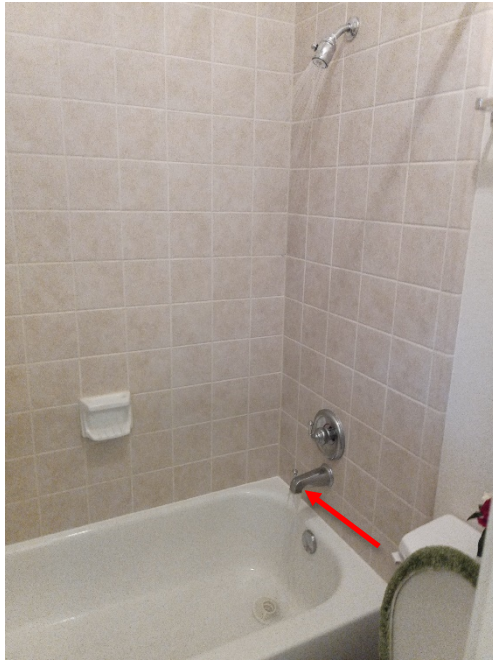
- d. Both upstairs shower tub diverters leak water when the shower is on; it is recommended that a qualified plumber be contacted to further evaluate and repair as needed;  
Photo is representative of the issue and may not include all locations;

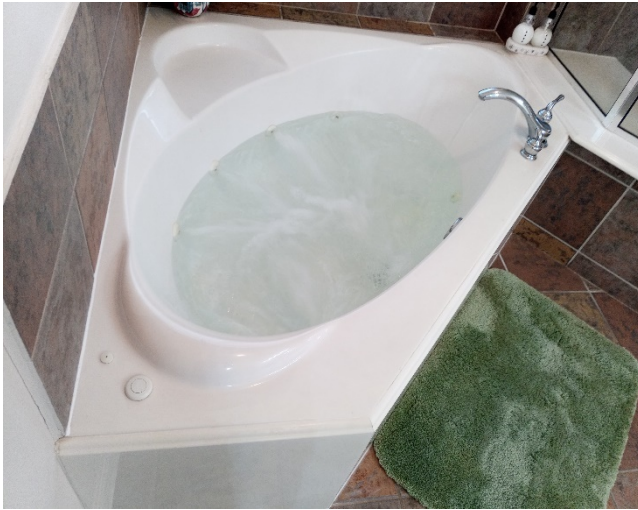
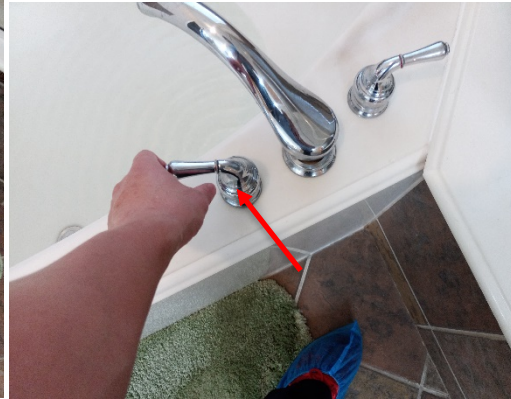
- a. This jacuzzi was tested and working properly at the time of inspection; However, the motor was not accessible for visual inspection. Inaccessibility does not fully comply with the National Electric Code (Reference NEC 680-72. Accessibility. "hydromassage bathtub electrical equipment shall be accessible for repair/replacement without damaging the building structure or building finish".) Should have access panel installed for servicing/access to pump motor IRC 4109.3;  
 The cold water faucet handle appears to be stripped possibly due to a failed rubber washer; it is recommended that a qualified plumber be contacted to further evaluate and repair as needed;

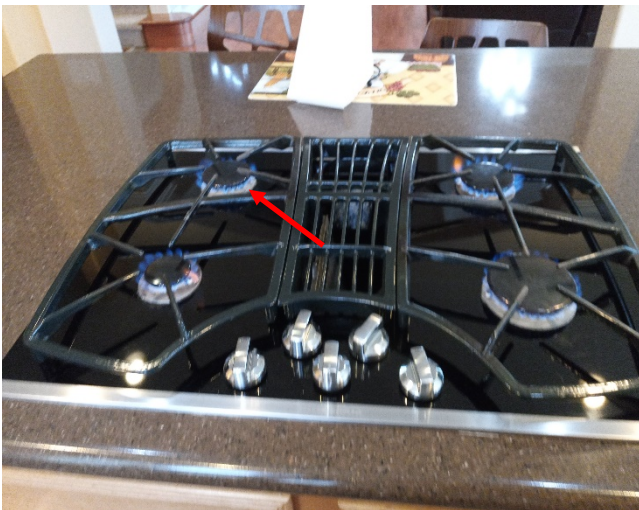
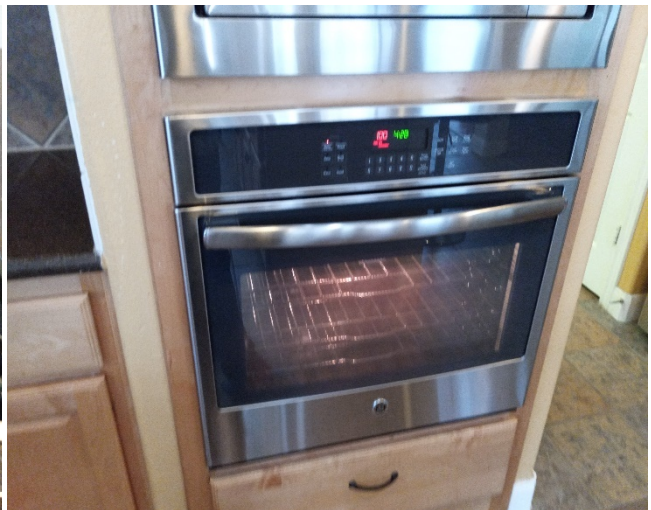
- a. *The upper left burner could not be lit possibly due to a faulty electric ignitor; recommend qualified professional to service/repair as needed;;*

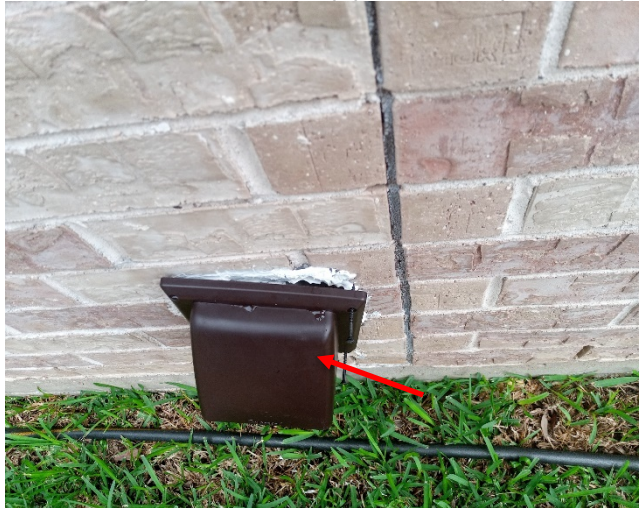
a. Loose dryer's louver vent cap (south wall) noted; recommend proper installation;

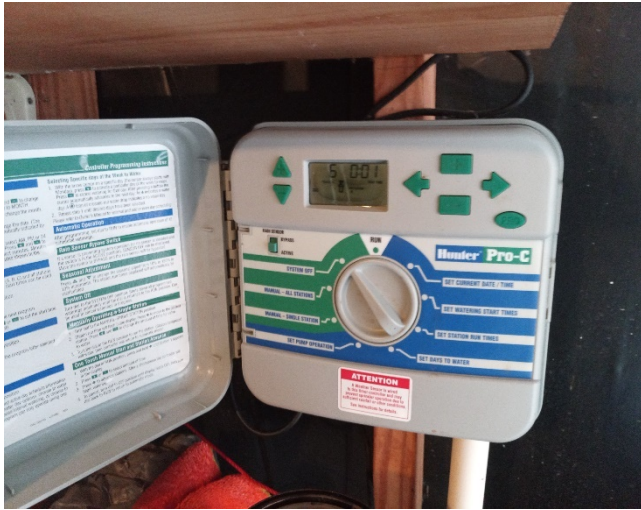
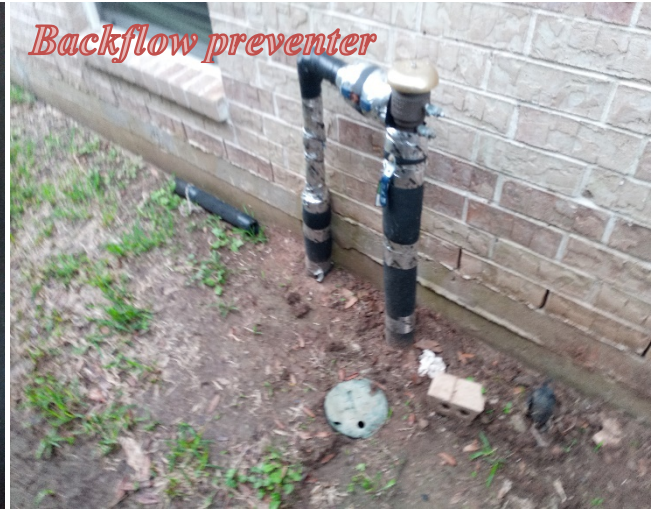
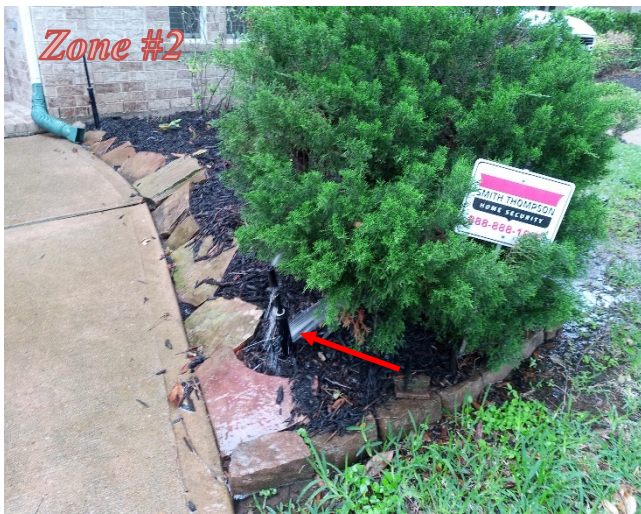
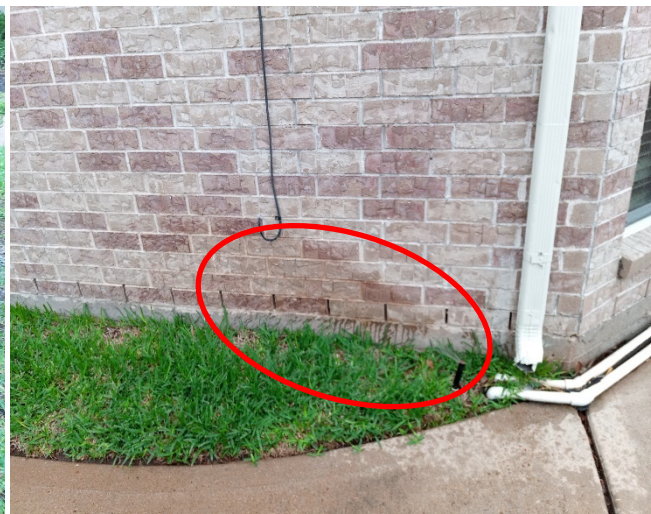
- a. One sprinkler head at zone #2 was leaking large amount of water when tested, it's also causing low pressure to other sprinklers in the same zone; recommend repair by a qualified professional; also recommend adjusting certain sprinkler heads to prevent water from being sprayed on brick walls; Excessive moisture can cause damaged to the structure and promote mold growth;

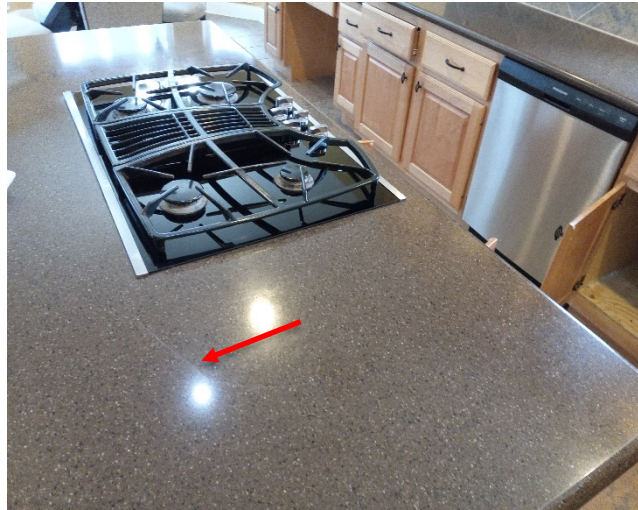
a. Noted a crack on kitchen granite countertop;

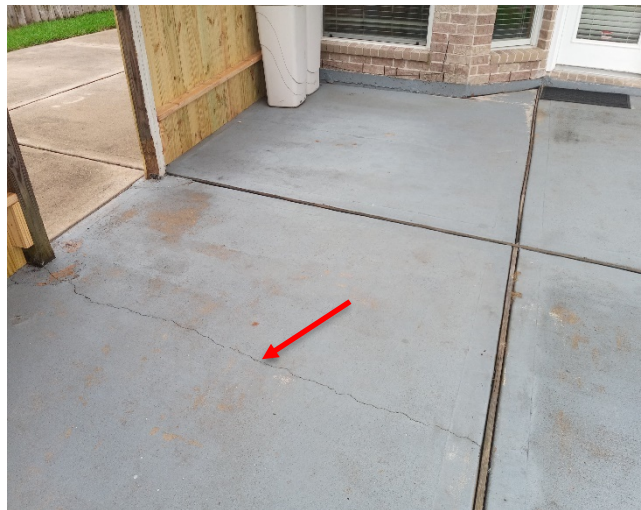
b. Observed concrete cracks at the back patio slab; this is common as concrete ages, and cracks observed are typical shrinkage/settlement cracks and not indicative of structural issue; it is recommended that this type of crack be sealed and monitored periodically to see if they increase in size, if it does, consult with a licensed structural engineer;  
Photo is representative of the issue and may not include all locations;

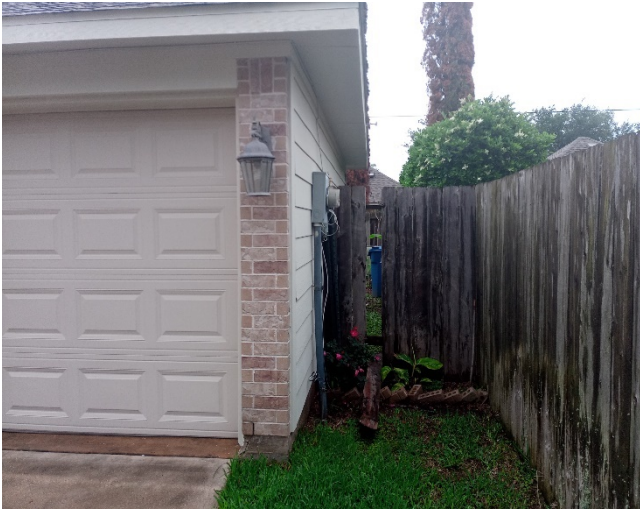
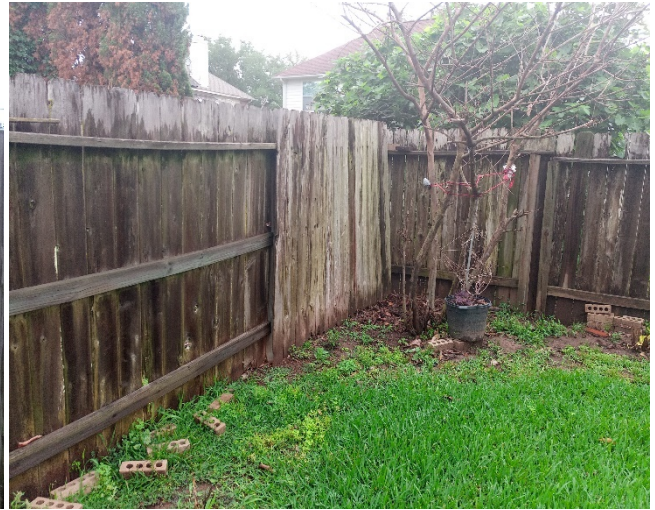
*c. Backyard fence show signs of deterioration and have loose/leaning panels at various locations; recommend repair/replacement;*
