## **Property Inspection Report**

**27815 Dewy Meadow Run Ct., Spring, TX, 77386**

INSPECTION PREPARED FOR: James Andrew Marr  
AGENT: Woody Marr - Team Marr Coldwell Banker  
Date of Inspection: 7/17/2020

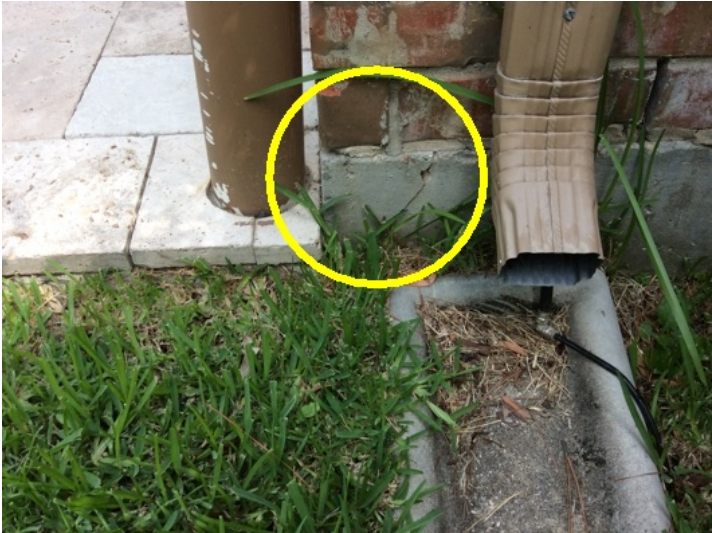
- All components were found to be performing and in satisfactory condition at the time of the inspection
- **Perimeter foundation corner spalling, or "corner pops" are typically caused by uneven curing and even carelessness during the construction phase. Usually these corners have no negative effect on the integrity of the foundation, and only has an aesthetic effect.**

*Corner pop*

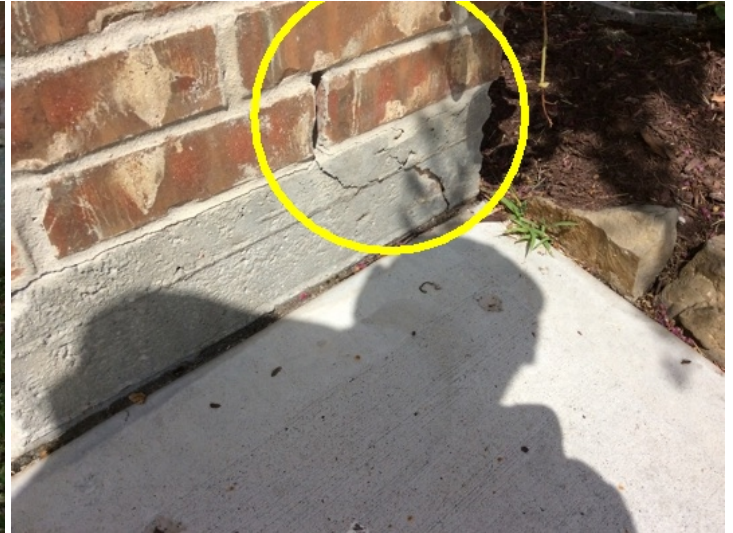
*Corner pop*

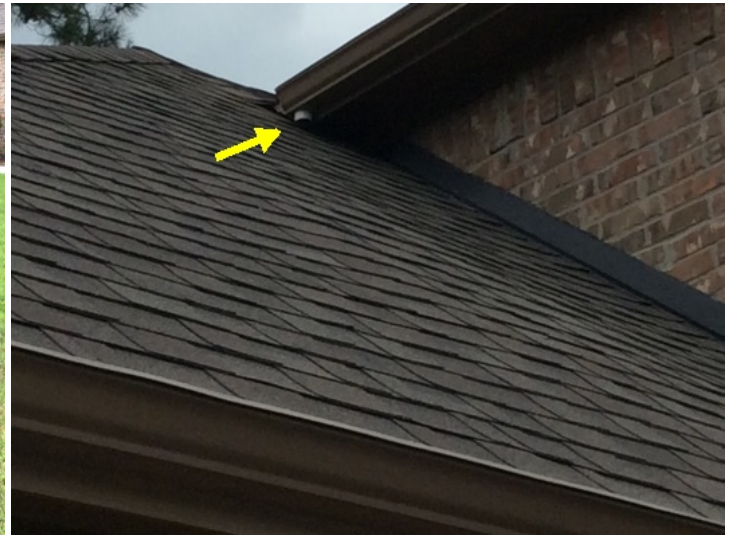
- The building site was relatively level and flat.
- There is at least one location where a gutter drains directly downward onto shingles below. This condition may cause premature failure of the roof shingles by washing the granular particulate material away from the shingle. This condition could potentially jeopardize the manufacturer's warranty. During this inspection, the shingle manufacturer could not be determined. Recommend referral to a roofing contractor for a determination if the manufacturer's warranty has been jeopardized.
- Vegetation too close to structure

Gutter downspout

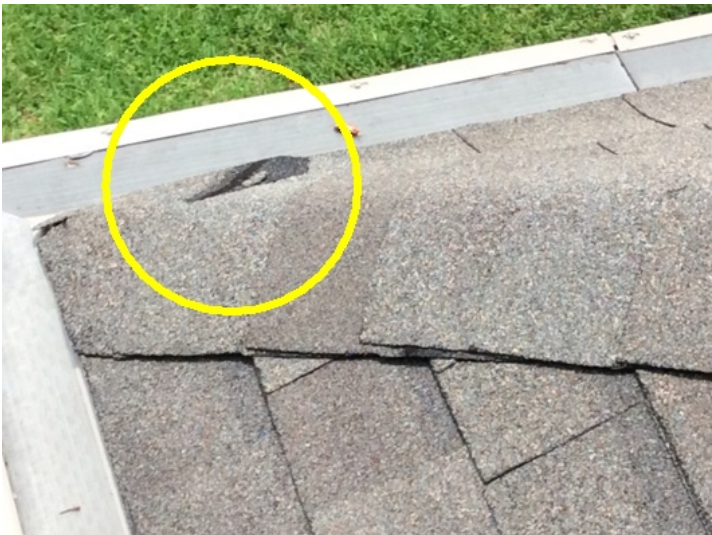
- Ridge vents were noted at the time of the inspection
- **Evidence of spots, markings and/or indentations were visible on the roof surface. It is recommended that a qualified roofing contractor be consulted for further evaluation**

*Damage to the roof*

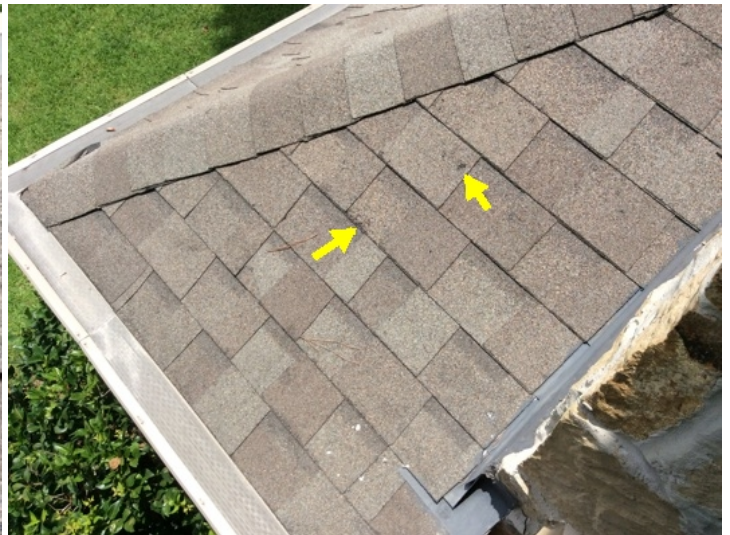
*Apparent roof damage*

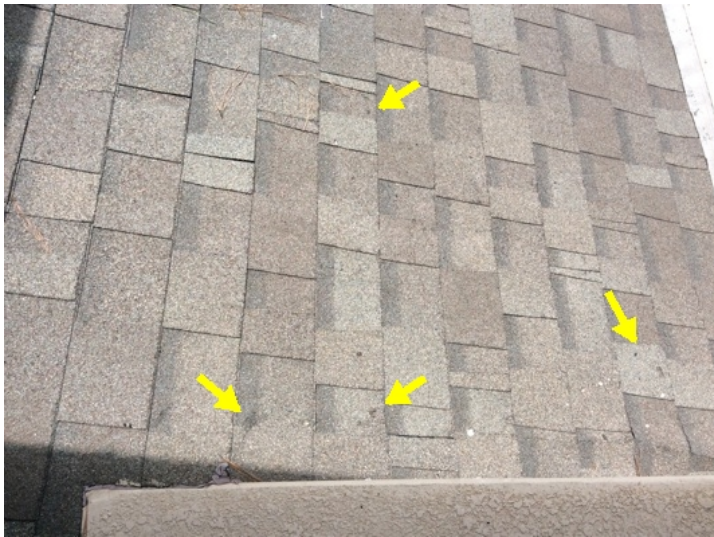
*Apparent roof damage*

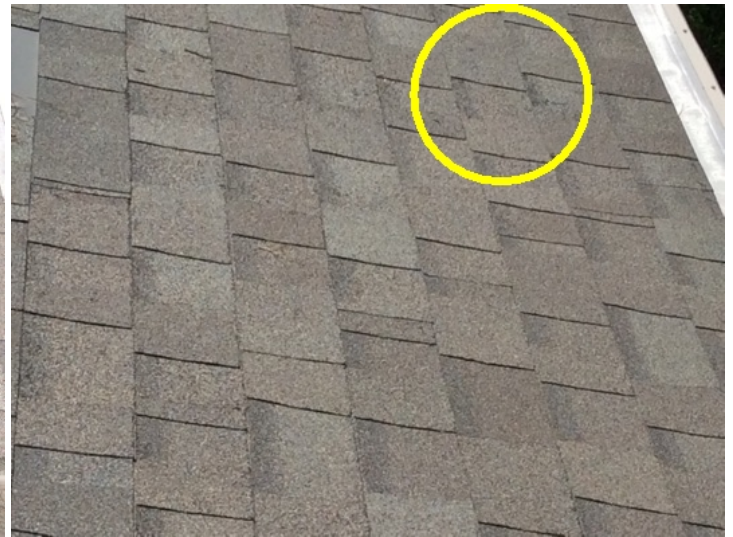
*Apparent roof damage*

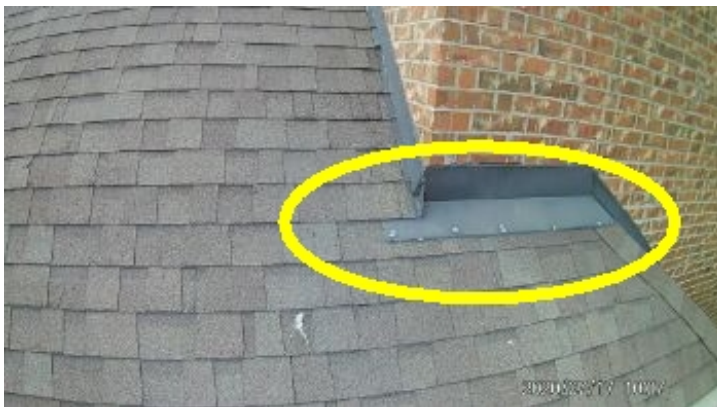
*Exposed fasteners*

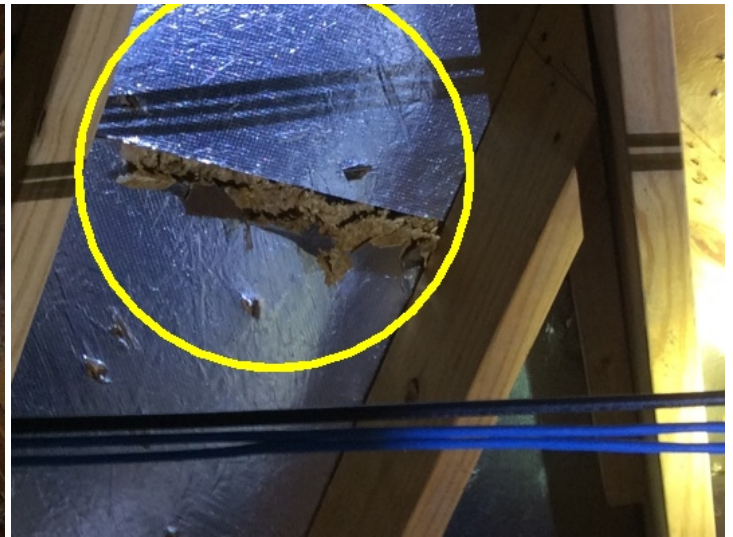
• Observed one area in the attic of the underside of the roof sheathing which appears to be compromised, most likely by moisture intrusion. Recommend consulting a roofing consultant to evaluate the cause for this damage and make necessary repairs.

*One area of OSB roof sheathing appears to be compromised as viewed from the attic*

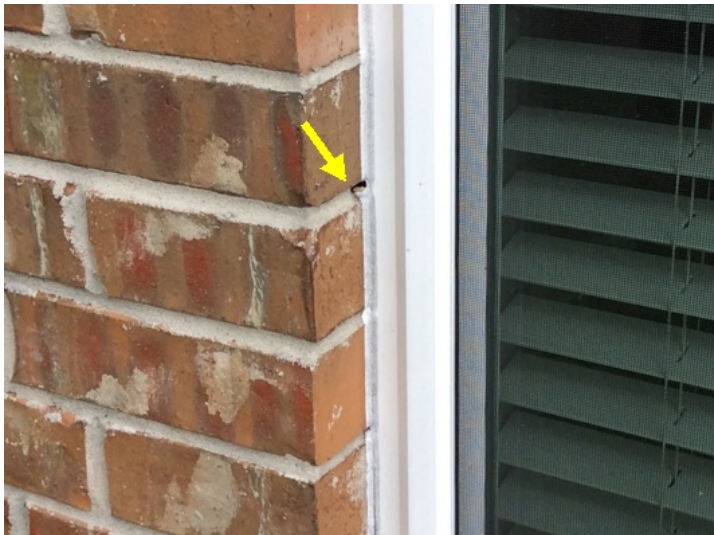
*West wall observed wasps coming and going through this tiny hole near the window*

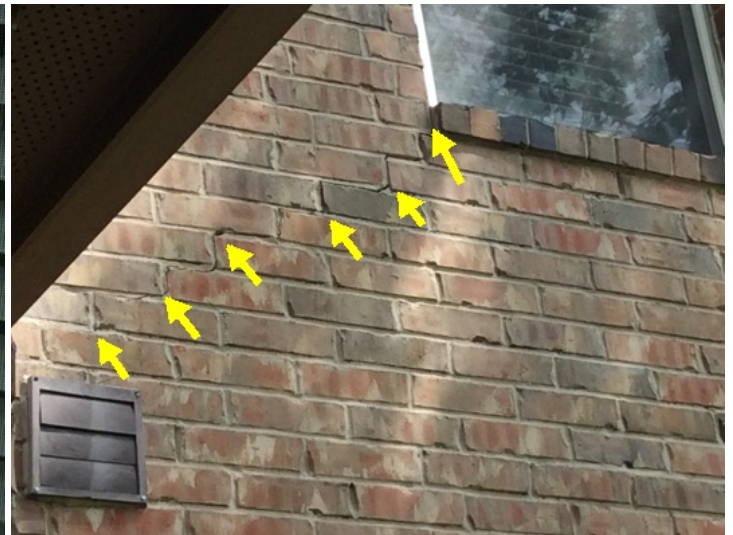
*Mortar crack east wall*

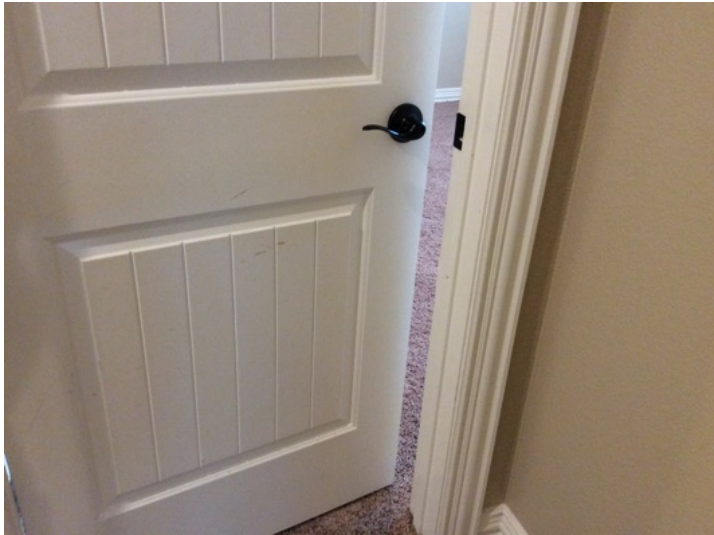
*Bedroom door doesn't latch*

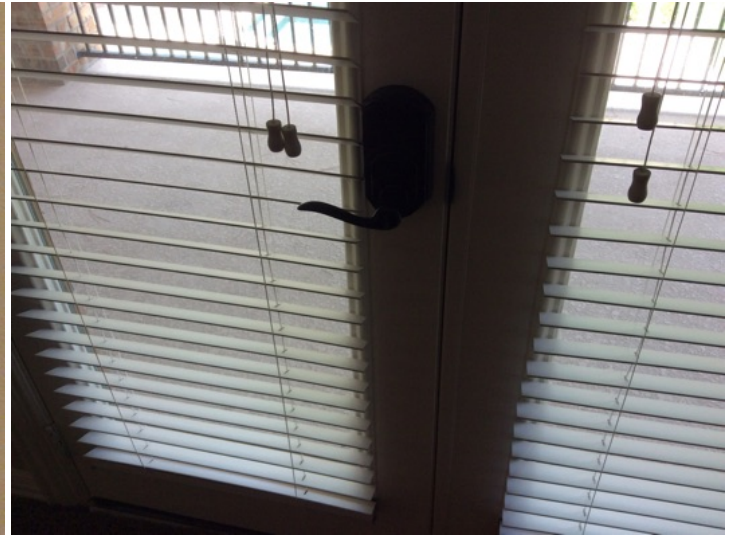
*Back balcony door does not lock*

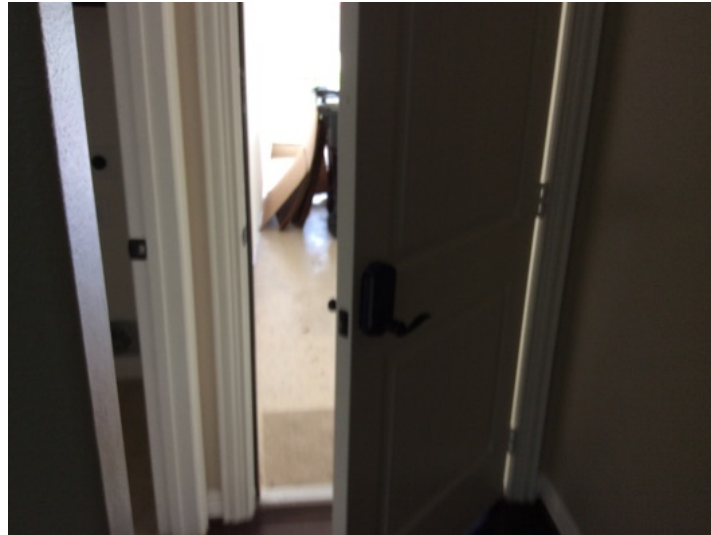
*Observed the entry door from the garage is not self closing*

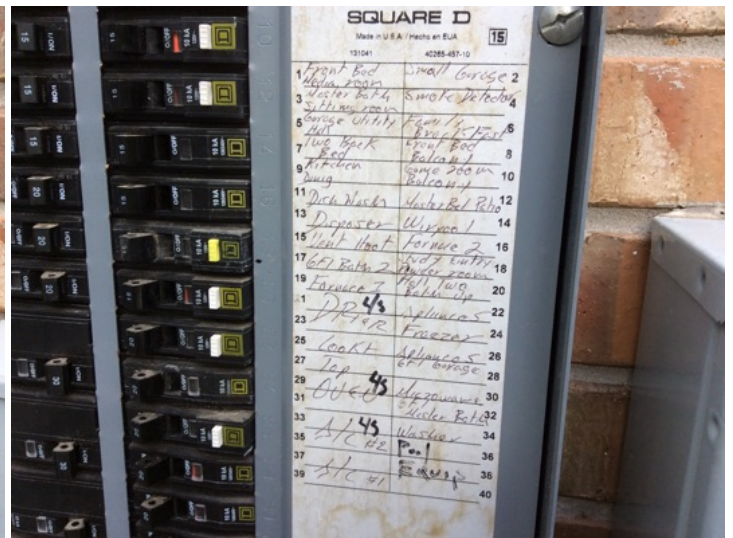
Noted the improper labeling in the electric service panel

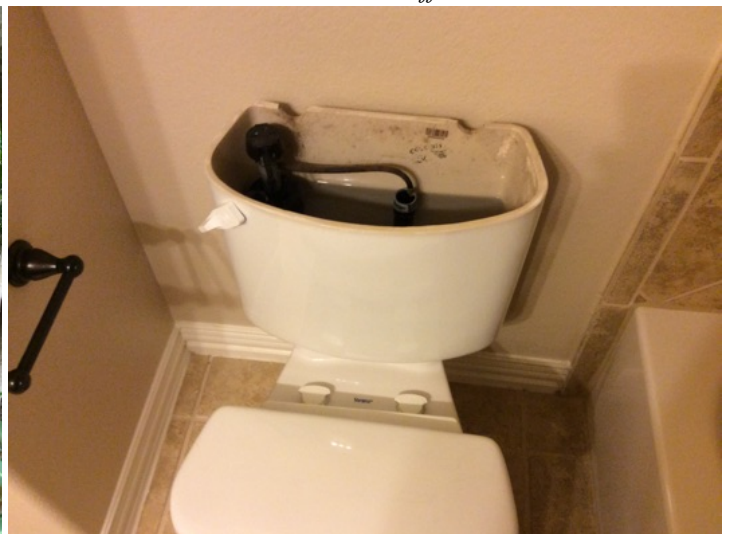
- All components were found to be performing and in satisfactory condition on the day of the inspection
- The static water pressure was observed at 60# psi
- The commodes were observed to be the water saving {1.6} GPF {gallons per flush} models
- An upstairs toilet has a broken flush rod, and requires repair. This inspector left the water to this toilet turned off rather than waste water.
- The flush handle was either damaged and/or improperly installed

*Upstairs hall bath toilet broken flush handle*

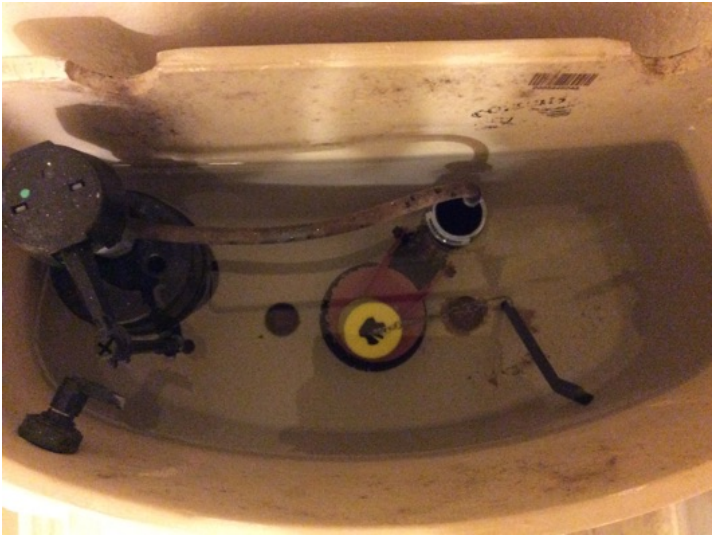
*Broken toilet flush handle requires repair*

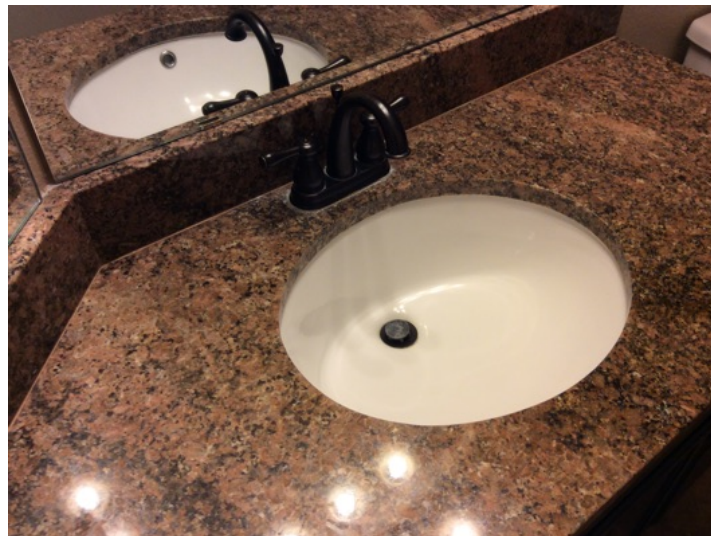
- The exterior main cleanout could not be located.
- Vent pipes are noted as **PVC**
- **Upstairs bathroom sink basin stopper requires repair**

*Upstairs back hall bath sink basin stopper requires repair*

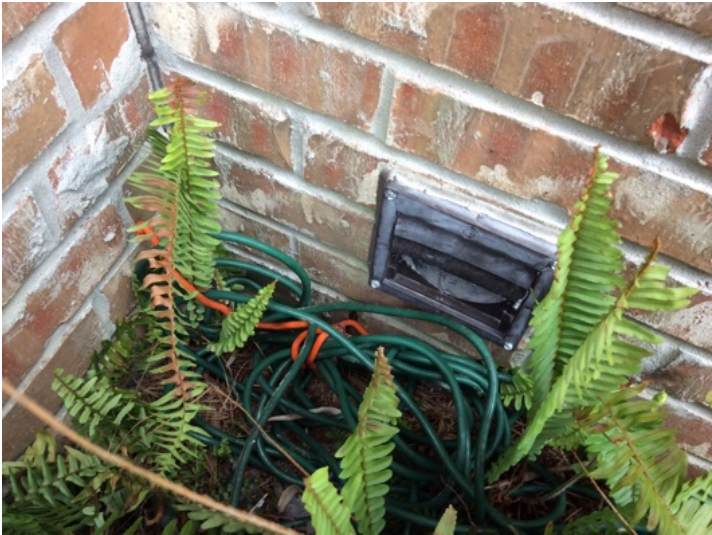
- This component appeared to be functioning as intended at the time of the inspection
- There is a properly installed GFCI receptacle available in the bathroom.
- It was observed that no access panel{s} were readily available to view the motor and/or equipment lines. This does not meet current building standards Code E4109.3 and its recommended for further evaluation
- There appears to be a exhaust vent from the underside of the jetted tub to the outdoors. The vent is damaged, and invites unwanted pests.

Broken exhaust vent from the equipment to the jetted tub

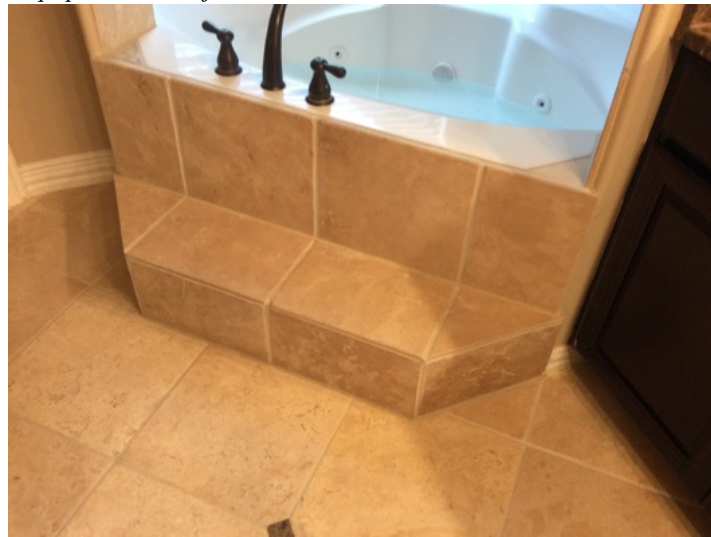
Observed there is no available access panel to service the jetted tub equipment

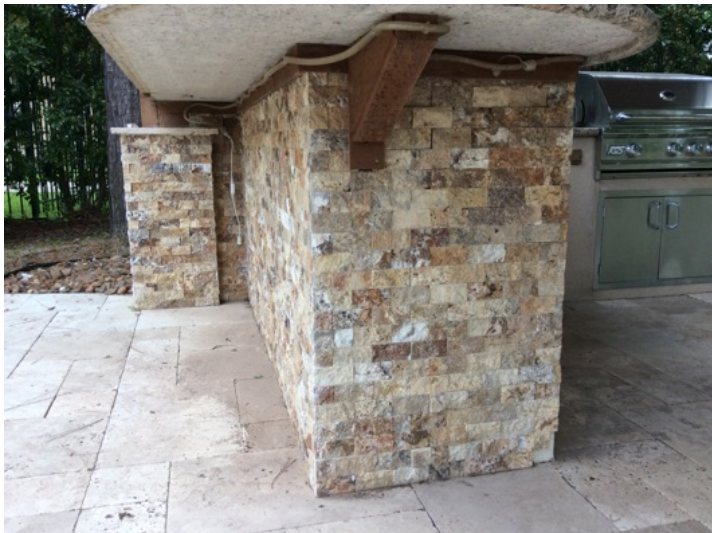
*Outside kitchen counter appears to have excessive unsupported granite counter top*

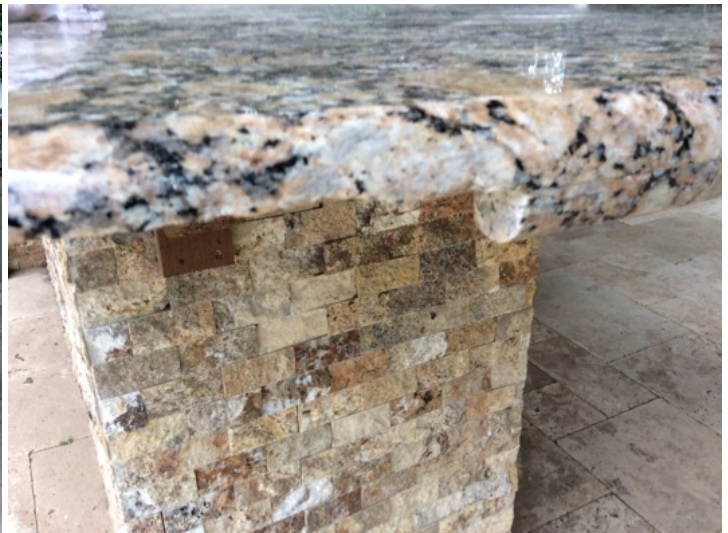
*Broken countertop edge*

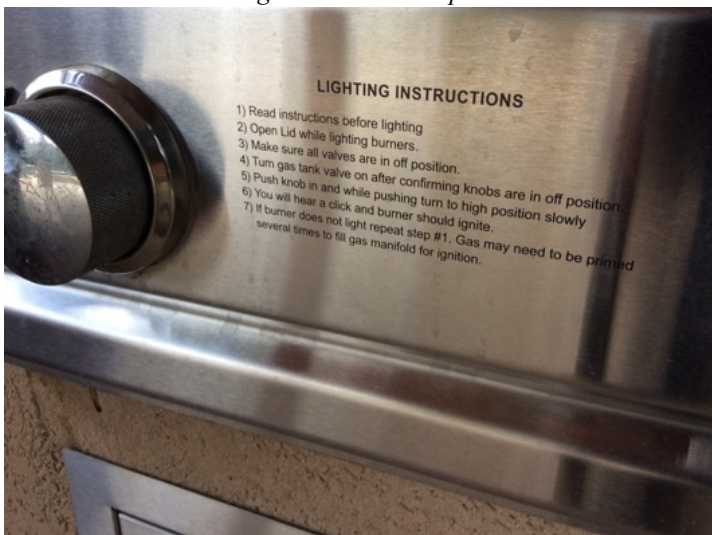
- Grill fuel source was natural gas
- **The automatic igniting burners did not appear to be functional. It is recommended a professional technician be consulted for evaluation and repairs.**

*Was unable to light the burners in the outside kitchen*

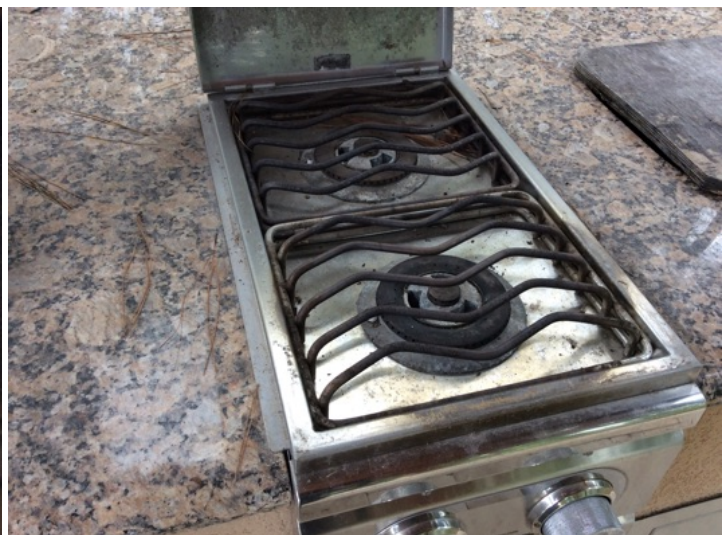
*Was unable to light the burners in the outside kitchen*
