REAL ESTATE INSPECTION REPORT

Prepared Exclusively For
Christopher Stamp & Kristyn Grimes

**28919 Copper Break Ct
Katy, TX 77494**

PROPERTY INSPECTION REPORT

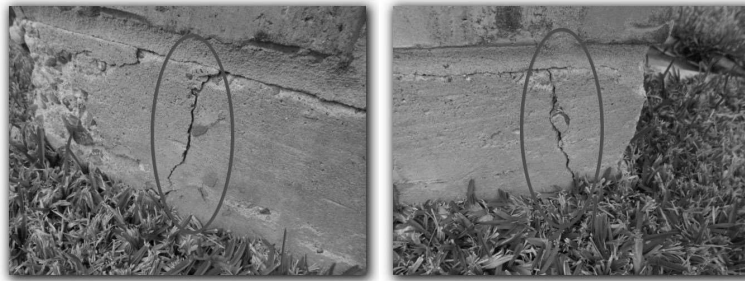
- Foundation corner fractures exist on both back corners which are generally the result of differential movement between the masonry walls(expanding) and concrete foundation (shrinking). Although this condition did not appear to adversely affect the structure, sealing these cracks may be desired as they could provide hidden access for wood destroying insects. A Pest Control licensee can be retained for more specific information. Please note that the corners should be examined periodically. If the fracturing worsens and the corner(s) break off then the brick veneer may lack proper support and repair would be needed.

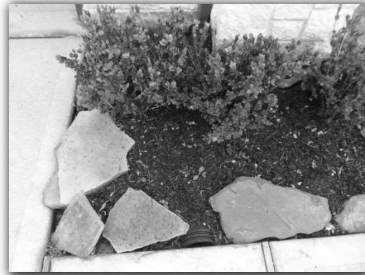
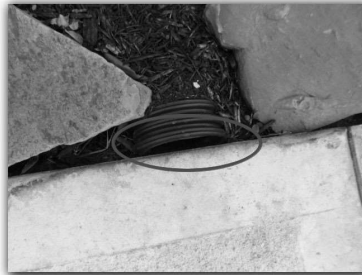
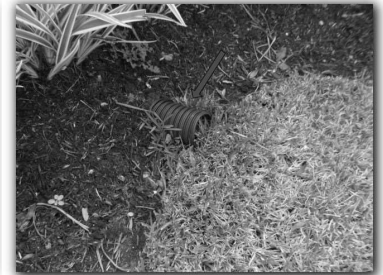
- The underground down spout extensions should allow free flow, not be blocked and be at a downward angle from the down spout.

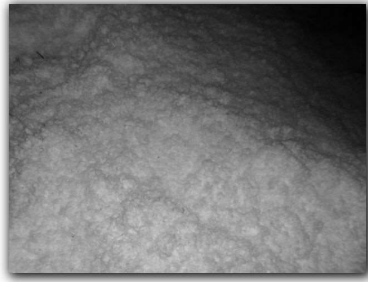
The attic of the residence was visibly inspected from inside the attic. The overall condition of the support structure and decking appear sound at time of inspection.

The insulation was observed at a depth of approximately 14".

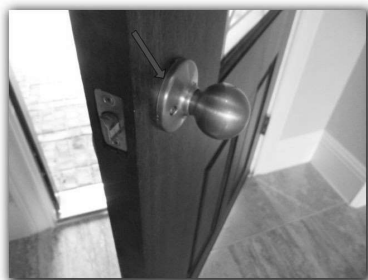
- The front door knob is loose to the door.

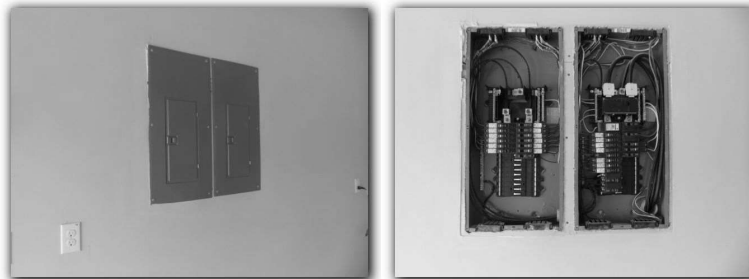
Main service wire is aluminum. Both the main service panel and secondary panel are located in the garage. The main panel has a 200 amp. main disconnect breaker. Wiring appears to be in good condition with no indications of overheating or arcing.

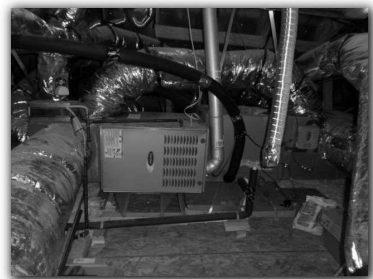
The gas fired heating system located in the garage was operated using the standard controls in the residence. The unit was visibly checked and there were no signs of damage or indication of any component failure.

Return air is 73 degrees. Supply air is 110 degrees. Temperature differential is 37 degrees. Normal differentials should be between 35 and 55 degrees. Unit seems to be heating properly.

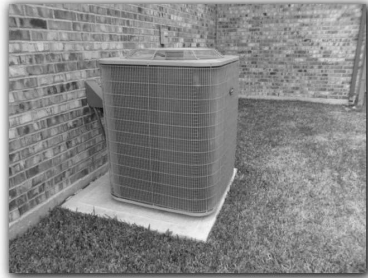
The split air conditioning system was operated using the standard controls in the residence. The unit was visibly checked and there were no signs of damage or indication of any component failure. The outside unit is a 5 ton Carrier manufactured in 2019.

Return air is 74 degrees. Supply air is 55 degrees. Temperature differential is 19 degrees. Normal differentials should be between 15 and 22 degrees. Unit seems to be cooling properly.

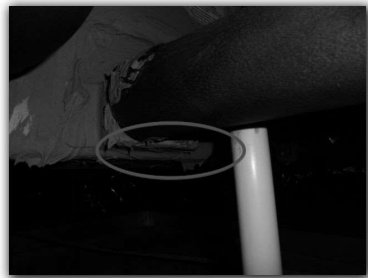
- Conditioned air was observed being forced into the attic from an opening under the condensate drain where attaches to the unit.

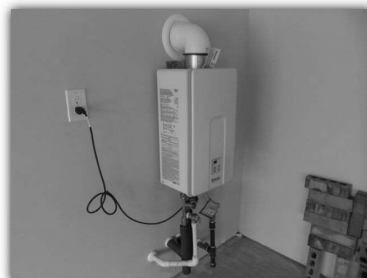
The tankless gas fired Rinnai water heating unit located in the garage was observed to be in good condition.

There was no evidence of leakage from the tank or visible piping. The safety relief valve drain pipe was intact and terminated to the exterior. The exhaust pipe was intact and appeared satisfactory.

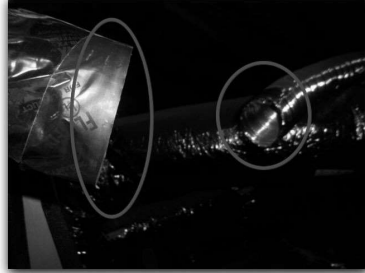
- One of the vent ducts in the attic has separated and is no longer venting to the exterior.

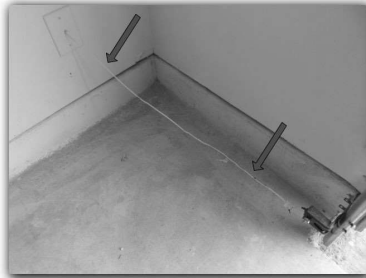
- The sensor wire appears to be stretched across the open floor space. This should be attached to the structure to prevent being pulled apart from the sensor.
