Inspection Report

Property Address:
12639 Pine Bush Dr
Houston TX 77070

Texas Real Estate Inspection Services, Inc

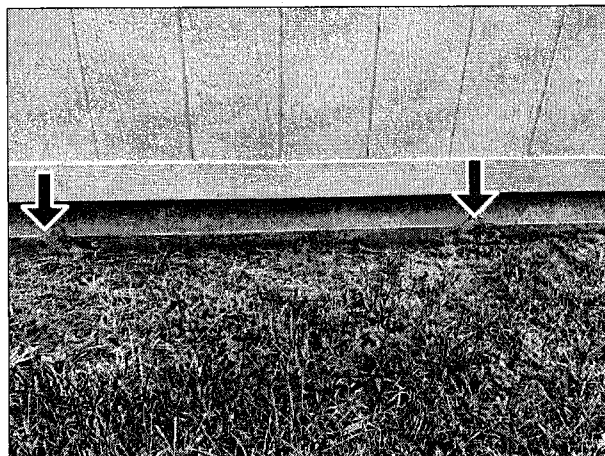
A. Item 3(Picture)

☒ (3) Corner shears and hairline cracking is occurring in the concrete slab at the front, rear and sides of home. Many homes have hairline or settlement cracks which have no effect on the function of the slab. This area should be properly prepped and sealed with a concrete patching material and it is recommended that you monitor periodically.

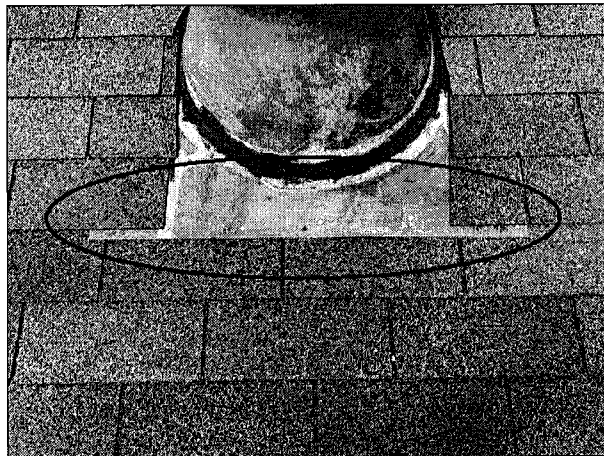
C. Item 1(Picture)

(1) The roof covering has exposed nail heads at the chimney and front ridge. This area will need periodical maintenance. A qualified person should repair or replace as needed.

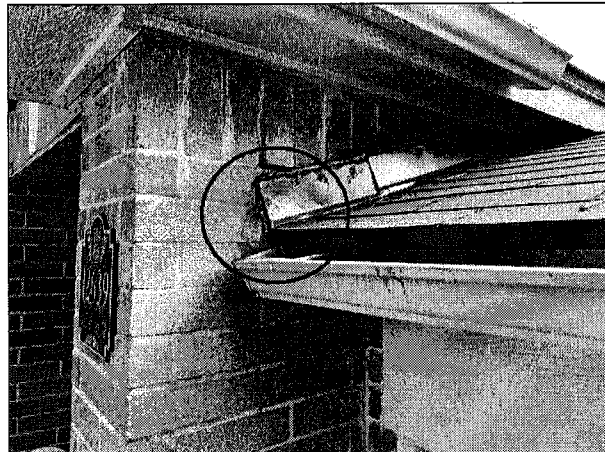
C. Item 3(Picture)

(2) Kickout flashings are missing at front of home. Kickout flashing is required where roof surface ends parallel with wall surface. This flashing prevents water leaks, damage, and discoloration of the walls. Recommend repair by a qualified contractor.

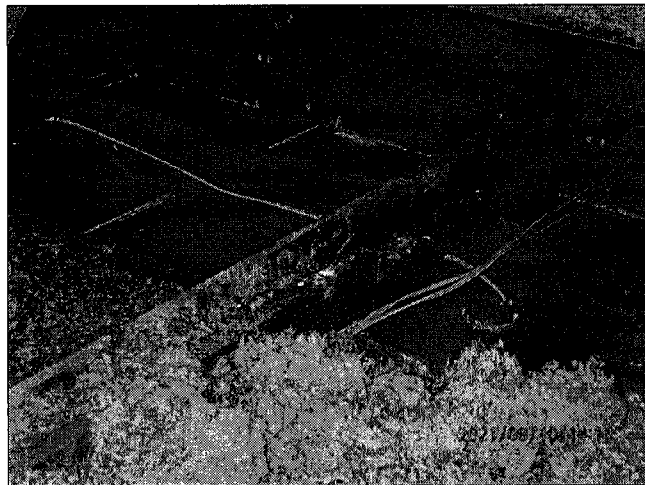
D. Item 1(Picture)

☐ (1) Insulation is missing in the attic, at the left side, front to back. This appears to have been removed to repair previous water damage. Failure to replace will affect the interior environment and reduce the energy efficiency of the structure. Repair as required with a minimum of an R38 level of insulation.

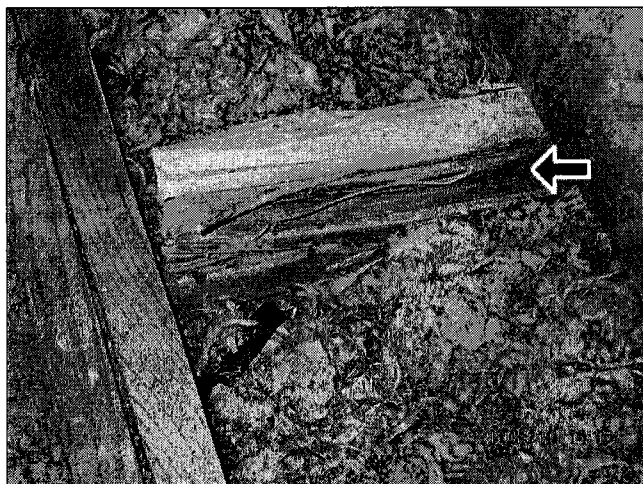
D. Item 4(Picture)

(2) Strongbacks are damaged in the middle portion of the attic. This area is located directly behind the furnace vent plenum. A qualified contractor should repair as needed.

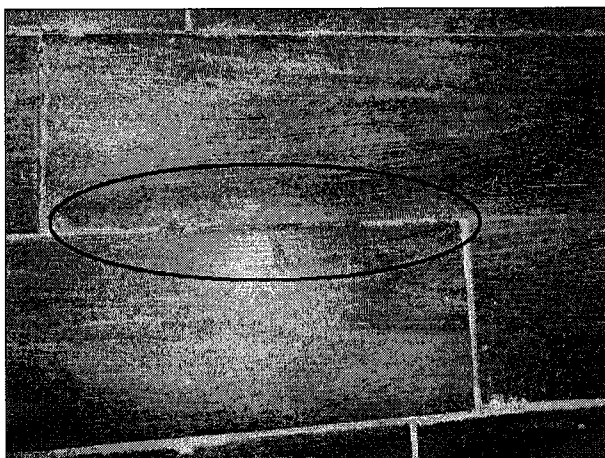
F. Item 1(Picture)

(1) Tile flooring has been installed poorly, most notably in front bedrooms, and there are repairs attempts throughout interior for cracks in tile, likely due to foundation settlement. Recommend repair of cosmetic issues as desired, and continue to monitor for further movement.

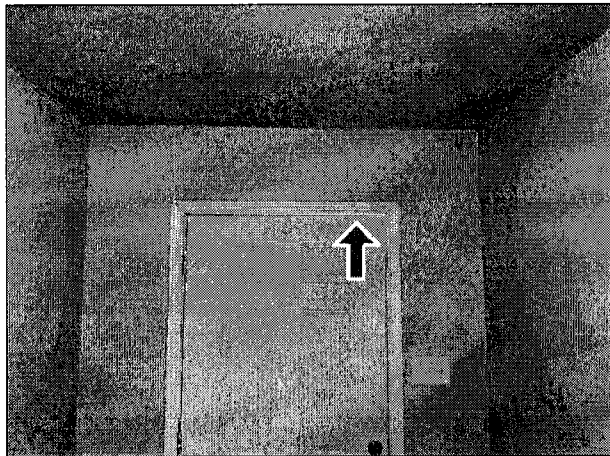
G. Item 1(Picture)

(1) All exterior doors reveal daylight when latched and do not fit opening properly (out of square). This can cause some heat loss in winter and loss of cool air in summer if not corrected. A qualified contractor should repair as needed.

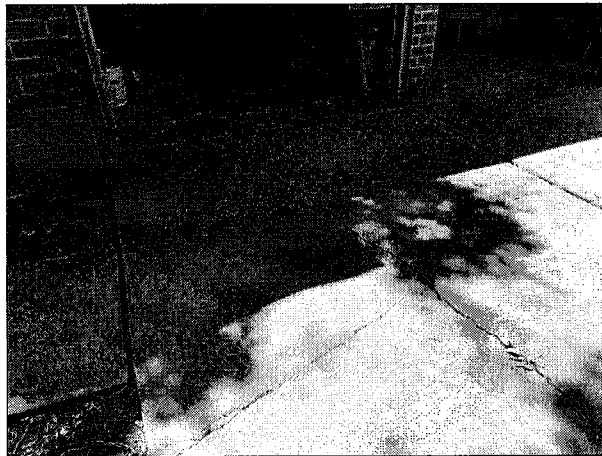
L. Item 1(Picture)

The concrete drive at the front of home has settlement cracks. This is for your information. I recommend repair as desired.

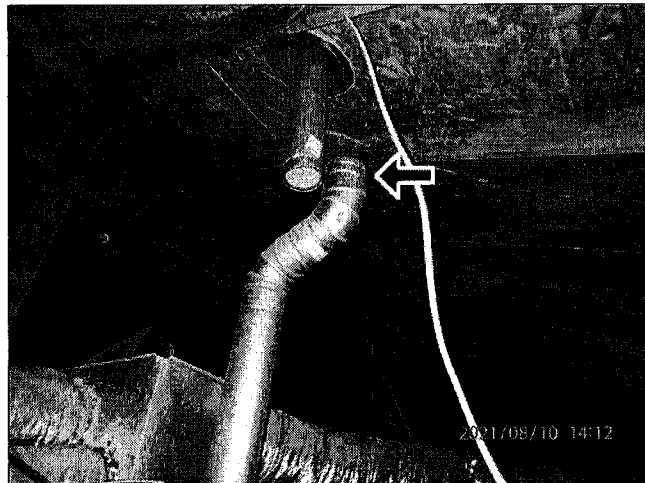
A. Item 1(Picture)

- (1) Exhaust vent pipe for furnace is separated in attic. Recommend repair by a qualified contractor.

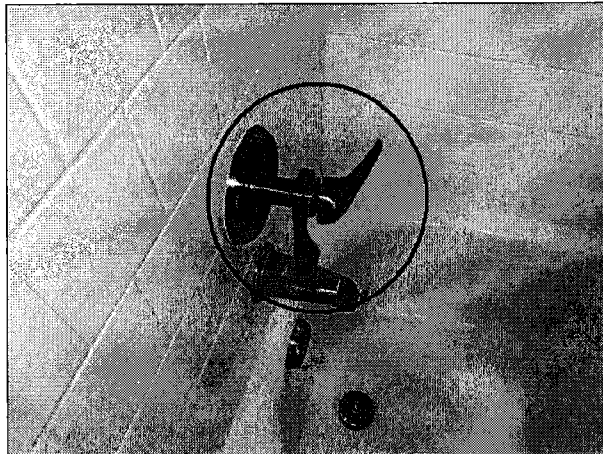
A. Item 1(Picture)

Control valve for both tubs is loose and not properly configured. Recommend repair by a qualified plumber.

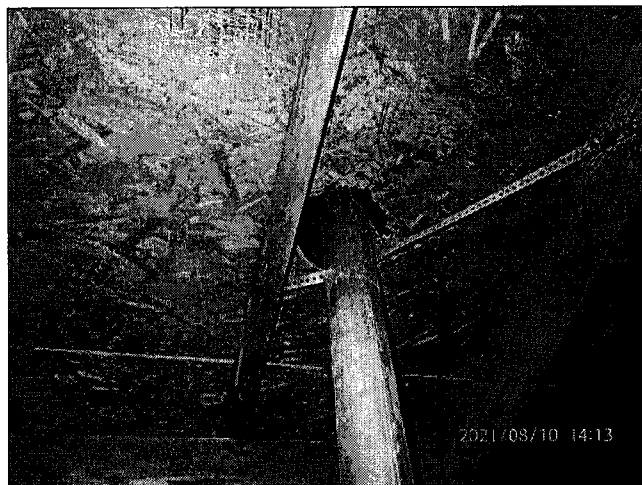
B. Item 2(Picture)

- (2) Drain stopper is not functional in both bathroom bath sinks. Recommend repair as desired. This is a small repair.
- (3) Water heater vent pipe is in contact with roof shingles. This is a combustible substance and all fuel gas exhaust vents should maintain a 1" minimum clearance. Recommend a qualified contractor repair as needed.

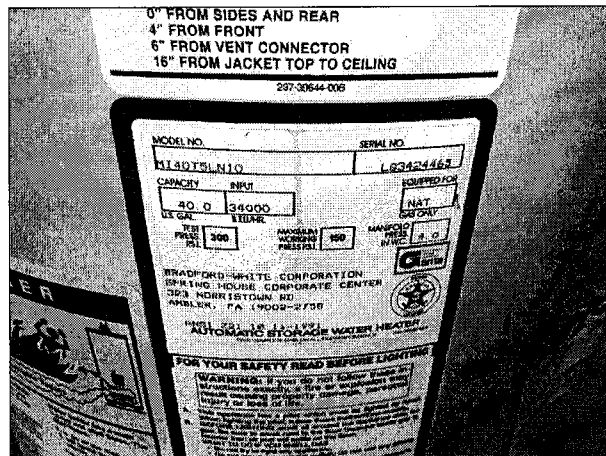
C. Item 2(Picture)

(2) TPR (temperature pressure relief) valve is seized at the water heater. TPR valves are the safety device in the event of a failure with excess temperature or pressure in the tank. Recommend replacement by a qualified plumber.

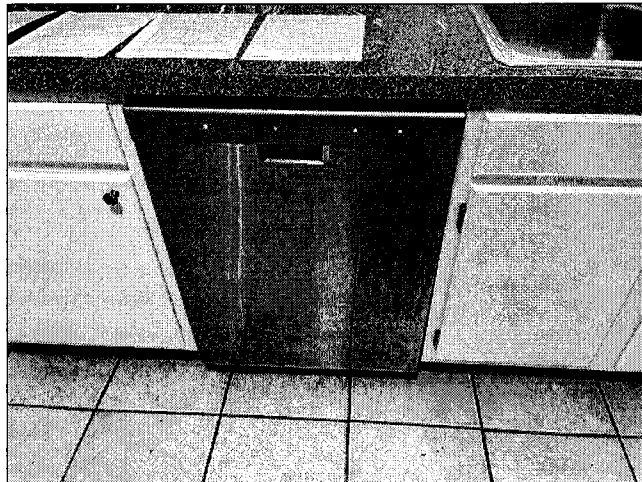
A. Item 1(Picture)

The dishwasher did not complete normal cycle. I recommend repair as necessary.

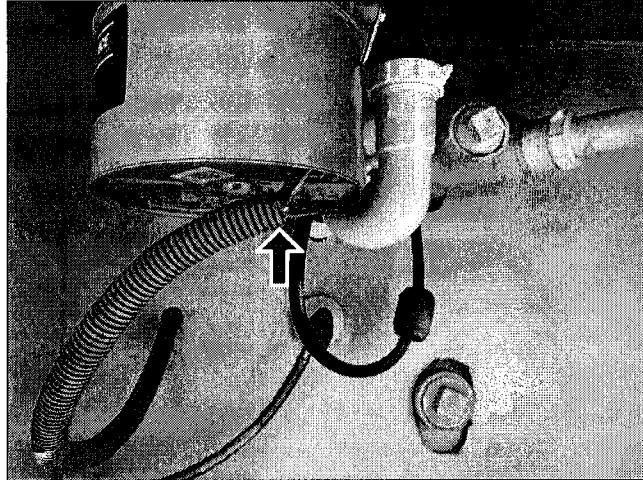
B. Item 1(Picture)

(1) The food disposer wiring is missing a romex connector (anti-strain device). I recommend repair as needed.
