# FOUNDATION

## Inspection Report

**INSPECTED PROPERTY ADDRESS:**  
25 Rockfern Ct  
Spring TX 77380

<b>Date:</b> 8/27/2021	<b>Time:</b> 01:30 PM	<b>Report ID:</b> 082720210130P
<b>Property:</b> 25 Rockfern Ct Spring TX 77380	<b>Customer:</b> Thomas Broussard	<b>Real Estate Professional:</b> Jeannine Ducommun Remax Woodlands

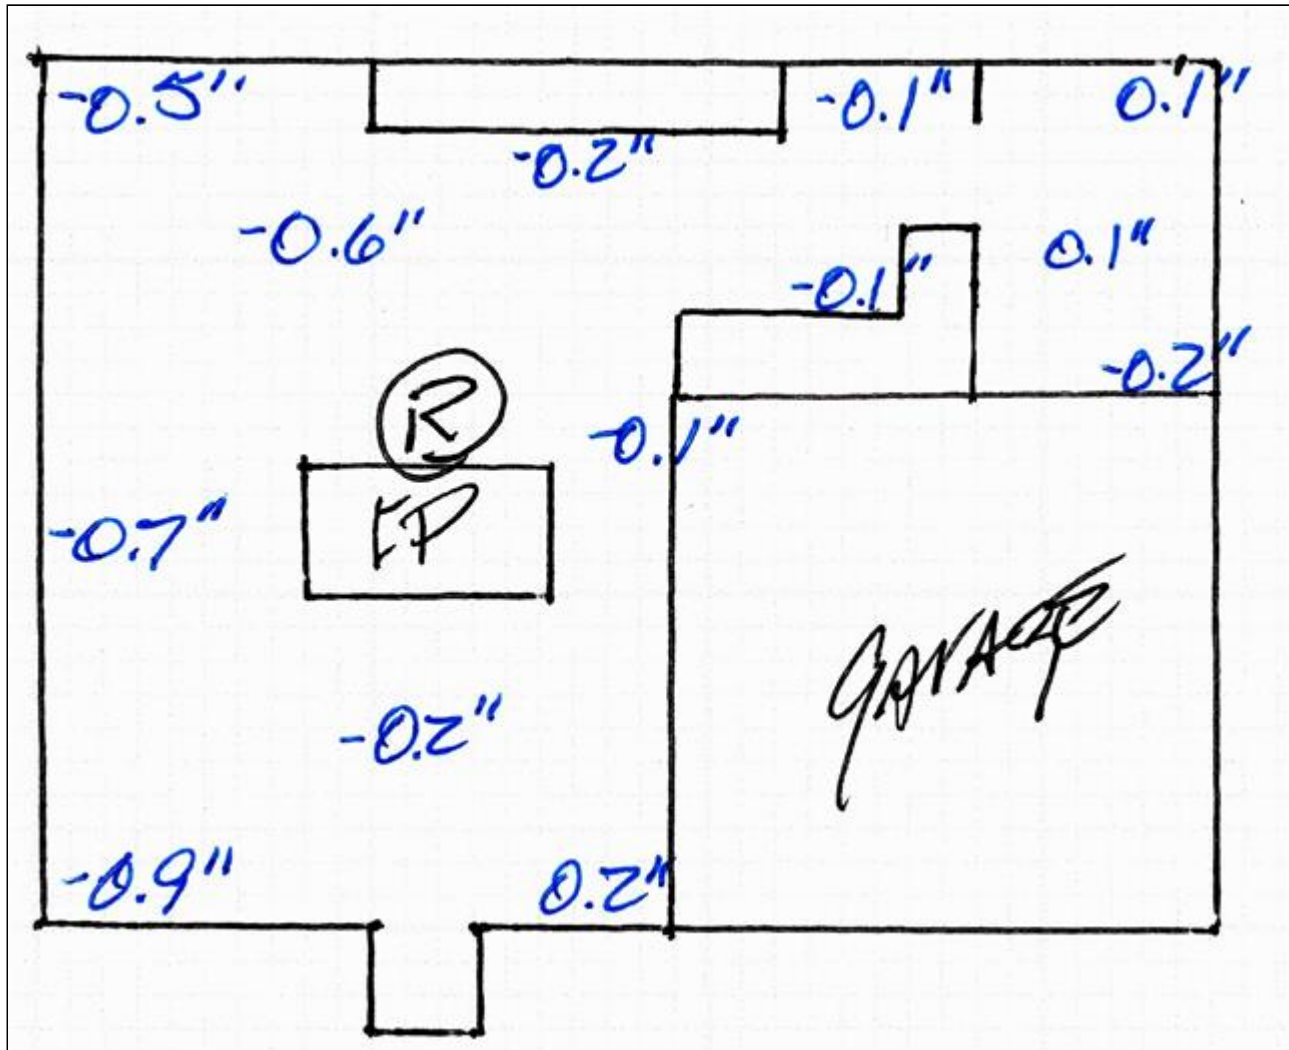
1.0 Item 1(Picture)

(1) The foundation in question was observed visually and with the use of a Zip Level Pro 2000 altimeter. The level readings were taken at various points. A central reference point is taken as a point of comparison. The reference point was taken behind the fireplace structure and is indicated on the diagram by an 'R'.

The overall level of the foundation is consistent. However, the left side does show some decrease in elevation with respect to the remaining portions of the slab on grade structure. This decrease in elevation ranges from 0.5" at the left rear corner to 0.9" at the left front corner. While there are decreases in elevation, these decreases are not extreme and do not indicate a need for mechanical leveling. Maintain even moisture levels around the entire structure, this will help to maintain an even settlement.

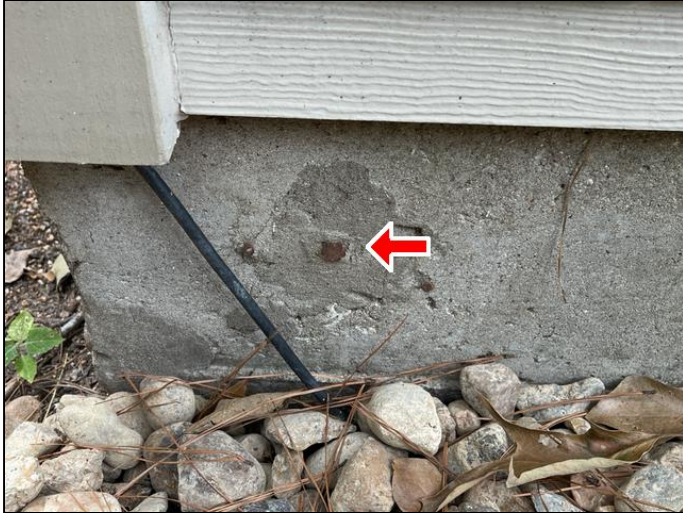
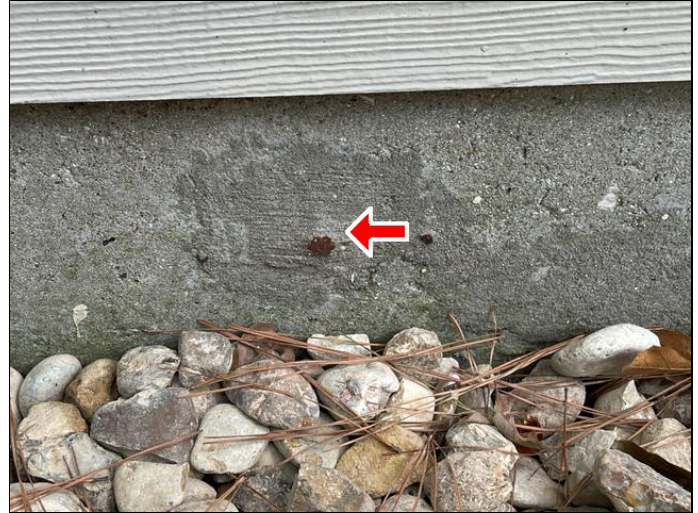
🔧 Cable ends are exposed at the left side and rear of the structure. Recommend patching these areas to prevent deterioration.

Cable ends are exposed at the left side and rear of the structure. Recommend patching these areas to prevent deterioration.

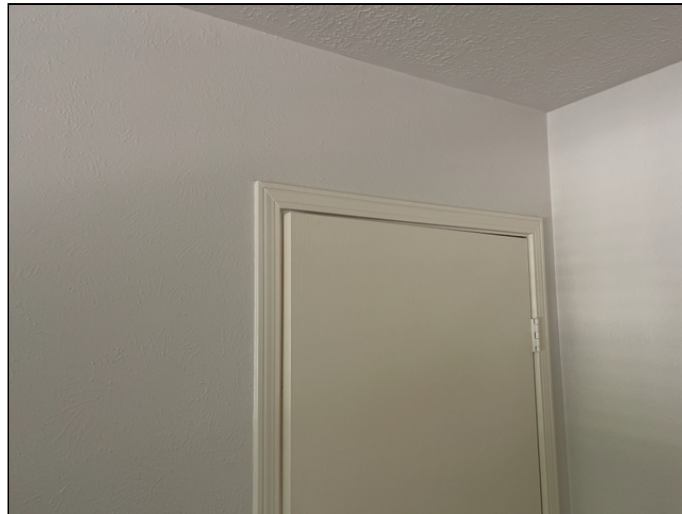
4.3 Item 1(Picture)

🔧 (1) The door to the upstairs left bedroom rubs at the jamb. Adjust as needed to close properly. This is a small repair.

(1) The door to the upstairs left bedroom rubs at the jamb. Adjust as needed to close properly. This is a small repair.
-

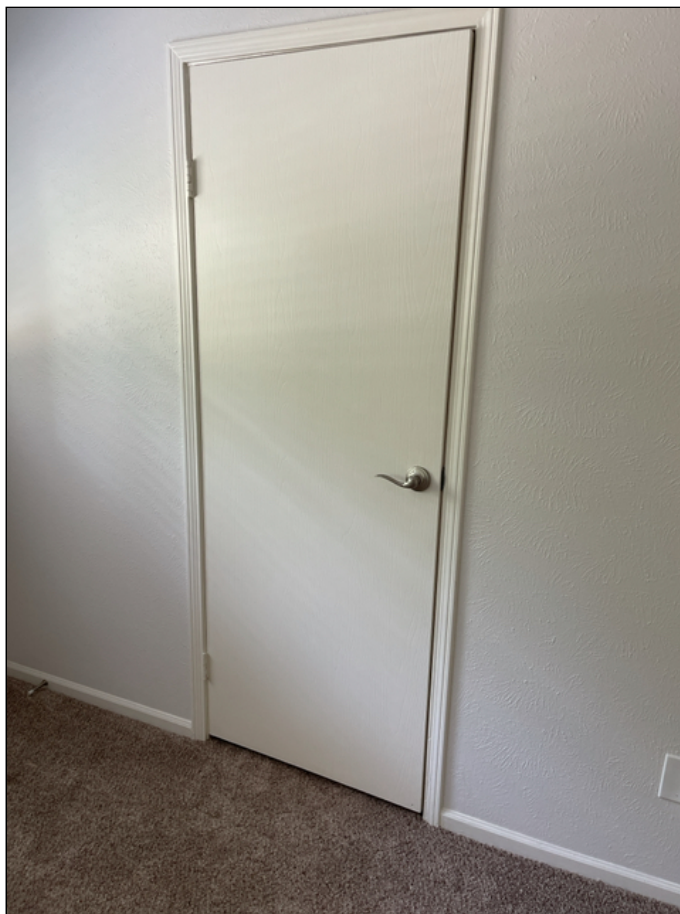
4.3 Item 2(Picture)

- 🔧 (2) The door at the upstairs left private bath will not latch properly. Adjust as needed to allow for proper closure. This is a small repair.

(2) The door at the upstairs left private bath will not latch properly. Adjust as needed to allow for proper closure. This is a small repair.
